SUBJECT: CLEAN AIR ACT INSPECTION REPORT
Waste Management Deer Track Park Landfill, Watertown, WI

Facility Name: Waste Management Deer Track Park Landfill, Watertown, WI

Date of Inspection: On Site Inspection: June 21, 2021
Virtual Conferences: June 22, 2021

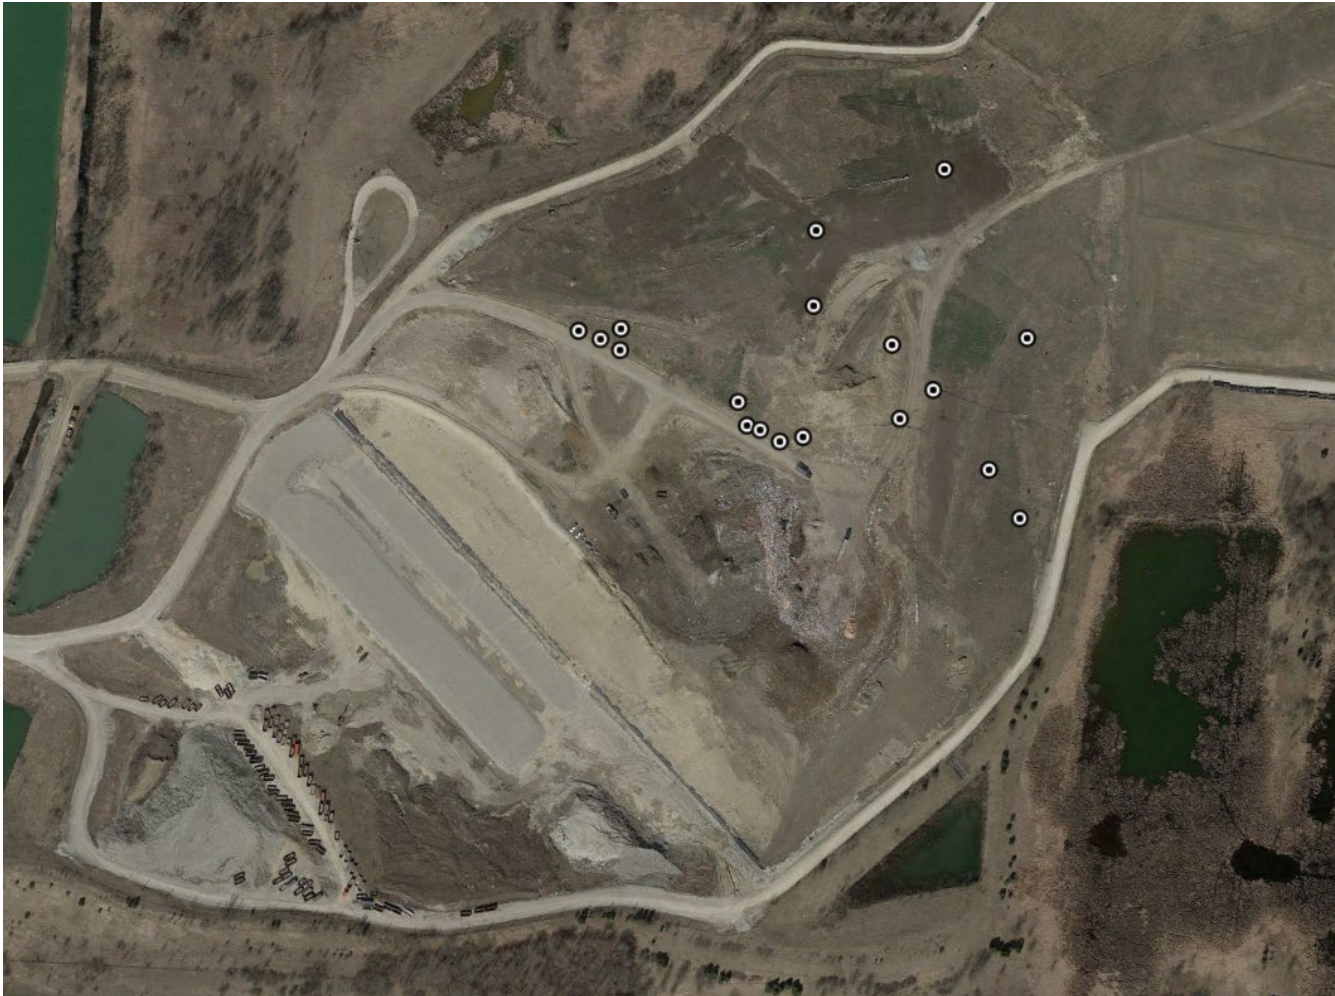
Map of Detected Hits

EPA conducted comparative surface emissions monitoring on the landfill. EPA found 18 points in exceedance of 500 ppm, particularly concentrated along the slope directly above the haul road. EPA observed distressed vegetation and strong odors of landfill gas. Exceedances were found both at wellheads and on the general surface of the landfill. EPA observed bentonite seals having dried out and pulled away from penetration points, resulting in leaking gas.

SEM hit locations plotted over satellite imagery from April 1, 2021 as depicted on Google Earth.
