## Region 6 Compliance Assurance and Enforcement Division

### INSPECTION REPORT

| Company Name: | <b>Graphic Packaging International, LLC</b> | | |
| Facility Name: | <b>West Monroe Paper Mill</b> | | |

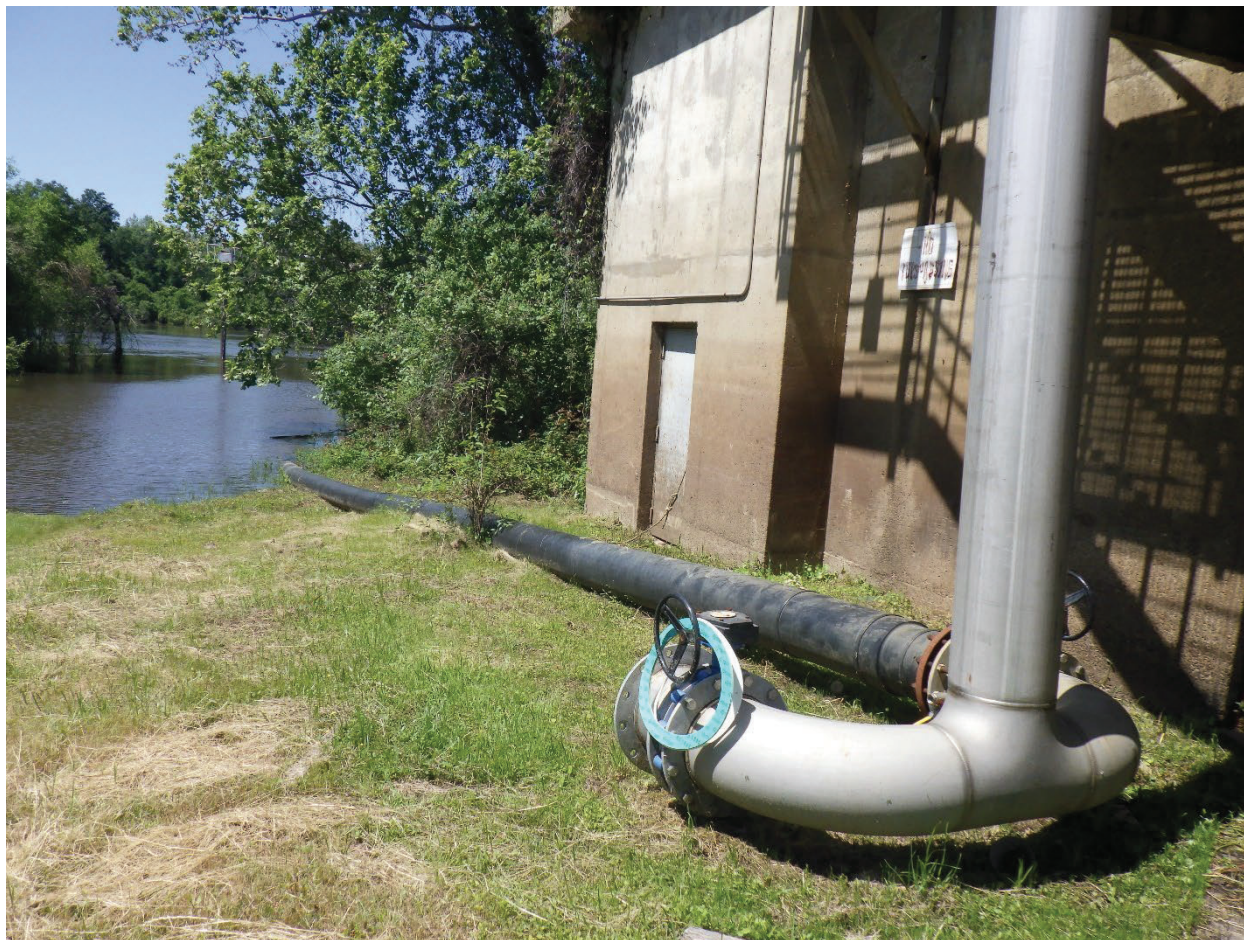
Photo No. 2

This image shows the Water Intake Structure that intake fresh water from Quachita River for the cooling and industrial processes at the facility. The facility actual intake inflow and withdraws from a freshwater river (Quachita River) is 8.7 MGD.

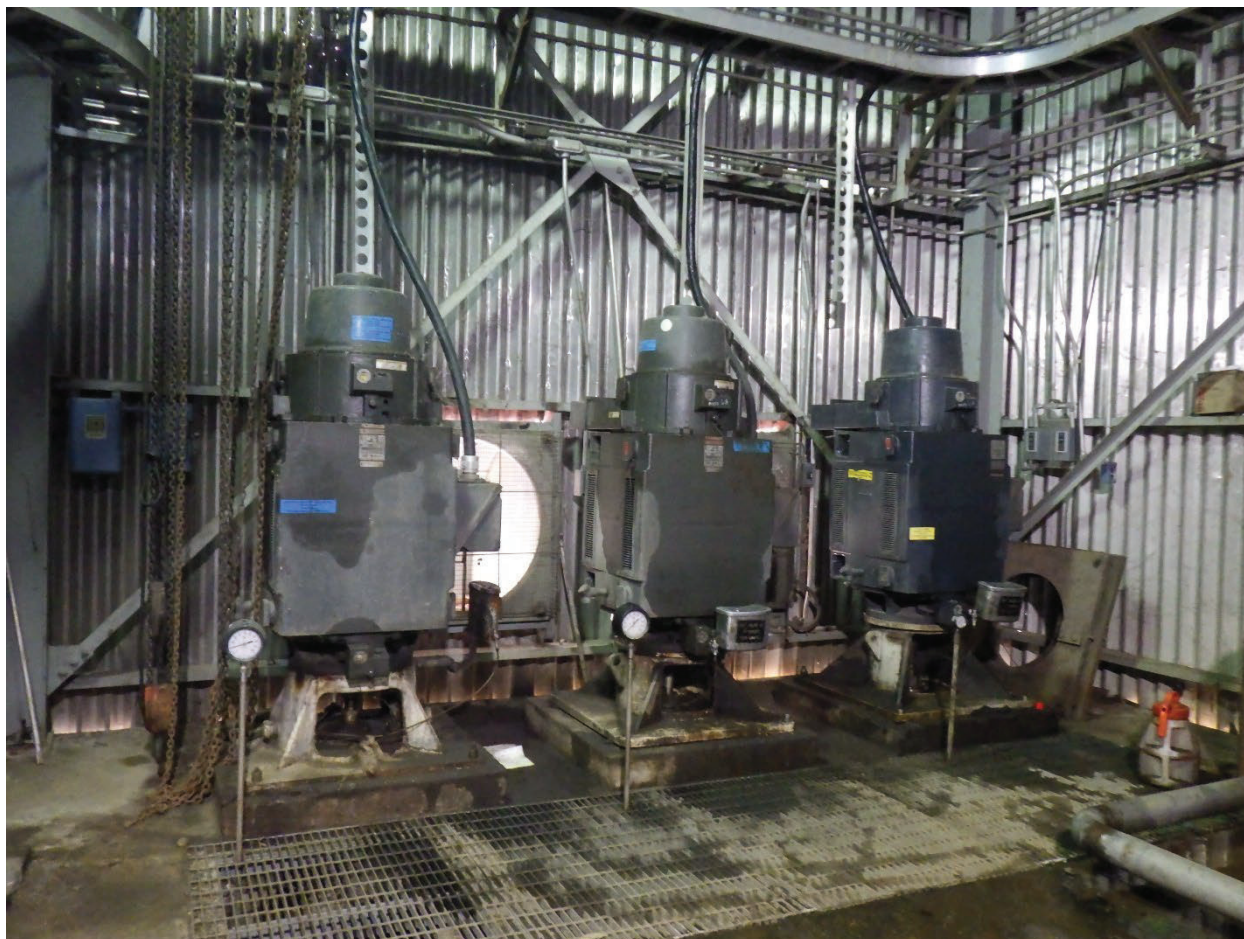
Photo No. 3

This image shows the water pumps #1, #2, and #3 that are used to intake fresh water from Quachita River for the cooling and industrial processes at the facility. The water passes through intake units through traveling pipes and screens (approximately 3/8-inch square steel mesh each) being pumped by circulating water pumps.

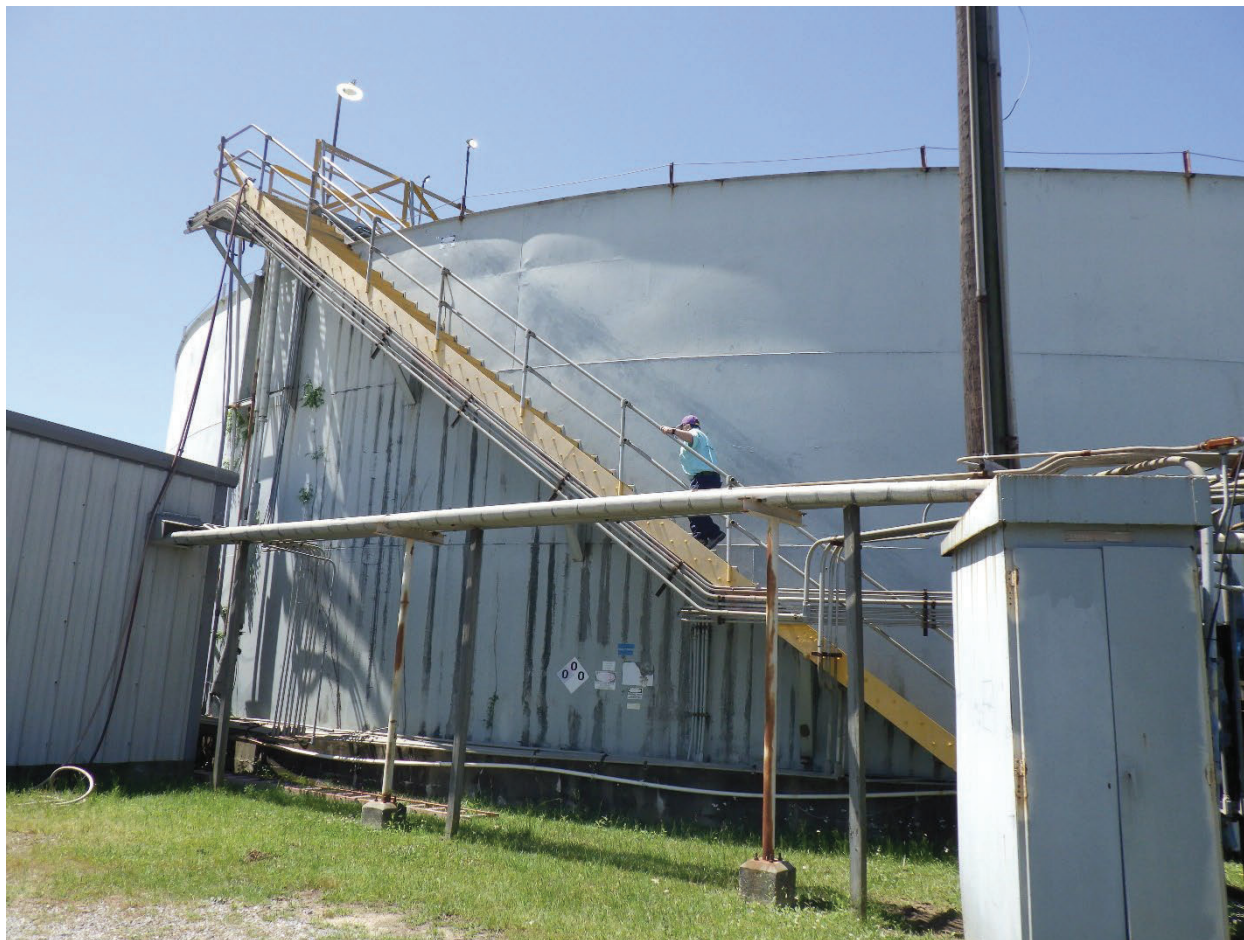
Photo No. 5

The purpose of the river water clarifiers is to remove solids/sludge from the river water (water intake procedure from Quachita River) through clarification procedures. These procedures consist of two treatments (primary and secondary clarification treatments) through tank systems. These treatments improve the removal of solids/sludge from the river water. At the time of the inspection, I did not observe any deficiencies on the water intake, clarification, containment, and transfer of the tank system (See Photo Nos. 5 – 6 in Appendix 1).

Description: This image shows the Mill River Water Clarifier Tank system (primary and secondary clarification treatment). This system removes solids/sludge from the river water (water intake procedure from Quachita River) prior to mill operations.

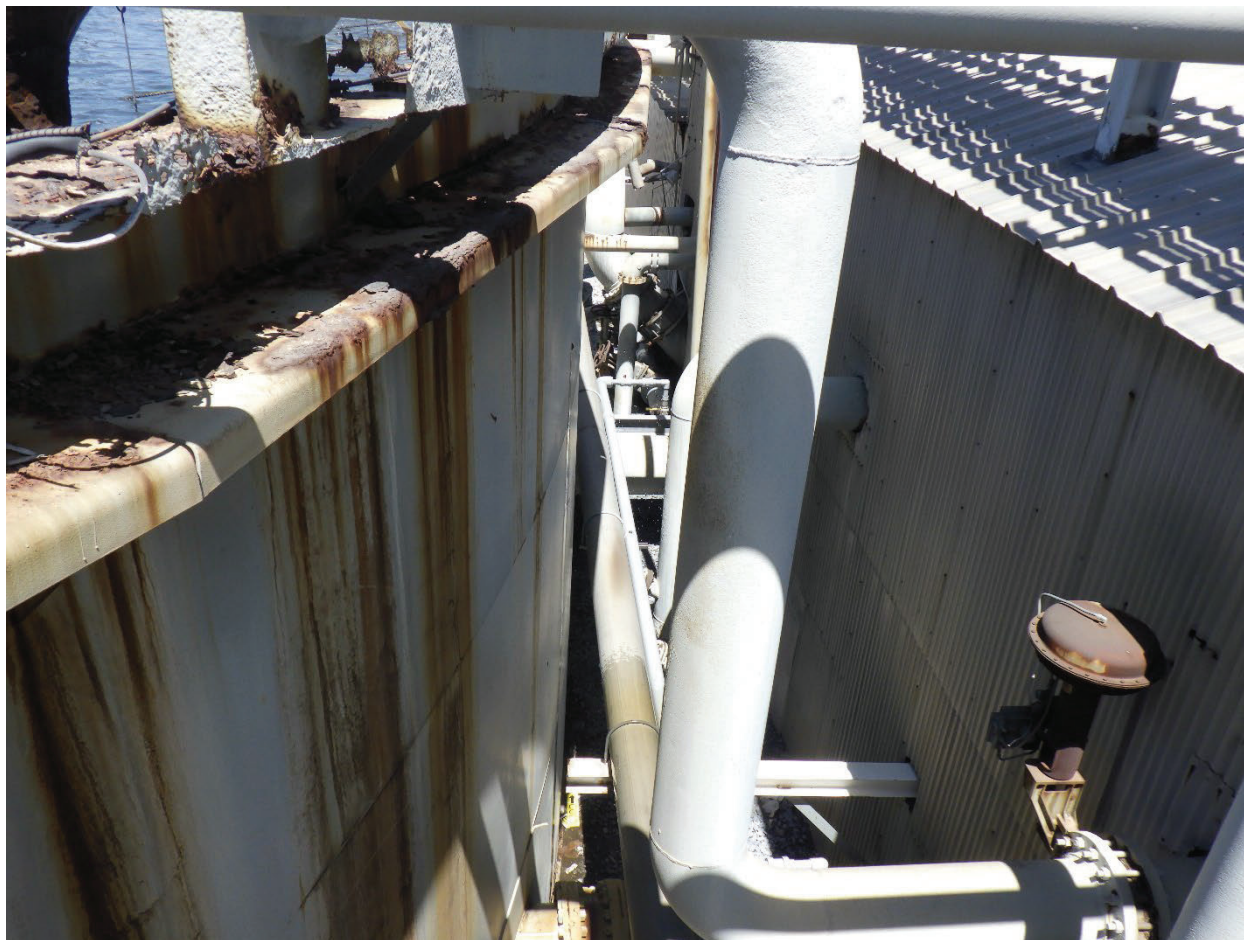
Photo No. 7

The mill water reservoir is a 1.25-million-gallon capacity holding tank for process water (river, well, and treated City of West Monroe wastewater). Its purpose is to provide capacity water to maintain mill operations for specific period of times. The reservoir provides process water in case of any temporary loss of the primary water source(s). At the time of the inspection, I observed water leaks on the containment wall of the tank and over a water valve that form part of the transfer system of process water. Also, I observed corrosion on the tank's wall and pipes as well as vegetation on the surface water of the tank. The facility needs to improve maintenance of the tank and resolve leaks, corrosion, and vegetation on the reservoir tank and structures (See Photo Nos. 7 – 9 in Appendix 1).

Description: This image shows the Mill Water Tank Reservoir. Also, this shows a water leak on the containment wall of the tank.

2. Facility should improve maintenance and resolve leaks, corrosion, and vegetation on the mill water reservoir tank and structures.
3. Facility will provide additional information (180 days after permit approval) connected to the public comments (colors in effluents discharged from outfalls 002, 003, 004, and 005 and results above the MQL for Total Aluminum outfall 401) regarding the impact of discharges on water quality from Graphic Packing new permit 2024 approval requirements.

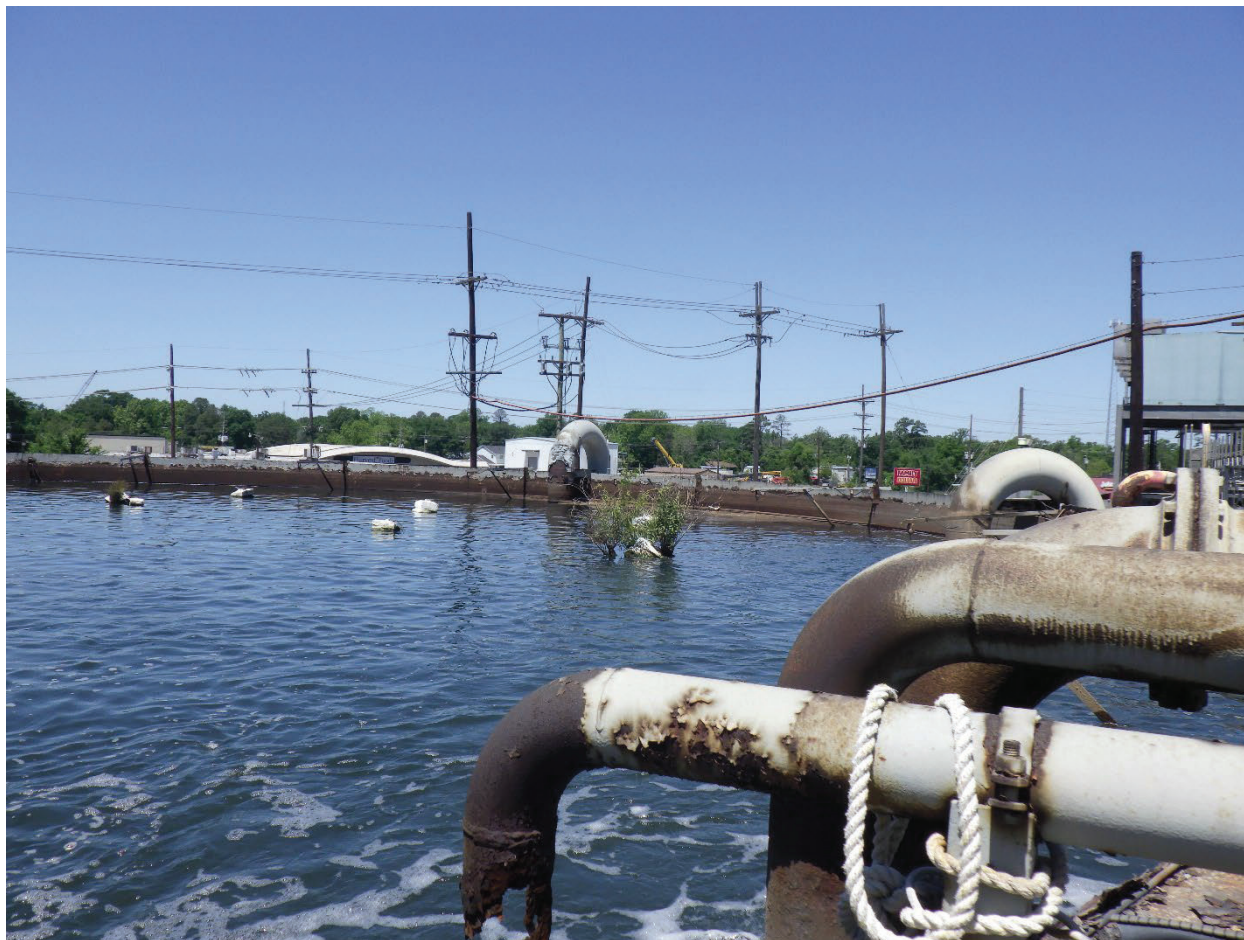
Photo No. 8

Photograph File Name: R0010851.JPG  
Date of Photograph: 04/23/2024  
Latitude and Longitude: 32.483716 -92.15419  
Orientation: NW  
Map Datum: WGS-84  
Time of Photo: 12:34 PM  
Photographer: Jack Arias  
Description: This image shows corrosion on tank structures and growing plants on surface water of the reservoir tank.

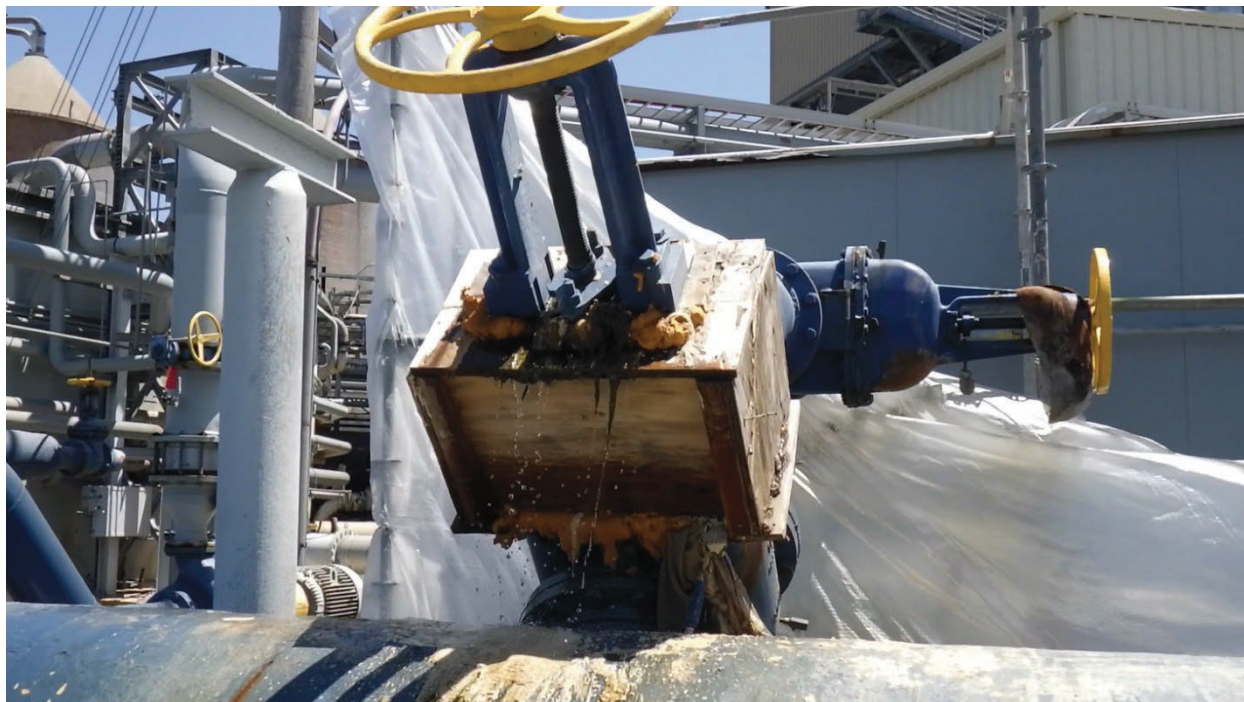
Photo No. 9

Photograph File Name: WaterValve.JPG  
Date of Photograph: 04/23/2024  
Latitude and Longitude: 32.483563 -92.154557  
Orientation: NW  
Map Datum: WGS-84  
Time of Photo: 12:45 PM  
Photographer: Jack Arias  
Description: This image shows a water valve's leak that form part of the transfer system of process water at the resevoir tank.

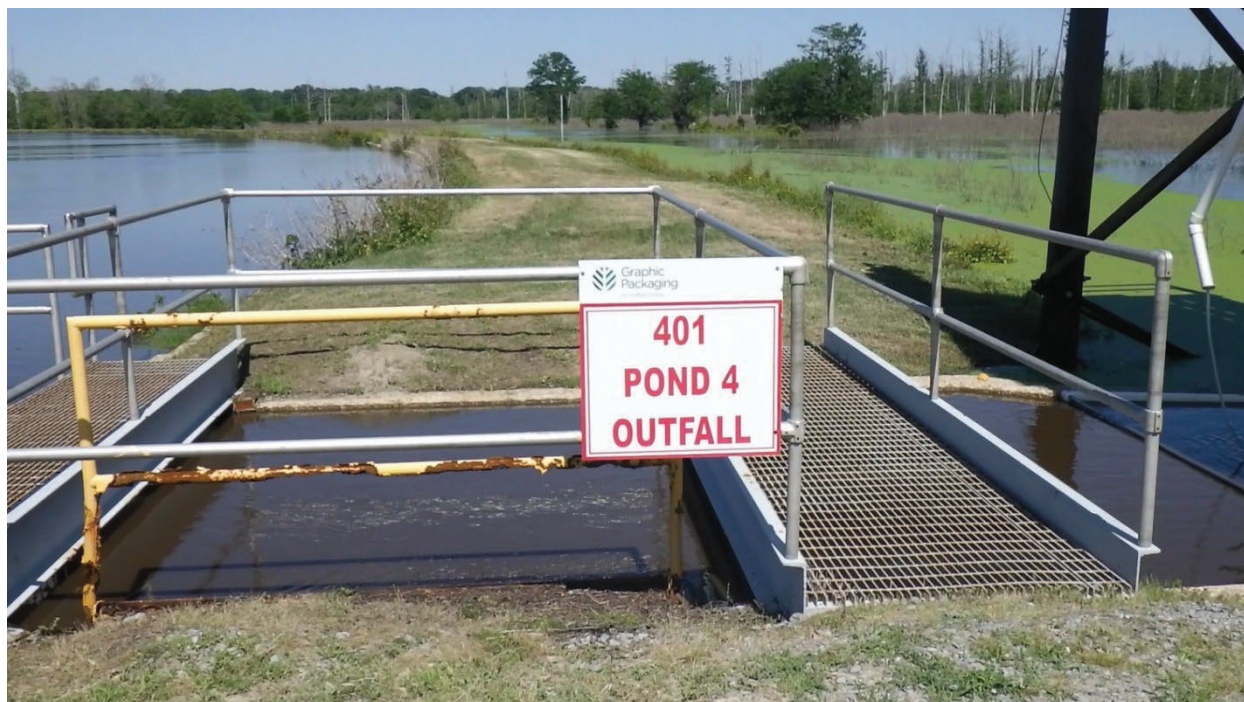
Photo No. 18

This outfall includes continues discharge of process area storm water in addition to excess storm water from the wet deck recirculation system at the West Monroe Chip Mill. Flows are routed to the wastewater treatment plant (including primary clarification, aerobic biological oxidation, sedimentation, and polishing ponds) which discharges to Outfall 401. Outfall 401 discharges to an unnamed tributary, thence to Outfall 001, thence to the Ouachita River. Outfall 401 is located at the discharge point from the polishing ponds. There was flow and discharge at the time of the inspection and the water was observed to have a brown tint (See Photo Nos. 18 – 19 in Appendix 1).

Description: This image shows outfall 401. This outfall includes continuous discharge of process area storm water, excess storm water, and settleable solids from settling ponds.

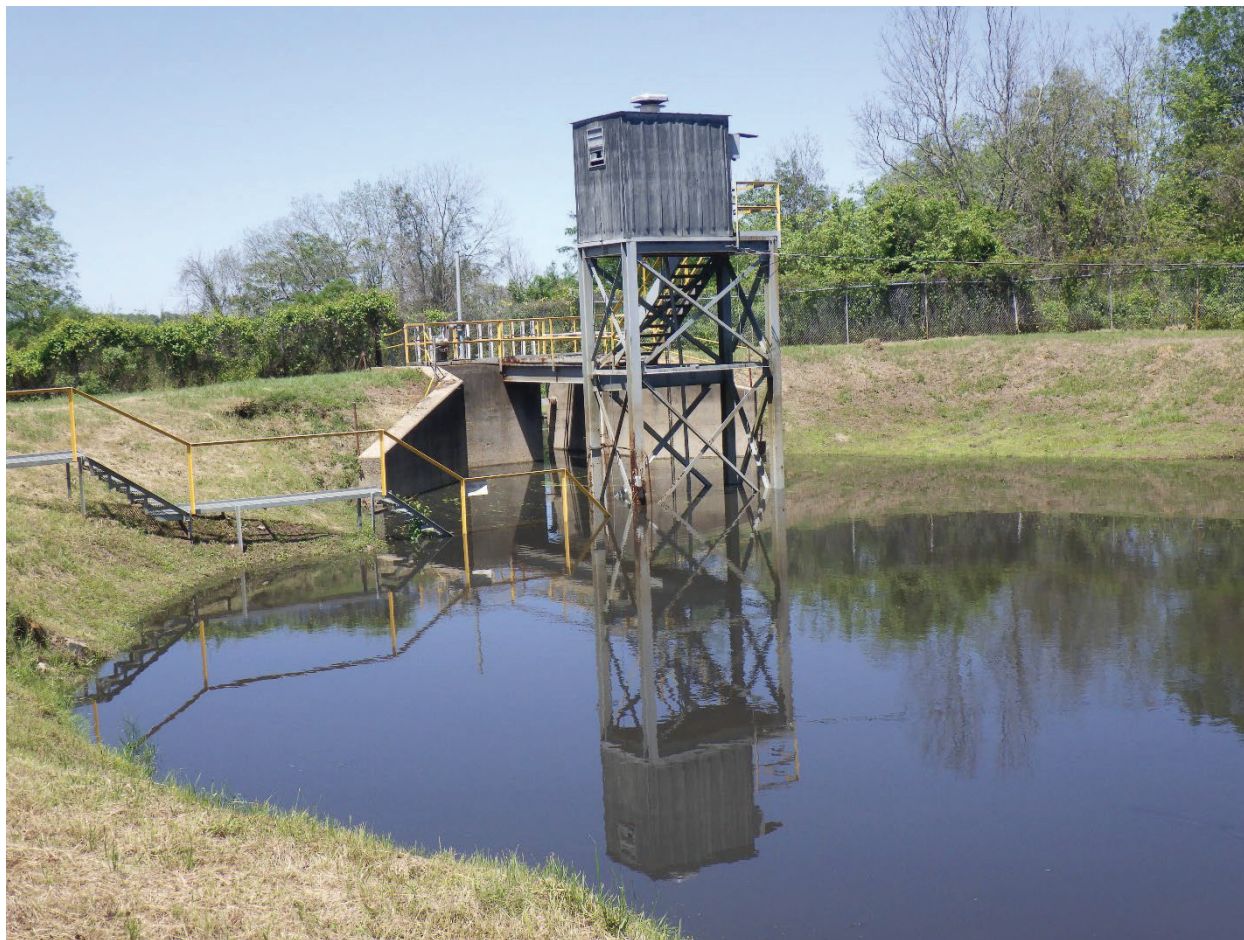
This outfall receives and includes intermittent discharge of previously monitored combined treated mill wastewater from Internal Outfall 401, treated municipal and parish sanitary wastewater from a public owned treatment works serving the City of West Monroe (LPDES permit LA0043982), and non-process stormwater runoff. Outfall 001 is in the southern portion of the property (32.45243, -92.121169) prior to discharge into the Ouachita River. I observed outfall 001. There was flow and discharge at the time of the inspection and the water had a brown tint (See Photo No. 20 in Appendix 1).

Description: This image shows outfall 001 which receives and includes an intermittent discharge of previously monitored combined treated mill wastewater and settleable solids from settling ponds from Internal Outfall 401 and unnamed tributary.

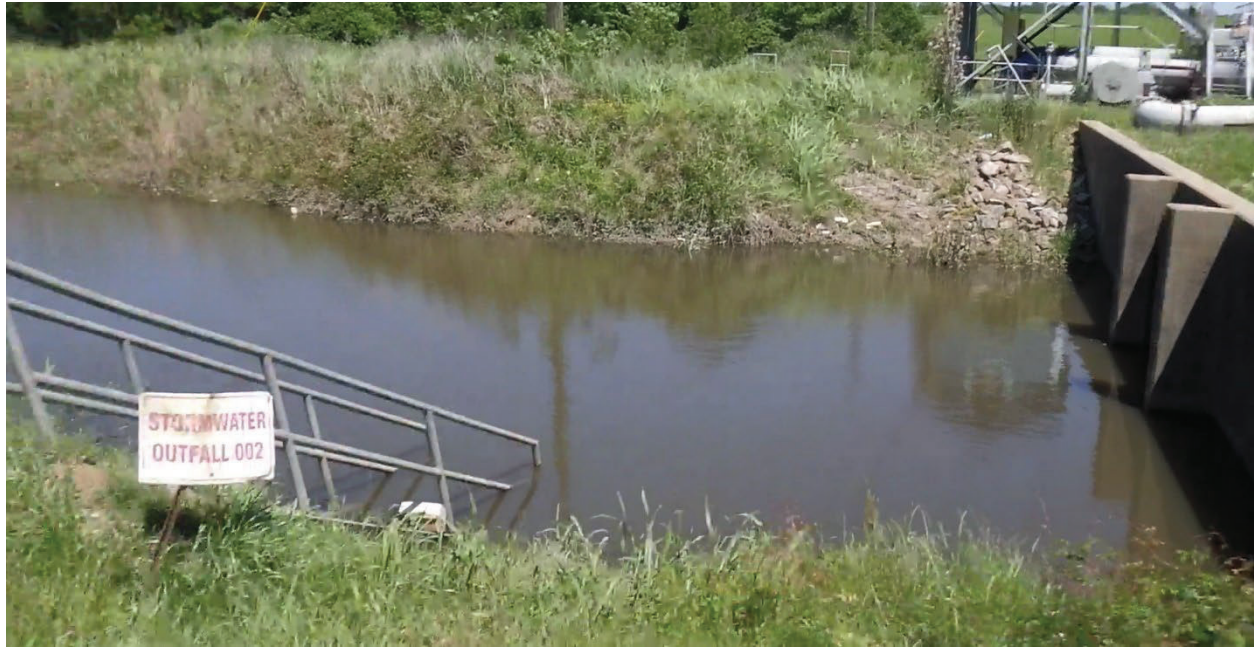
This outfall includes intermittent discharge of runoff from the rail car and tank truck loading and unloading areas, chips, plat roads, employee parking lots, solid waste and scrap metal containers, maintenance shop, storage tanks, partial roof from the N6 and N7 paper machine building, the contractor area north of the N6 and N7 paper machine buildings, roof runoff from plant 70 and natural areas southeast of the rail car switchyard and treated sanitary wastewater. Outfall 002 is centrally located (32.477947, -92.147732) within the facility and discharges into Judy Slough, thence to Toney Bayou, then Ouachita River. I observed outfall 002. There was no flow or discharge at the time of the inspection and the water had a green or brown tint (See Photo No. 21 in Appendix 1).

Description: This image shows outfall 002 which receives and includes intermittent discharges of runoff from the rail car and tank truck loading, unloading areas, chips, plat roads, employee parking lots, solid waste and scrap metal containers, maintenance shop, storage tanks, roof run offs, and treated sanitary wastewater.

4. Facility will update labels and provide any needed photos above the missing labels at the facility outfalls.
5. Facility will provide updates (180 days after permit approval) about the SWPP3 and SPCC plans.

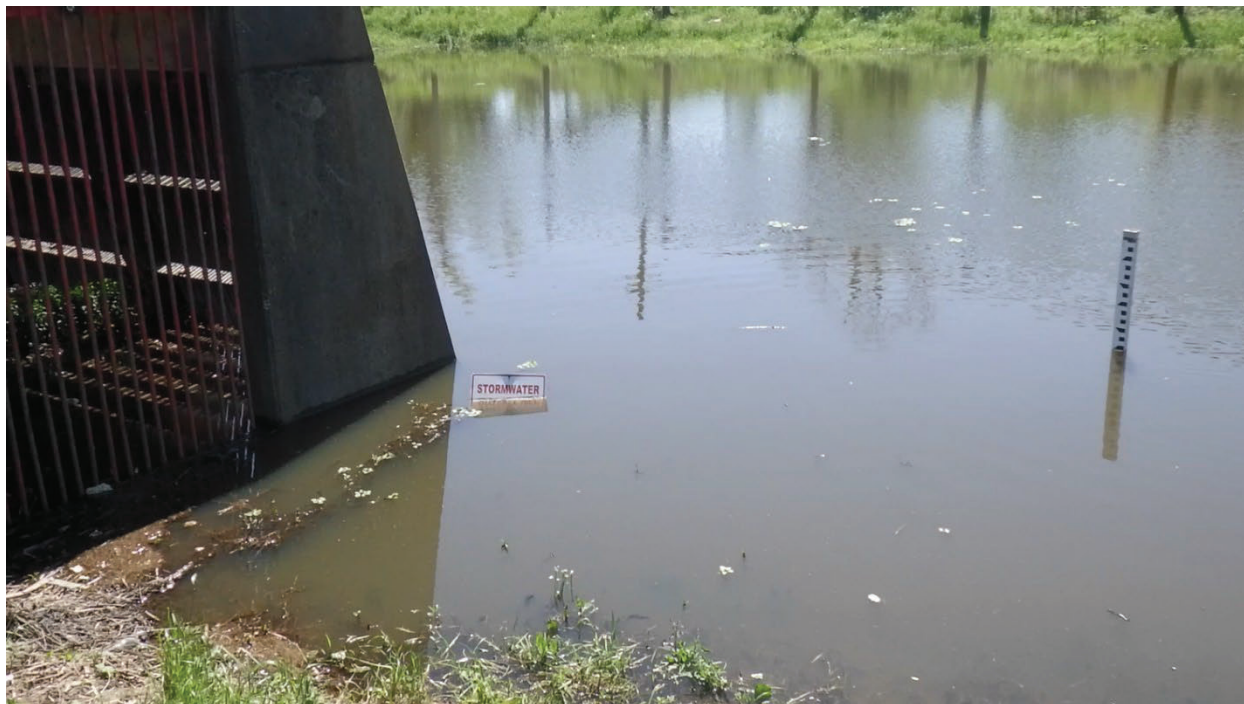
This outfall includes an intermittent discharge of non-process area stormwater runoff (including, but not limited to, stormwater runoff from roads and railroads), and storm water that accumulates within the undeveloped wooded area in the southernmost portion of the West Monroe Paper Mill. Parking, scales, and solid waste and scrap metal containers are also located within this drainage area. Additionally, the facility's wood-fired power boiler sluiced ash line traverses the outfall 003 drainage area. There is also a sanitary treatment plant located within the outfall 003 drainage area. Outfall 003 (32.47546, -92.149779) is in a surface drainage ditch that drains to Judy Slough, thence to Toney Bayou, thence to the Quachita River. There was no flow and discharge at the time of the inspection and the water was brown tint (See Photo No. 22 in Appendix 1).

This image shows outfall 003 which receives and includes intermittent discharges of non-process area stormwater runoff, and storm water that accumulates within the undeveloped wooded area in the southernmost portion of the West Monroe Paper Mill site discharges.

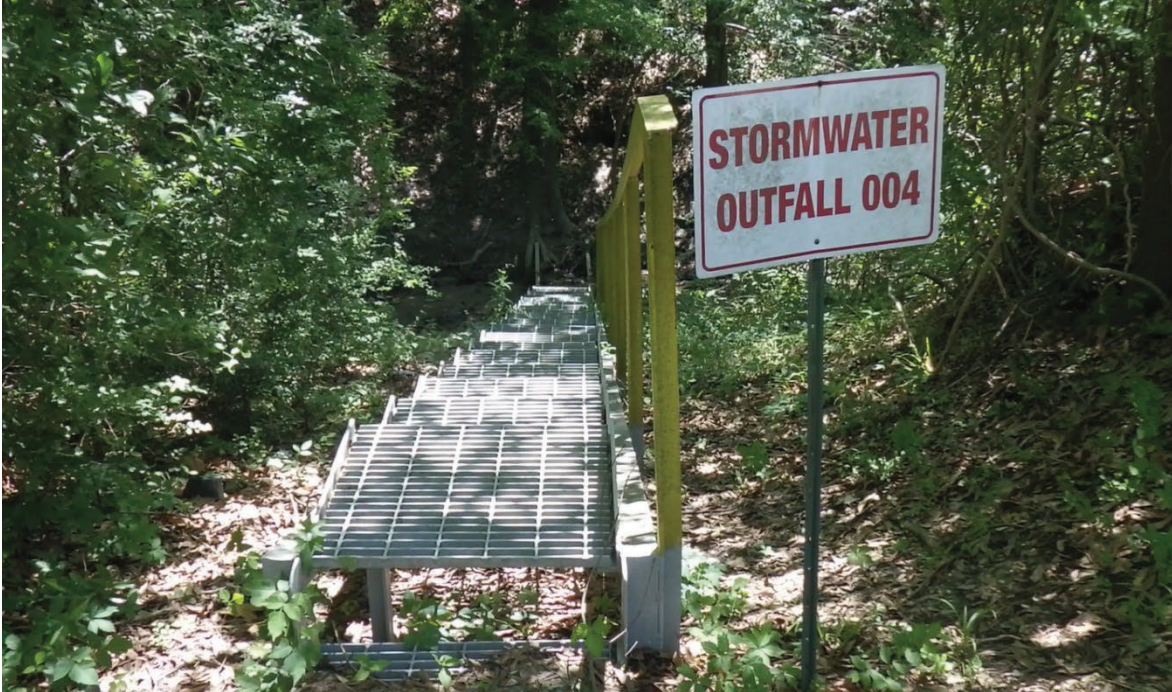
This outfall includes an intermittent discharge of non-process area stormwater runoff from the Plant 70 area and warehouse areas including roof runoff and employee parking, and solid waste and scrap metal containers. Outfall 004 is in the northeast corner of the site (32.485181 -92.14545), immediately south of Outfall 005. Outfall 004 discharges into Black Bayou, thence to Toney Bayou, thence to the Quachita River. There was not flow and discharge at the time of the inspection and the water (pool of water) was brown tint (See Photo No. 23 in Appendix 1).

Description: This image shows outfall 004 which receives and includes intermittent discharge of non-process area stormwater runoff from the Plant 70 area and warehouse areas including roof runoff and employee parking, and solid waste and scrap metal containers.

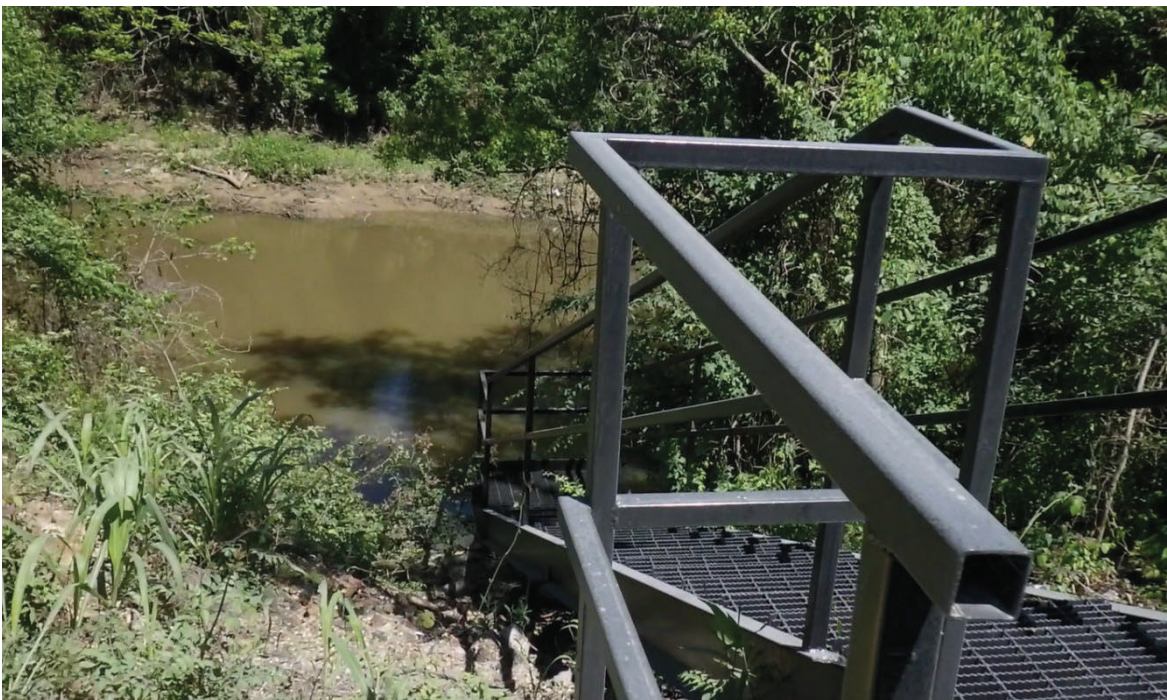
This outfall includes an intermittent discharge of non-process area stormwater runoff from the Plant 70 area and warehouse areas including roof runoff, employee parking, and solid waste and scrap metal containers. Outfall 005 is in the northeast corner of the site adjacent to a paved drive and discharges into Black Bayou, thence to Toney Bayou, thence to the Quachita River. There was not flow and discharge observed at the time of the inspection and the water had a brown tint (See Photo No. 24 in Appendix 1).
