**INSPECTION REPORT**

| <b>Type of inspection:</b> | CEI - Compliance Evaluation Inspection | |
| <b>Permittee Name:</b> | Maumee Metal Recycling | |
| <b>Facility/Site Physical Address:</b> | 1400 Estella Ave | |

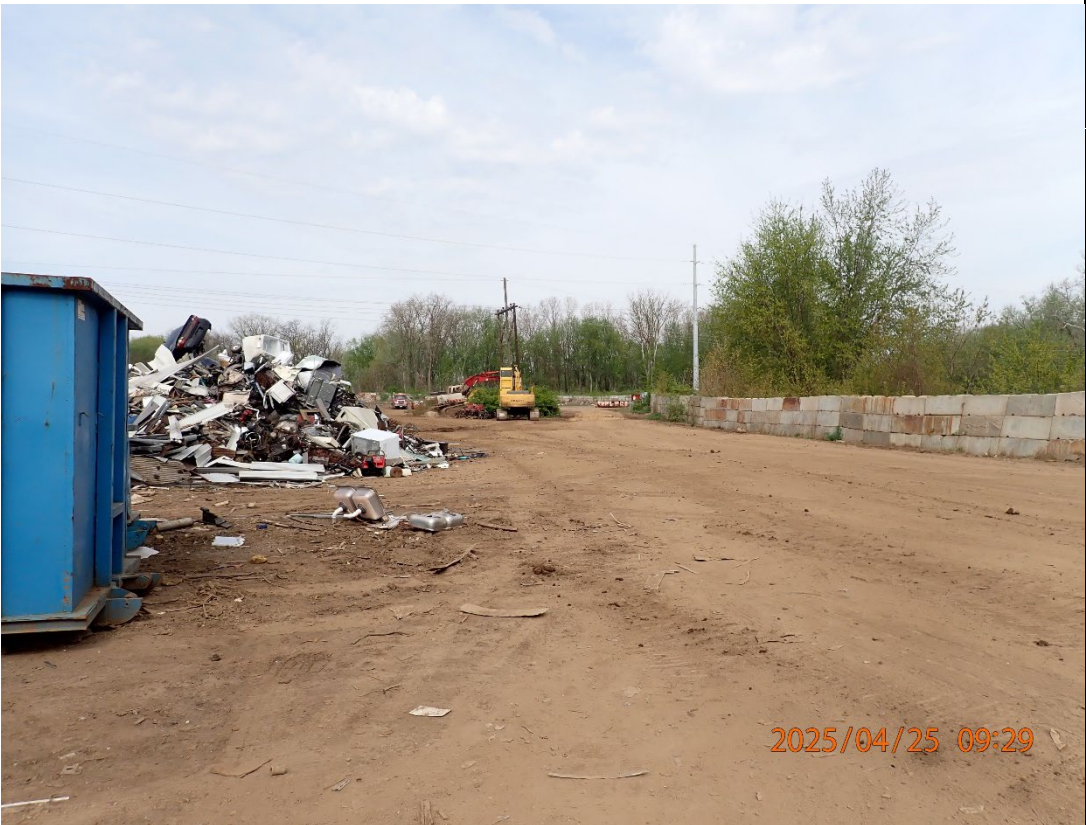
| <b>Photo No.: 1</b> | <b>Time:</b><br>10:29 AM | | |

| <b>Photo Description:</b><br>Scrap metal loading yard | | | |

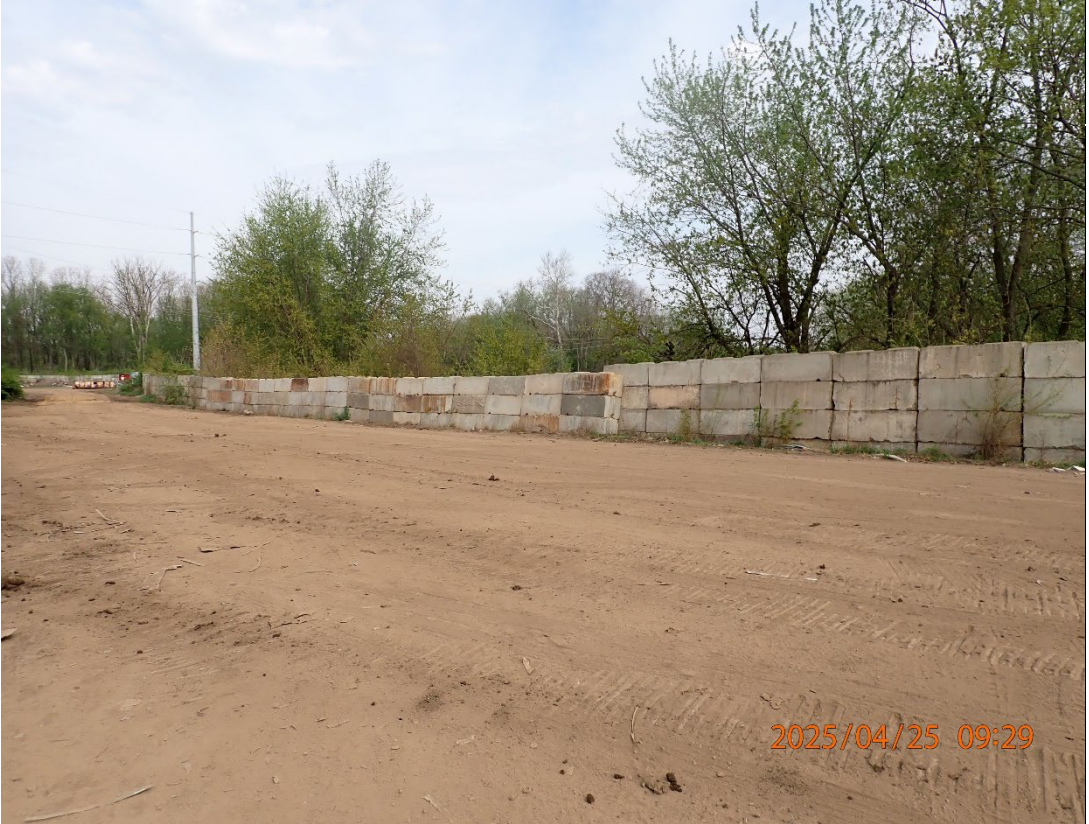
| <b>Photo No.: 2</b> | <b>Time:</b><br>10:29 AM | | |

| <b>Photo Description:</b><br>Concrete wall separating scrap yard from the Maumee River. | | | |

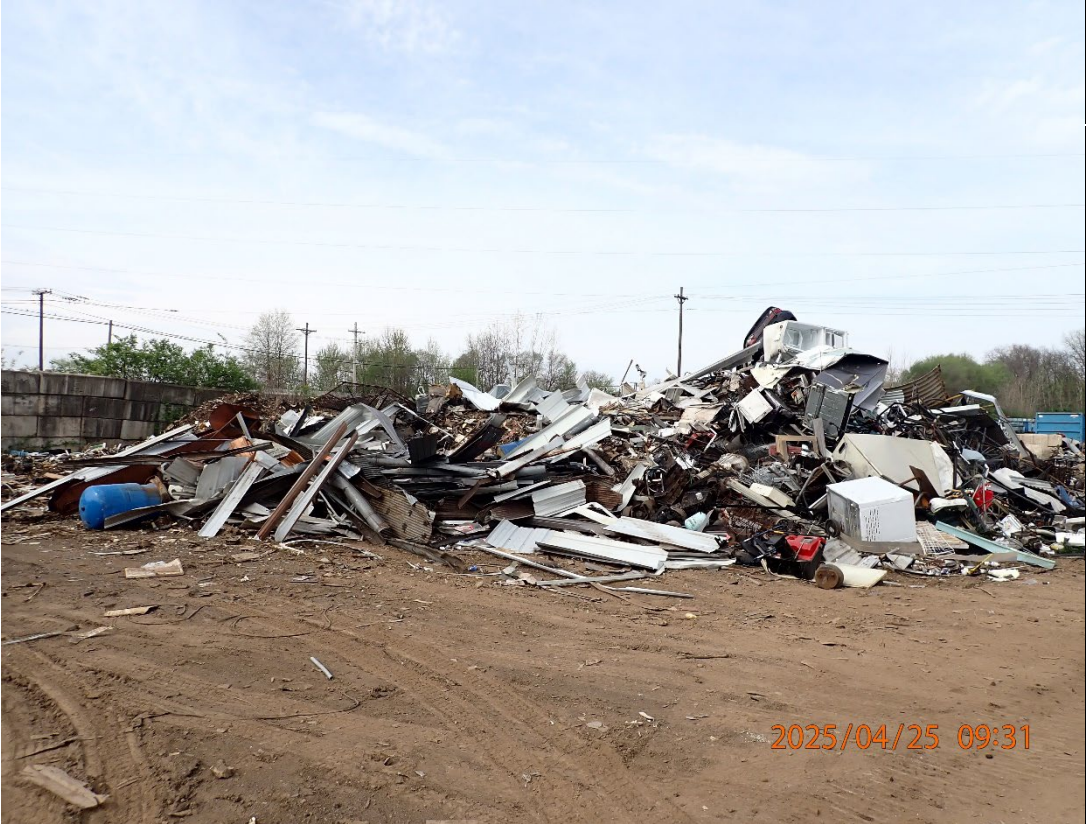
| <b>Photo No.:</b> 3 | <b>Time:</b><br>10:32 AM | | |

| <b>Photo Description:</b><br>Scrap metal pile. | | | |

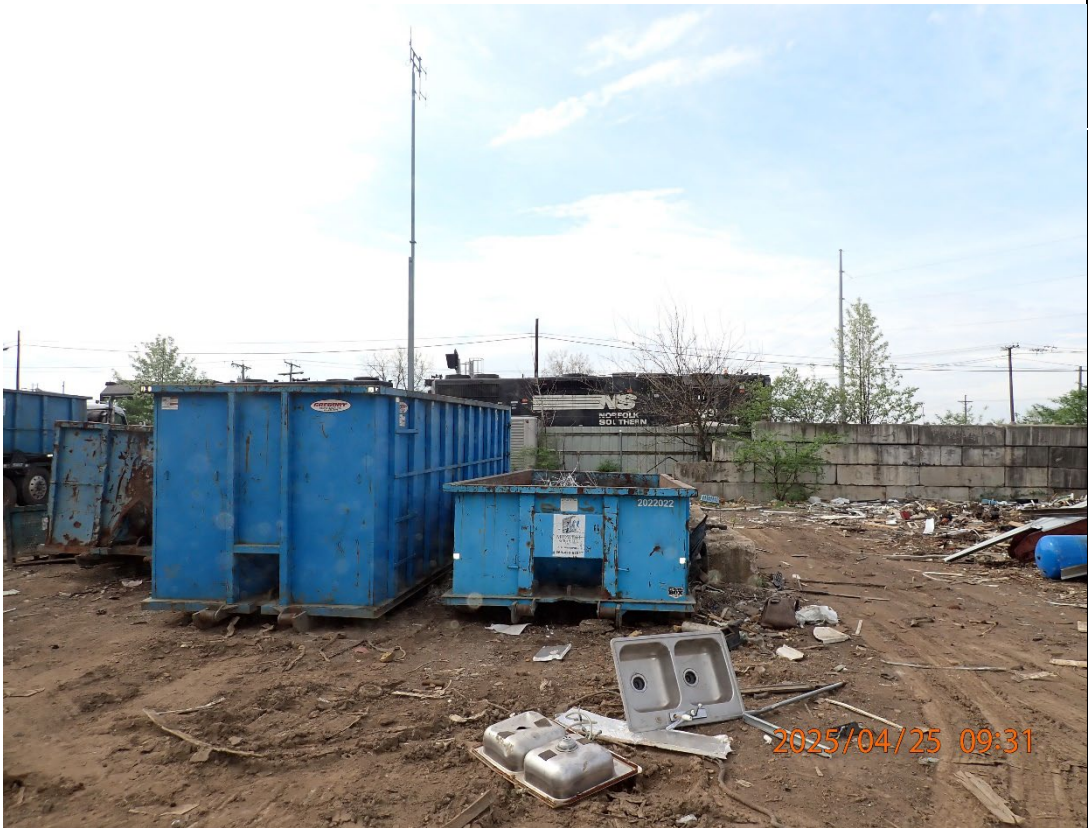
| <b>Photo No.:</b> 4 | <b>Time:</b><br>10:32 AM | | |

| <b>Photo Description:</b><br>Railcar behind berm. | | | |

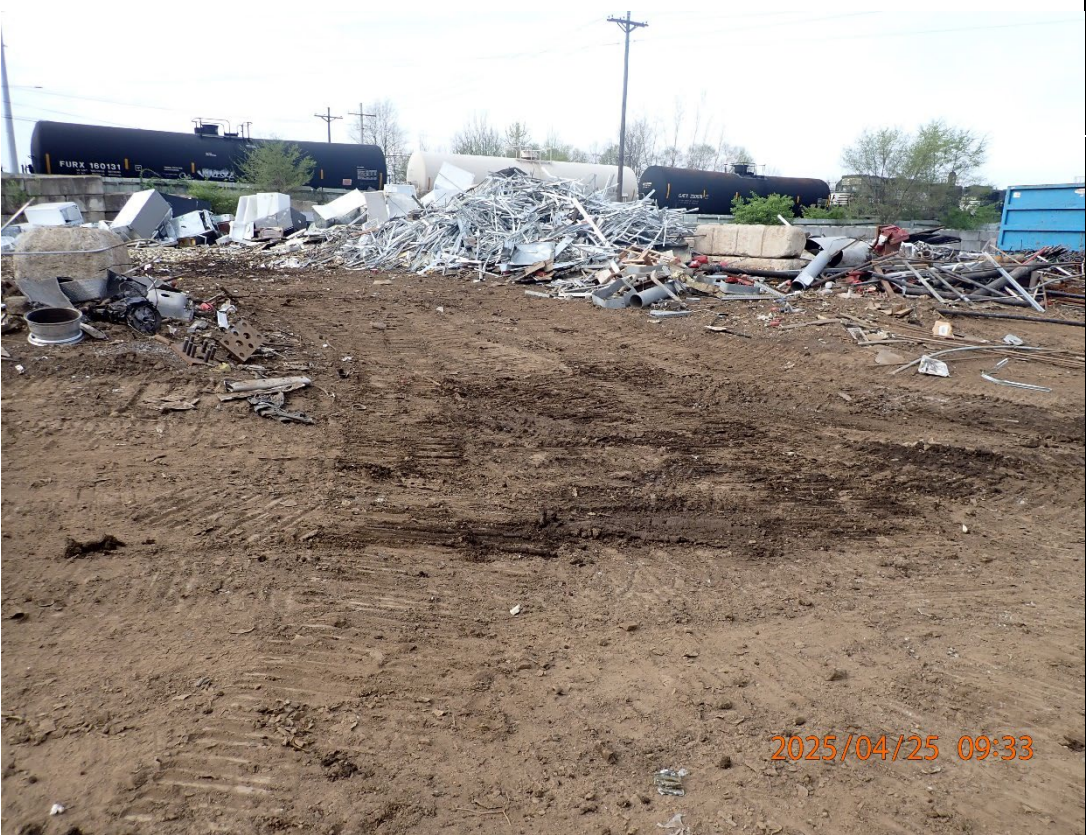
| <b>Photo Description:</b><br>Tire tracks from shipments. Stain stated to be from water. | | | |

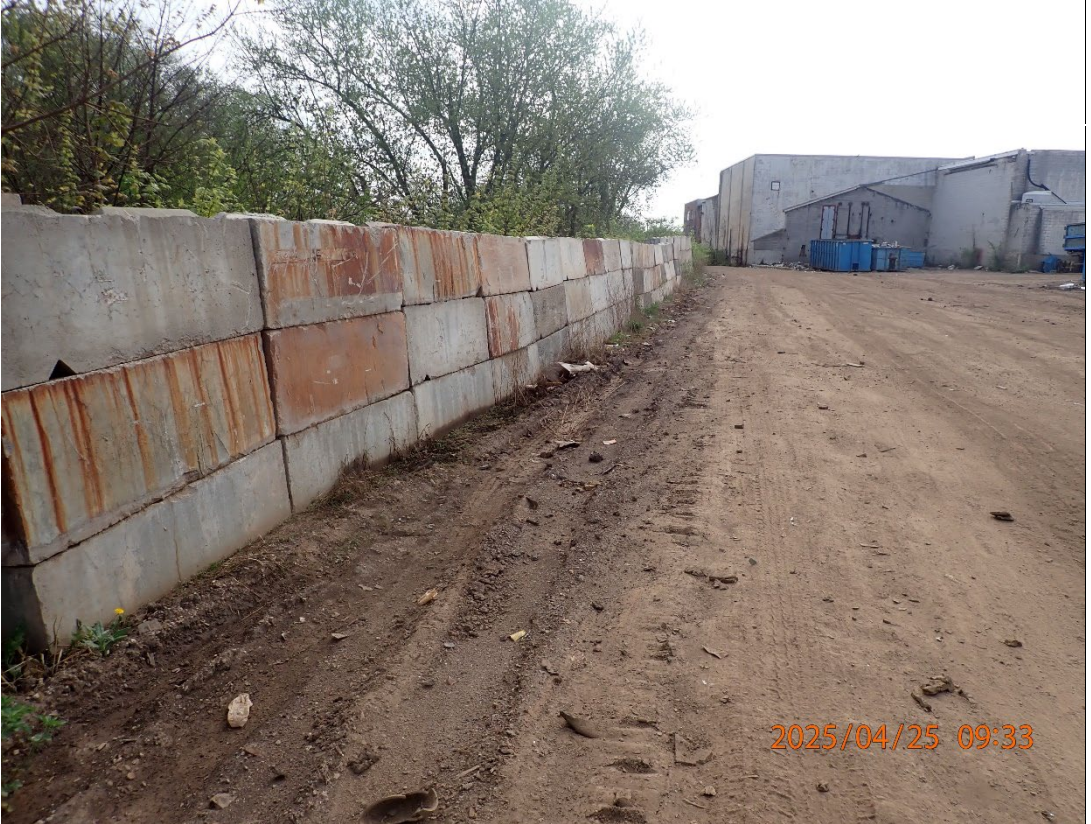
| <b>Photo No.:</b> 6 | <b>Time:</b><br>10:34 AM | | |

| <b>Photo Description:</b><br>Concrete wall separating yard from the Maumee River. | | | |

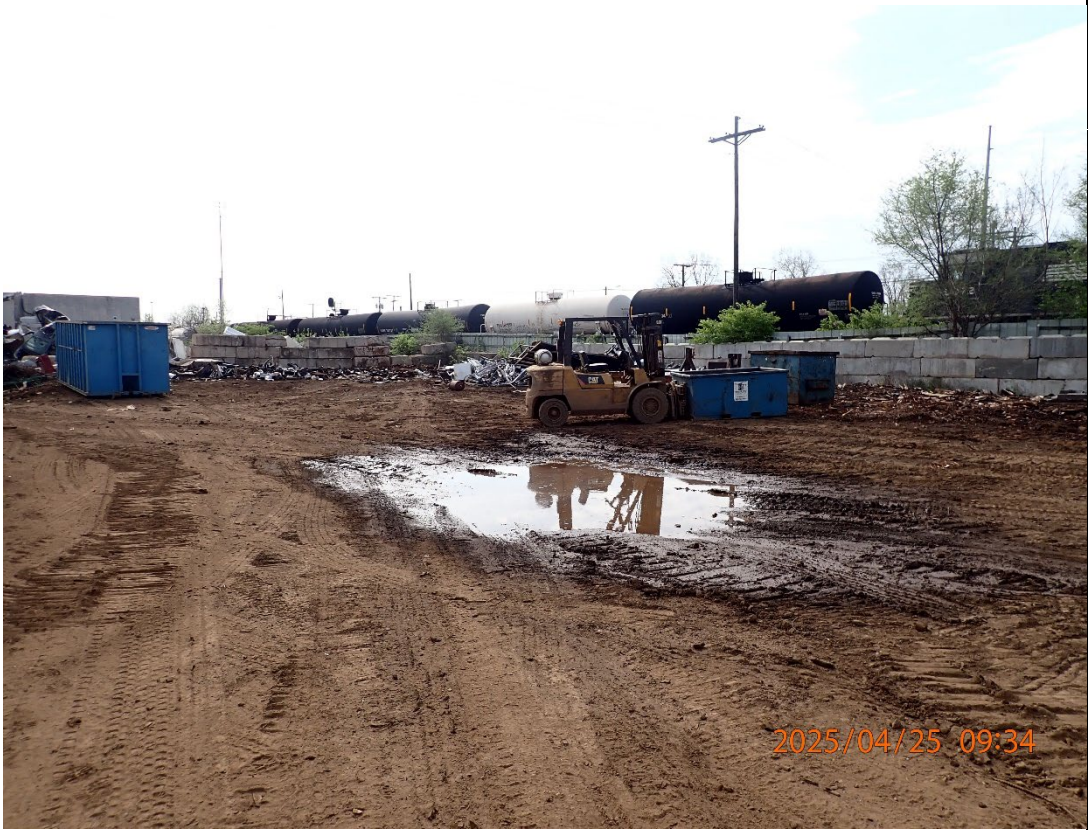
| <b>Photo No.: 7</b> | <b>Time:</b><br>10:34 AM | | |

| <b>Photo Description:</b><br>Pooling water. No sheen. | | | |

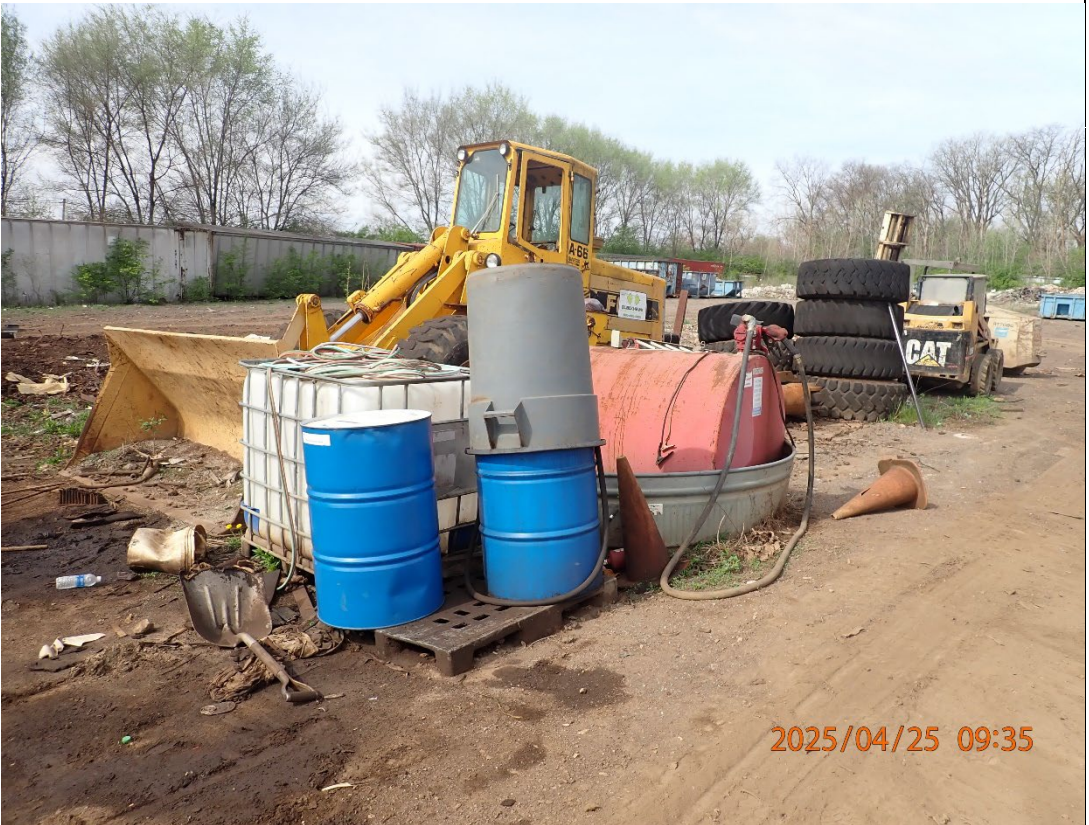
| <b>Photo No.:</b> 8 | <b>Time:</b><br>10:35 AM | | |

| <b>Photo Description:</b><br>Totes of hydraulic oil (blue). Fuel with secondary containment. Tote is empty. | | | |

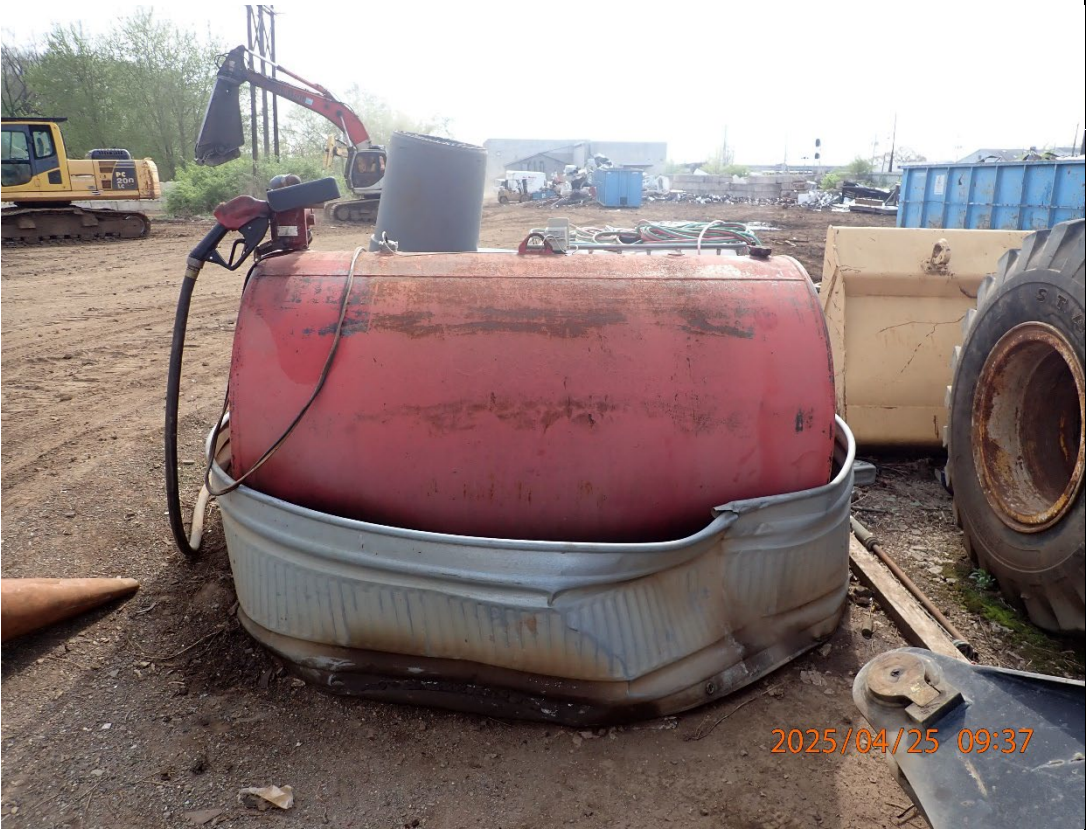
| <b>Photo No.:</b> 9 | <b>Time:</b><br>10:35 AM | | |

| <b>Photo Description:</b><br>Fuel Basin with secondary containment. | | | |

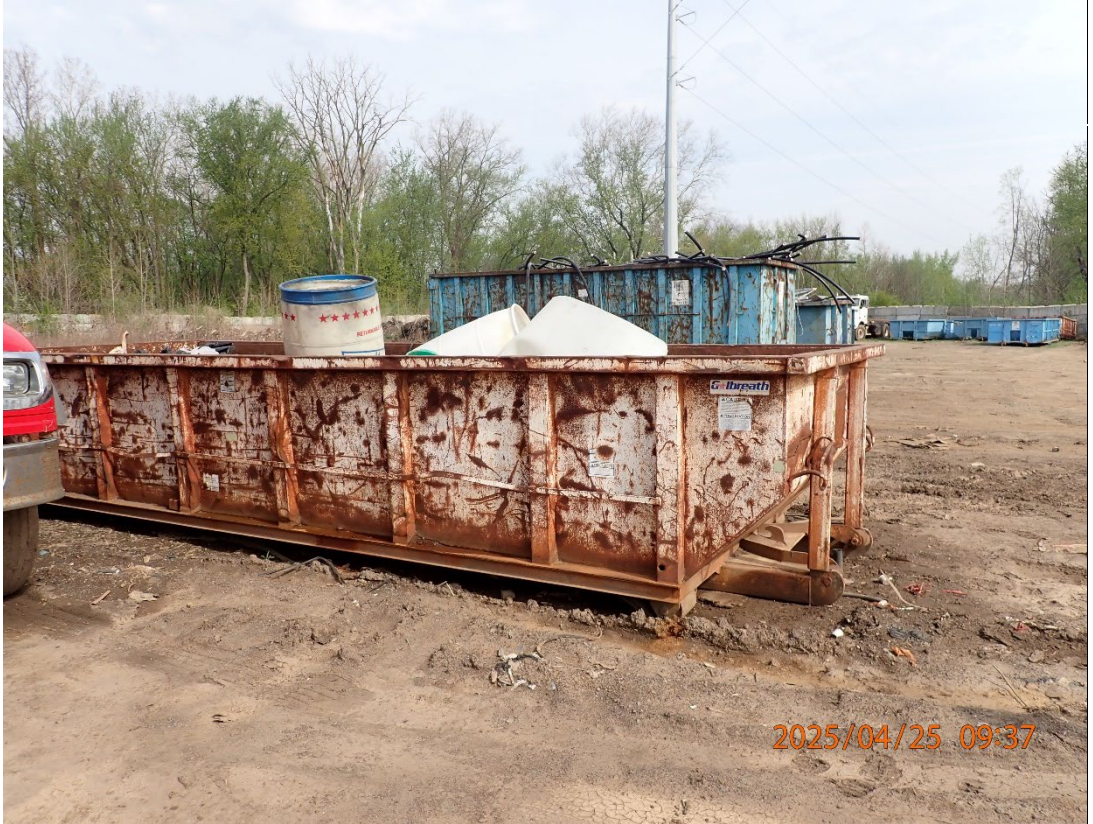
| <b>Photo No.: 10</b> | <b>Time:</b><br>10:35 AM | | |

| <b>Photo Description:</b><br>Trash bin. Holes in bottom | | | |

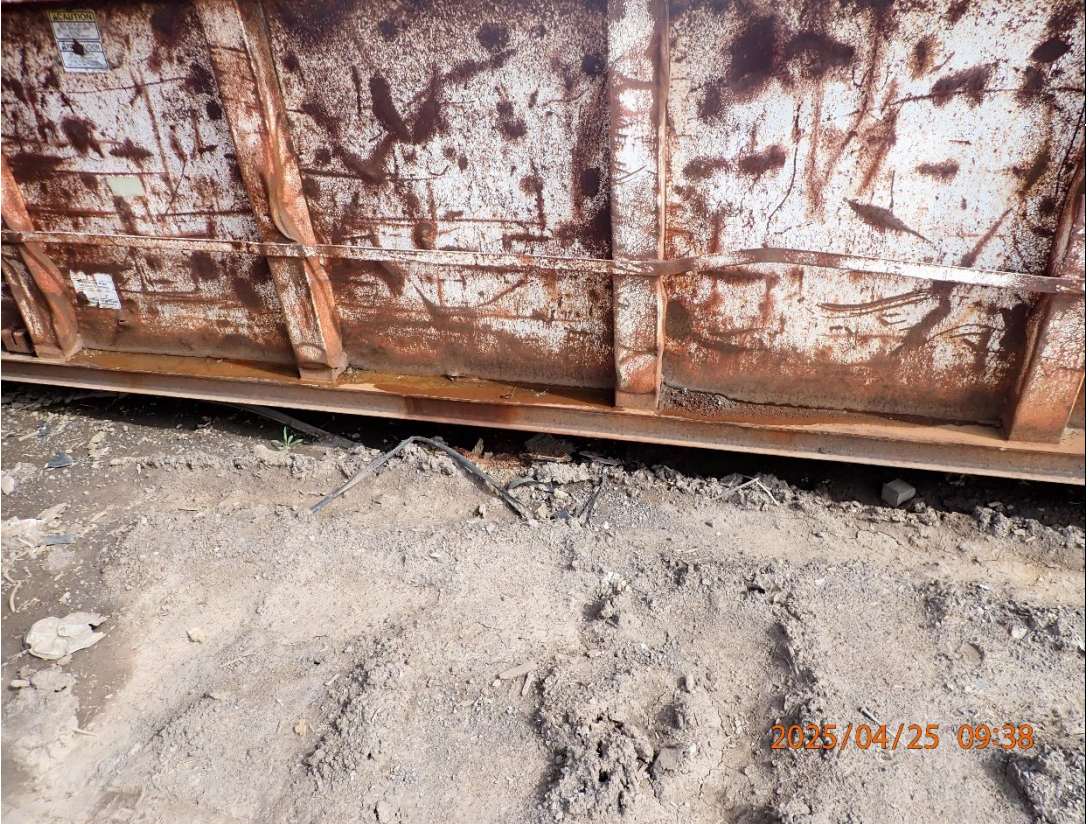
| <b>Photo No.: 11</b> | <b>Time:</b> | | |

| <b>Photo Description:</b><br>Trash bin. Openings at bottom of bin walls. | | | |

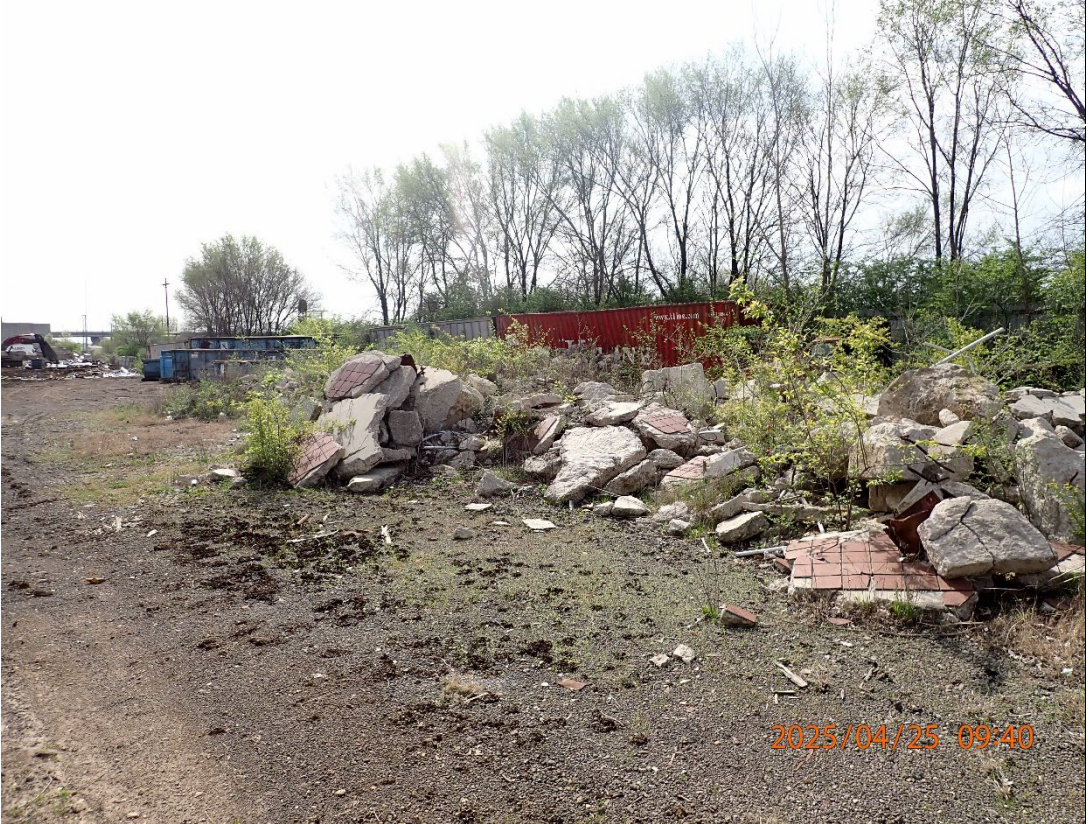
| <b>Photo No.: 12</b> | <b>Time:</b><br>10:40 AM | | |

| <b>Photo Description:</b><br>Concrete and wood and piles from owner's other properties. | | | |

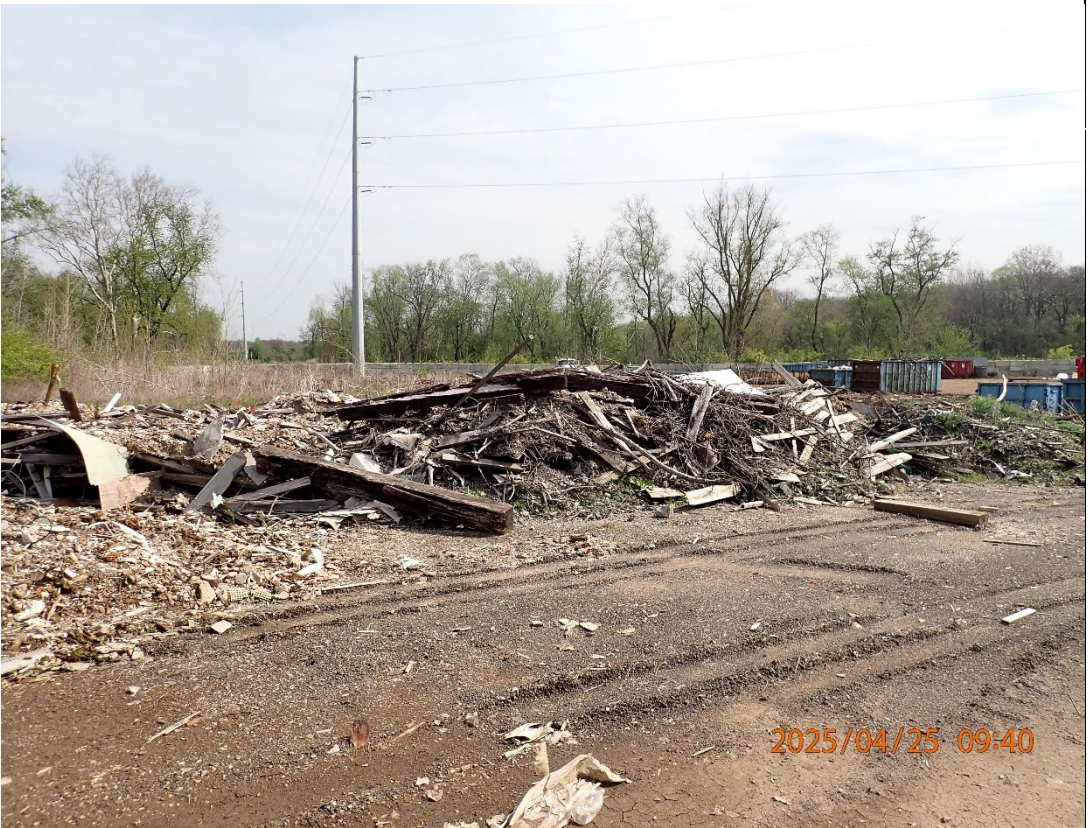
| <b>Photo No.: 13</b> | <b>Time:</b><br>10:40 AM | | |

| <b>Photo Description:</b><br>Wood piles. | | | |

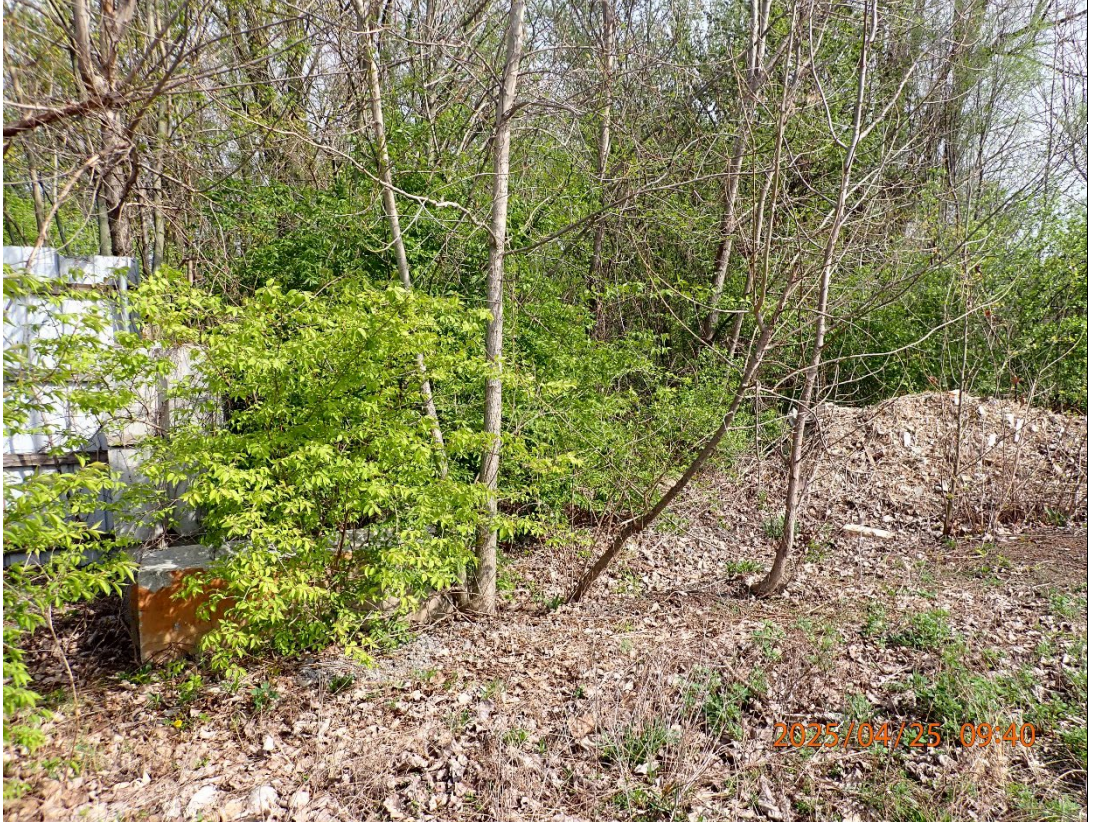
| <b>Photo No.: 14</b> | <b>Time:</b><br>10:42 AM | | |

| Unique Identifying No. | Observation | Area of Concern? |
|---|---|---|
| MS-OB-001 | During the site tour, Inspectors observed that the concrete wall surrounding the Facility failed to extend to the back area. In the back area, Inspectors observed a large pile of debris. | Yes |

| No. | |
|---|---|
| MS-OB-001 | <p>During the site tour, Inspectors observed that the concrete wall surrounding the Facility failed to extend to the back area where a large pile of debris was located.</p> <p>Barriers and other best management practices should be maintained to prevent any debris or stormwater from leaving site and entering navigable waters, such as the Maumee River.</p> |

| <b>Photo Description:</b><br>Wall ends and piles along edge of property. | | | |

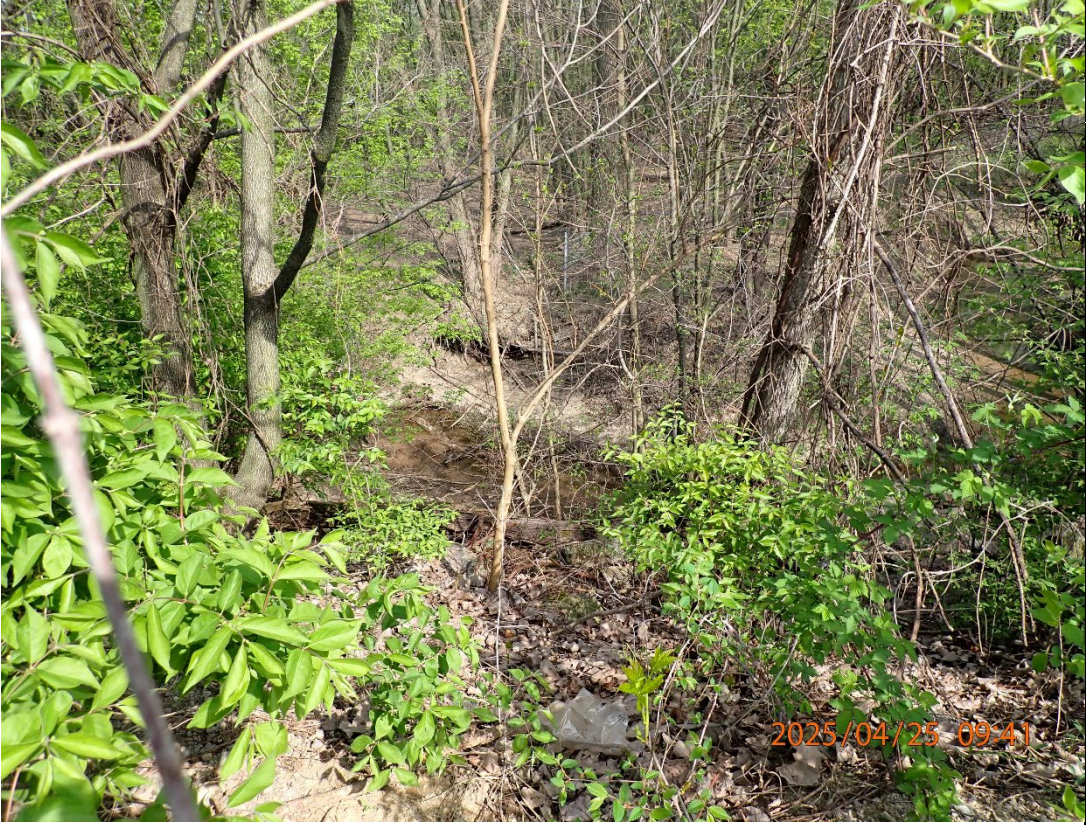
| <b>Photo No.: 15</b> | <b>Time:</b><br>10:43 | | |

| <b>Photo Description:</b><br>Maumee River on other side of piles. | | | |

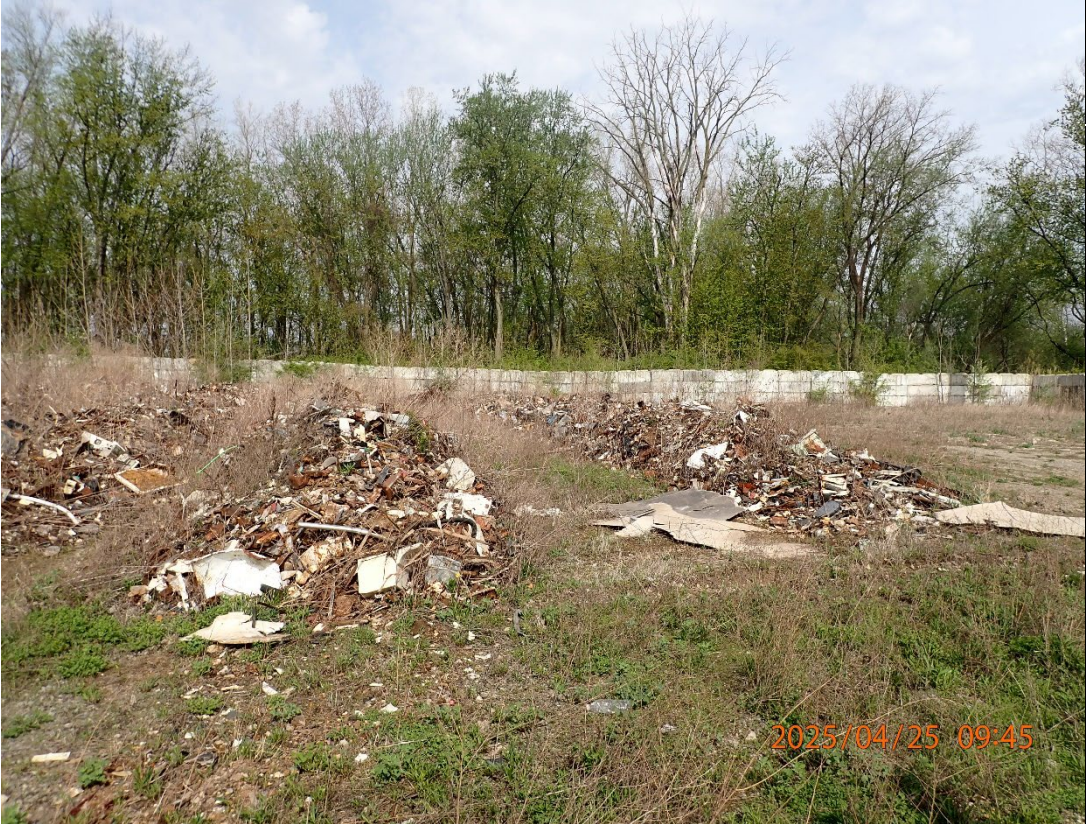
| <b>Photo No.: 16</b> | <b>Time:</b><br>10:4 | | |

| <b>Photo Description:</b><br>Scrap metal piles mixed with dirt to be separated. | | | |

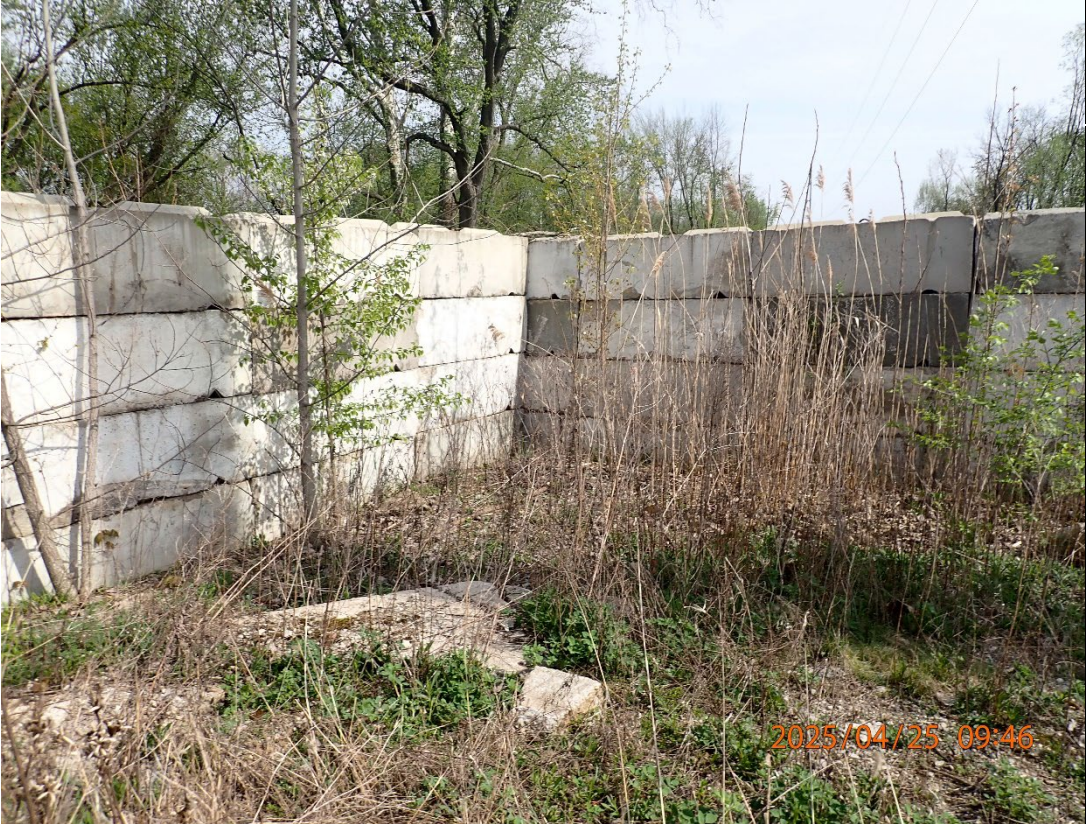
| <b>Photo No.: 17</b> | <b>Time:</b><br>10:47 AM | | |

| <b>Photo Description:</b><br>Corner of concrete berm. | | | |

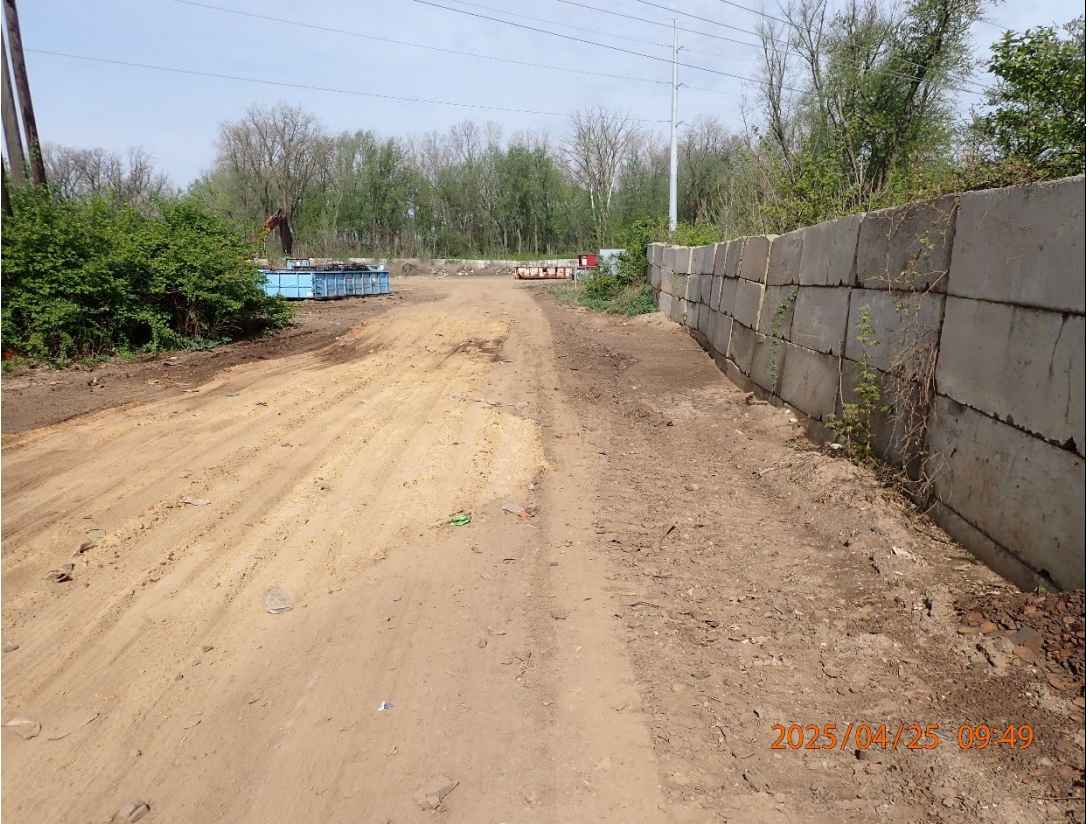
| <b>Photo No.: 18</b> | <b>Time:</b><br>10:50 AM | | |

| <b>Photo Description:</b><br>Elevated drive path. | | | |

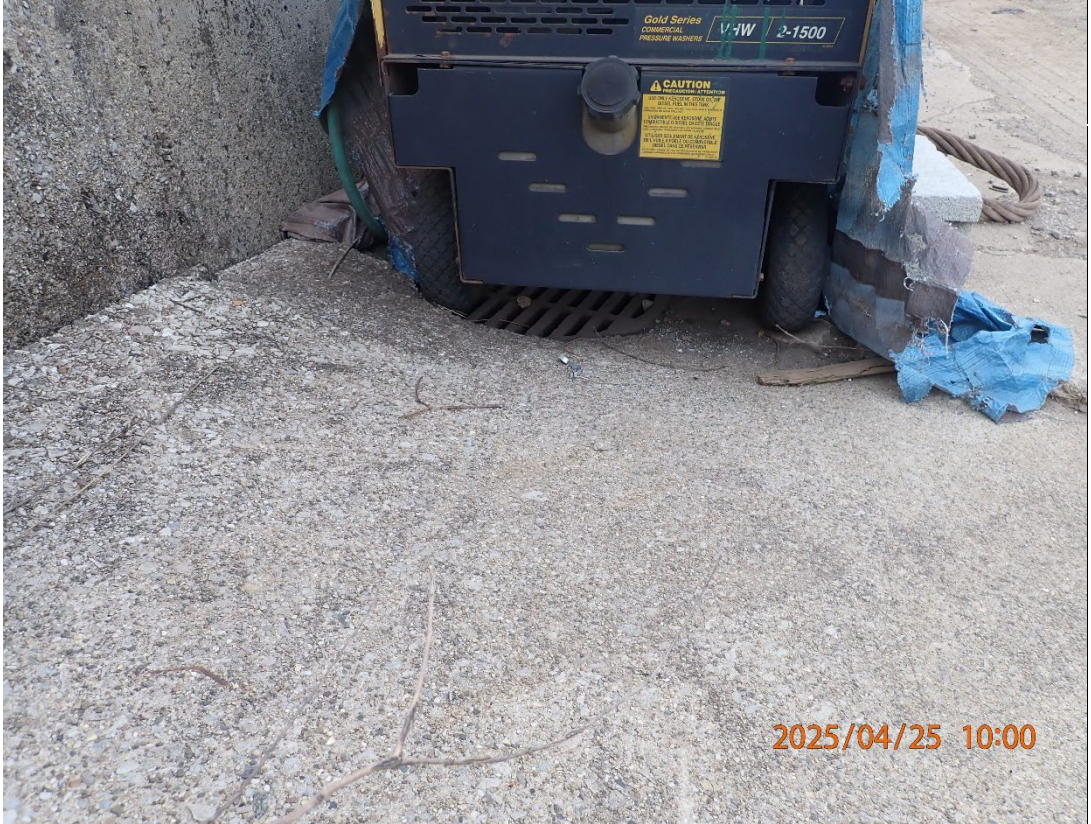
| <b>Photo No.:</b> 19 | <b>Time:</b><br>11:00 AM | | |

| <b>Photo Description:</b><br>Inlet grate. Unknown of where the drains goes. | | | |

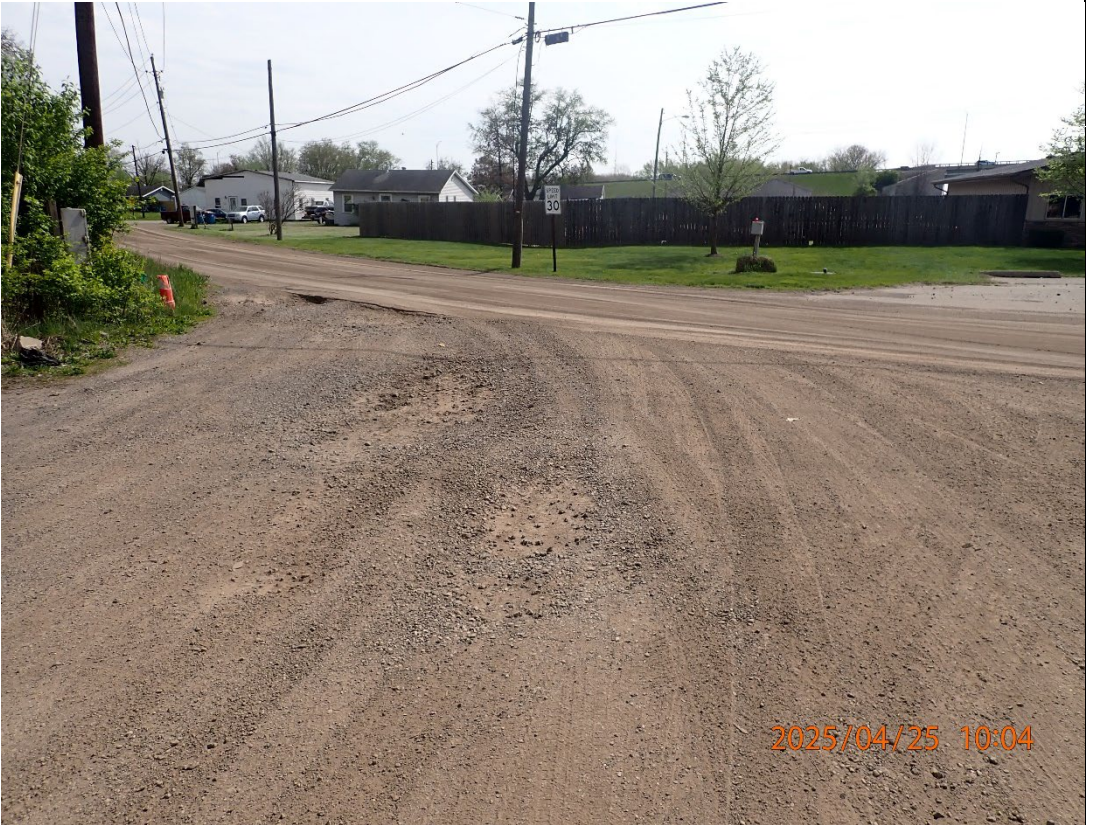
| <b>Photo No.: 20</b> | <b>Time:</b><br>11:05 AM | | |

| <b>Photo Description:</b><br>Driveway entrance with dirt tracking along road tot city street. | | | |
