## Region 6 - Enforcement & Compliance Assurance Division

### INSPECTION REPORT

| Company Name: | Aqua Texas, Inc. | |
| Facility Name: | Foxbane Combined WS | |

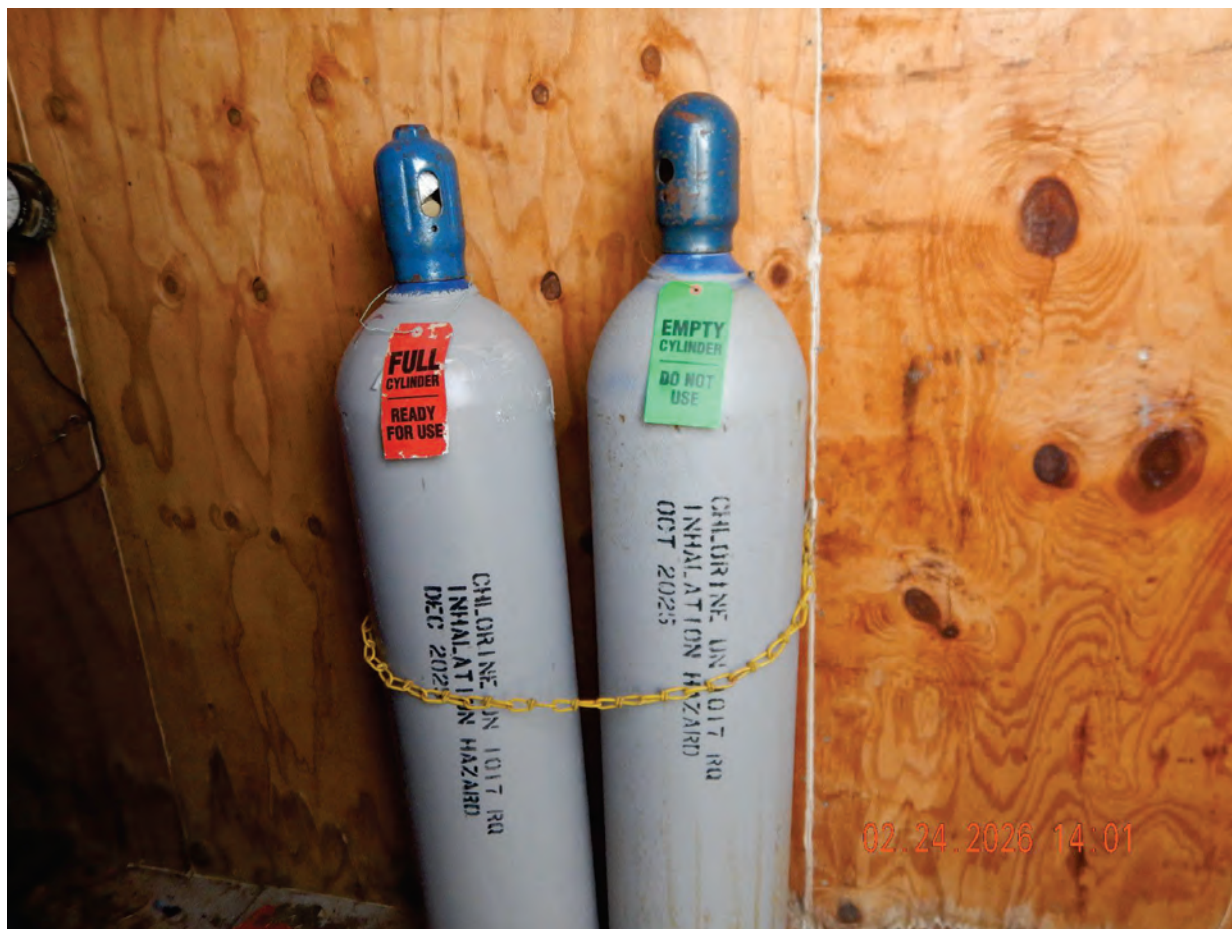
Photograph No. 1

| Description: | Plant 3: Chlorine gas tanks stored with a chain. | | | | |

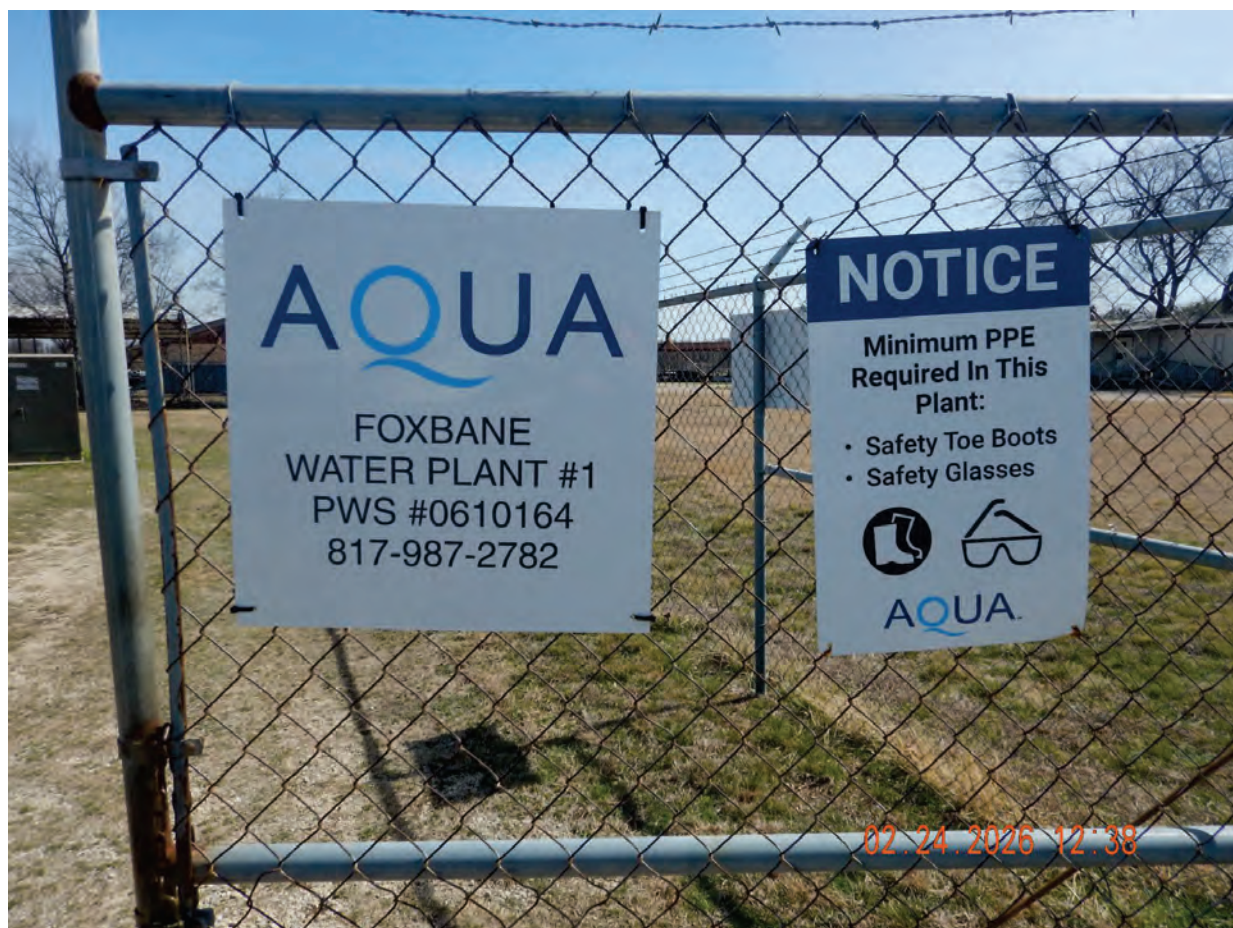
Photograph No. 2

| Description: | Locked fence with barbed wire and signage Plant 1 (Foxbane Plant). | | | | |

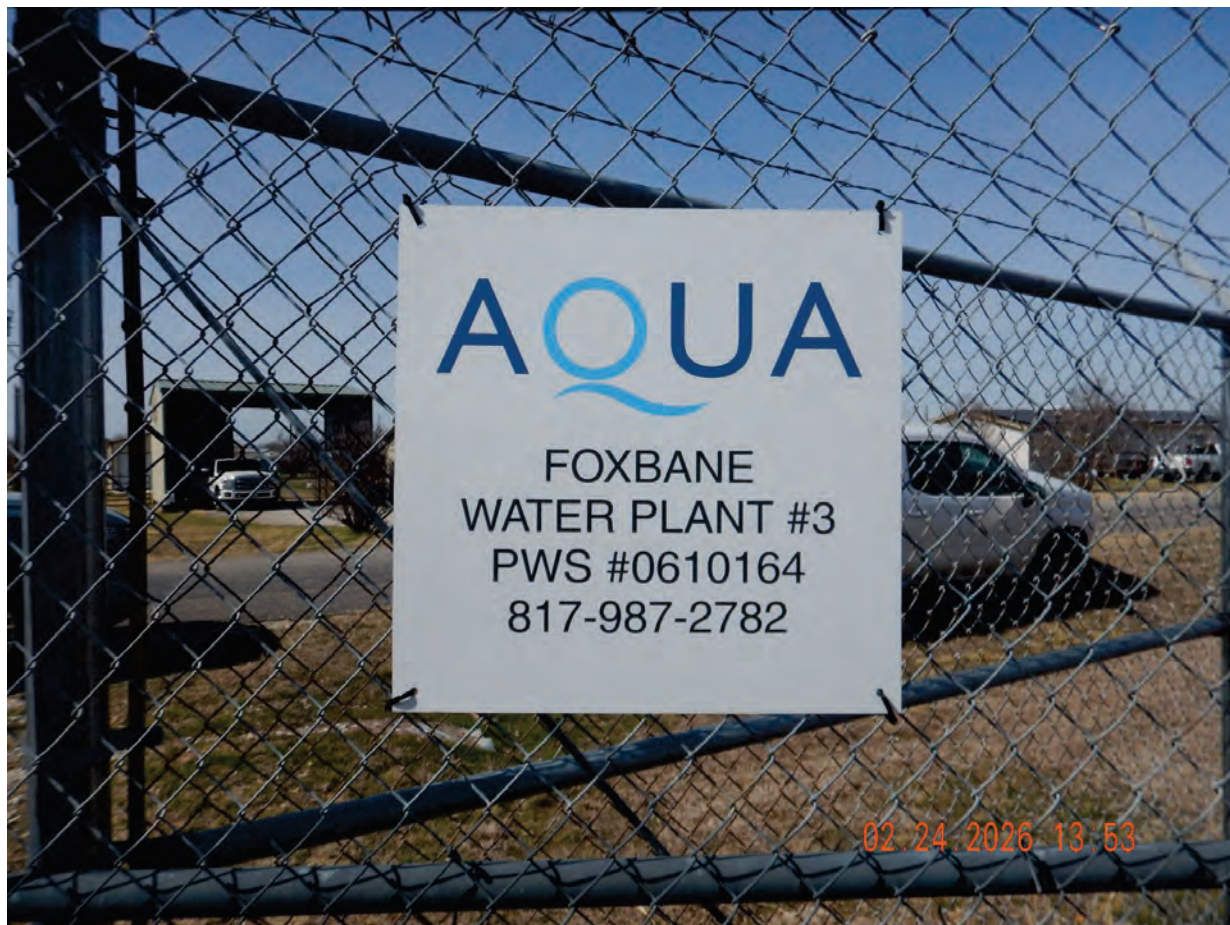
## Photograph No. 3

| Description: | Locked fence with barbed wire and signage Plant 3 (Sage Meadows Plant). | | | | |

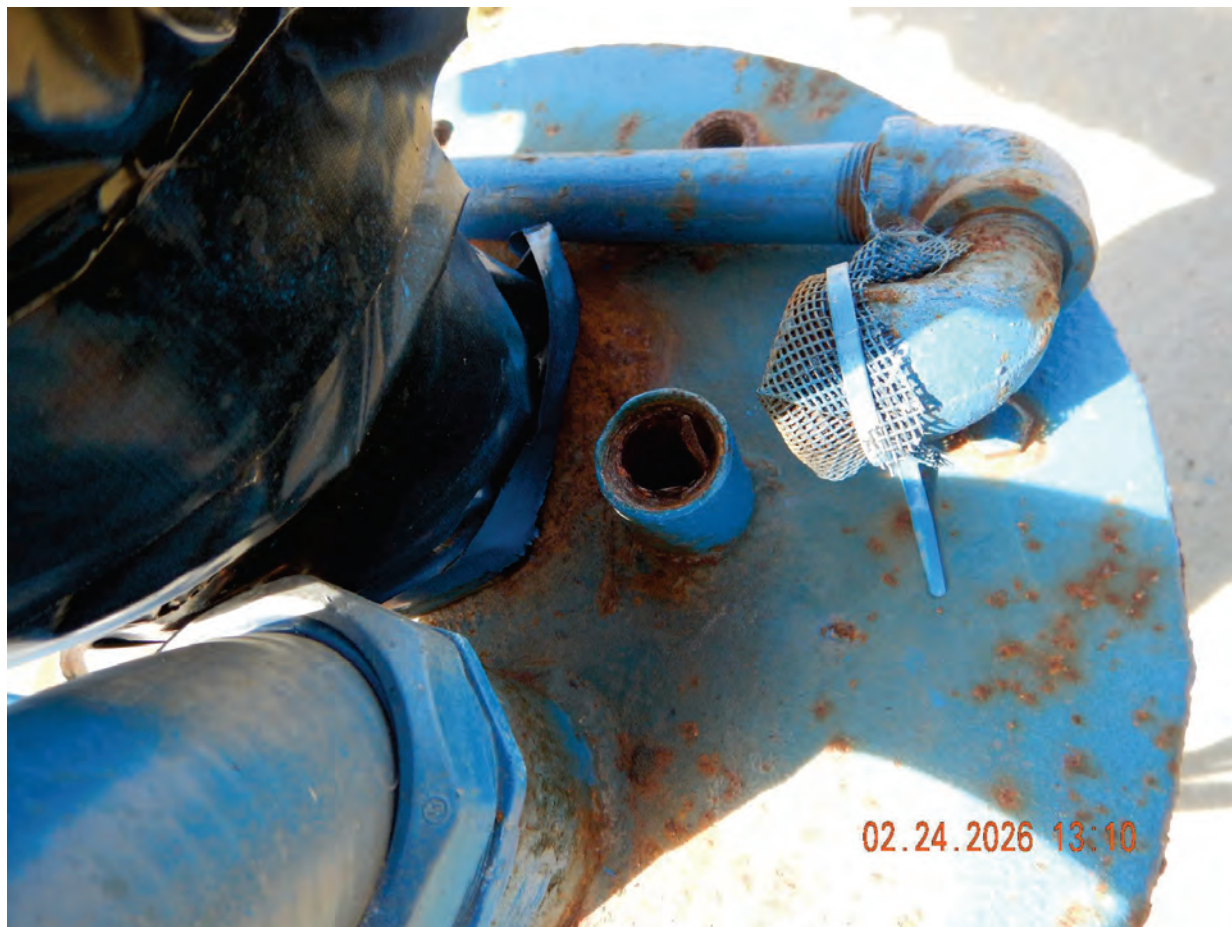
**Area of Concern 1.** Plant 1 (Foxbane Plant): Air vent part of the water well 1 (G0610164A) was broken/disconnected (Appendix 2, Photograph 12).

| Description: | Plant 1: Broken/disconnected Air Vent. | | | | |

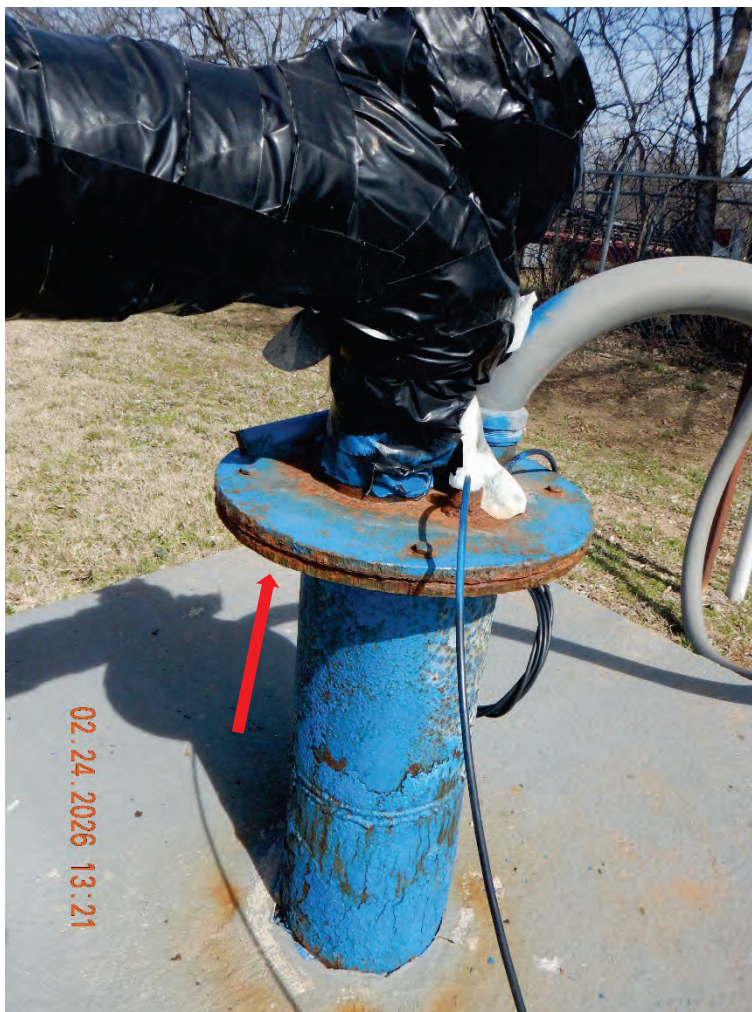
**Area of Concern 2.** Plant 1 (Foxbane Plant): deteriorating seal creating gaps around the wellhead (Appendix 2, Photograph 13).

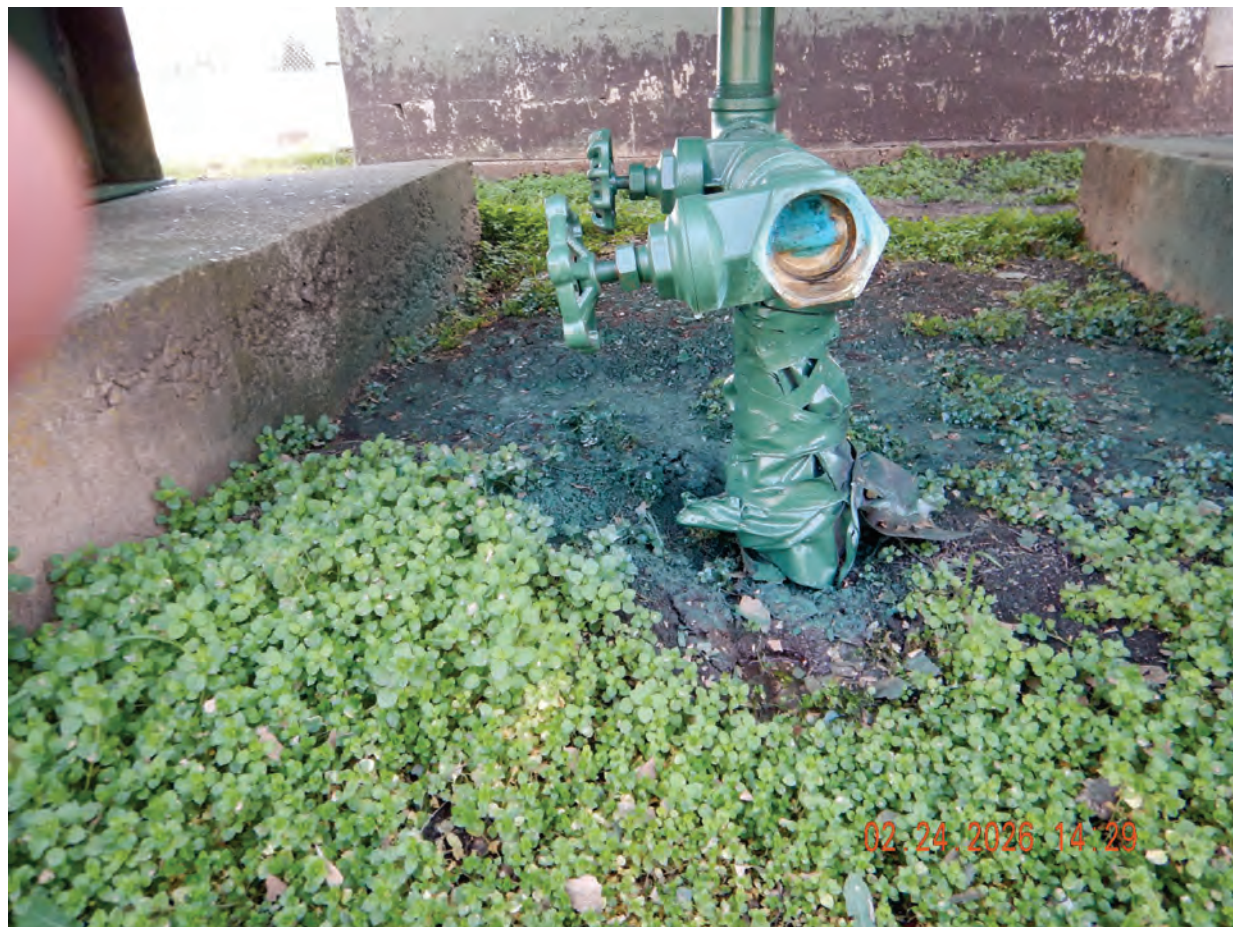
**Area of Concern 3.** Plant 4 (Riggs Place Plant): Leaking of the check valve or pressure release valve of the pressure tank (Appendix 2, Photograph 14).

| Description: | Leaking of the check valve or pressure release valve at Plant 4. | | | | |

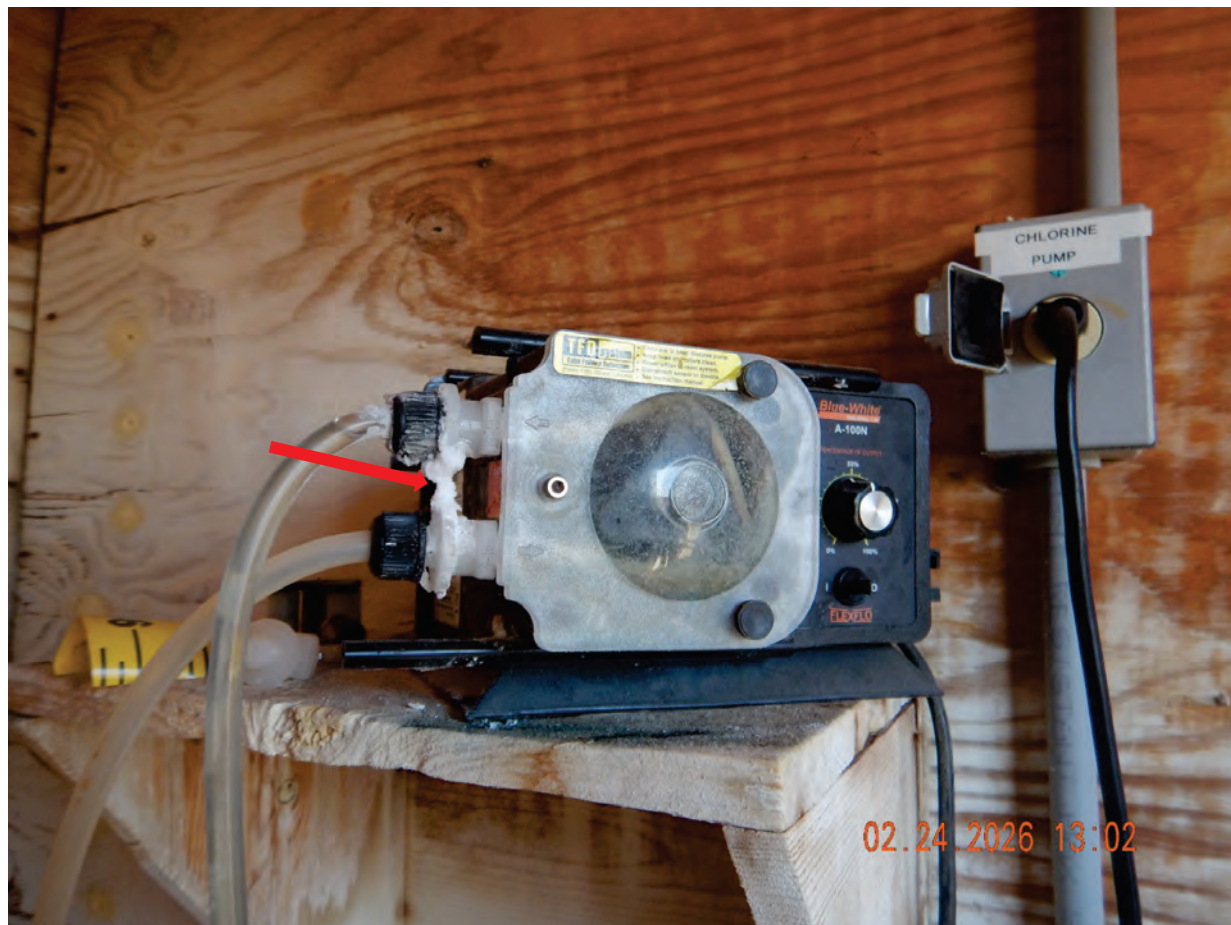
**Area of Concern 5.** Plant 1 (Foxbane Plant): Leaks creating a buildup around the Chlorine pump system (Appendix 2, Photograph 15).

| Description: | Leaks build-up around the Chlorine pump at Plant 1. | | | | |

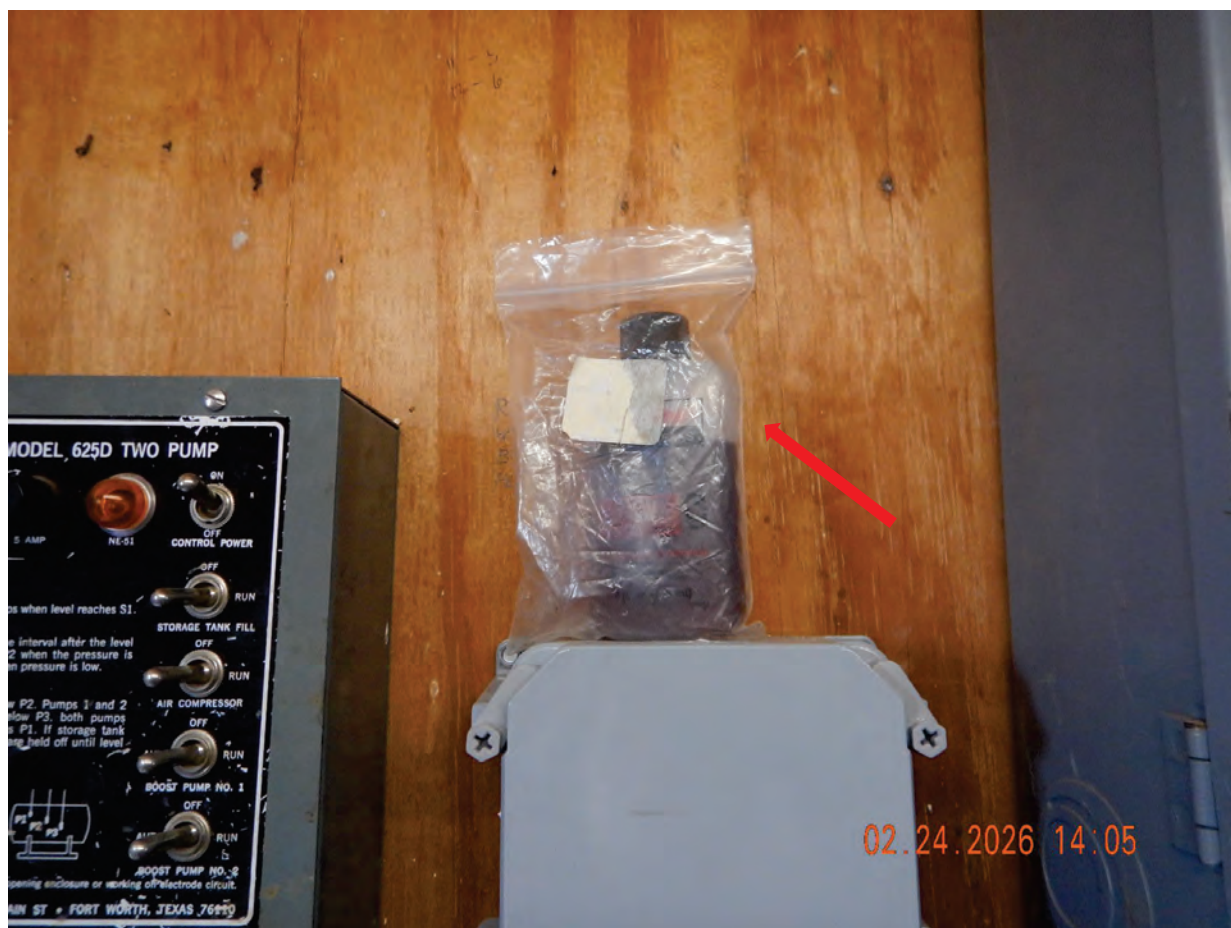
**Area of Concern 6.** Plant 3 (Sage Meadows Plant): unlabeled chemical bottle in the treatment room (Appendix 2, Photograph 16).

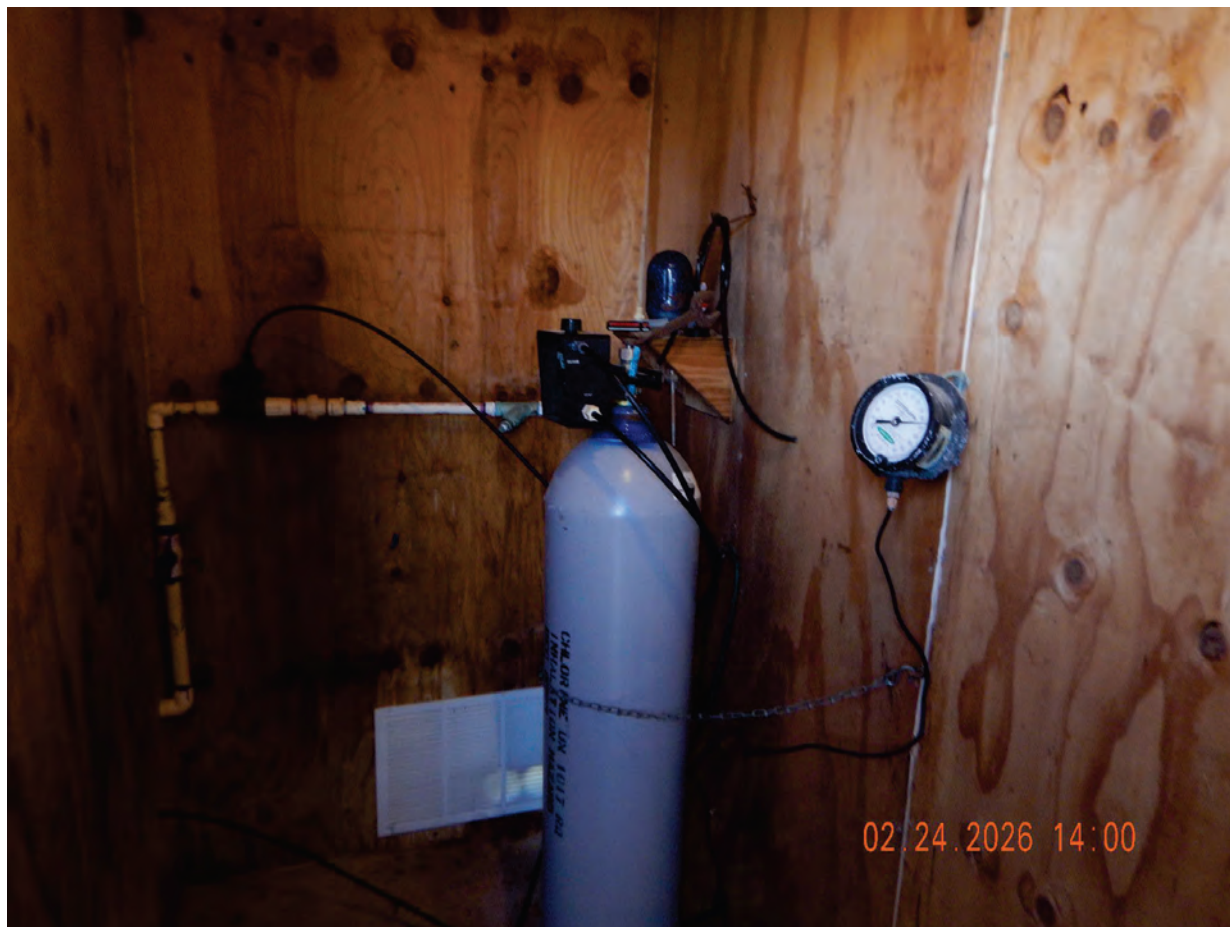
**Area of Concern 7.** Plant 3 (Sage Meadows Plant): No chlorine gas monitoring sensor is installed to detect leaks. Scot Foltz stated that management plans to eliminate the chlorine gas feed; however, a timeline for when this will occur was not provided (Appendix 2, Photograph 17).

| Description: | No chlorine gas monitoring sensor to detect leaks at Plant 3. | | | | |

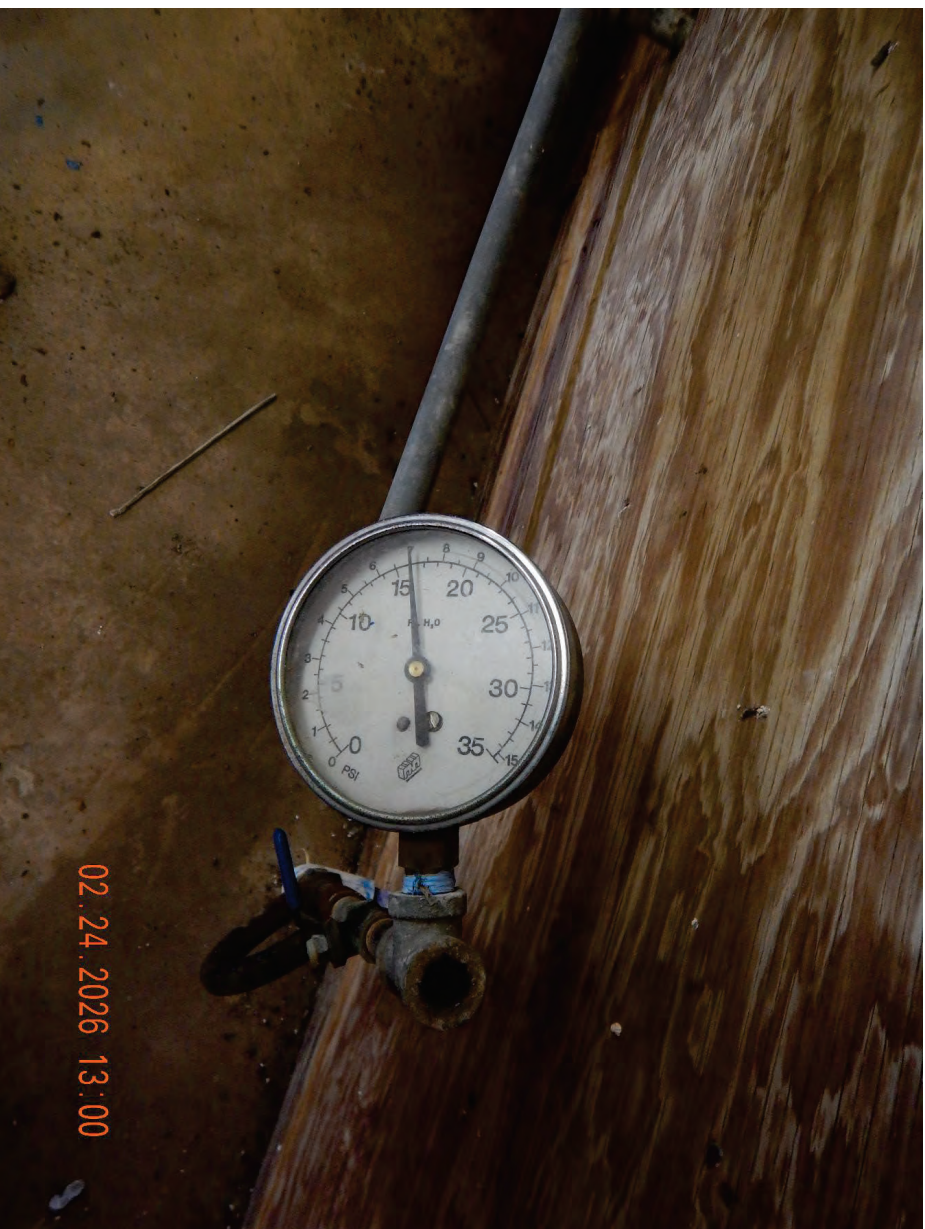
**Area of Concern 8.** Plant 1 (Foxbane Plant): pressure gauge indicated 16 PSI in the treatment room. It is unclear if the pressure gauge was connected to a water pressure tank in distribution (Appendix 2, Photograph 18).

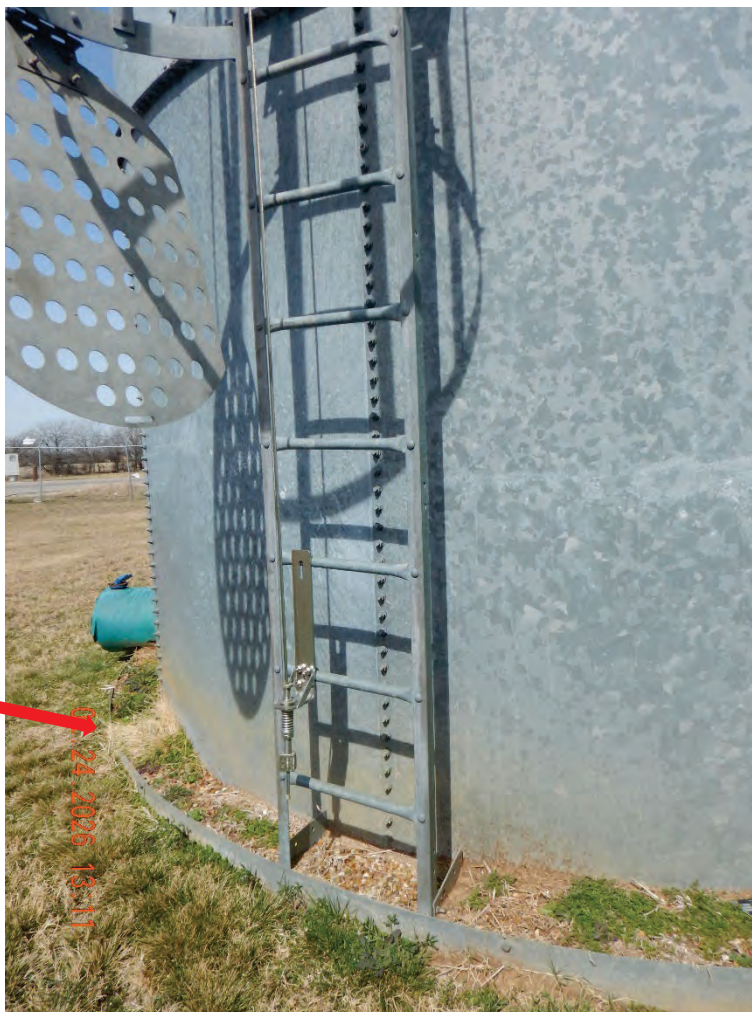
**Area of Concern 9.** Plant 1 (Foxbane Plant): No concrete pads to prevent overflow around the ground storage tanks which can lead to erosion potential damaging to tank foundation (Appendix 2, Photograph 19).

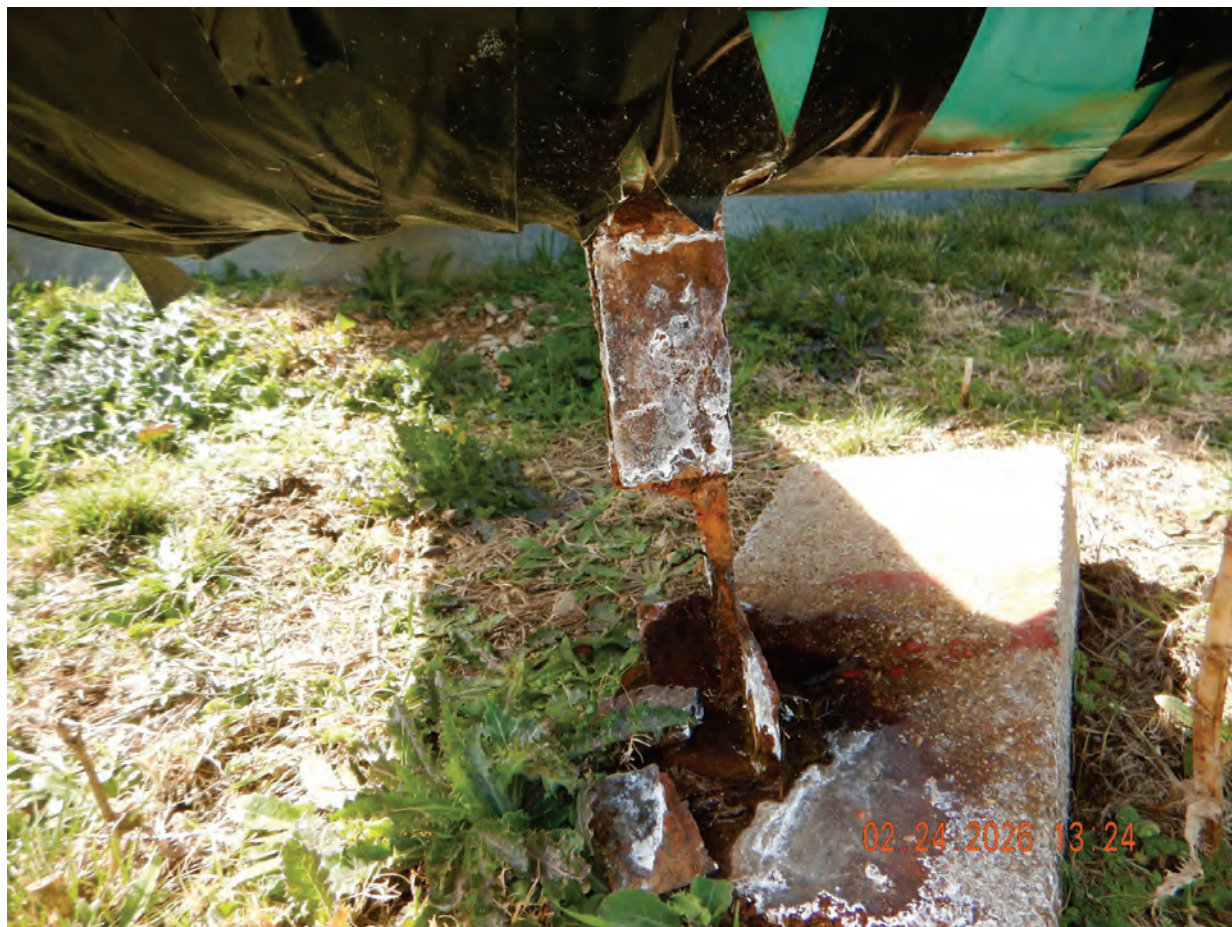
**Area of Concern 10.** Plant 1 (Foxbane Plant): The support underneath pressure tank has severe rusting (Appendix 2, Photograph 20).

| Description: | Severe rusting of pressure tank support at Plant 1. | | | | |

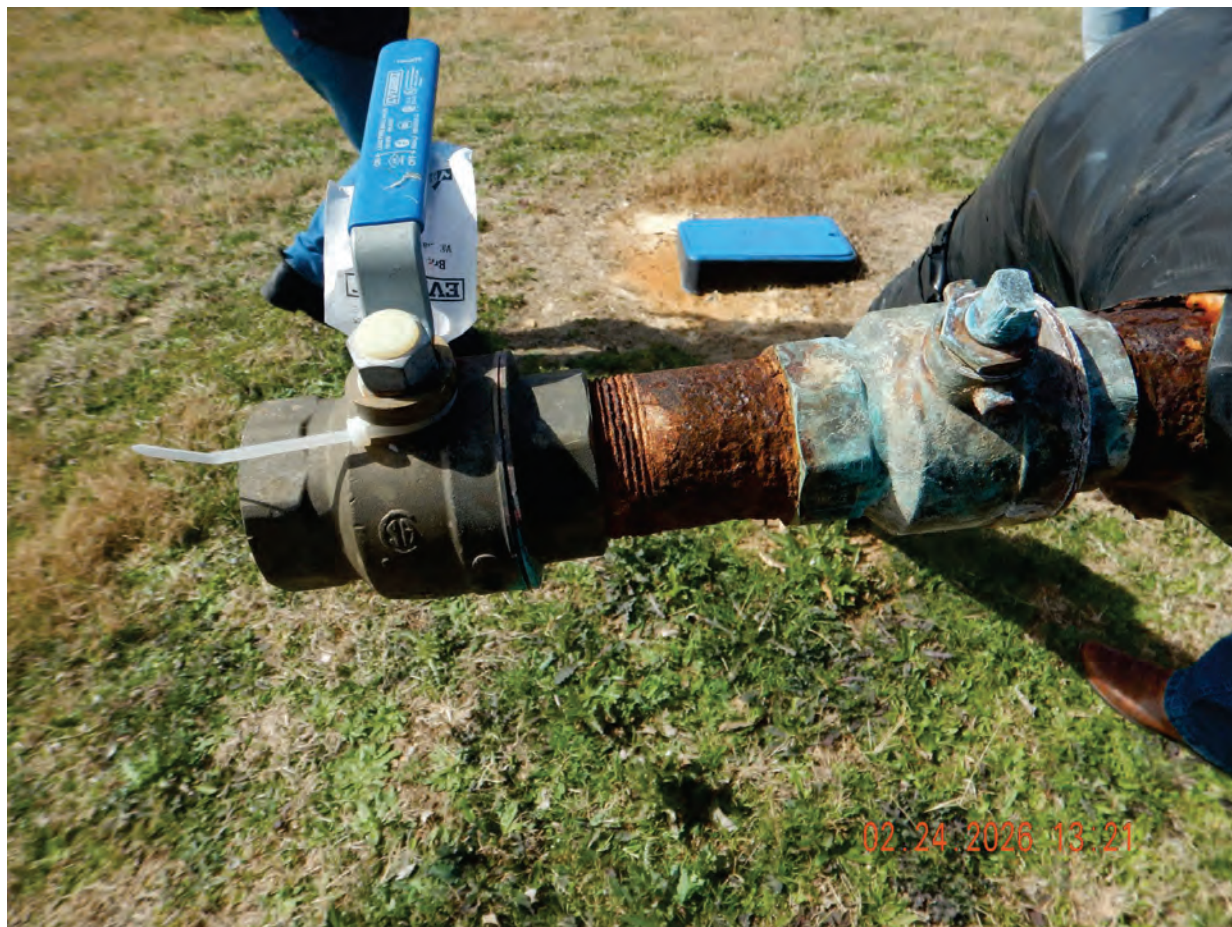
**Area of Concern 11.** Plant 1 (Foxbane Plant): Severe rusting around well head (Appendix 2, Photograph 21).

| Description: | Severe rusting around wellhead at Plant 1. | | | | |

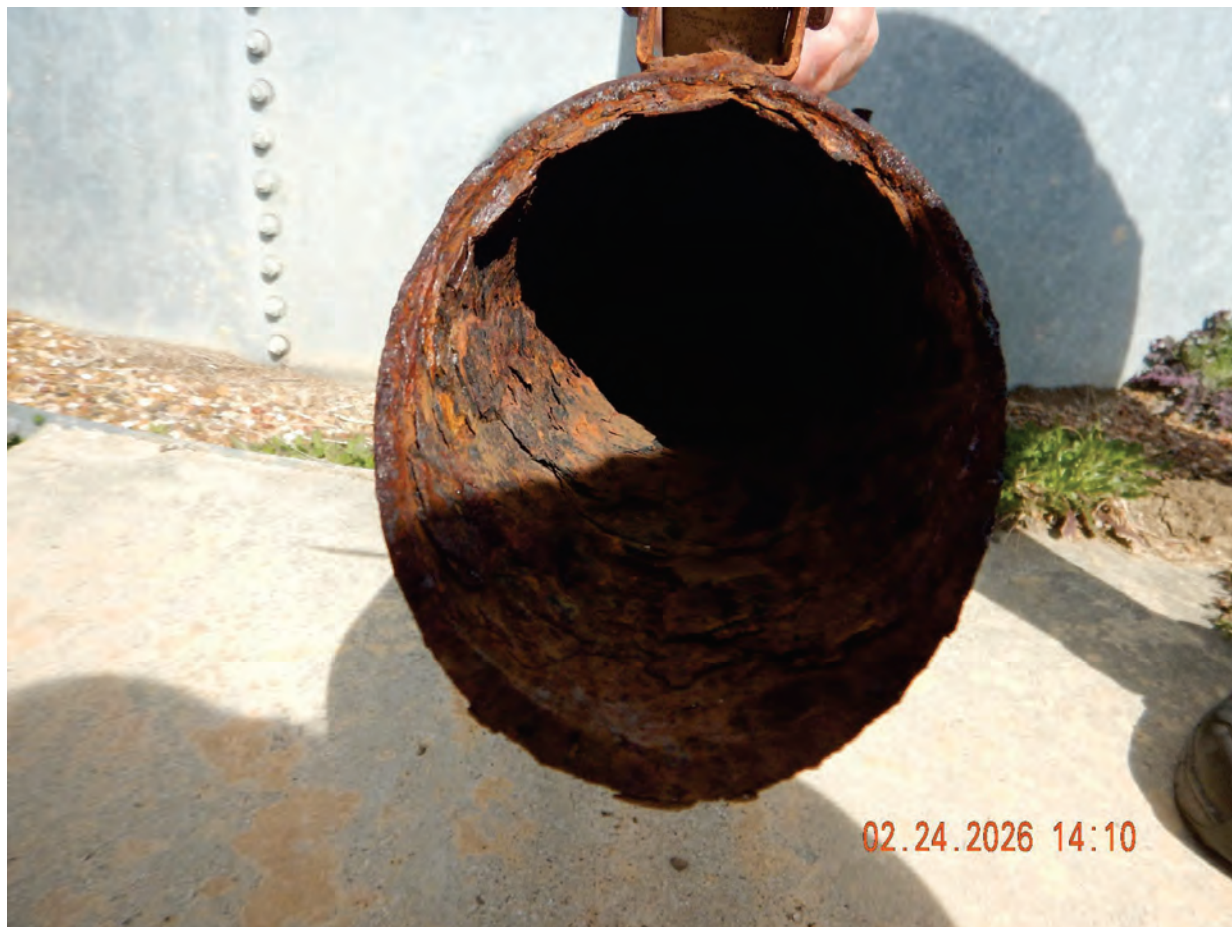
**Area of Concern 12.** Plant 3 (Sage Meadows Plant): severe rusting of drainpipe, potential contamination into the water (Photograph 22).

| Description: | Severe rusting of drainpipe at Plant 3. | | | | |

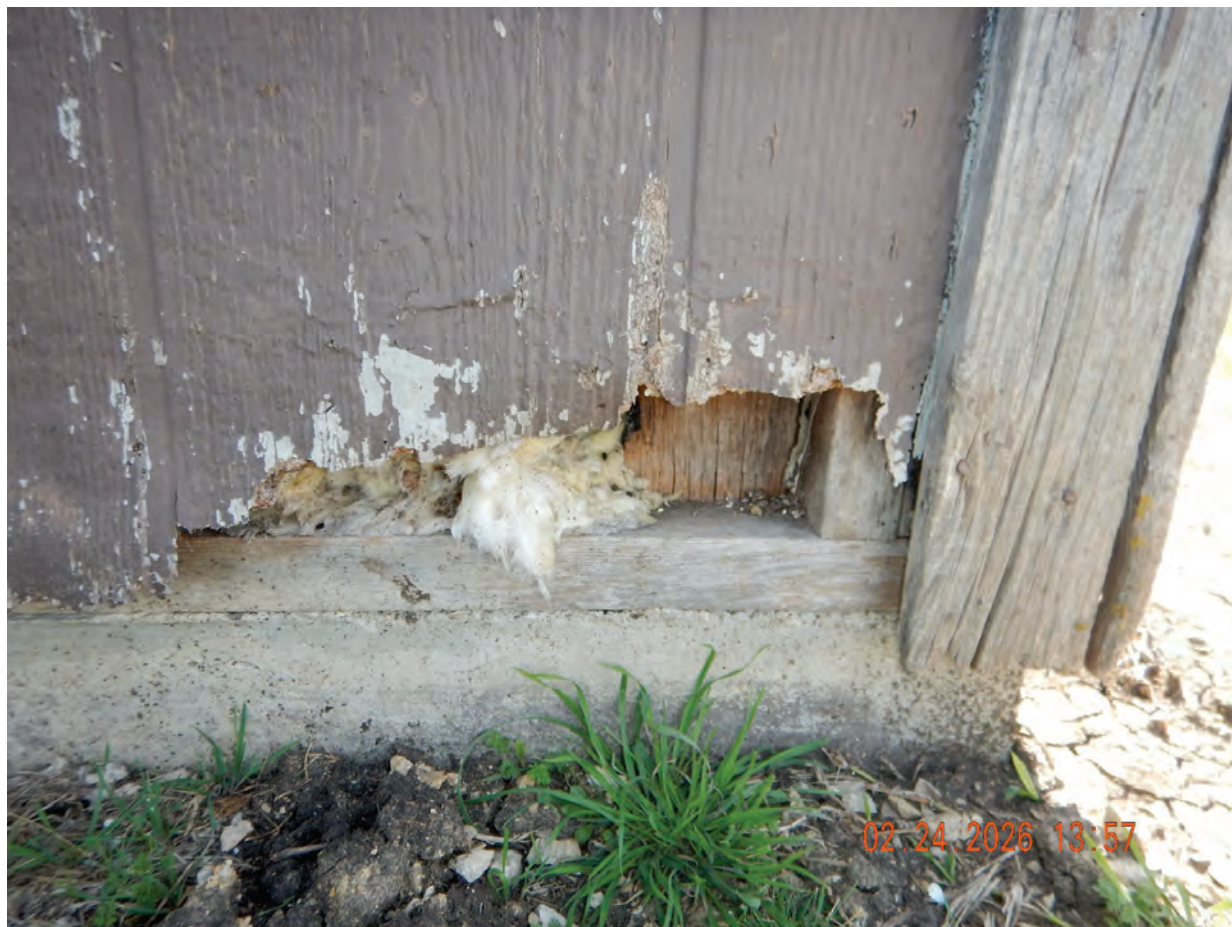
**Area of Concern 13.** Plant 3 (Sage Meadows Plant): Opening in Chlorine gas room exterior wall (Appendix 2, Photograph 23).

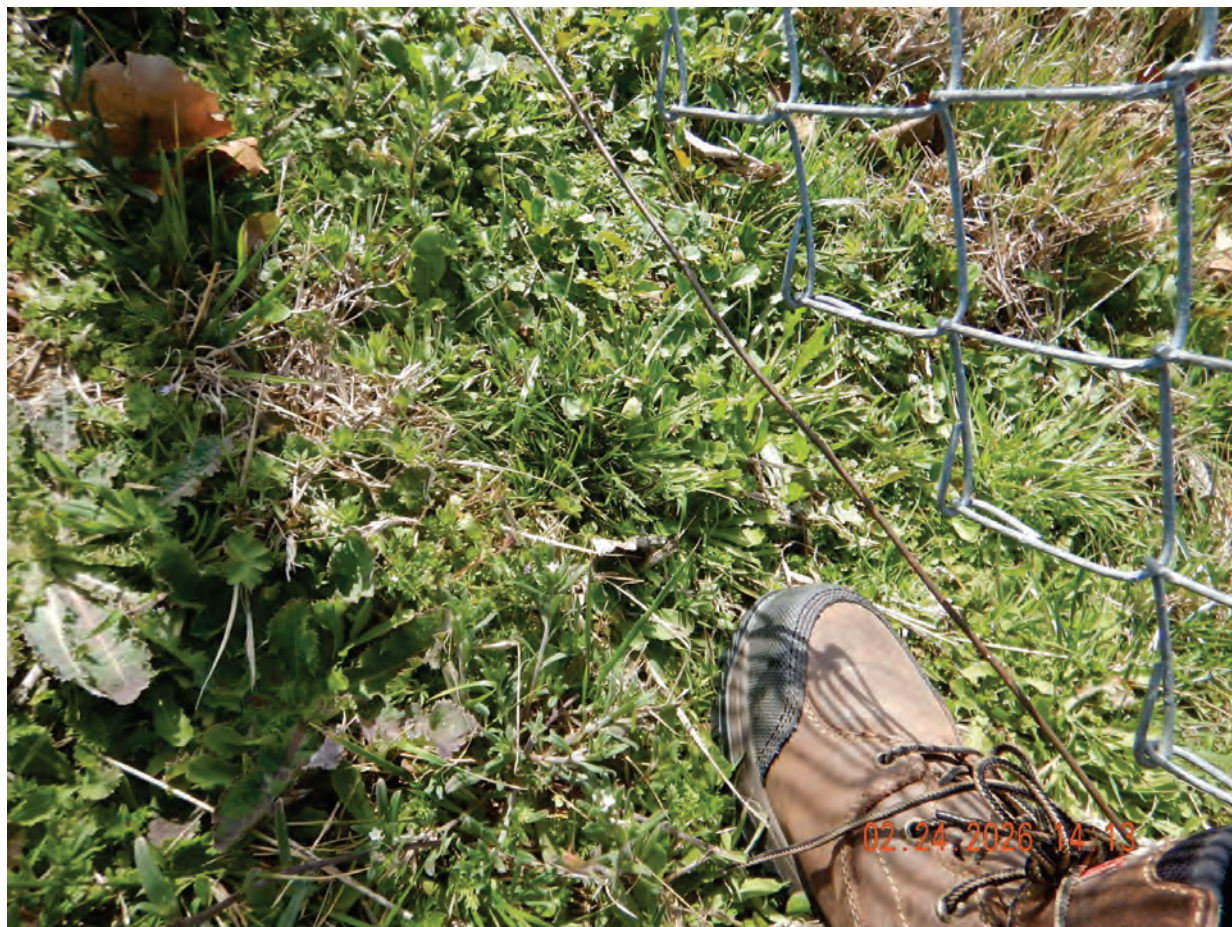
**Area of Concern 14.** Plant 3 (Sage Meadows Plant): There was a big gap in the fence facing South of the plant, and it needs to be sealed (Appendix 2, Photograph 24).

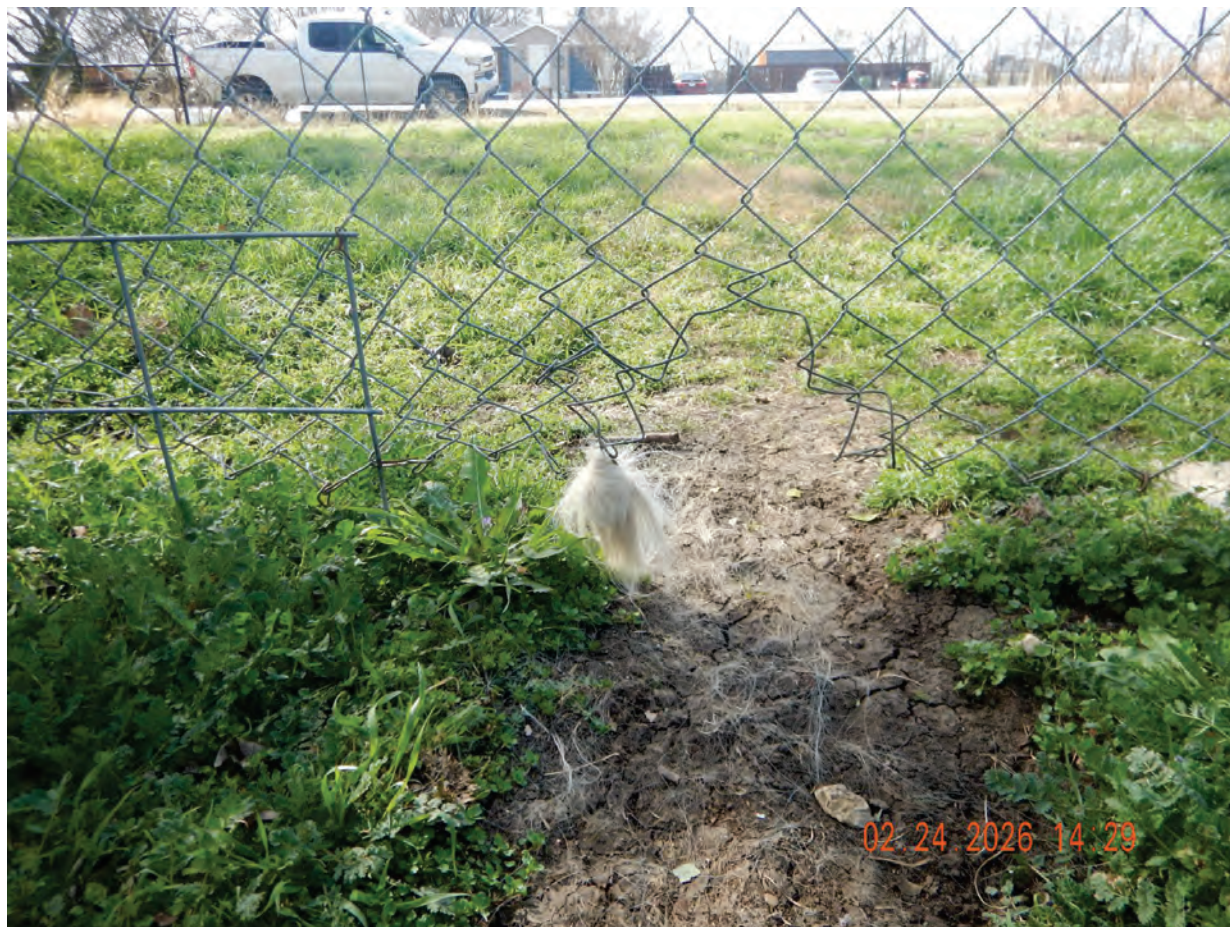
**Area of Concern 15.** Plant 4 (Riggs Place Plant): A big hole in the fence (Appendix 2, Photograph 25).

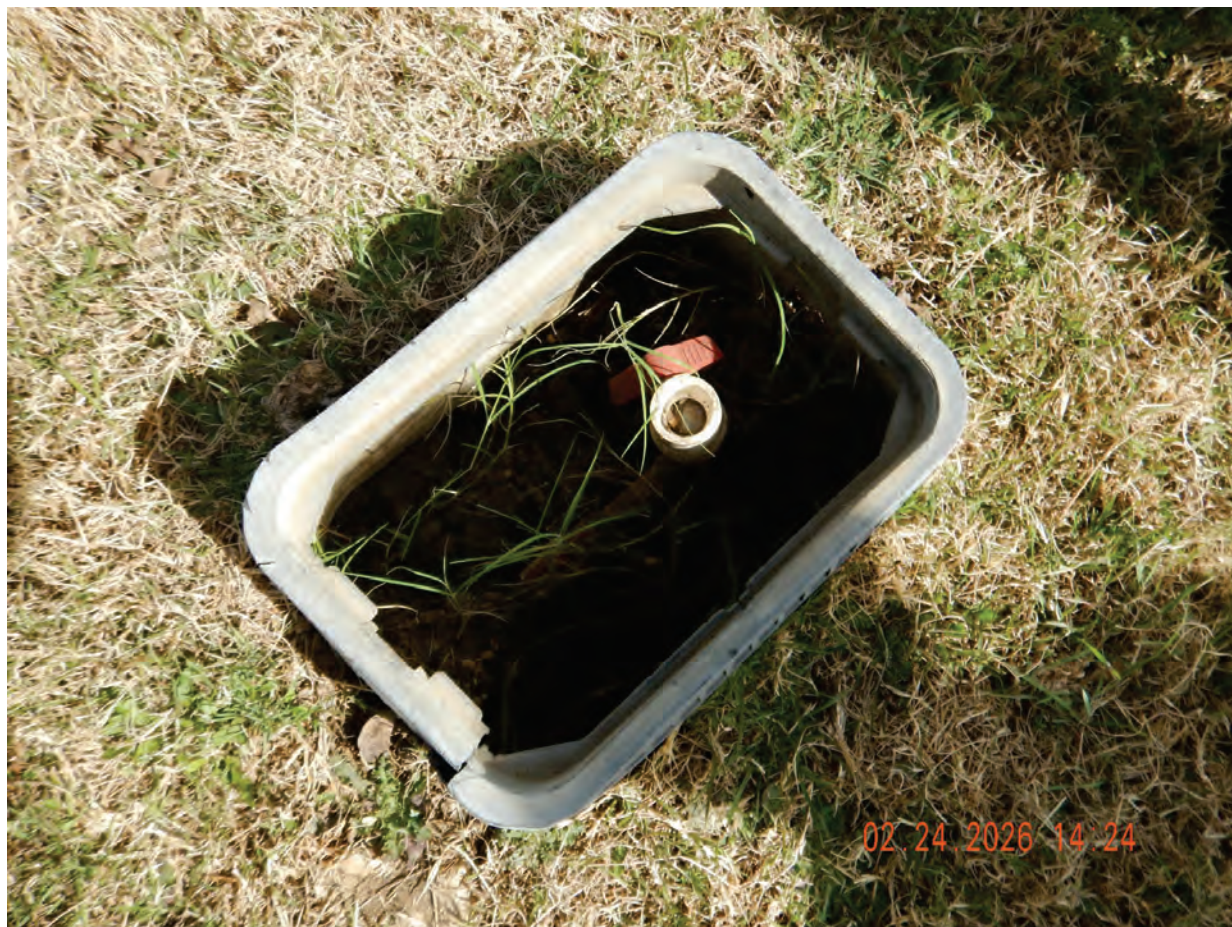
**Area of Concern 16.** Plant 4 (Riggs Place Plant): Vegetation growth in the injection point (Appendix 2, Photograph 26).
