B.F.GOODRICH CHEMICAL COMPANY  
Avon Lake General Chemical Plant

SUBJECT: Near Miss - Separation of Speed Line Flanges on Wash Down Line Bldg. 461

SUBJECT: Vinyl Chloride Release at Tank Farm - Repetitive Accident Type #10

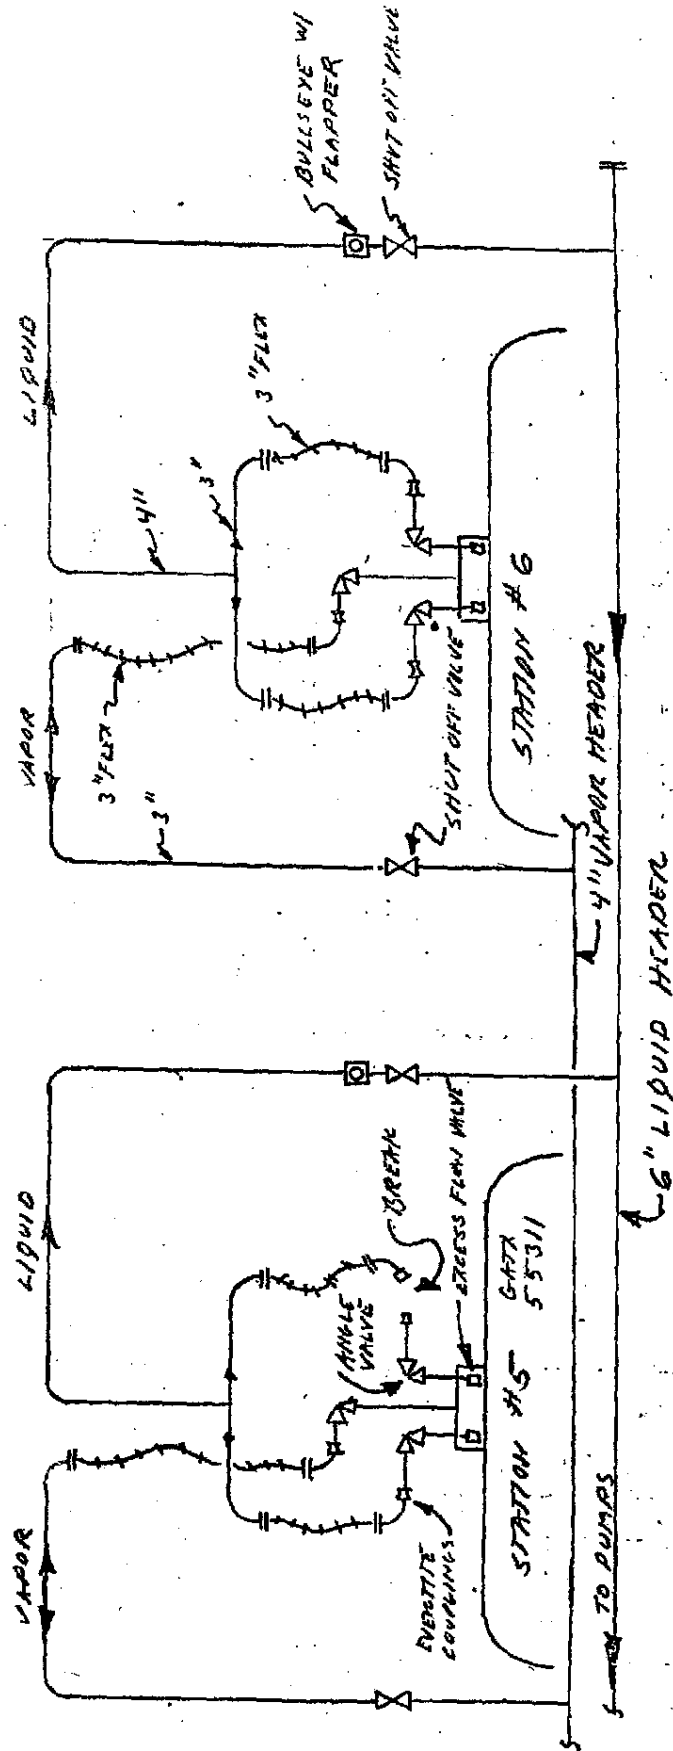
PIPING SCHEMATIC OF  
VCL UNLOADING STATIONS  
F.H.  
3/6/73

1. The tank farm operator had connected the tank car GATX 55311 located on station #5 for unloading to the sphere at 7:00 A.M.
  - a. In making the hook up he had wired down the Ever-Tite coupling clamp handles. It has been a practice during the last 8 - 10 years to use additional restraints on the Ever-Tite coupling handles for extra protection. This was initiated by tank farm operators because of an experience with a tank truck company transporting plasticizer whose hose coupling parted because of excessive wear. The wire used on the coupling in question was broken.

2. The Ever-Tite coupling that was uncoupled and permitted the VCl escape, was inspected and found in good condition.
3. When the Ever-Tite company was contacted they agreed that under certain conditions of vibration, the coupling can part. The tank farm operator stated that in many instances while unloading tank cars, the excess flow valves in the cars will chatter excessively and with a violence that shakes the car and transfer lines.

5. In approaching the tank car to close the valves, the tank farm operator and foreman both noticed the vinyl chloride being emitted in spurts from the rigid pipe connected to the tank car (male end of Ever-Tite coupling). The flexible hose with the female end of the coupling was also emitting VCl with enough pressure to make the flex hose whip violently. (See attached drawing).

- ①. The tank farm operators have regularly used DuPage screw type hose clamps to retain the 2" Ever-Tite coupling handles, but had started to use wire on the 3" couplings when they were installed last year. The operators have been instructed to discontinue use of wire and to use the hose clamps on all coupling clamp handles. This will be incorporated in the Tank Farm Unloading Procedure.

- ④.
  - a. The VCl unloading system transfer lines must be studied to determine if the design prevents the excess flow valves on the tank cars from operating per design.

- b. An engineering study will be made to determine if additional check valves in the system will be an advantage.
  - c. A report of the Engineering Department's study will be distributed when completed.

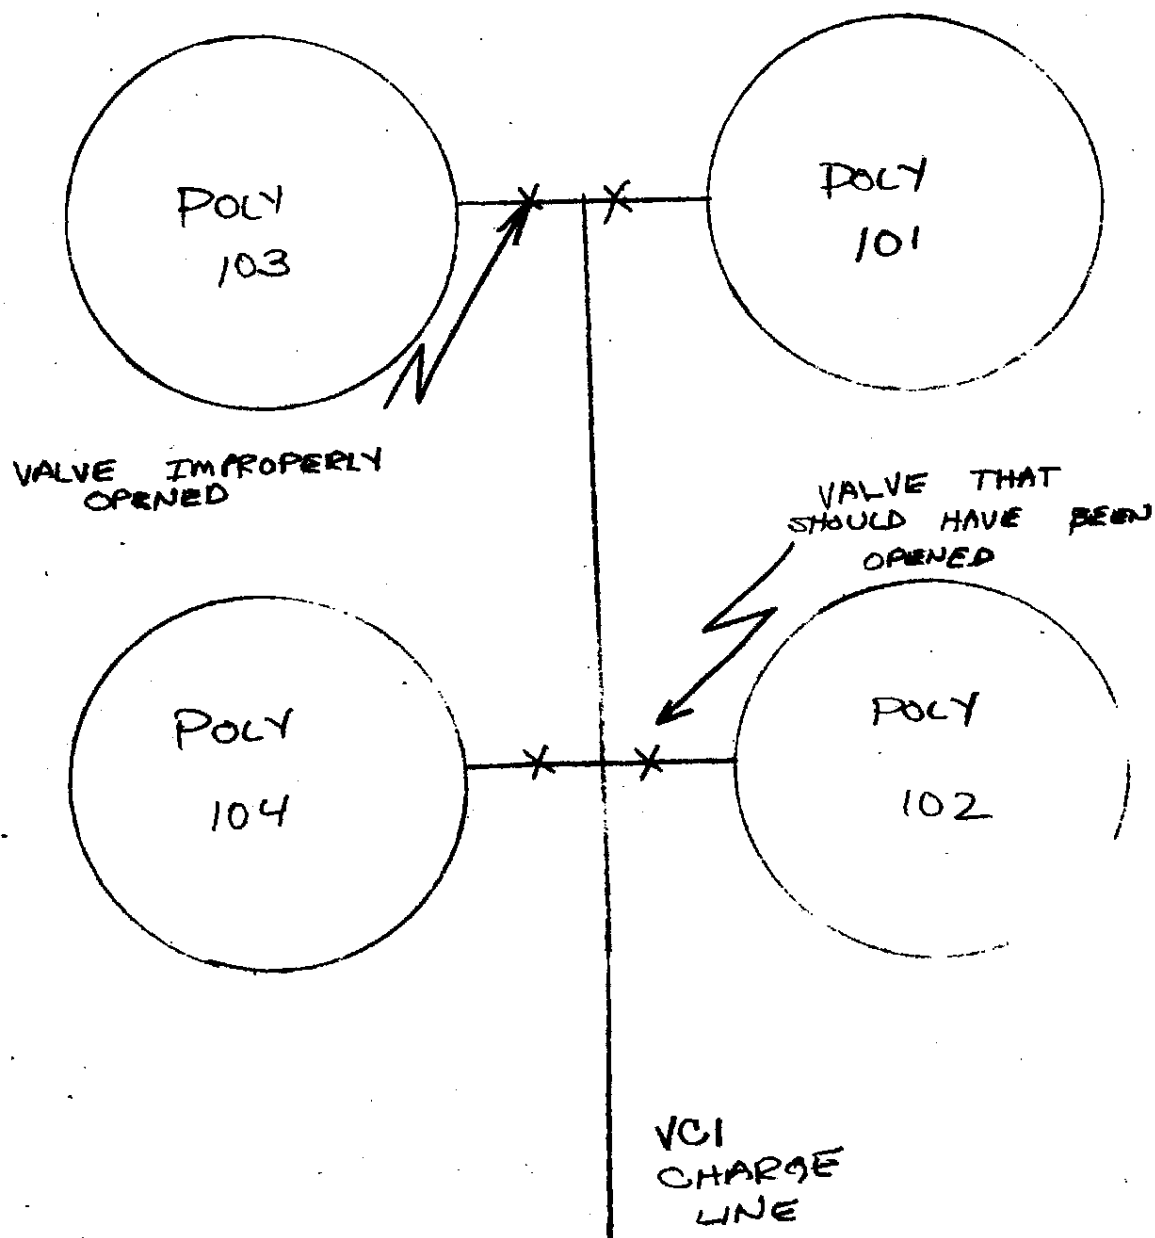
B/461 THIRD FLOOR  
IN AREA OF INCIDENT

On May 21, 1973 at 1440 hours, 370 gallons of Vinyl Chloride monomer discharged into the Geon West Pearl Building and filled the building with vapors. The building was evacuated for 10 minutes while the source of the discharge was found, stopped and the building cleared of the vapors. The discharge was the result of an operator error. He charged the wrong poly.
