**REGION 1**

Re: *Bemmer Petroleum Corporation*: Notice of Potential Violations Pursuant to Section 112(r) of the Clean Air Act, Inspection Close-Out List in Attachment 2, and Notice of Upcoming Compliance Order

## ATTACHMENT 1

### Sample Photographs from EPA's Inspection

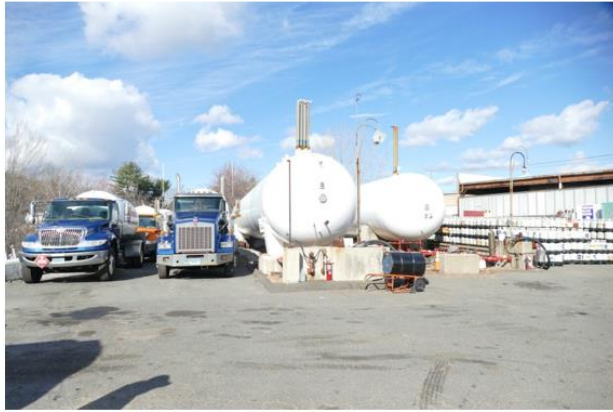
30,000-gallon and 60,000-gallon tanks of propane, filled by trucks. Not in compliance with industry standards of care (NFPA 58).

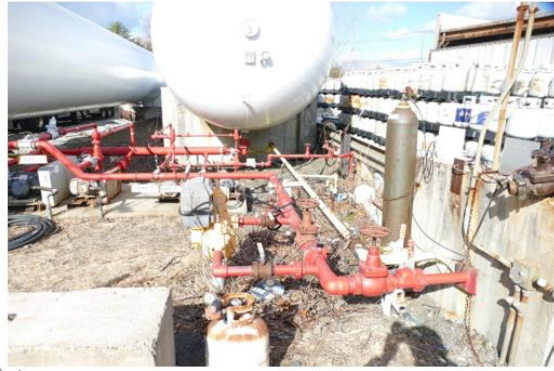
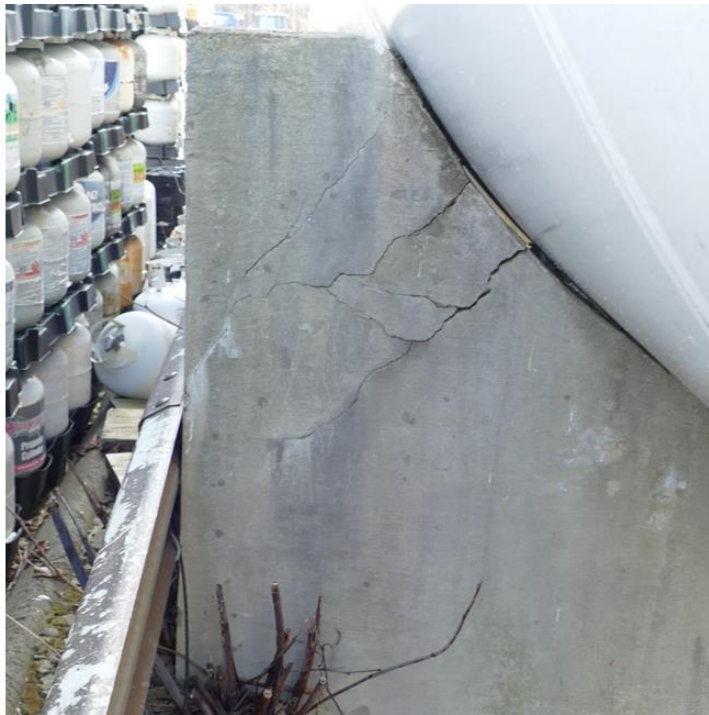
Tank support system in poor repair.
