**UNITED STATES ENVIRONMENTAL PROTECTION AGENCY**

**Subj:** Inspection Report  
Clean Water Act - National Pollutant Discharge Elimination System  
("NPDES")  
Nathan's Hill, Hanover, MA

- A. *Date(s) of inspection:* August 13, 2024
- B. *Weather Conditions:* Sunny, 79 degrees Fahrenheit
- C. *US EPA Representative(s):*  
Eleanor Horvath  
Karissa Oakes
- D. *State/Local Representative(s):*  
Sandra MacFarlane, Conservation Agent  
Joe Colangelo, Town Manager  
Gabrielle Guy and Sean Dever, Town Interns
- E. *Federally Enforceable Requirements Covered During the Inspection:*  
EPA 2022 Construction General Permit

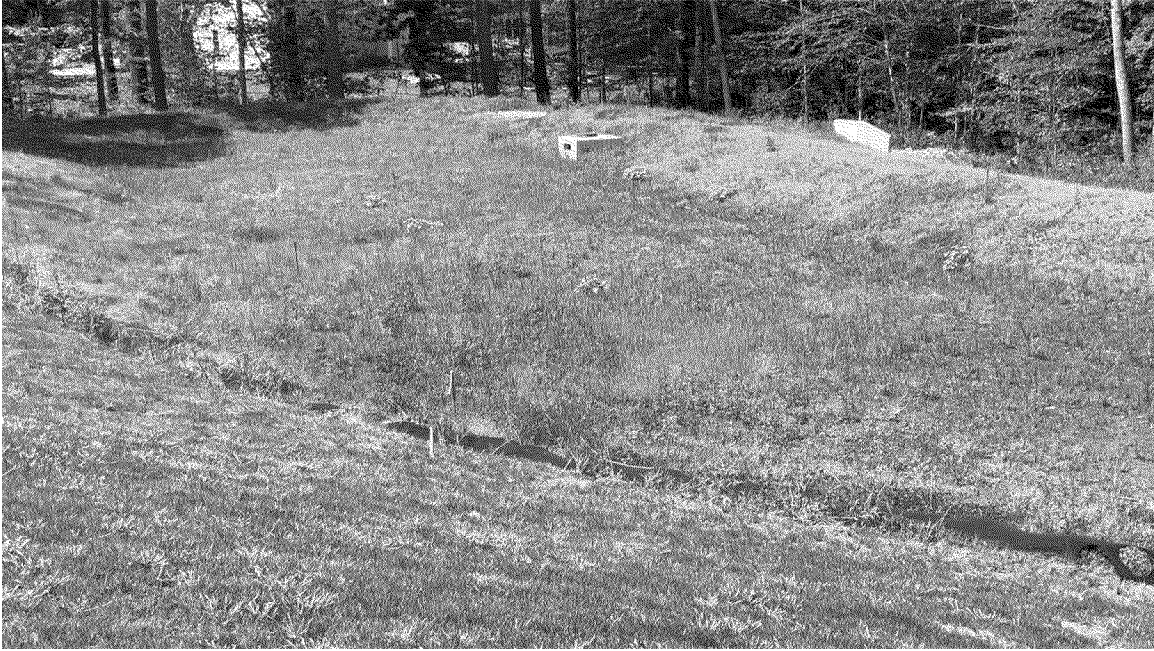
Image: Detention basin (8/13/2024 1:15 PM)
