INSPECTION REPORT

| Type of Inspection | Industrial Stormwater Inspection (ISI) | | |
| Facility or Site Name | Omni Polymers | | |
| Facility/Site Physical Address | 1925 Nebraska | | |

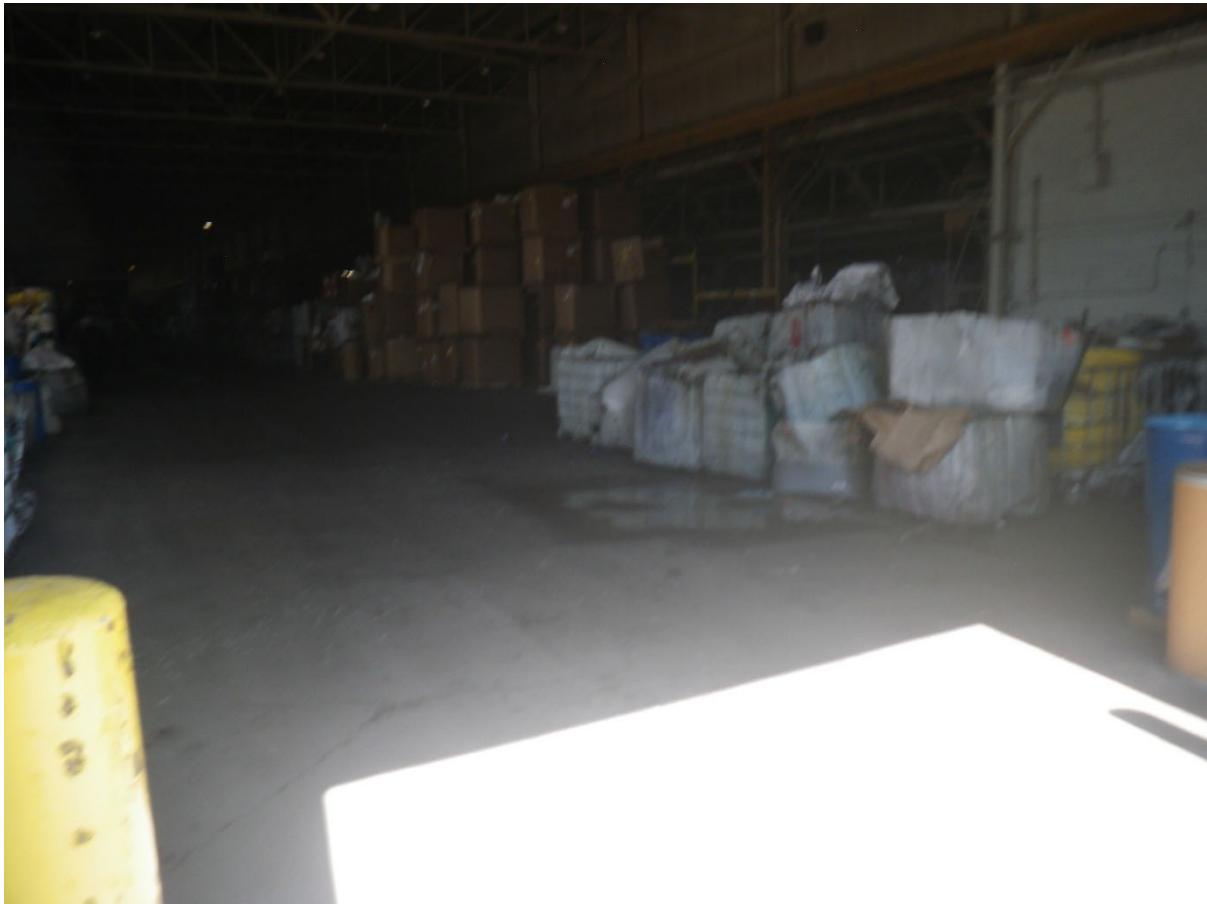
| Intermediate Bulk Storage Containers (IBC) can be seen inside the building through the bay door. A trench drain is at the entrance to the door. | | |

| Photograph 1. View inside Omni Polymers building | | | IMGP0033.JPG |
| East Side of Omni Polymers building looking west into the building showing a storage area | | | |

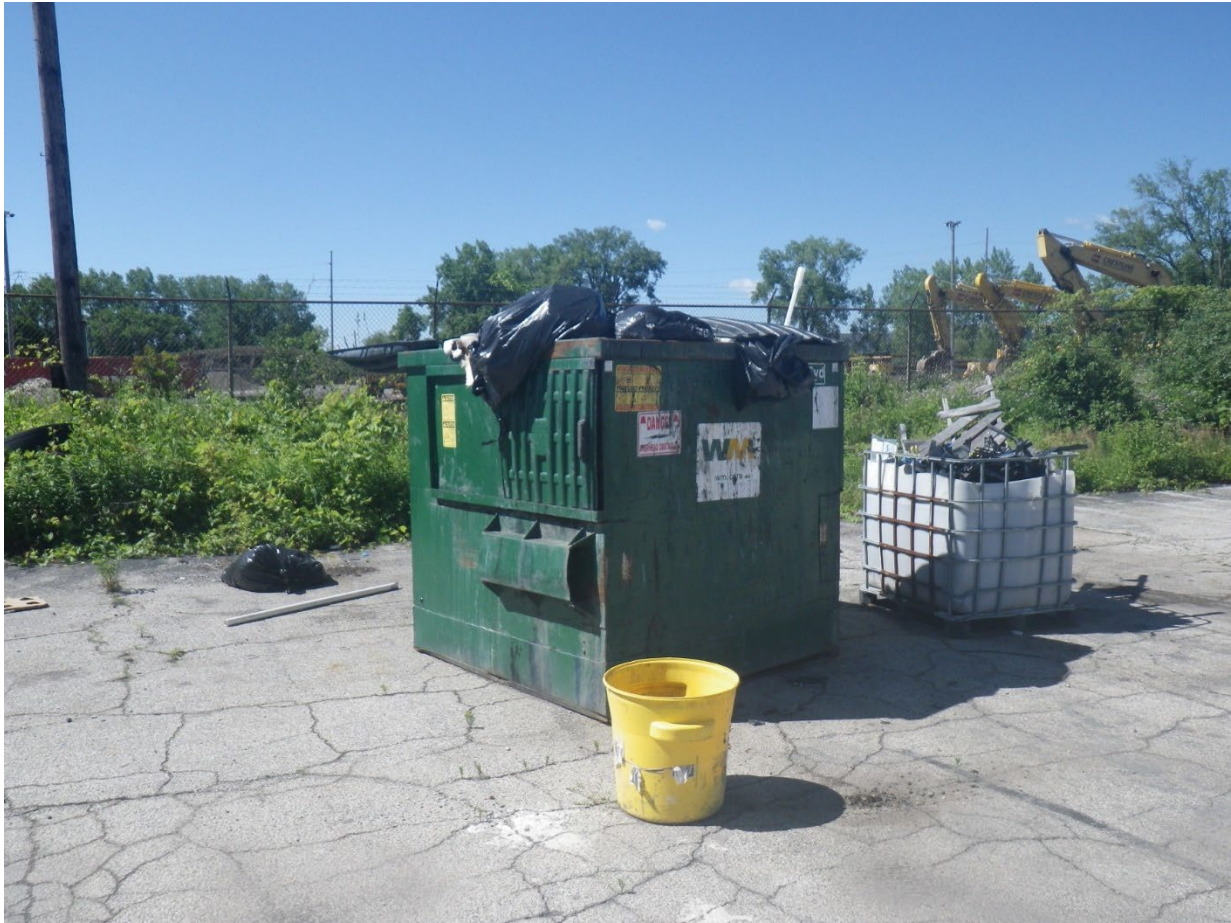
| The trash can is overflowing and trash bags are on the ground. There is a storm drain inlet nearby under a trailer. On top of the trailer is a fuel container with liquid inside of it. There is staining on the ground below where the fuel container is. | | |

| Photograph 3. Trash container with overflowing trash | | | IMGP0035.JPG |
| South-East side of site | | | |

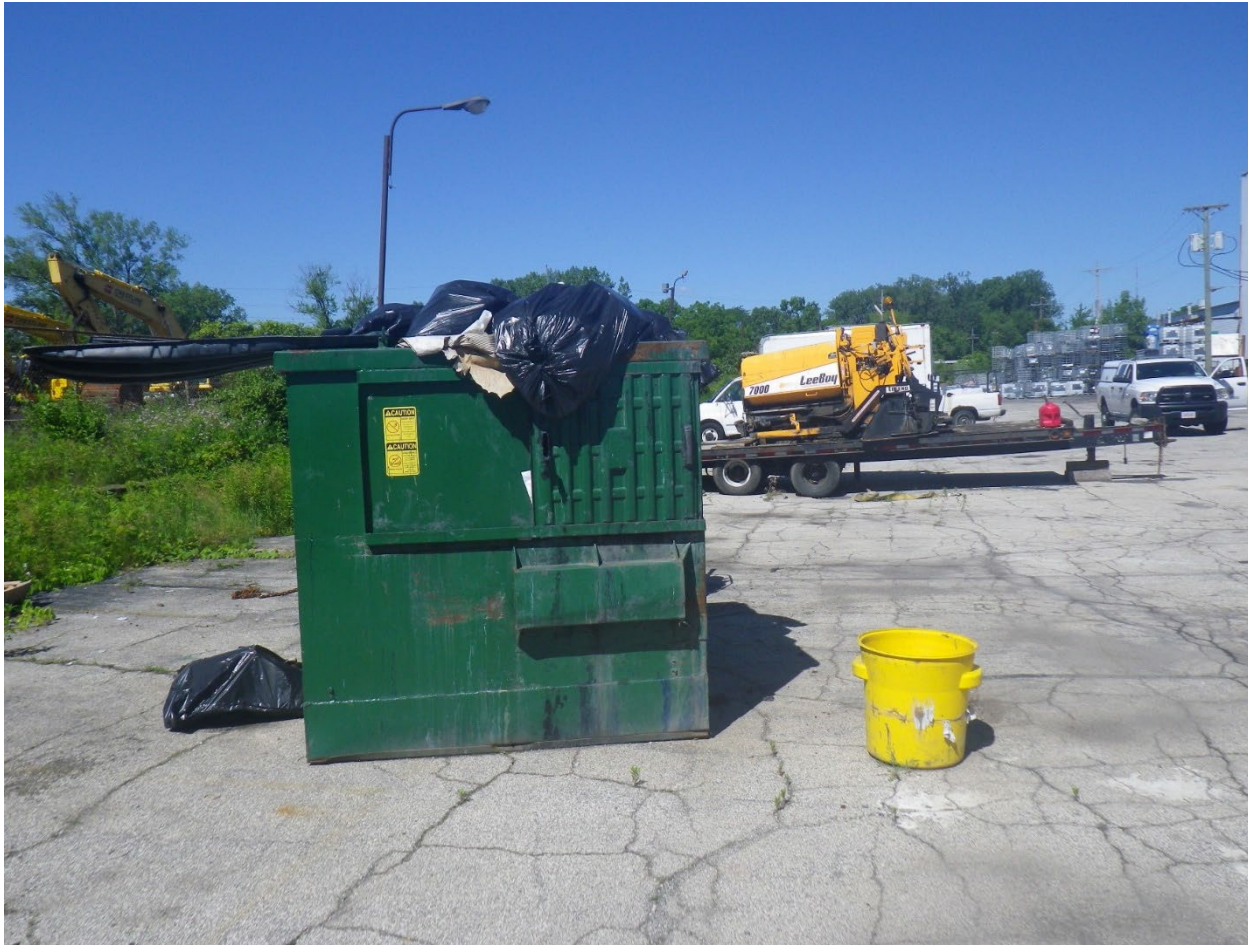
| Photograph 4. Trash container with overflowing trash | | | IMGP0036.JPG |
| South-east side of site. This container is also shown in photograph 3. | | | |

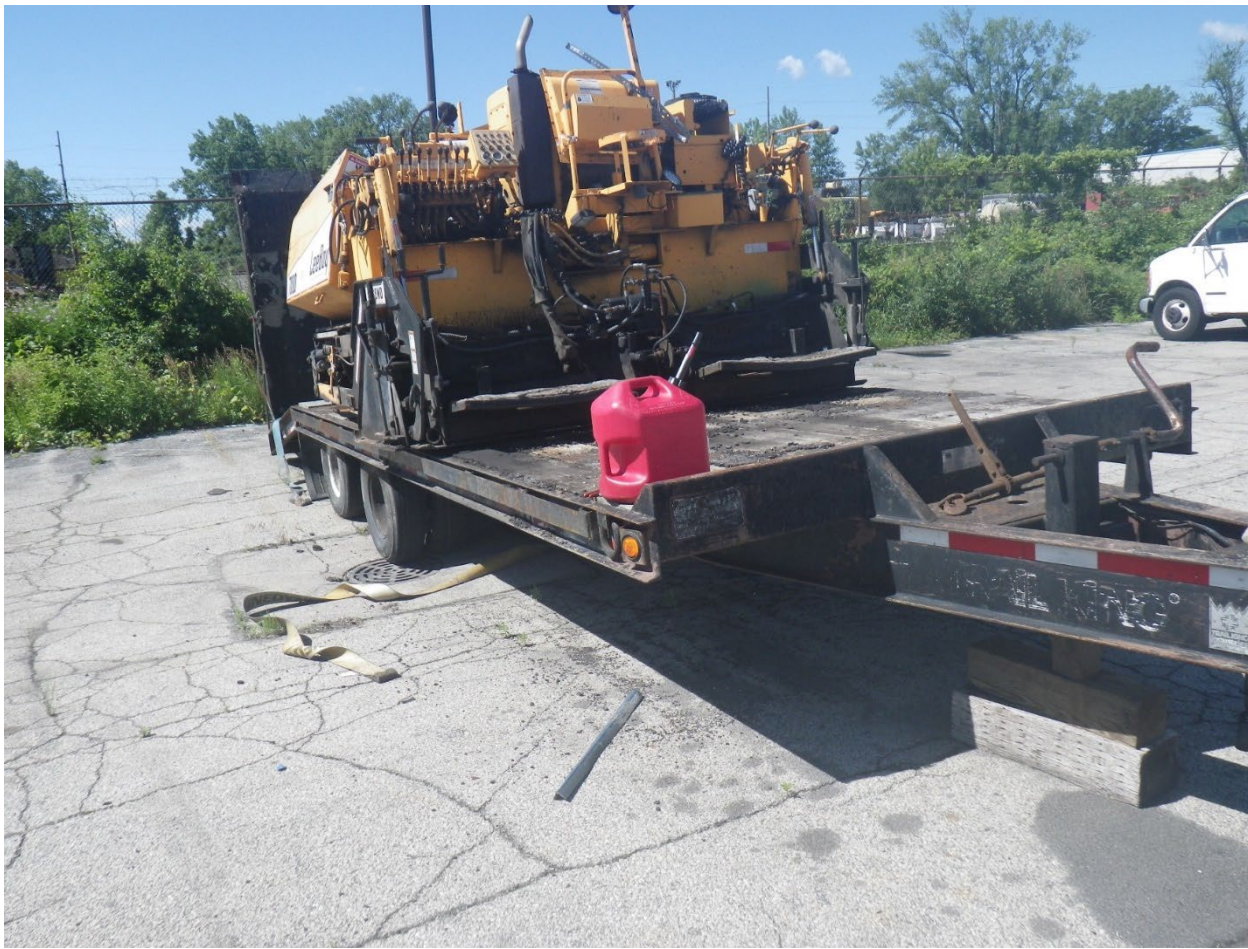
| Photo 5. Trailer with storm drain inlet under wheel. | | | IMGP0037.JPG |
| A gas can with liquid inside of it is on the trailer. Staining can be seen on the ground under the front of the trailer. The trailer is also shown in photograph 4. | | | |

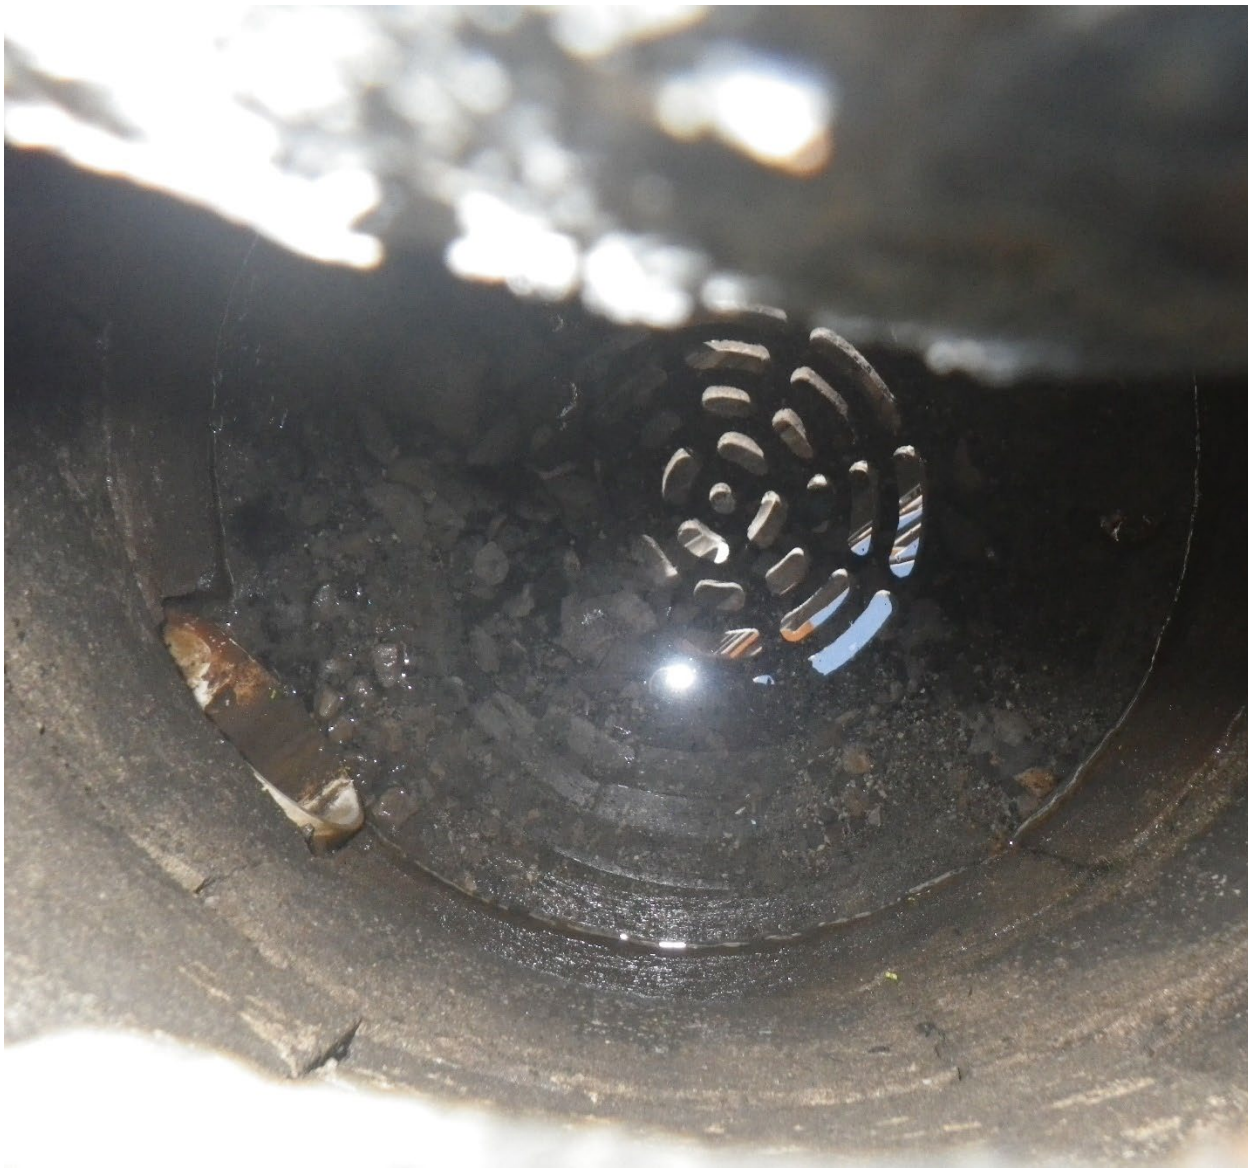
| Photograph 6. View inside of the manhole lid shown in photograph 5. | | | IMGP0038.JPG |
| The inside of the manhole shows a white pipe on the left leading into the structure. The pipe is brown at the bottom of the white pipe. | | | |

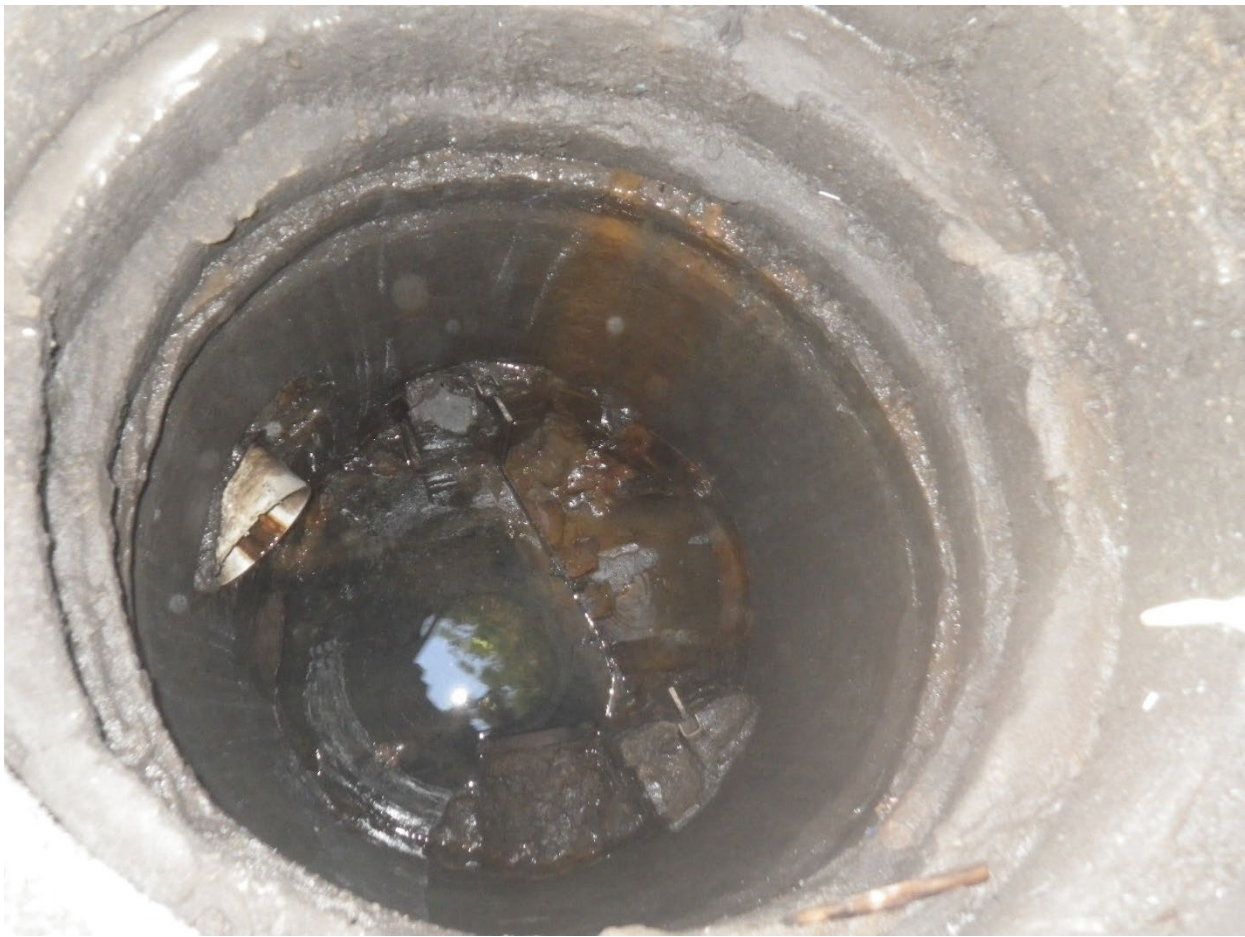
| Inside a manhole located in the southern end of the site near the fence there are multiple pipes connecting into the manhole. One white pipe and three darker pipes connect into the manhole here. The white pipe appears to be coming from a North-easterly direction. The darker pipes appear to go in a South, North and West Direction. | | |

| Photograph 7. Inside manhole #1. | | | IMGP0039.JPG |
| View of the inside of a manhole located in the southern end of the site near the fence line and marked in the attached general sketch as manhole #1, where multiple pipes are connecting into the manhole. One white pipe and three darker pipes connect into the manhole here. The white pipe appears to be coming from a North-easterly direction and has brown material in the bottom of it. The darker pipes appear to go in a South, North and West Direction. | | | |

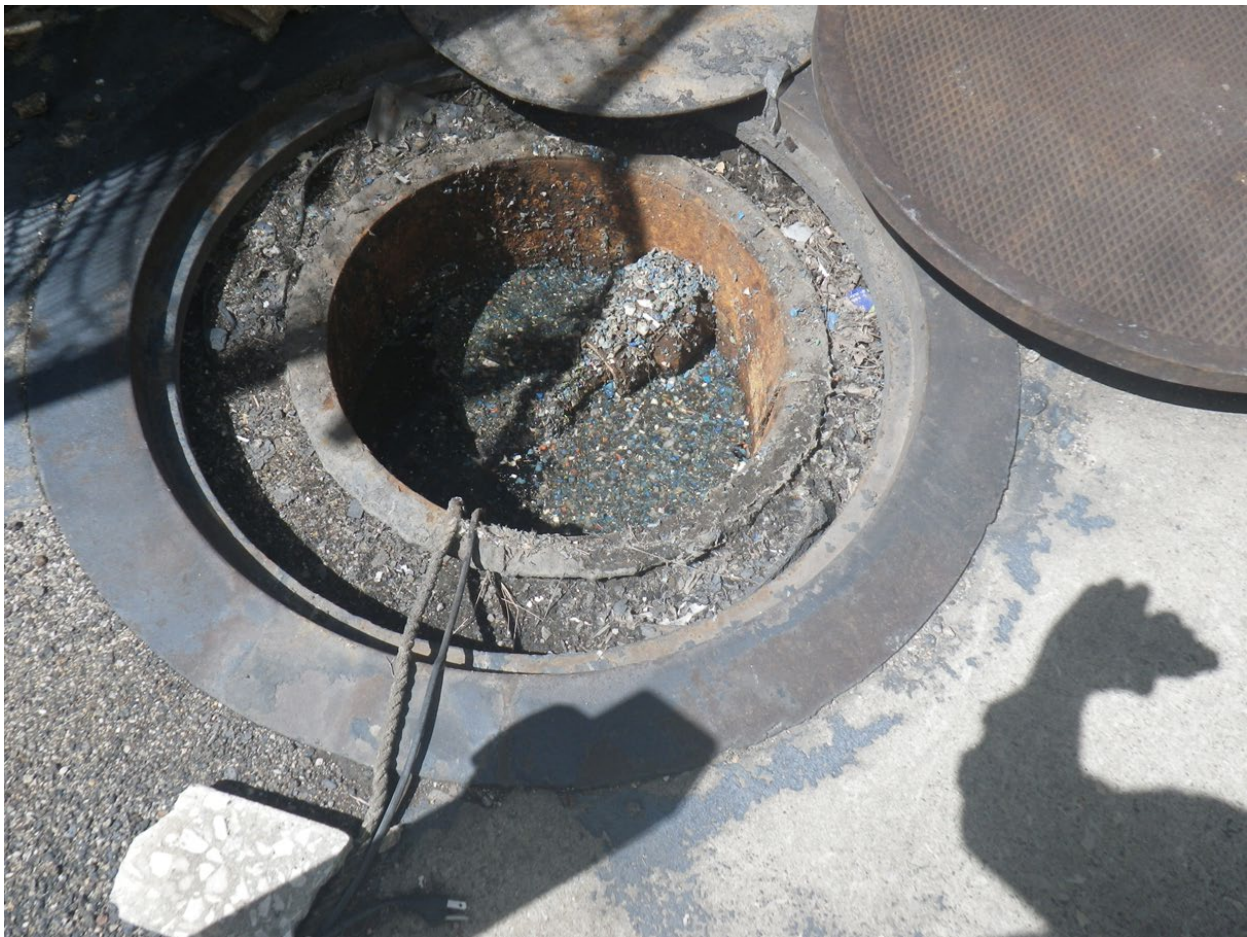
| <p>The inside of manhole #2 located on the south-east side of the building. Liquid appears to have filled it to the top of the manhole with little bits of what appears to be floating plastic on top of the liquid. A rope and what appears to be a black electrical cord stretch down into the liquid in the manhole.</p> | | |

The facility appears to have interior drains near the south bay door that are tied into the manhole shown in photograph 8.

| Photograph 8. Inside manhole #2 | | | IMGP0040.JPG |
| View of the inside of manhole located on the south-east side of the building). Liquid appears to have filled it to the top of the manhole with little bits of what appears to be floating plastic on top of the liquid. A rope and what appears to be a black electrical cord stretch down into the liquid in the manhole. | | | |

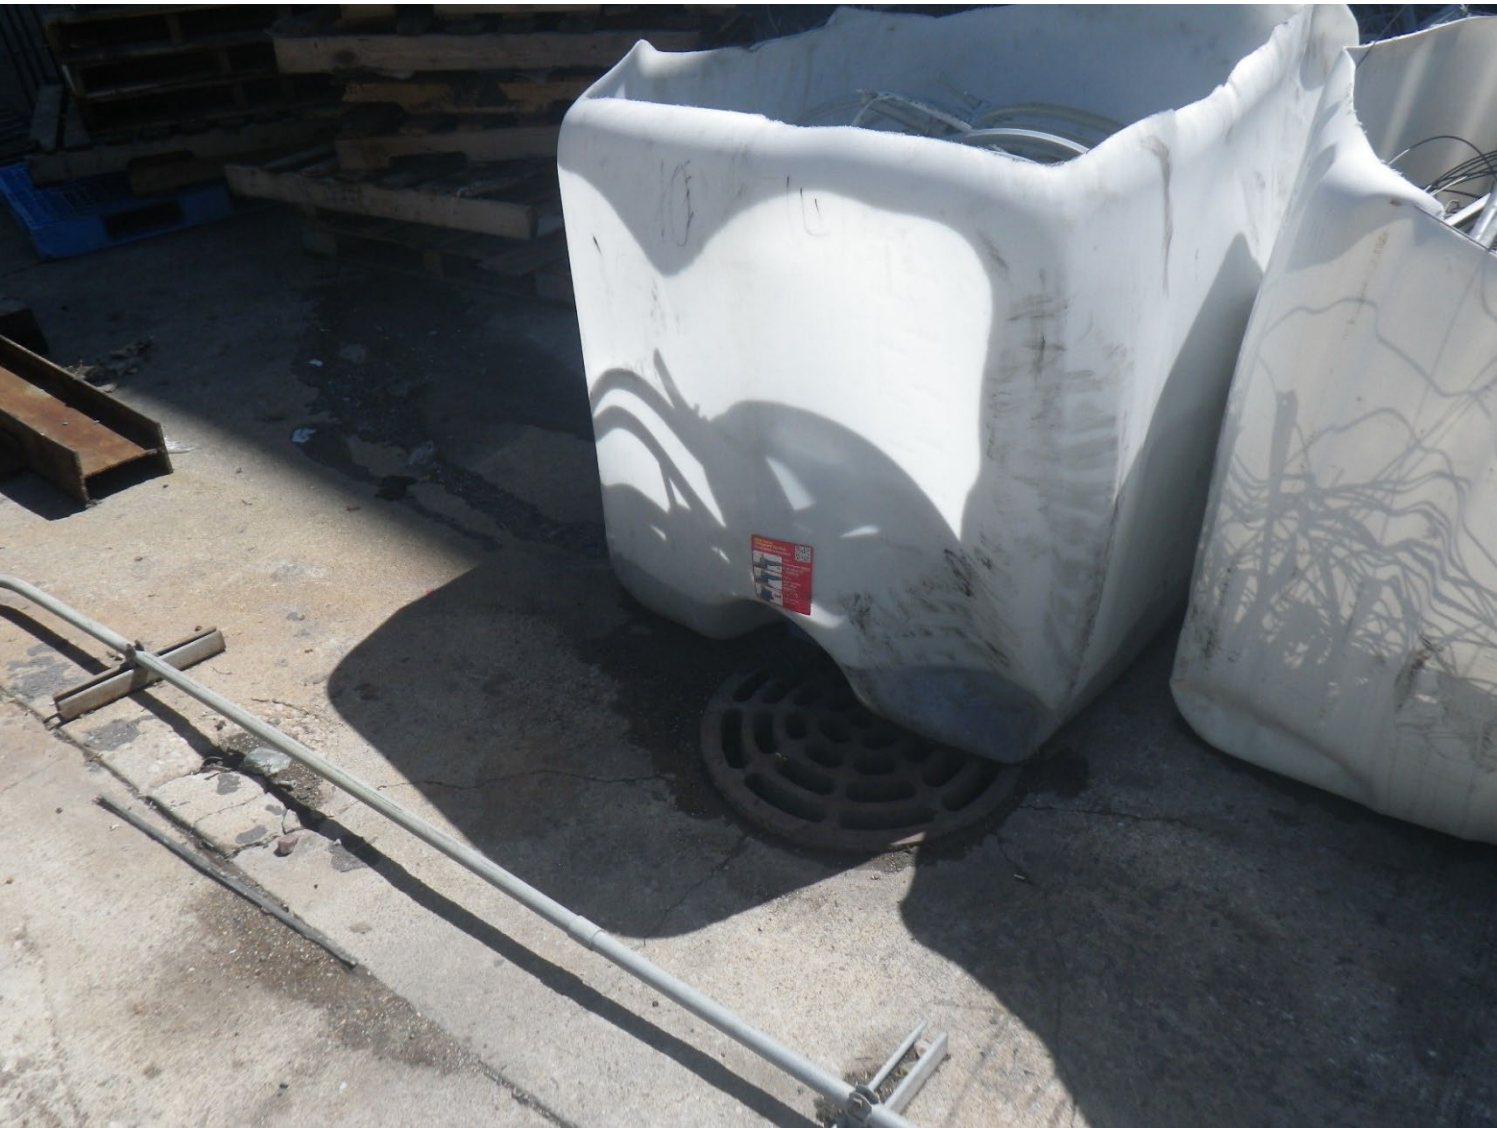
| Photograph 9. Plastic storage container with drain at bottom over storm drain inlet. This is just south of the building near the trash compactor. | | | IMGP0041.JPG |

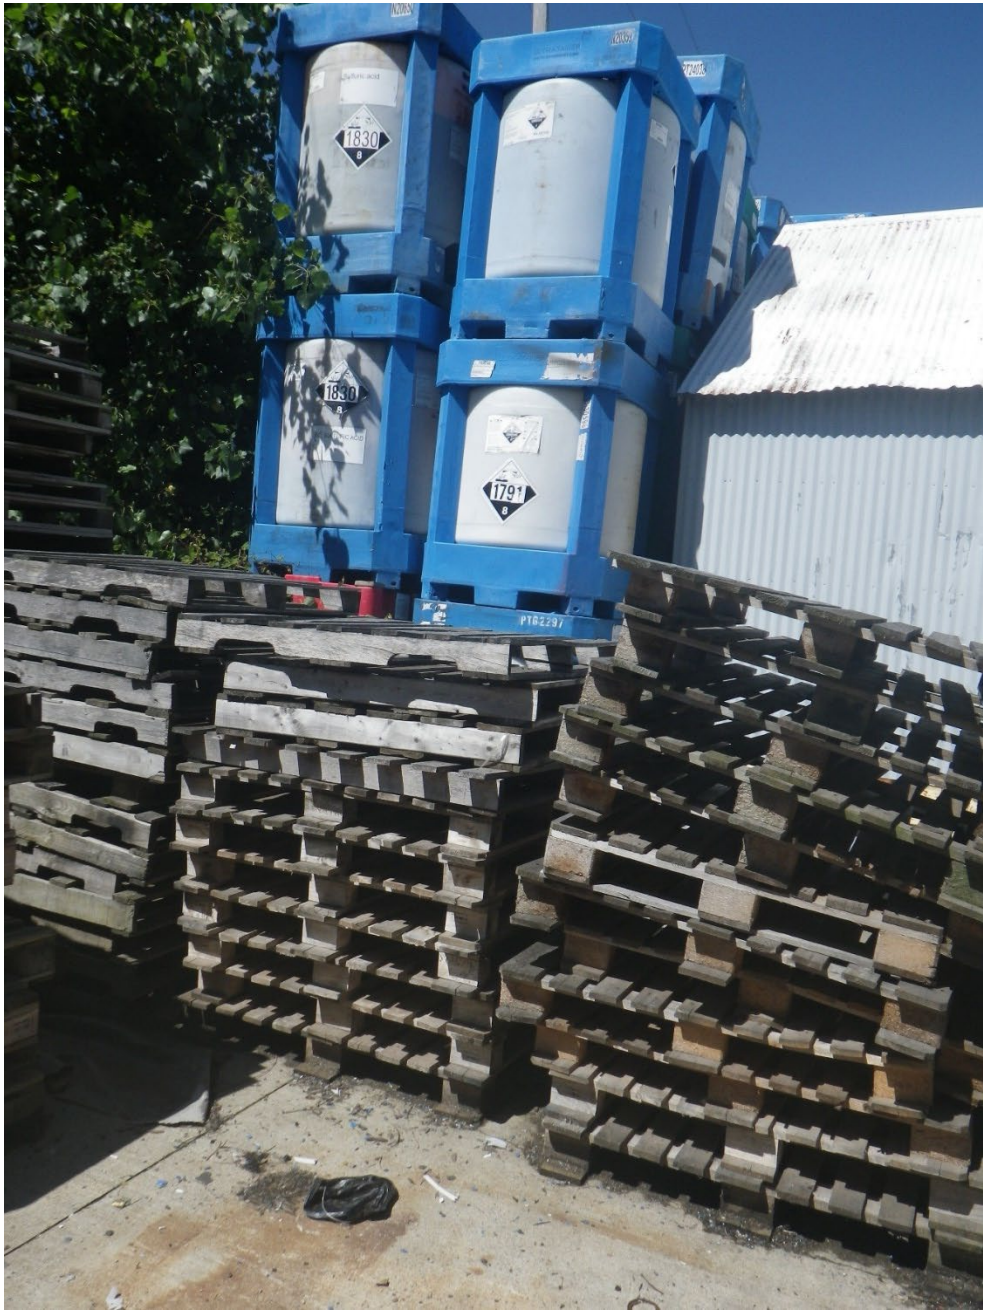
| Photograph 10. Drums stored outside. Two of the drums are marked Sulfuric Acid and the drums in the photo are also marked corrosive. | | | IMGP0042.JPG |
| Near the track compactor just south of the building | | | |

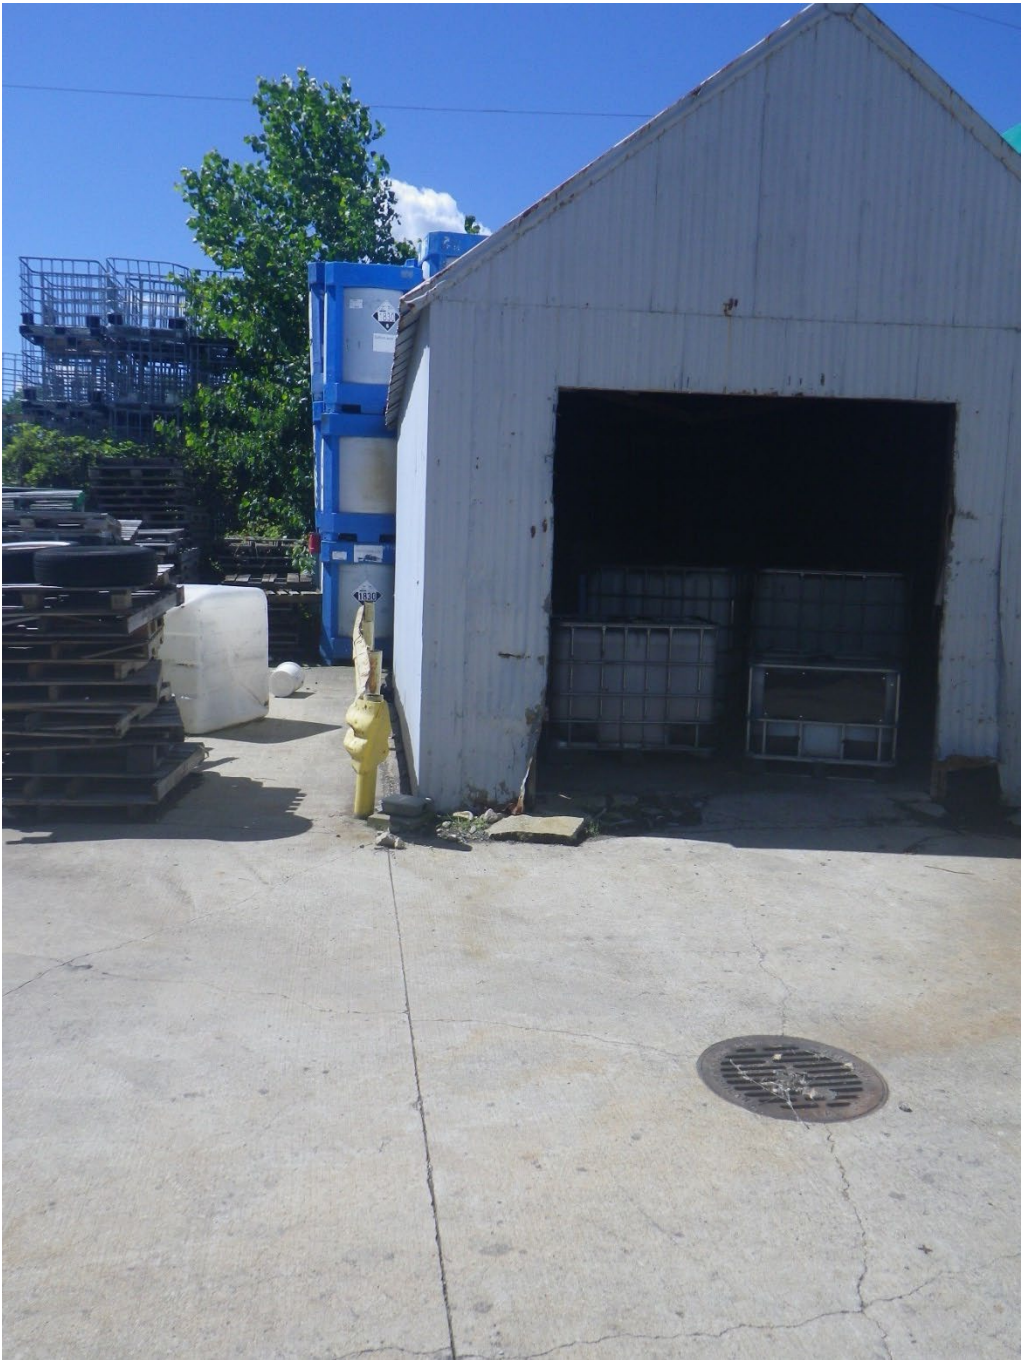
| Photograph 11. A stack of containers that are also shown in photograph 10. | | | IMGP0043.JPG |
| The containers are next to a small storage building. Shown in front of the building is an inlet to a manhole that water can flow through. | | | |

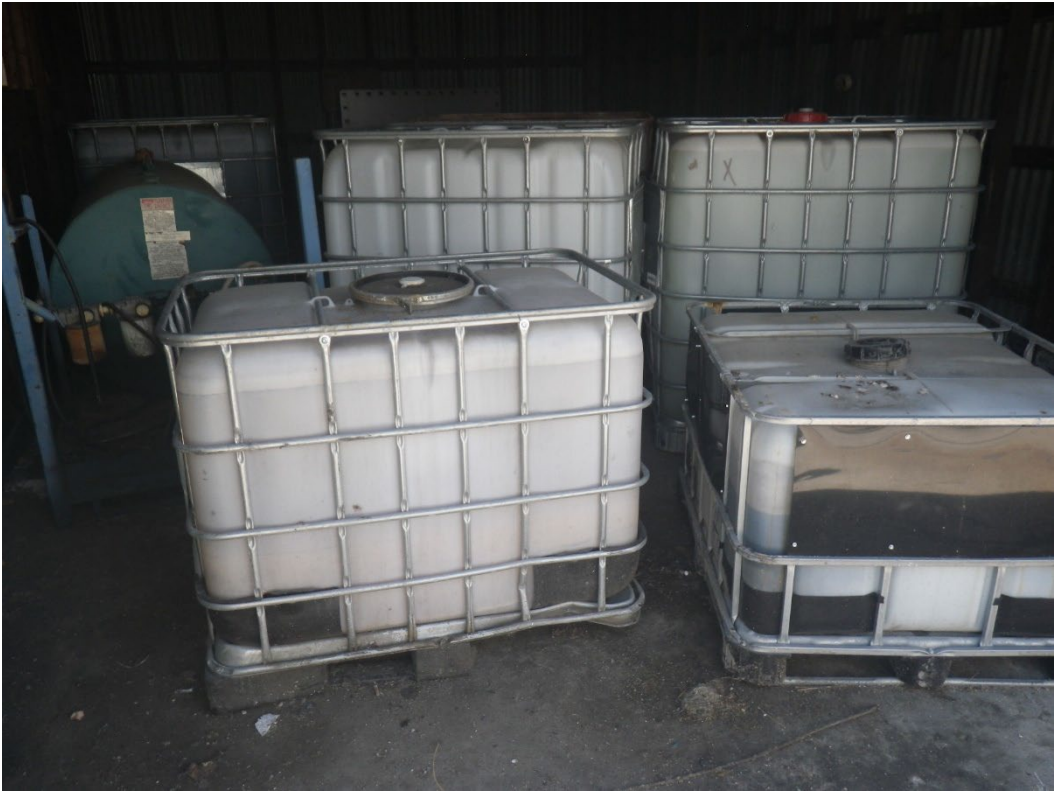
| Photograph 12. Intermediate Bulk Containers (IBC) stored in the building shown in photograph 11. The white IBC have liquid in them. The blue tank appears to be a fuel tank. The building does not have a berm to contain any spills. | | | IMGP0044.JPG |
| Inside the building shown in photograph 11. | | | [Geographic Coordinates] |

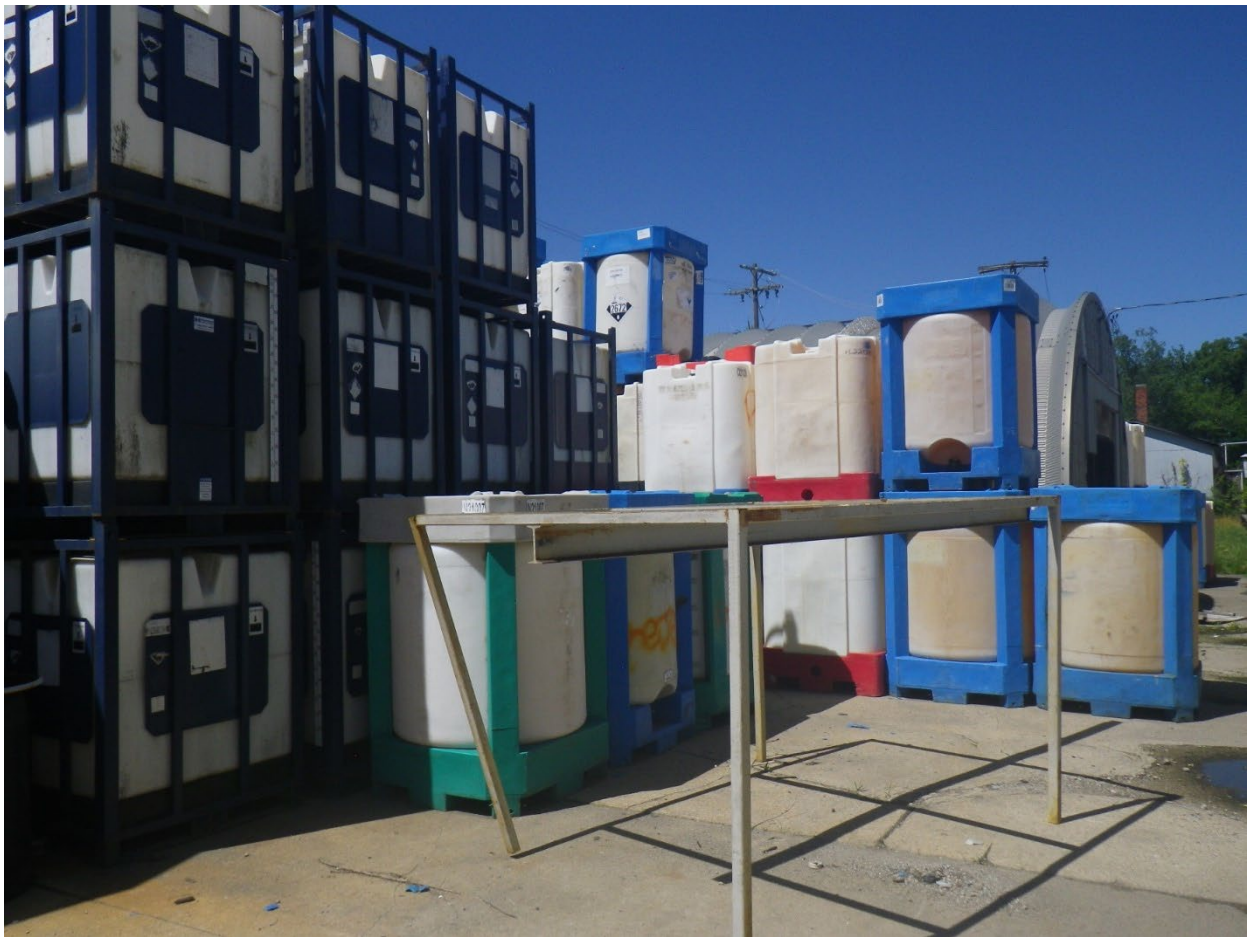
| Photograph 13. IBCs stored outside next to the building shown in photograph 11. | | | IMGP0045.JPG |

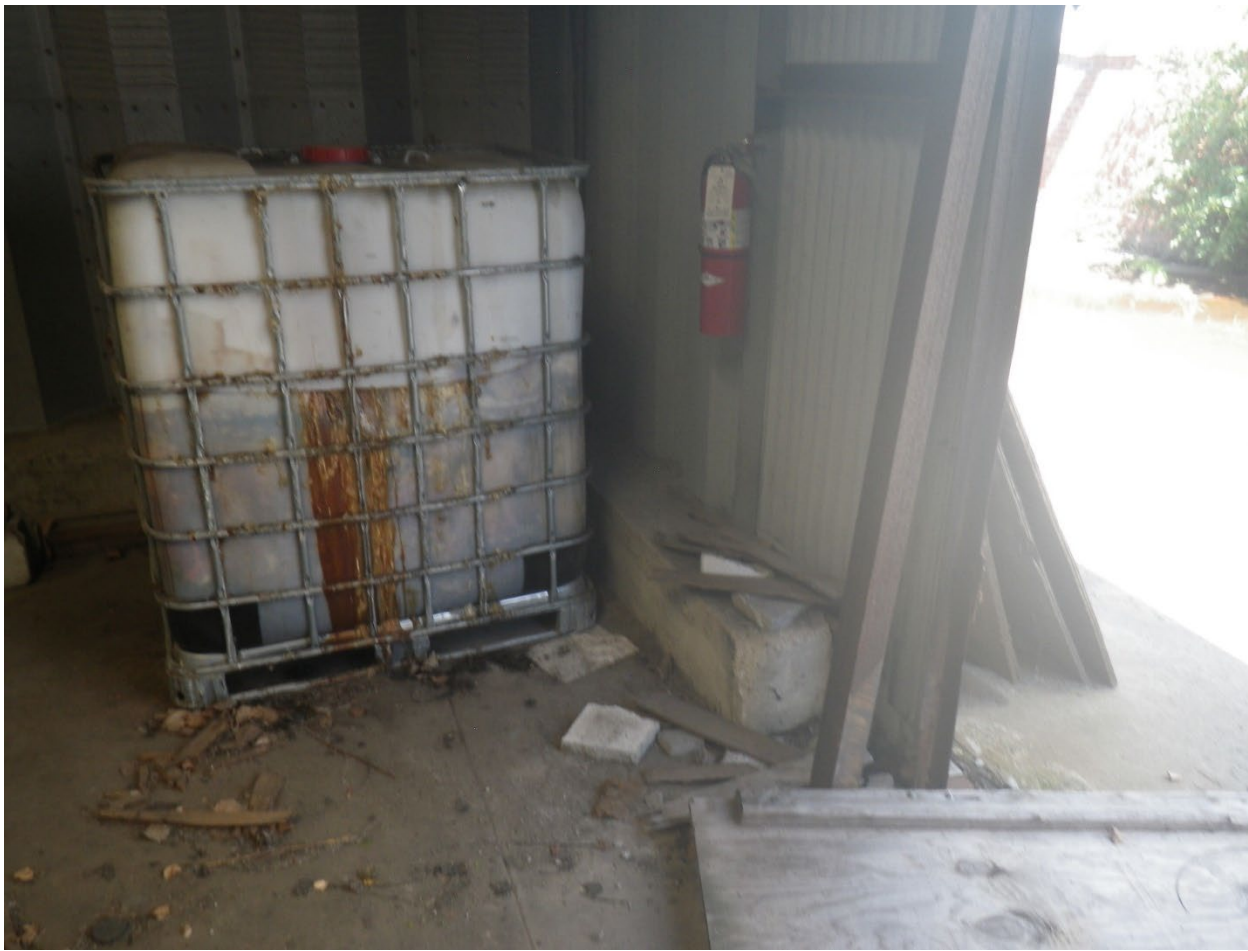
| Photograph 14. IBC with dark liquid dried on outside of it. The container is half filled with a dark liquid. | | | IMGP0046.JPG |
| South of main building to the west of the building shown in photograph 11. | | | |

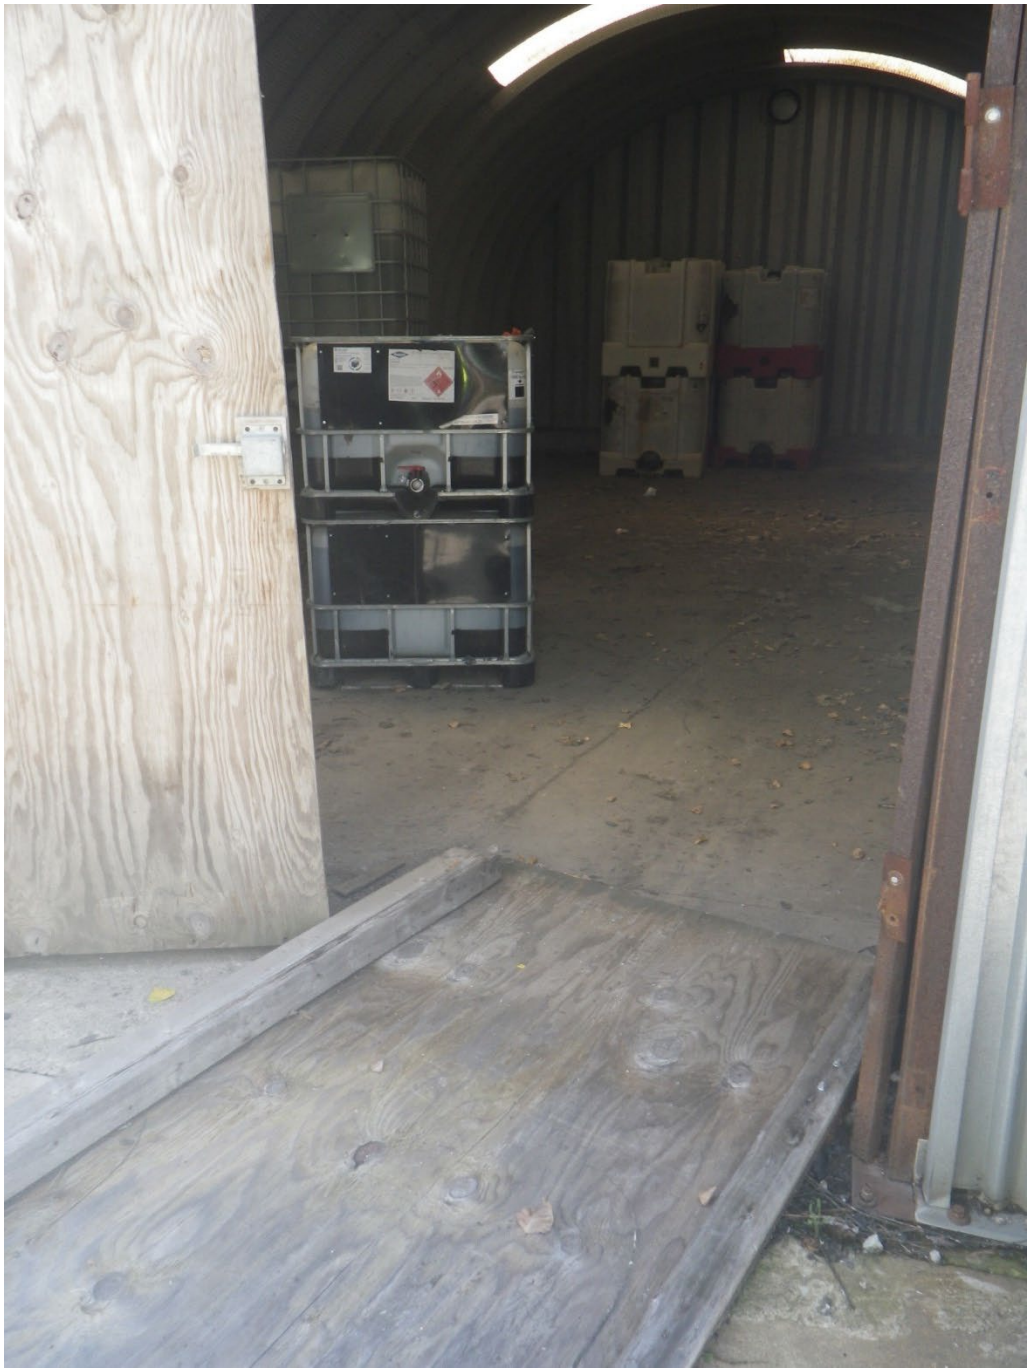
| Photograph 15. Building with IBCs inside of it. | | | IMGP0047JPG |
| Building south of the main building. This building is also shown in photograph 14. | | | |

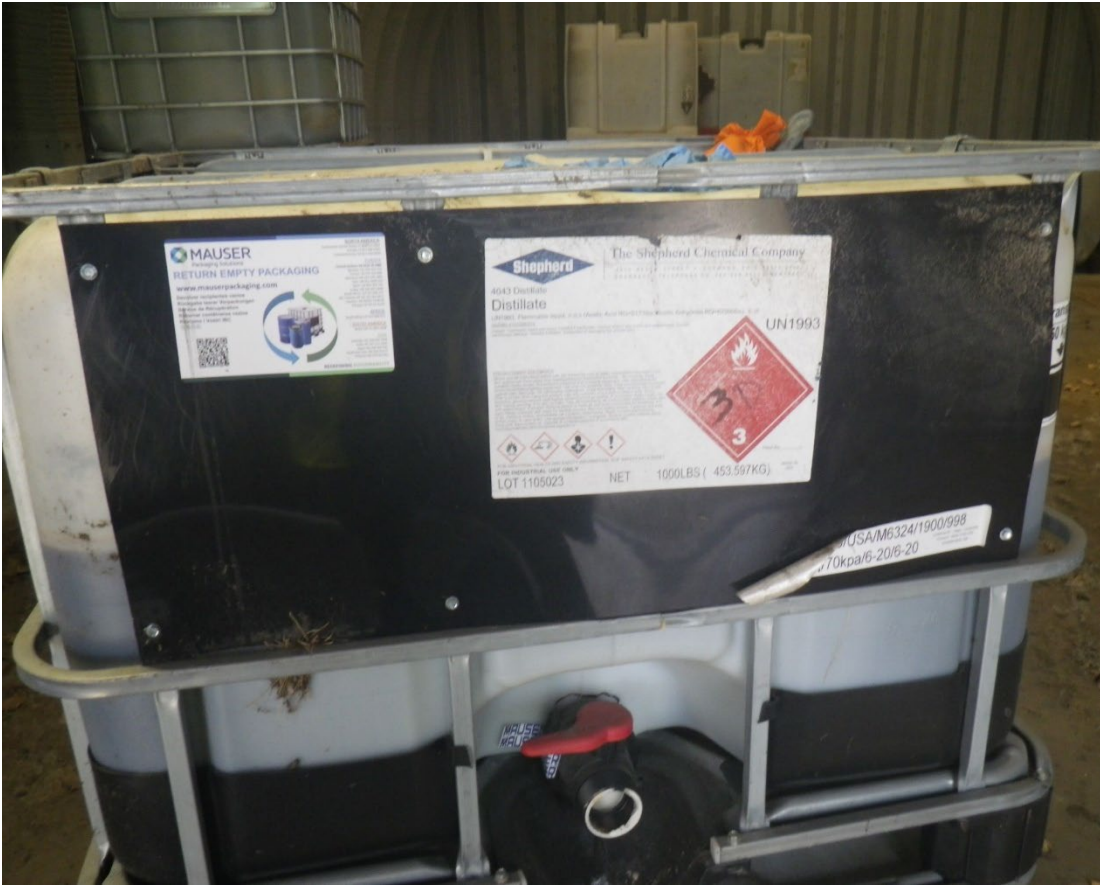
| Photograph 16. Close up of IBC shown in phtograph 15.<br>The container contained a dark liquid. | | | IMGP0048.JPG |

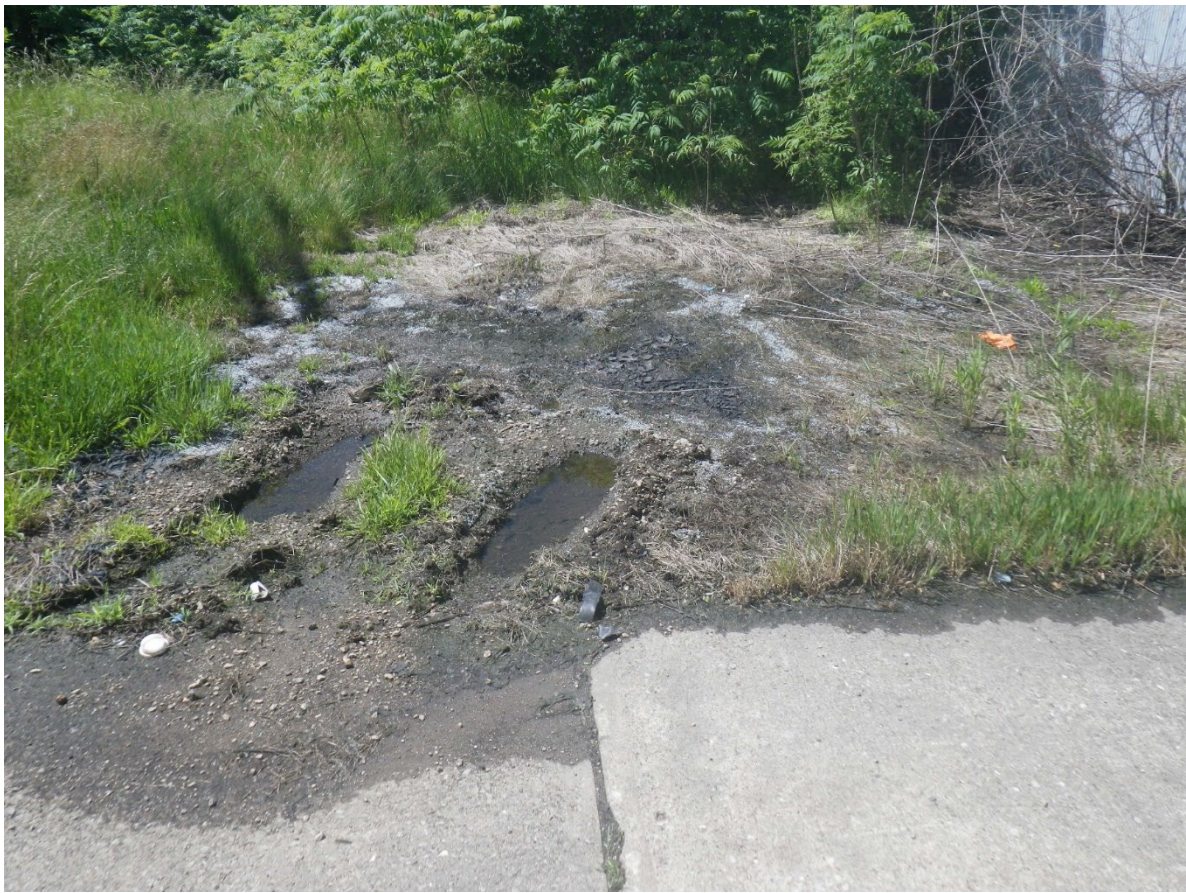
| Photograph 17. Former dumping area southwest of the main building | | | IMGP0049.JPG |

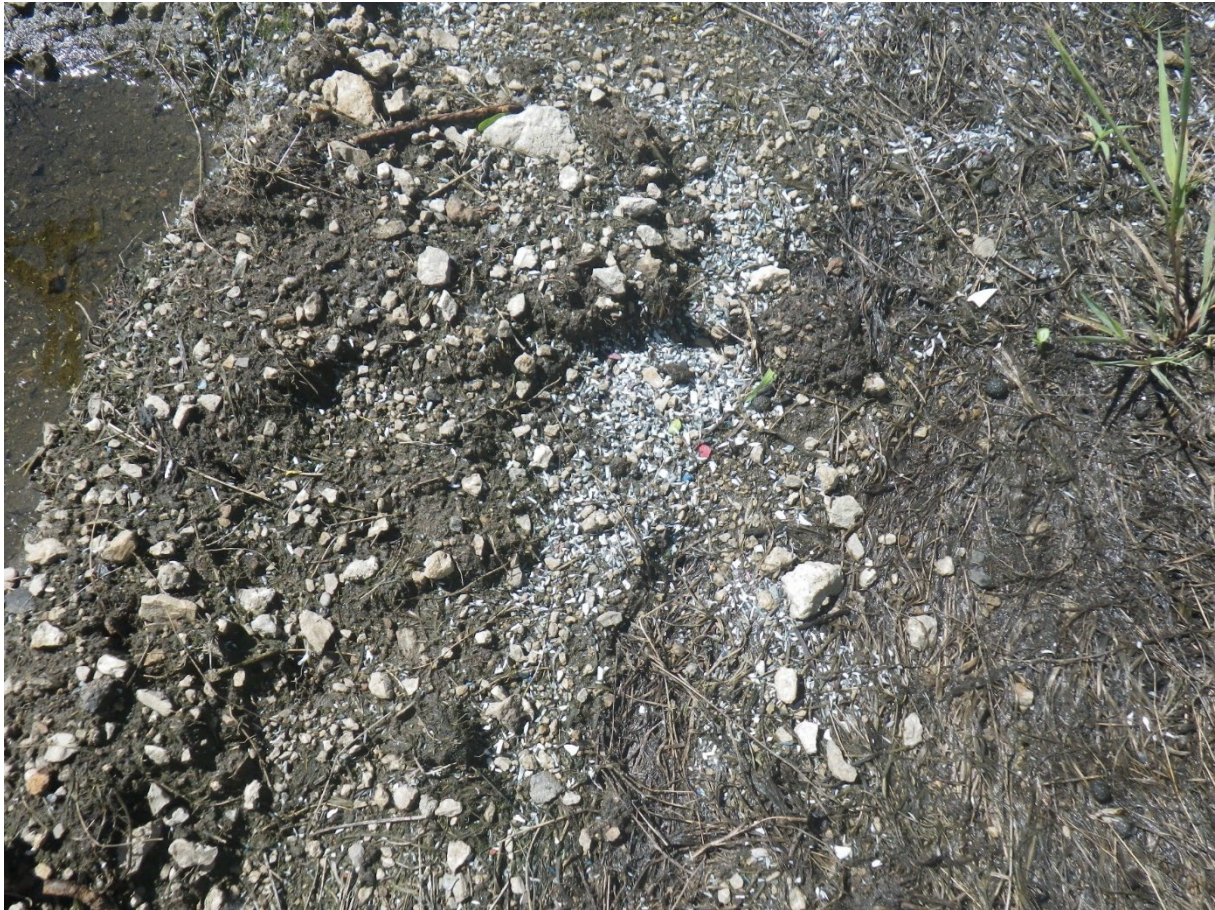
| Photo 18. Close up of area shown in photograph 17 showing what appears to be bits of plastic among the rocks/dirt | | | IMGP0050.JPG |

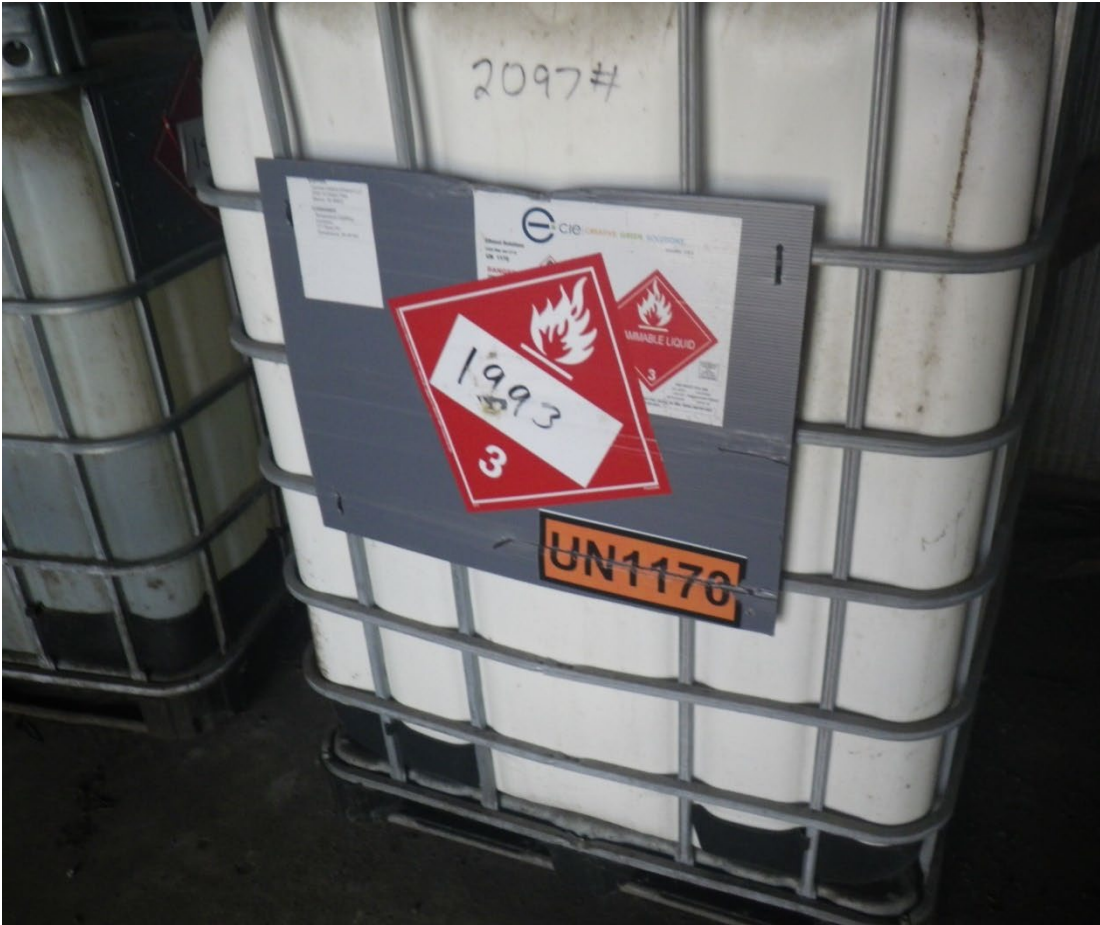
| Photo 19. Inside of the large shed south of the main facility that is used for storing alcohol. This container is also shown in photographs 20 and 21. | | | IMGP0051.JPG |
