INSPECTION REPORT

| Type of Inspection | Industrial Stormwater Inspection (ISI) | | |
| Facility or Site Name | Omni Polymers | | |
| Facility/Site Physical Address | 1925 Nebraska | | |

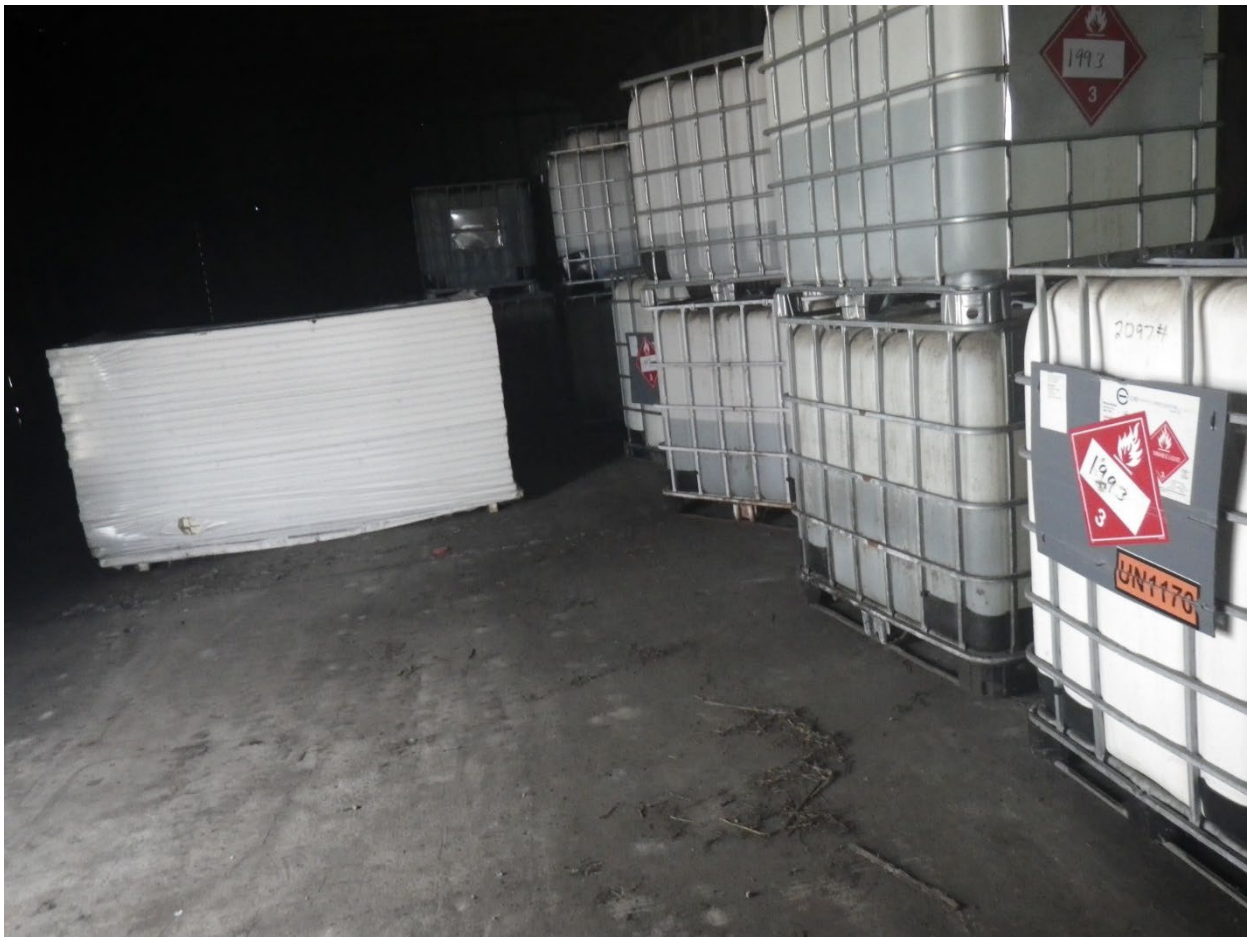
| Photograph 20. Photo inside of large shed where alcohol is stored | | | IMGP0052.JPG |

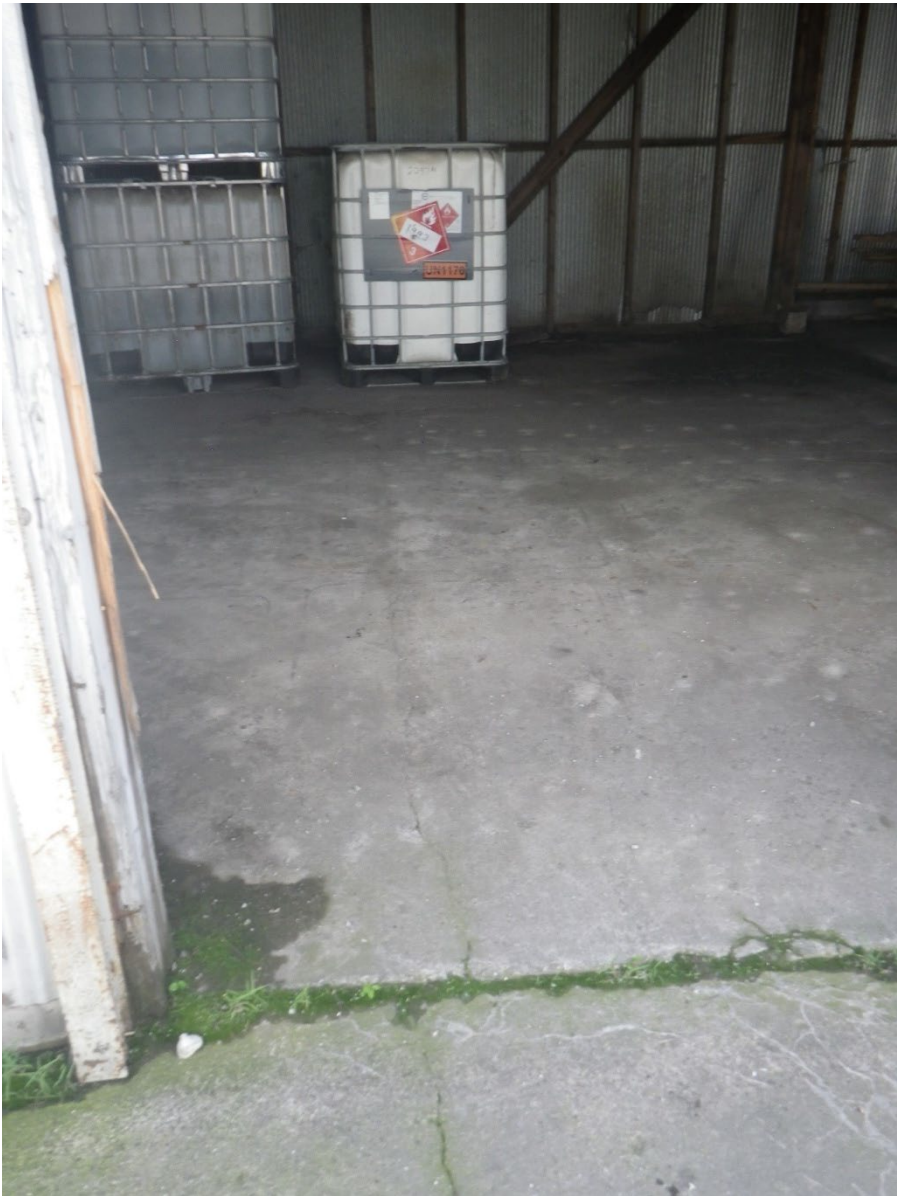
| Photograph 21. View inside of large shed showing container shown in photograph 19. | | | IMGP0053.JPG |

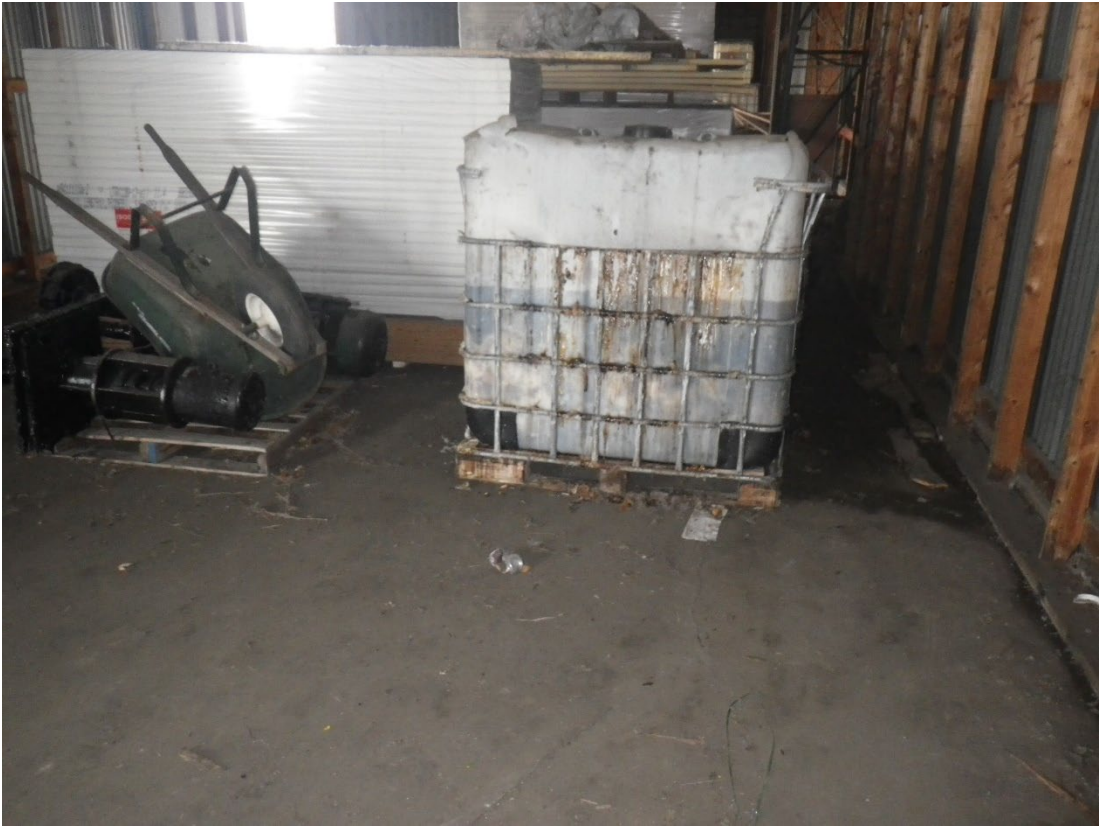
| Photograph 22. Photo inside of large shed where alcohol is stored | | | IMGP0054.JPG |

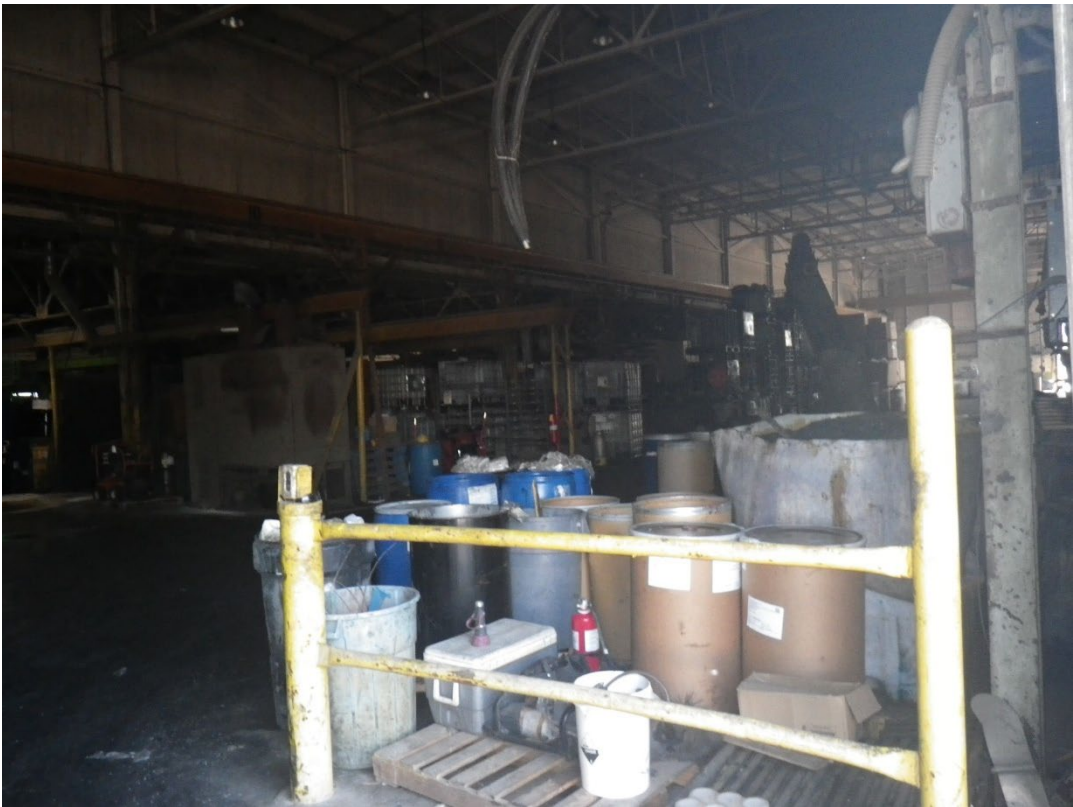
| Photograph 23. View inside of building from Bay door on south side of building looking to the right. | | | IMGP0055.JPG |

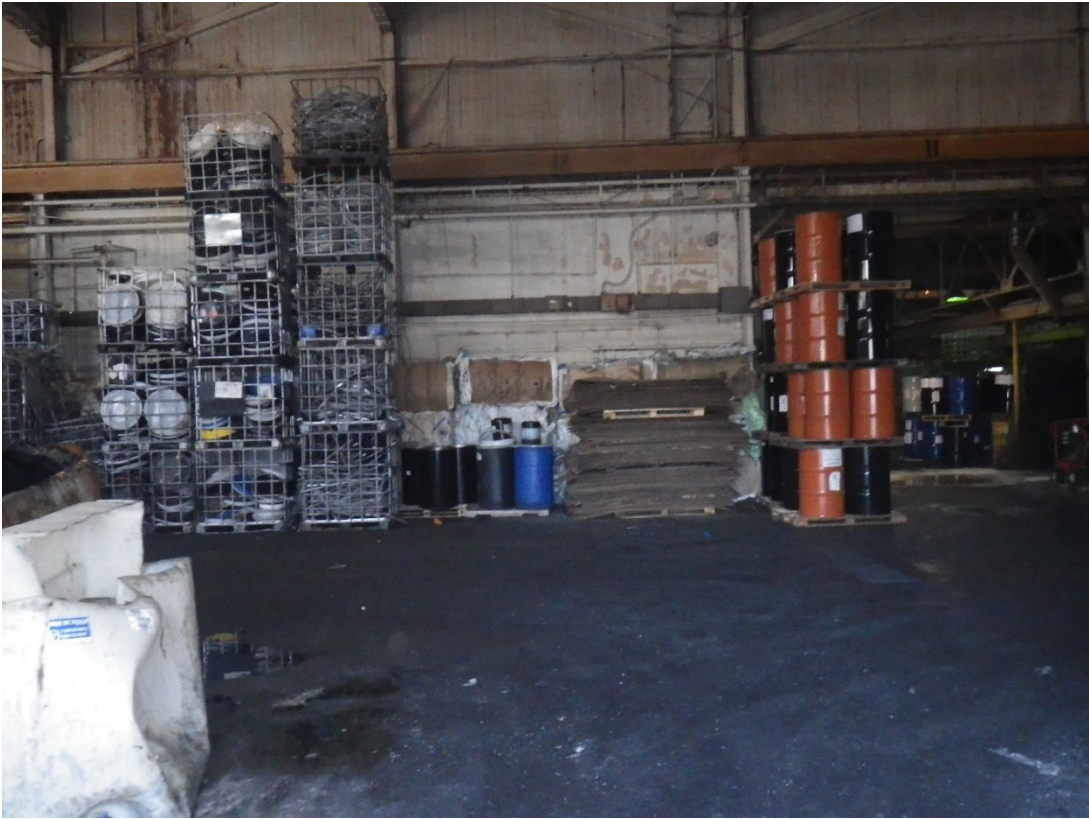
| Photograph 24. View inside of building from Bay door on south side of building looking straight in. | | | IMG0056.JPG |

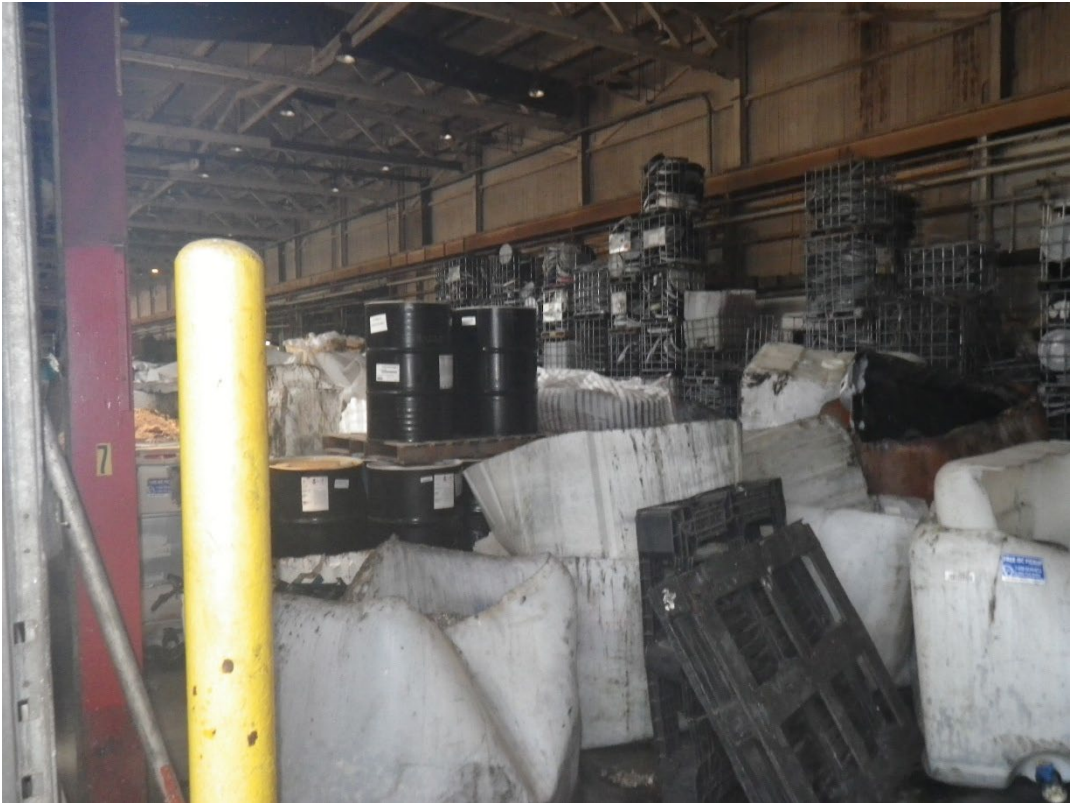
| Photograph 25. View inside of building from Bay door on south side of building looking to the left. | | | IMGP0057.JPG |

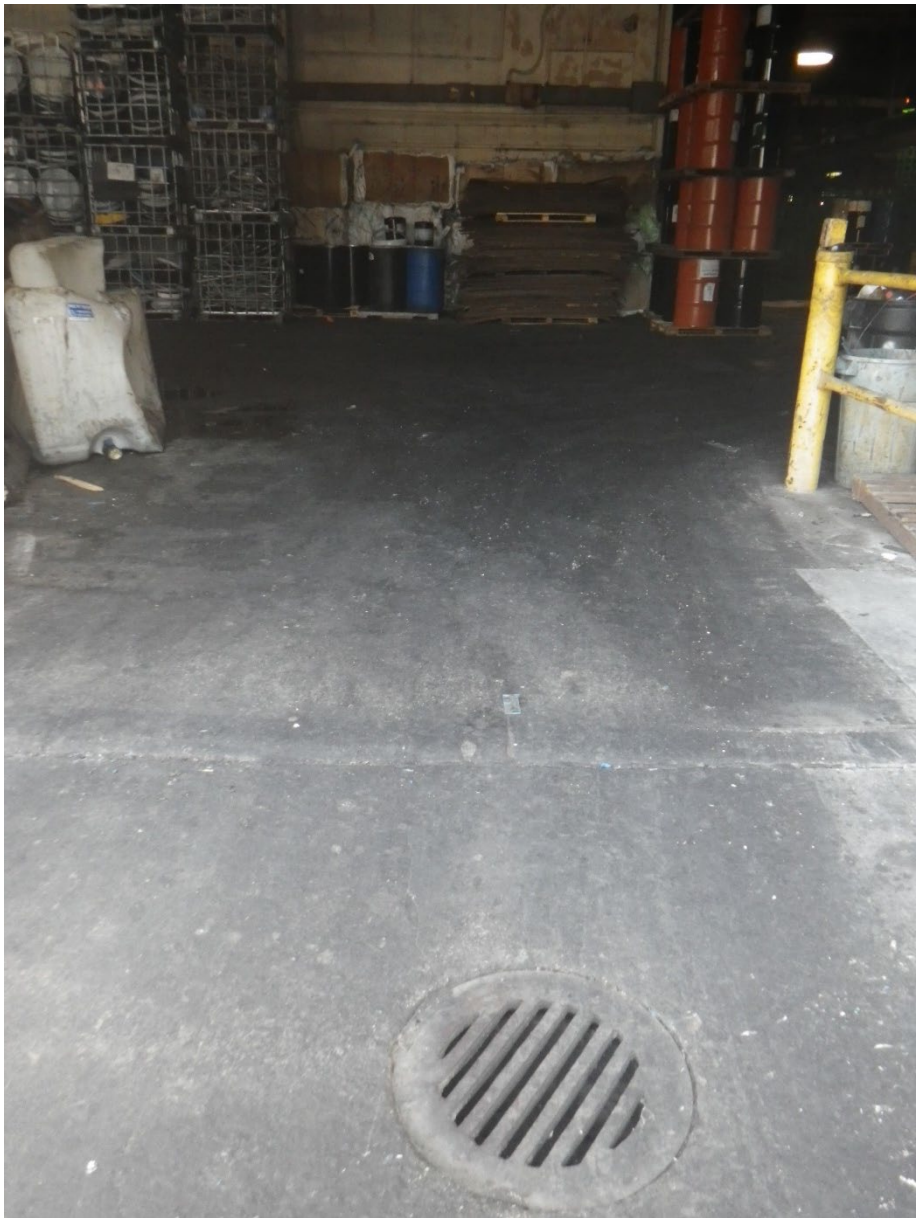
| Photograph 26. View inside of building from Bay door on south side of building looking straight into the building. A storm drain inlet is shown in the bottom of the photo that is just outside of the doorway. | | | IMGP0058.JPG |

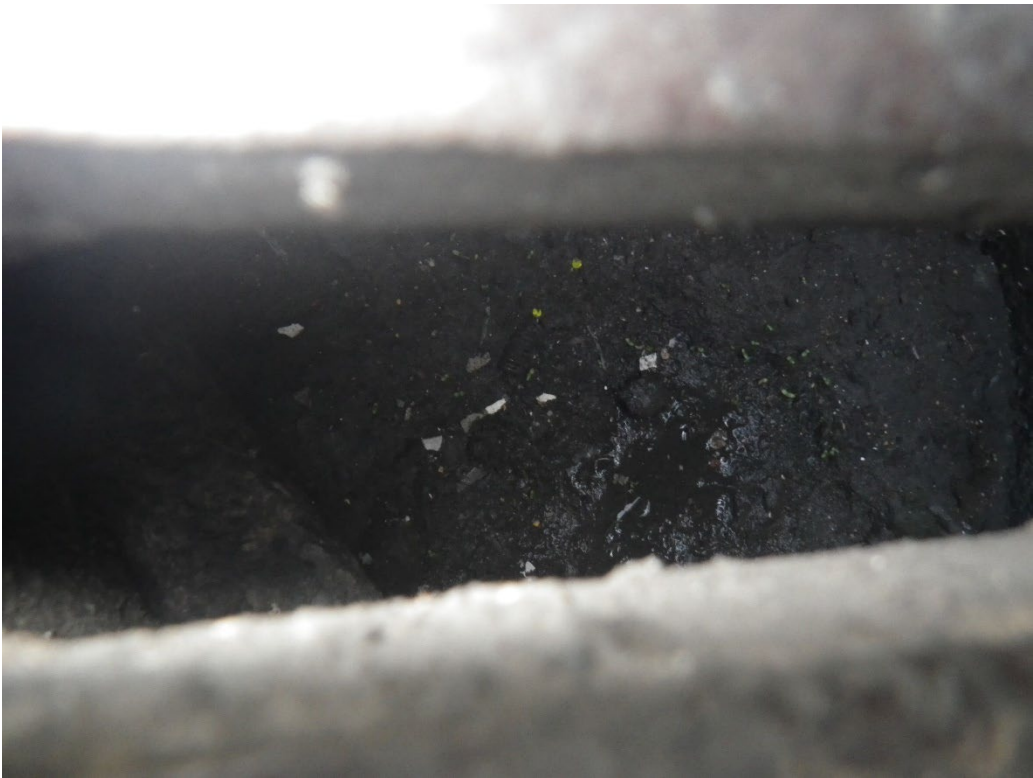
| Photograph 27. View inside of storm drain inlet shown in photograph 26. Bits of material can be seen in the photos that appear to be bits of plastic based on the shape and lighter color. | | | IMGP0059.JPG |
| Close up of manhole grate shown in photographs 26 and 28. | | | |

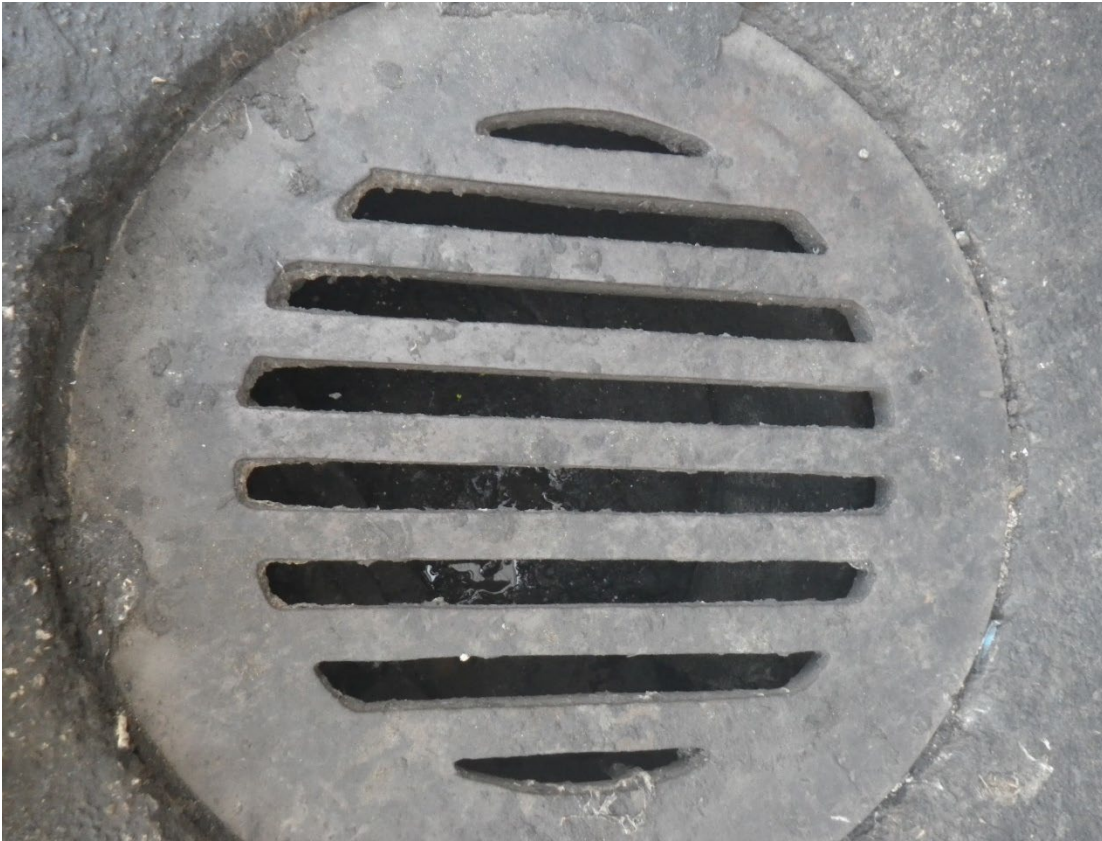
| Photograph 28. Close up of storm sewer inlet shown in photographs 26 and 27. | | | IMGP0060.JPG |

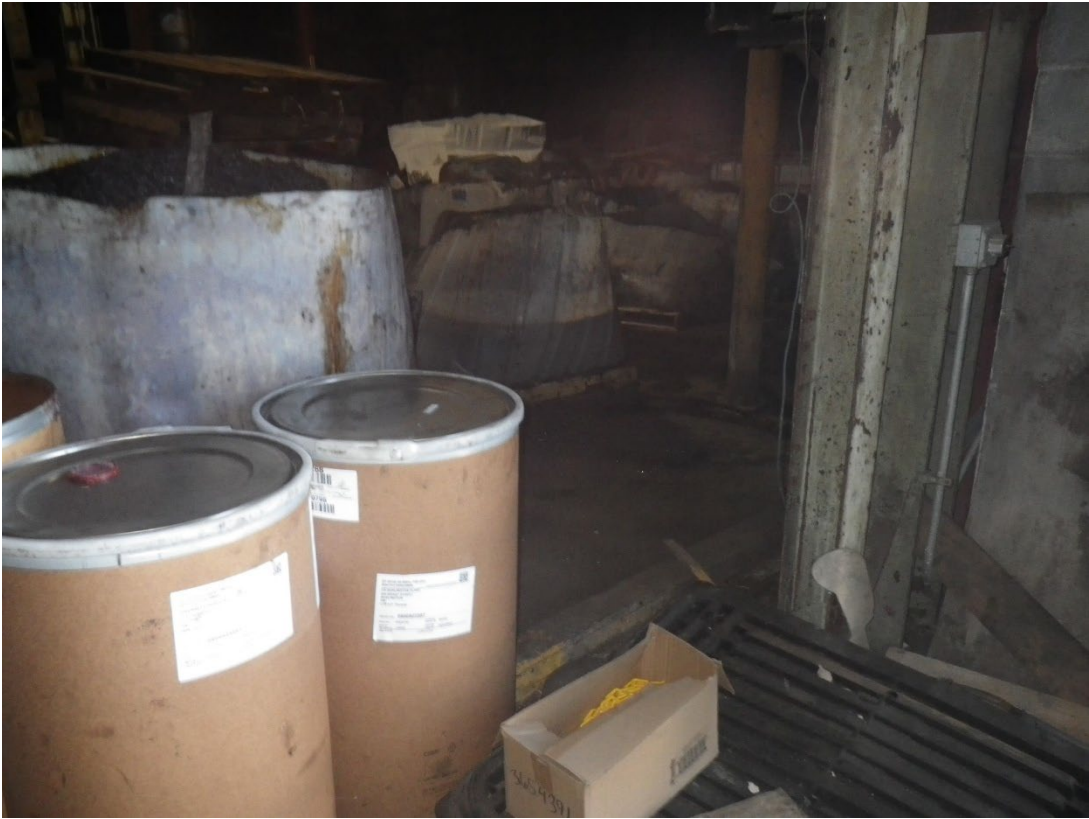
| Photograph 29. View from inside of the bay door of the area shown in photograph 23. | | | IMGP0061.JPG |

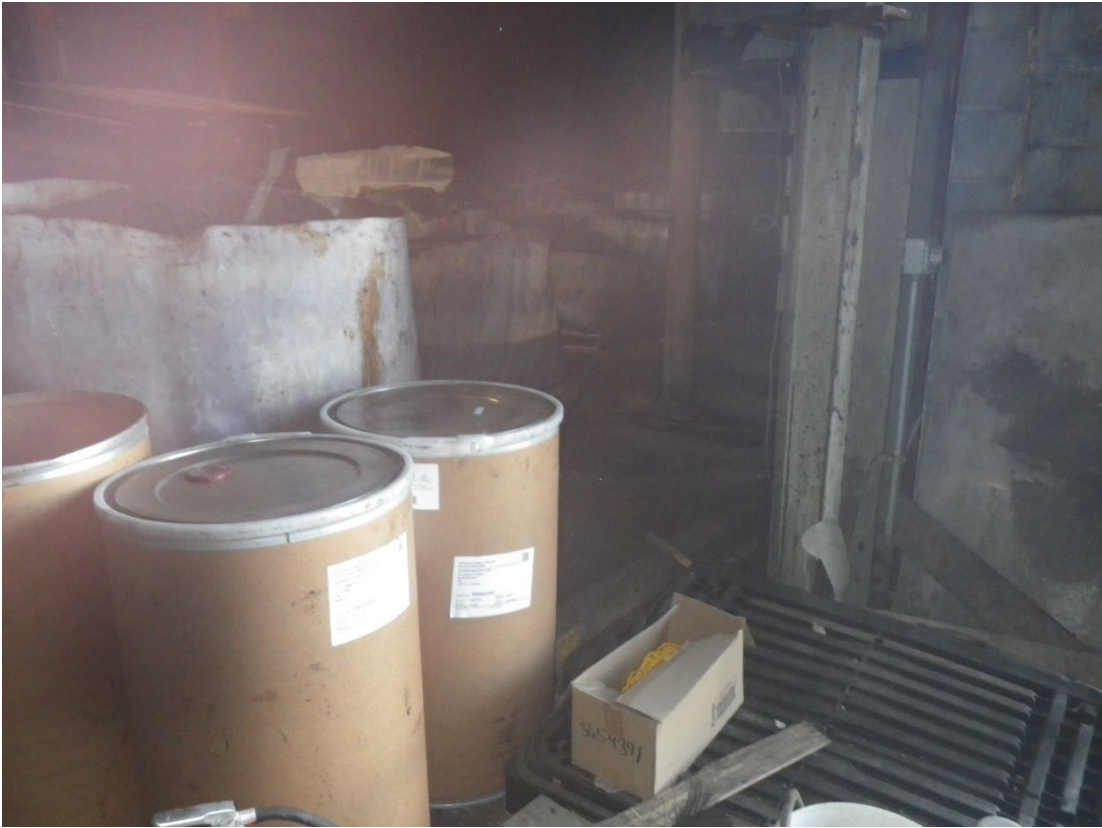
| Photograph 30. View from inside of the bay door of the area shown in photograph 23. | | | IMGP0062.JPG |
| An opening into the drain system is in the floor just to the right of the center of the photograph. | | | |

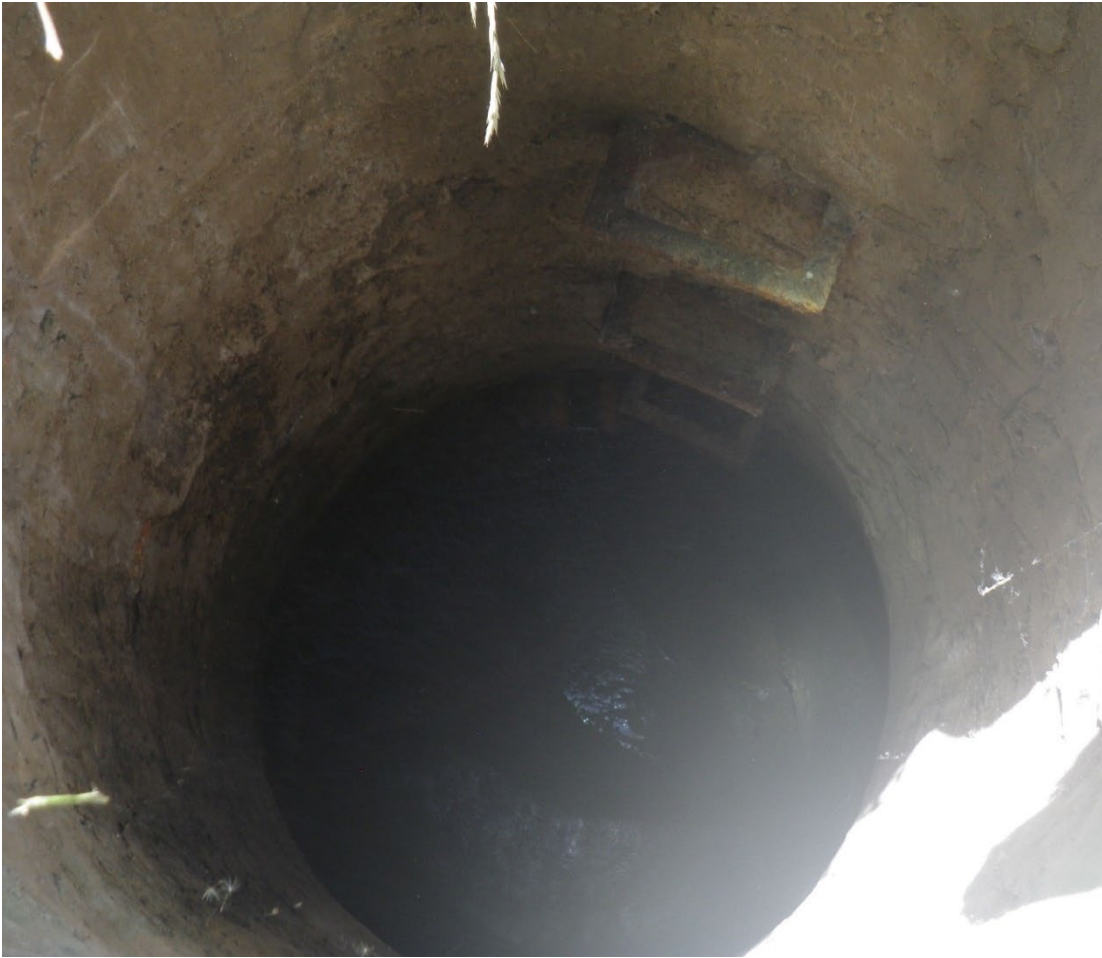
| Photograph 31. View inside of storm manhole at the northwest corner of the main building near Nebraska Ave | | | IMGP0063.JPG |

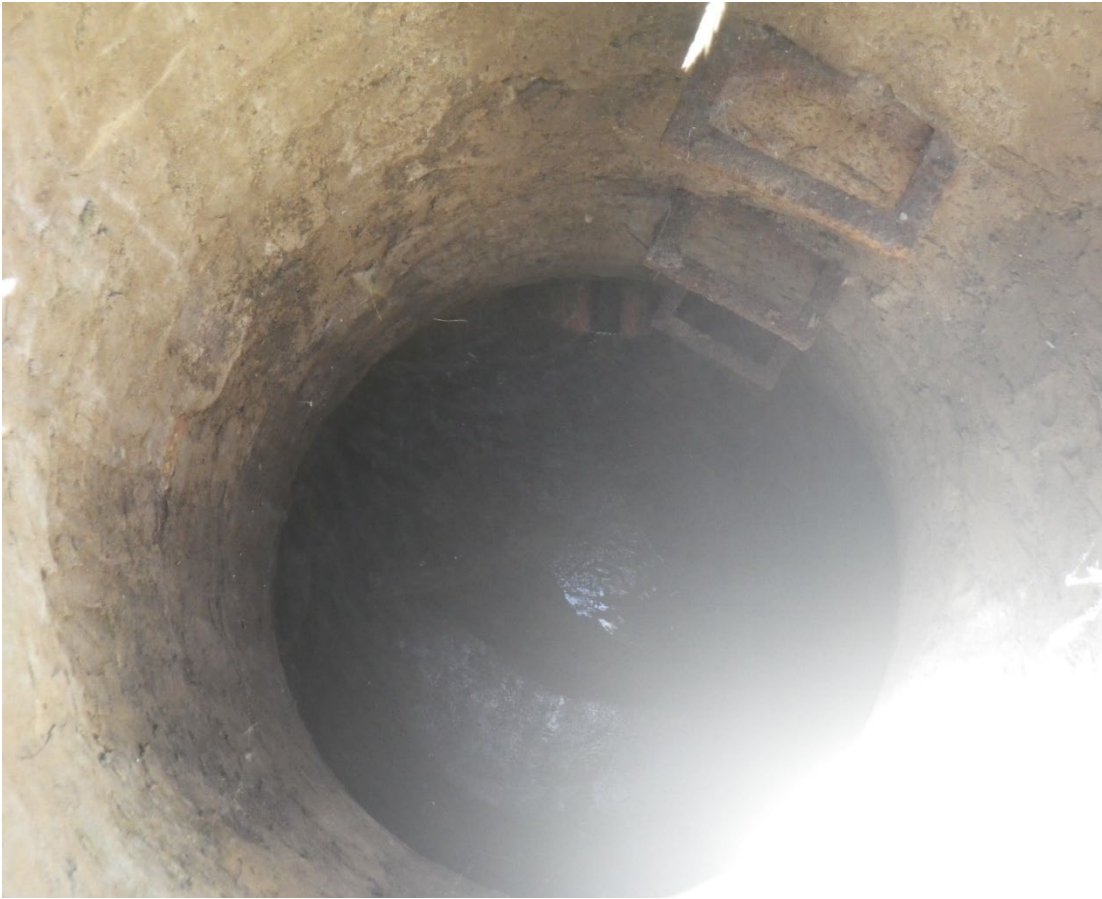
| Photograph 32. View inside of storm manhole to the Northwest corner of the main building near Nebraska Ave | | | IMGP0064.JPG |

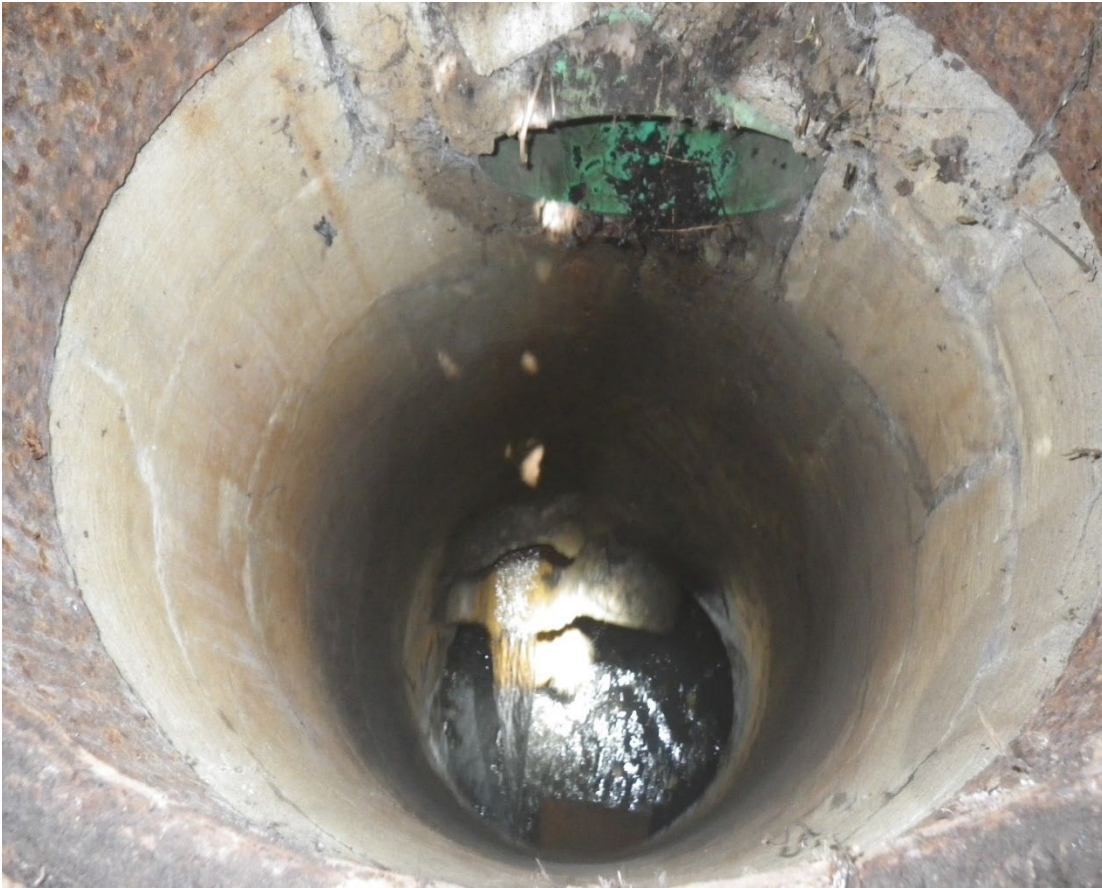
Water was flowing through the storm sewer.

| Photograph 33. View inside of storm manhole receiving downpipe of storm sewers connected to sound end of Omni Polymers. | | | IMGP065.JPG |

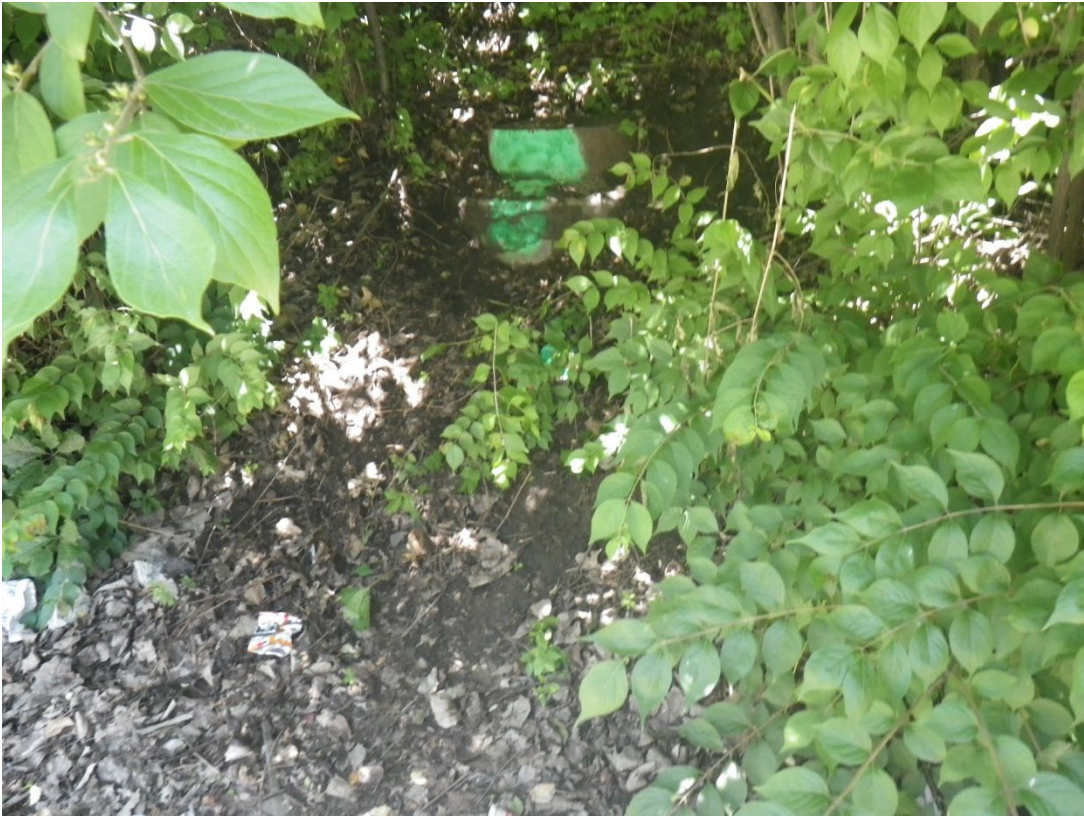
| Photograph 34. Top section of manhole with green paint.<br>The manhole is also shown in photograph 33. | | | IMGP0066.JPG |
| This is located along the north side of North Fearing Blvd south of the Omni Polymers facility between the railroad bridges | | | |

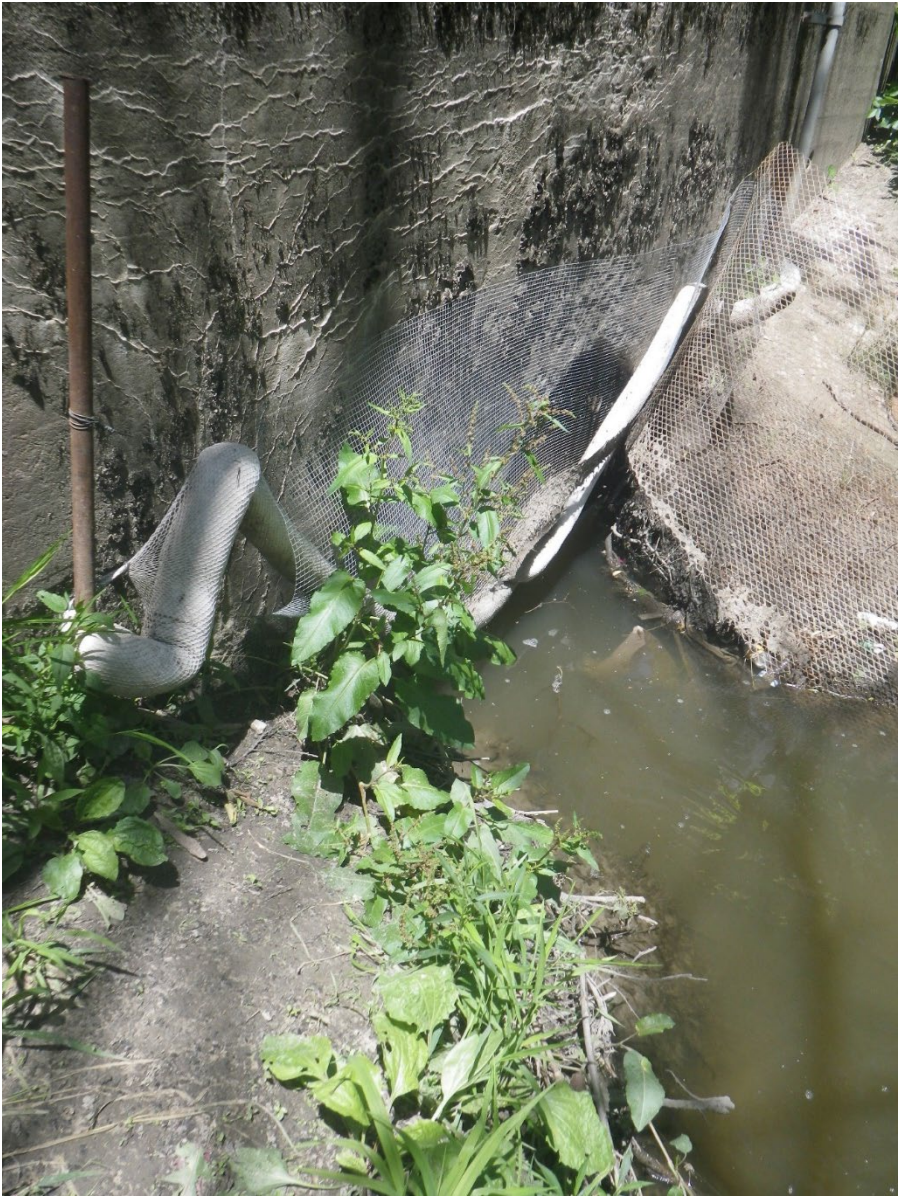
| Photograph 35. Storm water outfall into Swan Creek formerly known as CSO 124. A net and absorbent boom is in front of the outfall. | | | IMGP0067.JPG |
| The outfall is near Highland Park and Emery street in Toledo. | | | |

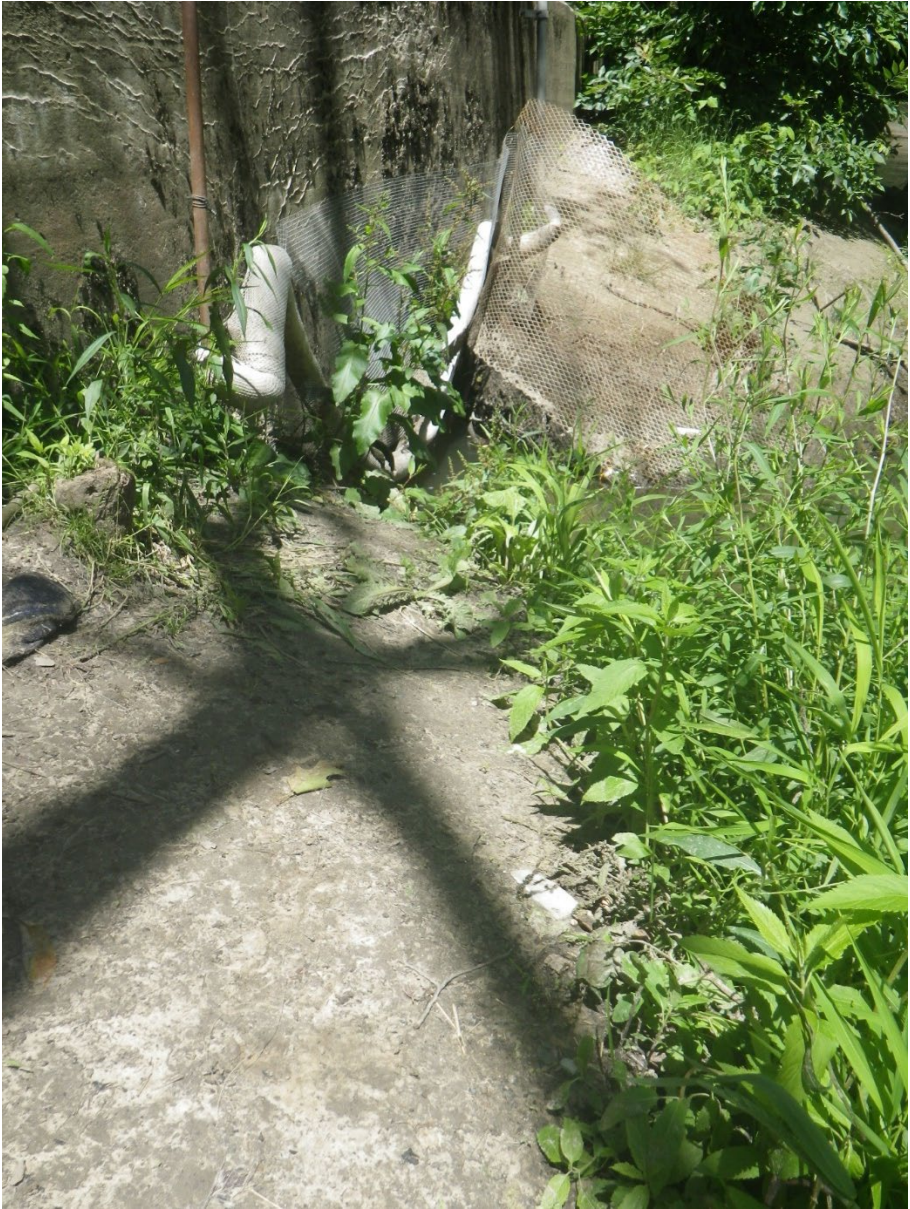
The facility has pollutants present outside of the building on the ground and in storm water catch basins. The facility has a catch basin on the south end of its site that has a pipe connected into it that leads to the south, in the direction of Swan Creek. Plastic was observed near the storm sewer outfall into Swan Creek.

| Photograph 36. Storm water outfall into Swan Creek formerly known as CSO 124. This is also shown in photograph 35. A white piece of plastic was observed near the bottom of the photograph. | | | IMGP0068.JPG |

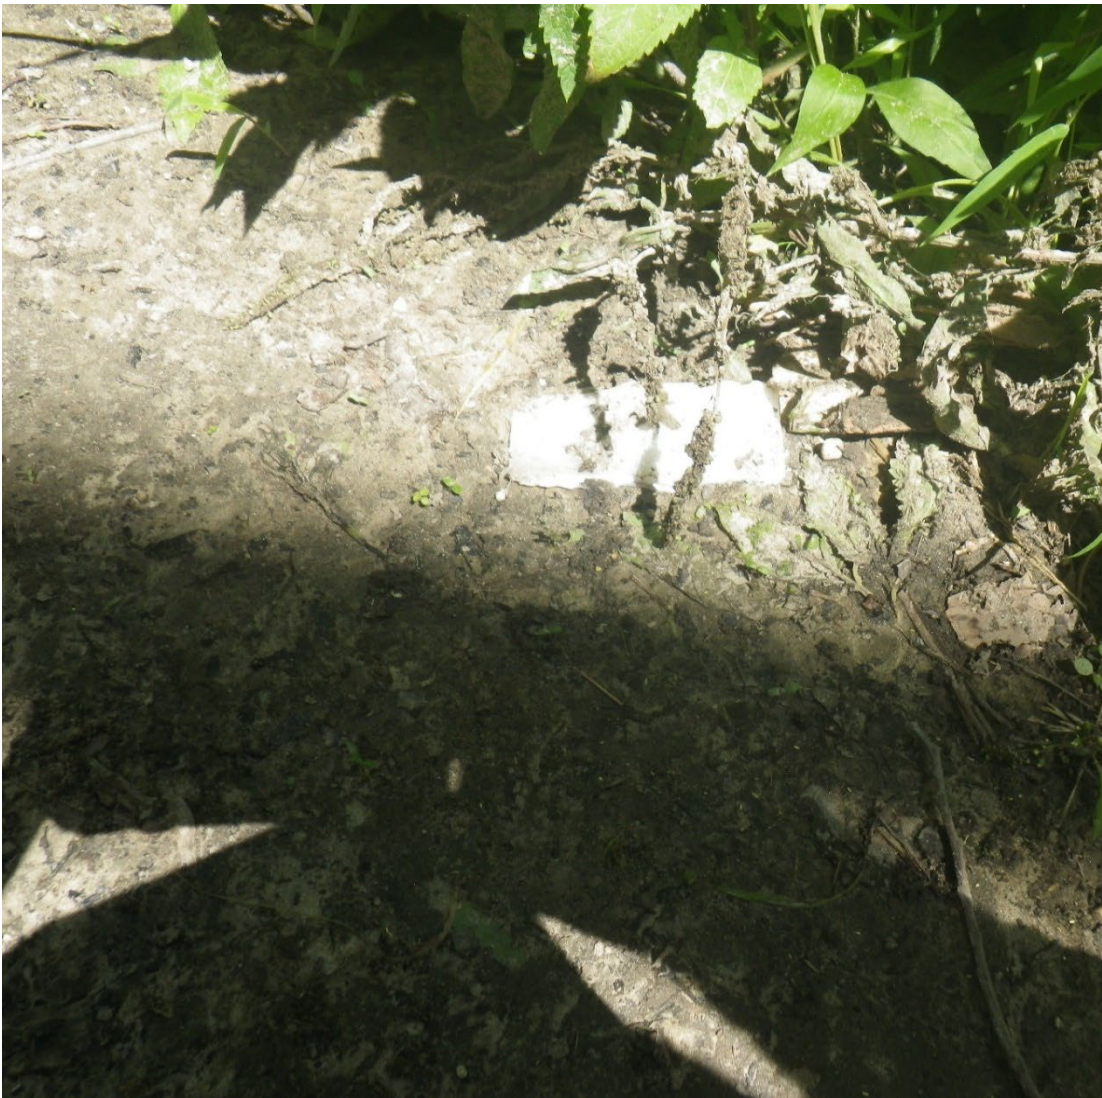
| Photograph 37. A close up of the white piece of plastic shown in photograph 36. | | | IMGP0069.JPG |
| This plastic is near the outfall shown in photograph 36. | | | |
