**UNITED STATES ENVIRONMENTAL PROTECTION AGENCY  
REGION 8  
RESOURCE CONSERVATION AND RECOVERY ACT**

Industrial Container Services Co, LLC  
(a.k.a., Mauser Packaging Systems)

**Date of Inspection:** August 10, 2023

**Type and Purpose of Inspection:** Compliance Evaluation Inspection  
Compliance with RCRA Subtitle C

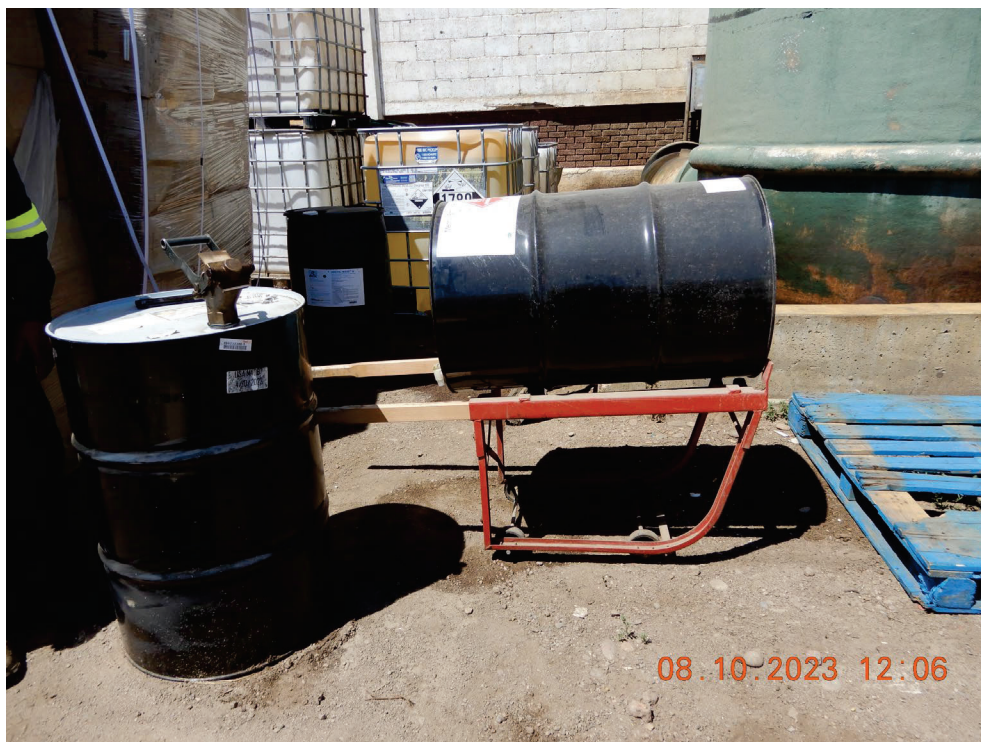
Outside the warehouse, we observed a 55-gallon drum of product MEK that was on its side on a hand cart (photo 1). The drum had a spigot on the top and Mr. Gonzalez explained that this is where they fill a 5-gallon carboy to bring inside the warehouse for use. We observed that the spigot had a constant slow leak that was dripping onto the soil, leaving a stain (photo 2). During the inspection, Mr. Gonzalez had some workers put the drum upright onto a pallet and move it into a conex box with a forklift. He said that they would put the drum onto secondary containment and would start cleaning up the soil that day. The inspectors advised them to dig up the soil until there was no staining, and explained that the soil would be considered a U159 and D035 hazardous waste because the MEK was a commercial chemical product that had not yet been used, as well as a characteristic hazardous waste.

Photo 1.  
Product drum of  
MEK with spigot  
on hand cart in  
outside yard  
visibly dripping  
onto soil.  
(DSCN0723.JPG)

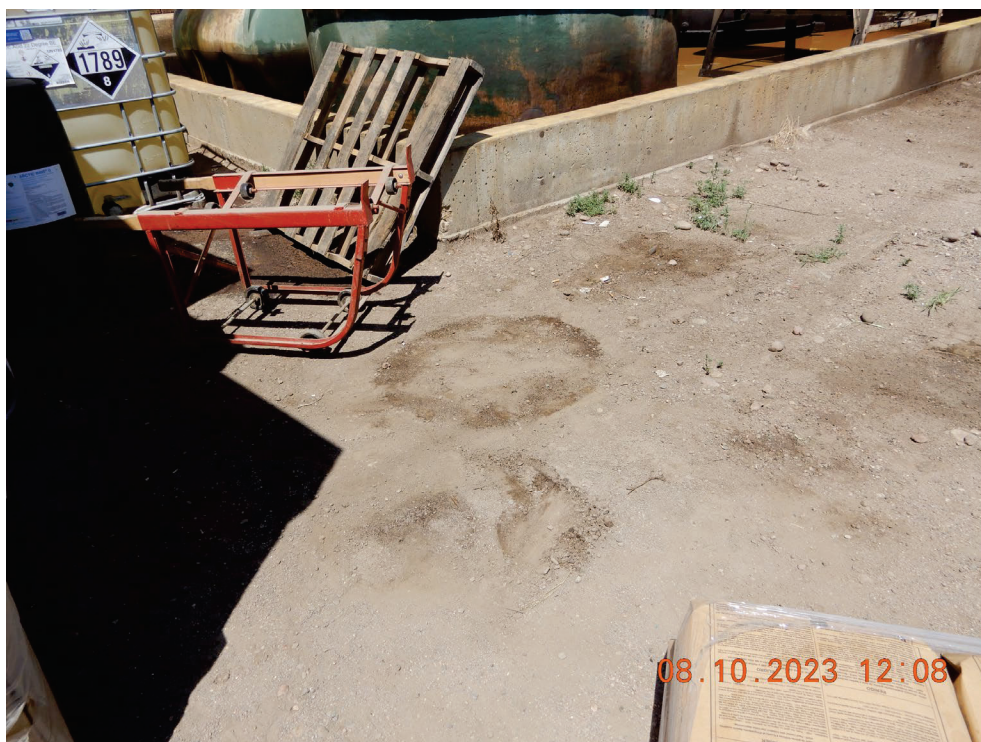
Photo 2.  
Visible stain on  
soil where MEK  
product drum  
was dripping,  
after removal of  
drum.  
(DSCN0724.JPG)

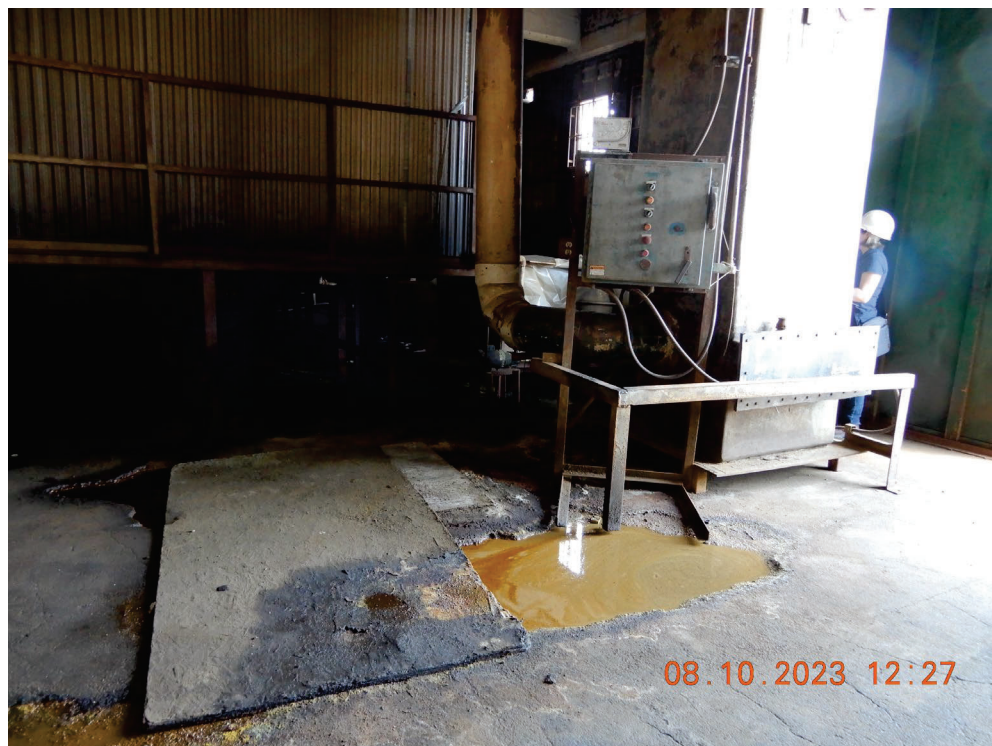
Gonzalez tested the pH of the acid on the floor using a pH strip and it was approximately pH 3. The inspectors advised Ms. James to make a hazardous waste determination on the liquid on the ground. We explained that because the liquid is no longer being used for its intended purpose, it is a waste, and if the pH is below 2, it would be a D002 corrosive hazardous waste. The inspectors also recommended best management practices, such as adding secondary containment under the acid tank and rinse area.

Photo 3.  
Liquid on  
warehouse floor  
near acid rinse  
area. Acid tank is  
visible in the  
background.  
(DSCN0725.JPG)

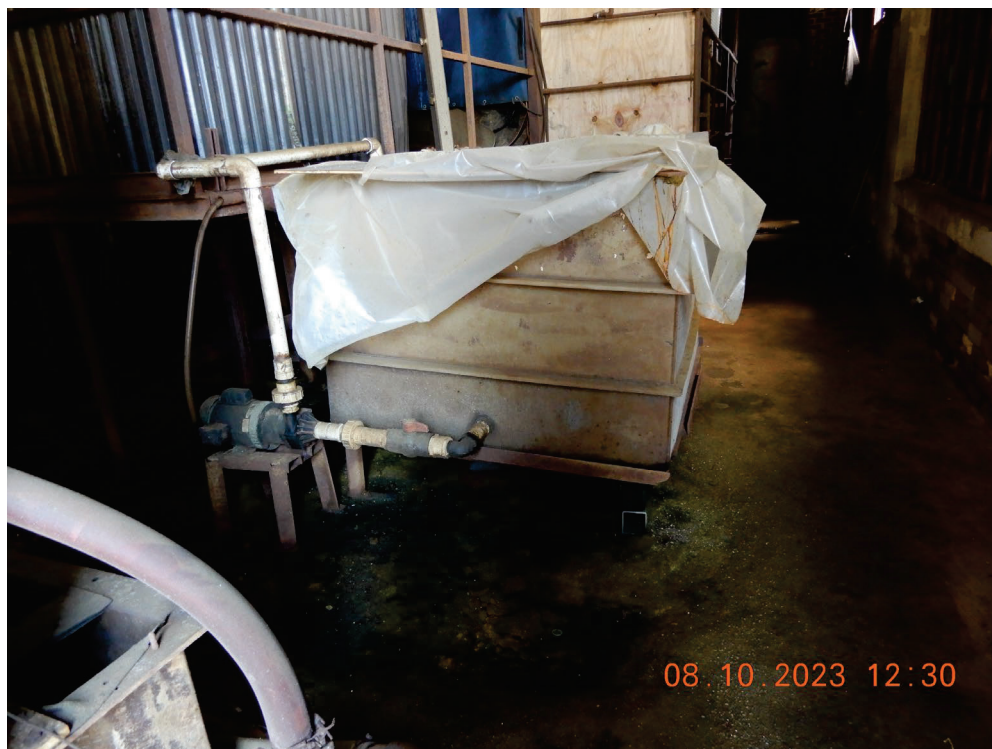
Photo 4.  
Poly tank  
containing acid  
rinse solution.  
Tank was  
covered with a  
plywood sheet as  
a cover.  
(DSCN0726.JPG)

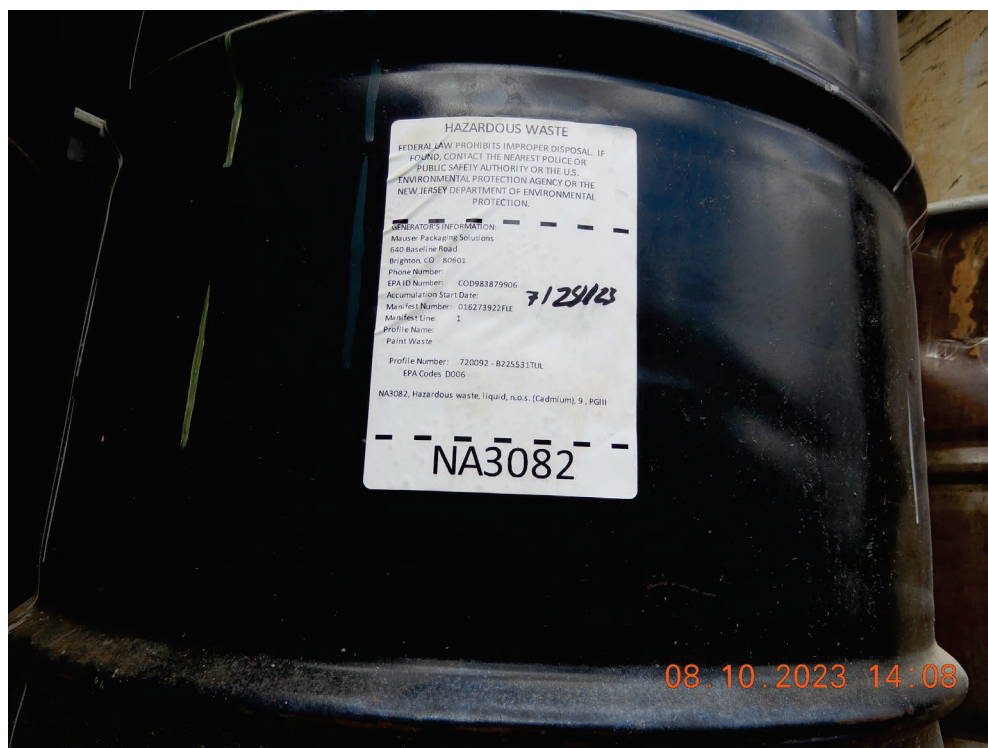
Photo 5.  
Drum in  
hazardous waste  
accumulation  
area labeled  
D006 hazardous  
waste and dated  
7/28/23.  
(DSCN0727.JPG)

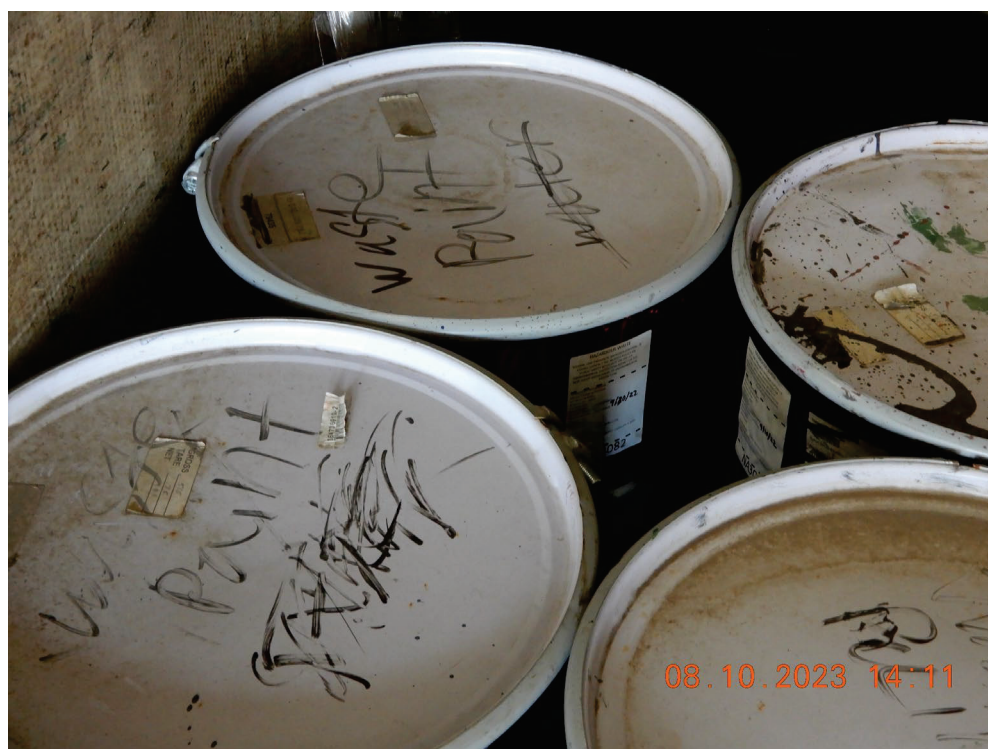
Photo 6.  
Drums in  
hazardous waste  
accumulation  
area labeled  
D006 hazardous  
waste and dated  
9/16/22 and  
9/20/22.  
(DSCN0728.JPG)

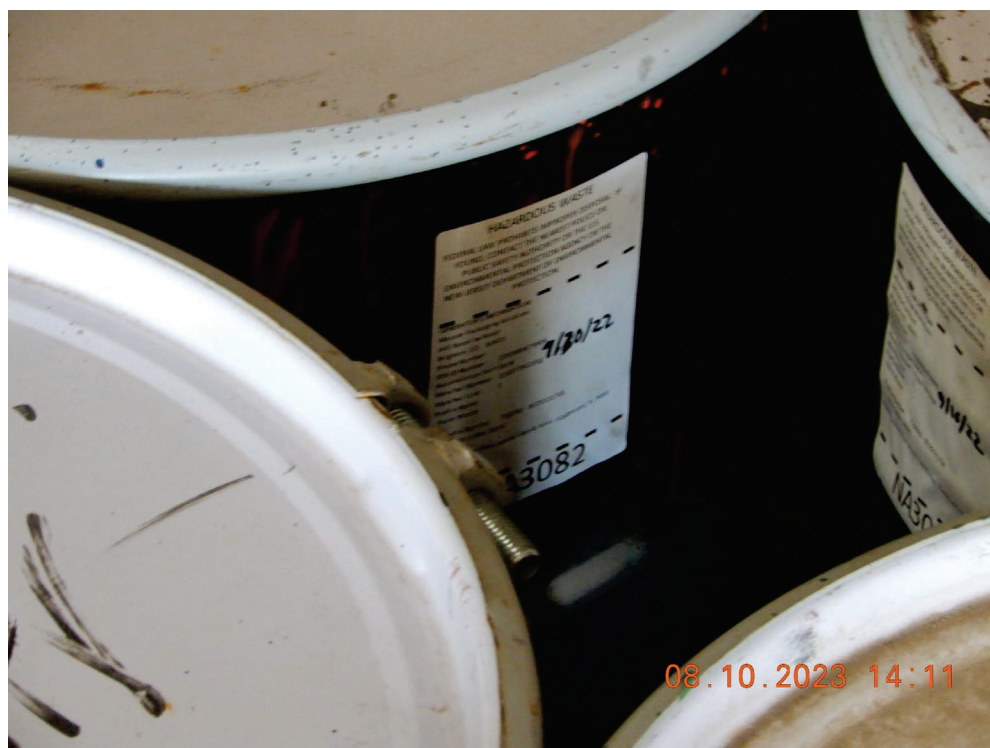
Photo 7.  
Same drums as  
photo 6; zoomed  
in on labels.  
(DSCN0729.JPG)

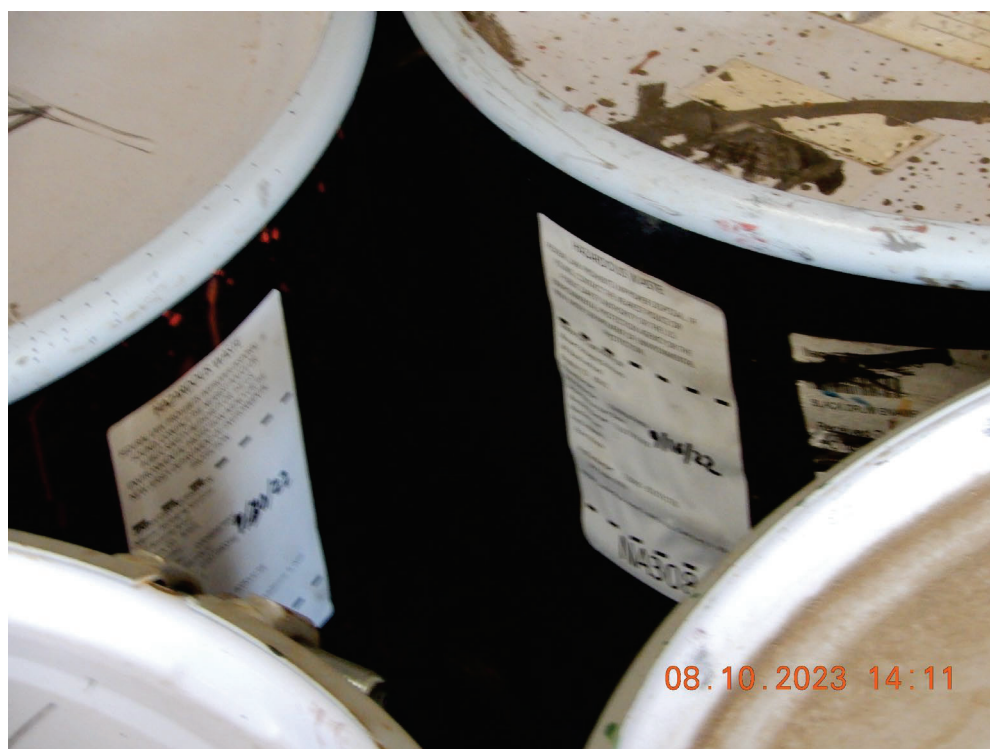
Photo 8.  
Same drums as  
photo 6; zoomed  
in on labels.  
(DSCN0730.JPG)

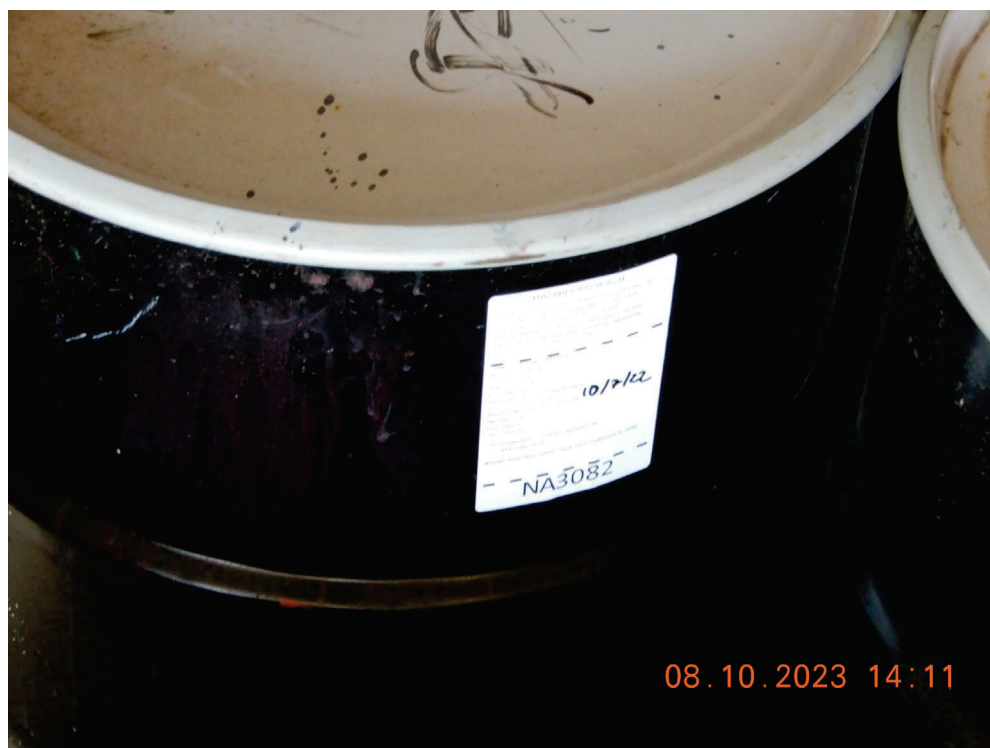
Photo 9.  
Drum in  
hazardous waste  
accumulation  
area labeled  
D006 hazardous  
waste and dated  
10/7/22.  
(DSCN0731.JPG)

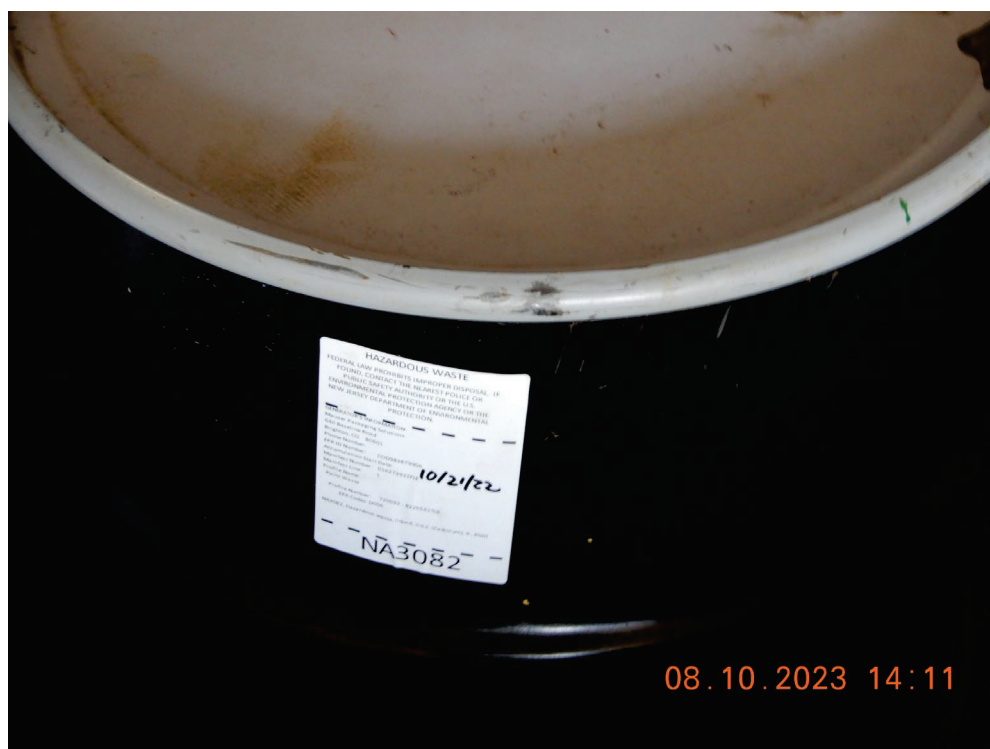
Photo 10.  
Drum in  
hazardous waste  
accumulation  
area labeled  
D006 hazardous  
waste and dated  
10/21/22.  
(DSCN0732.JPG)

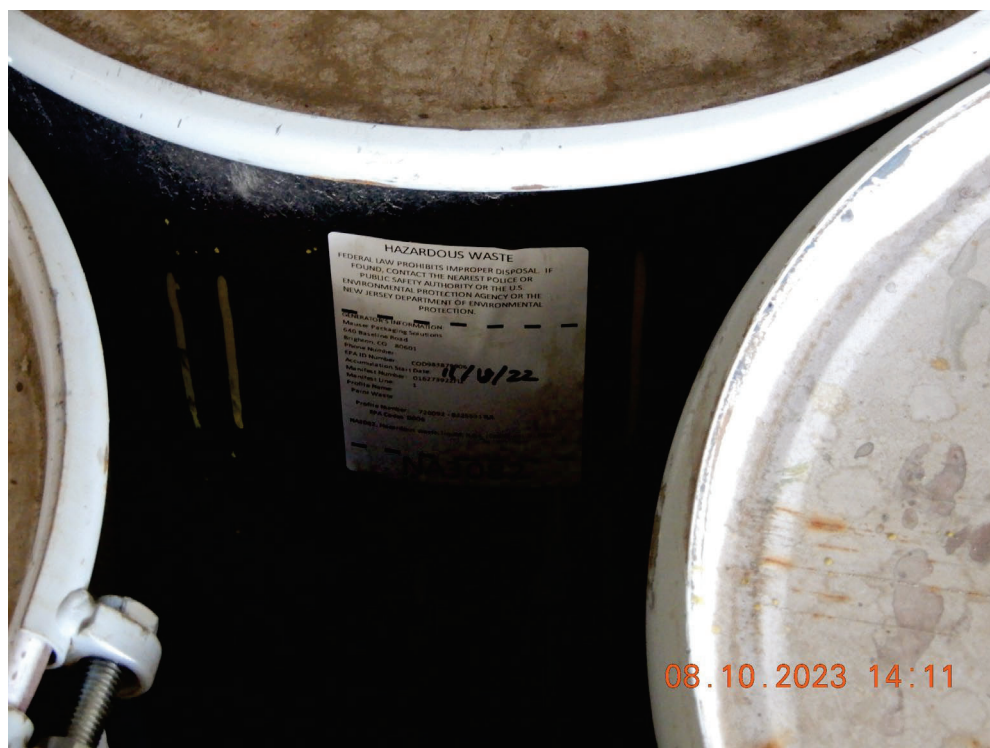
Photo 11.  
Drum in  
hazardous waste  
accumulation  
area labeled  
D006 hazardous  
waste and dated  
11/18/22.  
(DSCN0733JPG)

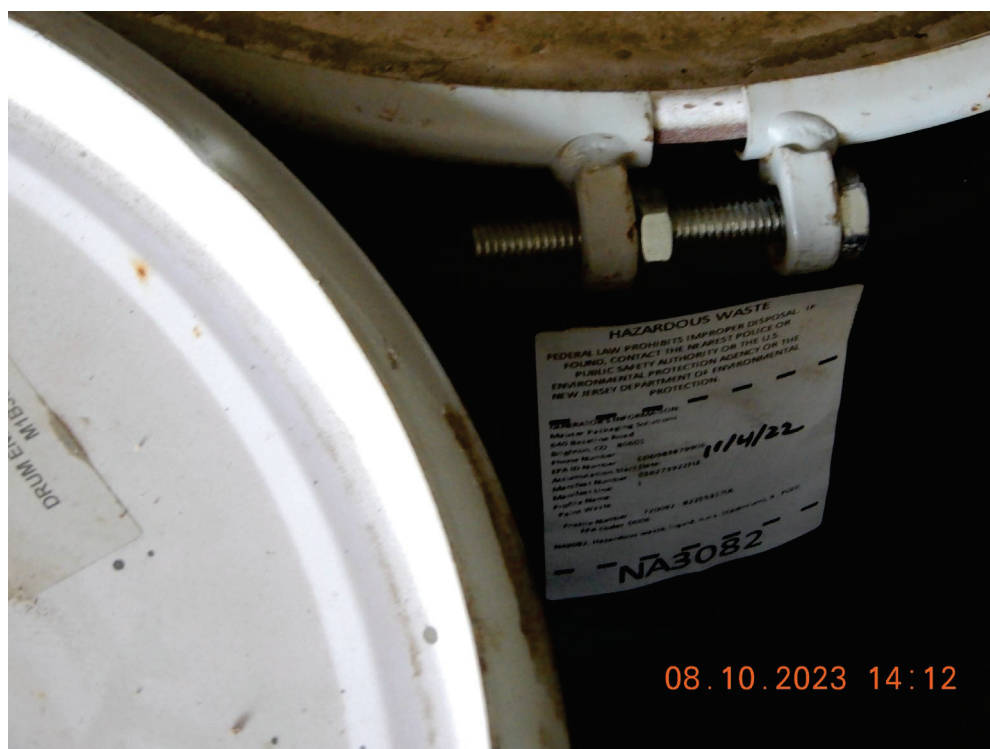
Photo 12.  
Drum in  
hazardous waste  
accumulation  
area labeled  
D006 hazardous  
waste and dated  
11/4/22.  
(DSCN0734.JPG)

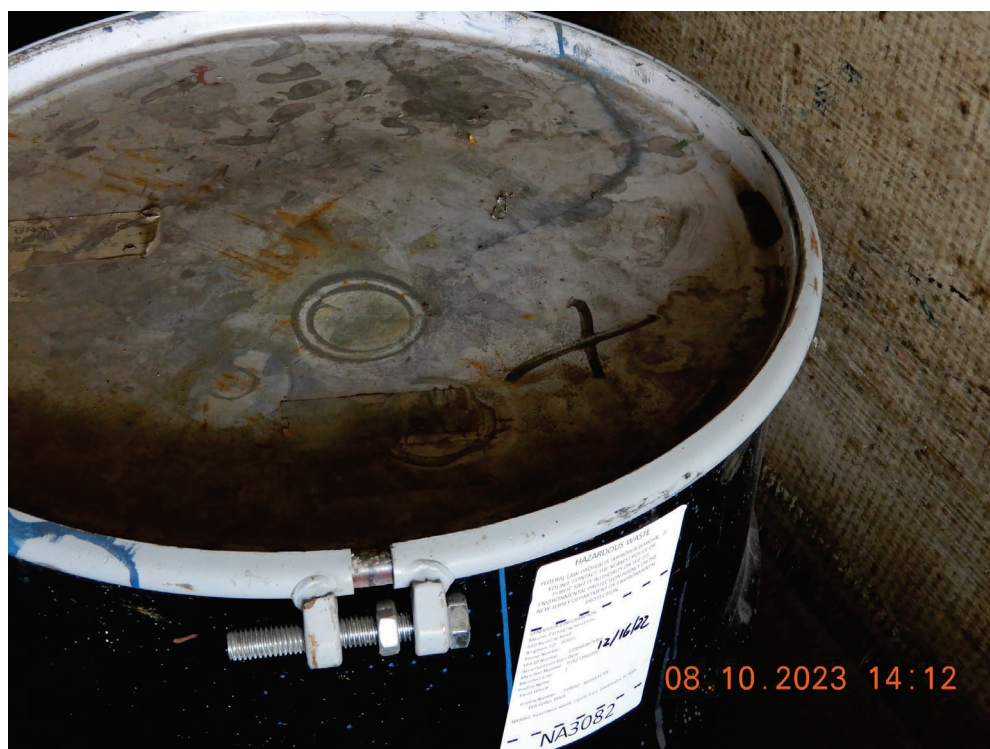
Photo 14.  
Drum in  
hazardous waste  
accumulation  
area labeled  
D006 hazardous  
waste and dated  
12/16/22.  
(DSCN0736.JPG)

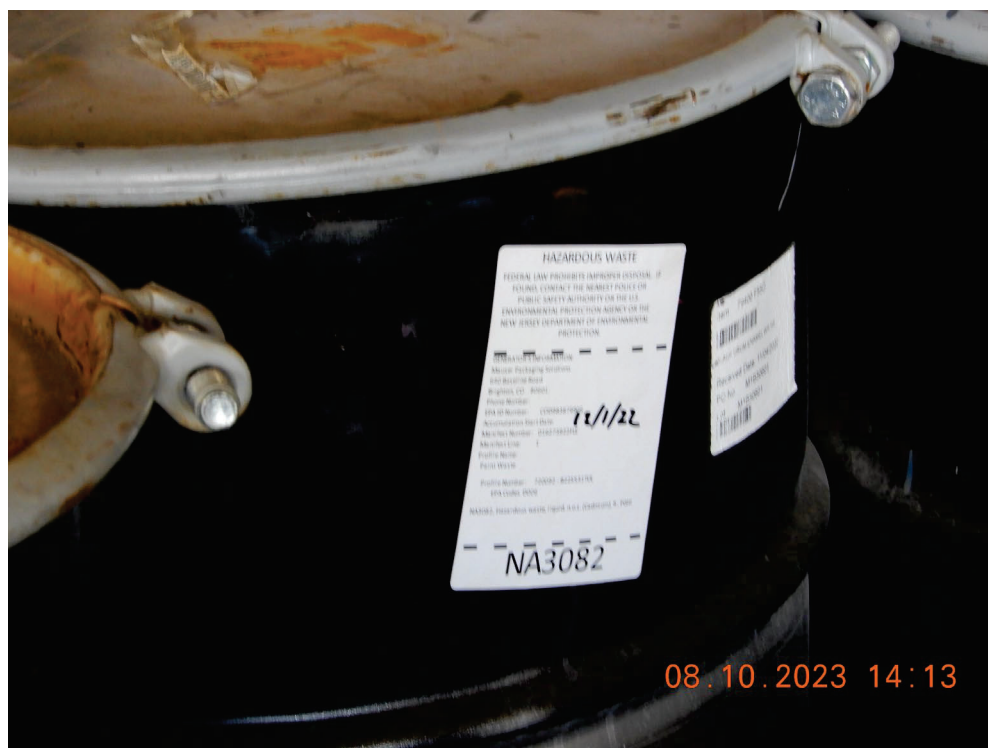
Photo 15.  
Drum in  
hazardous waste  
accumulation  
area labeled  
D006 hazardous  
waste and dated  
12/1/22.  
(DSCN0737.JPG)

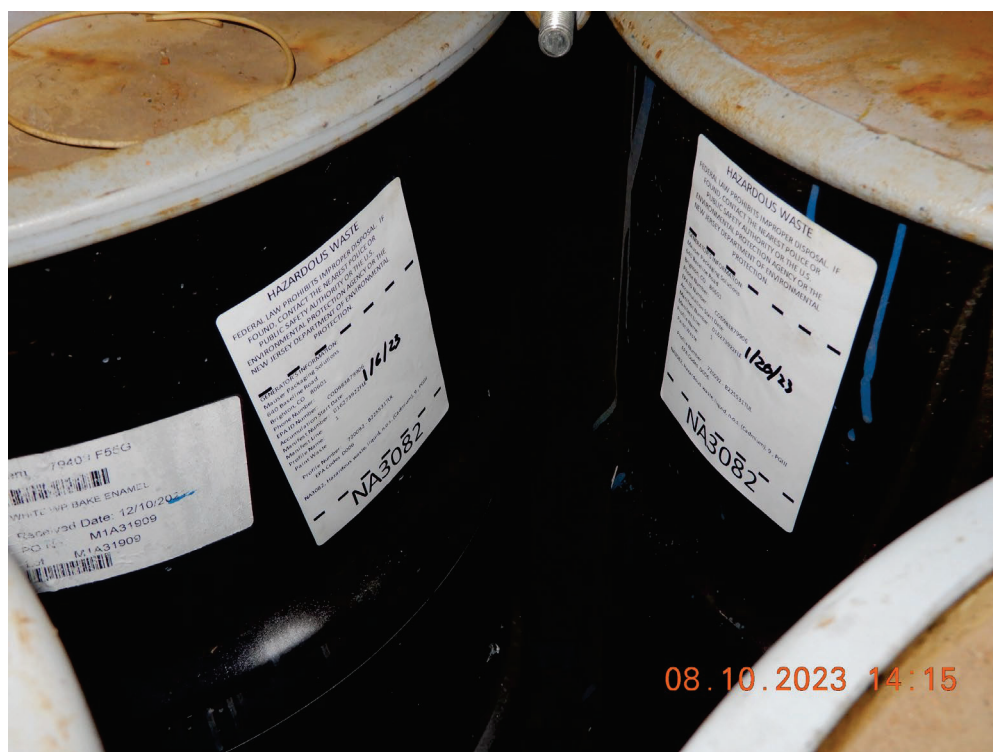
Photo 18.  
Clear photo for  
photos 16 & 17.  
Drums in  
hazardous waste  
accumulation  
area labeled  
D006 hazardous  
waste and dated  
1/6/23 and  
1/20/23.  
(DSCN0740.JPG)

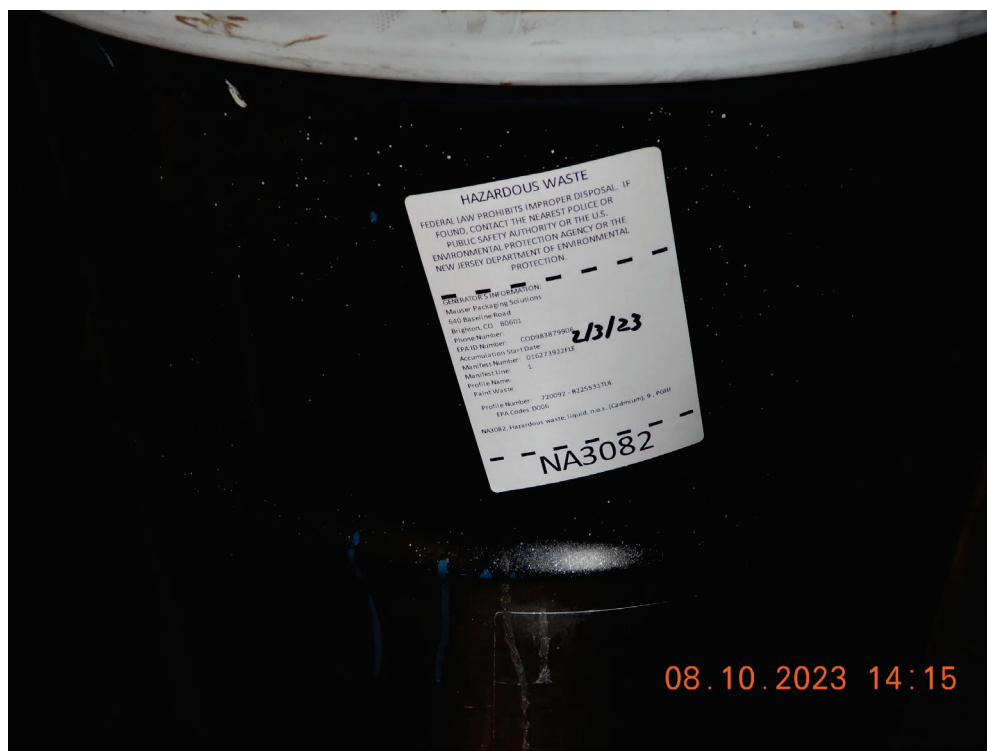
Photo 19.  
Drum in  
hazardous waste  
accumulation  
area labeled  
D006 hazardous  
waste and dated  
2/3/23.  
(DSCN0741.JPG)

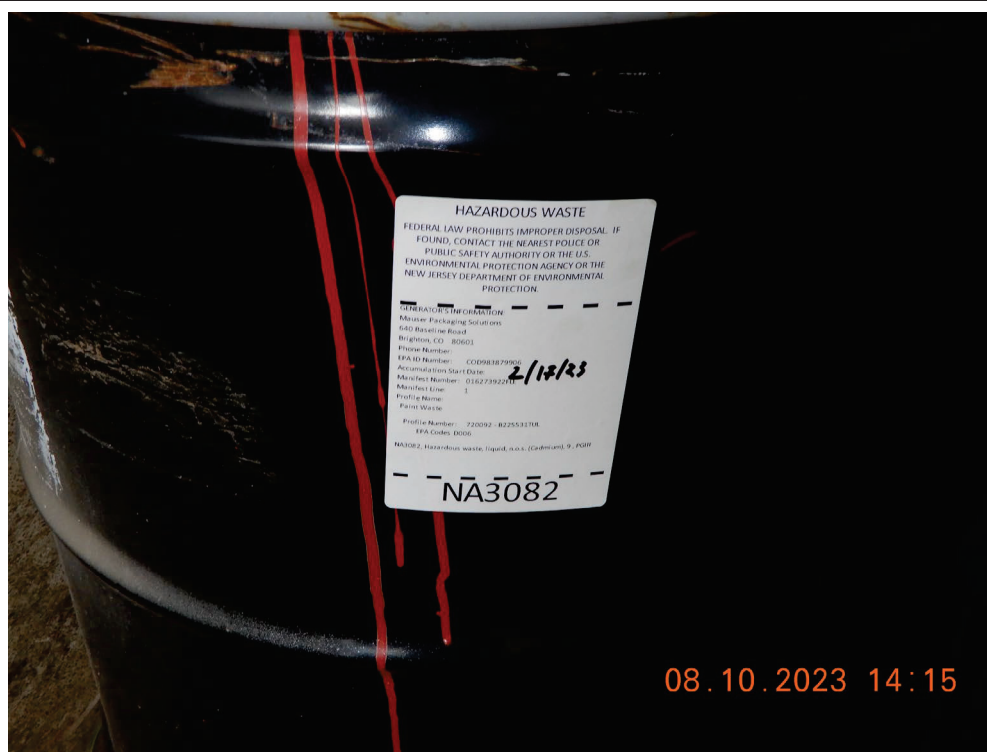
Photo 20.  
Drum in  
hazardous waste  
accumulation  
area labeled  
D006 hazardous  
waste and dated  
2/17/23.  
(DSCN0742.JPG)

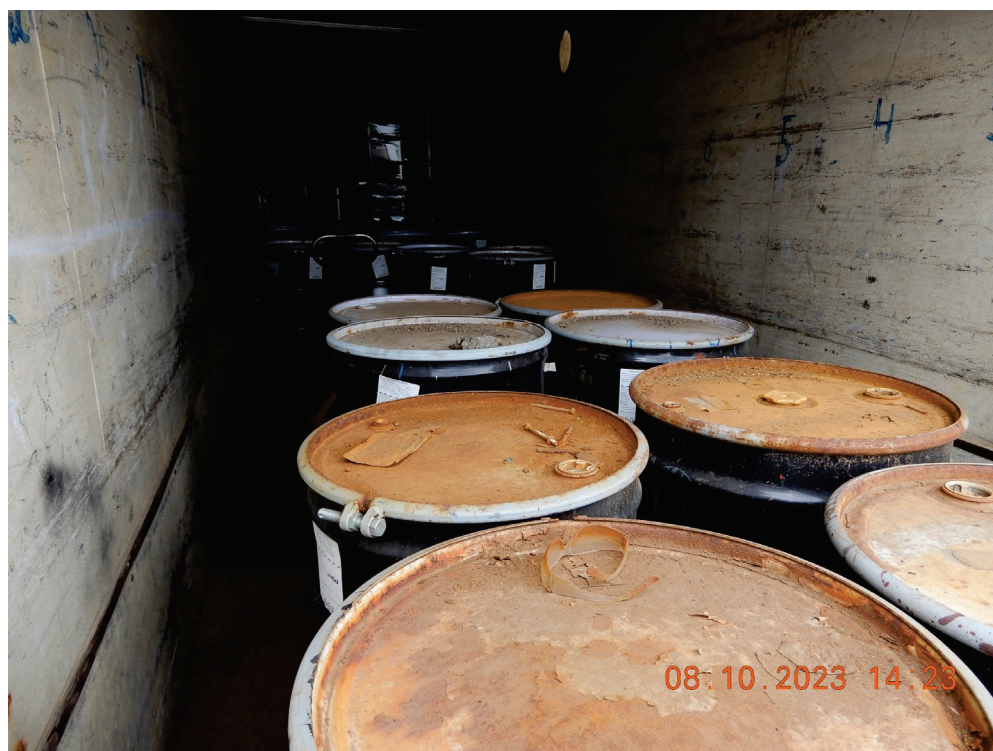
Mr. Gonzalez told us that the drums held paint waste and that they generated approximately two drums per month. At the time of the inspection, I observed 23 drums in the hazardous waste accumulation area (photos 22 and 23). The way that they were placed into the trailer made it impossible to examine all of the drums without climbing over some of them, so I mentioned the aisle space requirement for small quantity generators. All 23 drums were closed, marked with accumulation start dates, and labeled with the words hazardous waste. I observed that none of the drums were marked with an indication of the hazard.

Photo 22.  
Overview of  
drums on pallets  
in hazardous  
waste  
accumulation  
area.  
(DSCN0744.JPG)

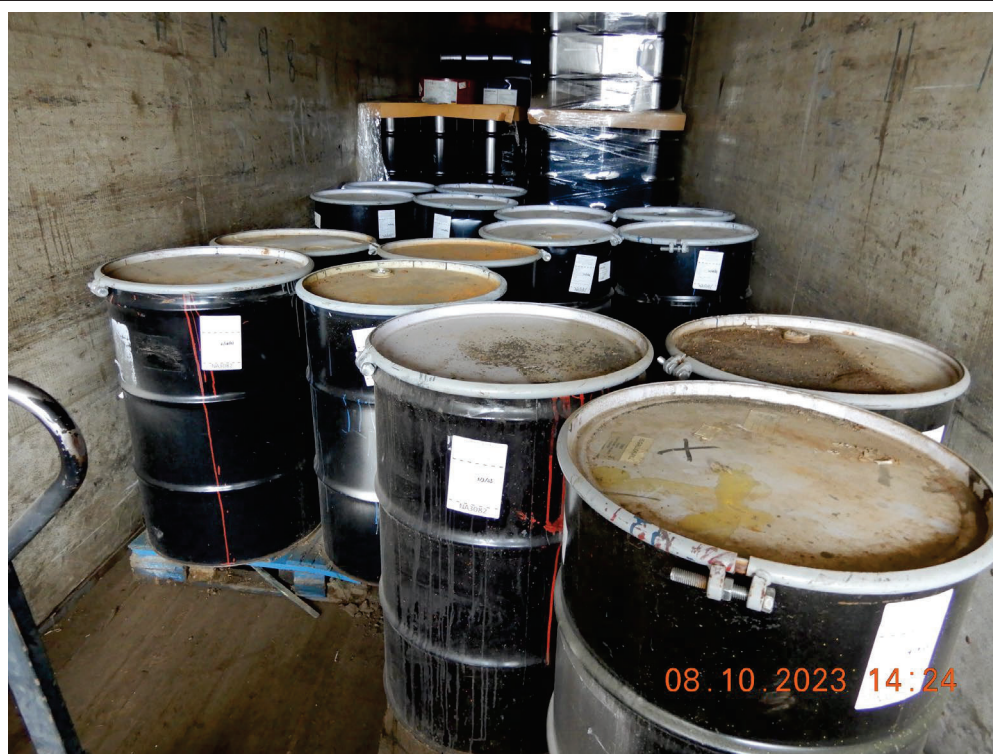
Photo 23.  
Overview of  
drums on pallets  
in hazardous  
waste  
accumulation  
area showing lack  
of aisle space.  
(DSCN0745.JPG)
