## CAA112(r) INSPECTION REPORT

| <b>Name:</b> Ray-Carroll County Grain Growers, Inc., Sumner | |
| <b>County:</b> Chariton | <b>Case No:</b> 24MO0827 |
| <b>Process:</b> 42491 Farm Supplies Merchant Wholesalers | |

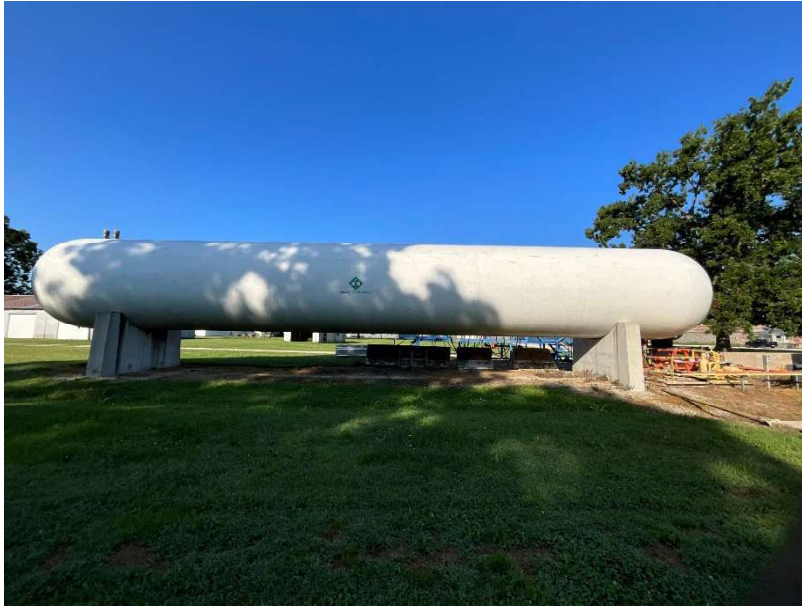
IMG\_0068.jpg

Concrete barriers protect the piping on the western side from collision but do not extend to protect all sides of the tank or the eastern side of the piping (IMG\_0068.jpg). CGA G-2.1 – 2014 section 6.7.1 states, “Containers and appurtenances shall be located or protected by suitable barrier to avoid damage by trucks or other vehicles.” 40 CFR 68.48(b) states, “The owner or operator shall ensure and document that the process is designed in compliance with recognized and generally accepted good engineering practices.” I identified the following finding:

- 1. Ray-Carroll failed to protect the entire container by suitable barriers to avoid damage by trucks per recognized and generally accepted good engineering practices (CGA G-2.1-2014 section 6.7.1) as required by 40 CFR 68.48(b).**

After the inspection, Ray-Carroll added more barriers around the tank on September 16, 2024. It appears that there are no barriers around the back of the tank. Photos are stored in the facility site file.

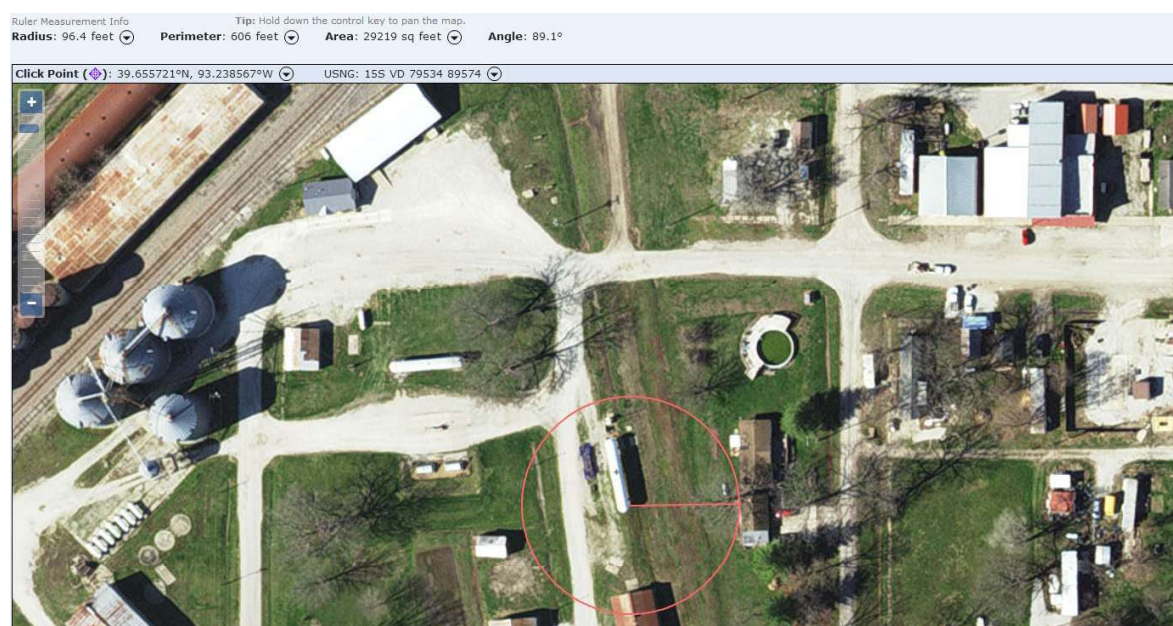
During the field tour I noticed that there was a house very close to the storage tank. According to Marplot, the house is about 96 feet from the bulk tank at its closest point.

CGA G-2.1 – 2014 section 5.3.4 states, "In the absence of specifications of minimum distance by local jurisdictions, separation distance(s) for new, additional or relocated ammonia stationary storage containers and placement of containers covered by Sections 9, 10, 11, and 12 after January 1, 2002 shall be in accordance with Table 5." Table 5 says an ammonia storage container with a capacity of over 2,000 gallons to 30,000 gallons should be at least 300 feet from a place of public assembly or residential occupancy.
