VCM RELEASES WHICH OCCURRED FEBRUARY 10, 1979,  
APRIL 14, 1982 AND JANUARY 8, 1983 BECAUSE  
OF THE PREMATURE FAILURE OF A  
REACTOR RUPTURE DISC

VCM RELEASES WHICH OCCURRED JANUARY 19, 1980  
AND JANUARY 13, 1983 DUE TO  
HYDROSTATICALLY OVERFILLED REACTOR CONDITIONS

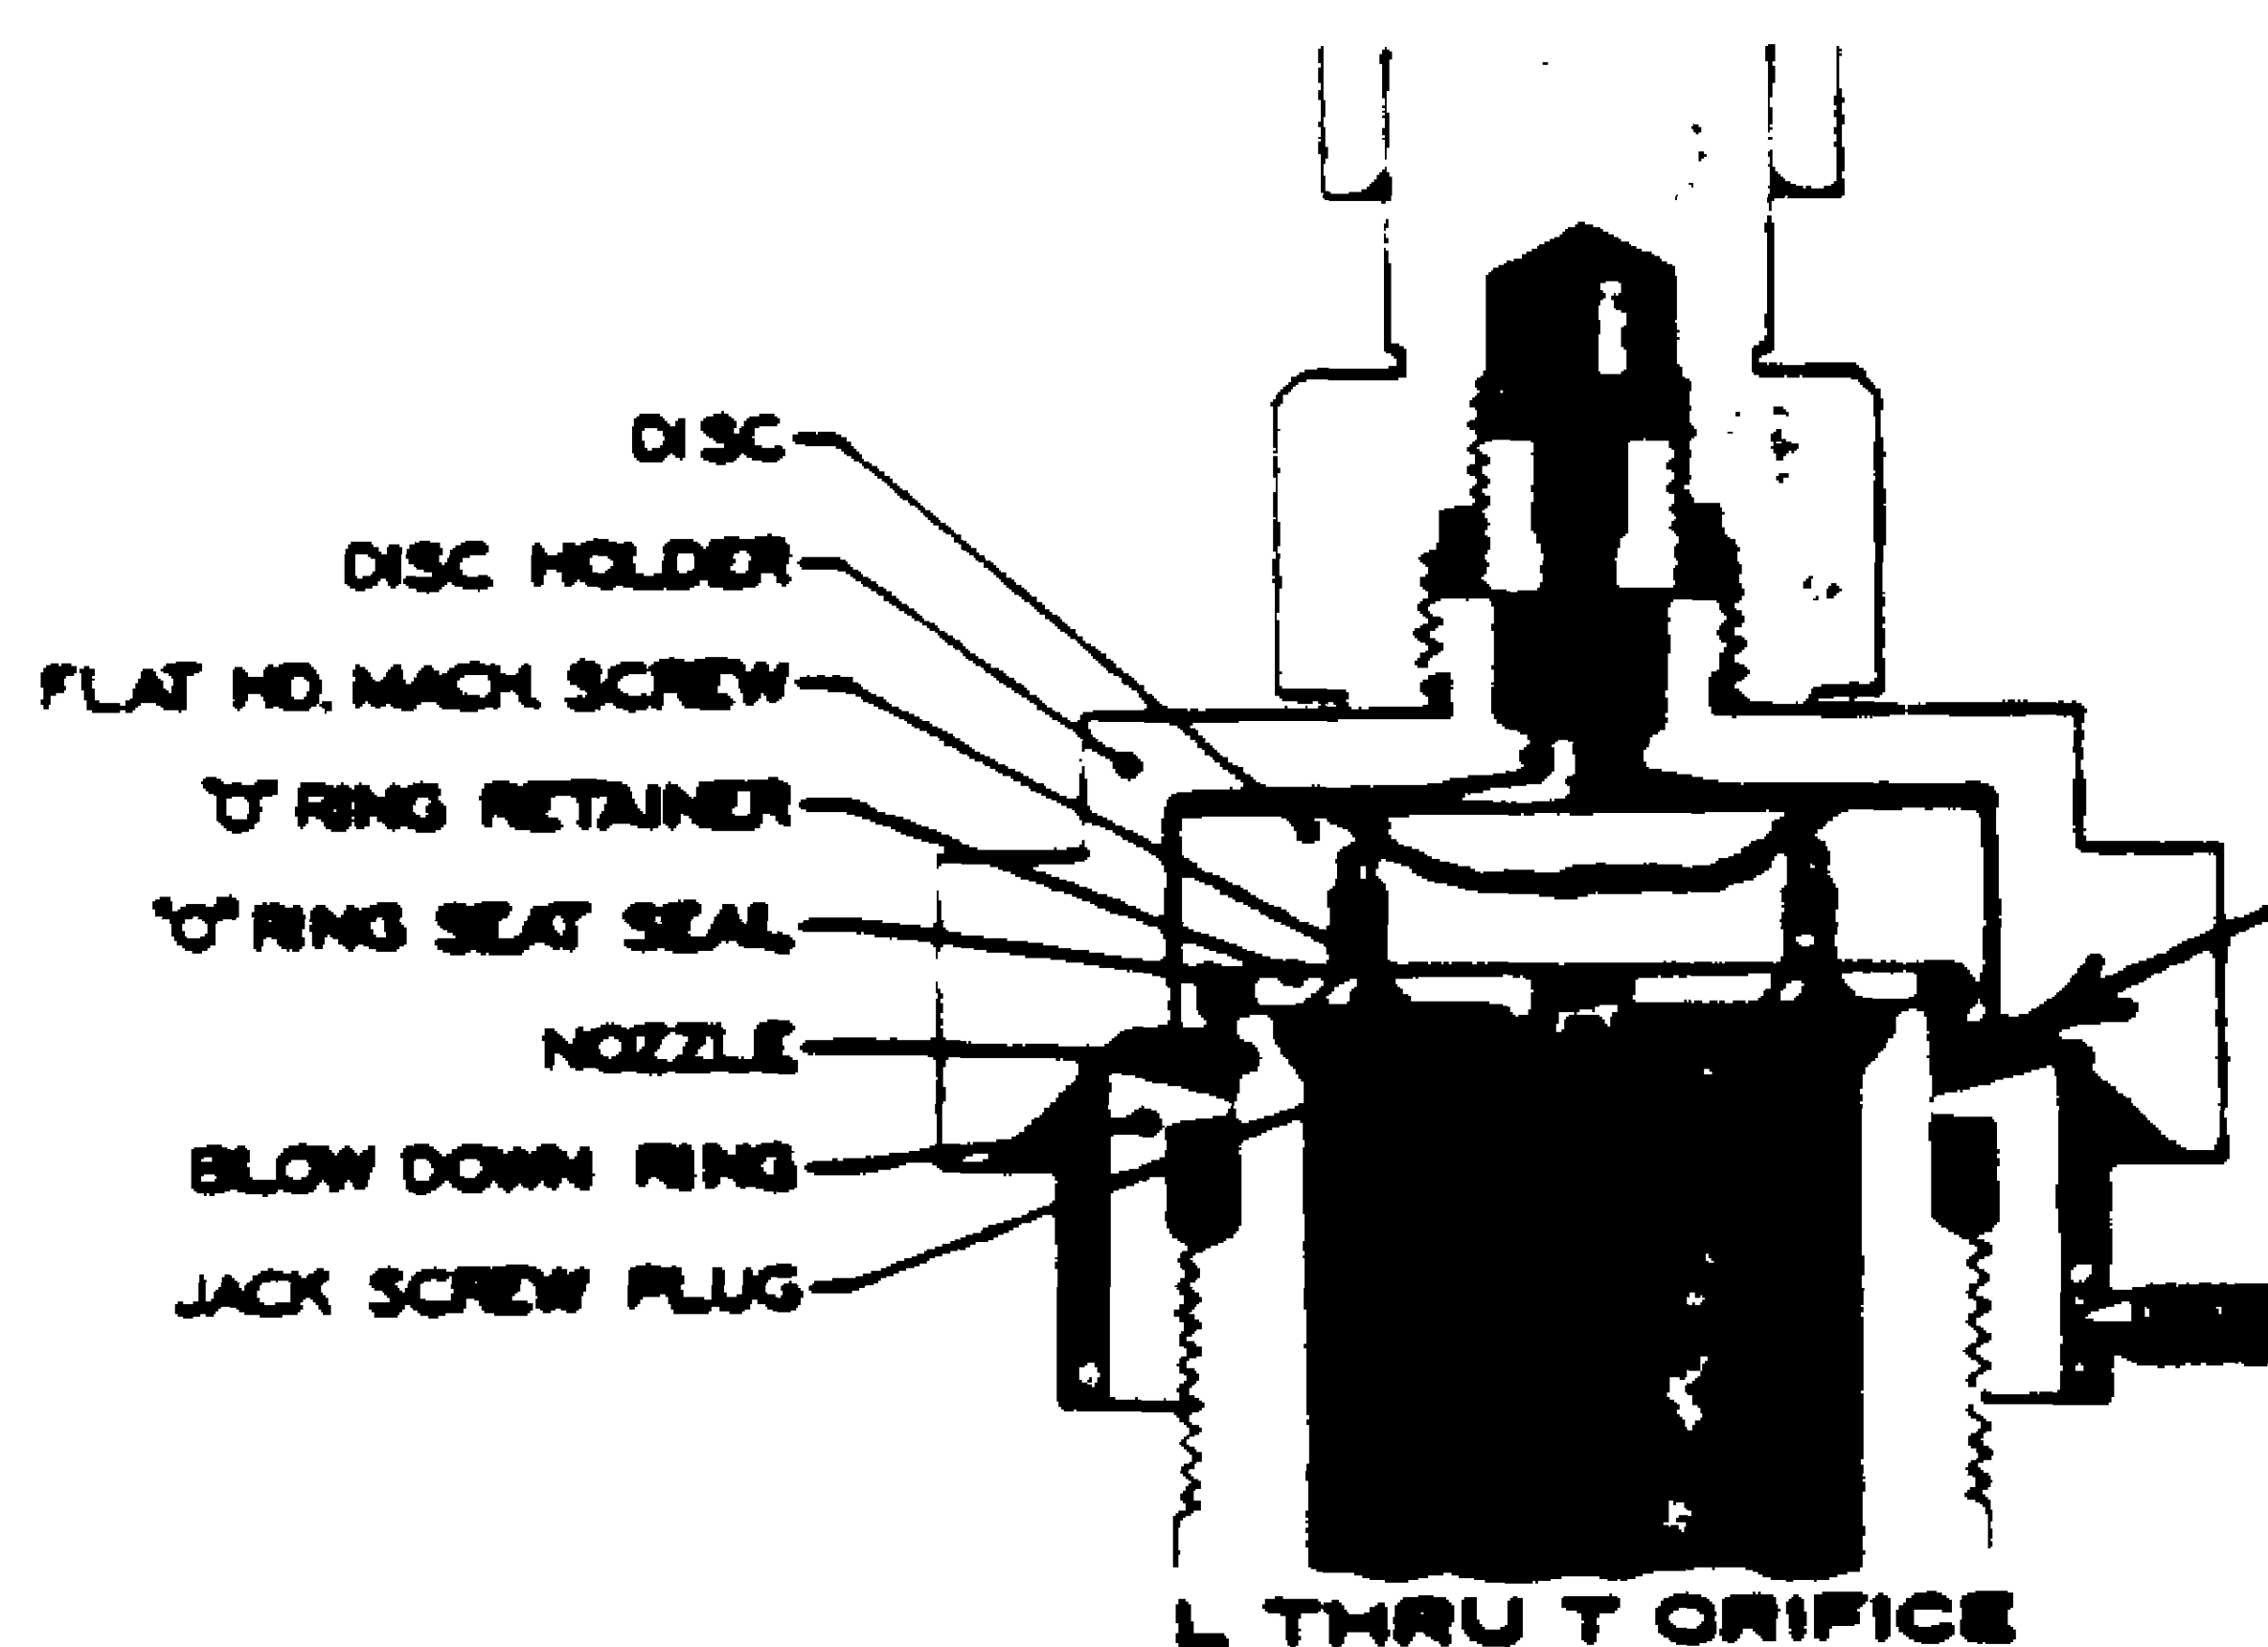
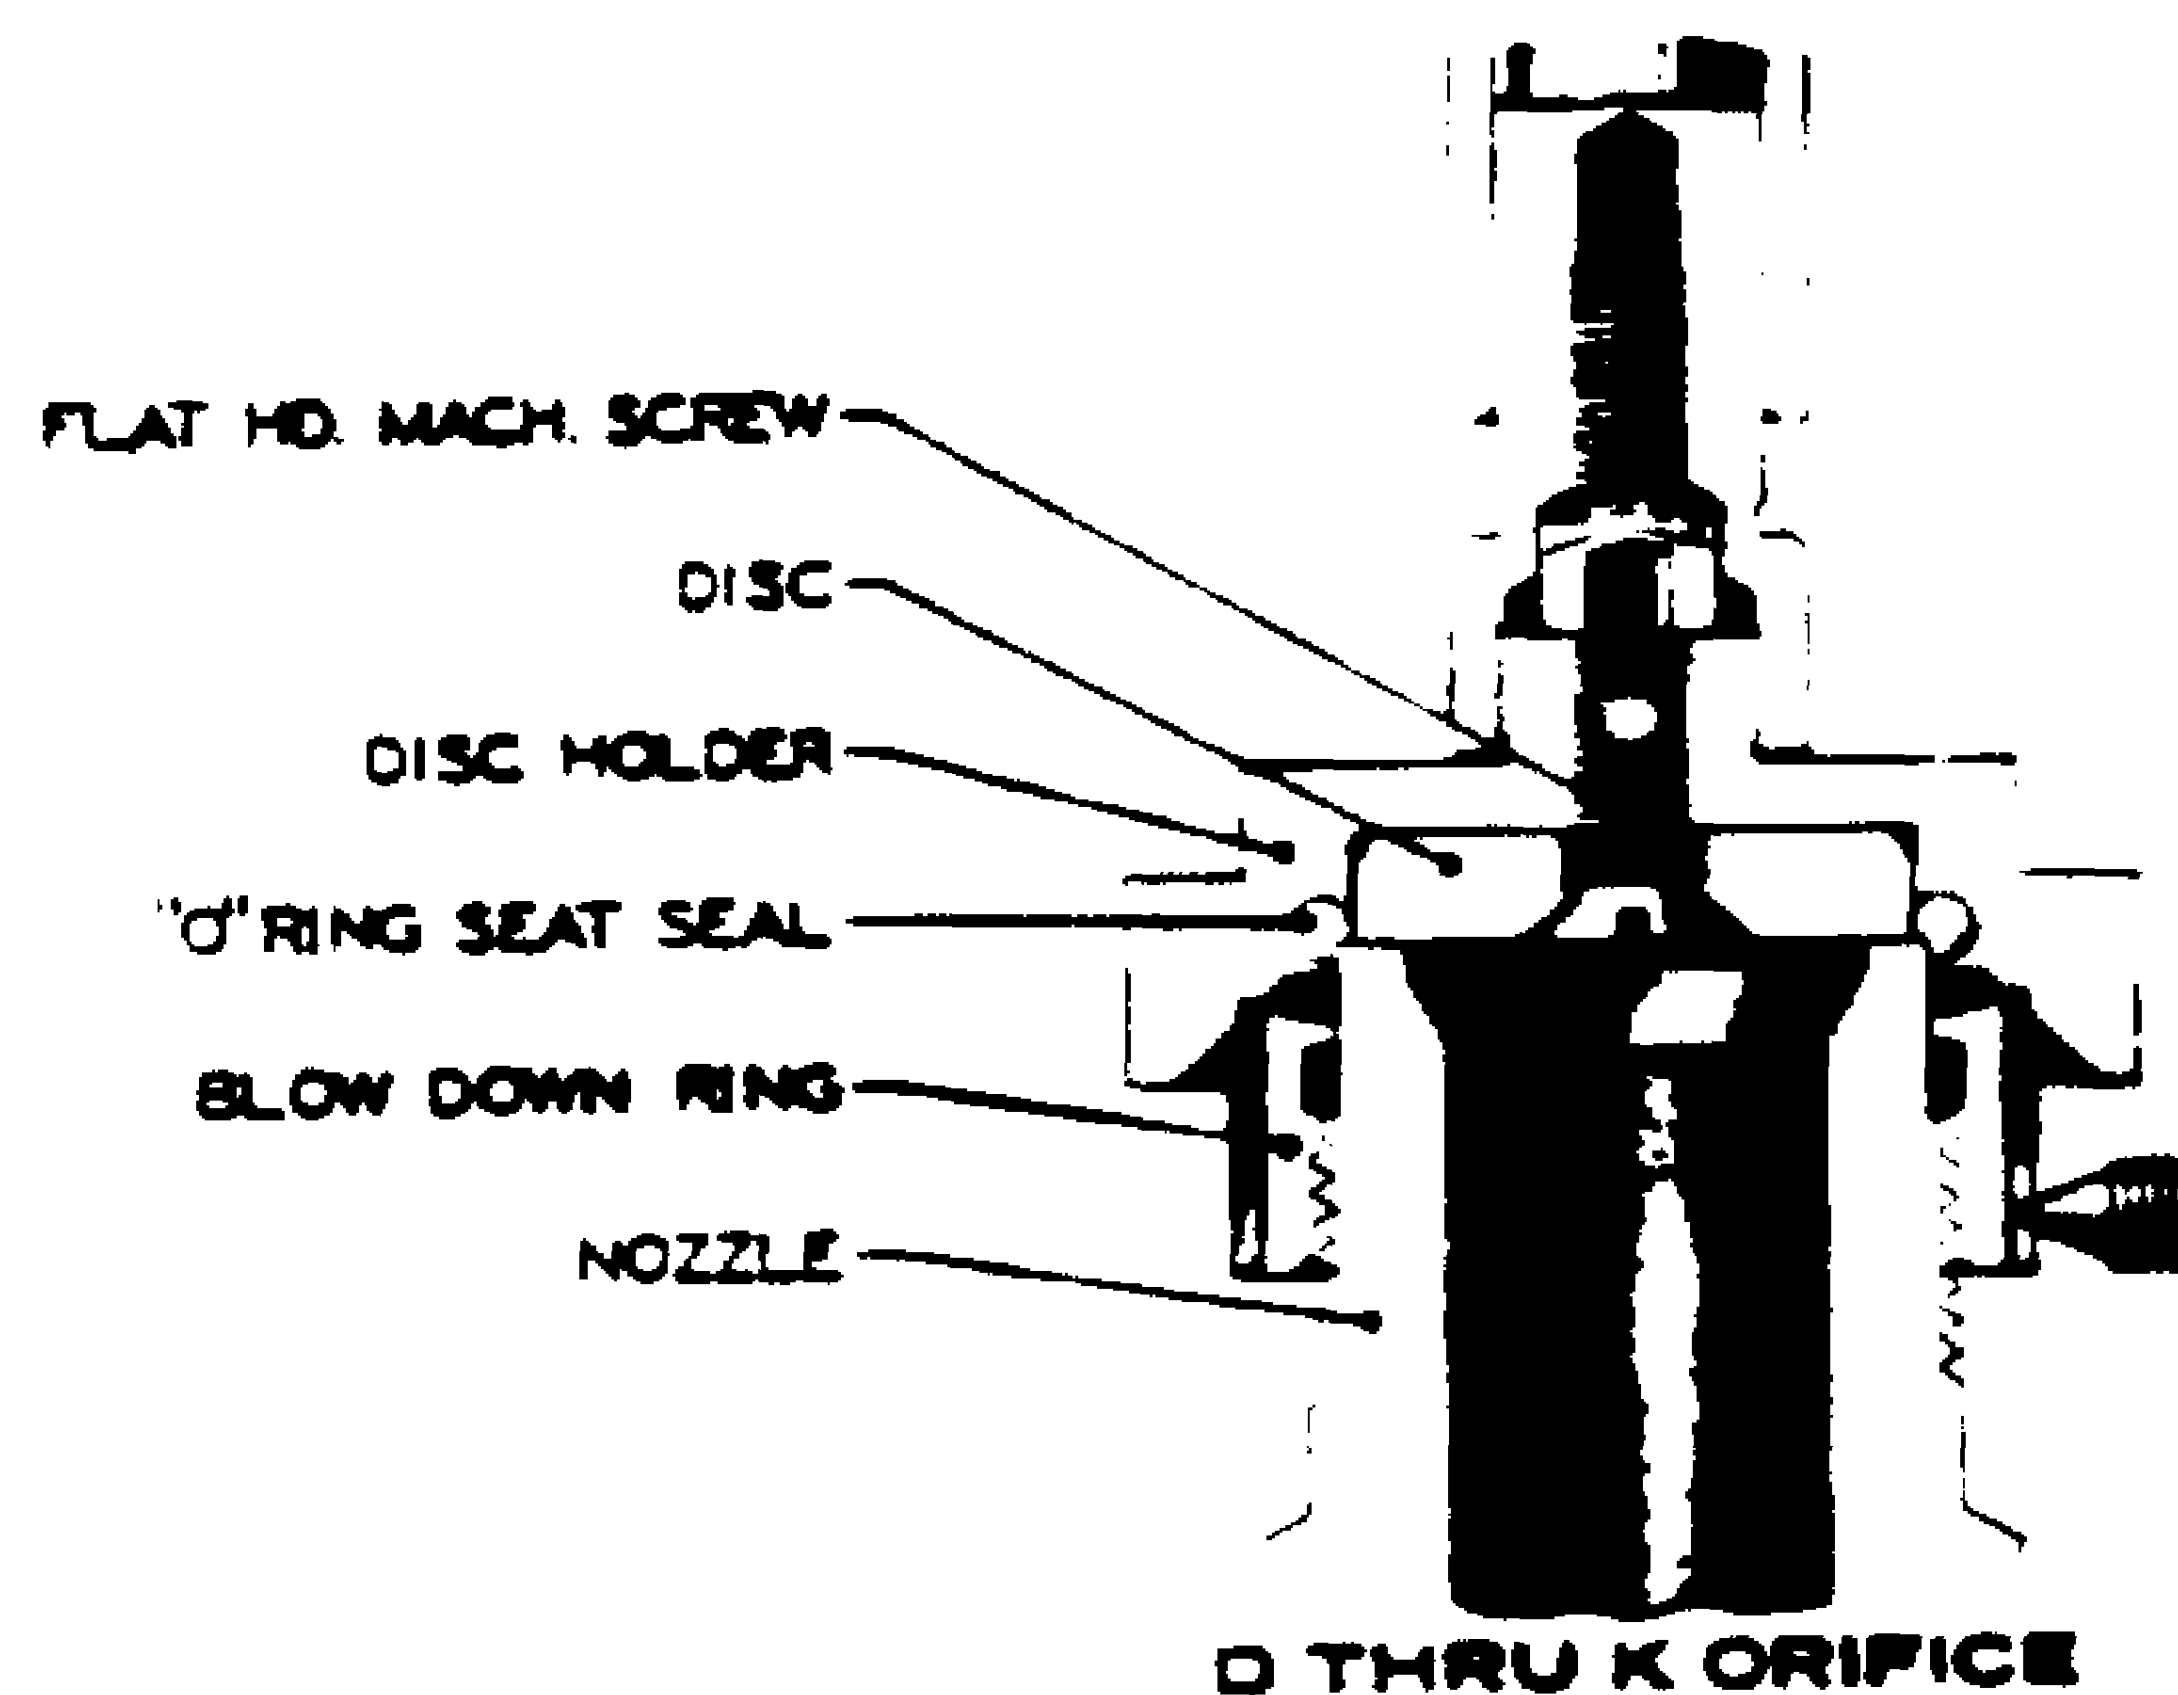
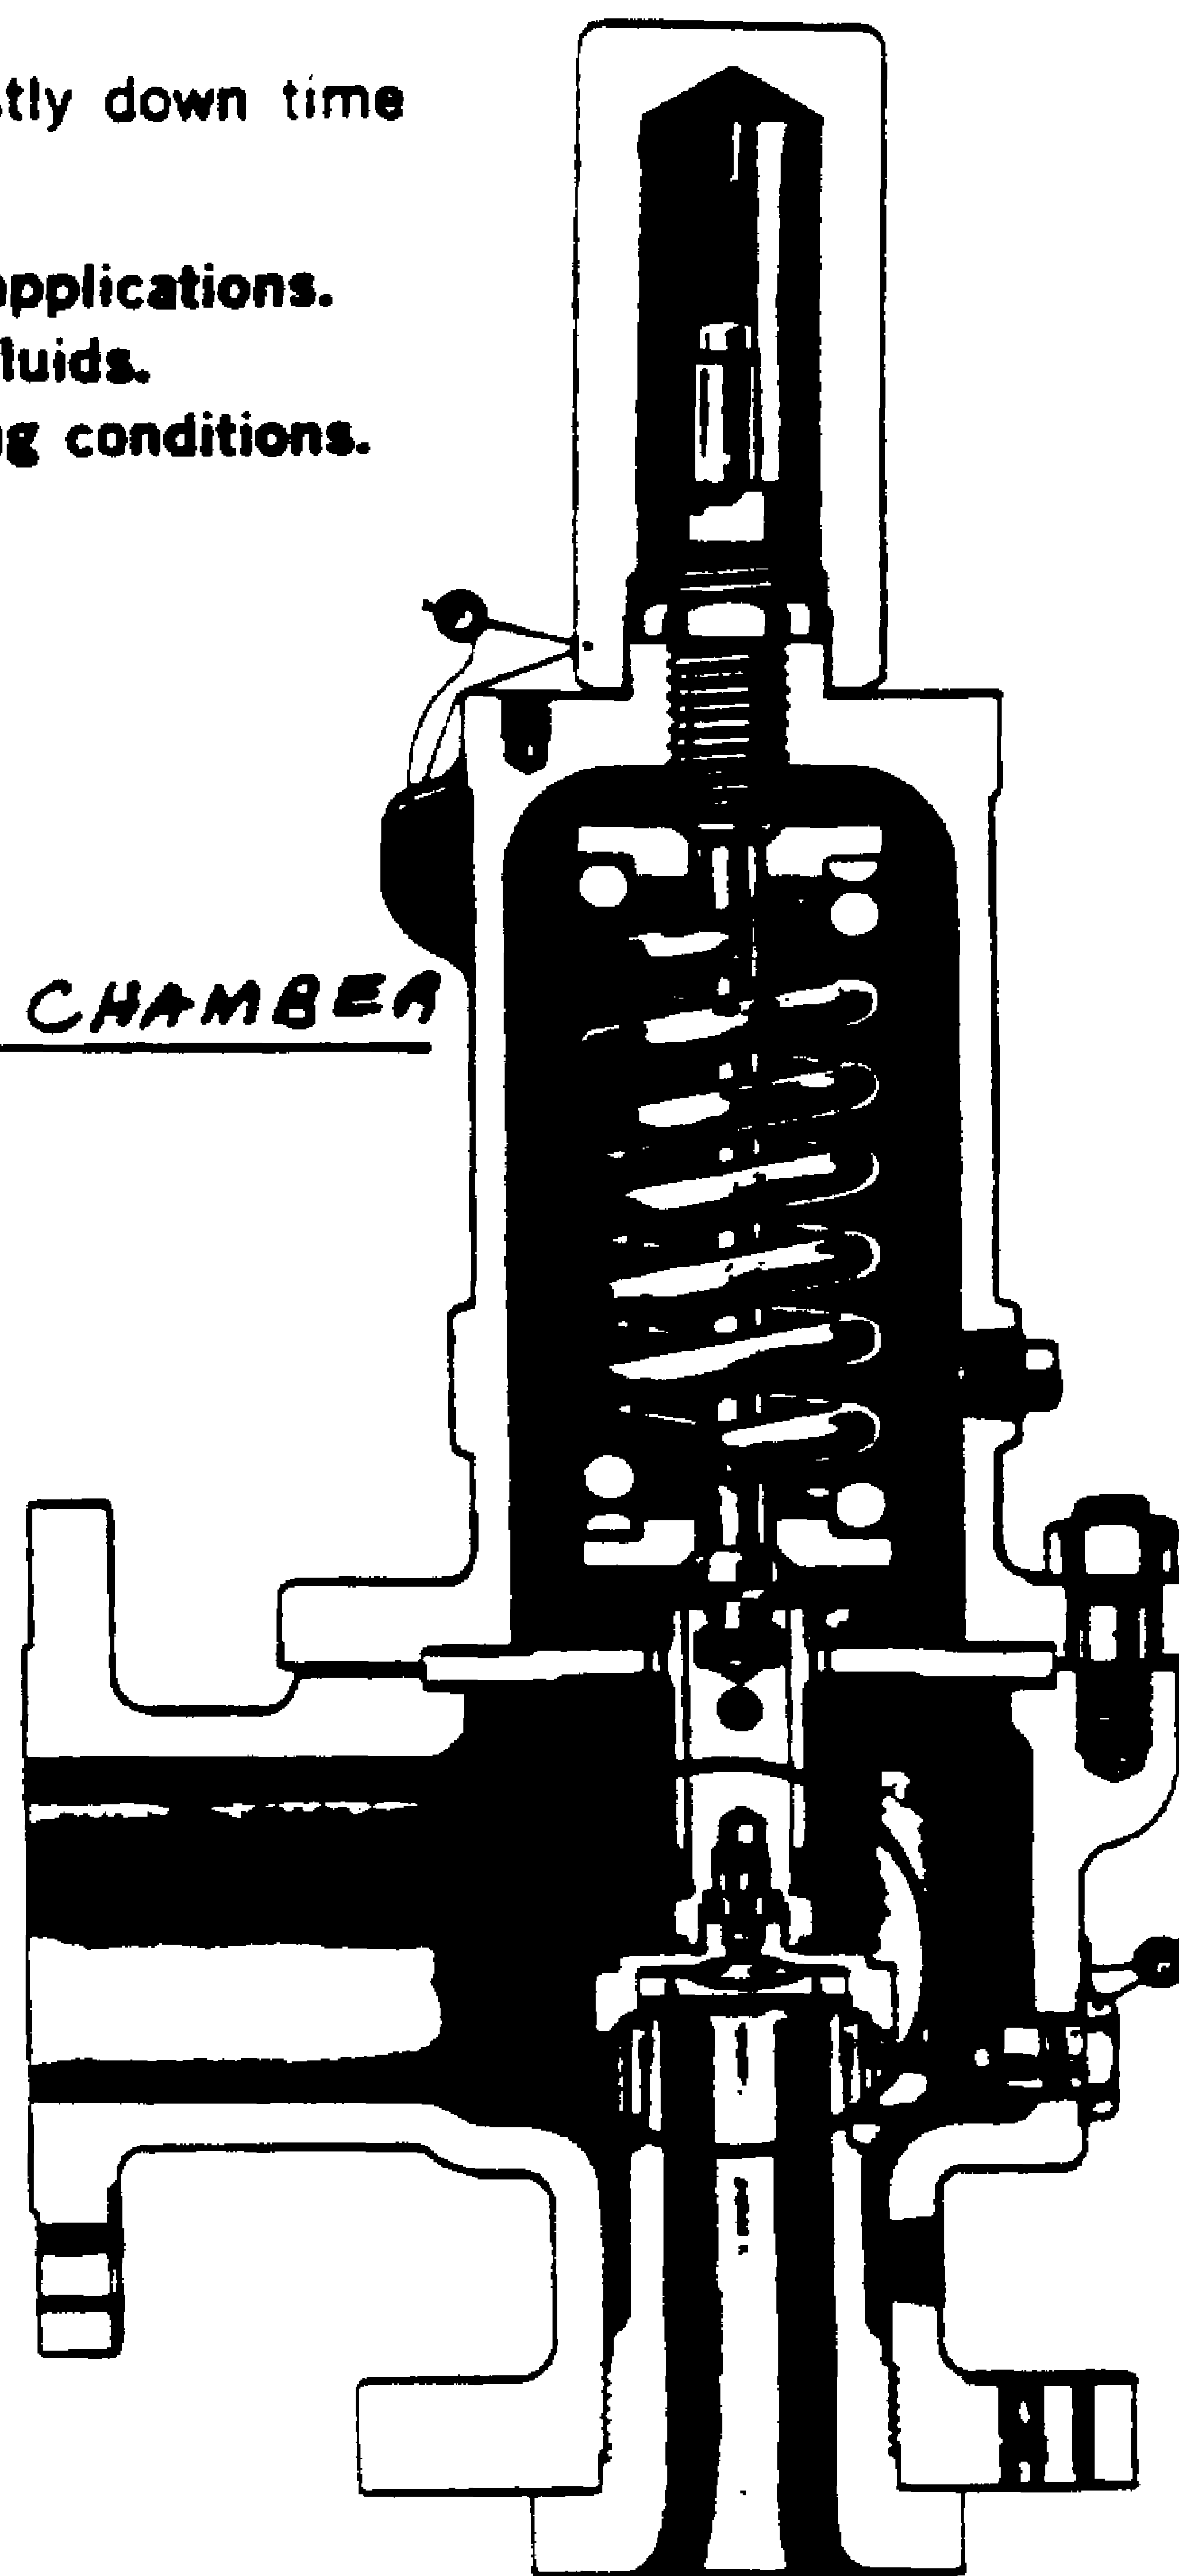
## 2600 Series

A discussion of how the blowdown ring affects safety relief valve operation will help to show why this change in blowdown ring setting will reduce the likelihood of VCM relief valve emissions. A diagram of the Farris 2600 safety relief valve which is used on most of the plant reactors is reproduced from the Farris catalog on the following page. An understanding of how the blowdown ring controls the relief valve reseating pressure at blowdown can be obtained by referring to the diagram. As the pressure increases in the protected vessel, the force against the disc begins to overcome the spring pressure. The disc then lifts slightly which allows some leakage past the valve O-ring seal into the huddling chamber. Leakage out of the huddling chamber (simmer) is controlled by the clearance between the blowdown ring and the disc holder. A setting of the blowdown ring close to the disc holder will thus reduce the clearance and the leakage rate out of the huddling chamber. When the leakage rate into the huddling chamber becomes greater than the leakage rate out then pressure will buildup in the huddling chamber. Pressure in the huddling chamber will lift the disc holder. The force on the disc holder added to the force on the disc overcomes the closing force of the spring and causes the valve to open quickly in the characteristic pop action. After the valve opens, it is kept open by the kinetic energy of the flowing gas as it changes direction in the huddling chamber. A gas flow of 25% or more of valve capacity is generally required to keep the valve open. When the relieving pressure drops below the valve set pressure, the spring force is able to overcome this kinetic energy and close the valve. However, if the blowdown ring is set close to the disc holder, pressure will again build in the huddling chamber as the disc holder approaches the blowdown ring and the force against the disc holder will prevent the valve from closing. Increasing the blowdown ring setting to a higher number of notches will increase the clearance between the blowdown ring and the disc holder and thus reduce the huddling chamber pressure and the force on the disc holder. This allows the spring to close the valve at a higher pressure. By positioning the blowdown ring further away from the disc holder, it should also be more difficult for the shock wave from a premature rupture disc failure to pop open the valve. This was confirmed by the plant tests. Thus a consideration of both the way the reactor safety relief valves are designed to operate and the results of the tests that were conducted leads to the conclusion that the new blowdown ring settings should reduce the possibility of VCM releases. Training in the changes that were to be made in the blowdown ring settings was provided to the plant engineers on July 13, 1984 which is documented in reference B-34, Appendix B.

These tests were run in May 1984 and a Farris representative participated. The tests evaluated the effect of the blowdown ring setting on the reseating pressure of the valve. The amount of relief valve opening when a rupture disc beneath the valve was burst below the valve set pressure was also investigated. From the results of these tests, it was concluded that the possibility of a VCM release would be reduced if the blowdown rings were set further away from the disc holder. This change was completed in October 1984 when all of the blowdown rings were set at 30 notches which is almost double the normal 18 notches. This change was documented in a plant memorandum dated October 29, 1984 which is attached as reference B-33, Appendix B.
