**Region 10 Enforcement and Compliance Assurance Division**  
**1200 6th Avenue**  
**Seattle, WA 98101**  
**INSPECTION REPORT**

| <b>Regulatory Program:</b> | CWA NPDES/Construction Stormwater | |
| <b>Site Name:</b> | Hill's Century Farm North Subdivision No. 2 | |

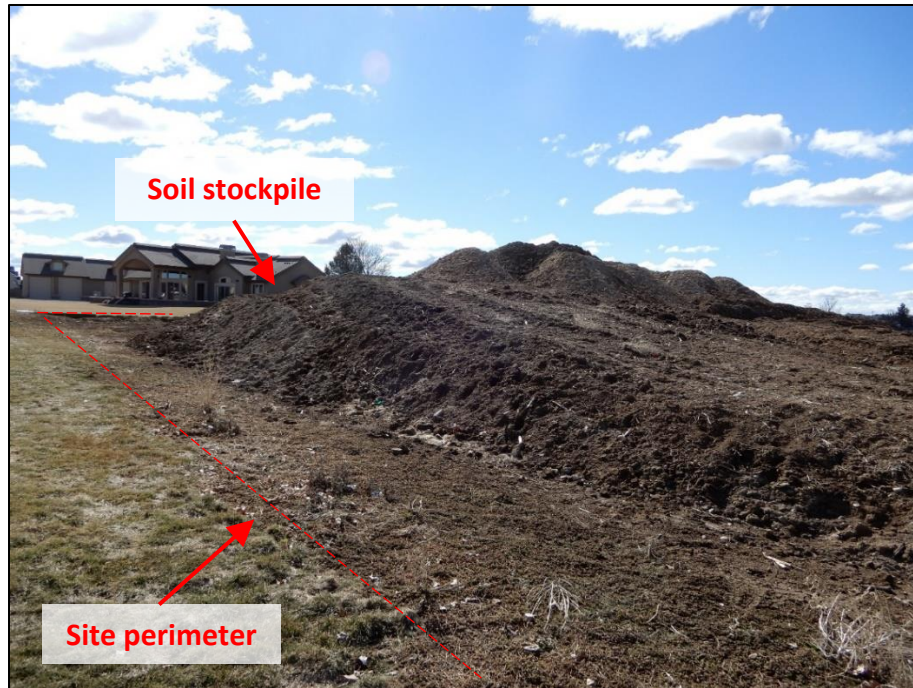
We observed three unstabilized soil stockpiles on site that did not have sediment barriers installed on all the down gradient perimeter areas. The stockpiles were located on the northeastern perimeter of the Site, the southwest perimeter of the Site, and the north-central perimeter of the Site. Additionally, the stockpiles located on the southwest and north-central perimeters of the Site were located within 50 ft from the concentrated flows from the irrigation canal and the dewatering ditch (refer to Attachment A, Photographs 1 through 4).

We observed a lack of perimeter control measures implemented on the eastern and southwestern perimeters of the Site (refer to Attachment A, Photographs 1, 3, and 7). Tire tracks were additionally observed in the unnamed irrigation ditch located on the western perimeter of the Site that receives Site drainage (refer to Attachment A, Photograph 9). A soil berm was observed south of the unstabilized soil stockpile along the northeastern perimeter of the Site (refer to Attachment A, Photograph 2). The Inspection Team noted during the document review that while the SWPPP described various BMPs that could be used as perimeter controls (e.g. silt fence, fiber rolls) no cohesive plan on how perimeter control would be maintained was included.

**Photograph 1.** View, facing southwest, of the Site's northeastern perimeter (photograph taken from off site). Note the lack of perimeter controls and the unstabilized soil stockpile that lacked sediment barriers installed on the down gradient perimeter area to the east.

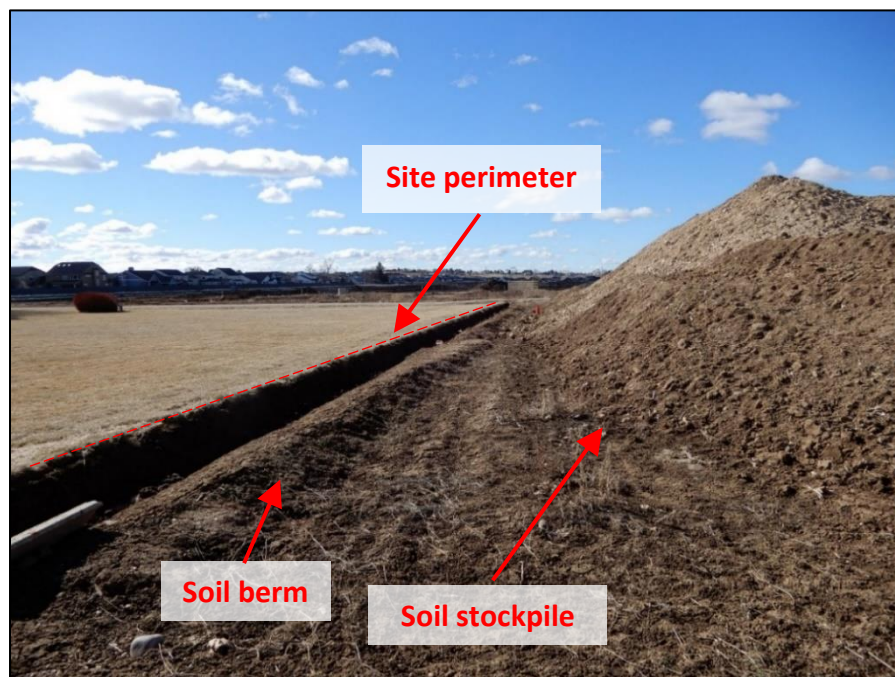
**Photograph 2.** Another view, facing west, of the Site's northeastern perimeter (photograph taken from on site). Note the soil berm on the southern side of the unstabilized stockpile.

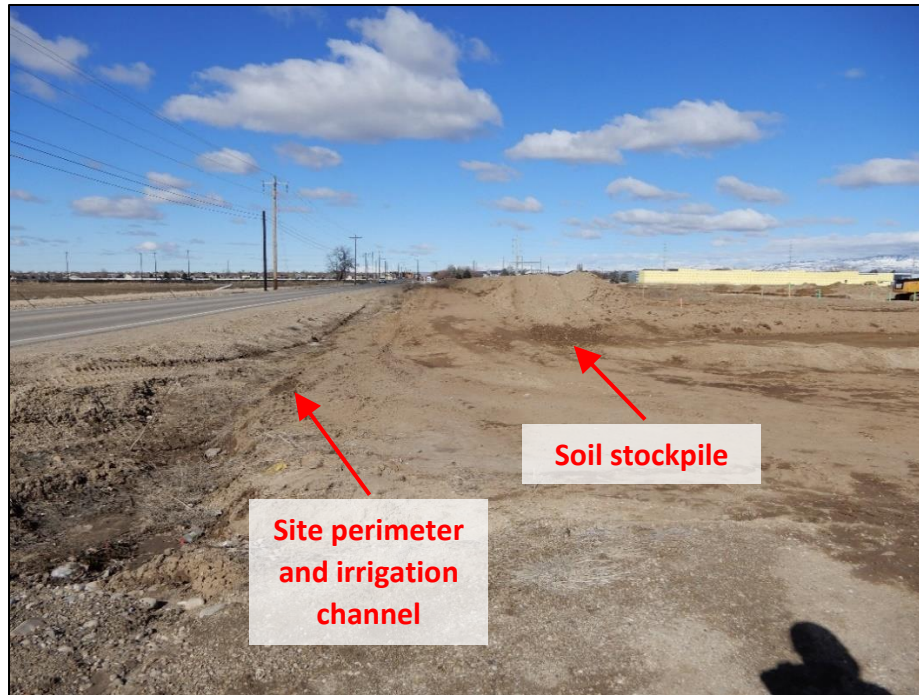
**Photograph 3.** View, facing north, of the irrigation channel along the western perimeter of the Site along South Eagle Road . Note the lack of perimeter control and the unstabilized soil stockpile that lacked sediment barriers installed on the down gradient perimeter areas.

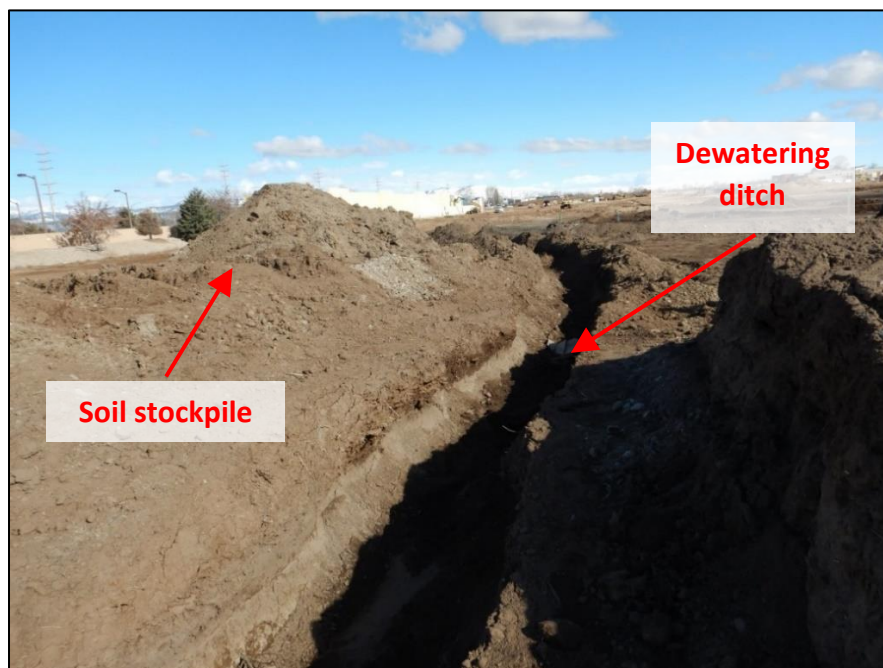
**Photograph 4.** View, facing northeast, of the dewatering ditch installed along the northern perimeter of the Site. Note the soil stockpile located adjacent to the dewatering ditch and the lack of sediment barriers installed on the down gradient perimeter areas.

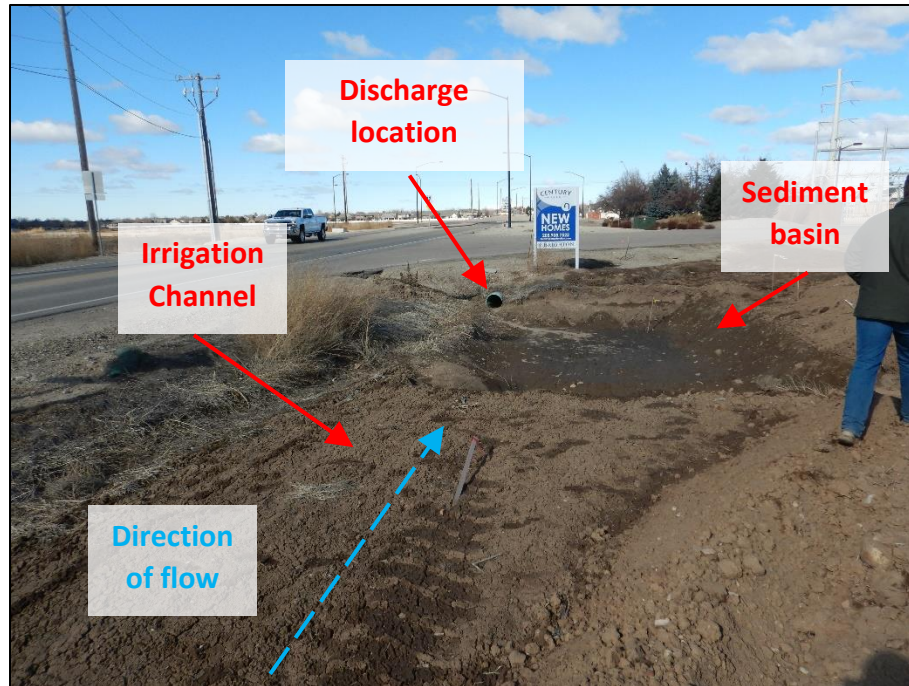
- Drainage patterns of stormwater and authorized non-stormwater before and after major grading activities (Permit Part 7.2.4.f);
- Stormwater and authorized non-stormwater discharge locations (Permit Part 7.2.4.g) – We observed a discharge location that was not identified on the SWPPP map that discharged into an offsite irrigation channel from a sediment basin located at the northwest perimeter of the Site. An irrigation ditch along the western perimeter of the Site and a drainage dewatering ditch along the northern perimeter of the Site discharged into the sediment basin (refer to Photographs 5 and 6).

**Photograph 5.** View, facing north, of the irrigation channel leading to the sediment basin located on the northwest perimeter of the Site. Note the signs of previous containment of water and the discharge point from the northwest perimeter.

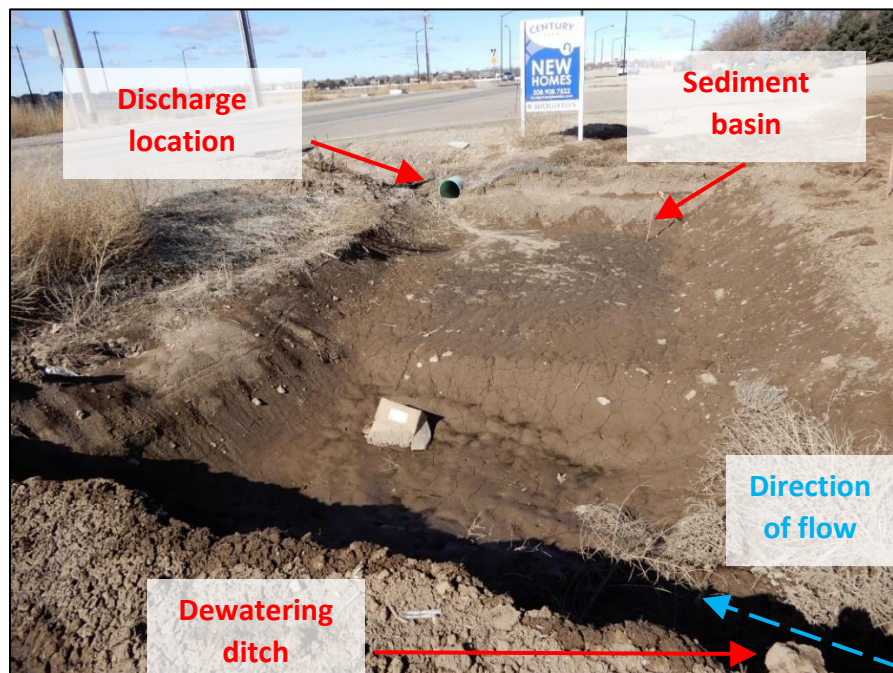
**Photograph 6.** Another view, facing north, of the sediment basin located on the northwest perimeter of the Site. Note the dewatering ditch leading to the basin, signs of previous containment of water, and the discharge point from the northwest perimeter.

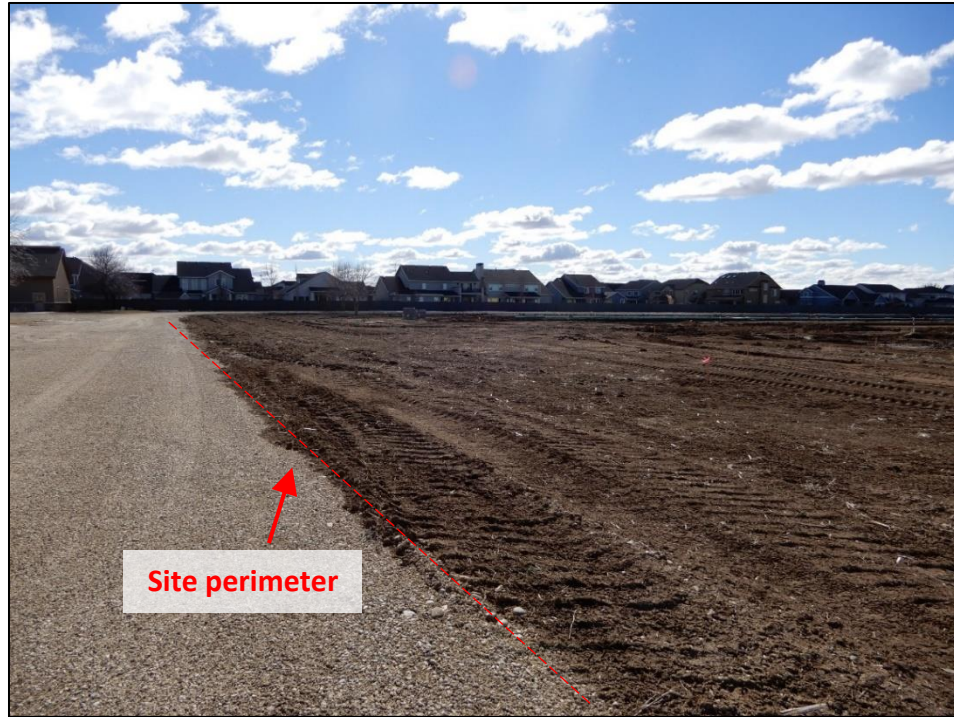
**Photograph 7.** View, facing south, of the southeast perimeter of the Site (photograph taken from off site). Note the lack of perimeter controls.

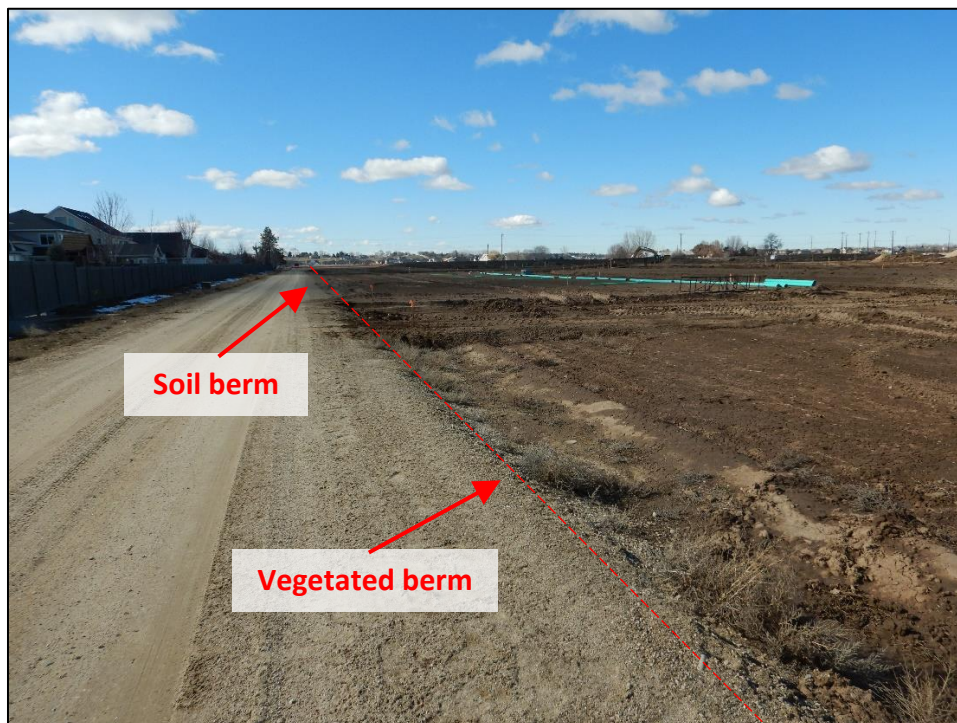
- Locations of stormwater controls, including natural buffer areas and any shared controls utilized to comply with this permit (Permit Part 7.2.4.i) – We observed that the onsite SWPPP map displayed fiber rolls installed at the perimeters of the Site; however, we did not observe fiber rolls. On the southern perimeter of the Site we observed vegetated berms and soil berms. On the northern and northwestern perimeters of the Site we observed soil berms. We did not observe perimeter controls on the eastern perimeter of the Site, except along one perimeter south of the unstabilized soil stockpile that had a soil berm (refer to Attachment A, Photographs 1, 2, 3, 7, 8, and 9).

**Photograph 8.** View, facing west, of the southern perimeter of the Site (photograph taken from off site). Note the use of berms as perimeter controls.

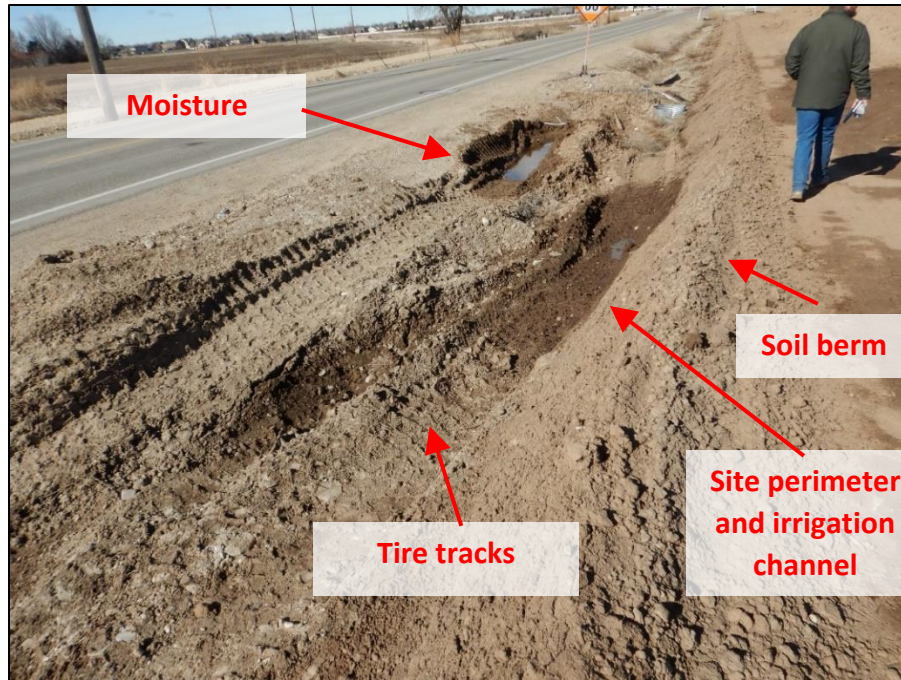
**Photograph 9.** View, facing northwest, of the irrigation channel on the northwestern perimeter of the Site along South Eagle Road. Note the moisture and the tire tracks in the irrigation channel and the soil berm.

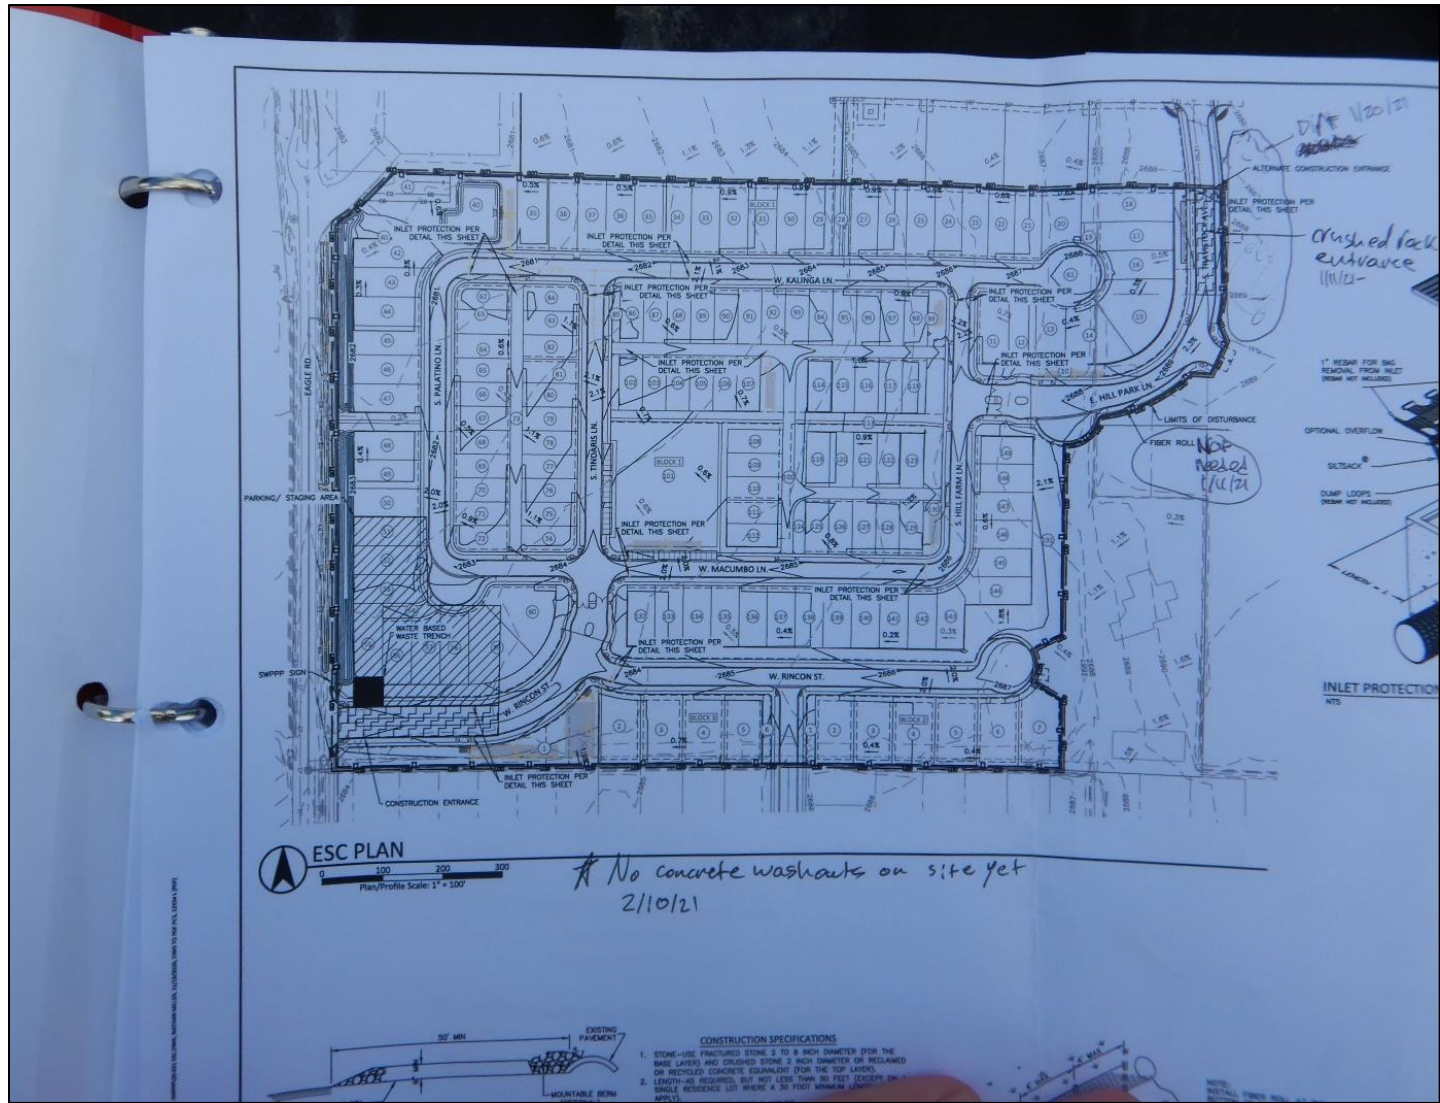
During the initial onsite records review, we observed that the SWPPP Site map did not include all minimum information as required by Part 7.2.4 of the Permit. The onsite map did not include the following information (refer to Attachment B, Exhibit 2):

- Locations where sediment, soil, or other construction materials will be stockpiled (Permit Part 7.2.4.b.iii) – We observed that the onsite SWPPP map did not include locations where sediment and soil would be stockpiled. The Site had three locations where soil was stockpiled – one location at the northeast perimeter of the Site, one location at the southwestern perimeter of the Site, and one location on the

**Exhibit 2.** Image of the Site map provided to the Inspection Team during the onsite inspection (image was cropped to focus on map details). It was noted the Site map does not contain all Permit-required elements, such as locations of stockpiles, drainage patterns of stormwater and authorized non-stormwater, authorized non-stormwater discharge locations, and updated perimeter controls.
