UNITED STATES ENVIRONMENTAL PROTECTION AGENCY  
REGION III

**Report Title:** Clean Water Act, Section 404 Inspection Report for the Route 19 Morris Development  
**Inspection Date(s):** 05/09/2022  
**Start Time:** 9:00am **End Time:** 1:30pm  
**Regulatory Program(s):** Inspections authorized pursuant to Clean Water Act, Sections 308 and 404 (33 U.S.C. §§ 1318 and 1344)  
**Site Name:** Route 19 Morris Development  
**Site Location:** Approximately 1.25 miles east on Route 19 from the intersection of Route 19 and I-79  
Sutton, West Virginia 26601  
**Latitude:** 38.6087 N **Longitude:** -80.7368 W  
**County/Parish:** Braxton County  
**Company:** Waco Oil & Gas Company, Inc.  
**Mailing Address:** P.O. Box 397  
Glennville, West Virginia 26351

**Unique Project #:** 3E22WW046A

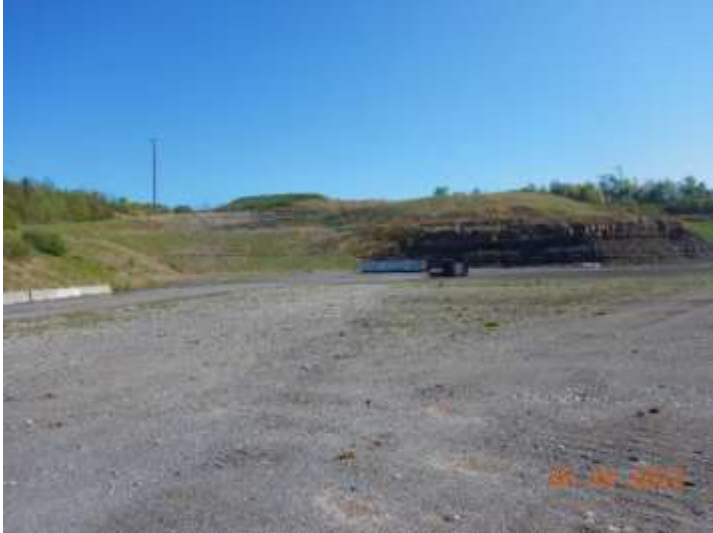
Following opening conference, the inspection walkthrough began on Pad 1. The buildings utilized by UPS were observed (See Attachment 3 - Photographic Log; DSCN3734 and DSCN3737). During the walk across Pad 1 the inspector asked CEC about excess fill or material that might occur following the restoration activities and that the stockpile locations should be identified in the upcoming plans. CEC stated they have not completed the earth balance for the work yet so don't know at this time but will include it in the appropriate plan sets. The inspector asked about the highwall and if there were any known safety concerns (DSCN3737). The potential need to address the highwall on the north side of Pad 1 where material had been removed from the hillside was discussed (DSCN3737). CEC stated that they are looking at that potential issue, but it would depend on what would be located underneath it. CEC explained that if, for example, cars were to be parking there, falling rock might be more of a concern, but other uses could be less of a safety concern. The proposed stream restoration with riparian buffer would provide less of a concern for falling rock so long as it didn't disrupt the stream restoration or performance standards. CEC further elaborated that the stream restoration plan would consider it and the riparian buffer could also include design considerations with regard to the regrading activity, but it was still being evaluated.

| | <p>Photo ID: DSCN3734.JPG<br/>Date: May 9, 2022</p> <p>Notes: UPS buildings on Pad 1;<br/>looking northeast</p> |

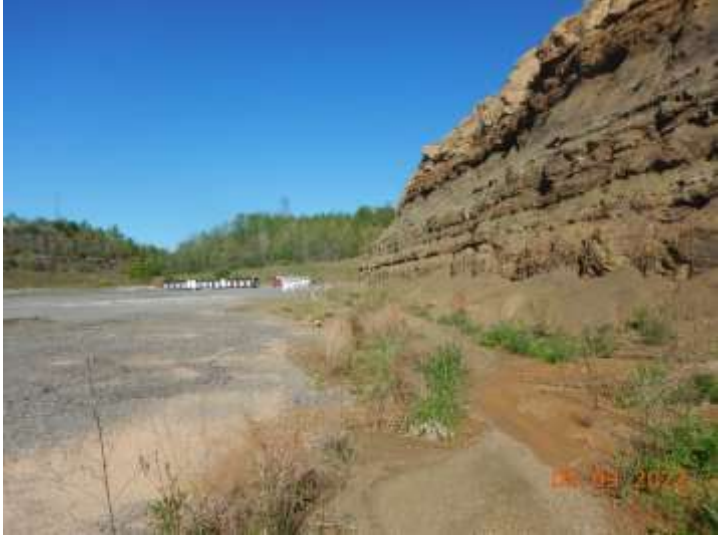
| | <p>Photo ID: DSCN3737.JPG<br/>Date: May 9, 2022</p> <p>Notes: Pad 1; looking west</p> |

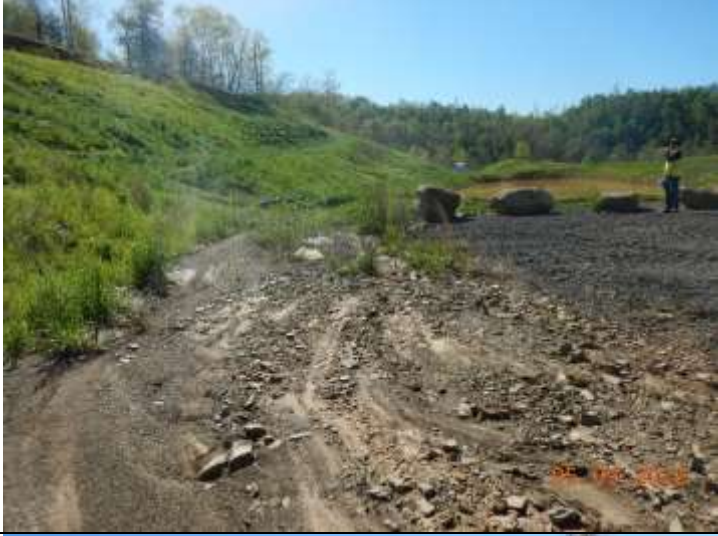
On the northwest edge of Pad 1 the sedimentation pond was observed (DSCN3738 and DSCN3740). Equipment and materials were staged on Pad 1 near the sediment pond. Erosional rills with some rip rap sized rock were observed in the hillside to the north of the sediment pond (DSCN3739). The erosional feature downstream of the sediment pond contained large rock and rip rap-sized rock (DSCN3747 and DSCN3748). The inspector asked about the downstream erosional feature and how it is being addressed in the development of the plans. CEC stated that since the proposal included regrading in the whole area the erosional features that were currently present would be addressed when those plans were implemented.

| | <p>Photo ID: DSCN3738.JPG<br/>Date: May 9, 2022</p> <p>Notes: Pad 1; looking east</p> |

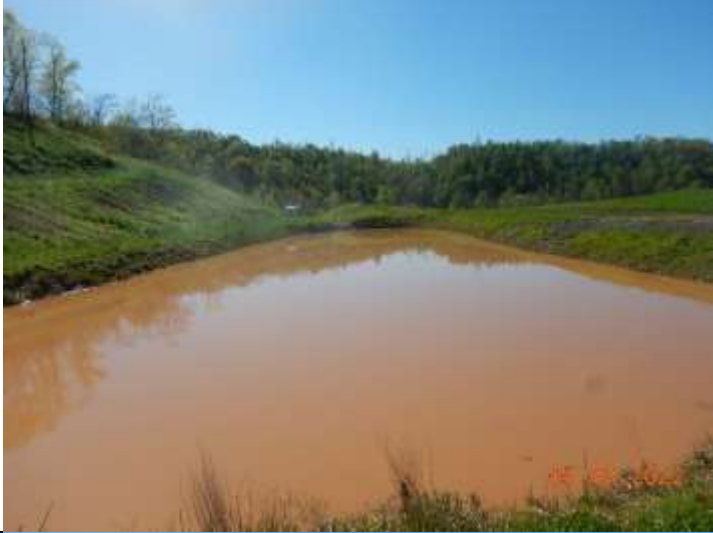
| | <p>Photo ID: DSCN3740.JPG<br/>Date: May 9, 2022</p> <p>Notes: sediment pond along Pad 1;<br/>looking east</p> |

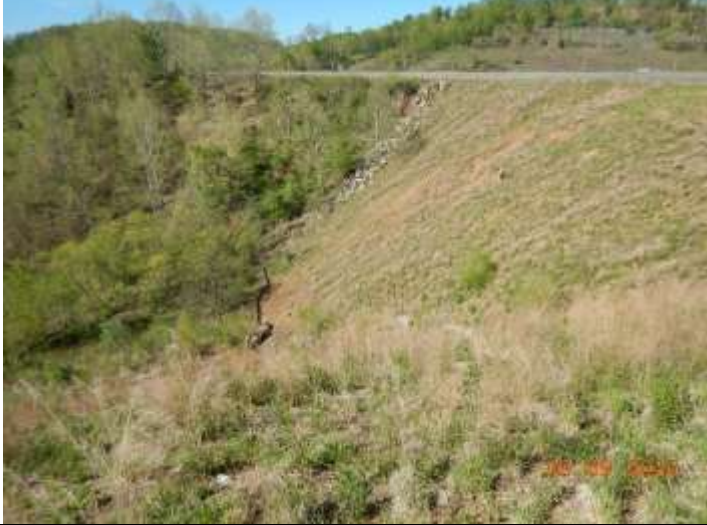
The walkthrough continued to observe the fill slope of Pad 1. The fill slope was sparsely vegetated with coverage below 70% based on an observational estimate (DSCN3745 and DSCN3749). A slip on the fill slope (east side of Pad 1) was observed (DSCN3746). The slip consisted of exposed fill dirt and did not have vegetation growing on it (DSCN3750 to DSCN3753). An access pathway and tracks for equipment were observed leading toward the slip area on Pad 1 (DSCN3749). CEC stated that this pathway provided access to install erosion and sediment control features/Best Management Practices ("BMPs"). Coir logs were observed near the toe of the slip material (DSCN3753 to DSCN3757). Water seeps were observed within the slip area on the slope for Pad 1 (DSCN3753). Near the discharge point for a seep, a discrete patch of willows was observed (DSCN3752). Some slip material was observed below the coir logs placed to the east of Pad 1 (DSCN3753). Two main areas of concentrated flow were observed discharging from the fill material downslope of Pad 1 (DSCN3757 and DSCN3761). CEC discussed the slip repair work and an overview of the proposed geotechnical work, including taking the slope from approximately 2:1 (current) to 3:1 (proposed) and installation of geo-grid to provide an additional factor of safety for long-term stability.

| | <p>Photo ID: DSCN3745.JPG<br/>Date: May 9, 2022</p> <p>Notes: slip at toe of Pad 1; looking south</p> |

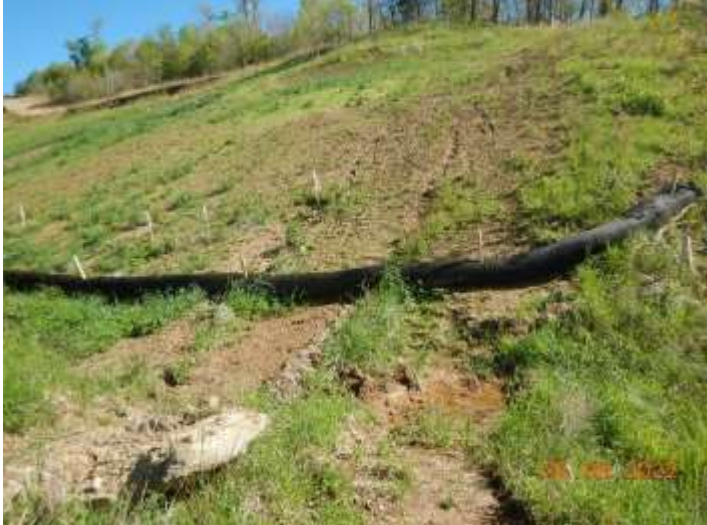
| | <p>Photo ID: DSCN3746.JPG<br/>Date: May 9, 2022</p> <p>Notes: erosional rills at Pad 1;<br/>looking northwest</p> |

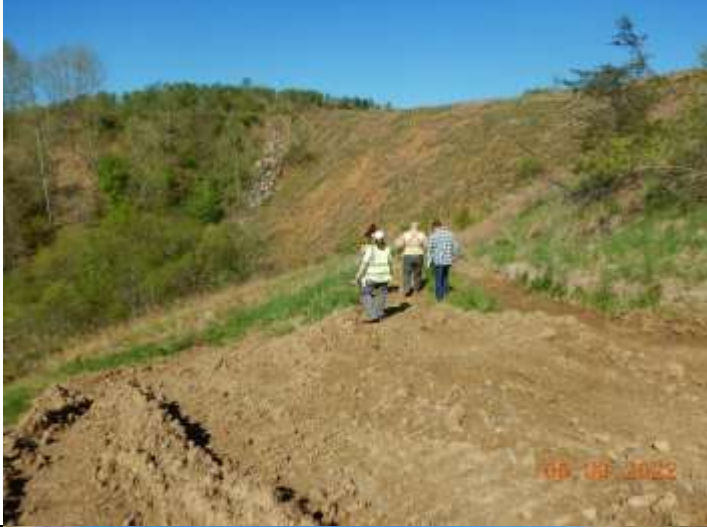
| | <p>Photo ID: DSCN3749.JPG<br/>Date: May 9, 2022</p> <p>Notes: Pad 1; looking south</p> |

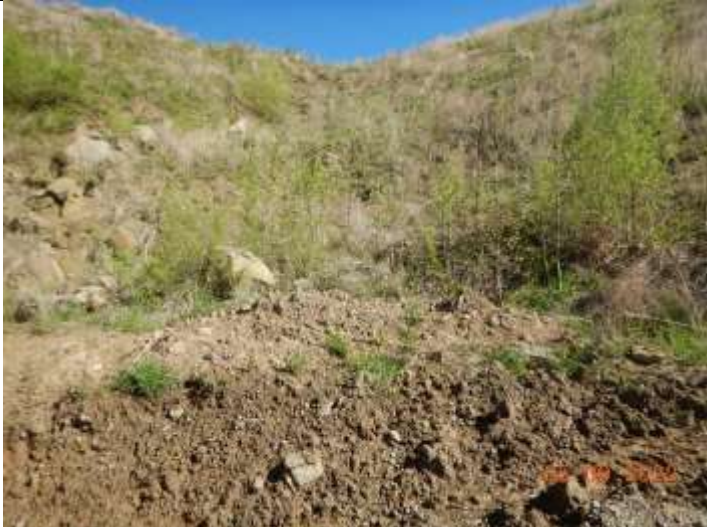
| | <p>Photo ID: DSCN3750.JPG<br/>Date: May 9, 2022</p> <p>Notes: slip area on Pad 1; looking west</p> |

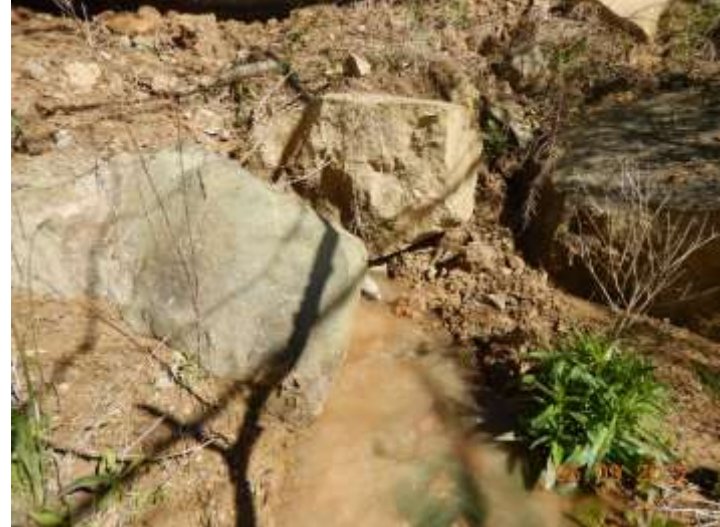
| | <p>Photo ID: DSCN3759.JPG<br/>Date: May 9, 2022</p> <p>Notes: consolidated flow discharging from the fill material of Pad 1</p> |

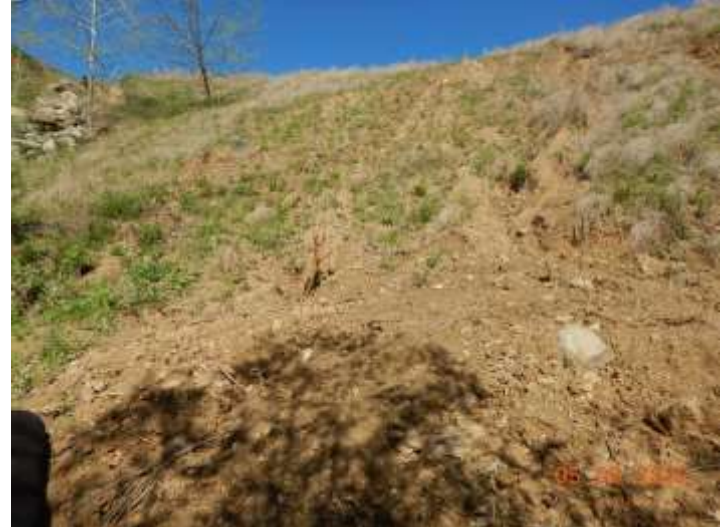
| | <p>Photo ID: DSCN3760.JPG<br/>Date: May 9, 2022</p> <p>Notes: slip on fill material of Pad 1; looking west</p> |

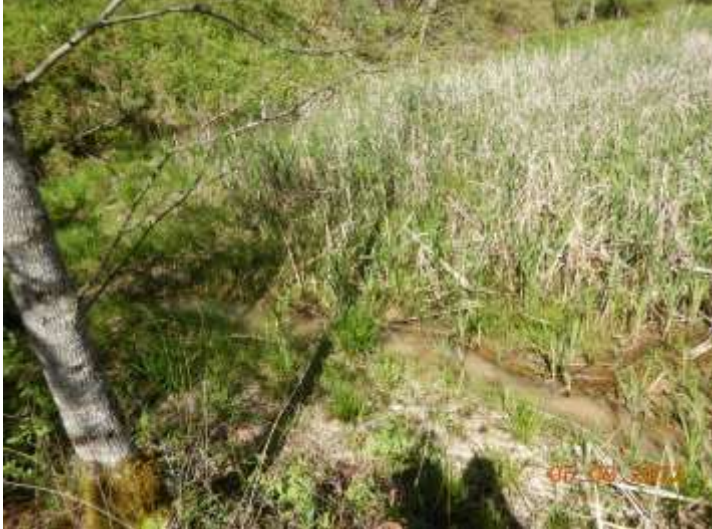
The walkthrough continued on and observed the wetland area that abuts Unnamed Tributary A (DSCN3766). This portion of Unnamed Tributary A was downstream of Pad 1. The stream had flow at the time of the inspection. The inspector observed the section of Bear Run that flows east of Pad 1 and downstream of Unnamed Tributary A.

| | <p>Photo ID: DSCN3766.JPG<br/>Date: May 9, 2022</p> <p>Notes: wetland area; looking southeast</p> |

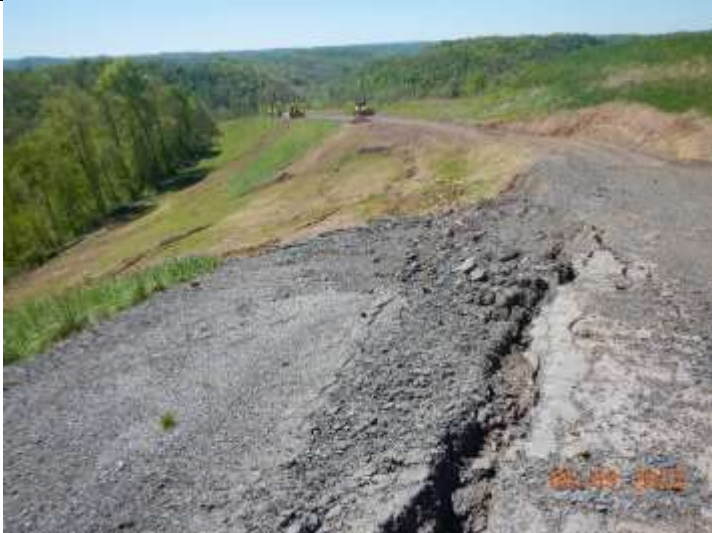
At approximately 11:13am the inspection continued by driving to the Pad 2 area. Near the headwaters of Unnamed Tributary C1 and Unnamed Tributary C2, a portion of the access road and hill slope had slipped (DSCN3774 and DSCN3777). The slip area was mostly unvegetated with portions of sparse herbaceous vegetation. There were soil cracks in the slip area that has water flowing in them downslope (DSCN3779 to DSCN3782). CEC pointed out inclinometers that they had placed to track soil movement. The walkthrough continued downslope to where the slip encroached into the tree line below Pad 2 (DSCN3785). The slip was observed downstream into the wooded area with slip material in the mainstem of Unnamed Tributary C (DSCN3785 to DSCN3800). Coir logs were observed near the base of the slip material (DSCN3790 to DSCN3793). Slip material and sediment-laden water were observed over and downstream of the coir logs (DSCN3794, DSCN3795, and DSCN3798 to DSCN3801). CEC indicated that they had placed the coir logs but are still working on receiving the authorization from West Virginia Department of Environmental Protection on the National Pollution Discharge Elimination System "NPDES" permit modification request so that they could access the area to conduct necessary repairs. The inspector and CEC discussed the location of Unnamed Tributary C3. The Unnamed Tributary C3 area was observed to be covered with slip material coming from the northern hillside (DSCN3803 to DSCN3807). The material was covering the channel of Unnamed Tributary C3 downstream of its confluence with Unnamed Tributary C2 (also identified as the mainstem).

| | <p>Photo ID: DSCN3774.JPG<br/>Date: May 9, 2022</p> <p>Notes: access road slip between Pad 1 and Pad 2; looking south</p> |

- Comments from EPA should be expected on the proposed schedule of geotechnical stability work and restoration plan shortly.
- Slip material at the access road/Pad 2 area has covered Unnamed Tributary C1 and Unnamed Tributary C3 and has made it downstream of their confluence with the Unnamed Tributary C mainstem (which is also identified as C2). The slip material is overtaking the coir logs and moving downstream. EPA acknowledges that CEC is working on modifying the NPDES permit so that access to that area for appropriate corrective action can be undertaken. CEC and West Virginia Department of

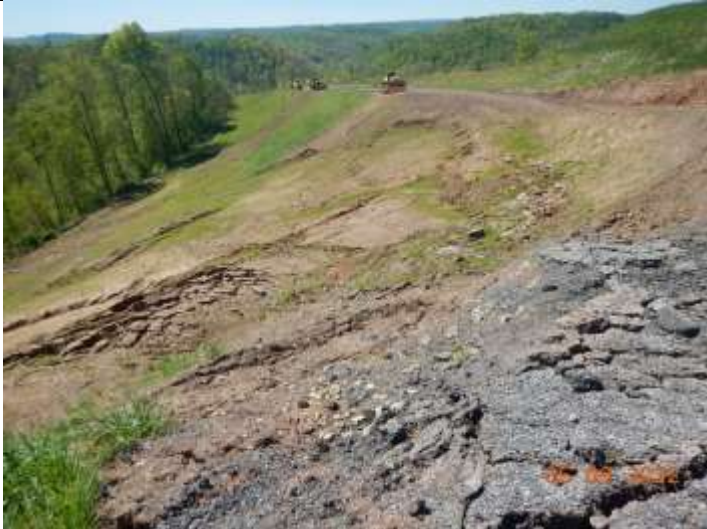
| | <p>Photo ID: DSCN3777.JPG<br/>Date: May 9, 2022</p> <p>Notes: access road slip between Pad 1 and Pad 2; looking south</p> |

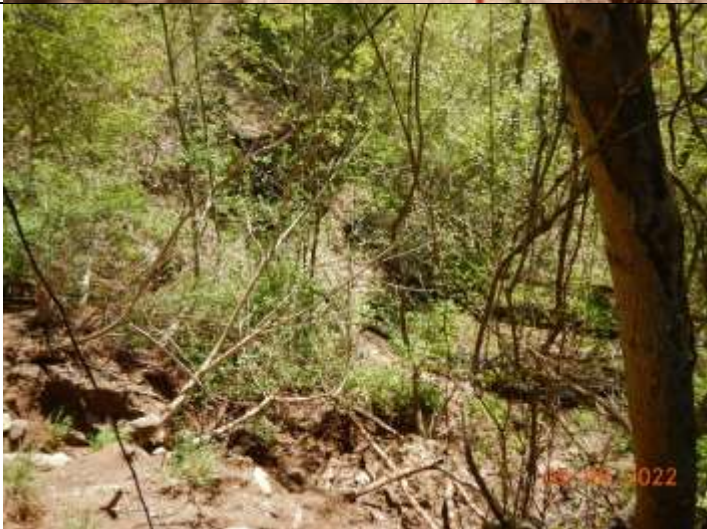
| | <p>Photo ID: DSCN3787.JPG<br/>Date: May 9, 2022</p> <p>Notes: slip area downstream into Stream C mainstem; looking east</p> |

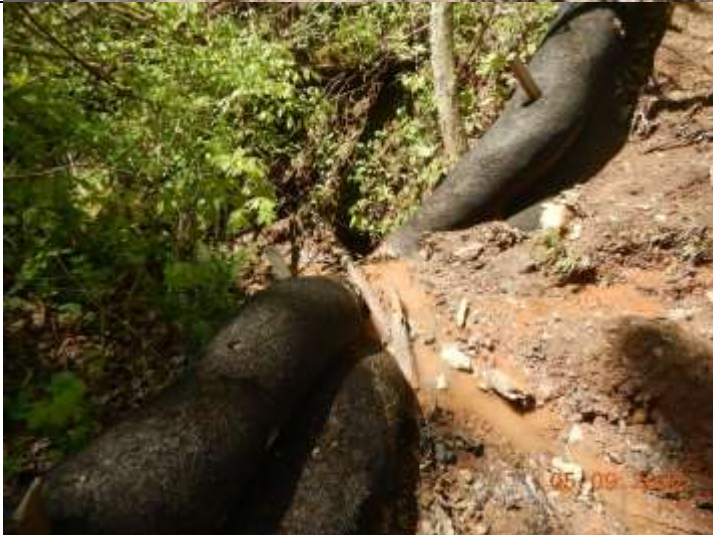
| | <p>Photo ID: DSCN3798.JPG<br/>Date: May 9, 2022</p> <p>Notes: slip material in Unnamed Tributary C mainstem</p> |

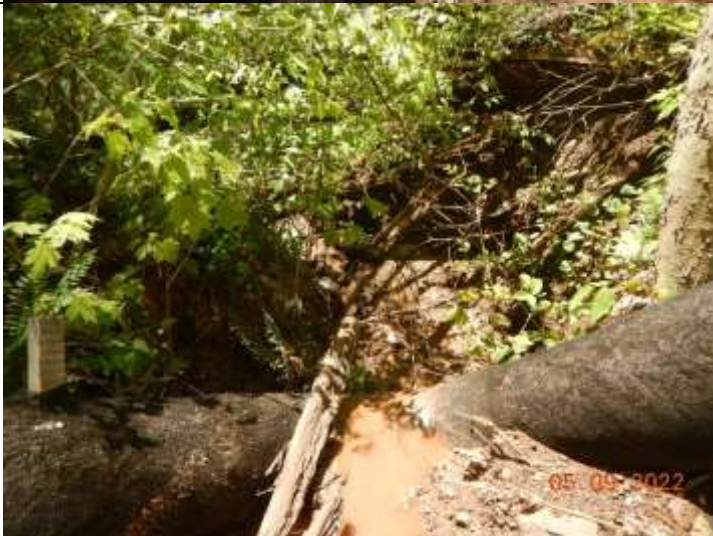
| | <p>Photo ID: DSCN3799.JPG<br/>Date: May 9, 2022</p> <p>Notes: slip material in Unnamed Tributary C mainstem</p> |

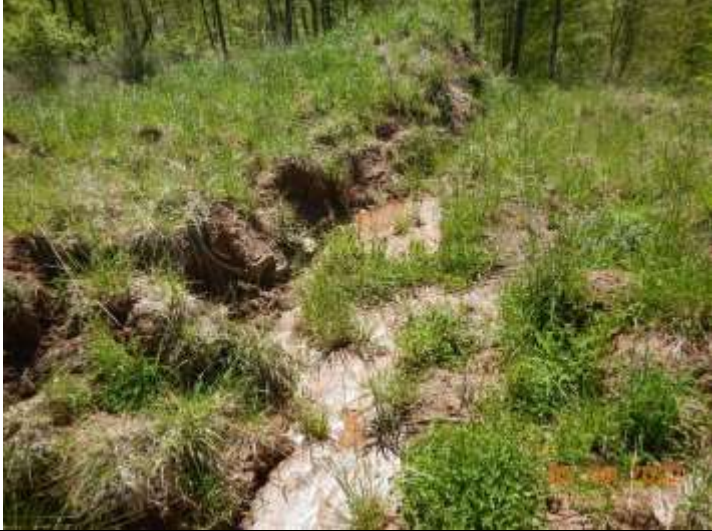
| | <p>Photo ID: DSCN3809.JPG<br/>Date: May 9, 2022</p> <p>Notes: wetland area formed near slip area near Unnamed Tributary C3; looking south</p> |

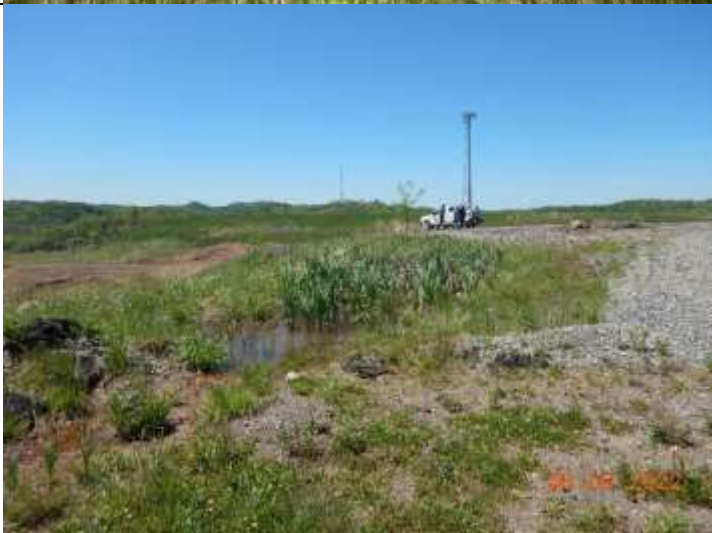
| | <p>Photo ID: DSCN3811.JPG<br/>Date: May 9, 2022</p> <p>Notes: wetland area formed on top of Pad 2; looking south</p> |

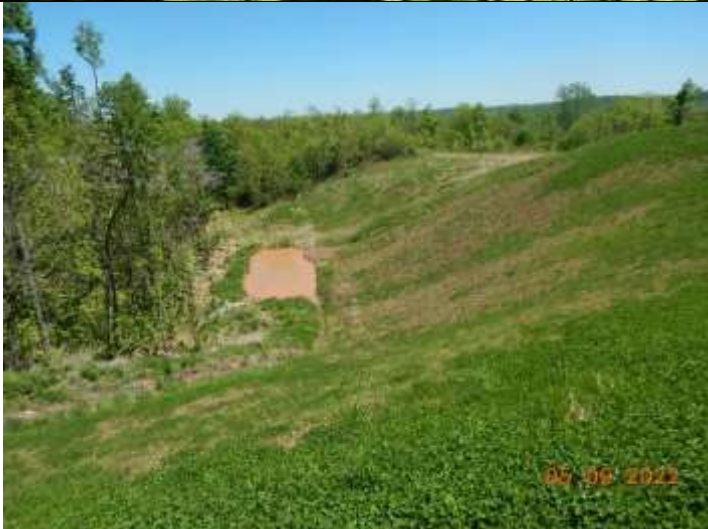
The inspection walkthrough continued to Unnamed Tributary H at the northwest edge of Pad 2. The sediment pond was observed at the base of the slope for Pad 2 (DSCN3819). Based on a visual observation, the sediment pond appeared to be full capacity. On the north side an erosional rill was observed from Pad 2 that discharged into the sediment pond (DSCN2821 and DSCN3822). Upstream, at the south end of sediment pond a rill/channel was also observed (DSCN3823). The feature formed within the side slope of Pad 2 and drained into the sediment pond. CEC discussed how, based on their desktop review, this feature followed the pre-disturbance topographic indications of a stream channel was likely the pre-disturbance flow pathway for Unnamed Tributary H. CEC stated that as part of the geotechnical and restoration work the sediment pond would be reclaimed. The feature was next to the rock-lined outlet of the sediment pond (DSCN3823 and DSCN3824). The outlet terminates near the limits of disturbance at the Site. The inspector then observed the area downstream of the sediment pond. At the limits of disturbance, piled woody and earthen debris were observed (DSCN3825). Downstream of this disturbance, the channel of Unnamed Tributary H was observed (DSCN3826). The stream had a continuous channel with an Ordinary High Water Mark. Flow was not observed in the channel at the time of the inspection. The inspector and CEC discussed that it was likely that the ephemeral- intermittent point for Unnamed Tributary H typically occurred near what is now the downstream end of the sediment pond. CEC stated that they were still evaluating the options for stream restoration in this area which currently focus on the space trade-offs between space for Pad 2 and lower gradient for stream restoration.

| | <p>Photo ID: DSCN3819.JPG<br/>Date: May 9, 2022</p> <p>Notes: sediment pond in Unnamed Tributary H; looking north</p> |
