THE DECONTAMINATION OF SILOS CONTAMINATED WITH  
POLYCHLORINATED BIPHENYLS (PCBs) -  
SOME IMPORTANT CONSIDERATIONS

L. B. Willett, April 1973.

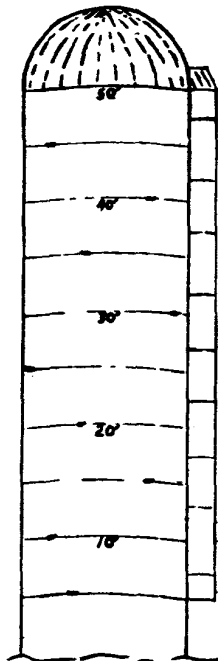
5-3-72      20,155.000      Scrapings  
5-3-72      7,131.885      Silage  
5-3-72      103.017      Silage

Silage      0.128      7-26-72      0.061      11-25-72  
Silage      0.081      8-9-72      0.051      12-16-72  
Silage      0.081      8-9-72      0.065      12-27-72  
Silage      0.271      8-18-72      0.020      1-10-73  
Silage      0.271      8-18-72      0.072      1-23-73

1. Silo was built and coated with a material that contained PCBs in 1957.
2. The silo cleaned with a wire brush, coating was Thoroseal<sub>R</sub> hydraulic cement with an Acryl-60<sub>R</sub> bonder on 6-5-72. - Standard Dry Wall Inc., Miami, Florida

3. The silo was filled with chopped grass 6-17-72 and opened 6-24-72
4. The silo was refilled with chopped corn in late October 1972.

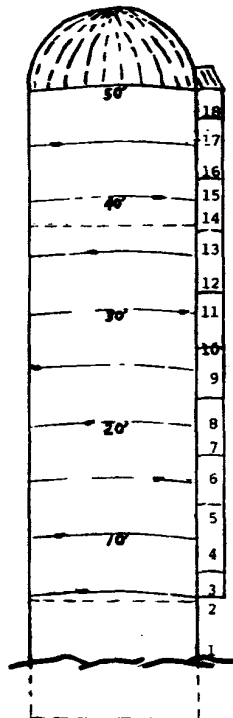
| 9-7-72 | 314.017 | Scrapings |
| 9-7-72 | 175.365 | Scrapings |
| 9-7-72 | 705.236 | Scrapings |

| MATERIAL | PPM OF PCB | DATE | PPM OF PCB | DATE |
|---|---|---|---|---|
| Silage | 58.997 | 11-10-72 | 13.433 | 2-27-73 |

1. Silo was built and coated with a material that contained PCBs in 1954.

2. In 1966 lower 8 feet and the pit were coated with Silenzcrete, Universal Cooperatives, Alliance, Ohio.

3. On 9-16-72 the silo was cleaned and recoated with Water based Epoxy - Action! Plastic, Inc. Charlotte, Michigan; from the base of the pit to 37 feet above ground level.

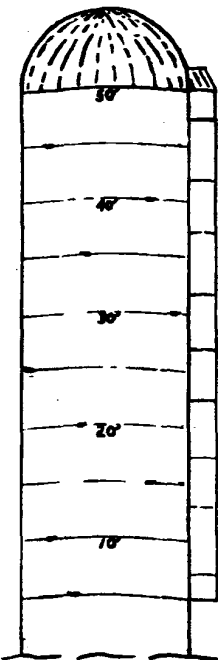
| 5-3-72 | 20,155.000 | Scrapings |
| 5-3-72 | 7,131.985 | Silage |
| 5-3-72 | 103.017 | Silage |

1. Silo was built and coated with a material that contained PCBs in 1957.
2. The silo cleaned with a wire brush, coating was Thoroseal<sub>R</sub> hydraulic cement with an Acryl-60<sub>R</sub> bonder on 6-5-72. - Standard Dry Wall Inc., Miami, Florida

3. The silo was filled with chopped grass 6-17-72 and opened 6-24-72
4. The silo was refilled with chopped corn in late October 1972.
