**Region 6 Compliance Assurance and Enforcement Division  
INSPECTION REPORT**

| Inspection Date(s): | 06/27/2019 | | |
| Company Name: | MX-7 Dairy | | |
| Identification/Permit Number: | TXG920625 | | |

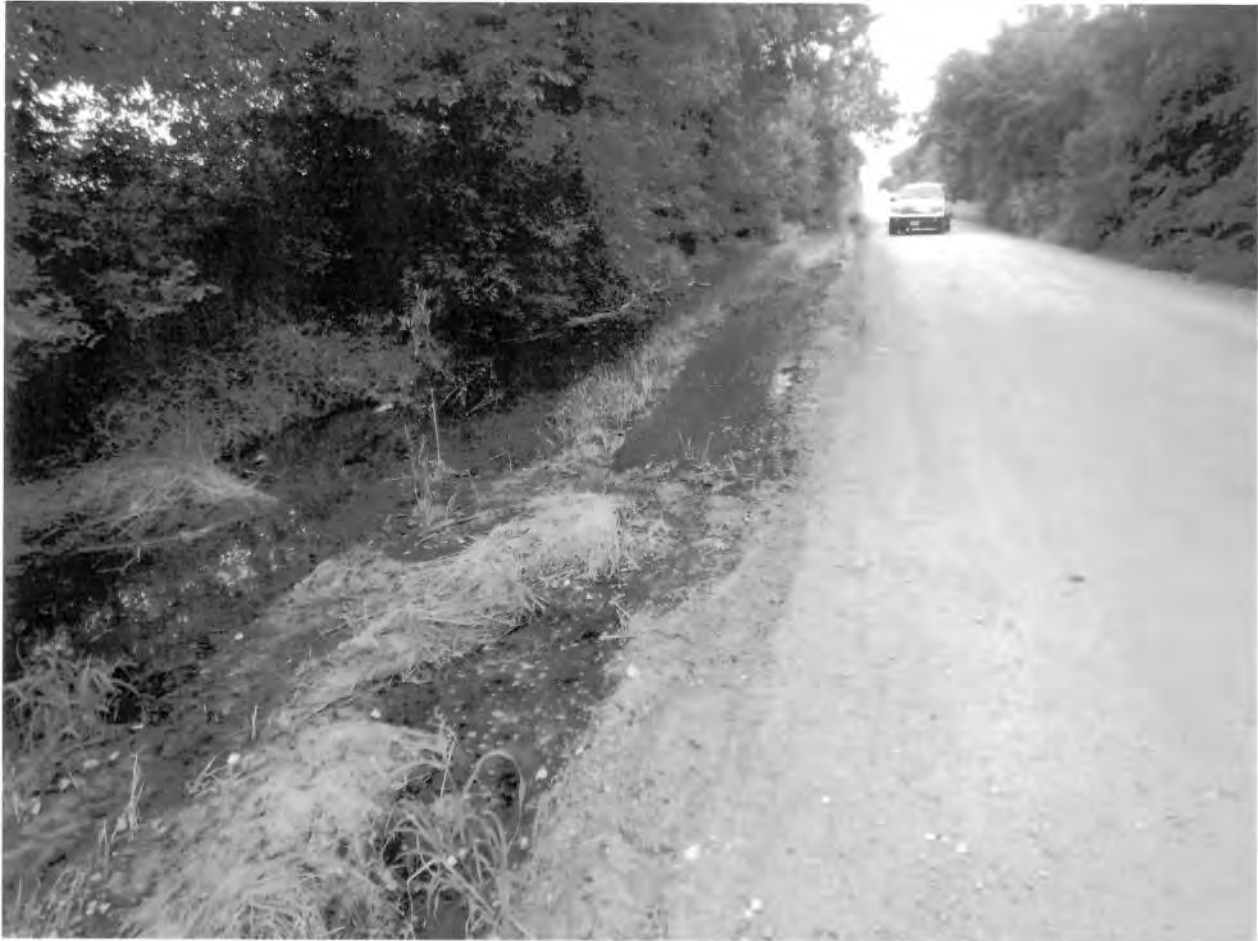
Photo No. 1

During the inspection, I noted that there had been recent discharges out of RCSs 3, 4 and 5 as evidenced by manure wastewater found in the vicinity of these RCSs. As of the 4/20/2019 RCS weekly level readings, all of the lagoons had capacity to contain the 25-yr/24-hr rain event. However, the dairy received 8.2" of rain during the time period of 4/22-23/2019 causing the RCSs to begin discharging under the chronic rainfall provision of the TCEQ CAFO General Permit. The dairy had several permitted discharges of wastewater in April and May in addition to reported discharge to the TCEQ on the day of the inspection. The facility had irrigated wastewater from the RCSs to the LMUs in an attempt to stop the discharges. This discharge, however, was permitted since the dairy had experienced chronic rainfall during the months of April and May. I called the TCEQ to verify that the facility had made the required notifications and to ensure that the TCEQ verified whether or not the dairy had properly operated and maintained the RCSs prior to the permitted discharges. Discharges occurred from RCSs 3, 4 and 5. The discharges from RCS 3 and RCS 5 are documented within Appendix 1 Photolog, photos 1, 5 and 11.

Description: Looking north along the bar ditch where wastewater from RCS 5 had discharged due to recent chronic rainfall conditions. Wastewater was not seen leaving this area at the time of the inspection.

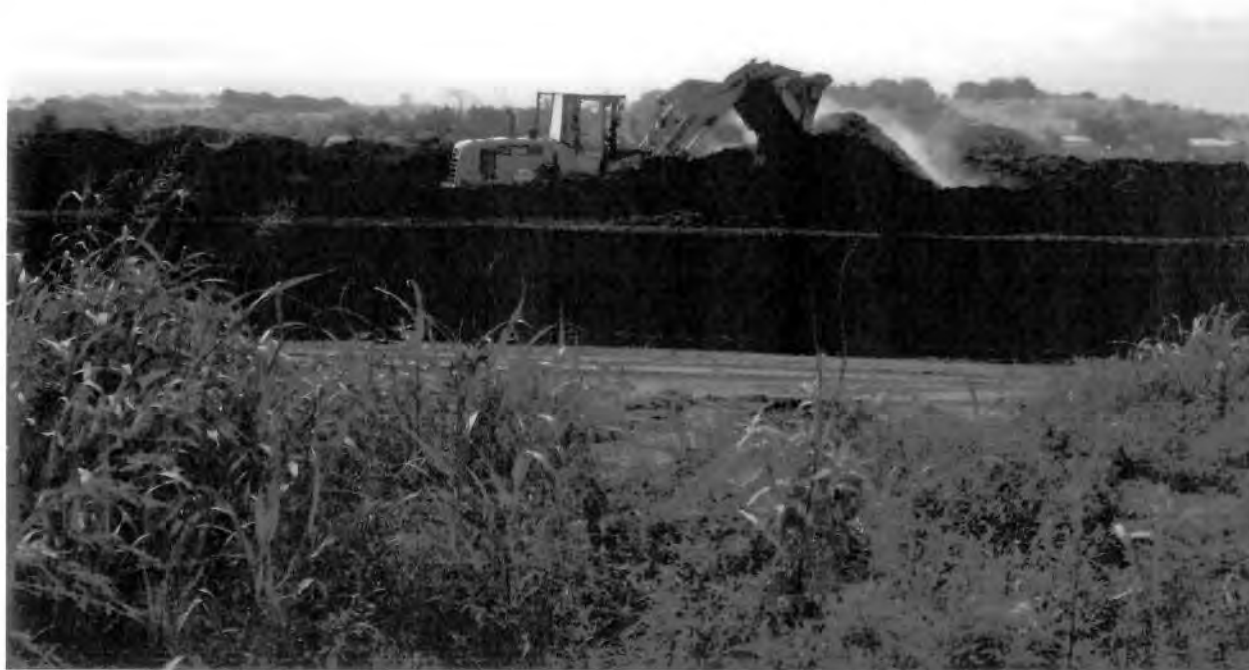
Photo No. 2

Description: Looking east at the dairy's manure composting area. Note the tractor which was actively working the windrows of manure compost and the steam that was coming from the piles. This large composting area was well bermed and contained within the watershed or RCS 5.

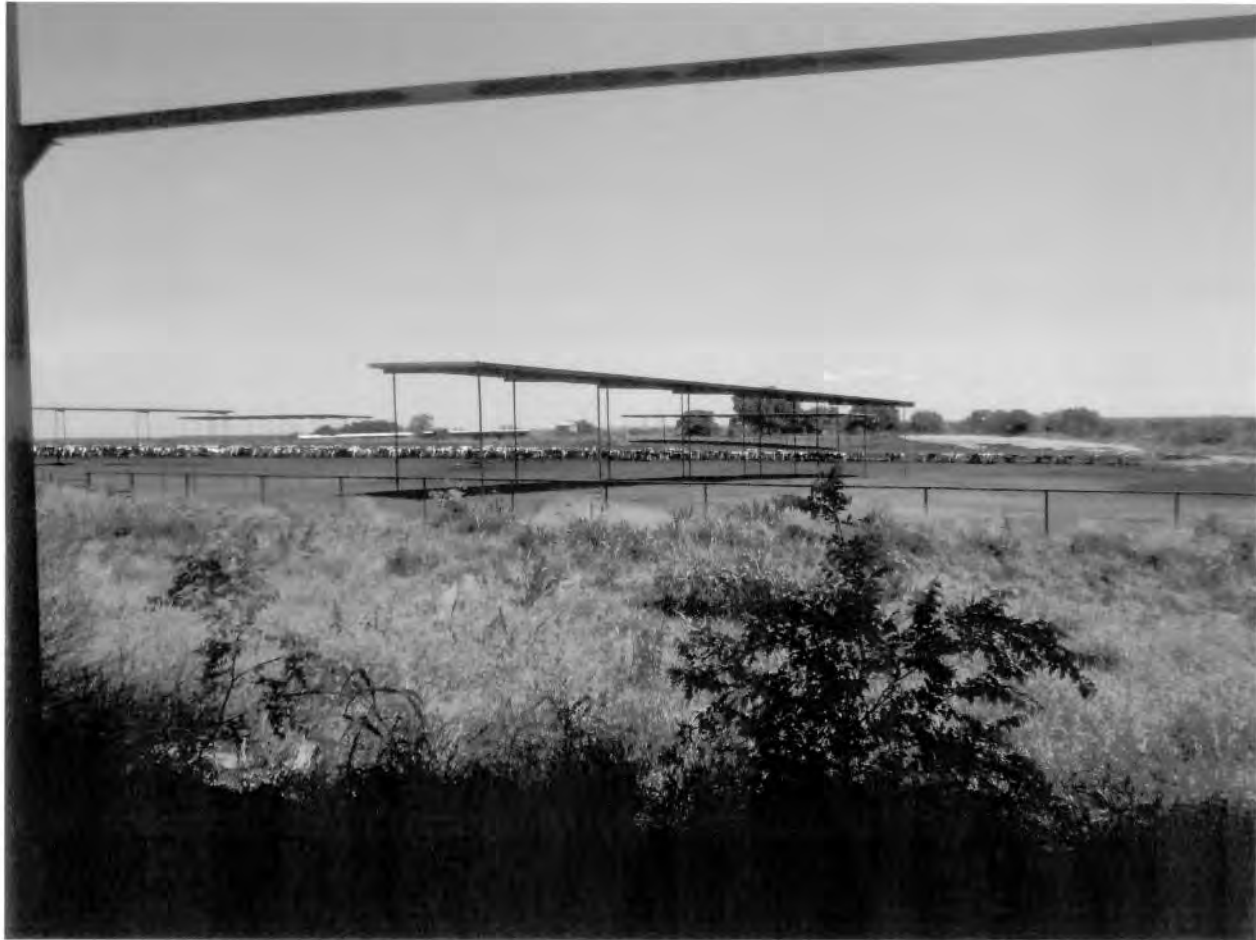
Photo No. 3

Description: Looking north at the dairy's cow pens located upslope of RCS 5.

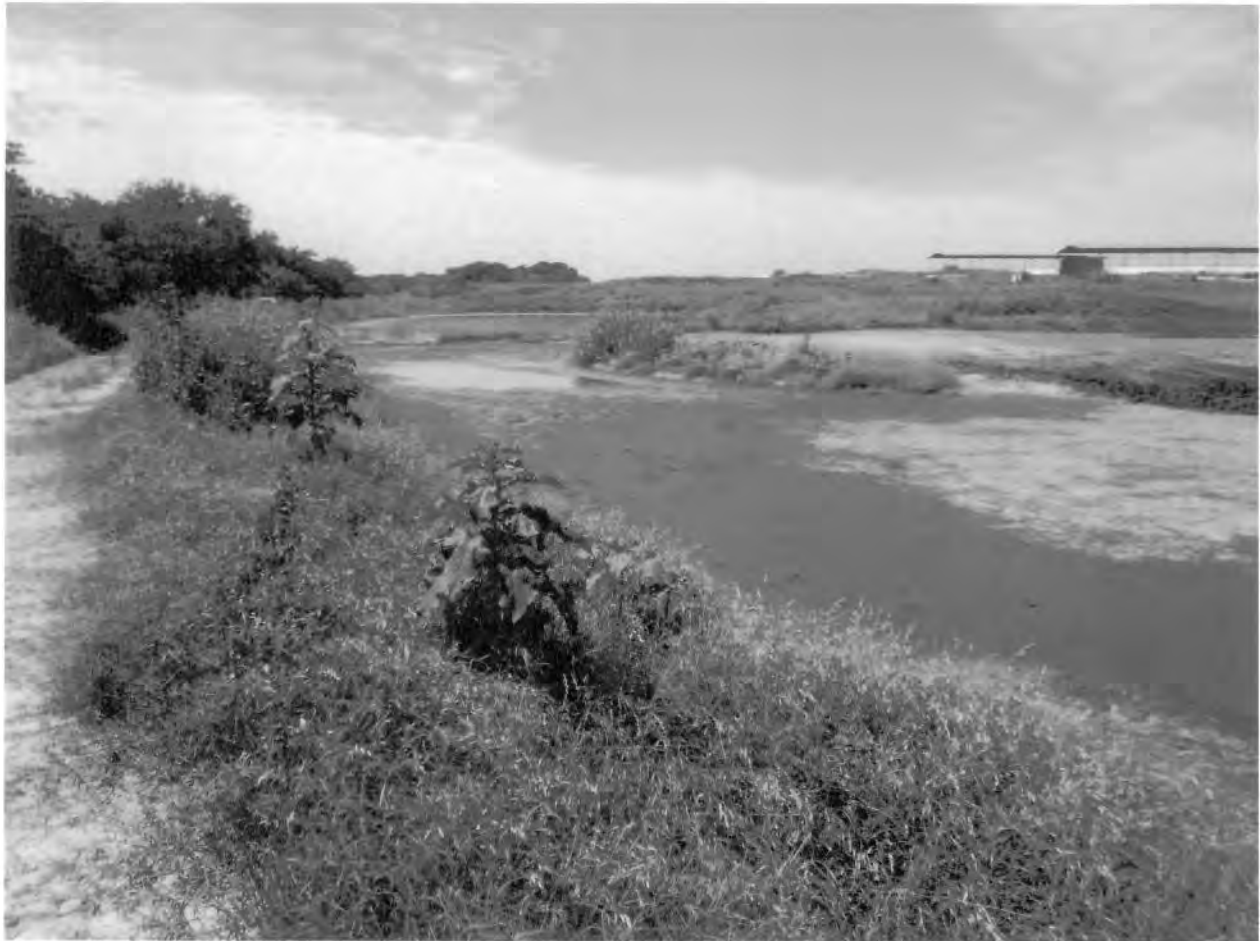
Photo No. 4

Description: Looking south at RCS 5 in the background. The foreground is part of the bermed channel that directed runoff into the RCS. Note the trees and brush on the RCS embankment.

4. Trees must not be allowed to grow on the embankment of RCS 5 such that the roots would compromise the liner or embankment per the TCEQ General Permit No. TXG920000, Part III. A. 10.(f)(3).

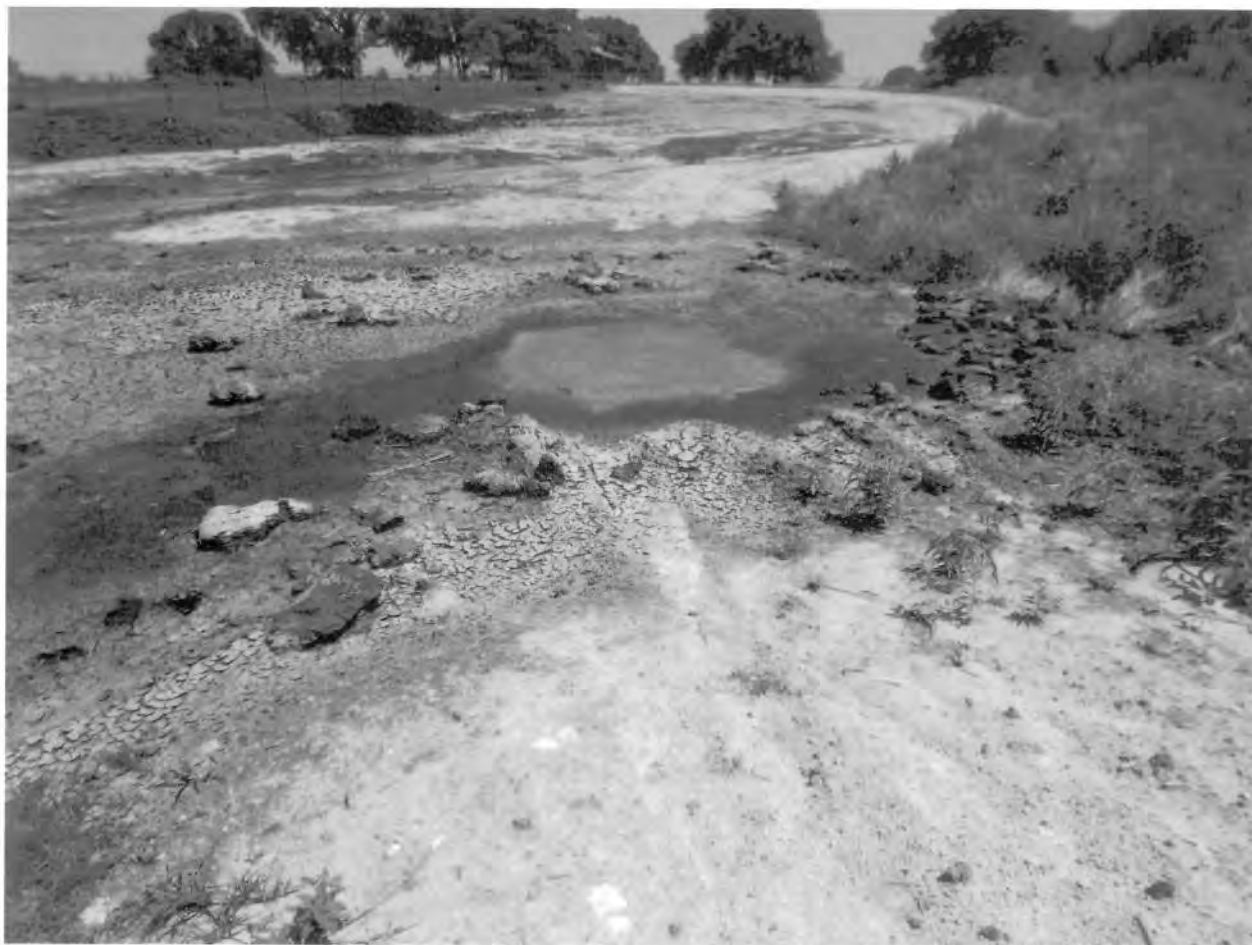
Photo No. 5

The berm on the northeast end of RCS 5 needed to be rebuilt to ensure that the cattle lot runoff going into RCS3 was contained within a berm that was designed, constructed and maintained to channel flows from the 25-yr/24-hr rain event. Photos 1 and 5 showed that the berm designed to channel storm water runoff flows from the cattle pens above RCS 3 was overtopped and discharged to the bar ditch located along County Road 105. This issue was noted during a previous EPA inspection at this dairy conducted on 6/20/2013. Additionally, the berm leading to RCS 1 and the berm around the compost area leading to RCS 5 needed to be evaluated and maintained to ensure capacity for the 25-yr/24-hr rainfall event. See the attached Photolog and Location of Significant Photos map. The east side of the lagoon embankment at RCS 5 had numerous trees growing along the embankment.

Description: The point (at the pool) at which the failed berm and/or the lagoon had discharged cow pen runoff into the bar ditch shown in photo 1. The discharge left the bermed area at the right of the pool. RCS 5 is not seen in this photo, but was located behind the inspector and to the left.

1. The berm on the northeast end of RCS 5, at the far east end of the cattle pens, was not constructed or maintained to contain the 25-yr/24-hr rain event. This is a repeat concern addressed in the EPA inspection from 6/20/2013. This concern is addressed per the TCEQ General Permit No. TXG920000, Part III. A. 6.(c)(3) and Part V. D.

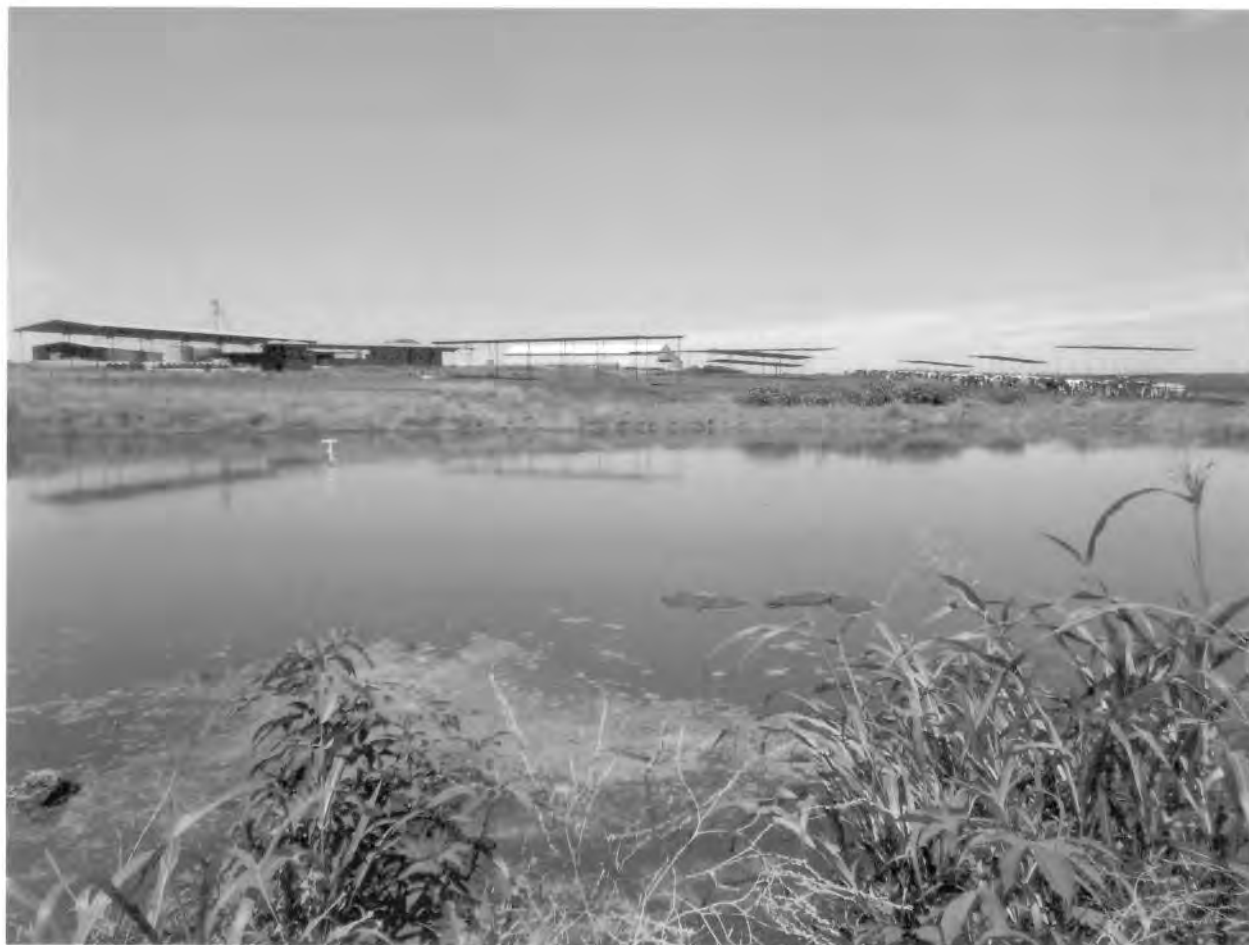
Photo No. 6

Description: Looking west at RCS 5. The top of the pole marker indicated approximately 0.5' of freeboard which was confirmed during the site visit. The cattle pens were located upslope of the RCS and are seen in the background on the right side of the photo.

2. Although impacted by recent chronic rainfall, RCS 3, 4, and 5 had less than six inches of freeboard. Capacity for the 25-yr/24-hr rain event needed to be re-established as soon as possible per the TCEQ General Permit No. TXG920000, Part III. A. 10.(a)(1)

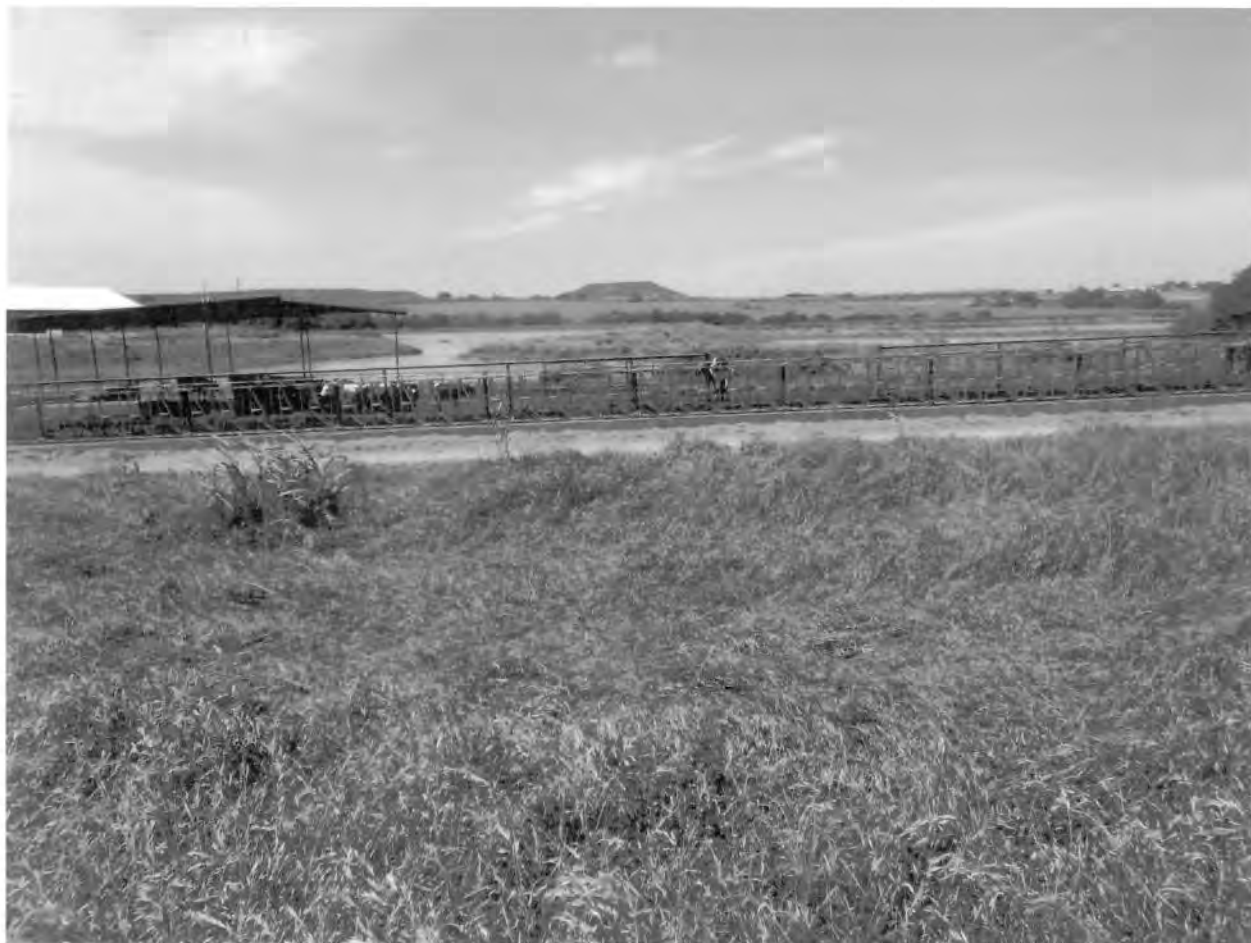
Photo No. 7

Description: Looking west at the manure settling pond (foreground behind the feedlane) and RCS 1 and 2 (background). The manure screen shown in photo 8 was located to the right of this photo.

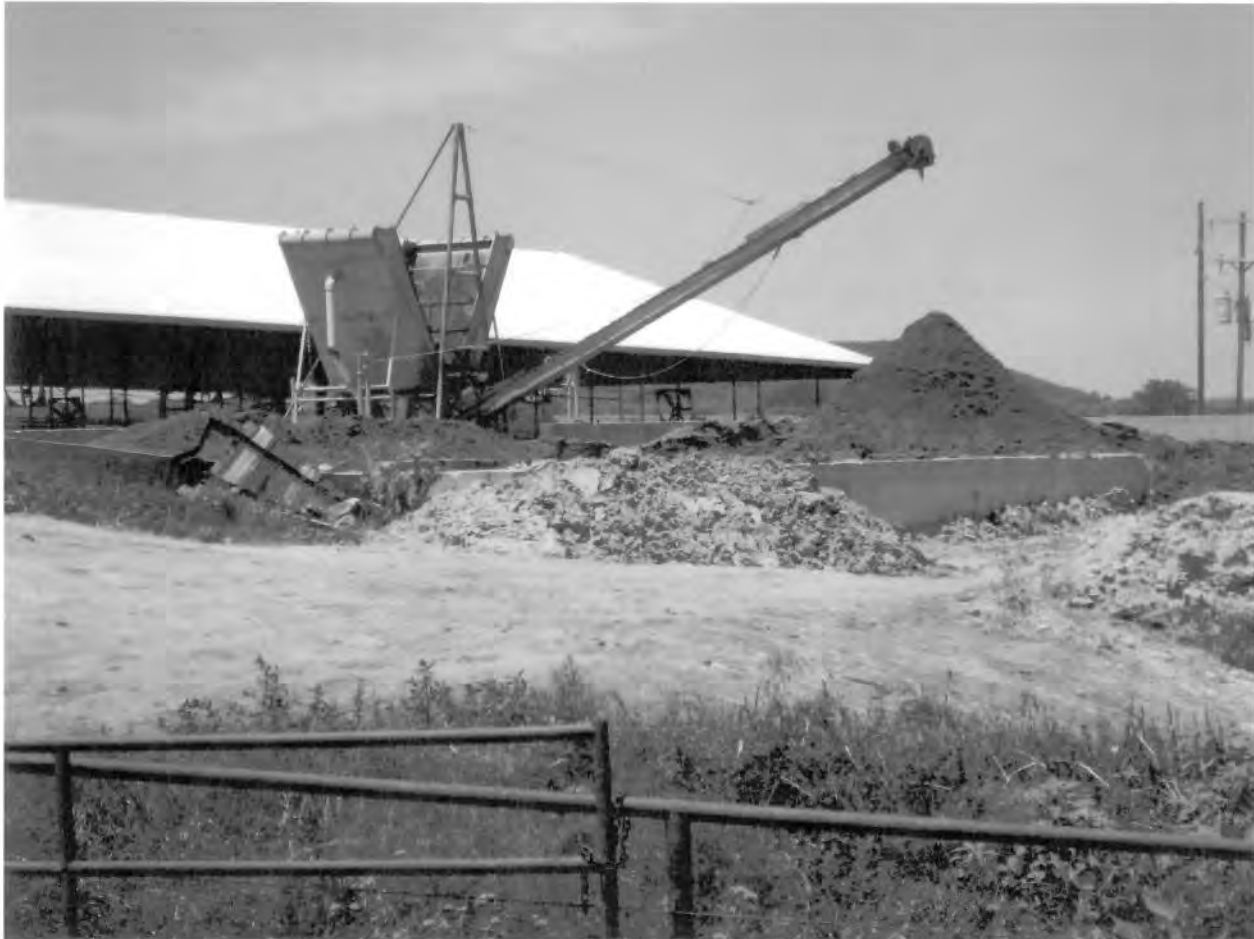
Photo No. 8

A large amount of manure spilled out onto the ground surrounding the solids screening and settling units. The area had poor housekeeping and needed to be cleaned up of manure and lot scrapings. This manure must be properly managed at the manure compost area.

Description: Looking west-southwest at the manure screen that served the freestalls and milking parlor.  
Note the accumulation of manure and scrapings that needed to be moved to the composting area.

5. Large amounts of manure spilled out from the solids screening and settling units. The area needed to be cleaned up of manure and accumulated lot scrapings and have it properly managed at the manure compost area.
6. Application of wastewater at agronomic rates must utilize the correct 2018 wastewater nutrient value, rather than the value from 2017.

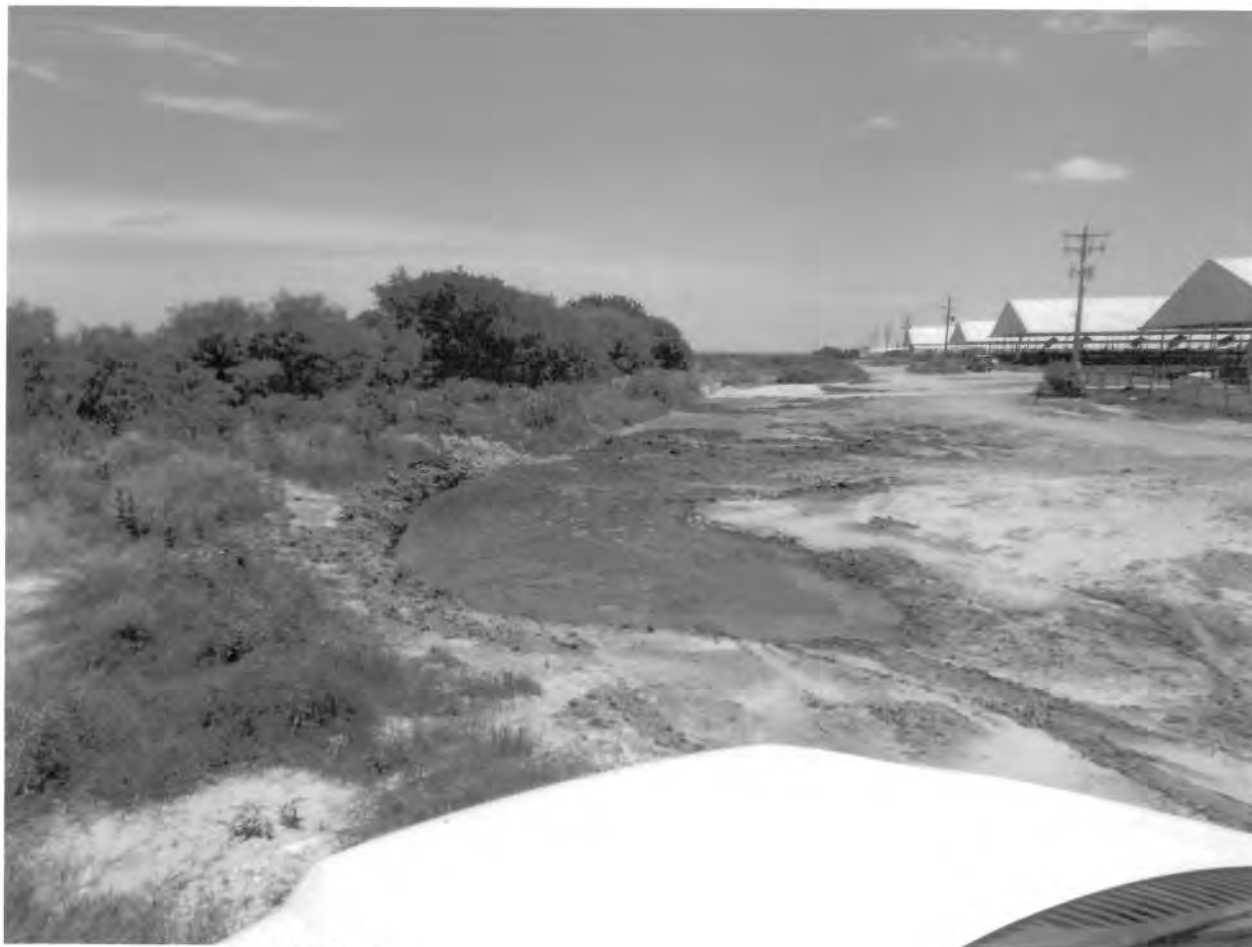
Photo No. 9

Description: Looking north at the berm which channeled cow lot runoff from the pens toward RCS 1 (not seen in the background). The berm could not be adequately assessed for weekly inspections due to the tall vegetation. The vegetation will prohibit proper berm inspection and maintenance to ensure that capacity existed for the 25-yr/24-hr rain event. Freestalls were located on the distant right side of the photo.

3. Mowing of tall grass and vegetation needed to be done around the RCSs, manure screen, settling basins and settling pond. Additionally, the berm leading to RCS 1 and the berm around the compost area leading to RCS 5 needed to be mowed and maintained to enable visual inspections of the RCS for unit conditions and capacity for the 25-yr/24-hr rainfall event per TCEQ General Permit No. TXG920000, Part III.A. 15.(a)(1) and Part V. D.

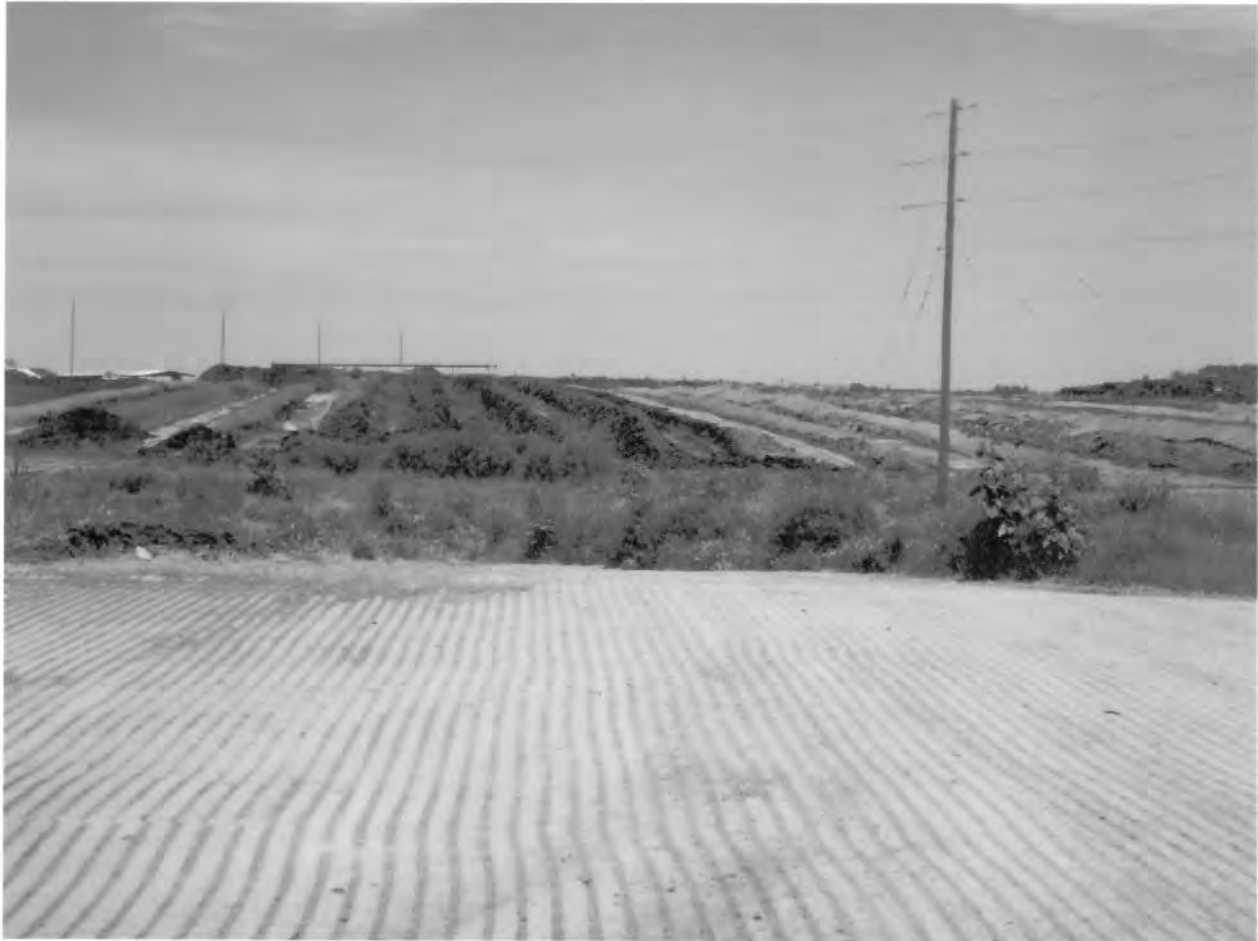
Photo No. 10

Description: Looking north at composted windrows located within the compost area. The compost area was located within the watershed of RCS 3.

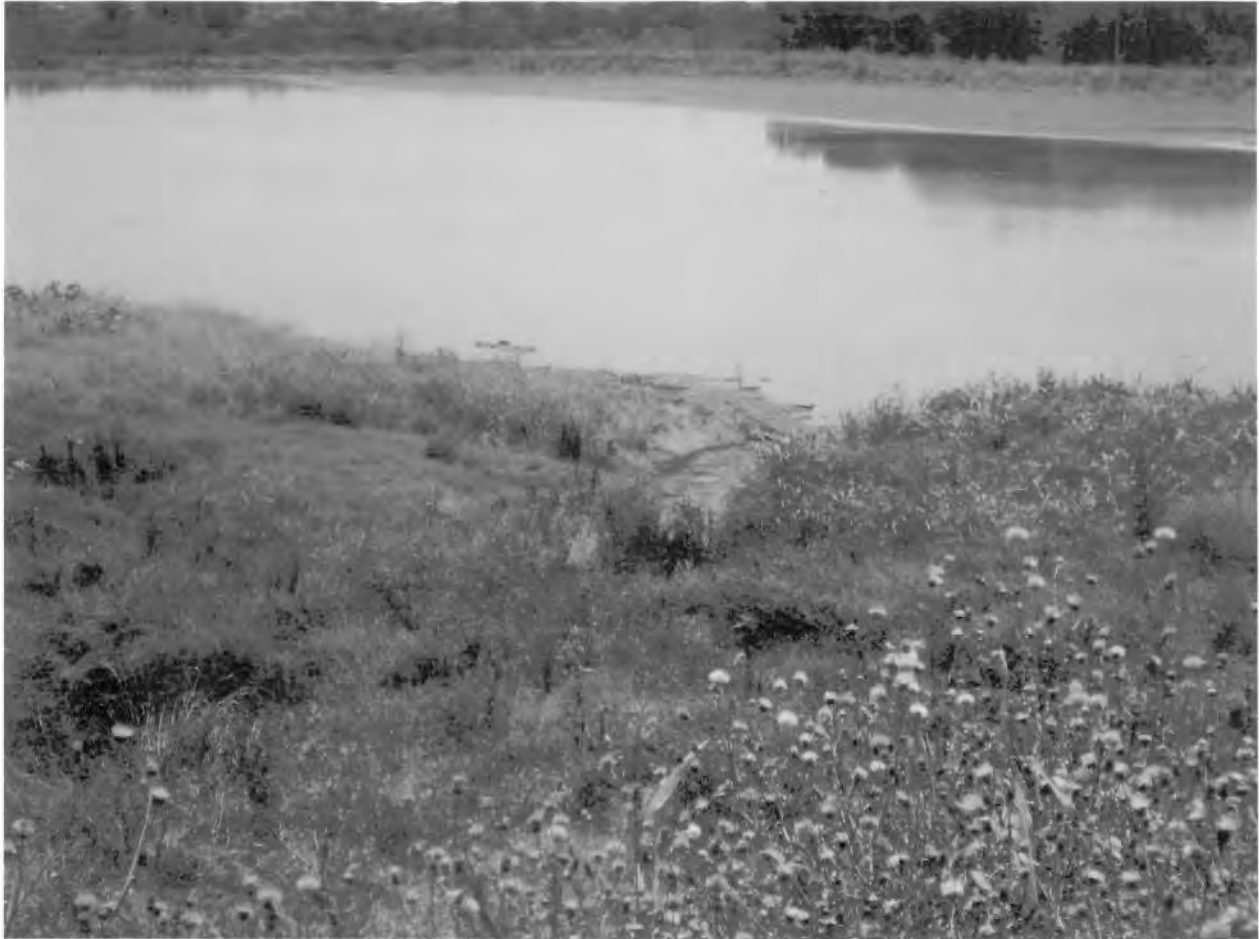
Photo No. 11

Description: Looking southeast at the discharge point of RCS 3 which received runoff from the compost area. The discharge point was located at the northwest corner of the RCS. No process wastewater discharge was seen leaving the property although the tall grass made it difficult to properly assess the lagoon's embankment.

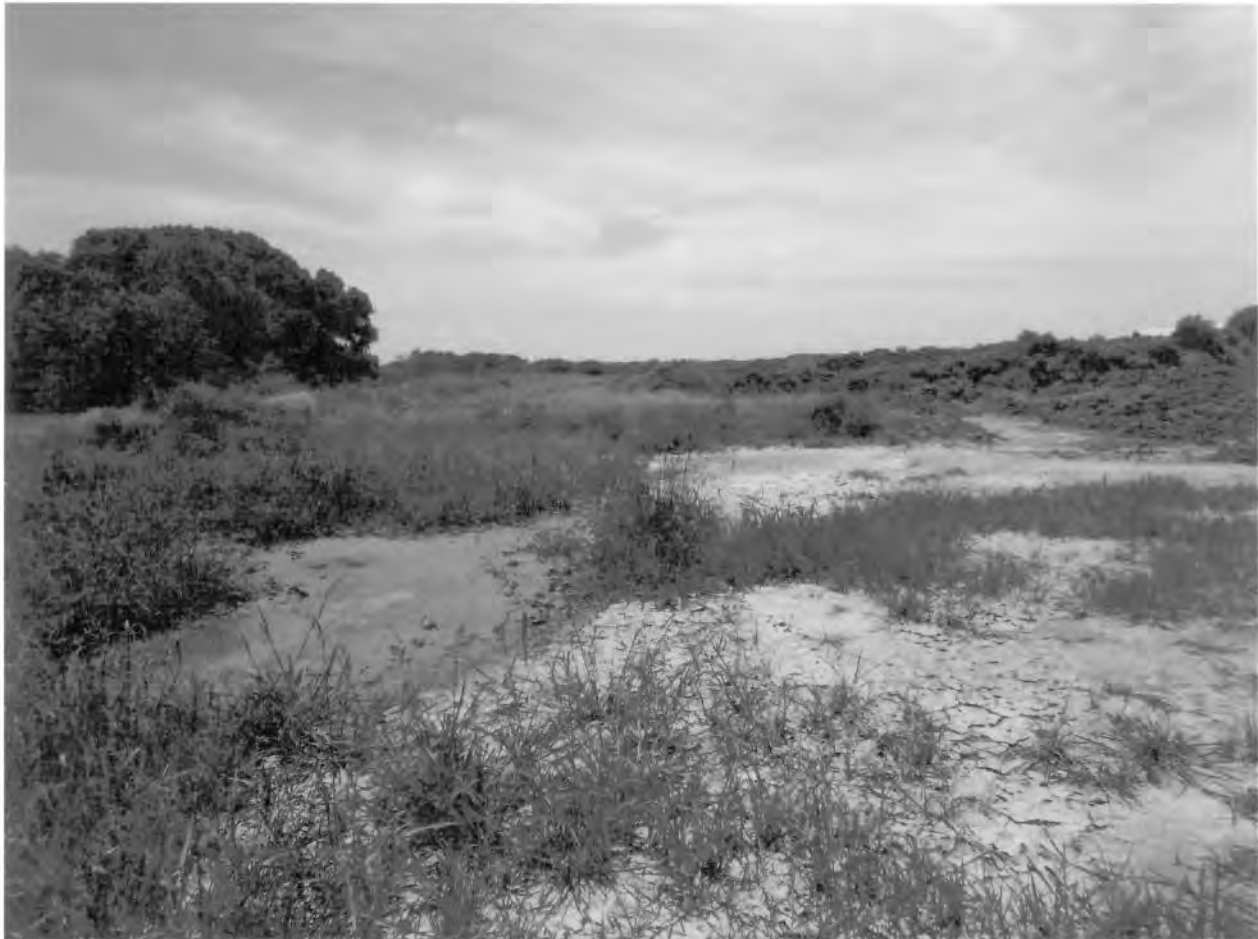
Photo No. 12

Description: Looking south at the unmaintained berm which channels runoff toward RCS 3 (on the left side of the photo). This berm was located on the east side of the compost area. The berm had tall vegetation which prevented an evaluation of this control structure to determine if it could contain the runoff from the 25-yr/24-hr rainfall event.
