## CHITOLIE TRUCKING SERVICE, NPDES Reconnaissance Stormwater Inspection (SWI) Photo Album; 11-2-2022 Walkthrough

### A. Observations that revealed potential non-compliance with regulations implementing the CWA and TPDES Stormwater Rules during the SWI Walkthrough

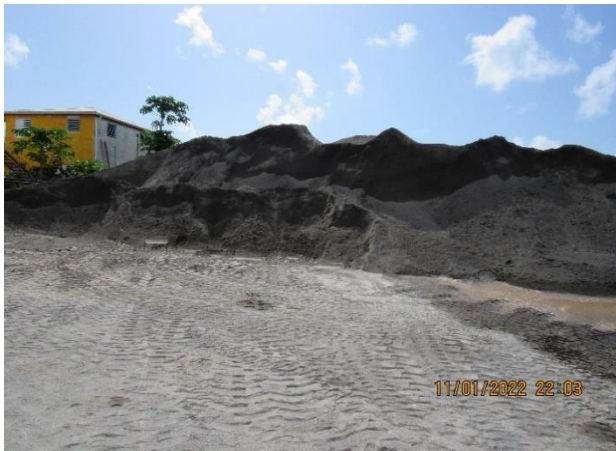
**IMG 760**-Storage cell with sand situated about mid-way along the eastern border of the Facility. Cell is exposed to rain and stormwater runoff flow.

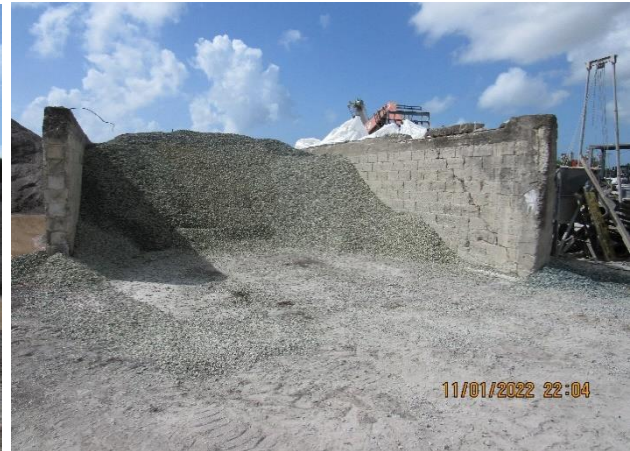
**IMG 762**-Storage cell with gravel situated next to sand storage. Storage area exposed to stormwater runoff flow, leading to wash-off of material.

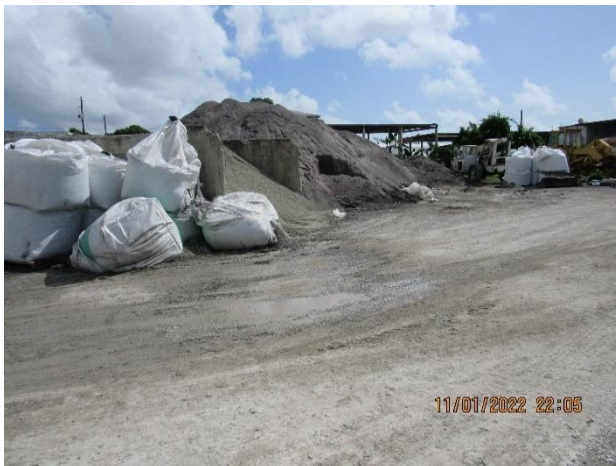
**IMG 767**-Bags of cement stored immediately next to aggregate (sand & gravel) cells. Some bags were ripped, with cement spilled onto ground.

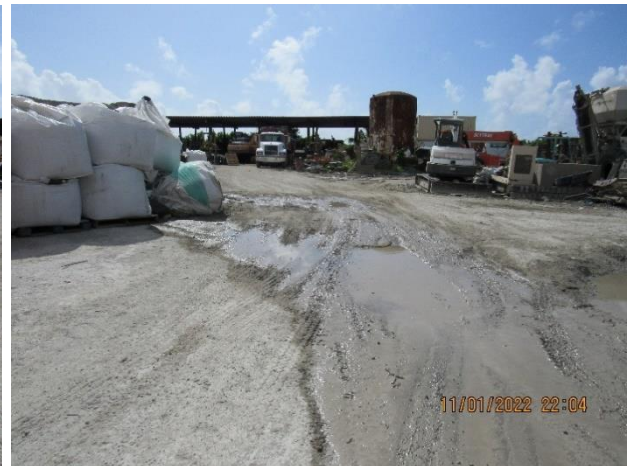
**IMG 768**-Observed that the cement bags and spilled cement sits in the stormwater flow path. Cement spilled will be washed-off by stormwater runoff.

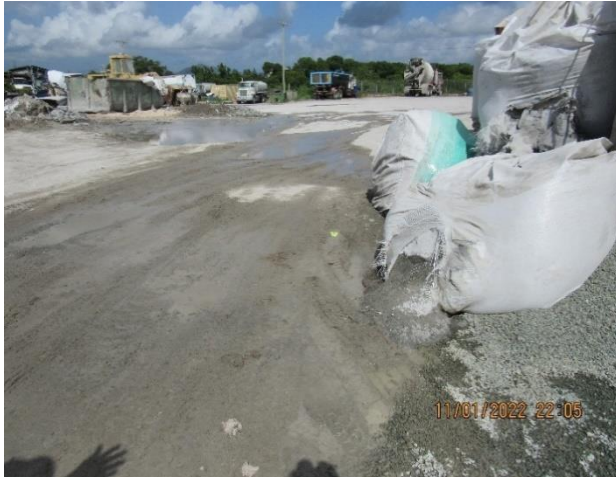
**IMG 765**-Close-up of cement and gravel in the path of stormwater flow that drains toward the retention

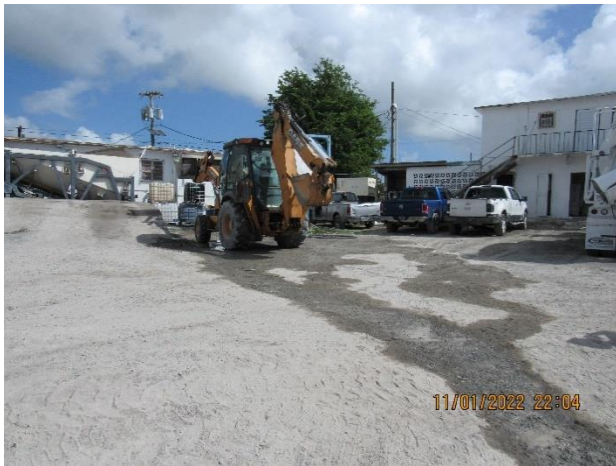
**IMG 763**-Observed dry-weather flow coming from the ready-mix concrete plant and drained towards the pond.

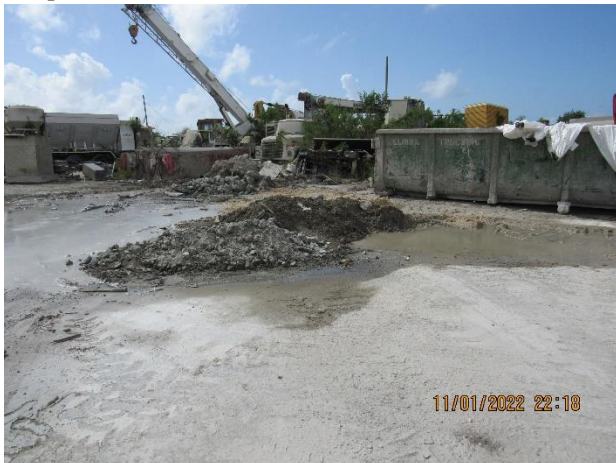
**IMG 773**-Edge of the pond where spent concrete to a berm. The berm ineffective because a dry-weather flow drained from the pond. and out of the Facility. wastewater).

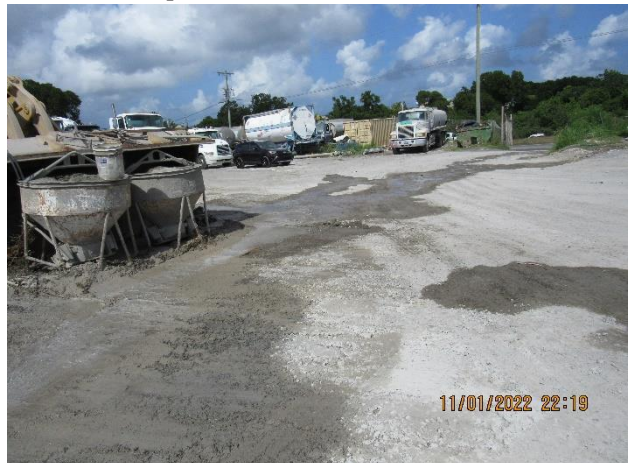
**IMG 774**-Dry-weather flow the pond drains away from the pond across the yard towards the lower entrance/exit, transporting pollutants (e.g., industrial wastewater).

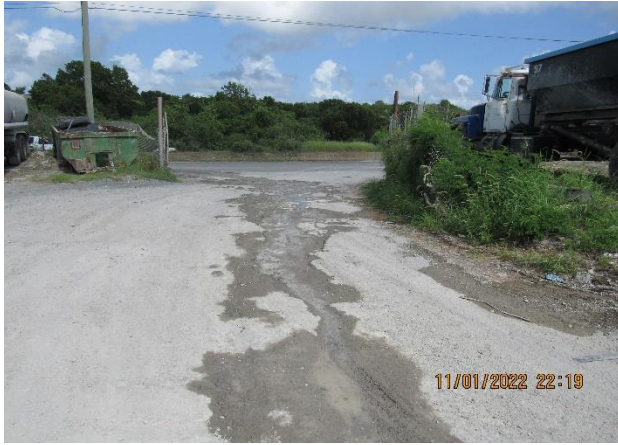
**IMG 775**-Dry-weather flow being discharged from Facility through the lower entrance/exit.

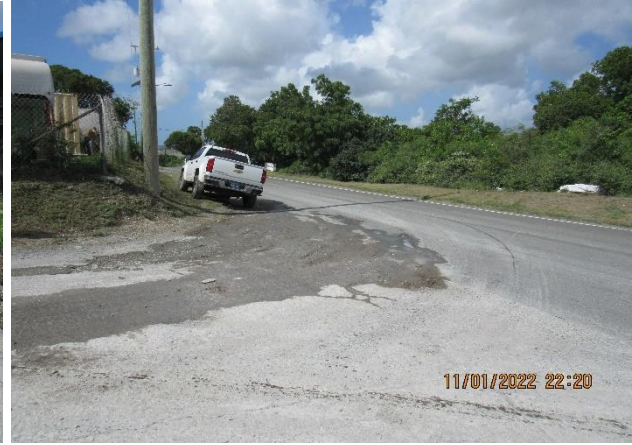
**IMG 777**-Dry-weather flow leaving the Facility and out into the public road.

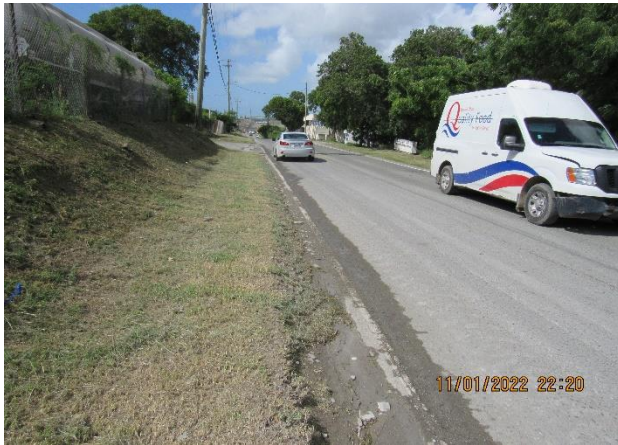
**IMG 778**-View of dry-weather flow event occurring and running along left side of the road downhill in the stormwater flow path along the road.

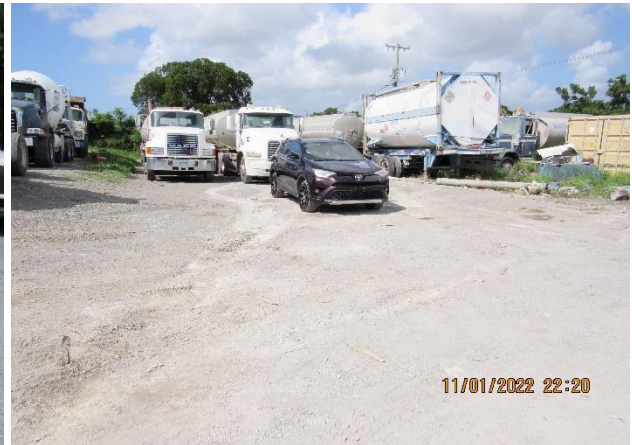
**IMG 776**-Evidence of stormwater flow path from a staging area for fuel-tanker trucks, dump trucks other heavy equipments before draining off-site.

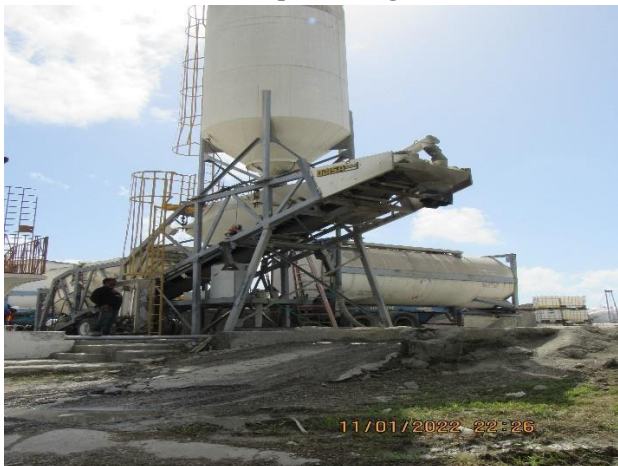
**IMG 786**-View of ready-mixed concrete loading bay, the wider ready-mixed manufacturing plant, situated adjacent to the Admin Office.

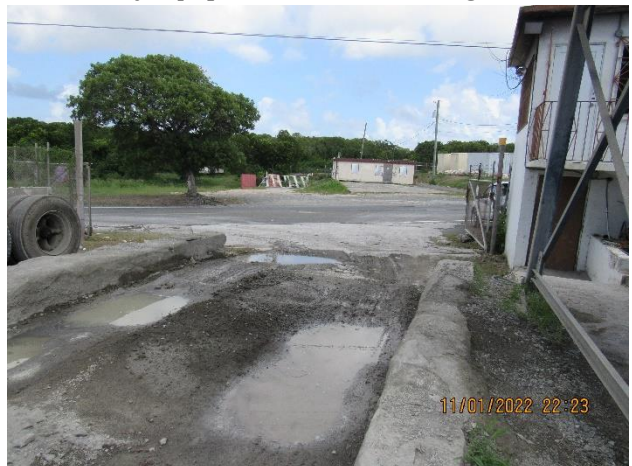
**IMG 780**-Close-up of the ready-mixed concrete loading bay, inclined down towards the public road.

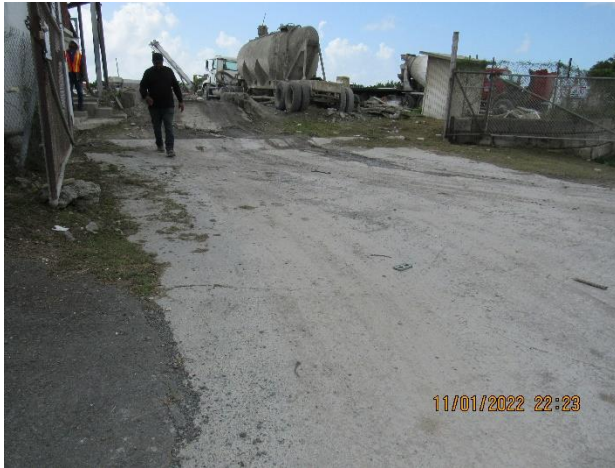
**IMG 781-**View of the ready-mix loading bay, upper entrance/exit and stormwater flow path out of the Facility and into the public road.

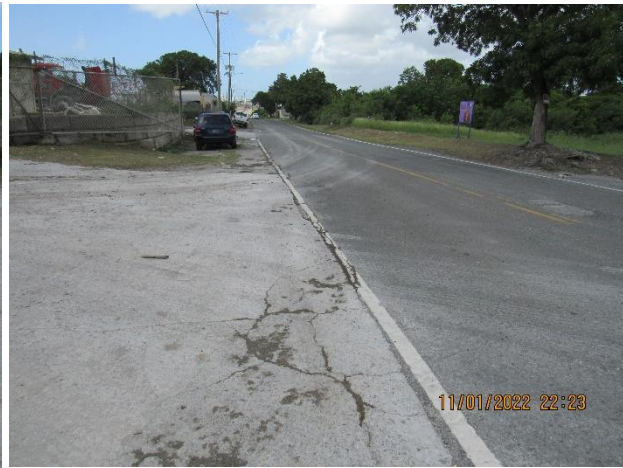
**IMG 782-**Evidence of track-out of pollutants from Facility and into the public road. Path of stormwater runoff leaving the Facility from upper entrance/exit.

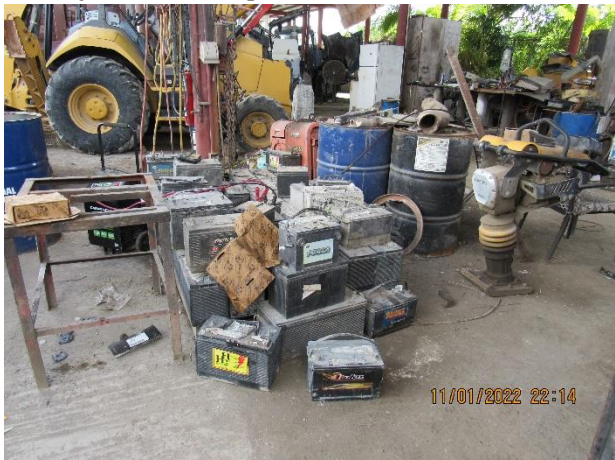
**IMG 771-**Accummulation of spent auto batteries situated on floor of maintenance shed in potentially managed under incompatible conditions.

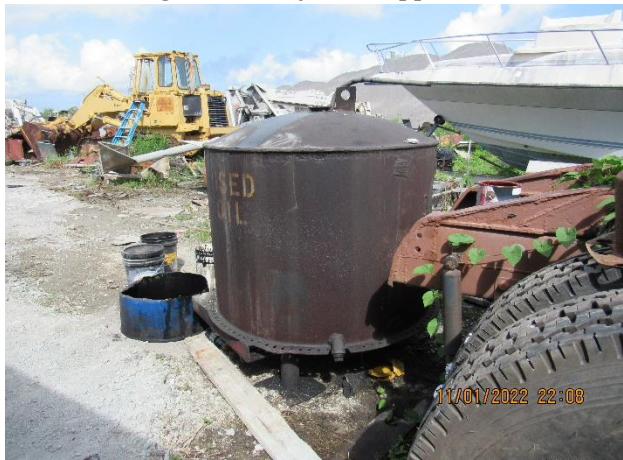
**IMG 769-**Container in which the Facility's used oil is collected and stored on-site. Improper housekeeping conditions observed and documented.

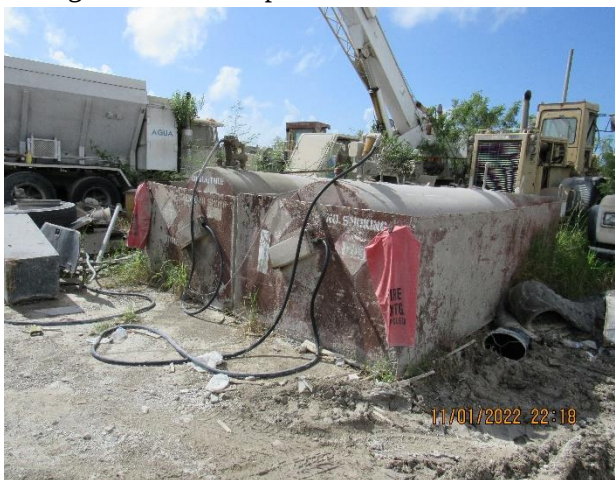
**IMG 772-**Facility's fueling terminal situated in path of stormwater flow. No containment in area where vehicles are staged for fueling service.

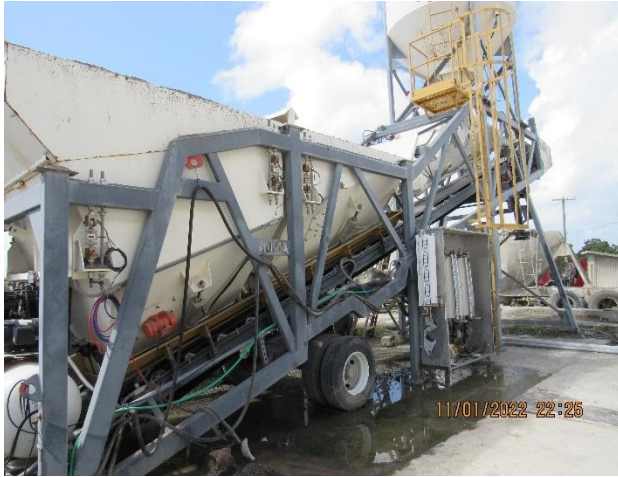
**IMG 785**-Accumulation of water beneath ready-mix concrete batch plant related to operations of the system. Source of a dry-weather flow observed.

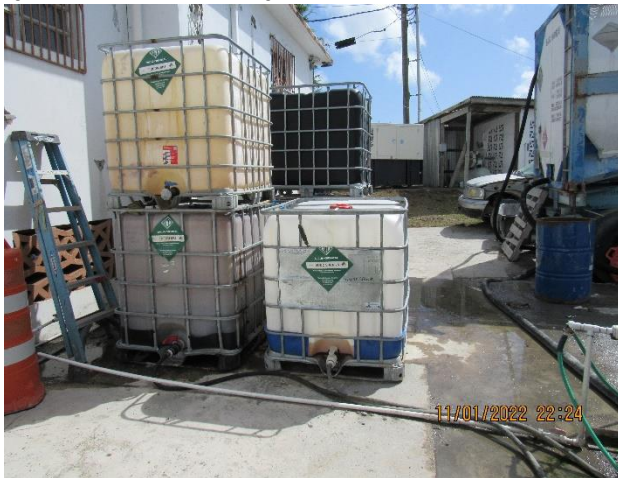
**IMG 784**-Observed totes of chemical additives with connective application hoses by stormwater into the ready-mix concrete manufacturing process.

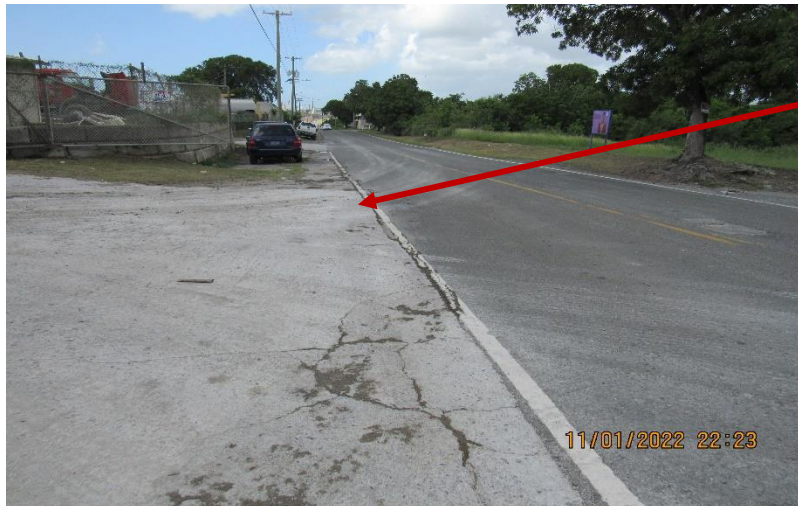
**Outfall 1** – Discharge of stormwater flow from the upper driveway into area stormwater drainage system, then into Cane Garden Bay

**IMG 782**-Discharge point where stormwater runoff flow from around the Ready-Mixed Concrete Plant loading bay and vicinity of the Administrative Building are combined and discharged into the public road through the upper entrance/exit. Stormwater flow drains into Fig Tree Ghut, and Cane Garden Bay downstream.

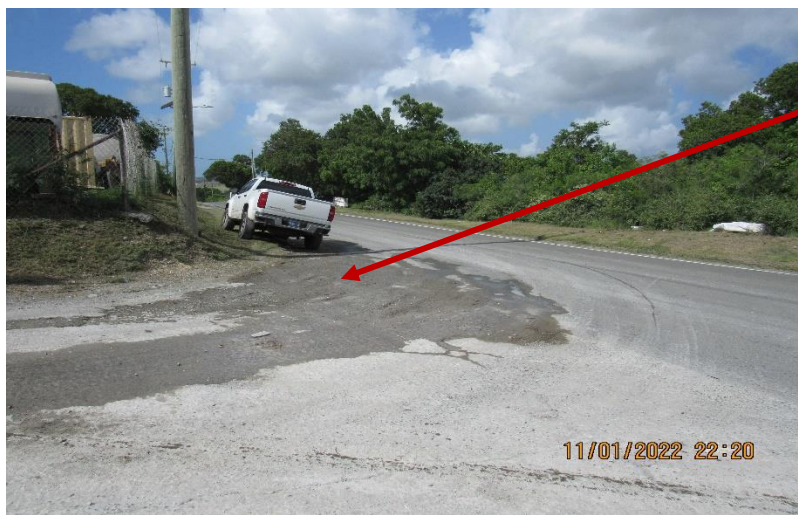
**Outfall 2** – Discharge of stormwater flow from the lower driveway into the area stormwater drainage system, then into the Cane Garden Bay

**IMG 777**- Discharge point where stormwater runoff flow from the central area (shallow retention pond) combined with flow from the northwestern (truck parking area) of the Facility and discharged into the public road through the lower entrance/exit. Stormwater flow drains into Fig Tree Ghut, and Cane Garden Bay downstream.
