## Region 6 - Enforcement & Compliance Assurance Division

### INSPECTION REPORT

| Company Name: | <b>Edna Oil Company, LLC</b> | |
| Facility Name: | <b>Henry Corley Tank Battery</b> | |

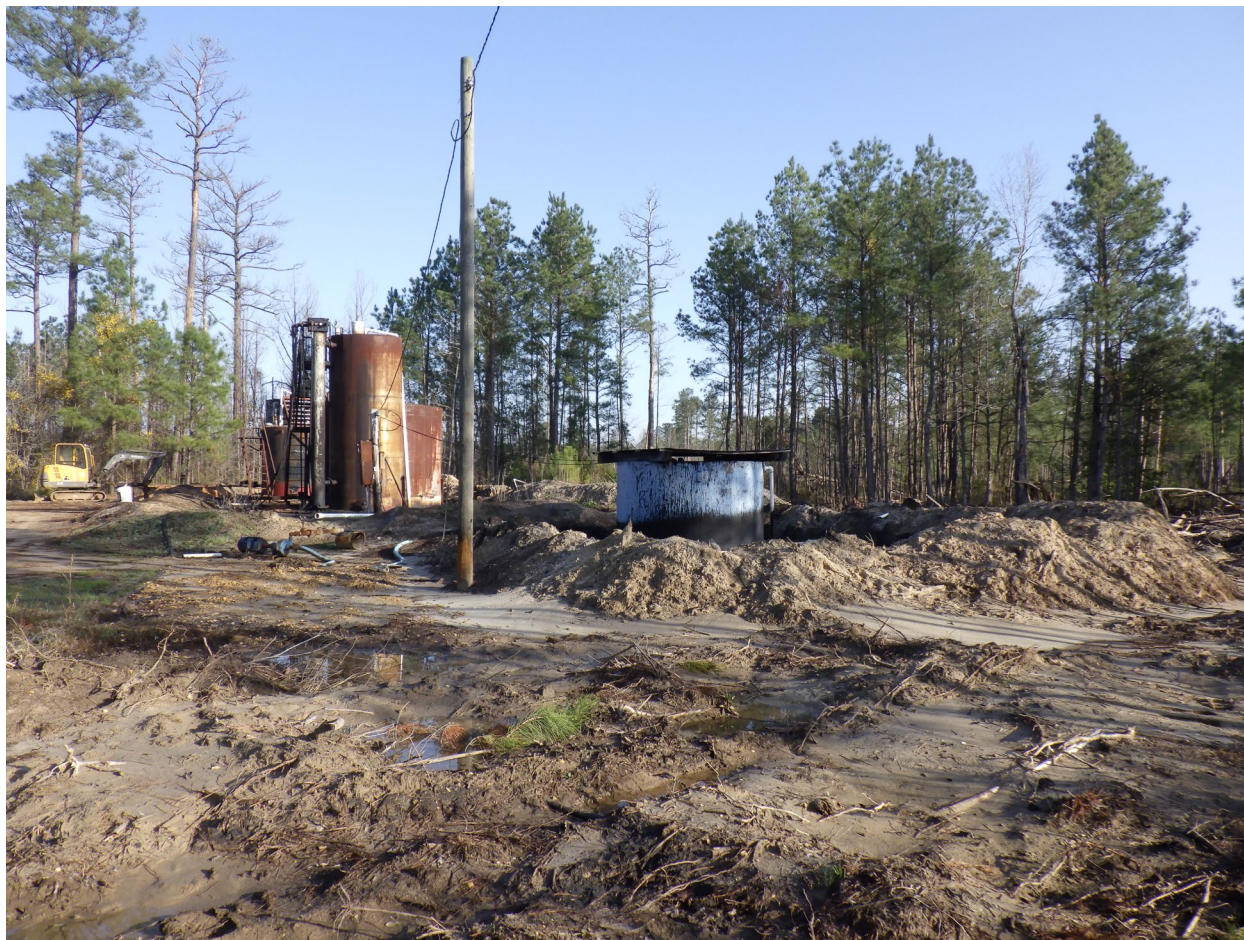
Photo No. 1

I observed the facility sign, secondary containment, oil separators, pipes, and tanks located at the facility, see Appendix 1 (photo log), photo No. 1. For additional GPS location and photo metadata, see Appendix 1.

**Description:** This photo was taken looking NE showing an overview of the facility. This facility did not have a facility sign.

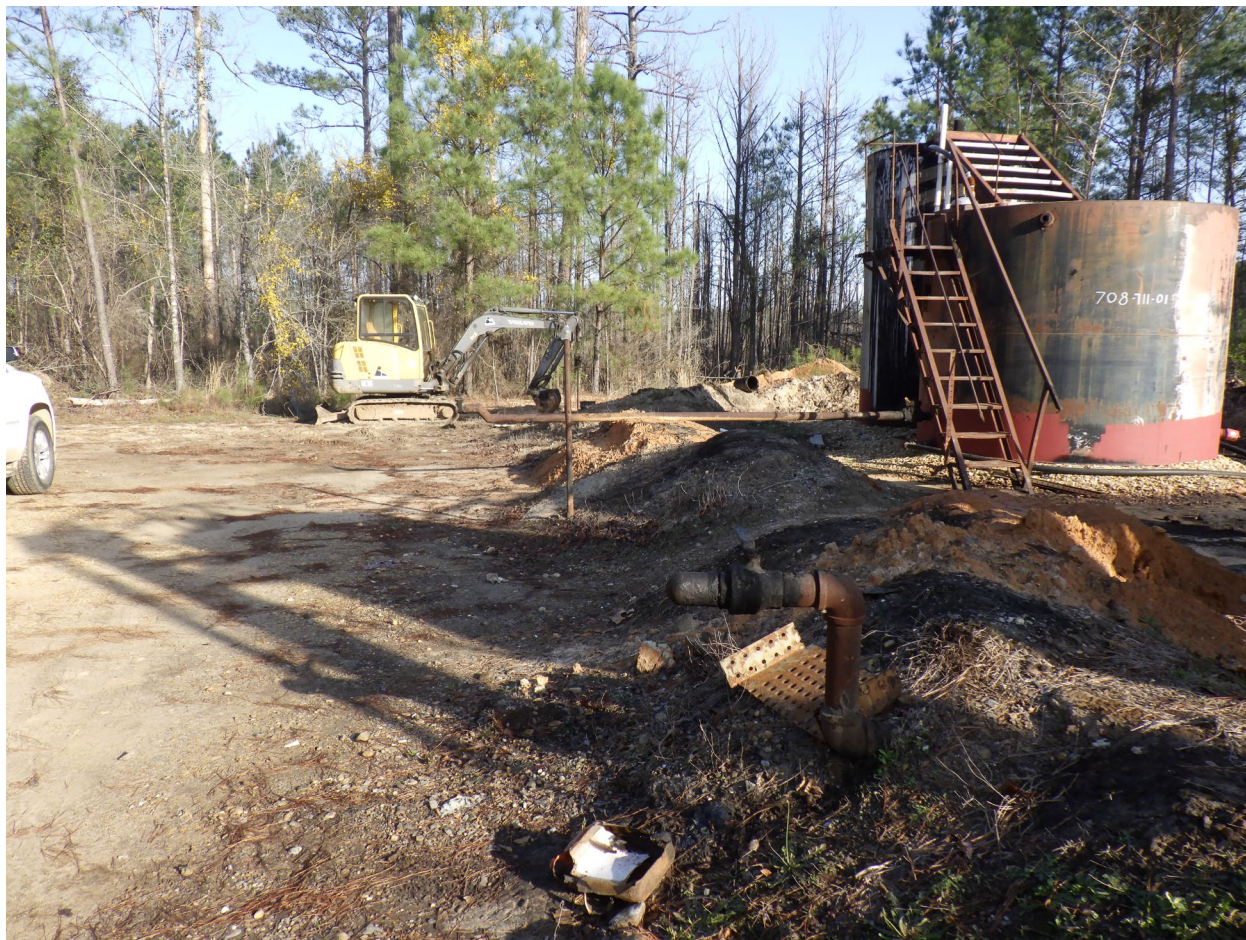
Photo No. 2

I observed the missing catchment buckets under the loading pipes outside of secondary containment, see photo No. 2.

**Description:** This photo was taken looking NW at the facility showing the loading lines outside of secondary containment without catchment buckets.

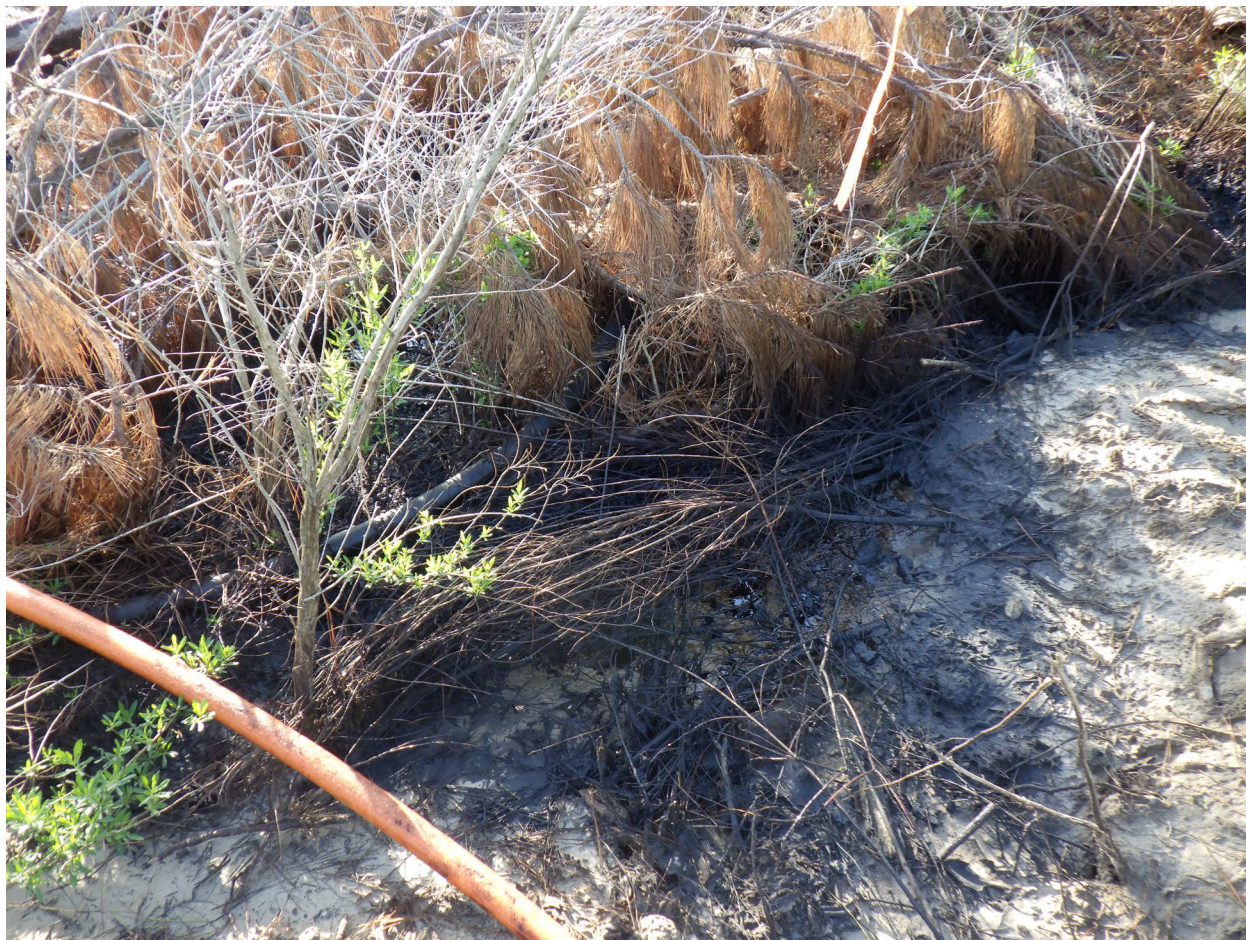
Photo No. 3

I observed loose oil outside of secondary containment near the open top tank as well as loose oil inside secondary containment, see photo No. 3, photo No. 4, and photo No. 6.

**Description:** This photo was taken looking SW showing oil staining outside of secondary containment SE of the facility.

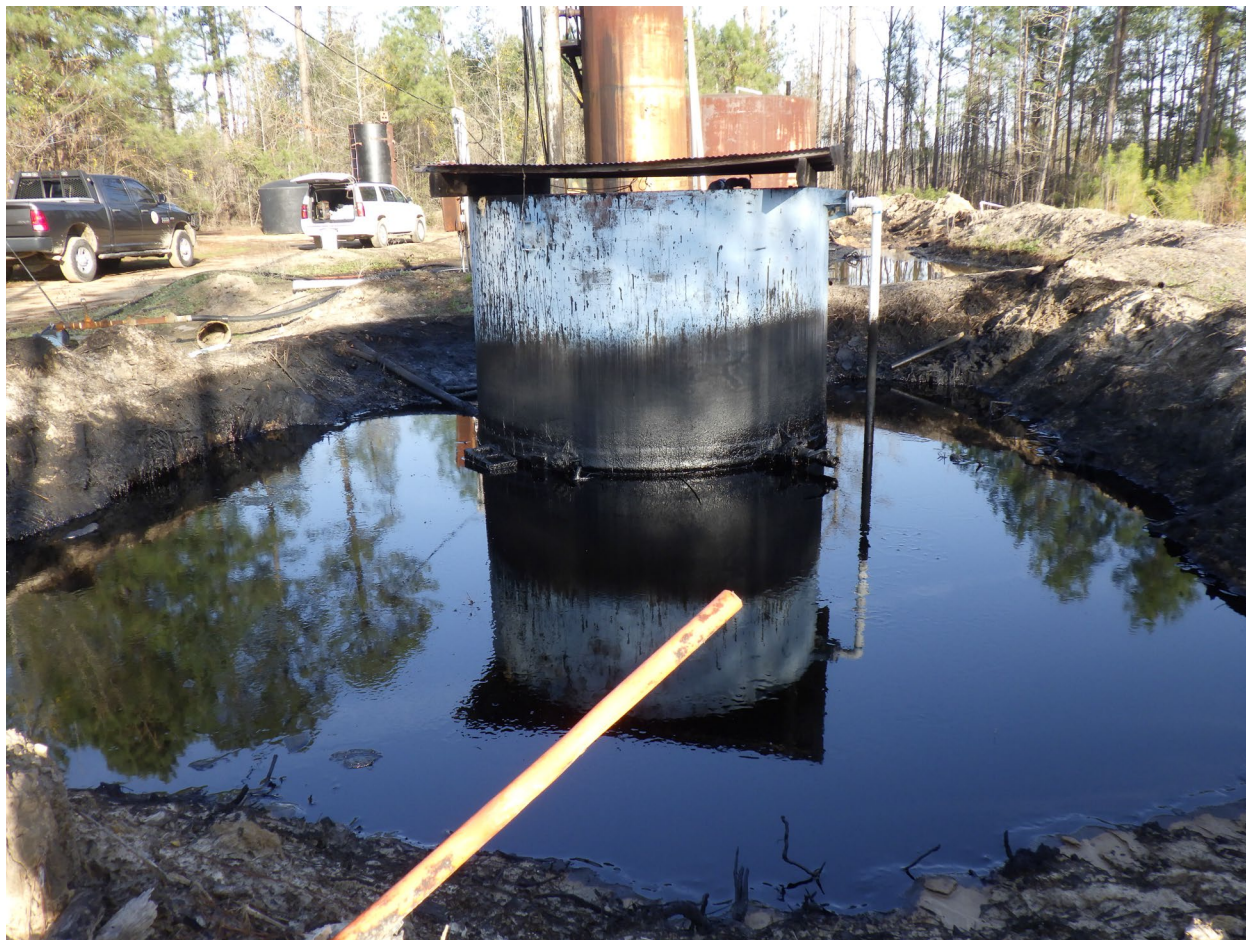
Photo No. 4

**Description:** This photo was taken looking NW showing the loose oil within secondary containment that contains one open top tank.

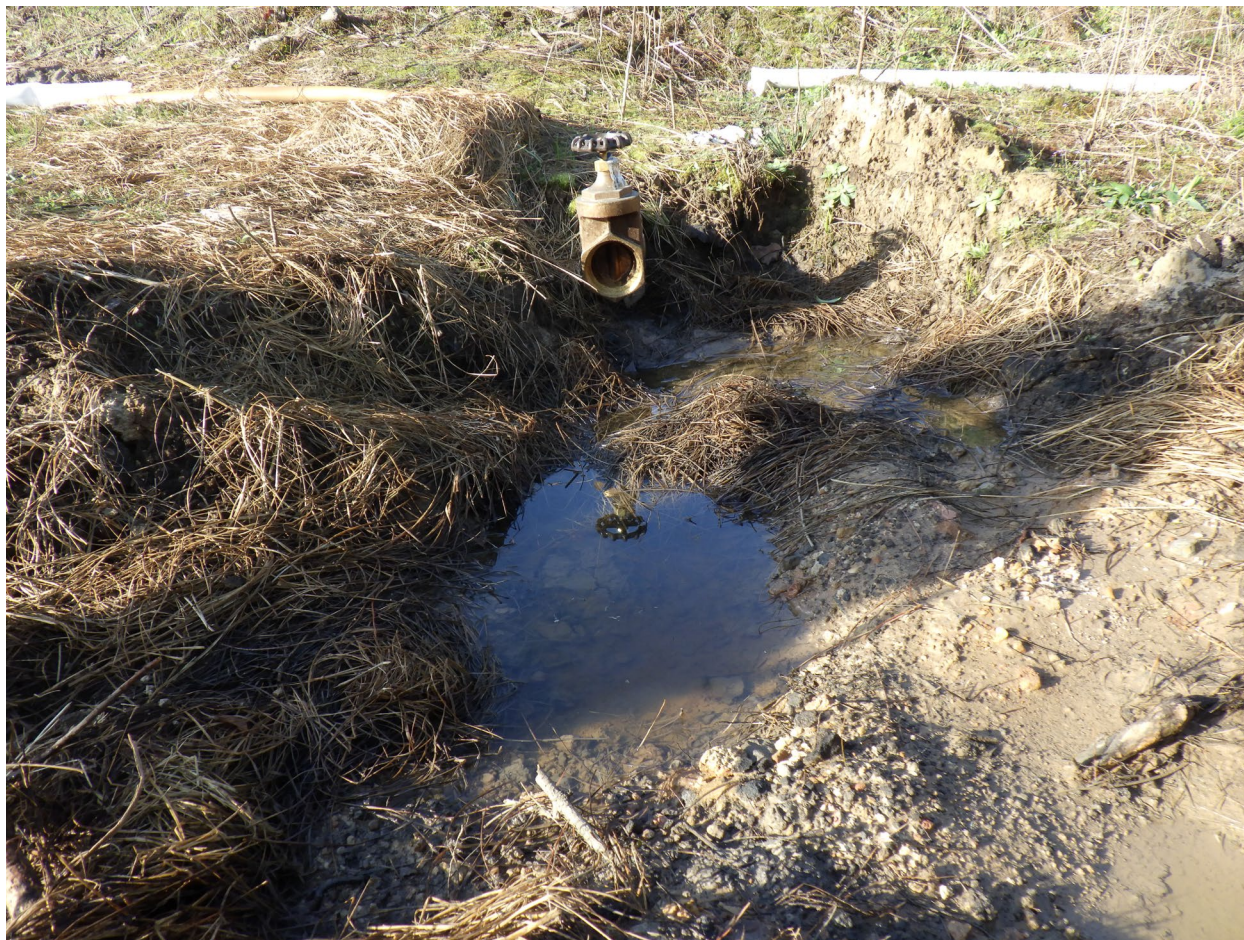
Photo No. 5

I observed the secondary discharge valve without a cap with standing water below the valve, see photo No. 5.

**Description:** This photo was taken looking SW showing the secondary containment discharge valve without a cap and standing water below the valve.

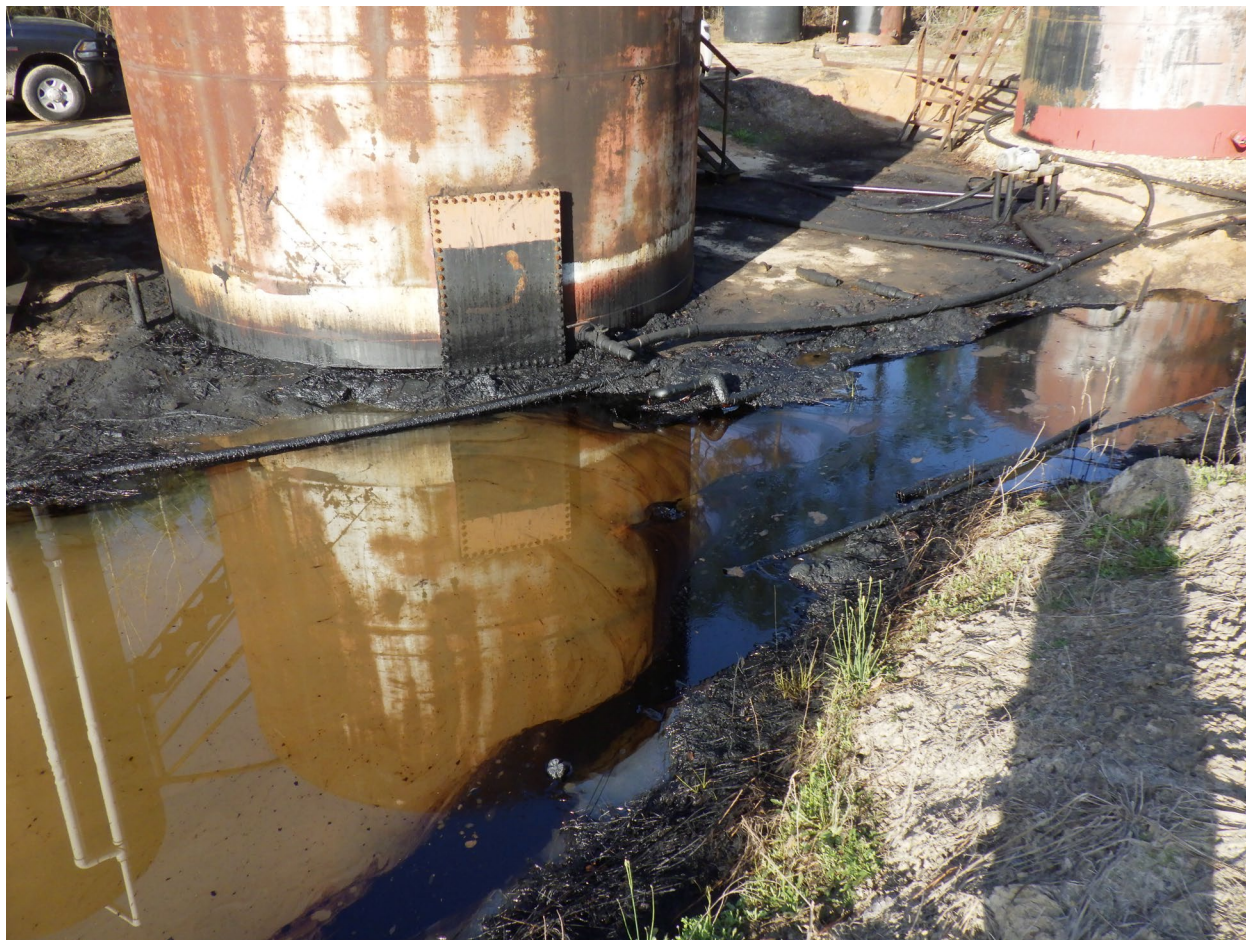
Photo No. 6

**Description:** This photo was taken looking W showing loose oil and water inside secondary containment.

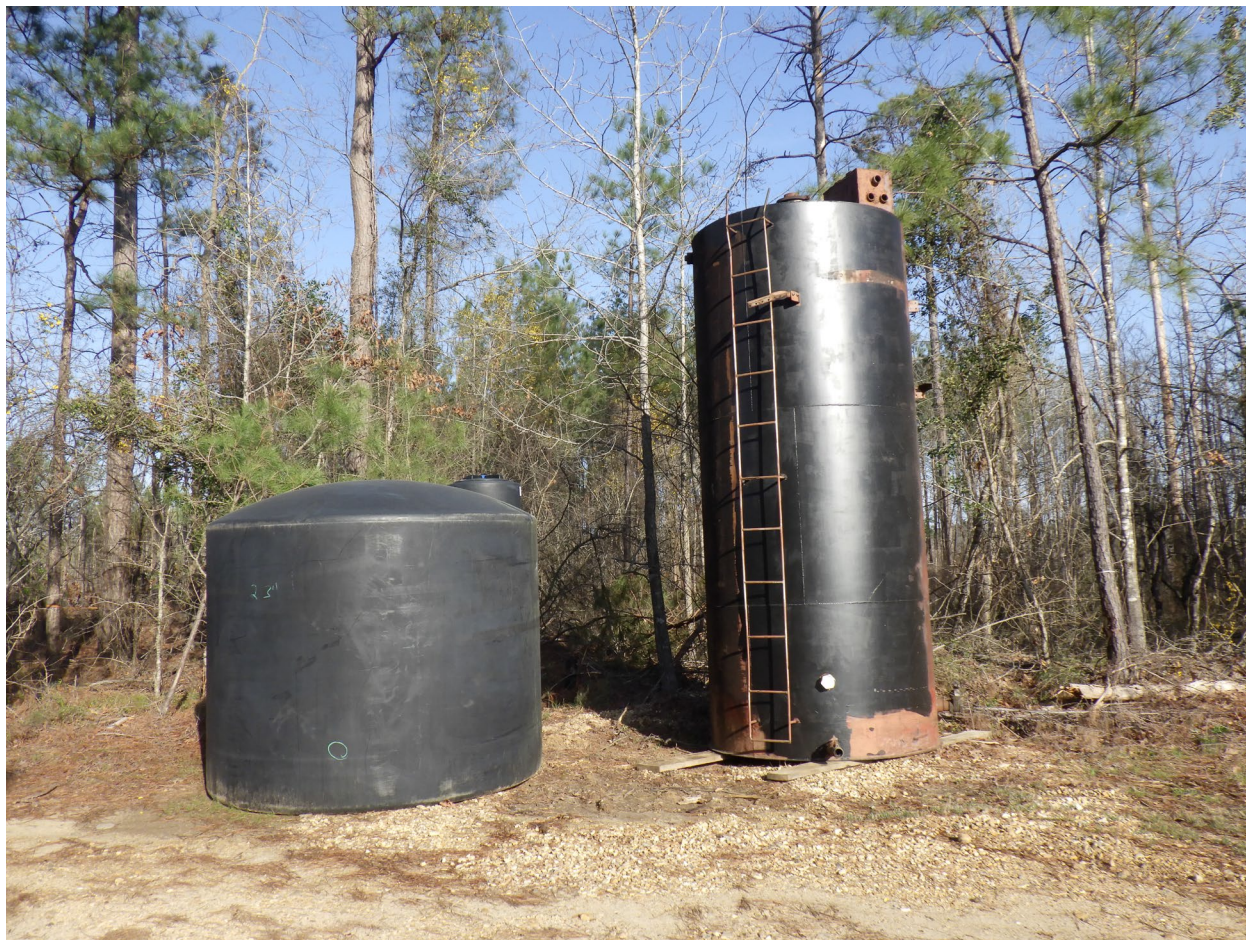
Photo No. 7

Outside of secondary containment, I observed a separator and a tank disconnected and clean without proper out of service markings, see photo No. 7.

**Description:** This photo was taken looking NW showing the clean and disconnected tanks outside of secondary without proper out of service markings.

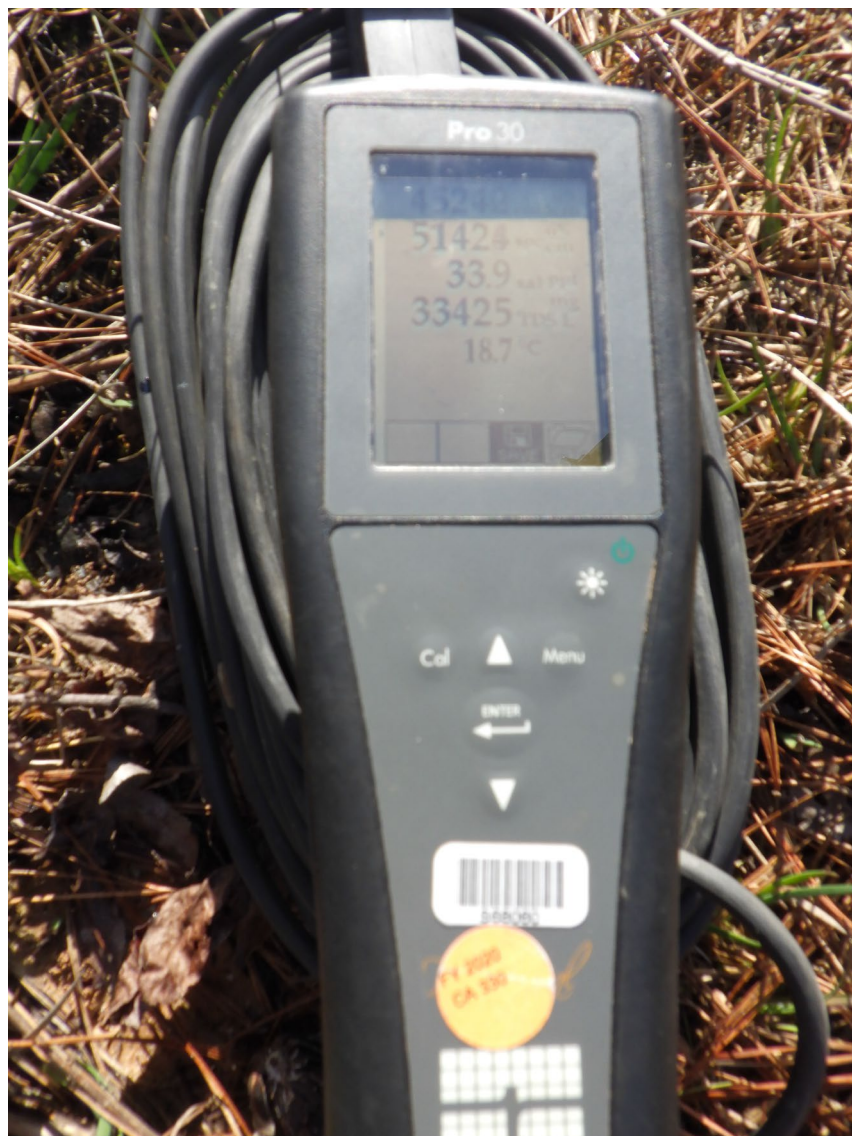
Photo No. 8

I observed a Total Dissolved Solids (TDS) reading of 33,425 mg/L outside of secondary containment in a low spot behind (NE) the facility, see photo No. 8 and photo No. 9.

**Description:** This photo was taken showing a Total Dissolved Solids (TDS) reading of 33,425 mg/L outside of secondary containment in a low spot behind (NE) the facility.

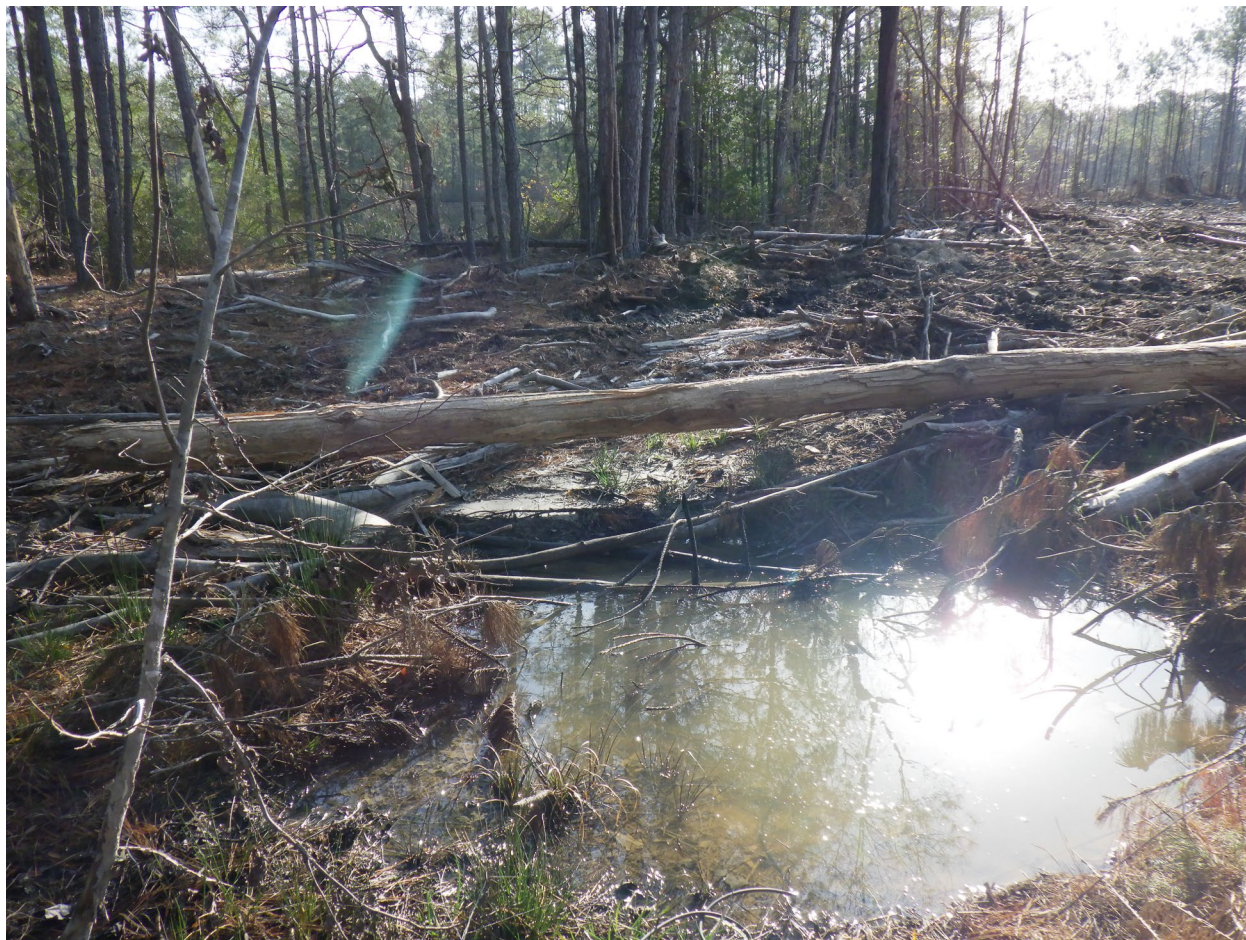
Photo No. 9

**Description:** This photo was taken at the same location as photo No. 8 showing the low spot behind (NE) of the facility where the TDS reading was taken.

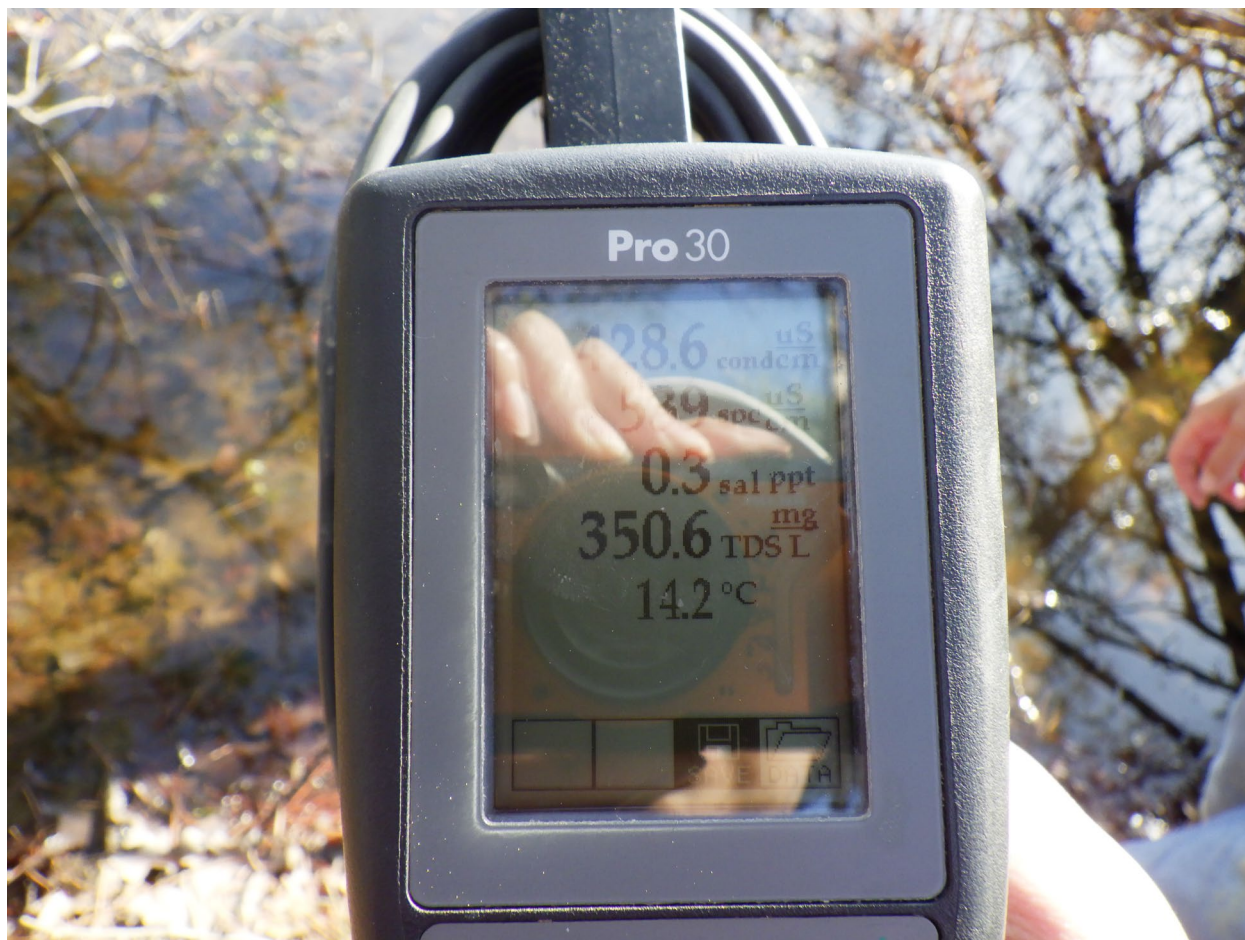
Photo No. 10

I observed a TDS reading of 350.6 mg/L in the tributary behind (NE) the facility, see photo No. 10 and photo No. 11.

**Description:** This photo was taken showing a TDS reading of 350.6 mg/L in the tributary behind (NE) the facility.

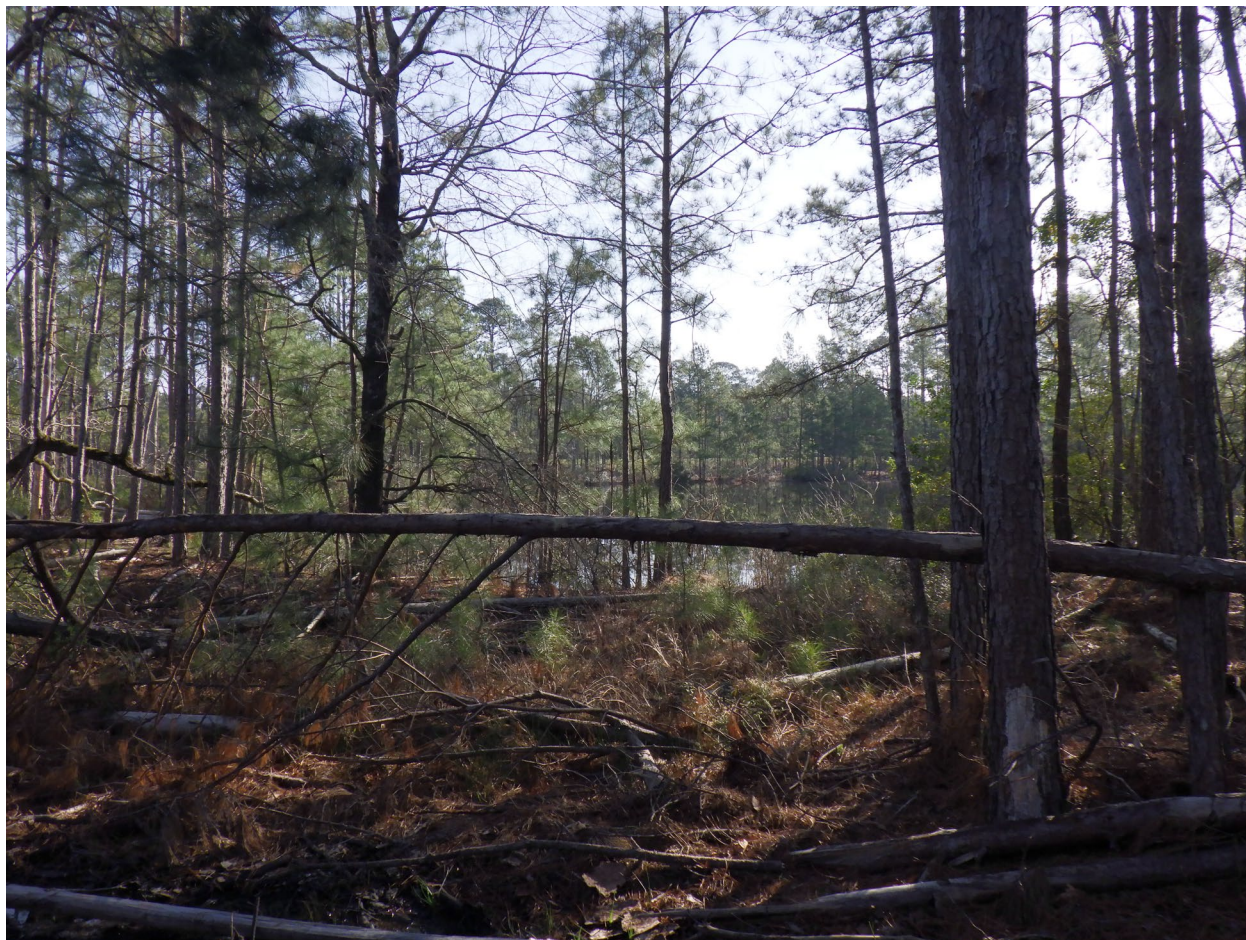
Photo No. 11

**Description:** This photo was taken at the same location as photo No. 10 showing the tributary (NE) of the facility where the TDS reading was taken.
