**Region 10 Enforcement and Compliance Assurance Division**  
**1200 6th Avenue**  
**Seattle, WA 98101**  
**INSPECTION REPORT**

| <b>Inspection Date:</b> | 02/24/2021 | |
| <b>Regulatory Program:</b> | CWA NPDES/Construction Stormwater | |
| <b>Site Name:</b> | Dallas Harris South Subdivision No. 1 | |

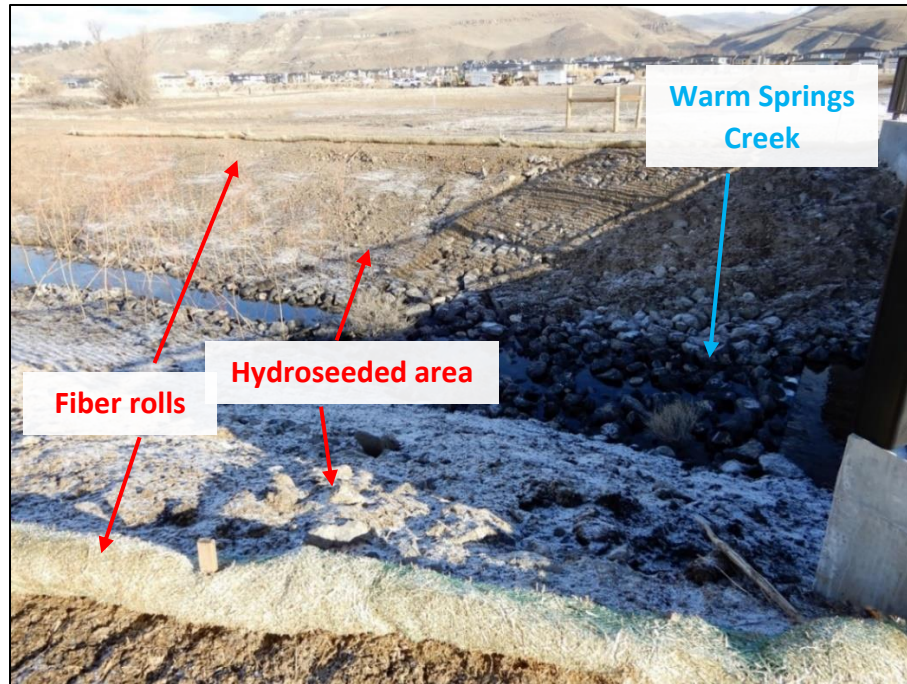
We observed that the fiber roll BMPs along the southern perimeter were not properly installed or maintained in accordance with good engineering practices. On the Site's southern perimeter, to the west and east of East Millbrook Way, we observed fiber rolls installed upgradient of the hydro seeded area along Warm Springs Creek to provide protection to the creek while vegetation was established. Fiber rolls were not located downgradient, allowing sediment and pollutants to potentially enter Warm Springs Creek (refer to [Attachment A, Photographs 1 through 4](#)).

**Photograph 1.** View, facing north, of Warm Springs Creek located on the southern perimeter of the Site west of East Millbrook Way. The fiber rolls are installed upgradient of the hydro seeded area next to the creek.

After the inspection on March 3, 2021, Mr. Terrell sent the Inspection Team three pictures of the corrected BMPs (refer to [Attachment B, Exhibits 3 through 5](#)).

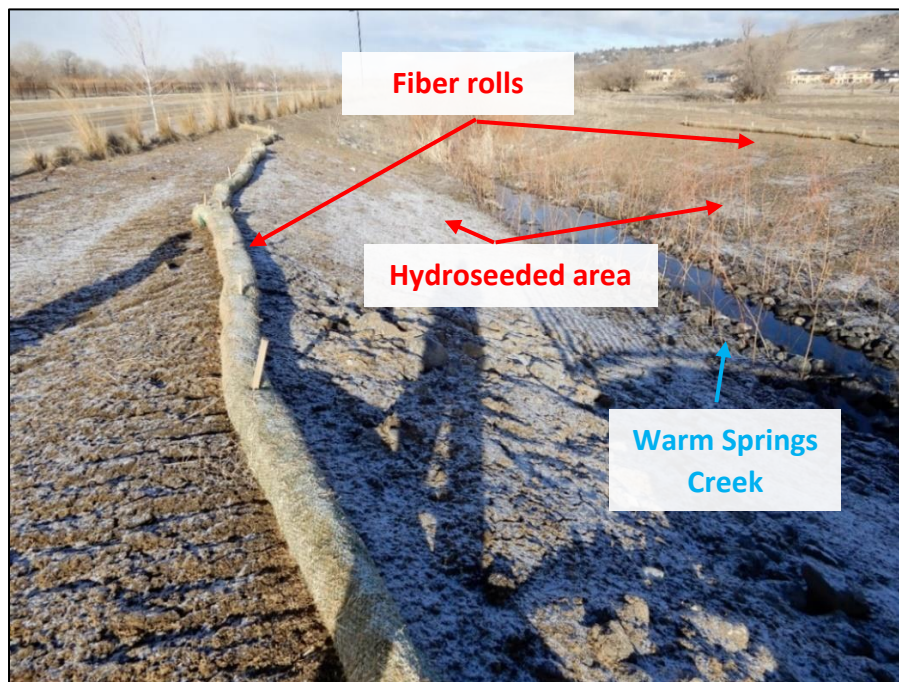
**Photograph 2.** View, facing west, of Warm Springs Creek located adjacent to the southern perimeter of the Site west of East Millbrook Way. The fiber rolls are installed upgradient of the hydro seeded area next to the creek.

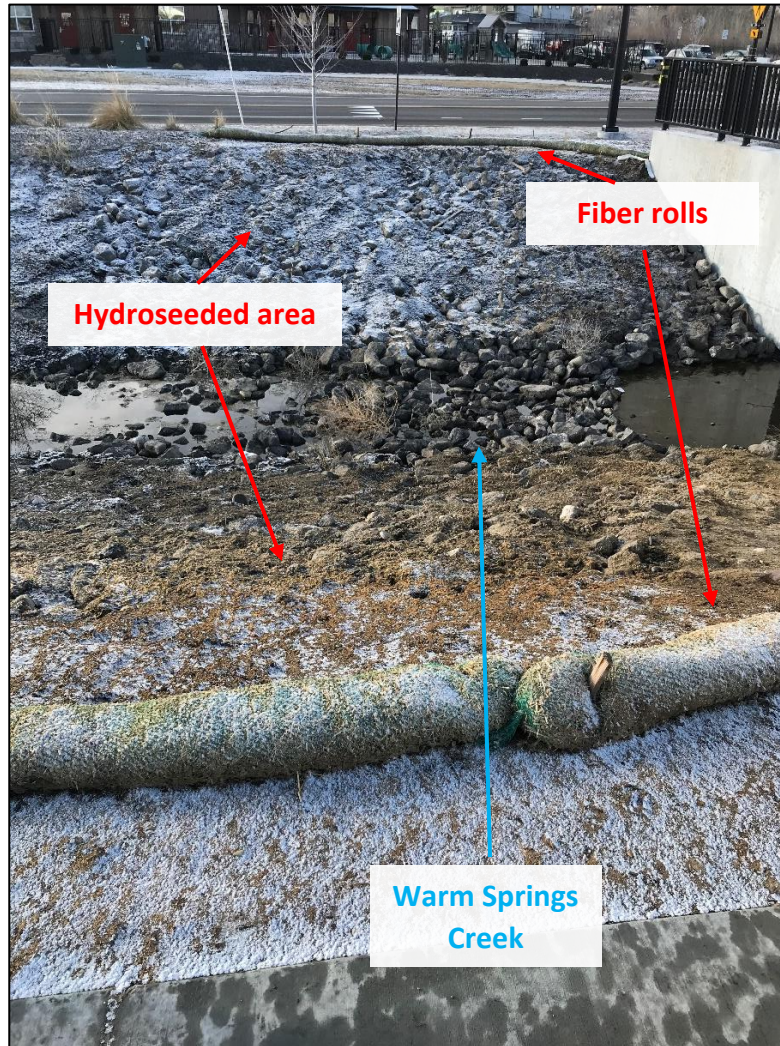
**Photograph 3.** View, facing south, of Warm Springs Creek located adjacent to the southern perimeter of the Site to the east of East Millbrook Way. The fiber rolls are installed upgradient of the hydro seeded area next to the creek.

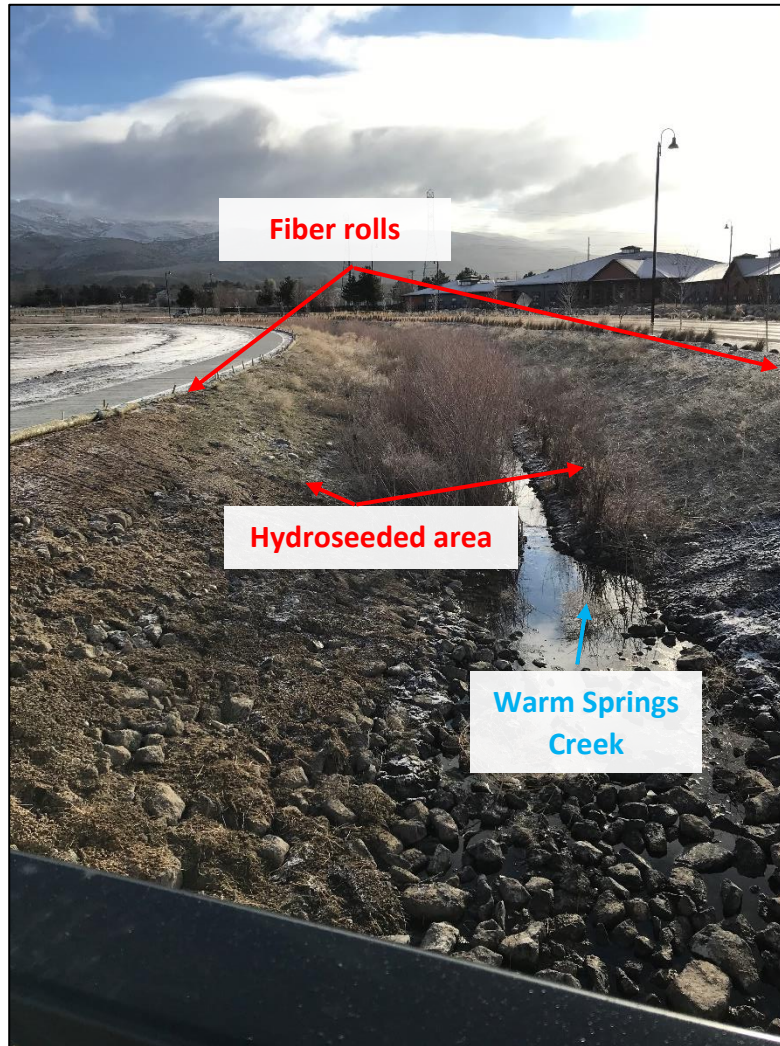
**Photograph 4.** View, facing east, of Warm Springs Creek located adjacent to the southern perimeter of the Site to the east of East Millbrook Way. The fiber rolls are installed upgradient of the hydro seeded area next to the creek.

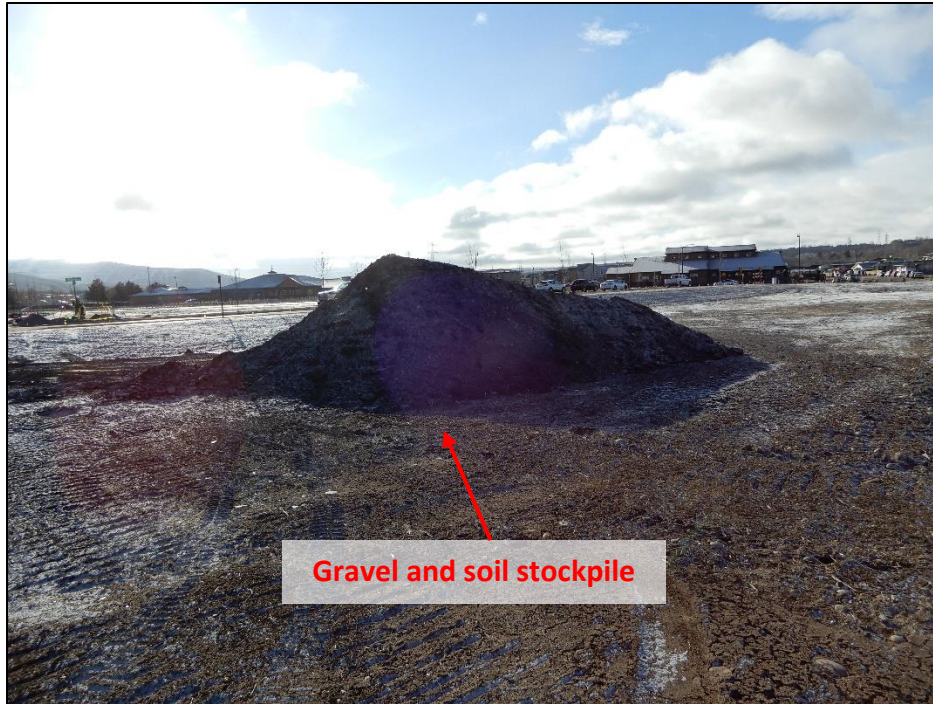
We observed one unstabilized soil and gravel stockpile along the north-central portion of the Site (refer to Attachment A, Photograph 5). We observed fiber rolls installed downgradient of the stockpile along Warm Springs Creek that provided perimeter protection (refer to Attachment A, Photographs 1 through 4).

**Photograph 5.** View, facing east, of an unstabilized gravel and soil stockpile. It was noted that fiber rolls were installed downgradient of the stockpile along Warm Springs Creek that provided perimeter protection.

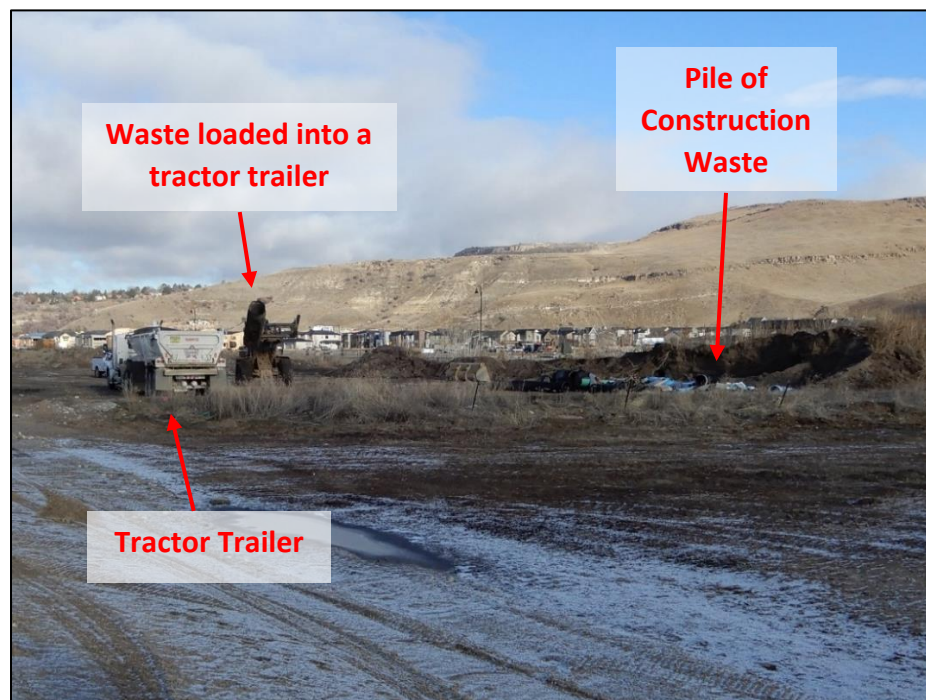
We observed an uncontained pile of construction waste and debris along the north-central perimeter of the Site that was piled on the ground. At the time of the inspection, a crew was loading the waste into a tractor trailer for disposal offsite (Refer to Attachment A, Photograph 6).

**Photograph 6.** View, facing northwest, of a pile of uncontained construction waste and debris. At the time of the inspection, the waste was actively being loaded into a tractor trailer.
