**Region 6 - Enforcement & Compliance Assurance Division**  
**INSPECTION REPORT**

| Inspection Date(s): | December 3, 2025 | |
| Regulatory Program(s) | RCRA Used Oil Transporters | |
| Company Name: | Elite Oil Service | |

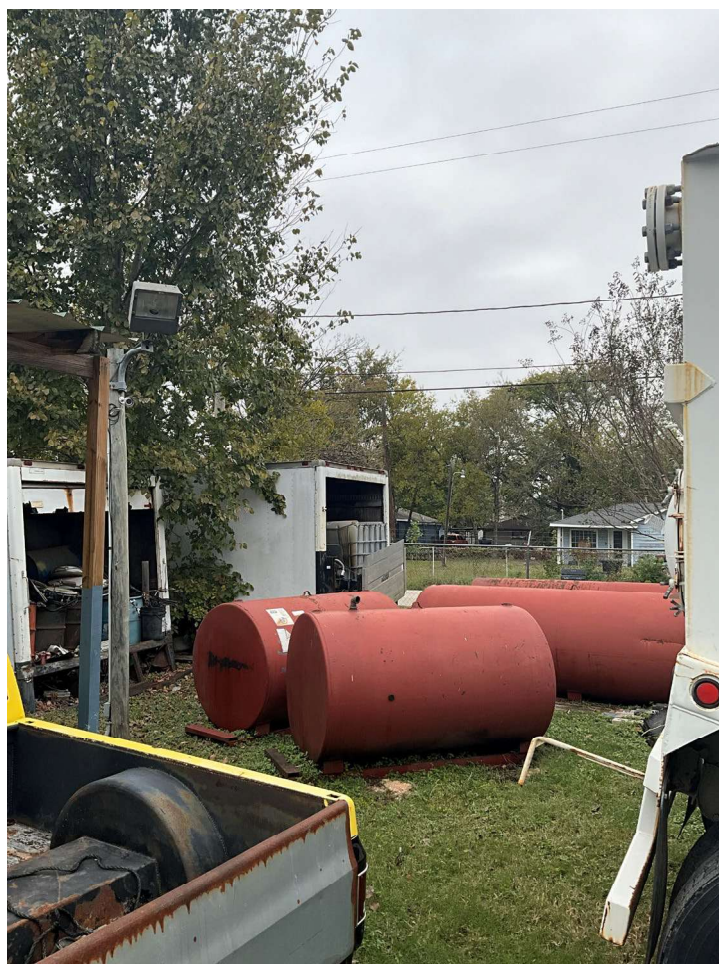
Photo No. 1

| Description: Two (2) red 500-gallon tanks and two (2) red 800-gallon tanks all empty and two (2) box trucks with scraps and aerosol cans in yard area to the right of office trailer. | |

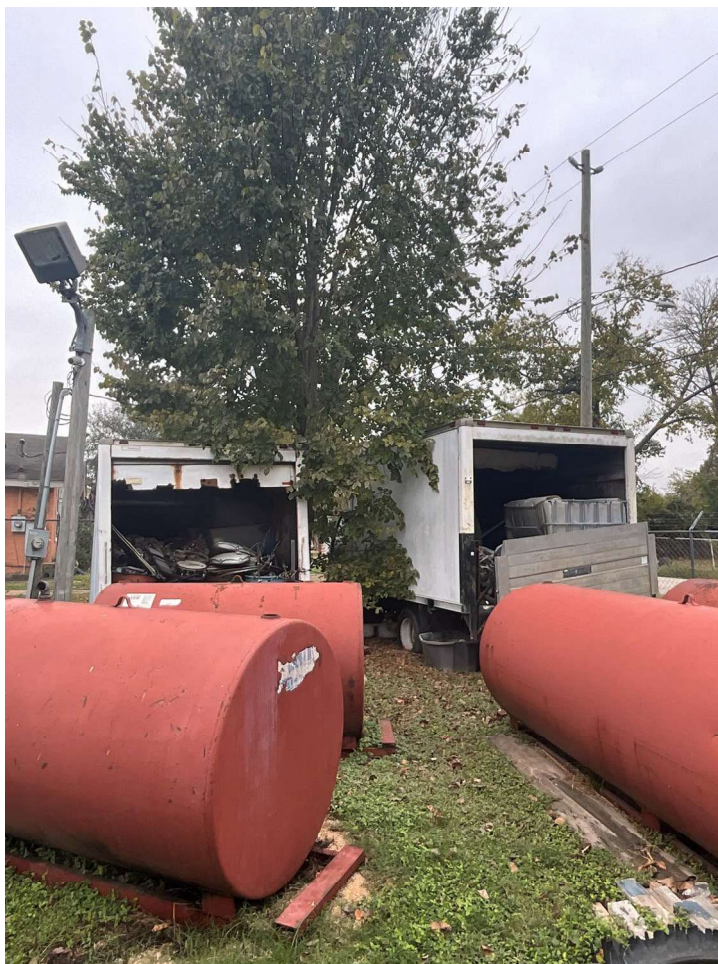
Photo No. 2

| Description: Two (2) red 500-gallon tanks and two (2) red 800-gallon tanks all empty and two (2) box trucks with scraps and aerosol cans in yard area to the right of office trailer. | |

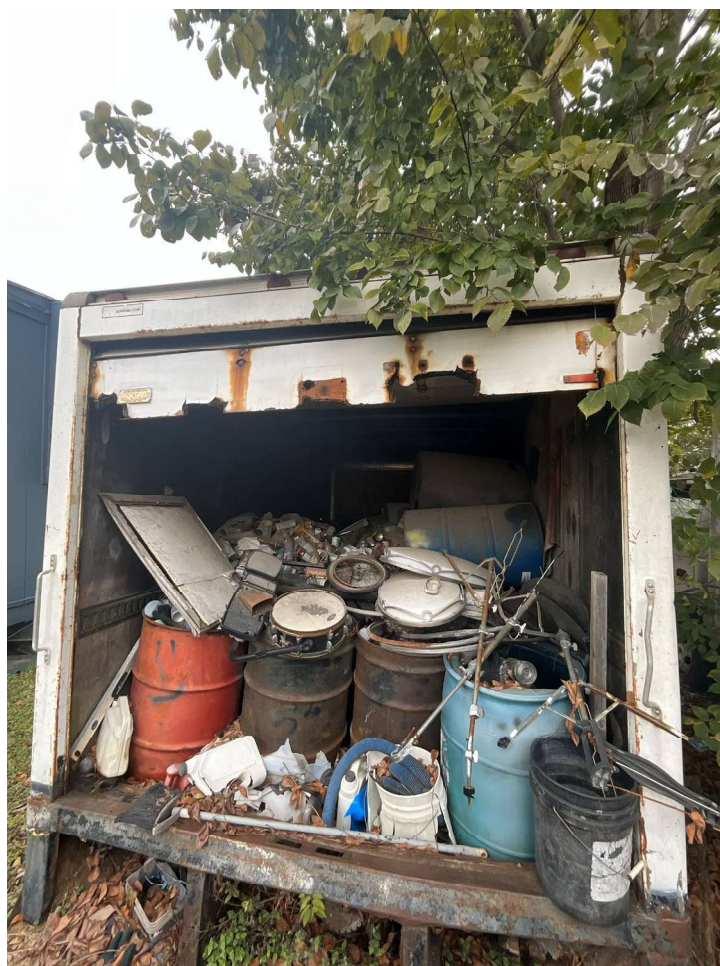
Photo No. 3

The EPA inspectors identified a box truck with a tote of waste aerosol cans overflowing. The container was not structurally sound and could not prevent leakage.

The EPA inspectors identified a tote of waste aerosol cans overflowing and not labeled.

The EPA inspectors identified a tote of waste aerosol cans inside a box truck overflowing and Mr. Reyes stated the tote was already on-site when he began his lease in 2020.

| Description: Box truck with drums in poor condition overflowing with aerosol cans. Mr. Reyes stated this truck belongs to previous owner. | |

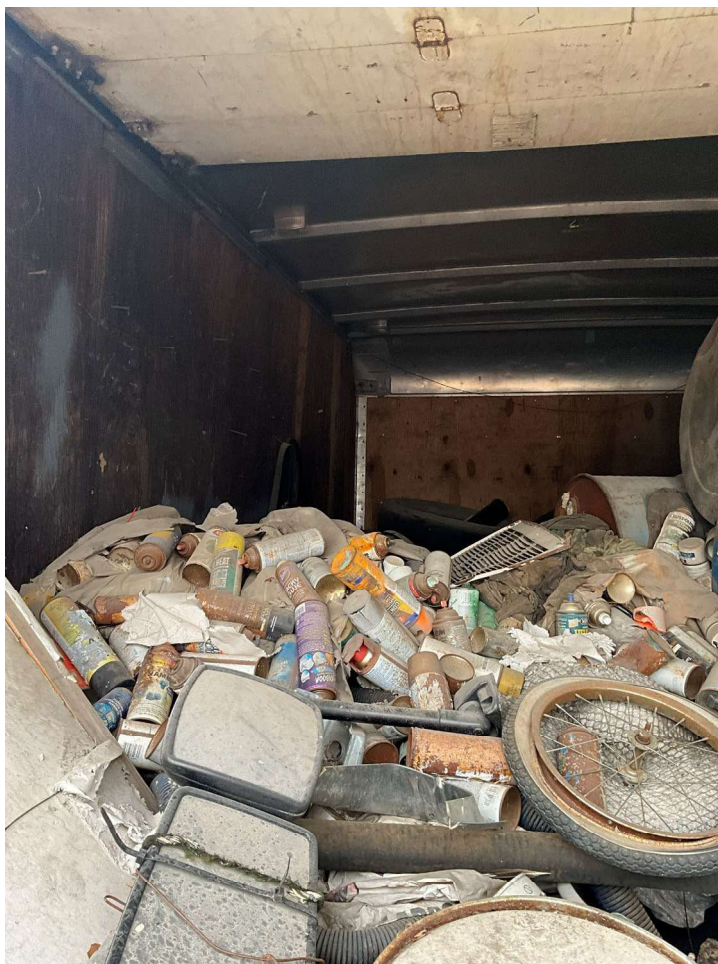
Photo No. 4

| Description: Close-up of box truck containing aerosol cans open, unlabeled, and in poor condition. | |

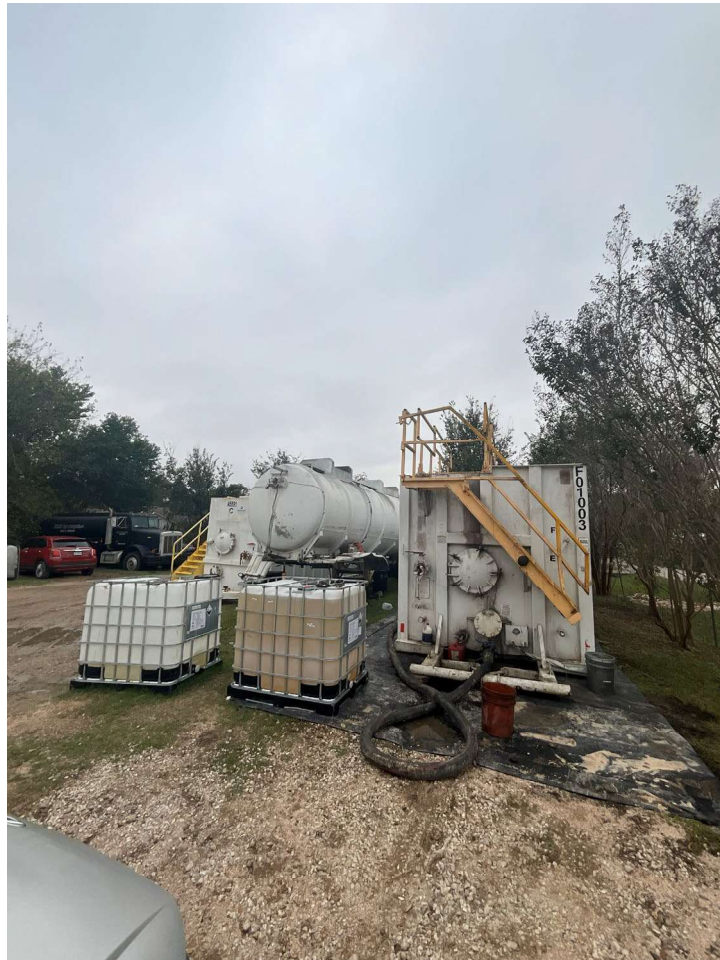
Photo No. 6

In the middle of the property, there were three frac tanks and two 275-gallon totes (See Photo #6). Mr. Reyes stated that one tote was empty and the other had motor oil. Of the three frac tanks, Mr. Reyes said that two were empty and the one labeled 'F01003' had about 1,500 gallons of used oil stored in it, however the frac tanks were not labeled **[AOC #3]**. There was a tarp placed under the frac tank in-use as secondary containment, but it was in poor condition. This tarp did not appear to meet the requirements for berms, dike or wall. **[AOC #5 – 40 CFR §279.45(f)]**. Around the frac tank, there were five 10-gallon buckets. One of the buckets had used oil with no label and the other buckets were closed and empty (See Photo #7-9). Mr. Reyes stated these were used to hold the tarp to form a wall for the secondary containment. During a follow-up meeting on December 11, 2025, to go over photos taken during the inspection, Mr. Reyes told the EPA inspectors that the contents in the F01003 frac tank had been removed a couple days after the inspection but could not remember the exact date since he does not keep documentation when he receives and sends off the used oil. We also identified one 10-gallon bucket along the fence line facing the street with used oil and an oily rag not labeled (See Photo #10-11) **[AOC #3]**. Mr. Reyes stated that he was unsure why this bucket was there.

The EPA inspectors identified a tarp being used as a secondary containment system for the frac tank in use storing used oil. However, this tarp was in poor condition, did not include an observable dike, berm, or retaining wall, and was not sufficiently impervious to prevent any used oil from being released to surrounding soil.

| Description: Three (3) frank tanks, two empty tanks and one tank labeled 'F01003' storing 1500 gallons of used oil with secondary containment tarp in poor condition. Two (2) 275-gallon totes, one empty tote and Mr. Reyes claimed full of motor oil. | |

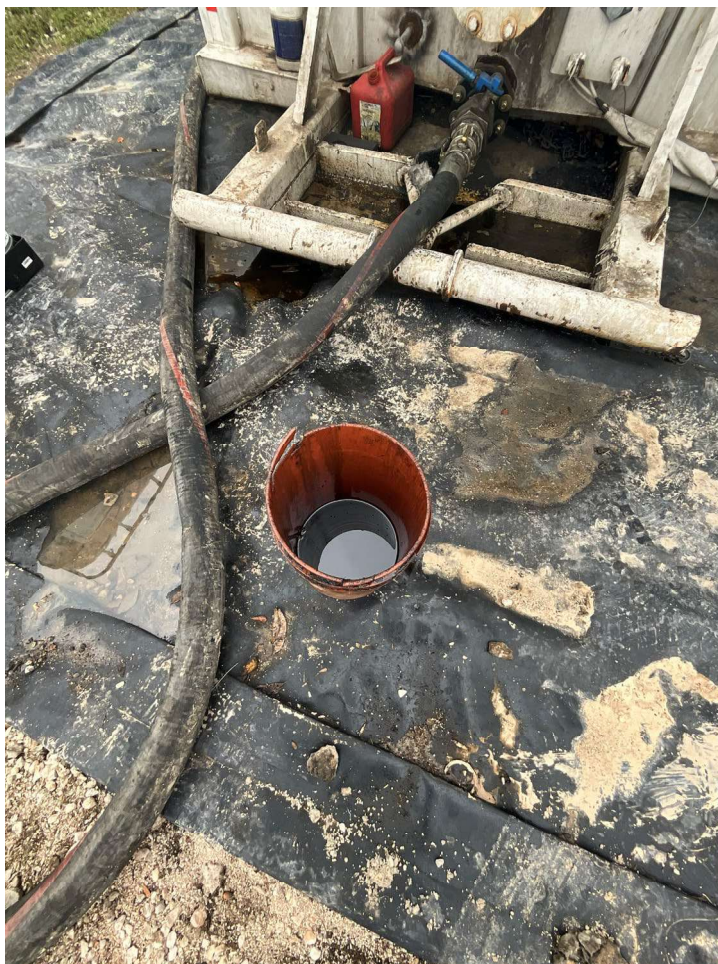
Photo No. 7

| Description: Open 10-gallon bucket with no label with used oil in front of 'F01003' frac tank. | |

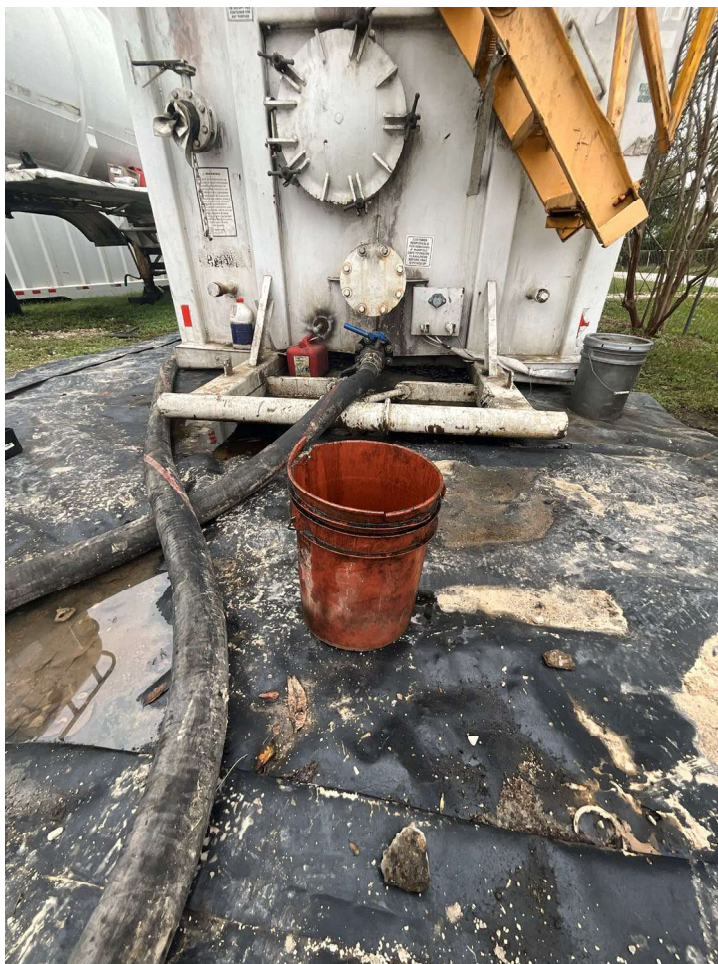
Photo No. 8

| Description: Open 10-gallon bucket with no label with used oil in front of 'F01003' frac tank. | |

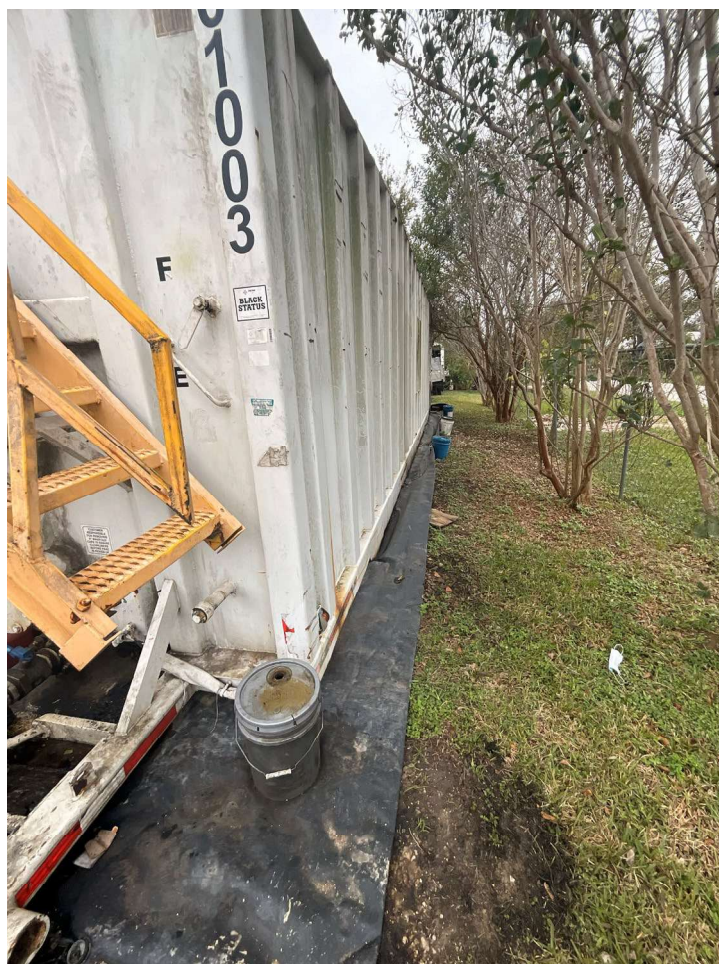
Photo No. 9

| Description: Four (4) closed and empty 10-gallon buckets. Mr. Reyes said these buckets are used to form a wall and hold up secondary containment tarp. This tarp did not appear to meet the requirements for berms, dike or wall. | |

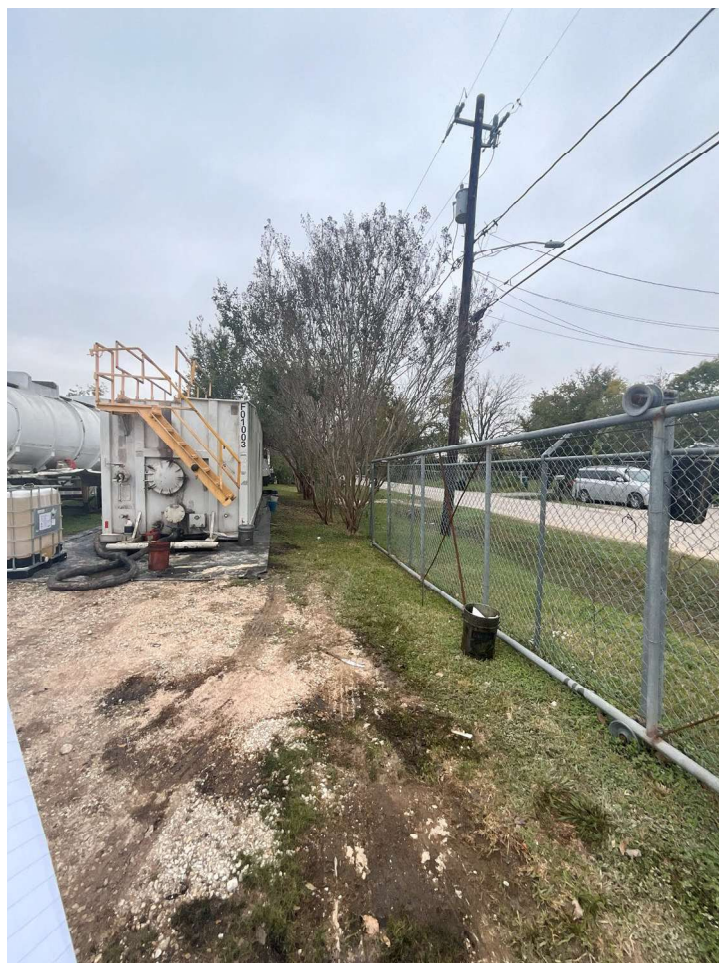
Photo No. 10

| Description: One (1) 10-gallon bucket along fence line facing the street with used oil and oily rag not labeled. | |

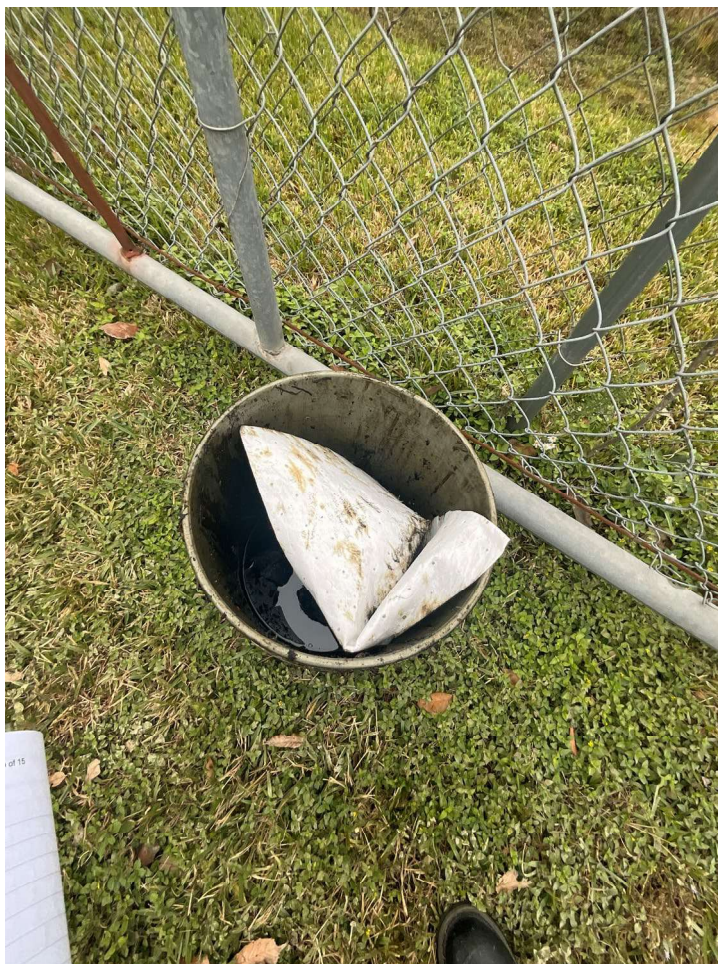
Photo No. 11

| Description: One (1) 10-gallon bucket along fence line facing the street with used oil and oily rag not labeled. | |

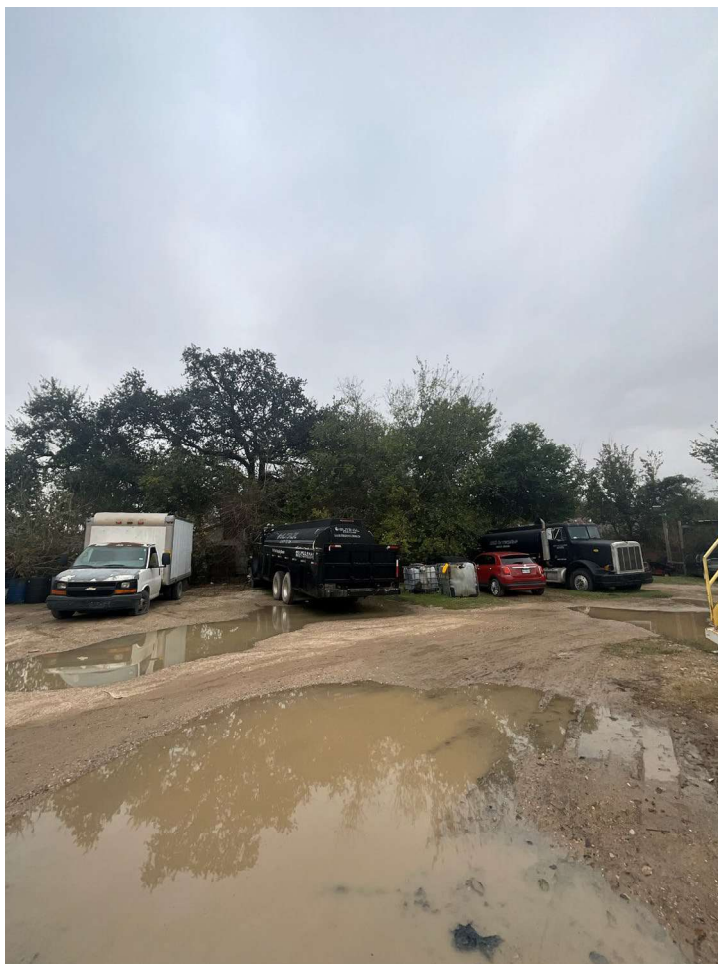
Photo No. 12

Along the south side of the property, we identified two black tanker trucks with one 3,000-gallon truck with the company's label and the other labeled "JRO Enterprise" (See Photo #12). Mr. Reyes stated that he only uses the truck with their company label to collect used oil from customers and the last time it was used was about 4-5 months ago. The other black tanker truck is empty and has never been used. In between these trucks, there are two totes in poor condition (See Photo #13-14). One tote was full of used oil filters spilling out of the container and was not labeled **[AOC #3, AOC #6 – 40 CFR §279.45(c)]**. Mr. Reyes stated he did not know where these totes came from and that they had been on-site for about 8 months.

| Description: Overview of two (2) black tanker trucks, one (1) box truck, and two (2) totes along back fence line. One tanker truck with company logo is in use while the other without company logo is empty and has never been used. | |

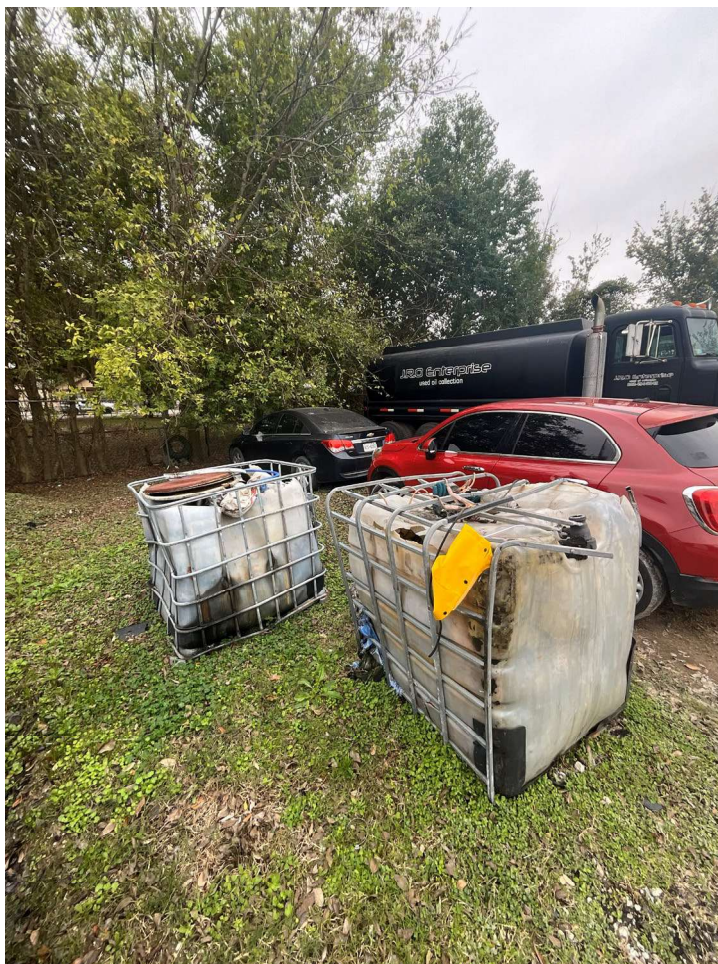
Photo No. 13

| Description: Front side of two (2) totes in poor condition with no labels. | |

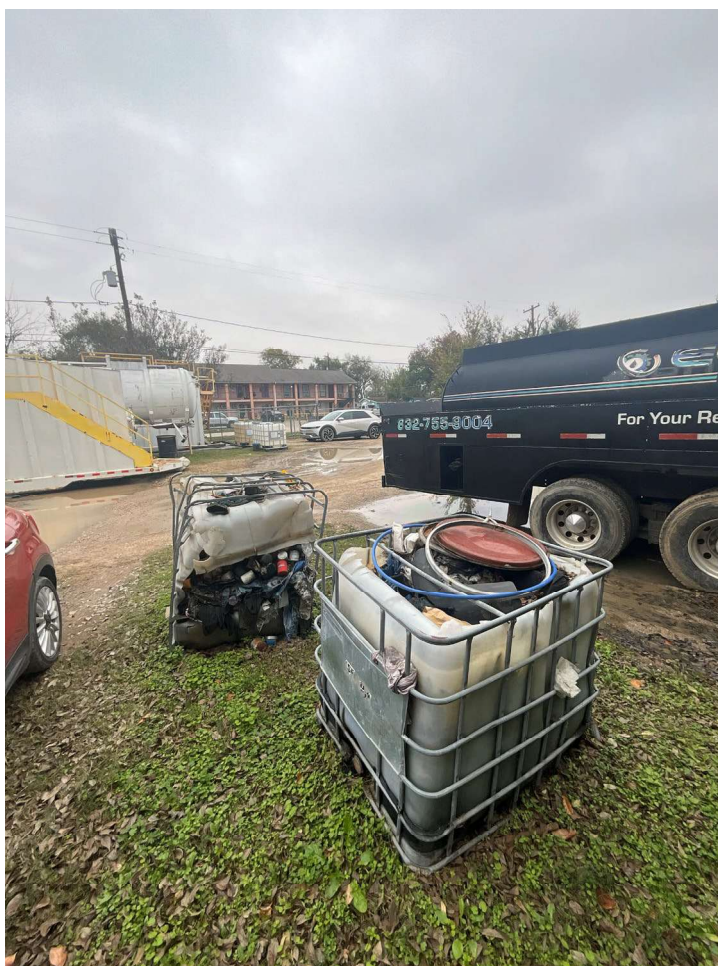
The EPA inspectors identified an unlabeled tote of used oil filters in poor condition with the contents spilling onto the ground.

| Description: Back side of two (2) totes in poor condition with no labels. One tote full of used oil filters spilling out of container. | |

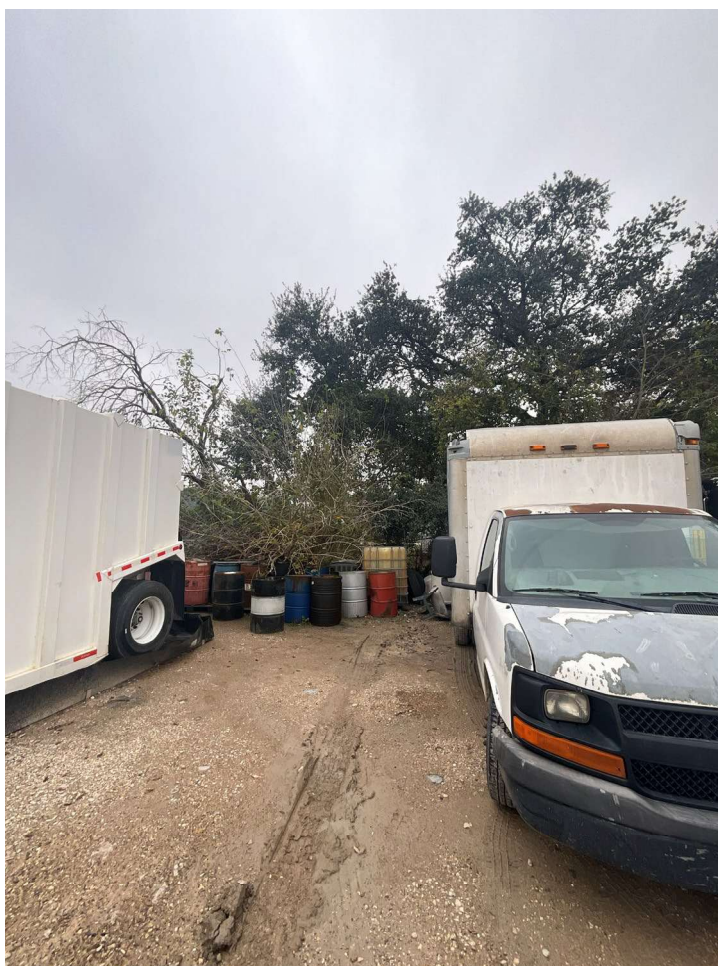
| Description: Overview of many 55-gallon drums along back fence line. Mr. Reyes claimed they were all empty. However, inspectors found some to be full but could not verify contents because drums were sealed. Mr. Reyes stated if they were full, it was due to rainwater. | |

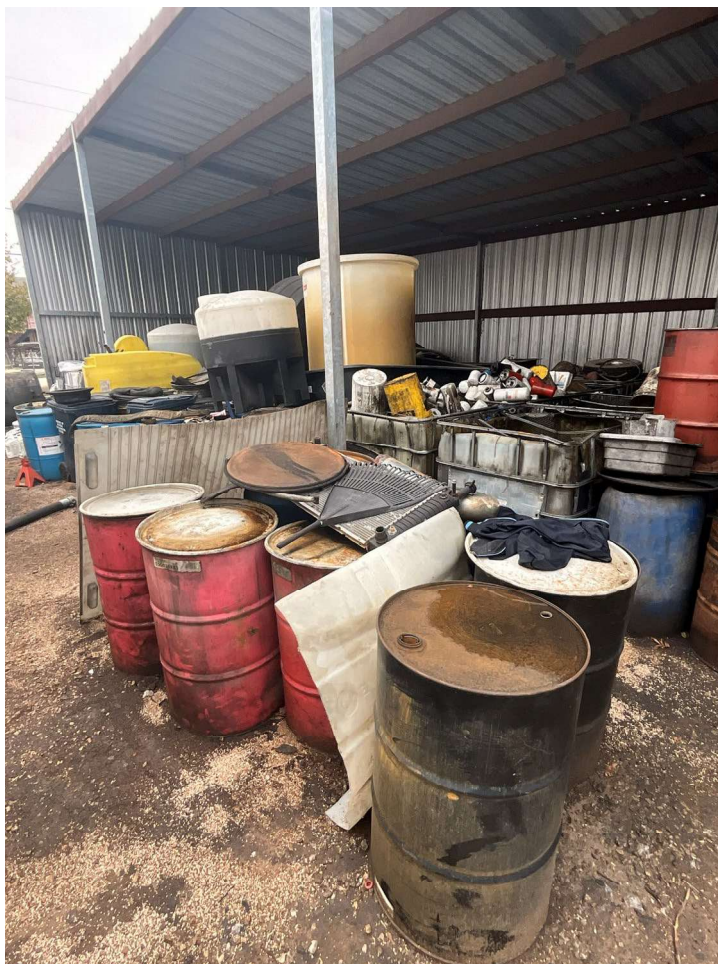
| Description: Overview of shed storage area showing containers in poor condition, staining on ground, unlabeled containers, and poor aisle spacing. | |

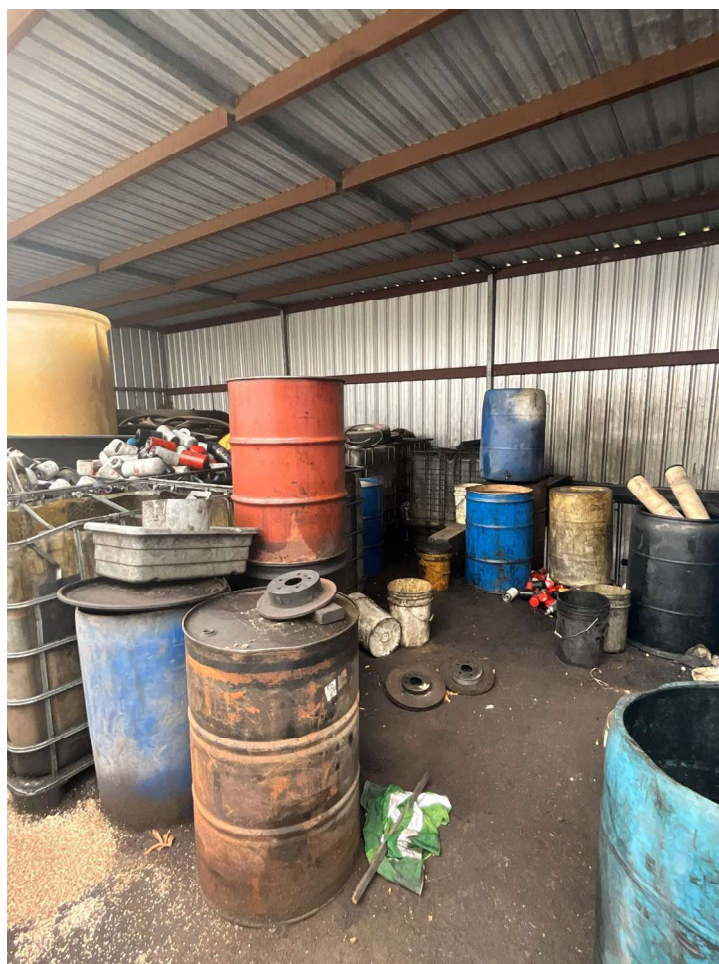
| Description: Overview of shed storage area showing containers in poor condition, staining on ground, unlabeled containers, and poor aisle spacing. | |

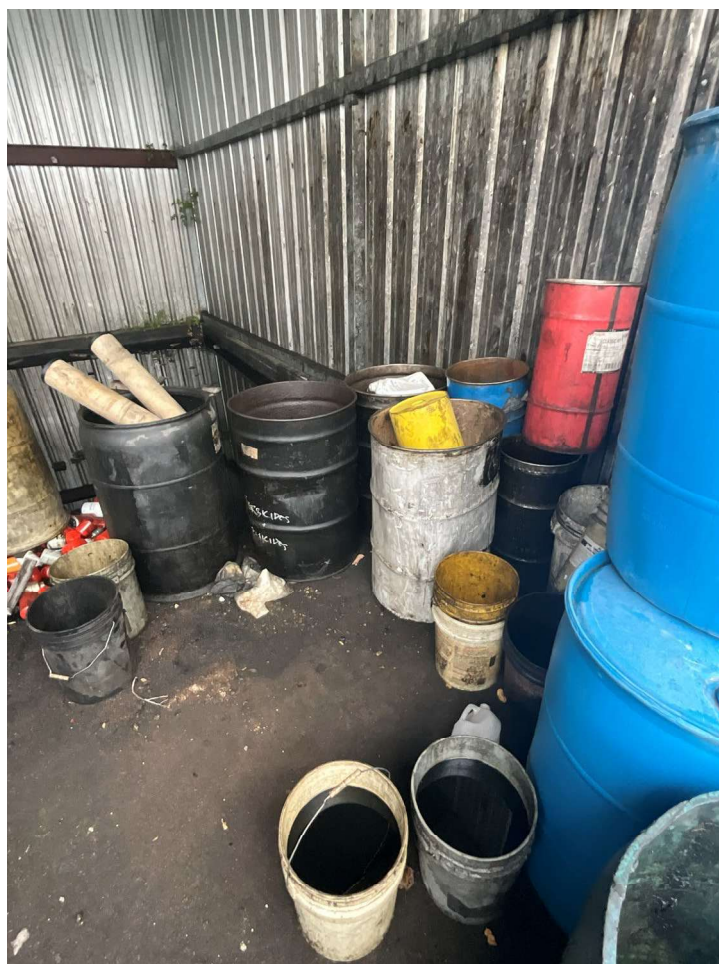
| Description: Overview of two (2) 10-gallon buckets of used oil unlabeled in shed storage area. Secondary containment in shed area flooded with rainwater at the backside. Used oil filters not contained, on the ground with staining. | |

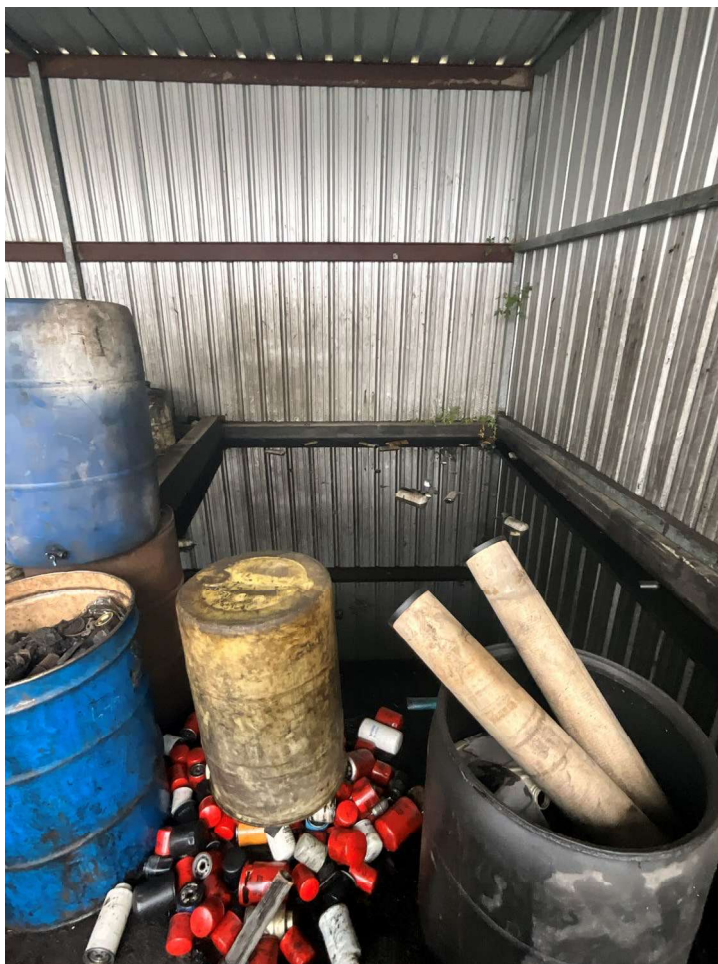
The EPA inspectors observed staining of used oil in the shed storage area, secondary containment system tarp, and surrounding soil.

| Description: Secondary containment in shed area flooded with rainwater at the backside in shed storage area. Used oil filters not contained, on the ground with staining. | |
