## Region 6 Compliance Assurance and Enforcement Division

### INSPECTION REPORT

| Company Name: | <b>Sheridan Production Co., LLC</b> | | |
| Facility Name: | <b>Fittstown</b> | | |

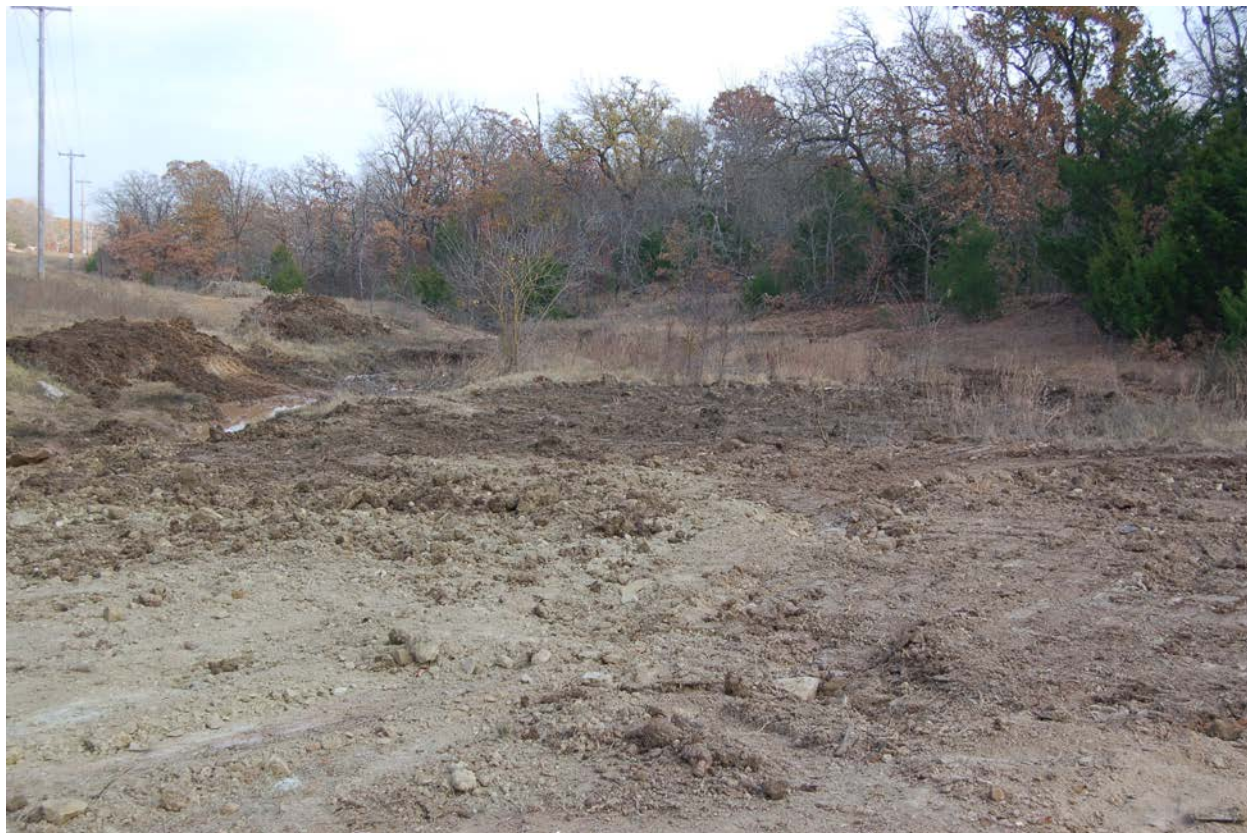
Photo No. 1

Description: This photo shows the location where the discharge originated from a flow line. A twelve-inch injection line split underground and released about 1,500 barrels of produced water, or brine, to a nearby tributary. That tributary flows into Mill Creek. At the time of the inspection, the flow line had been repaired and reburied.

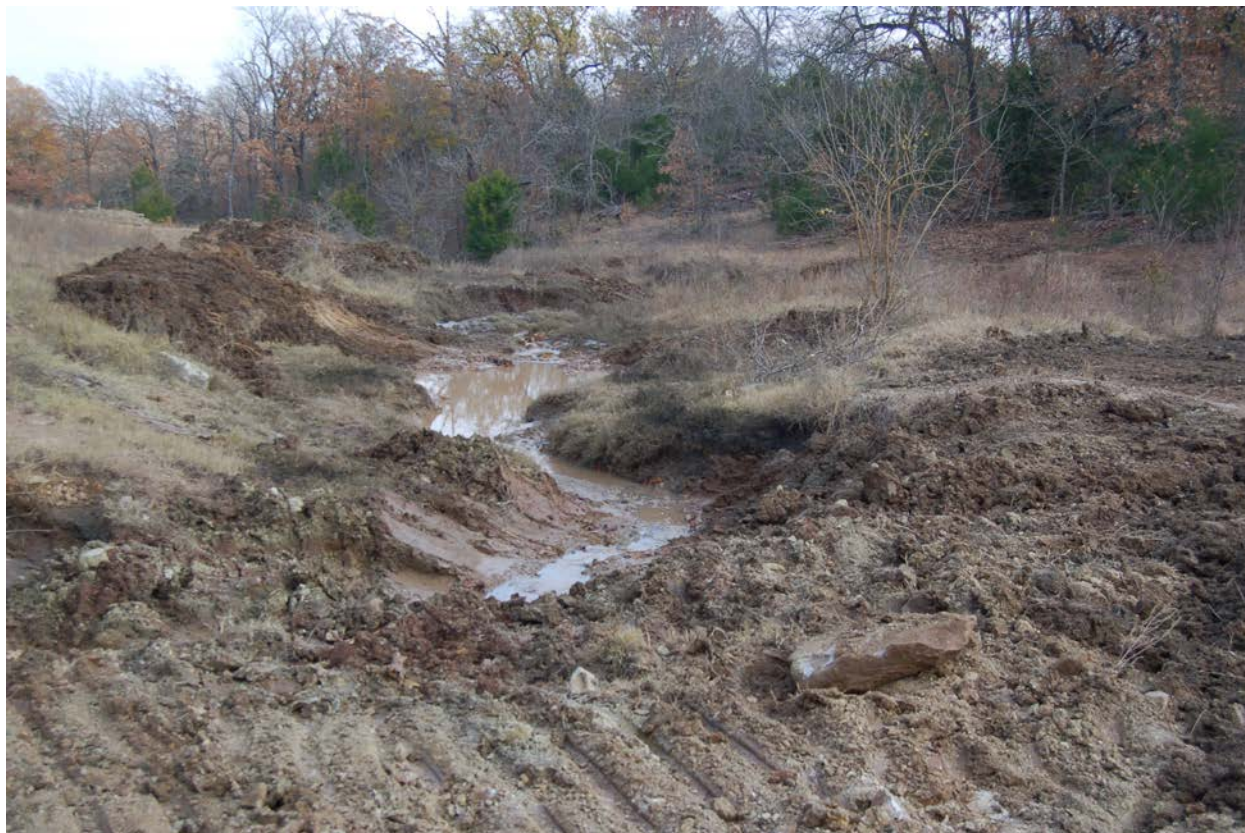
Photo No. 2

Description: The discharge entered this small tributary which flows to Mill Creek.

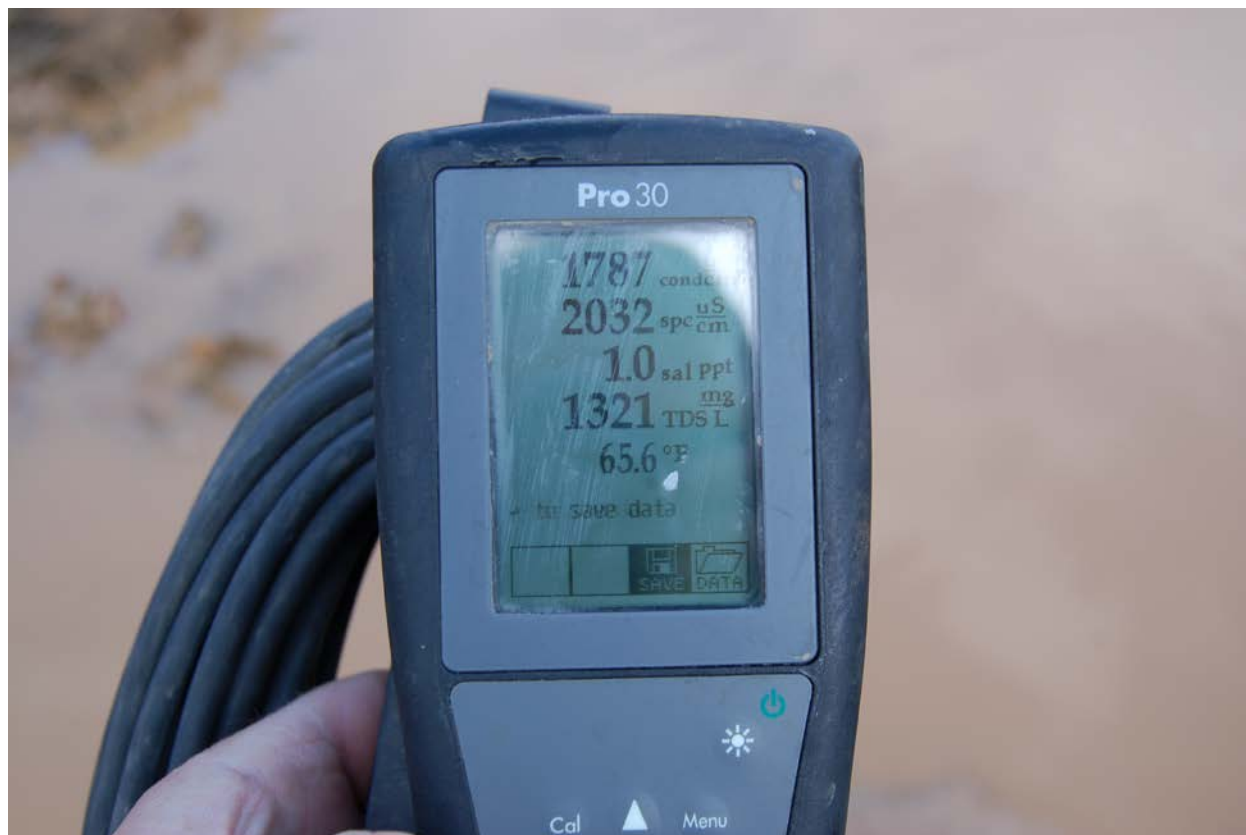
Photo No. 3

Description: With a calibrated YSI 30 Pro conductivity meter, a Total Dissolved Solids (TDS) reading was taken at the entry point to the tributary of Mill Creek and was 1,321 milligrams per liter (mg/l).

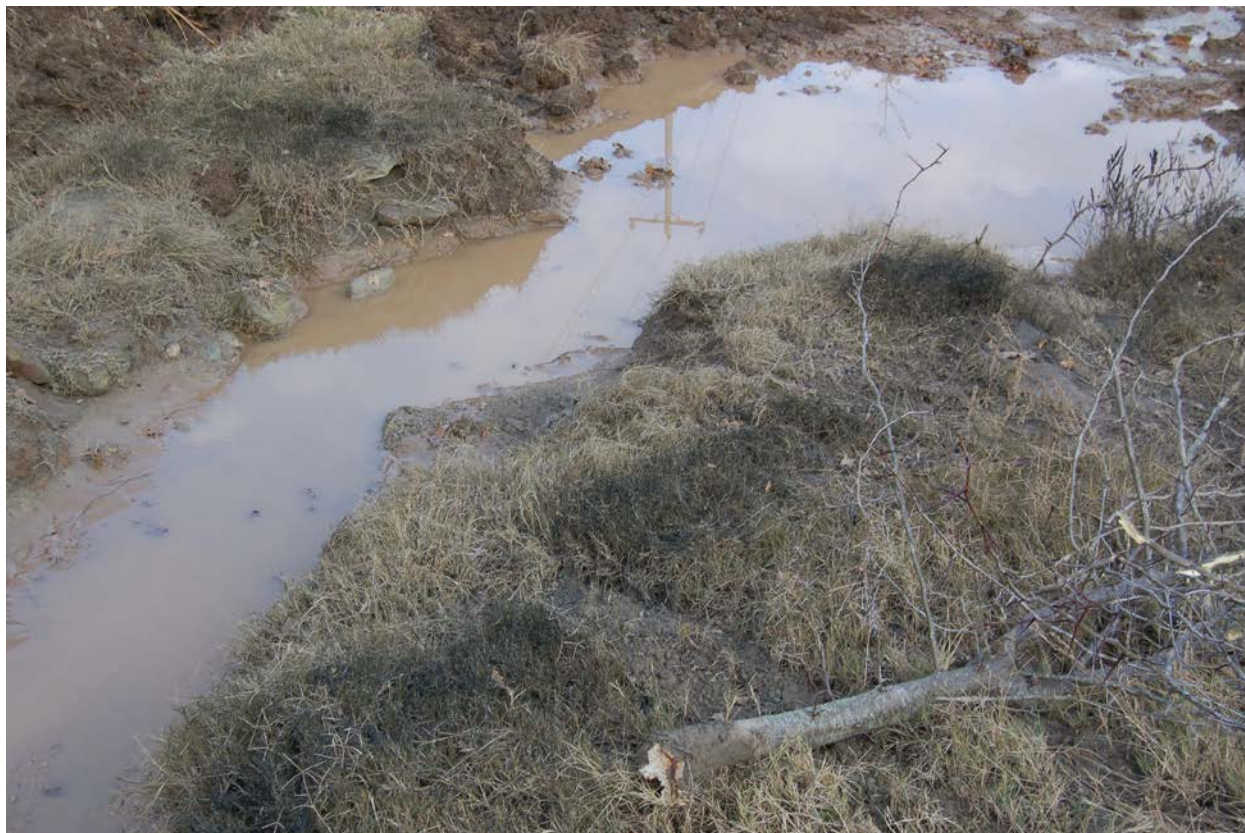
Photo No. 4

Description: This image shows the point of entry to the small tributary. I observed slight oil stain on the vegetation, and no sheen on the water was present at the time of the inspection. Also, the operator was flushing this section of the tributary from upstream to displace brine.

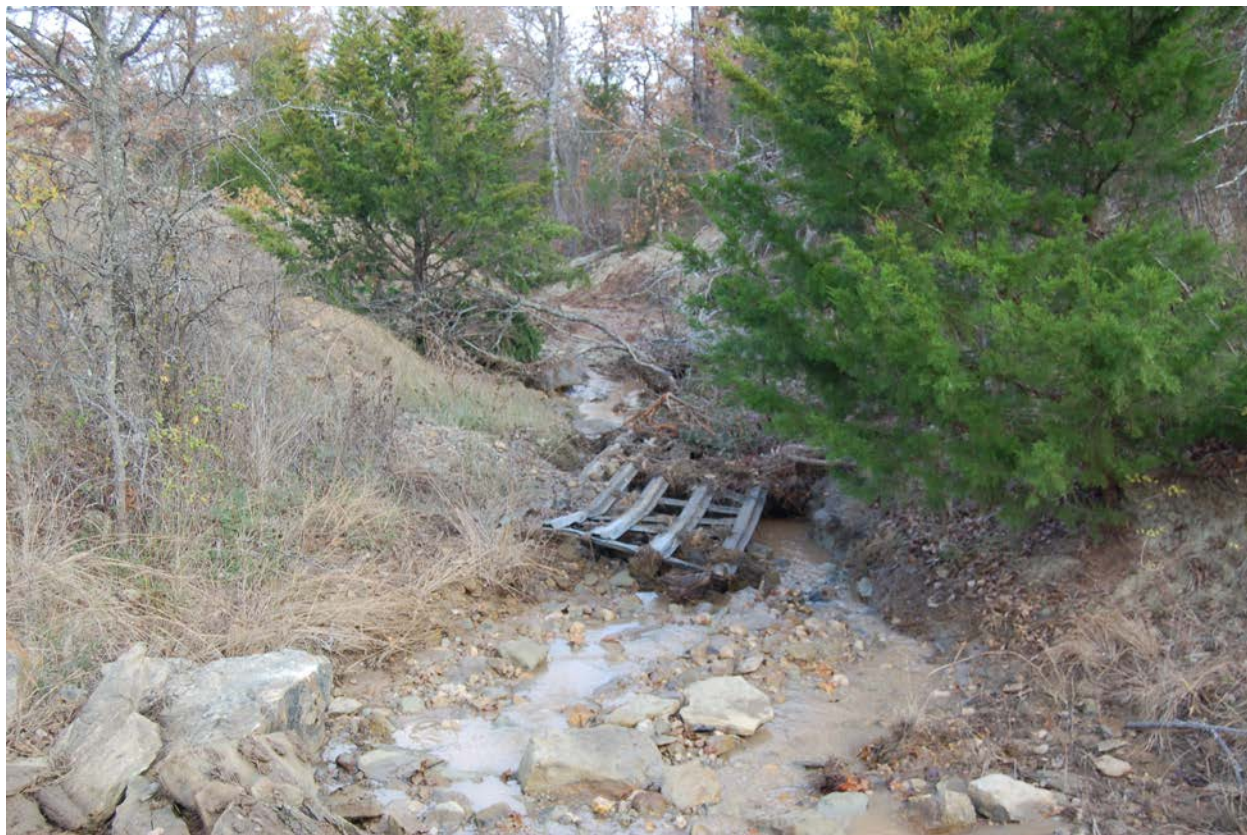
Photo No. 5

Description: The tributary is shown here about 40 yards downstream from the initial entry point. There was flow in the tributary from remedial activities, including flow from the flushing operations of the tributary.

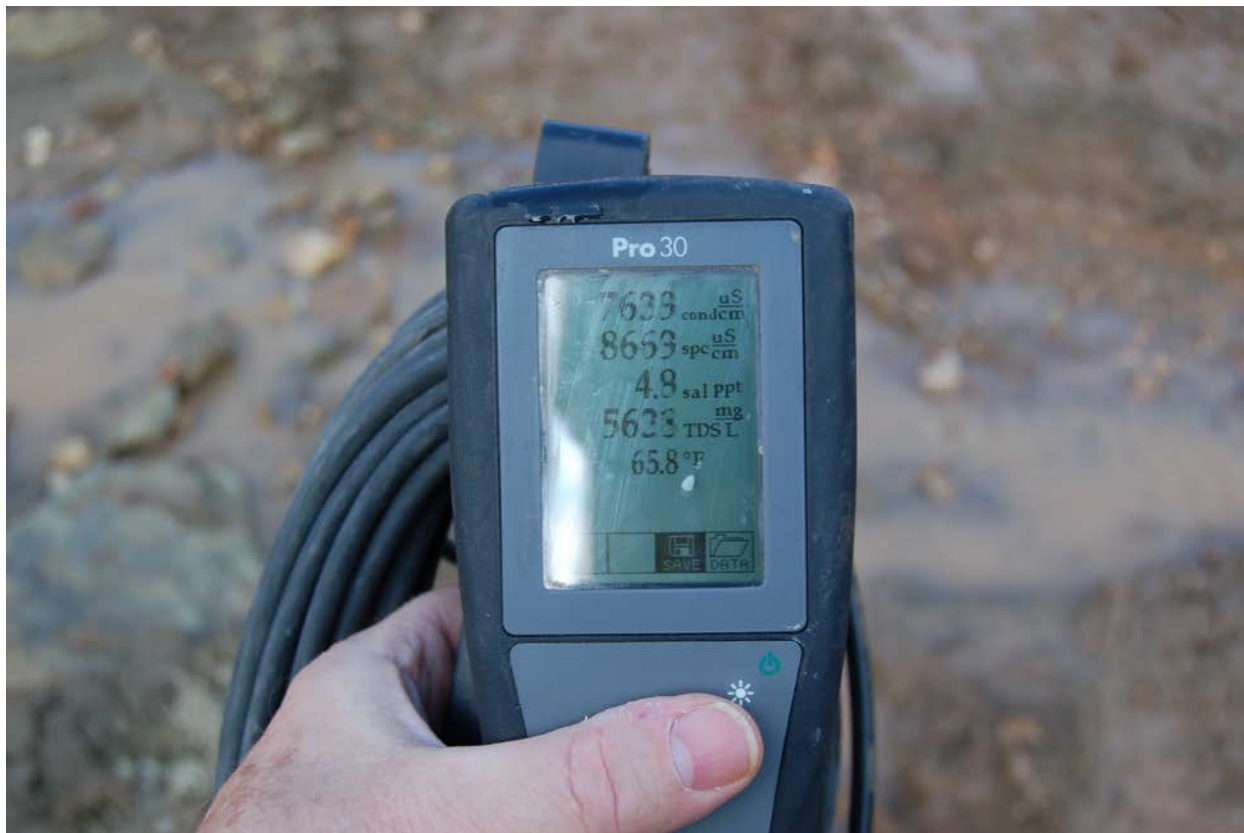
Photo No. 6

Description: The TDS reading at the location shown in Photo 5 was 5,628 mg/l.

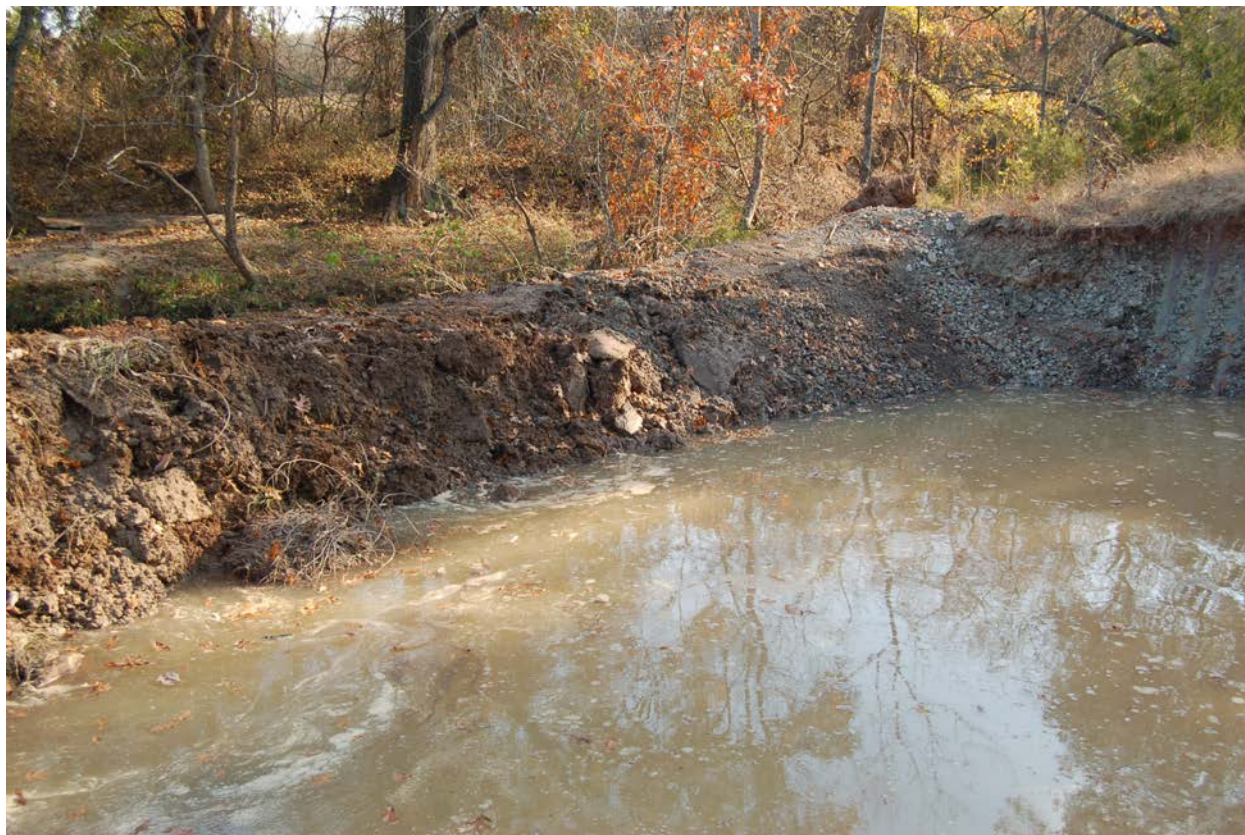
Photo No. 7

Description: This temporary dam was built at the point of entry from the tributary to Mill Creek. The water shown here was mostly flush water used to clean the tributary of the brine contamination. Mill Creek was directly behind this dam flowing east.

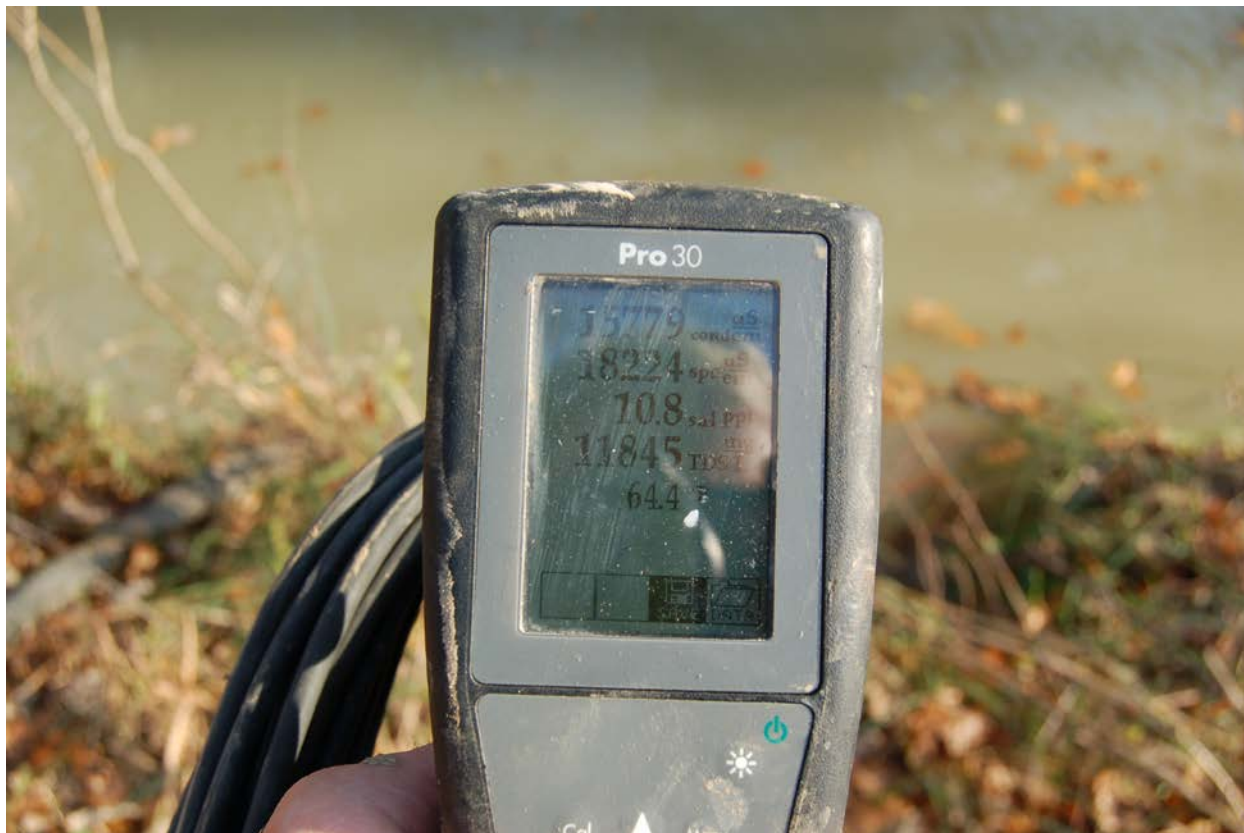
Photo No. 8

Description: This photo shows a TDS reading from the dammed portion of the tributary shown in Photo 7 was 11,845 mg/l.

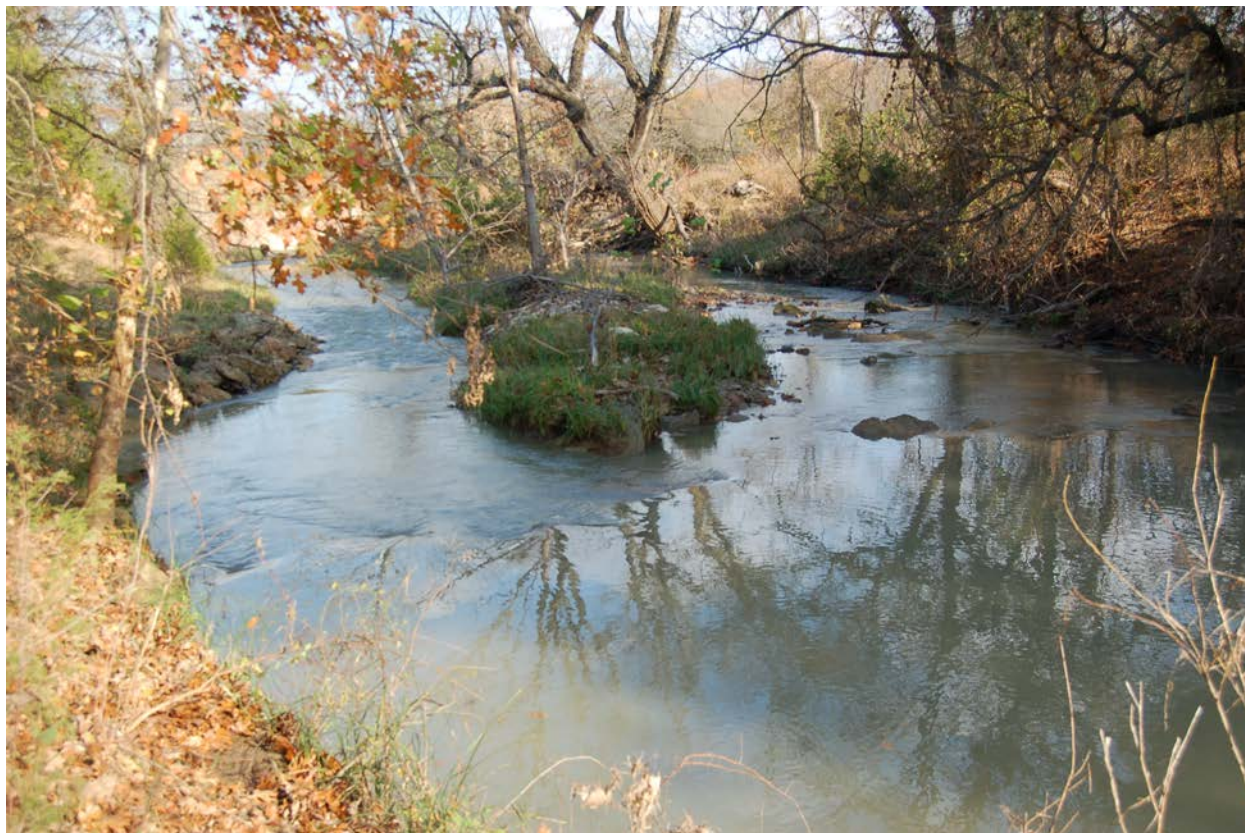
Photo No. 9

Description: This image shows Mill Creek, looking downstream and the flow was east. The entry point of the tributary into Mill Creek was here. I observed that the water was muddy due to construction and water removal activities upstream in the tributary.

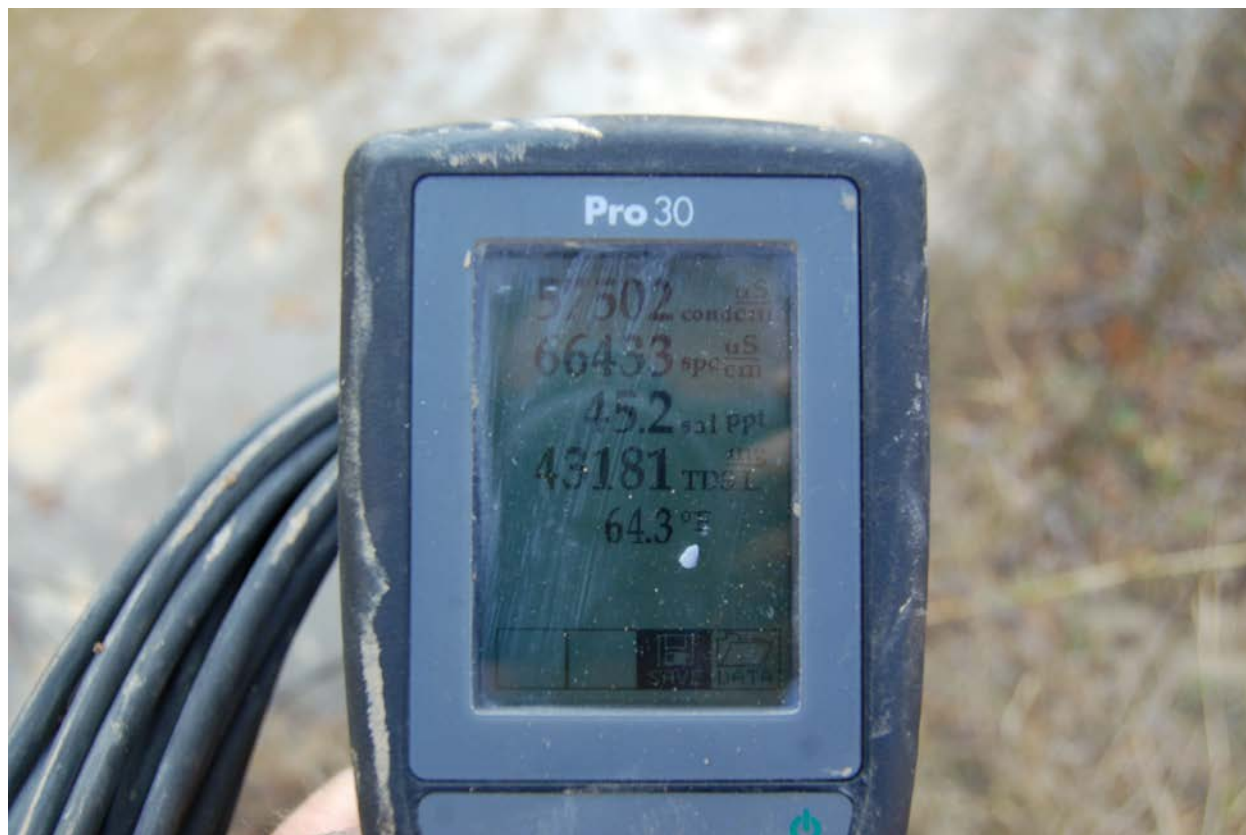
Photo No. 10

Description: At the confluence of the tributary and Mill Creek, a TDS reading of 43,181 mg/l was taken.

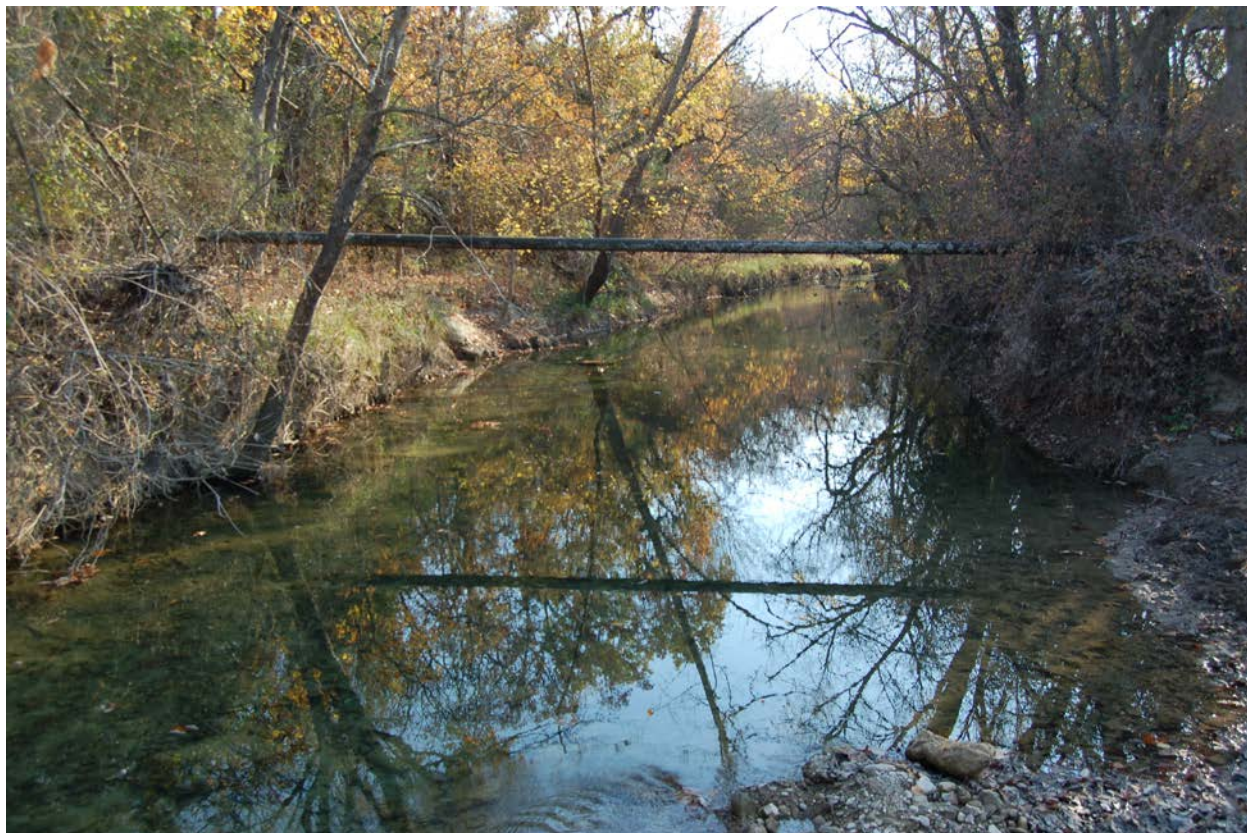
Photo No. 11

Description: This was a view upstream of the confluence of the tributary of Mill Creek and Mill Creek.

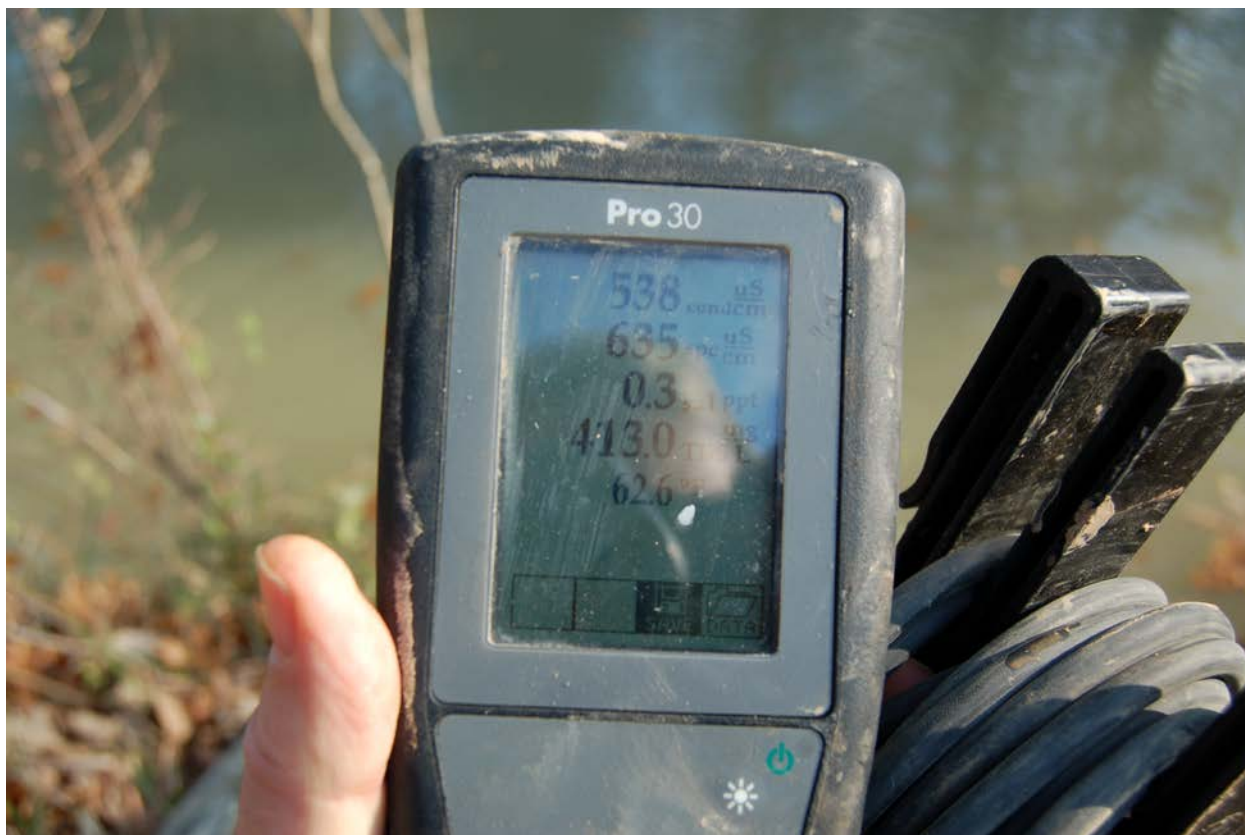
Photo No. 12

Description: A TDS reading of the unaffected water just upstream of the confluence of the tributary of Mill Creek and Mill Creek was 413 mg/l.

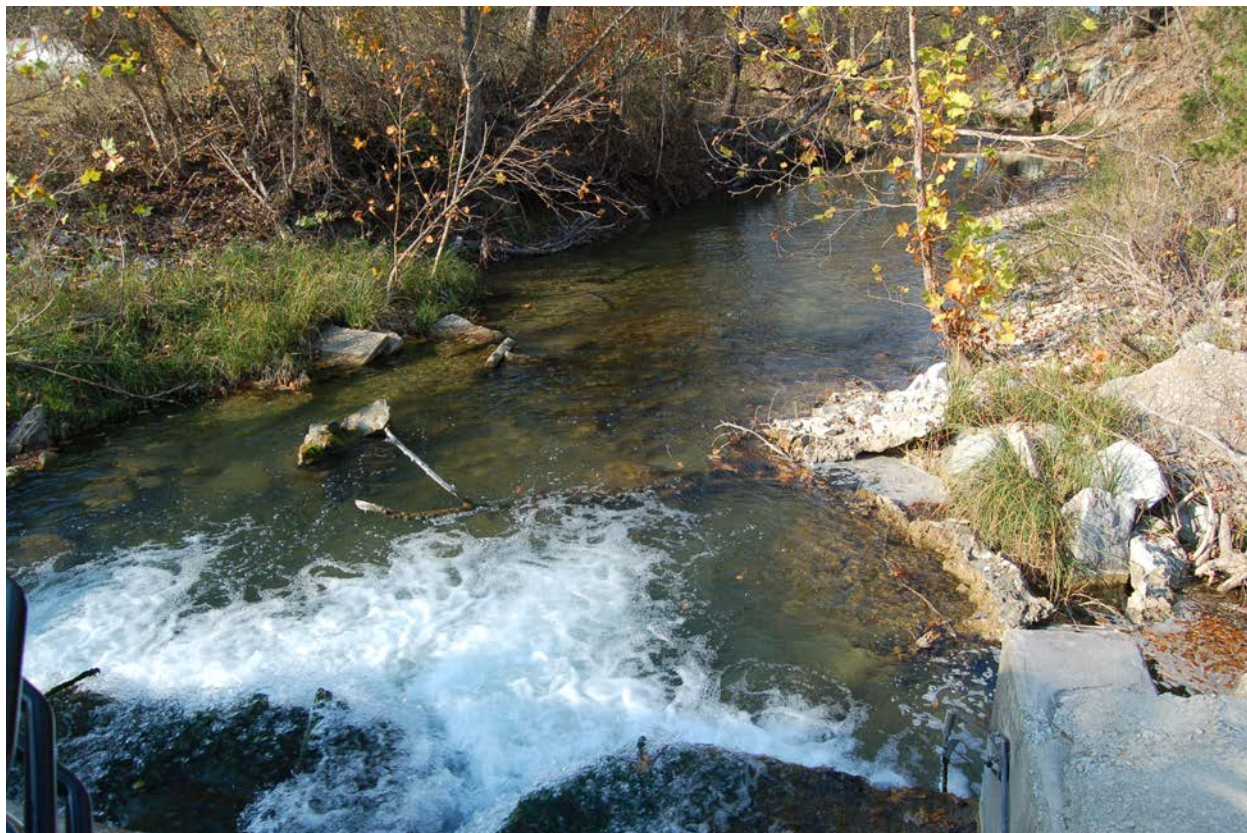
Photo No. 13

Description: This photo was Mill Creek farther upstream from the confluence of the tributary and Mill Creek.

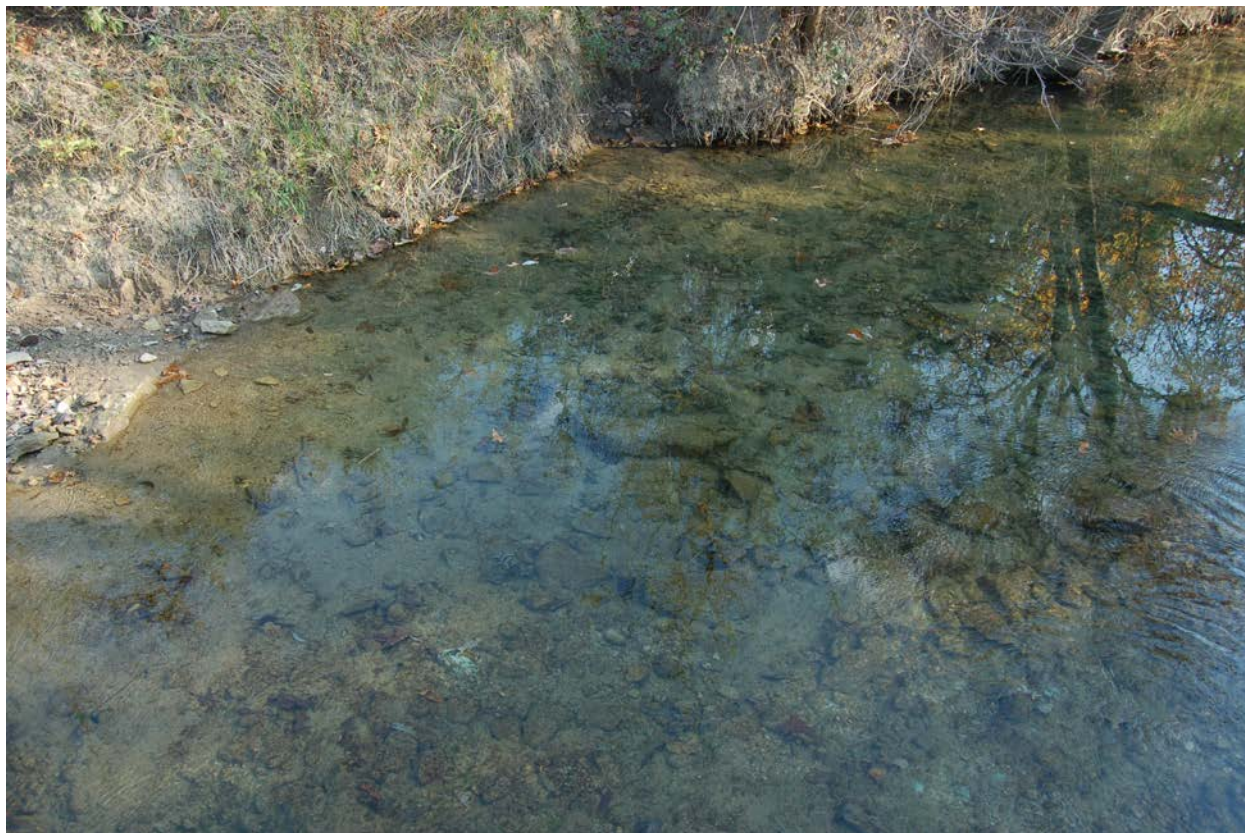
Photo No. 14

Description: This image showed an additional image of Mill Creek upstream of the confluence of the tributary and Mill Creek. I observed that the water was clear and flowing.

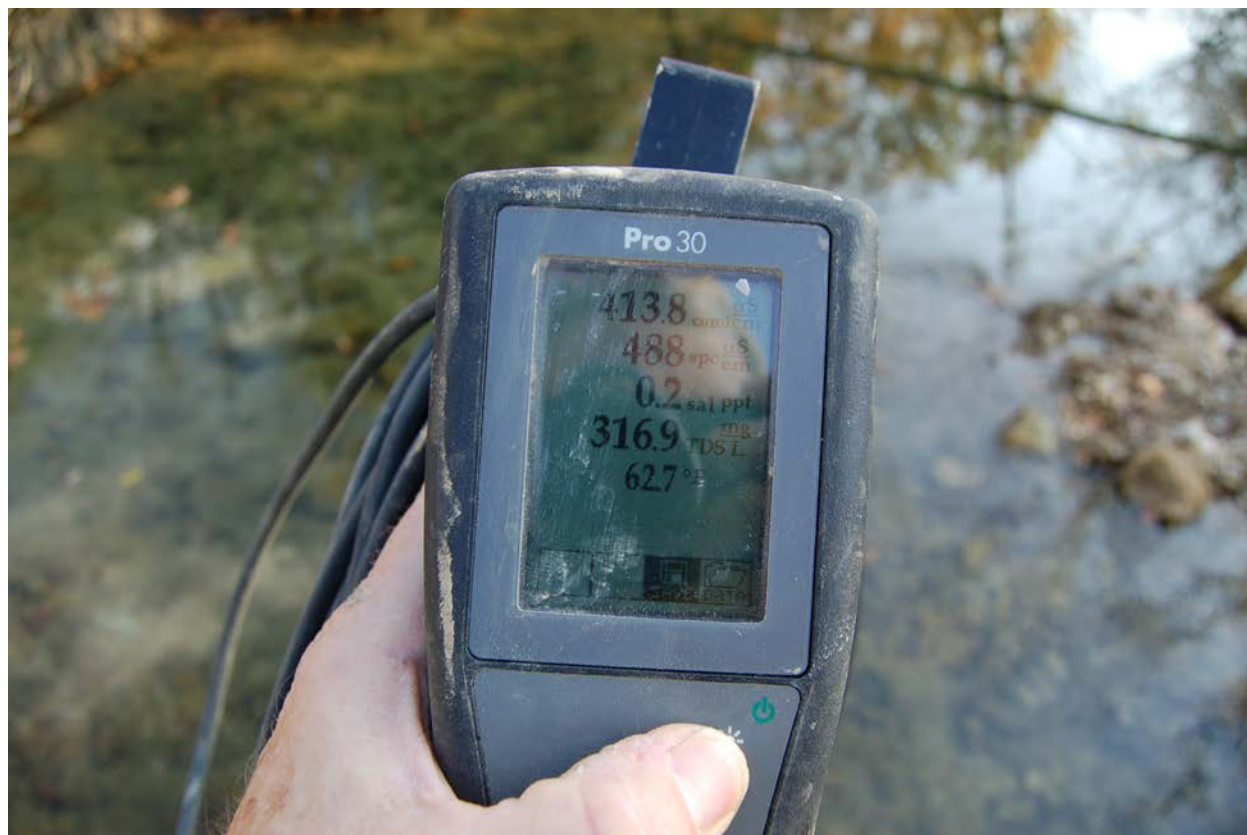
Photo No. 15

Description: A TDS reading was taken upstream in Mill Creek at the location shown in Photo 14 and was 317 mg/l.

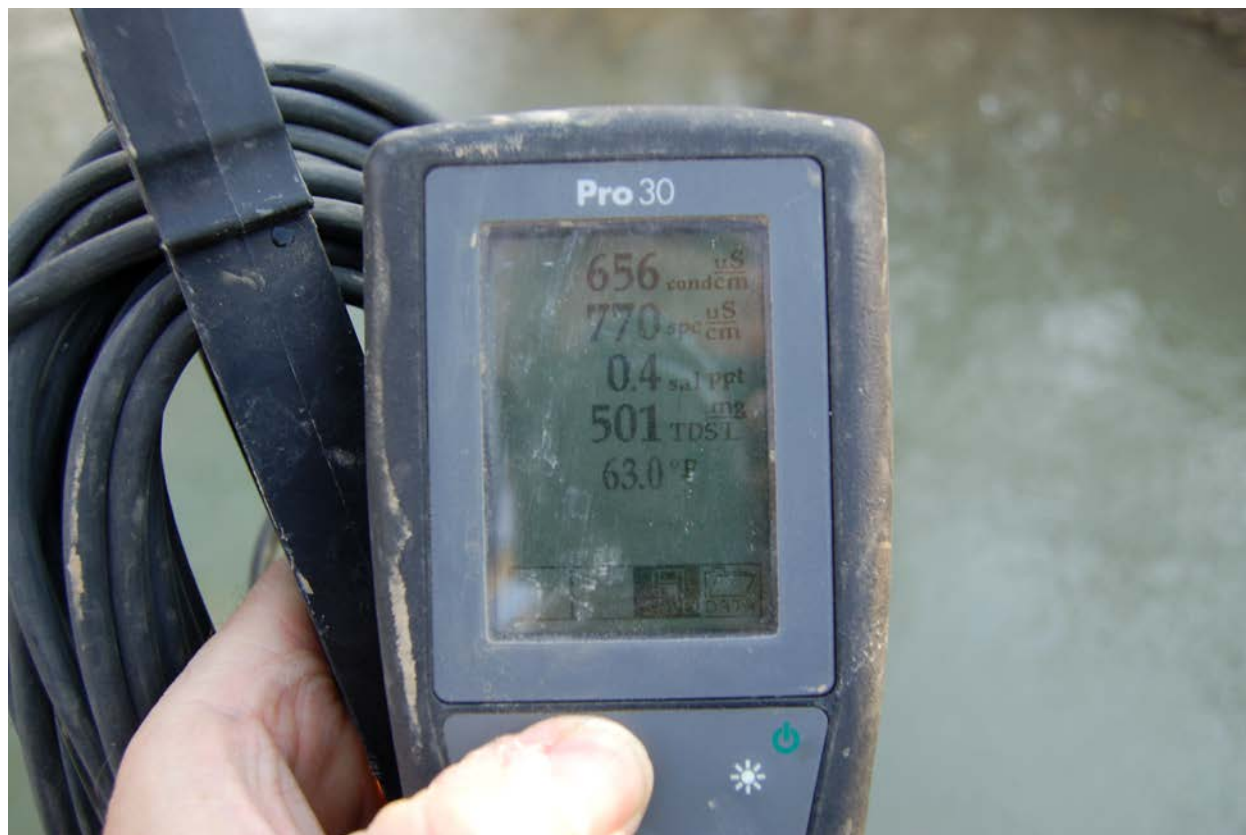
Photo No. 16

Description: A TDS reading of 501 mg/l in Mill Creek was taken about 1 mile east, or downstream, of the confluence of the tributary and Mill Creek.

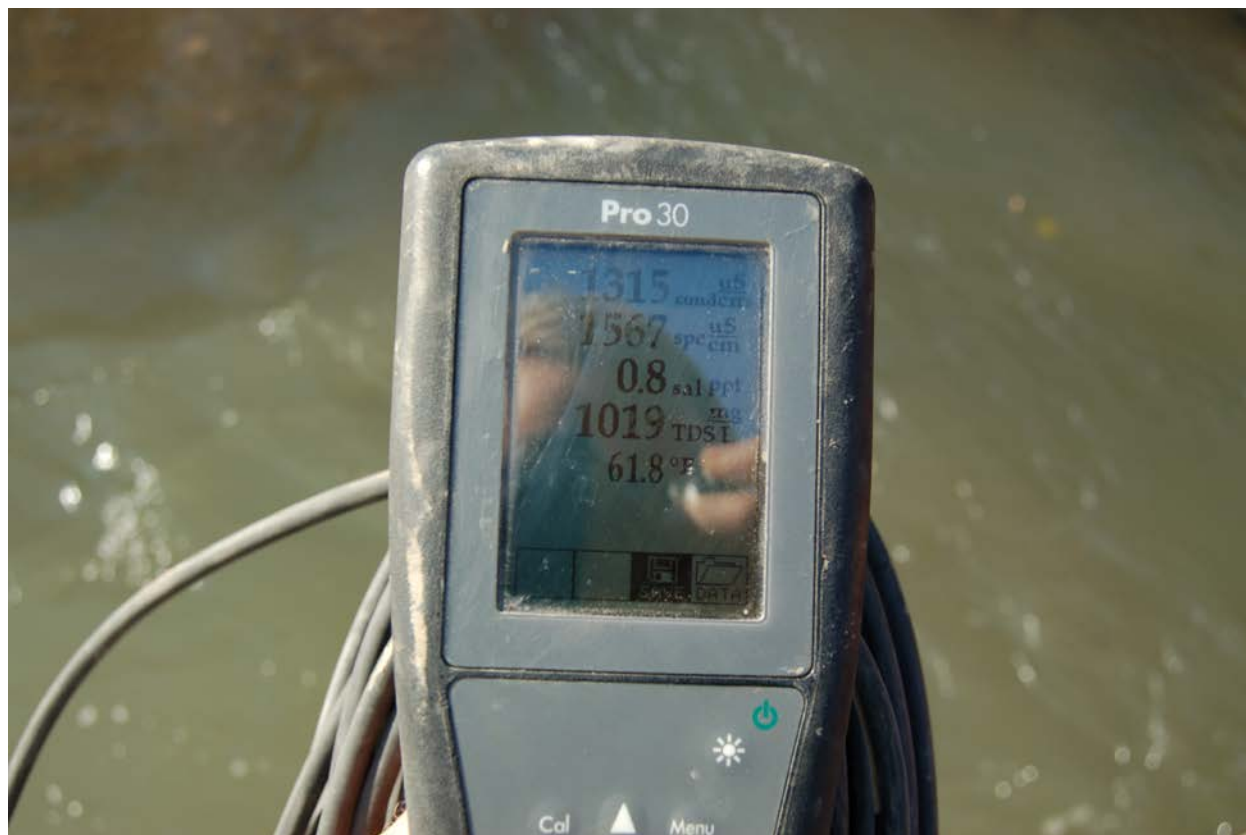
Photo No. 17

Description: A TDS reading of Mill Creek about 2 miles east of the confluence of the tributary and Mill Creek was 1,019 mg/l.
