**Well Inspection**  
**Osage DNR / Environmental Protection Agency**  
**1201 Elm Street, Suite 500**  
**Dallas, Texas 75270**

| | | <b>Well ID</b> | CI-14 | | |
| <b>Inspection Reason</b> | Plugging Witnessed | <b>Responsible Company at Time of Inspection</b> | Bandwheel Production Company, | | |

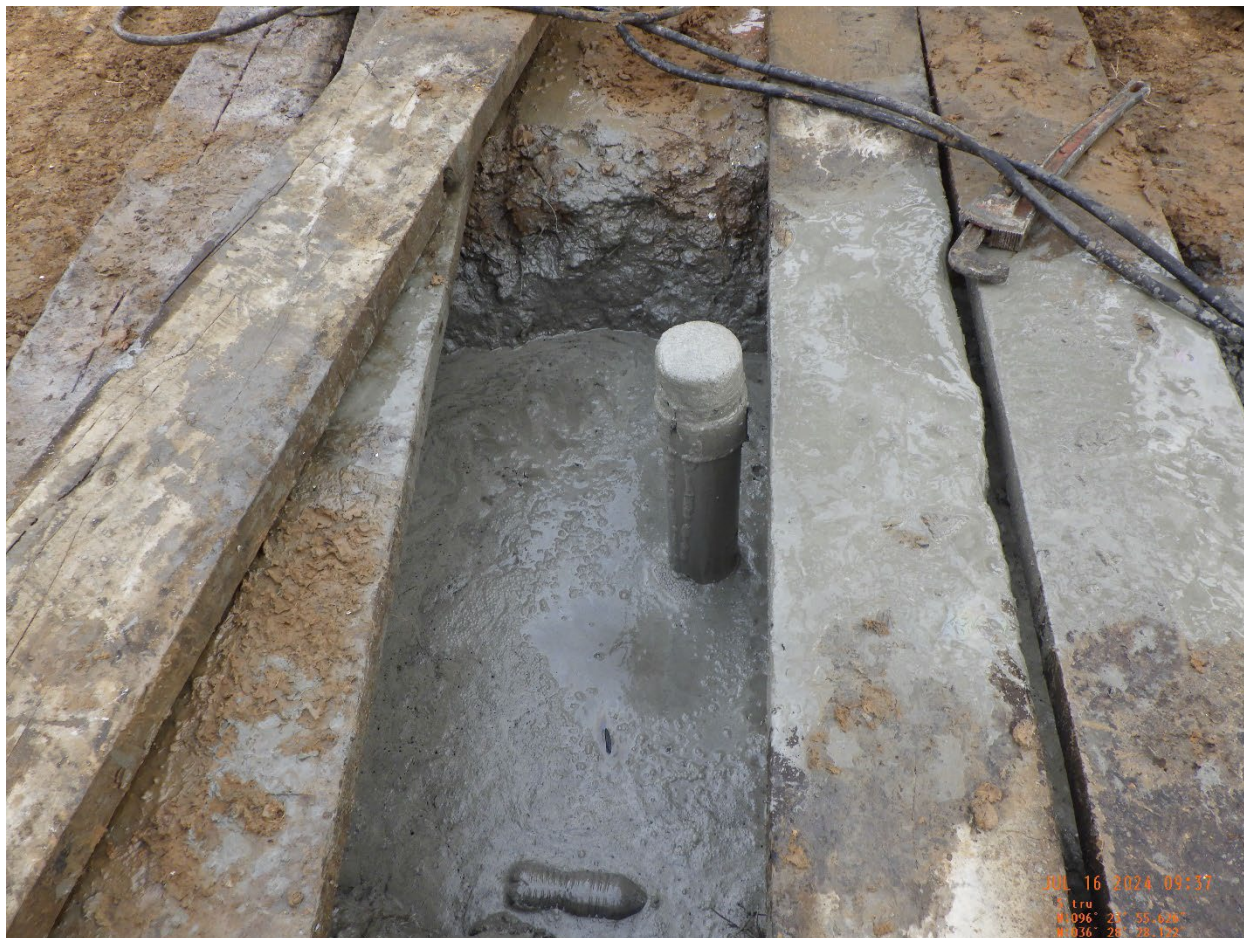
Photo No. 1

| <b>Inspection Comments</b> | Inspector observed Lester well service run in hole and tag the top of cement on the bottom plug at 800 feet below the surface, this plug was set and observed by EPA on 7/15/2024. From 800 feet, Lester well service circulated 70 sacks of cement to the surface. Inspector observed cement standing at the surface with no fall back. | | | | |

**Description:** This was well OS3272000 standing full of cement at the end of plugging operations.
