**NPDES Stormwater Reconnaissance Inspection  
Industrial Site**

**TROPICAL SHIPPING CONSTRUCTION COMPANY LIMITED, LLC**

**TROPICAL'S CONTAINER PORT MARINE CARGO TERMINAL**

Inspection Date: March 29, 2023

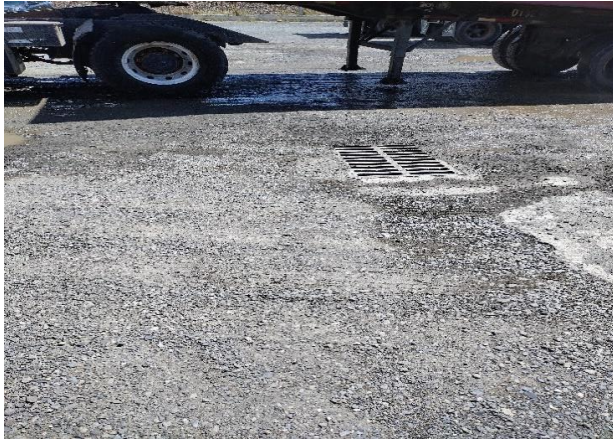
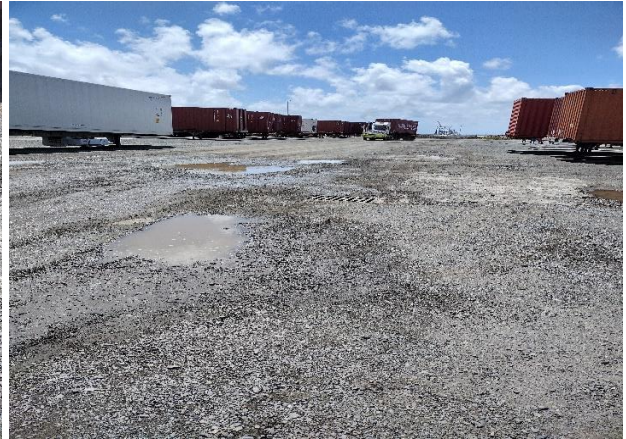
**IMG 8864**-Storm inlet in north of CommUseArea 1. **IMG 6541**-Storm inlet midway in CommUseArea 1. The storm inlet is not protected from the influent of The stormwater basins are aligned in series from east gravel, sediment and trash carried by stormwater runoff flows to west across the referenced area.

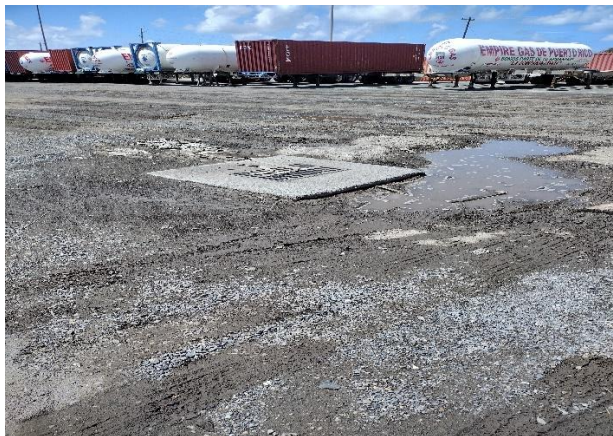
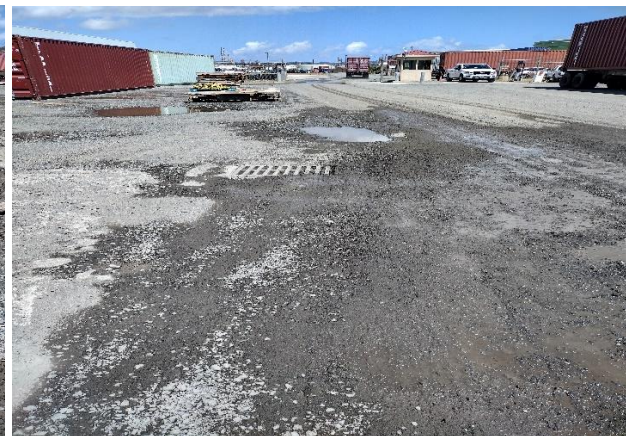
**IMG 6032**-Storm inlet and concrete base in which it sits situated in mid-section of the CommUseArea 1. **IMG 2954**-View of storm inlet along eastern side of CommUseArea 1.

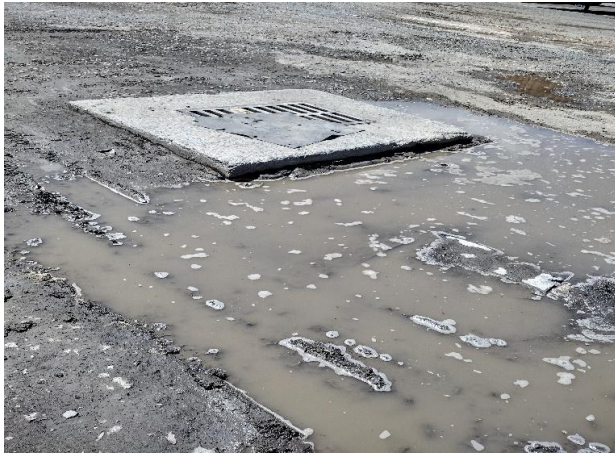
The road surface around several of the stormwater catchment basins in this section in question appeared deteriorated and gutted-out. The existing condition could potentially lead to compromise of the structural integrity of the stormwater catchment basins. See **IMGs 6032, 6258, and 2816 of TROPICAL’S March 29, 2023 NPDES Stormwater RI Photo Album, ATTACHMENT 1**, of the 2023 Inspection Report.

**IMG 6258**-Storm inlet and road surface about inlet is deteriorated, and unmaintained. Debris clogging metal grate.

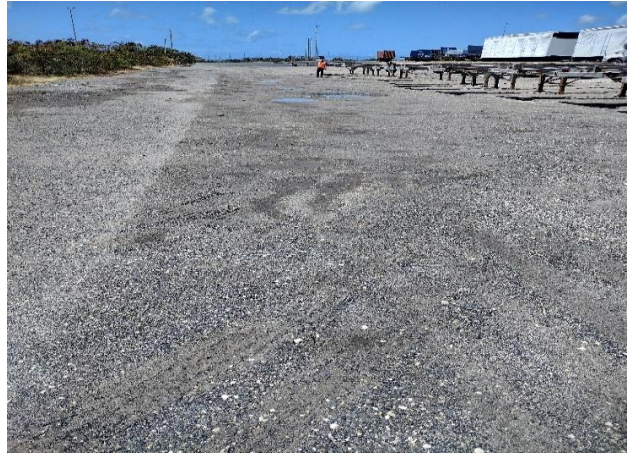
**IMG 5595**-Unpaved south area of CommUserArea 1. Grade allows stormwater flow from east to west.

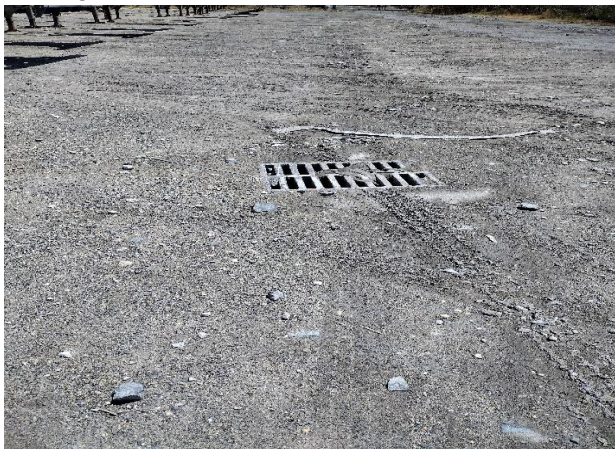
**IMG 5058**-Partially clogged storm inlet midway of unpaved south section of CommUserArea 1.

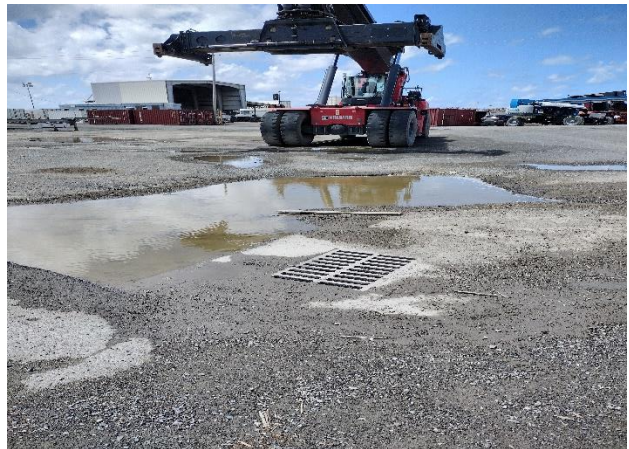
Identified a series of stormwater catchment basins which appeared to be interconnected as part of the stormwater management system that drains that section of the Container Port into nearby Lime Tree Bay. Inlets of the series of stormwater catchment basins observed in the Common Use Area 1 were not outfitted with a provision to prevent or minimize the transport of sediments, gravel, and other pollutants such as residual oils and grease. See **IMGs 8864, 2954, 8118 and 3660 of TROPICAL’S March 29, 2023 NPDES Stormwater RI Photo Album, ATTACHMENT 1**, of the 2023 Inspection Report.

**IMG 2816**-Retention area where stormwater runoff from the unpaved south section of CommUserArea 1 is collected and drained-off. Inlets are unprotected.

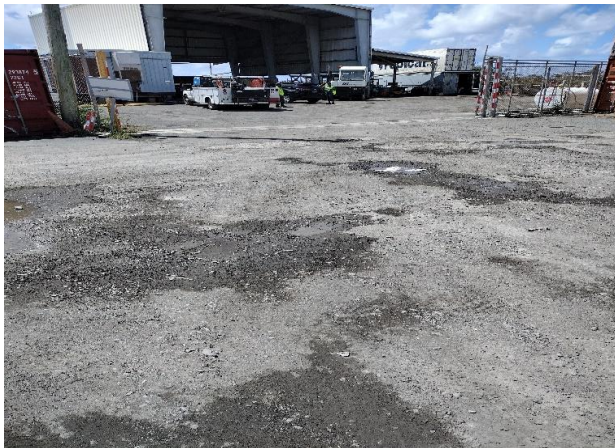
**IMG 0179**-Sloped entrance into maintenance shed, where Tropical's vehicle fleet and equipment are regularly serviced. Potential for transport of sediments and gravel into stormwater catch basin.

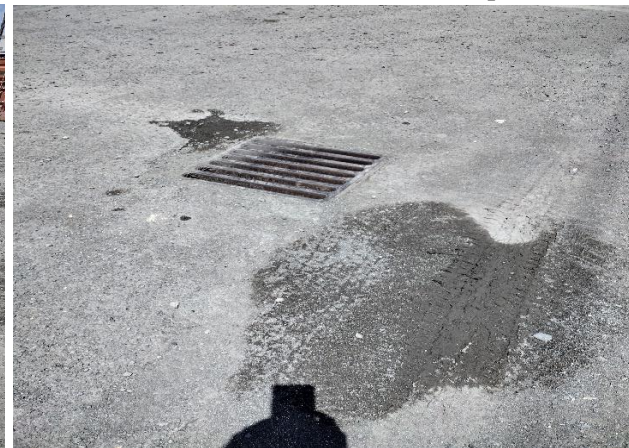
**IMG 3660**-Accumulated sediment at base of sloped entrance into the Facility's maintenance shed area. Storm inlet unprotected from transport of sediment by stormwater runoff into stormwater catch basin.

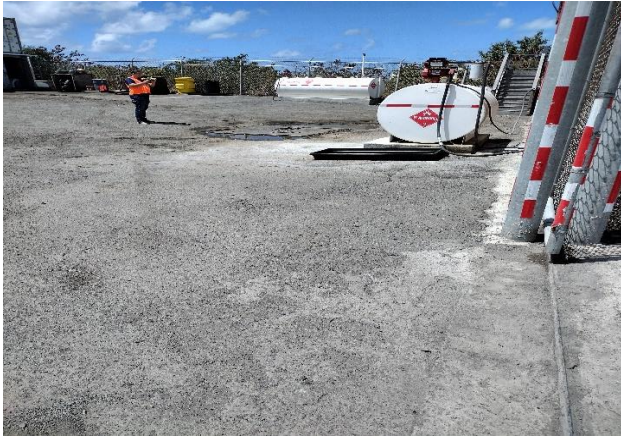
Based on the existing set-up and positioning of two (2) fueling stations (hoses and dispensing nozzles), any accidental releases of fuel from spills and leaks that may occur during fueling operation of the fueling stations will not be readily contained. Releases of petroleum product from a diesel-fuel station will drain into and/or during wet weather events will be transported by stormwater runoff flow into a “large catchment basin”<sup>6</sup> covered by a metal grill situated about 10 feet slightly down gradient from the diesel-fuel station.

**IMG 5366**-Fueling terminal unit within fenced area of Tropical's maintenance shed. Yard surface slopes toward large stormwater catch basin.

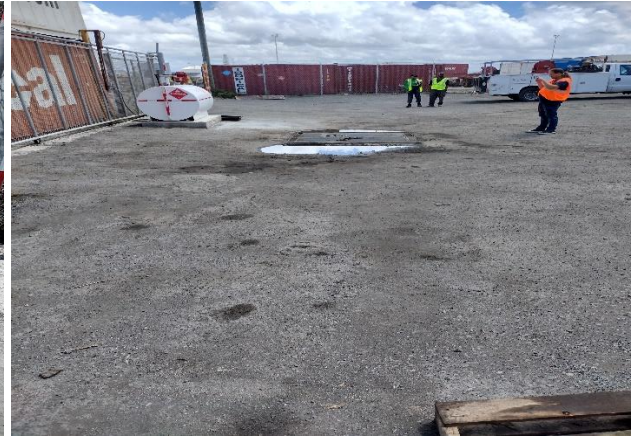
**IMG 5320**-Sloped yard surface towards large stormwater catch basin within the fenced area of the maintenance shed. Basin not within a containment.

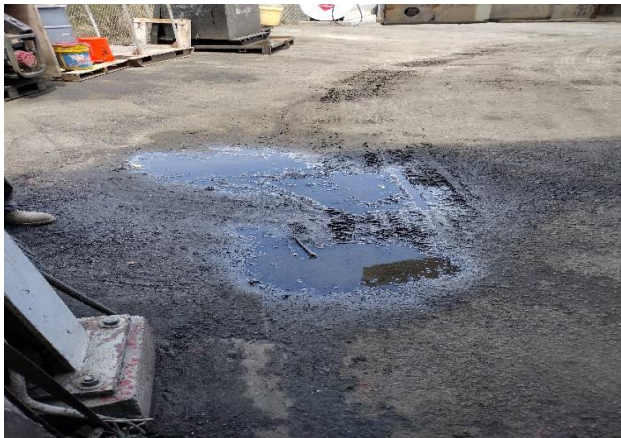
Evidence revealed that stormwater runoff flow from the vicinity of the service platform in the front yard of the maintenance operations will come in contact with pollutants release on the yard surface and transported downhill towards the large catchment basin along a defined flow path into the large catchment basin during dry or wet weather events. See **IMGs 1616, 2768 and 8118 of TROPICAL’S March 29, 2023 NPDES Stormwater RI Photo Album, ATTACHMENT 1** of this 2023 Inspection Report.

**IMG 1616**-Stormwater runoff path observed from front of the shed flowing downhill towards a large stormwater catch basin at the low-point in the yard.

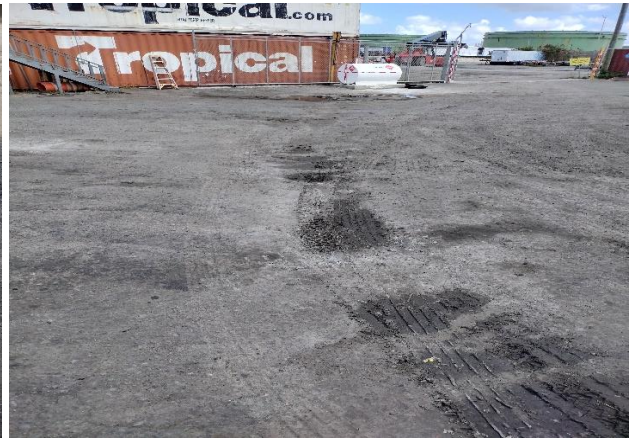
**IMG 2768**-Close-up of stormwater runoff path that appeared saturated with oil patches along the stormwater path towards the stormwater catch basin.

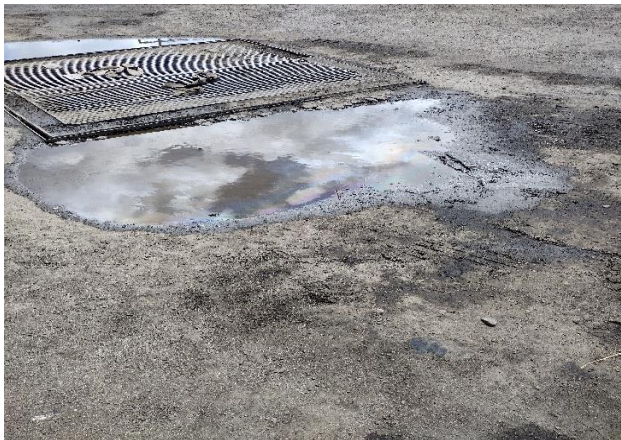
**IMG 8118**-View of the large stormwater catch at low point in the yard of the maintenance shed. Oil spills patches next to the puddles observed.

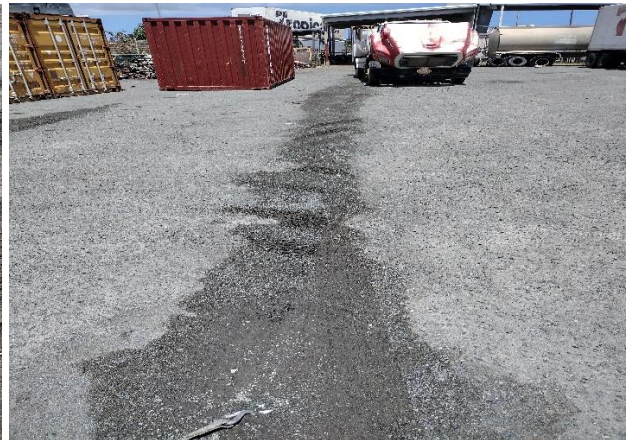
Evidence revealed that stormwater runoff flow from the vicinity of the service platform in the rear yard section of the maintenance operations will readily drain along the paved surface and eventually towards the western edge of the Facility and then into the shoreline of Lime Tree Bay. See **IMGs 0111, 6966 and 1793 of TROPICAL’S March 29, 2023 NPDES Stormwater RI Photo Album, ATTACHMENT 1** of this 2023 Inspection Report.

**IMG 0111**-Evidence of stormwater runoff flow path from rear side of the maintenance shed, that runs across paved yard area.

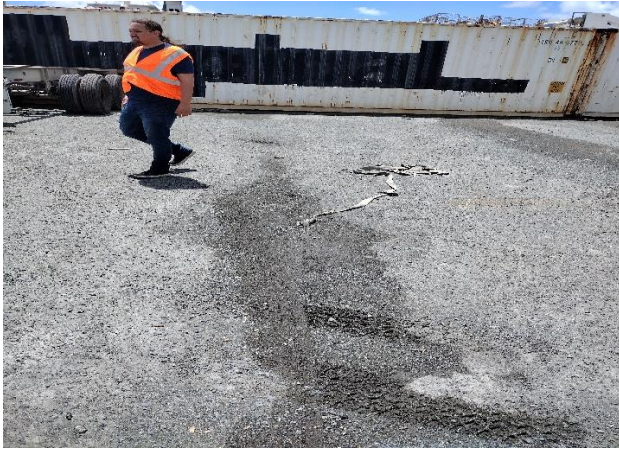
**IMG 6966**-Flow path of stormwater flow in the rear yard area of the maintenance shed.

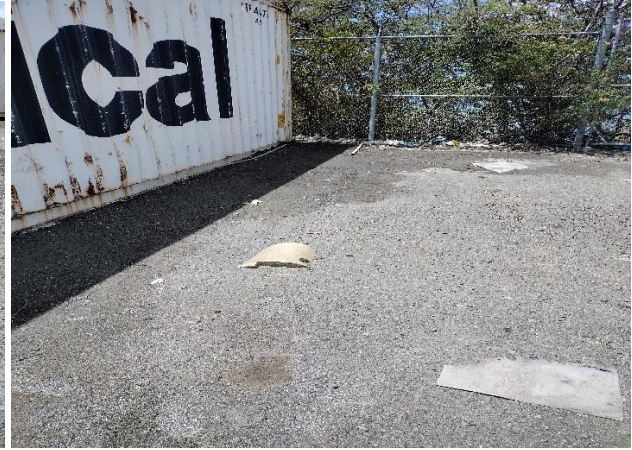
**IMG 1793**-Evidence observed that stormwater flow within the rear yard area drains off at the western fence line of the Facility.

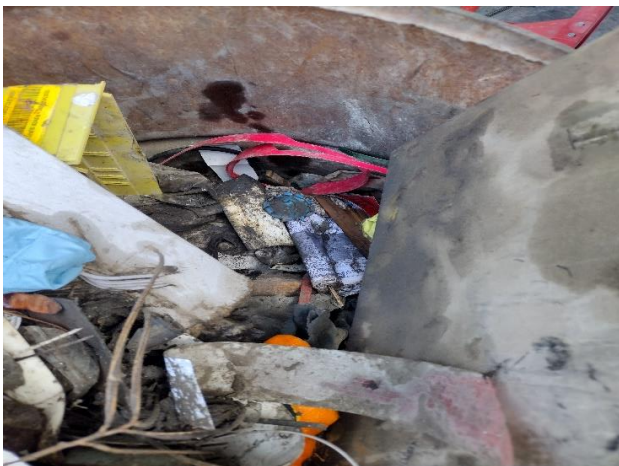
Identified oil-soaked rags and gloves, chemical and paint residues mixed with generated refuse in a 55-gallon drums used as garbage bins staged along the front yard of the maintenance operations area. According to personnel stationed in the maintenance operations arear, accumulation refuse in the 55-gallon containers are disposed along with regular garbage. See **IMG 4022 of TROPICAL'S March 29, 2023 NPDES Stormwater RI Photo Album, ATTACHMENT 1** of this 2023 Inspection Report.

**IMG 4022**-View of oil-soaked rags, crushed tube casing of chemical materials and paint residues discarded among regular garbage.

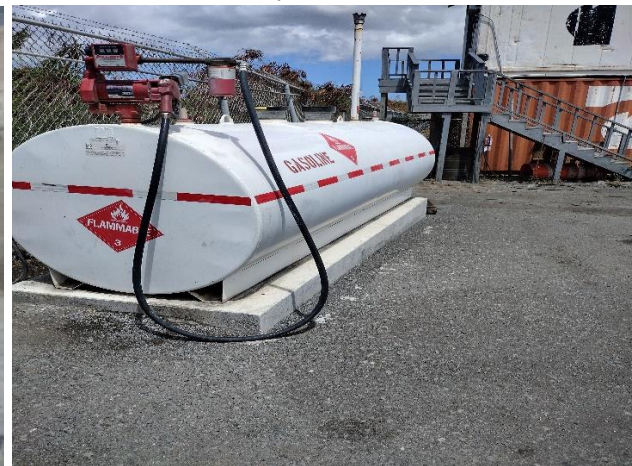
**IMG 9911**-Closeup of fueling terminal unit with no containment around the system. Oil-soaked spot next to the tank, and exposed to stormwater runoff.

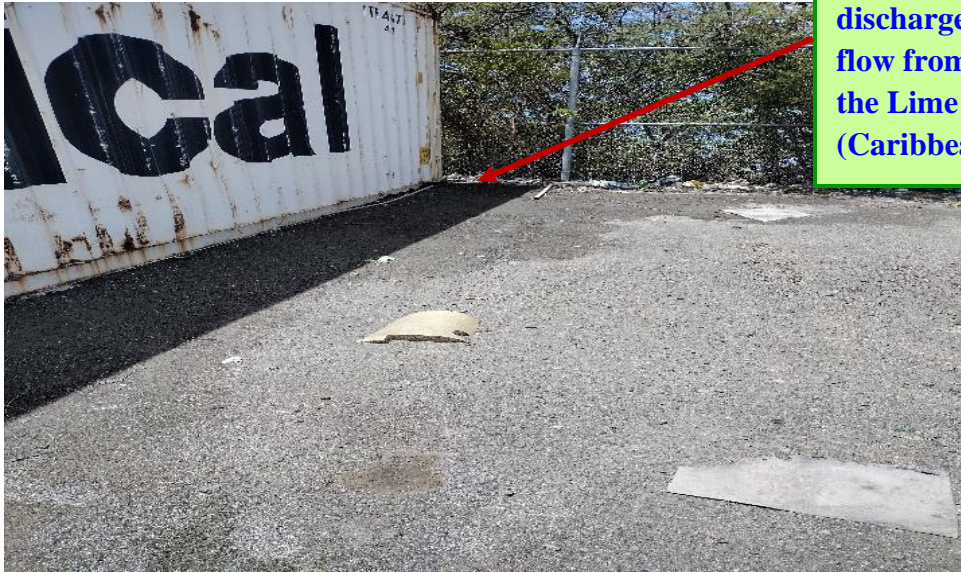
**Outfall 1**

***Outfall A*** – *A discrete stormwater conveyance through which stormwater runoff flows out of the rear yard of Maintenance Operations Area is conveyed and eventually discharged at the western fence line into Lime Tree Bay. Outfall 1 is featured in **IMG 1793 of Part B of TROPICAL'S March 29, 2023 NPDES Stormwater RI Photo Album, ATTACHMENT 1**, of the 2023 Inspection Report.*

**Outfall 1 – Official point of discharge of storm water flow from the Facility into the Lime Tree Bay (Caribbean Sea)**

**IMG 1793-**Discharge point where storm water from the rear yard area of the maintenance shed reaches the a point along the western fence line of the Facility, and drains into Lime Tree Bay.
