**Region 6 Compliance Assurance and Enforcement Division  
INSPECTION REPORT**

| Inspection Date(s): | July 25, 2018 and August 9, 2018 | | |
| Company Name: | <b>4D Oil and Gas, LLC</b> | | |
| Facility Name: | <b><i>South Cedar Creek</i></b> | | |

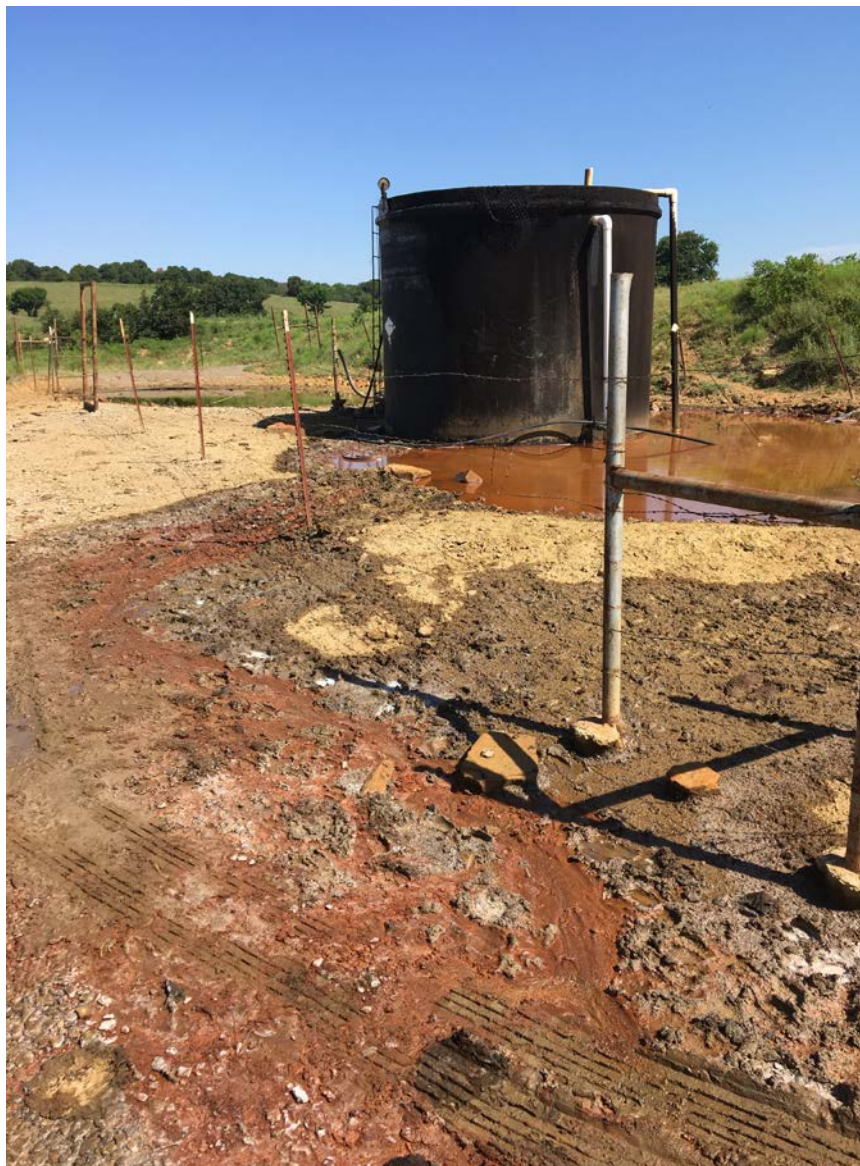
Photo No. 1

Description: The discharge originated from this brine tank and pit.

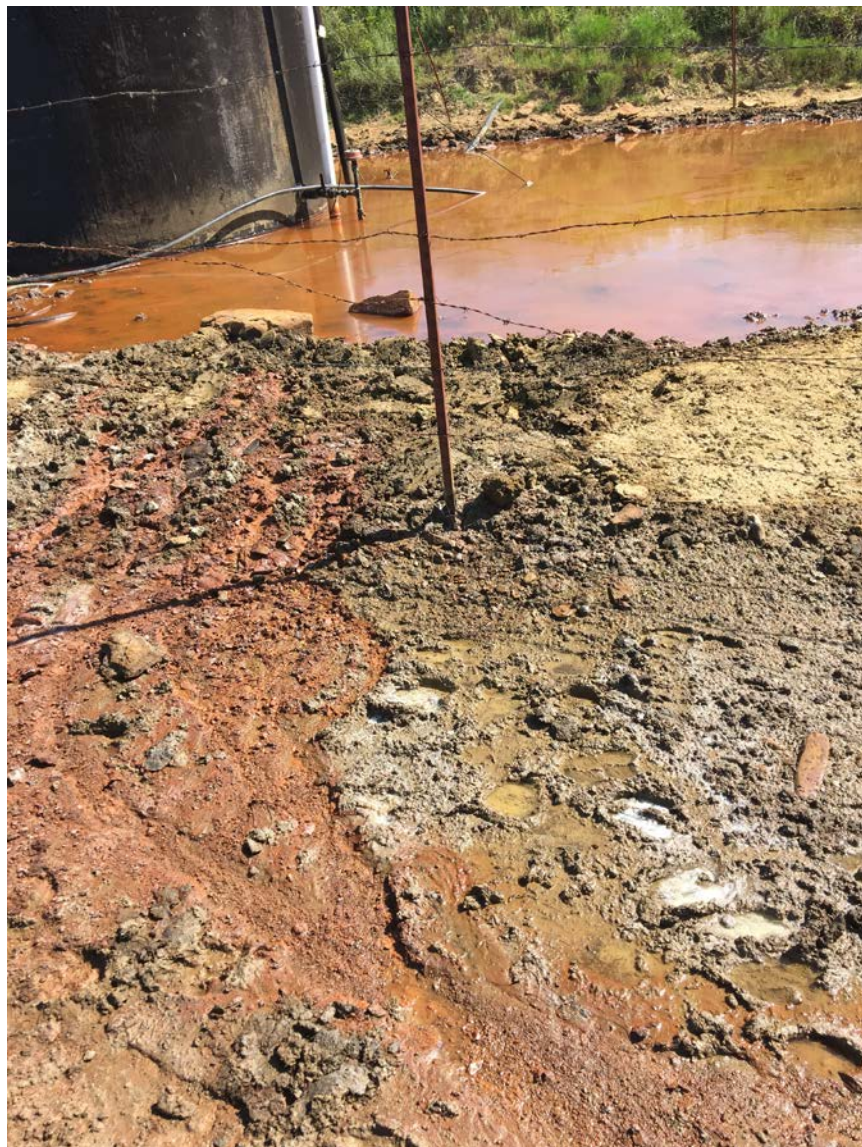
Photo No. 2

Description: The brine flowed from the inadequate containment area here. The alarm on the tank did not work according to the operator. There was not a sign at the facility.

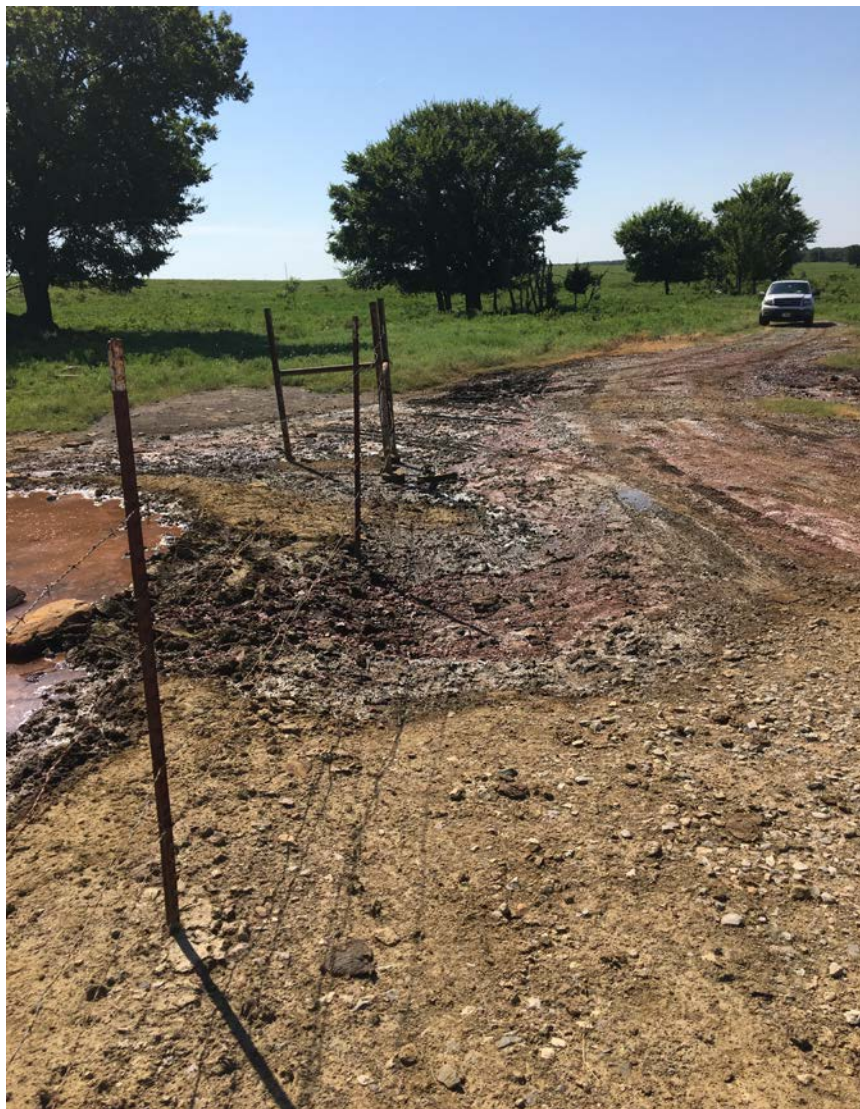
Photo No. 3

Description: The discharge path flowed south shown in this photo toward an eroded trench, which flowed towards Elm Creek.

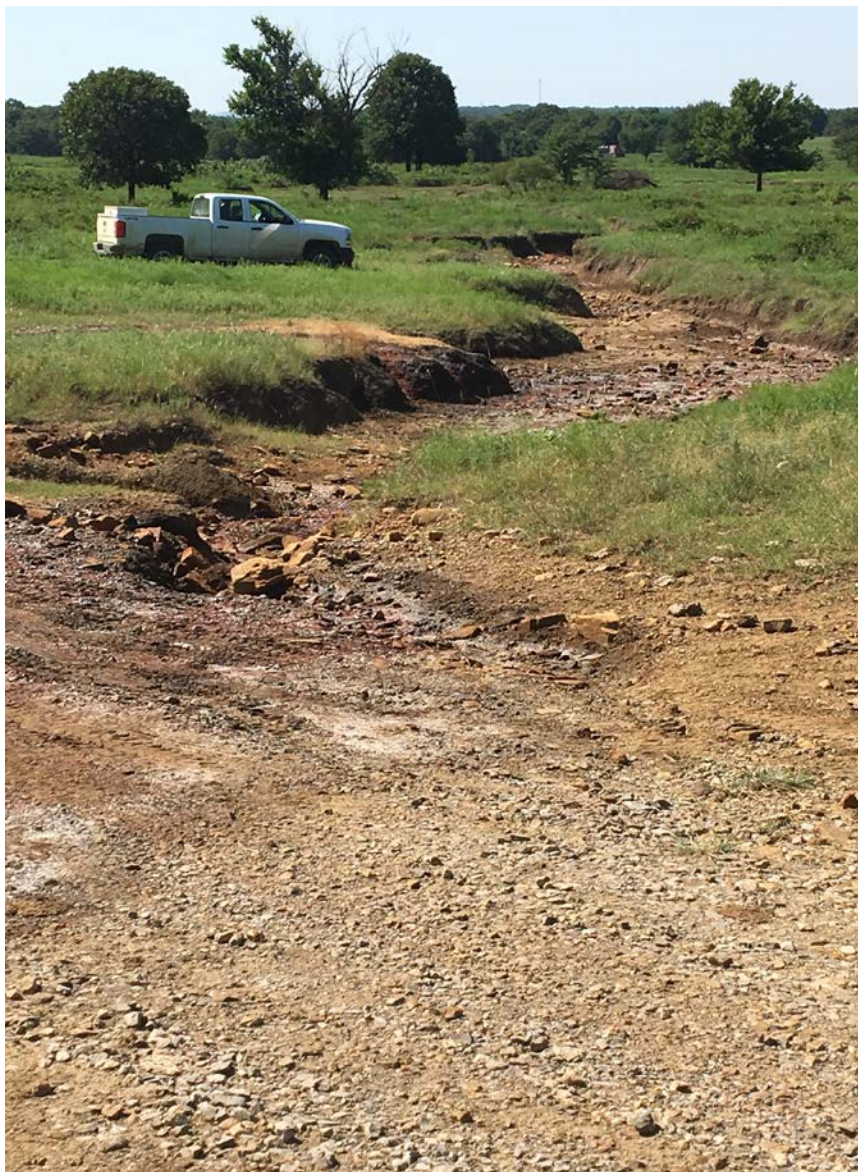
Photo No. 4

Description: The brine entered the trench here and continued to flow south from this location to the point of entry of brine fluids into Elm Creek.

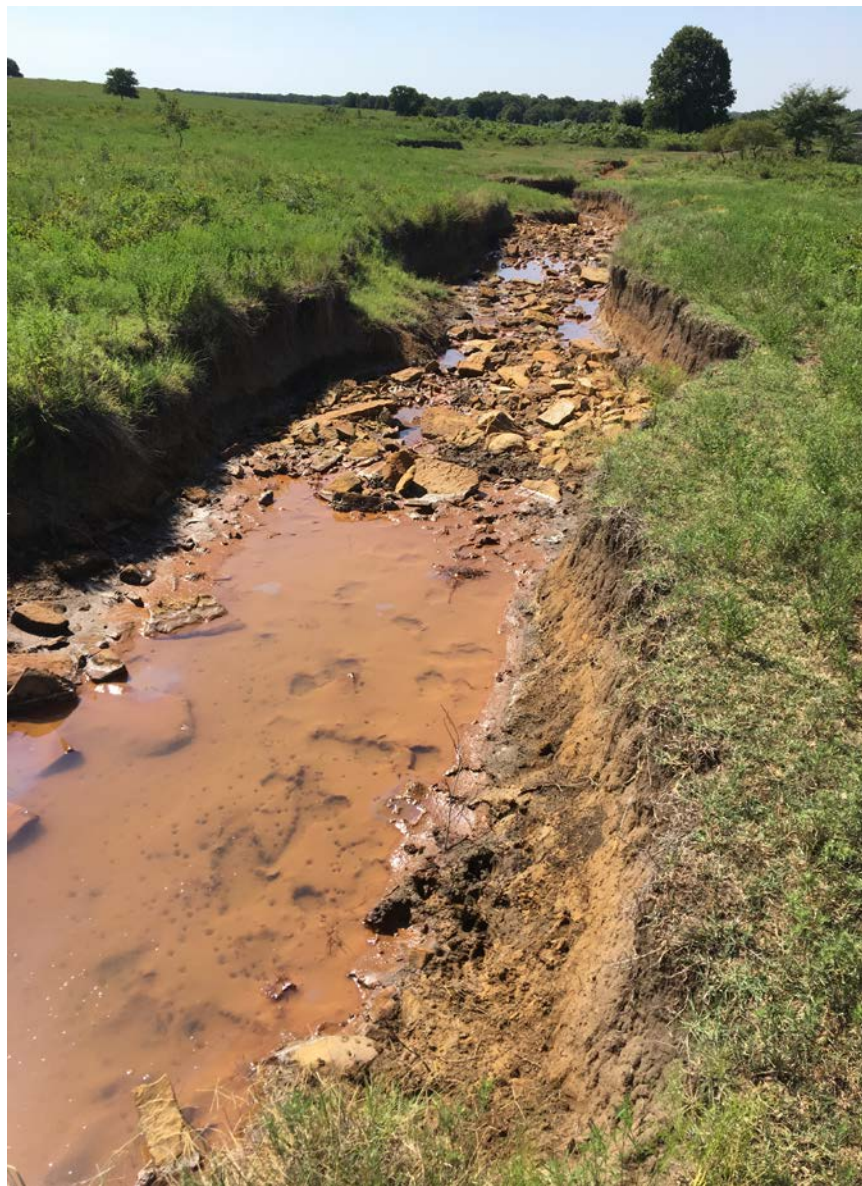
Photo No. 5

Description: The brine fluids in the trench flowed to Elm Creek to the south. The trench was flowing at the time of the inspection and had defined bed and bank.

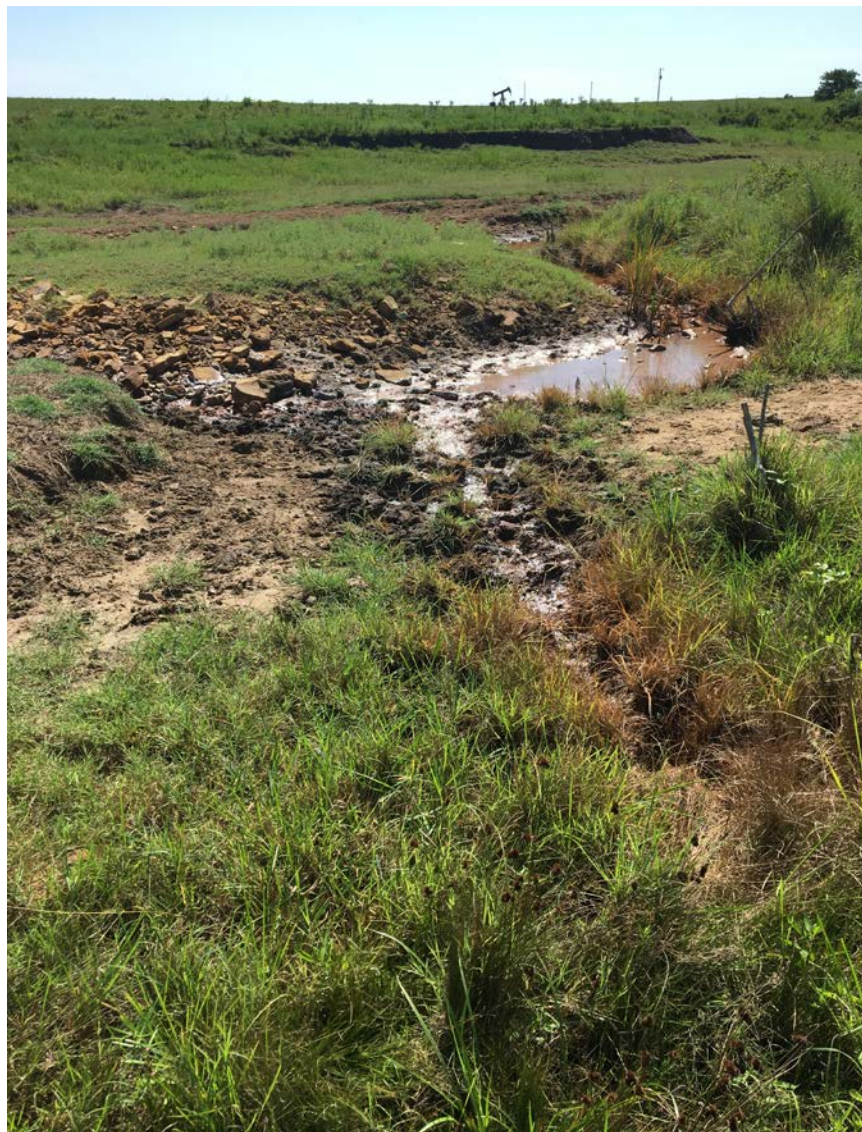
Photo No. 6

Description: The trench flowed into Elm Creek here. The creek had a large pond built along the flow path upstream of this point. Then Elm Creek flowed south from here.

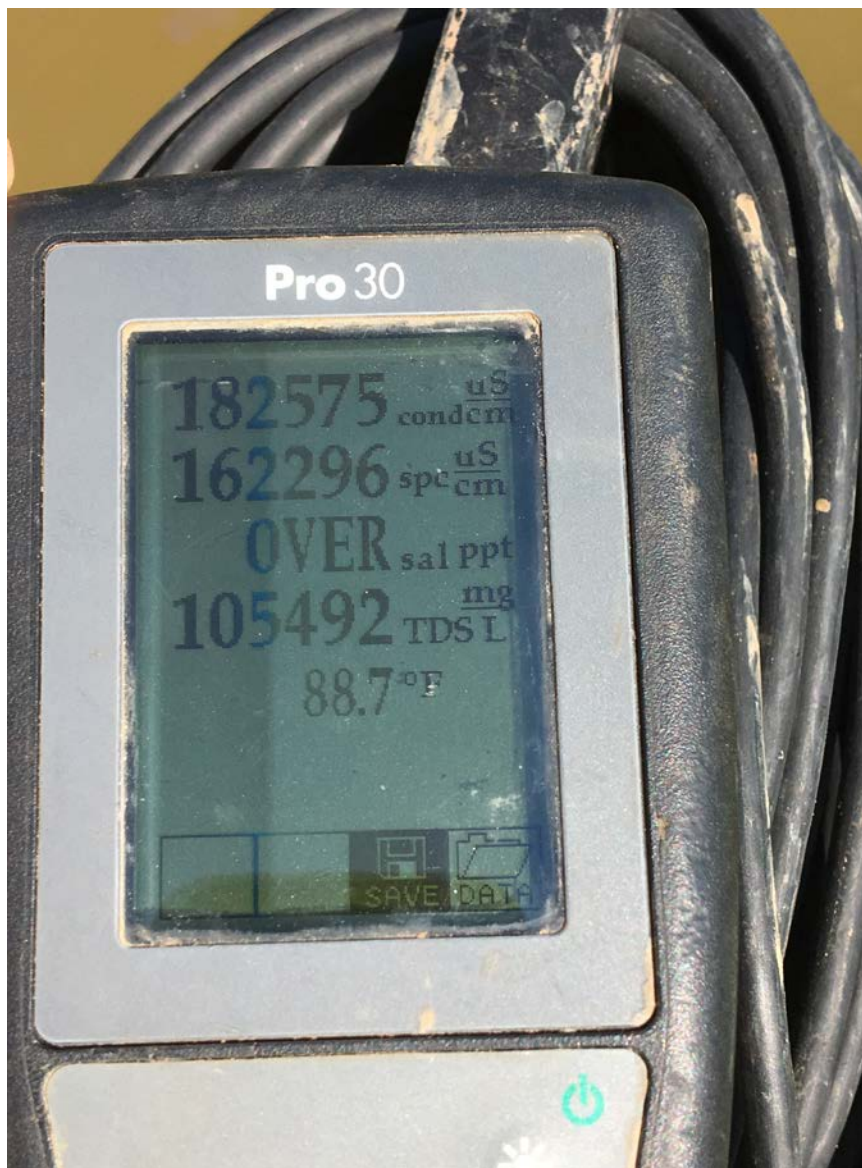
Photo No. 7

Description: With a calibrated YSI 30 Pro Conductivity Meter, a Total Dissolved Solids (TDS) reading of the creek at the point of entry was 105,492 mg/L.

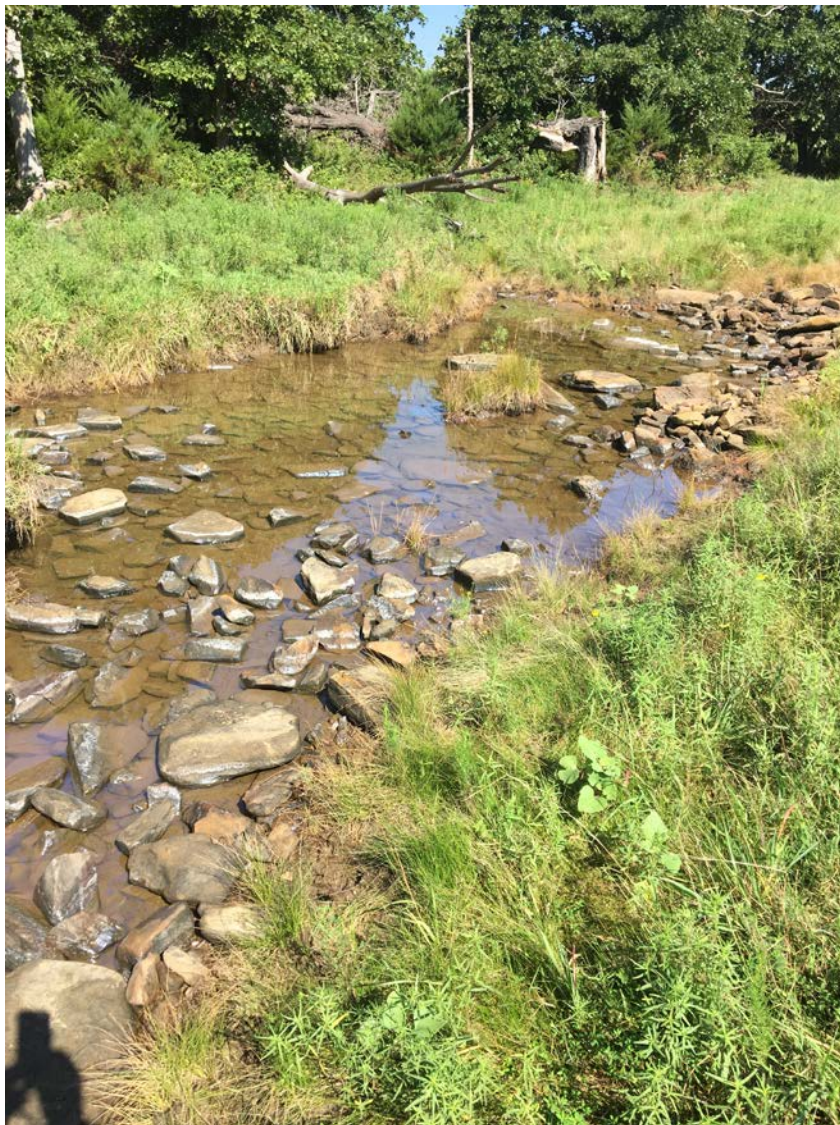
Photo No. 8

Description: This was Elm Creek upstream from the first constructed dam and downstream from the point of entry of brine fluids into Elm Creek. I observed salt staining on the rocks in the creek.

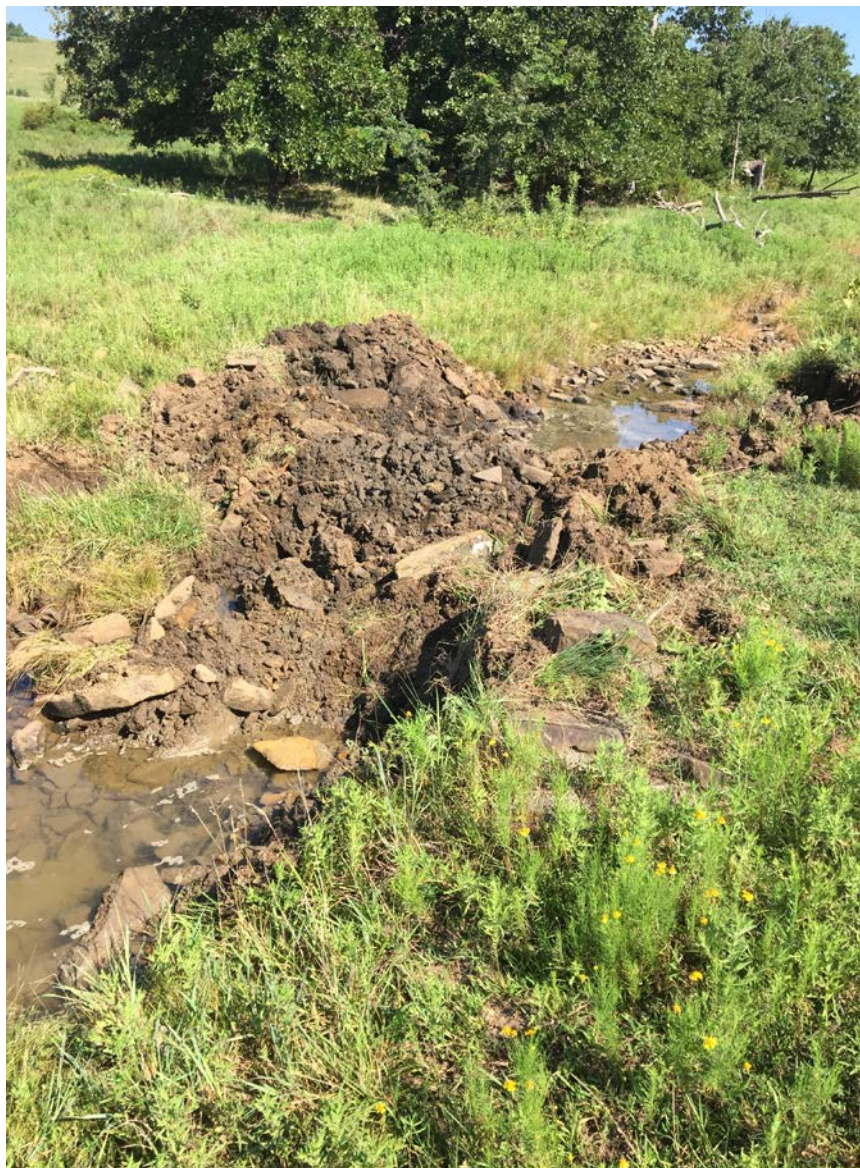
Photo No. 9

Description: This was the first dam built on the creek, south of the point of entry and facility.

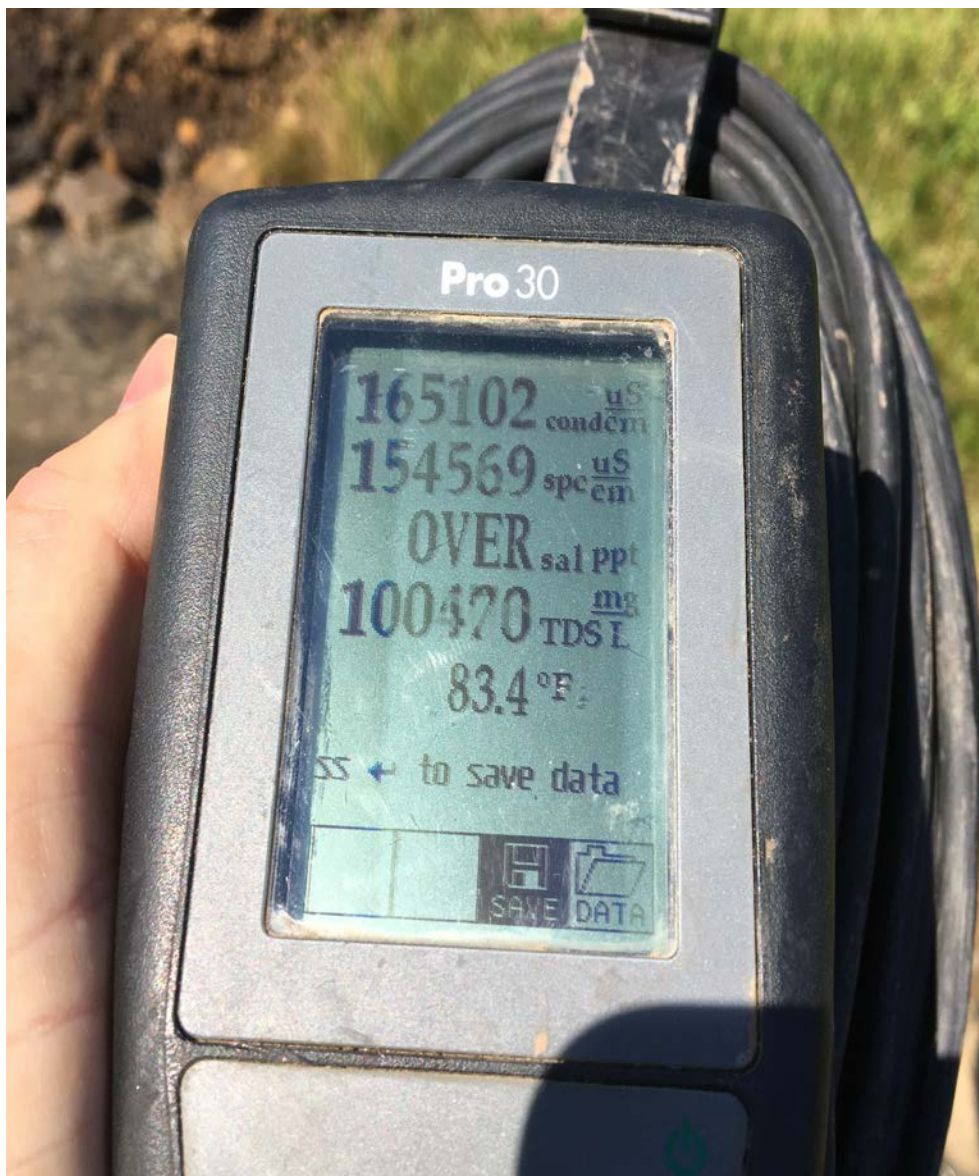
Photo No. 10

Description: The TDS of the water at dam number one was 100,470 mg/L.

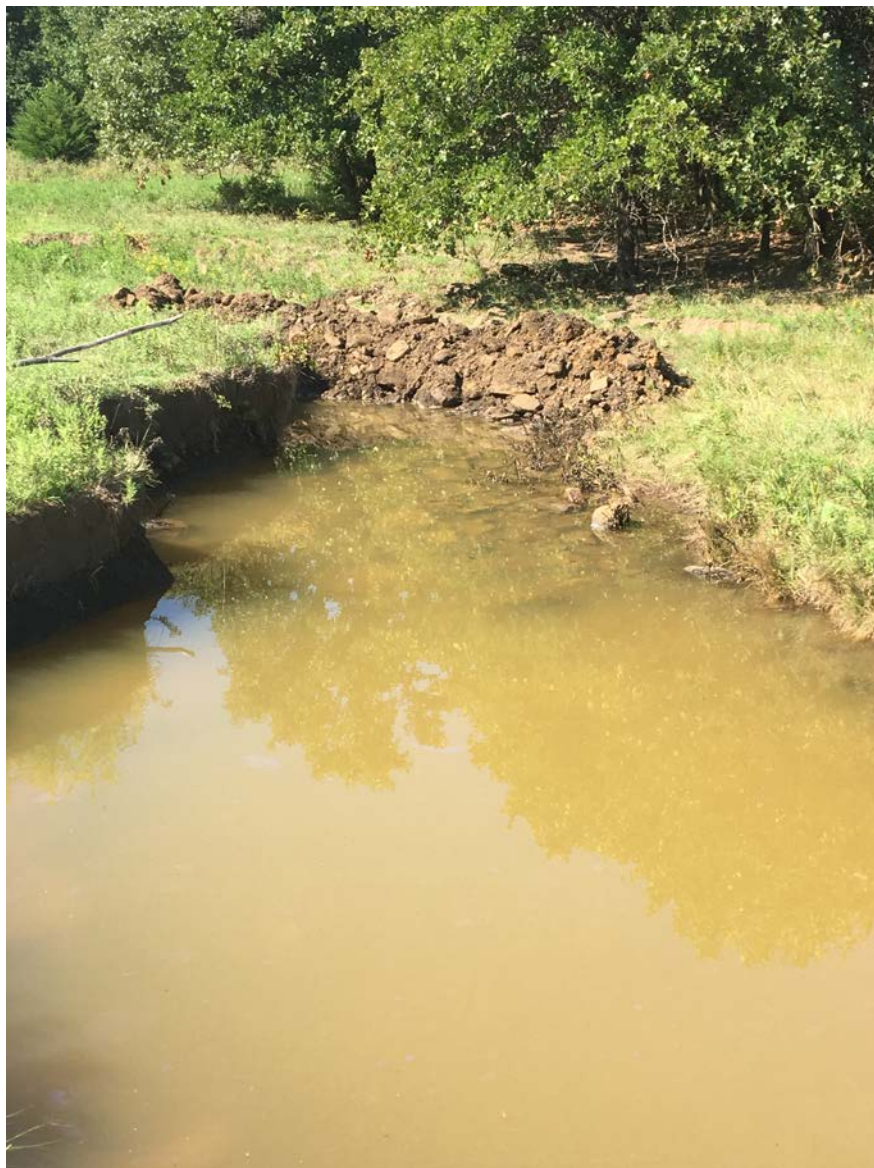
Photo No. 11

Description: This was dam number two constructed south of the brine tank on Elm Creek.

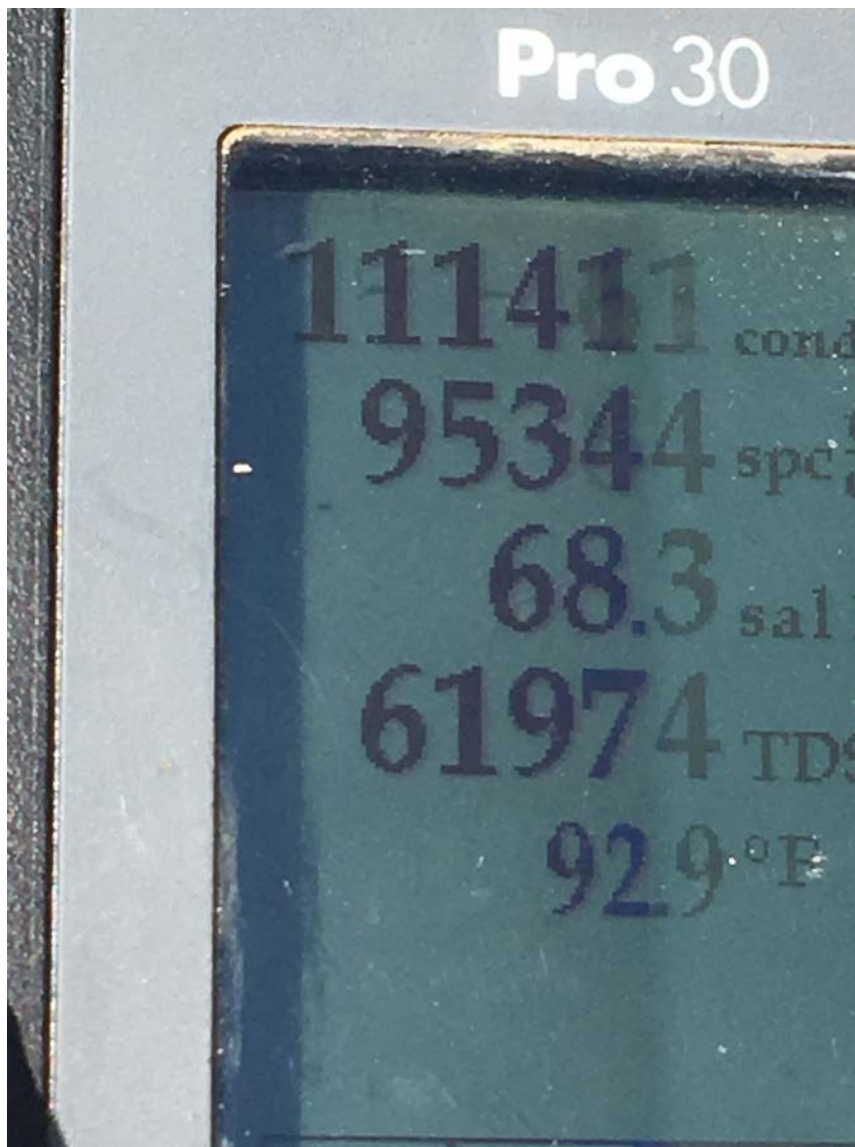
Photo No. 12

Description: The TDS at dam two location was 61,974 mg/L.

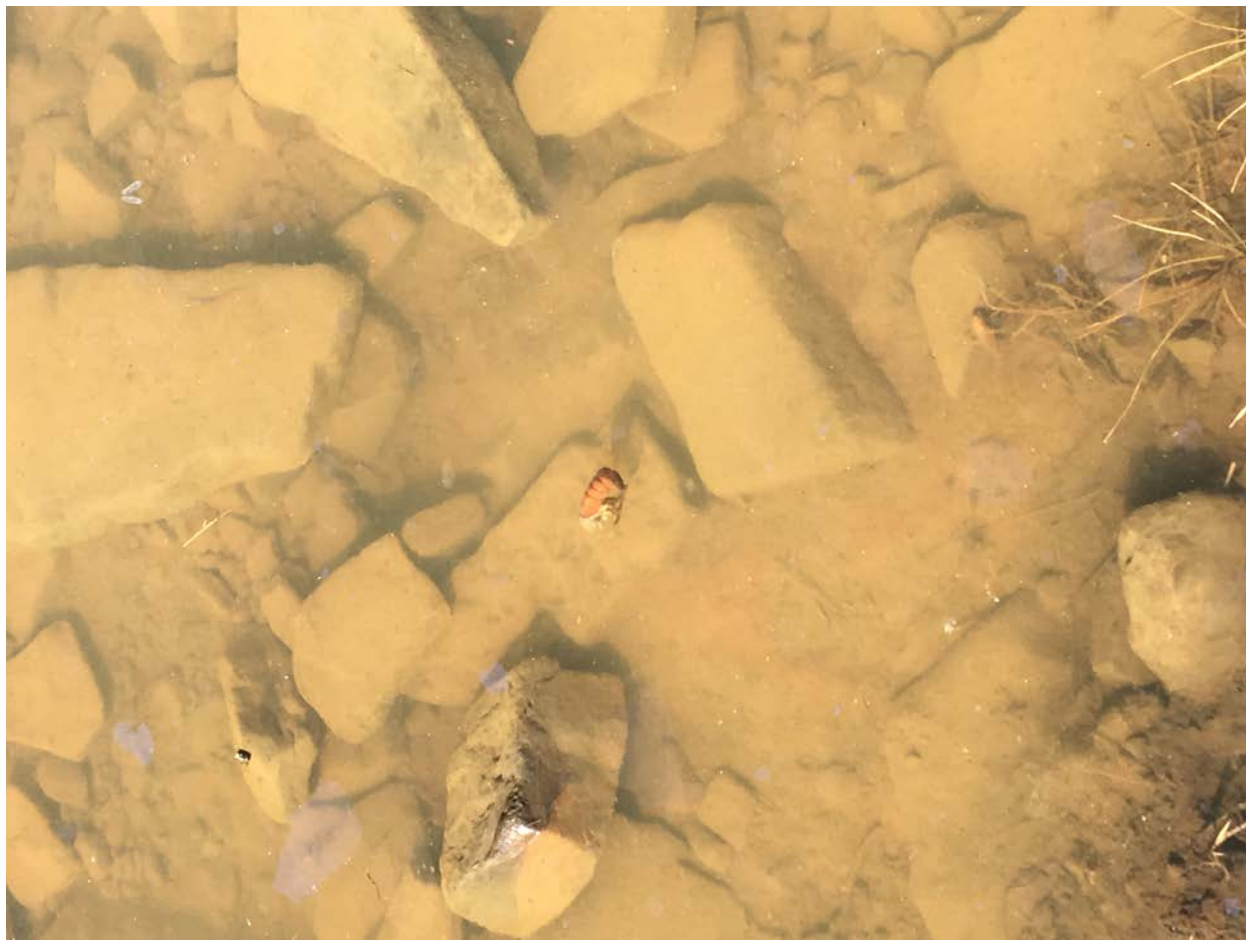
Photo No. 13

Description: I observed dead crayfish in a pool of Elm Creek at the dam two site.

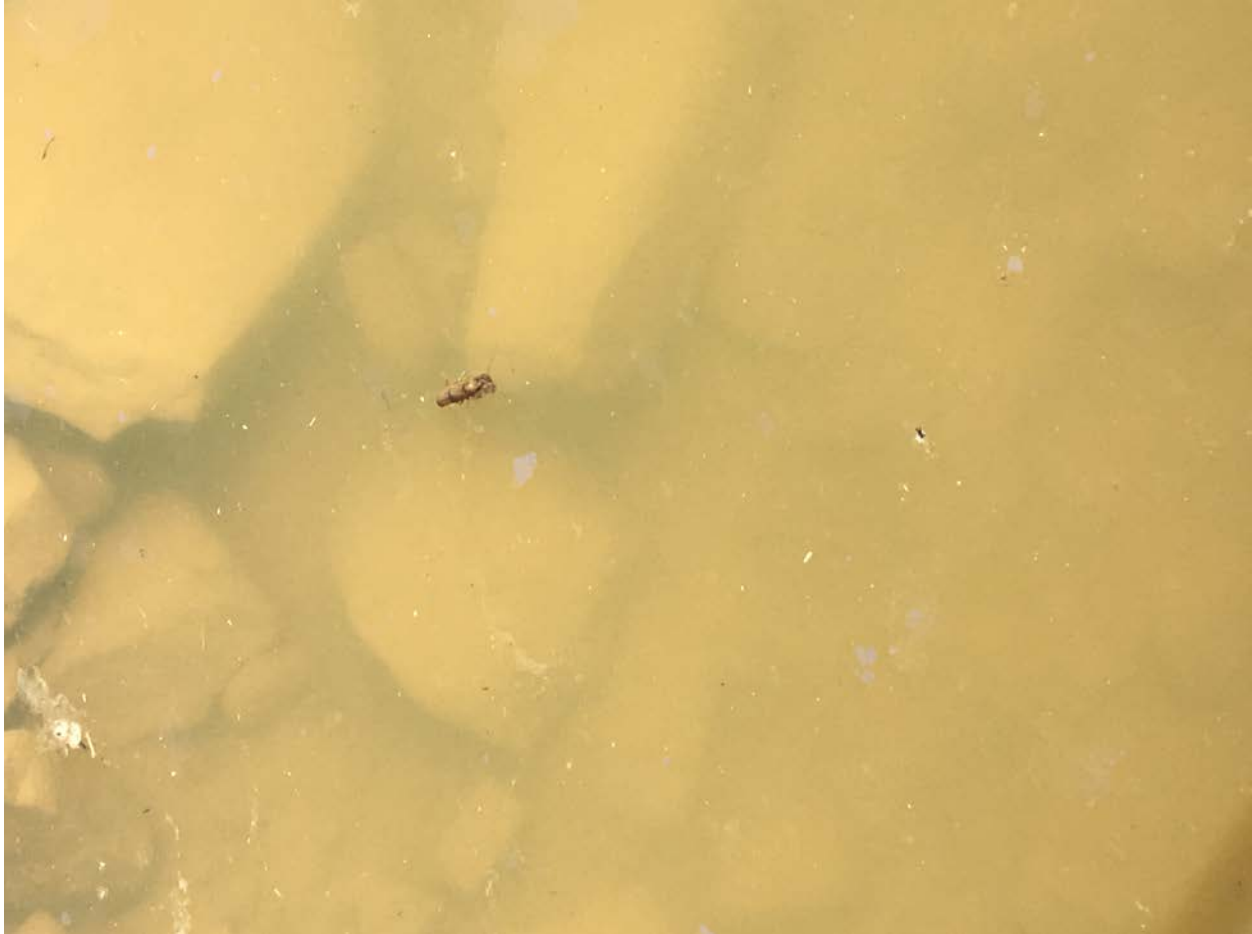
Photo No. 14

Description: I observed more dead crayfish in the pool at dam two.

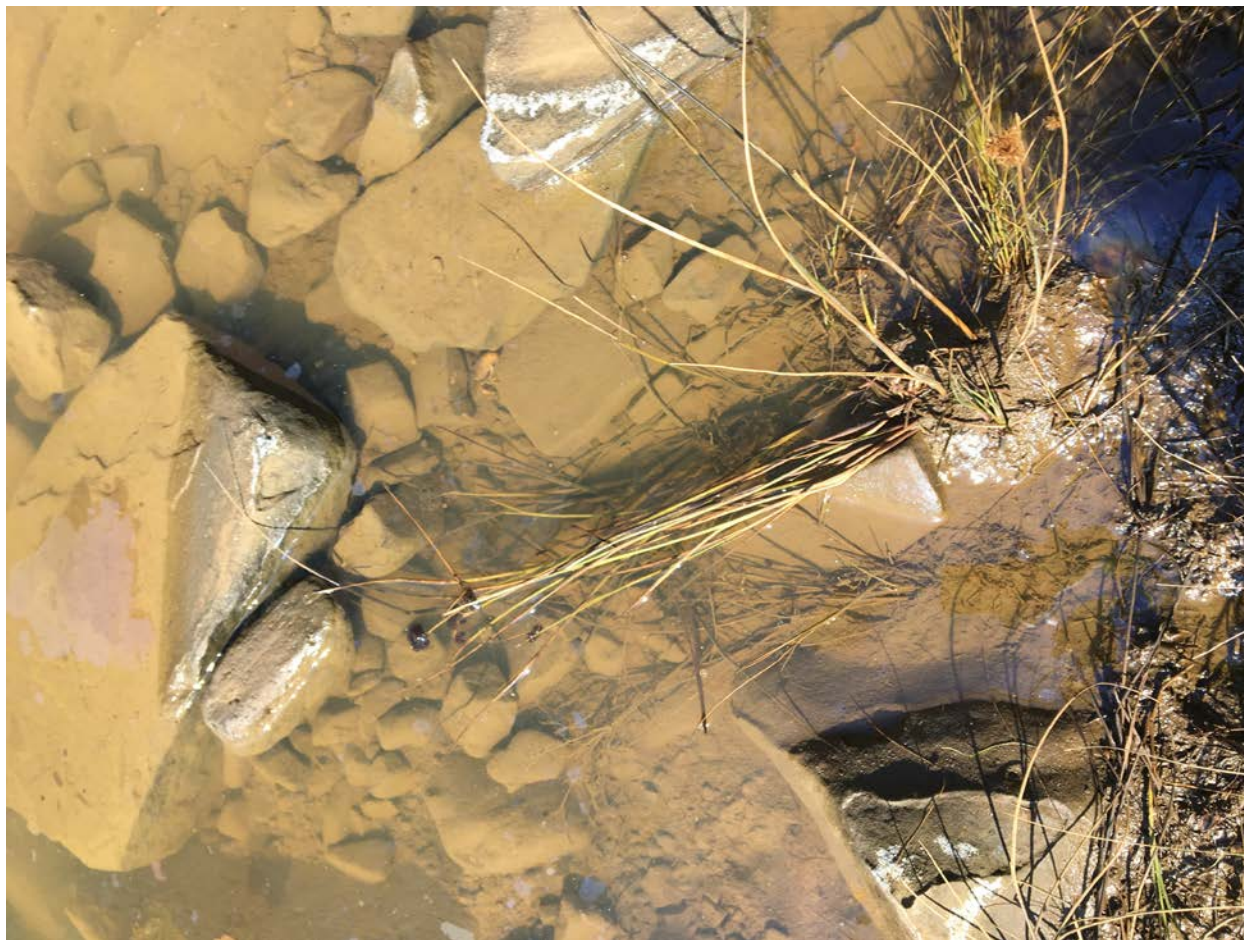
Photo No. 15

Description: I observed salt staining on the rocks in Elm Creek and dead crayfish near dam two.

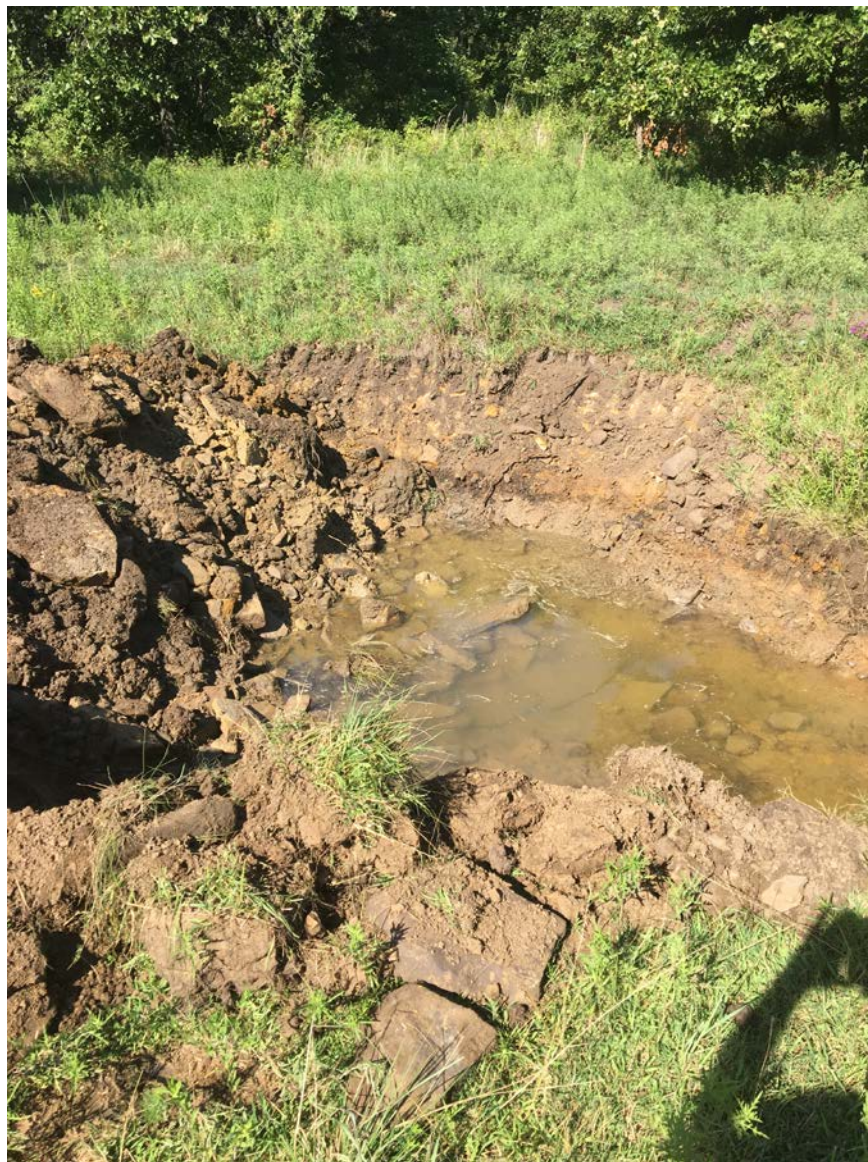
Photo No. 16

Description: This was dam number three constructed south of the discharge point on Elm Creek.

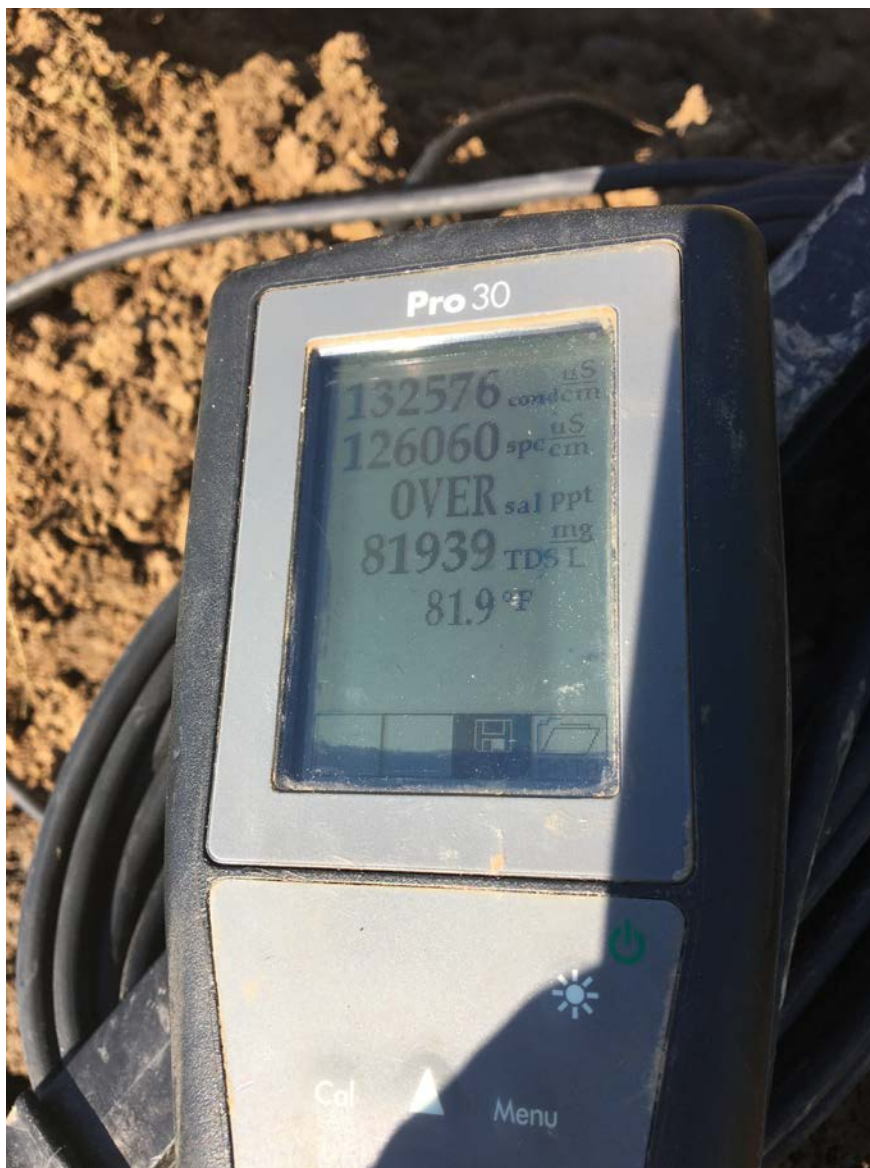
Photo No. 17

Description: The TDS of the pool in Elm Creek at dam three site was 81,939 mg/L.

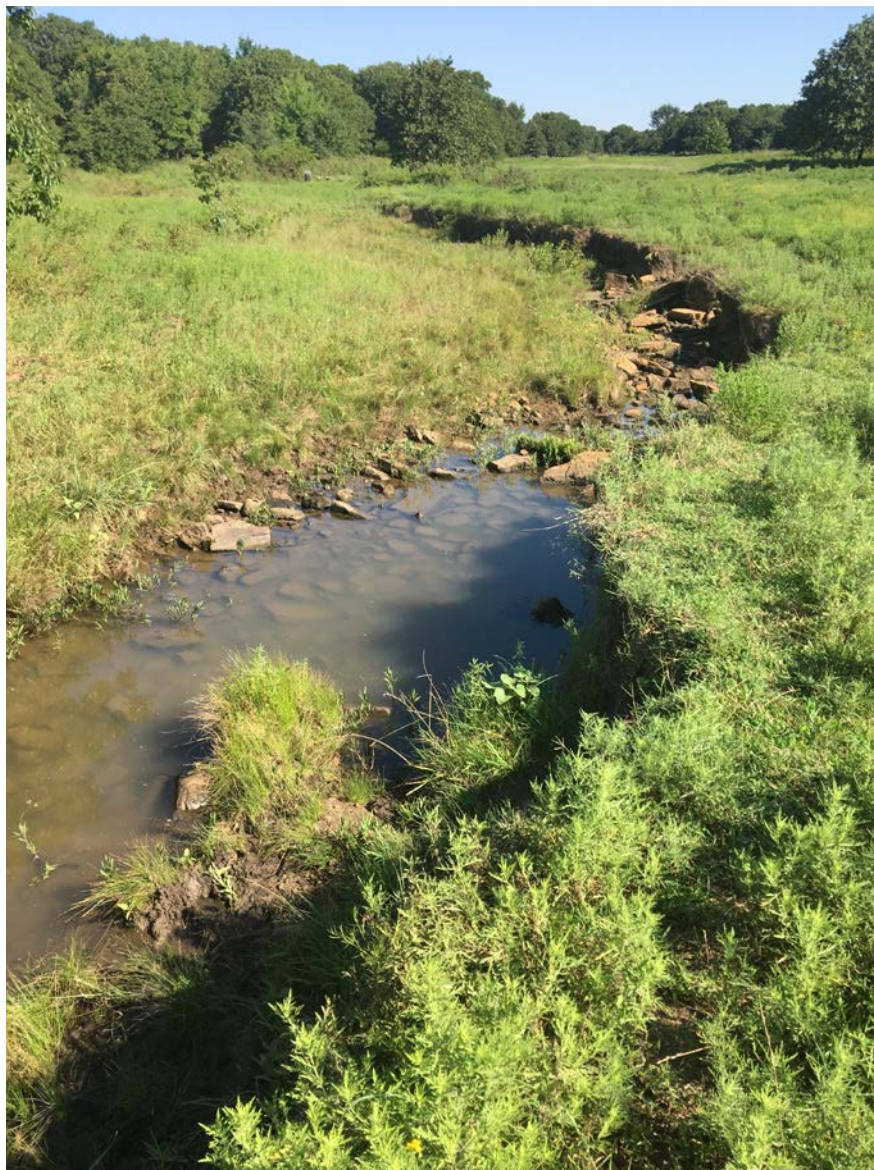
Photo No. 18

Description: This was Elm Creek between dam three and dam four. I observed bed and bank at this location.

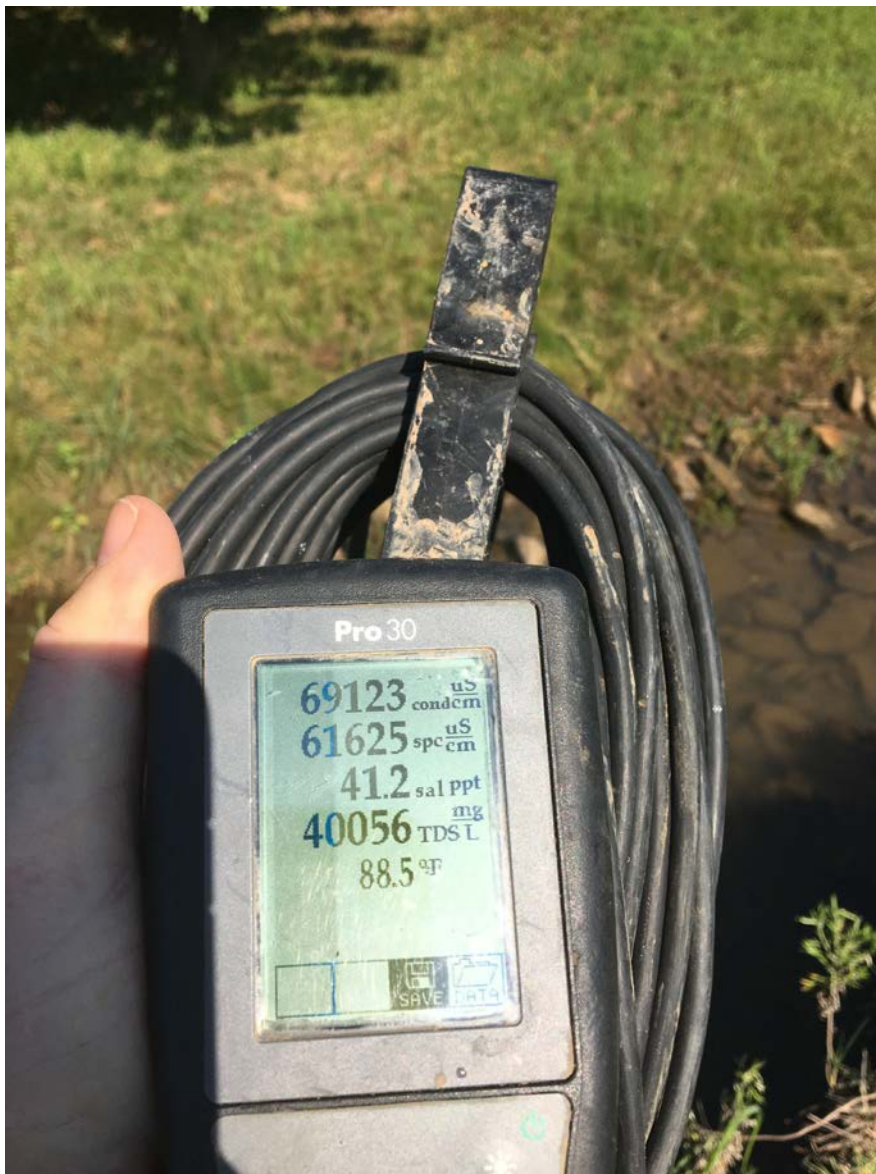
Photo No. 19

Description: The TDS was 40,056 mg/L in the creek shown at the location in Photo 18.

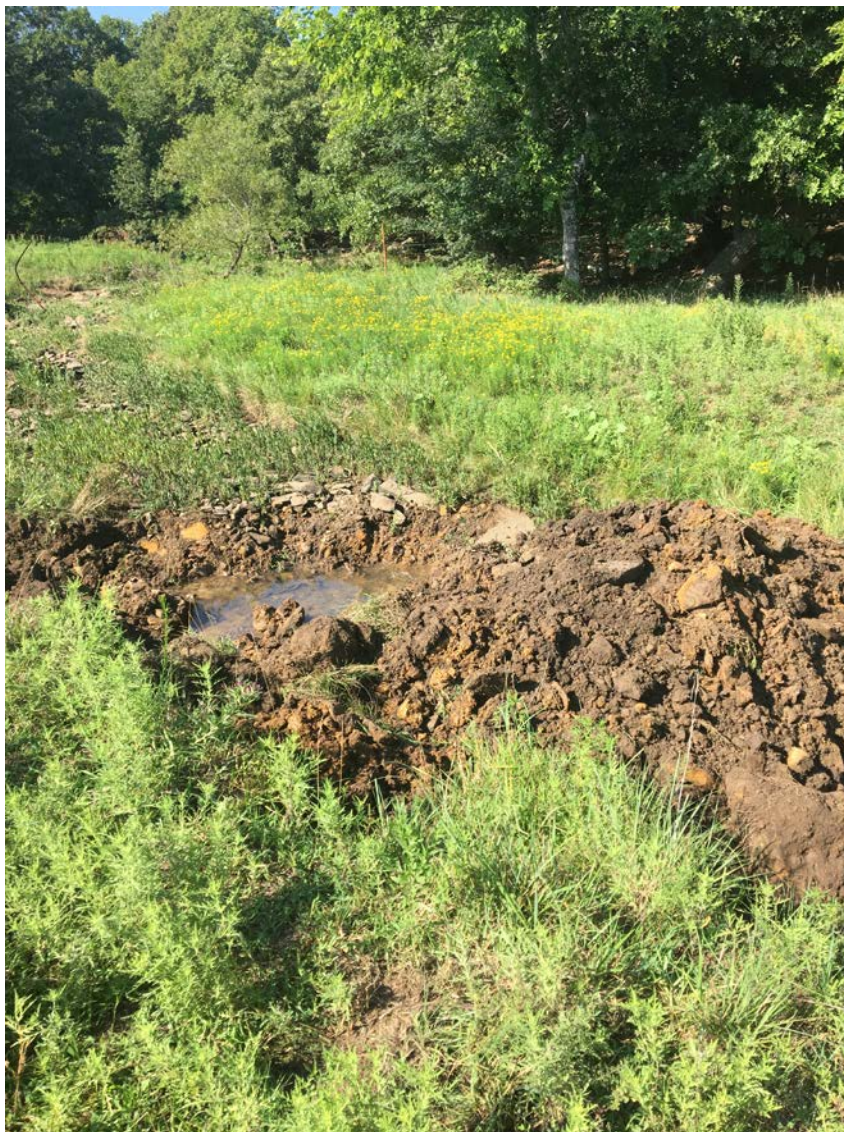
Photo No. 20

Description: This was dam number 4 south of the brine tank and discharge in Elm Creek.

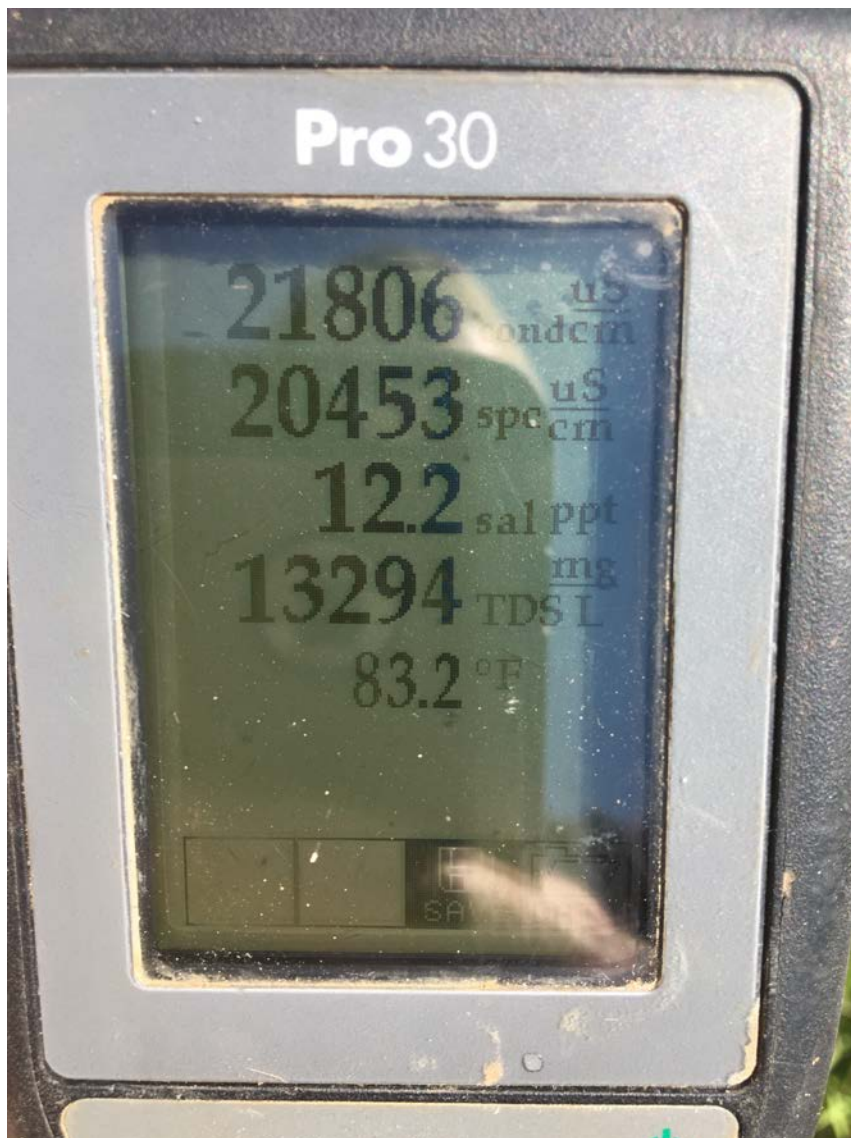
Photo No. 21

Description: The TDS at the dam four location was 13,294 mg/L. There was no flow past this point due to trucks pumping and hauling out fluids from Elem Creek.

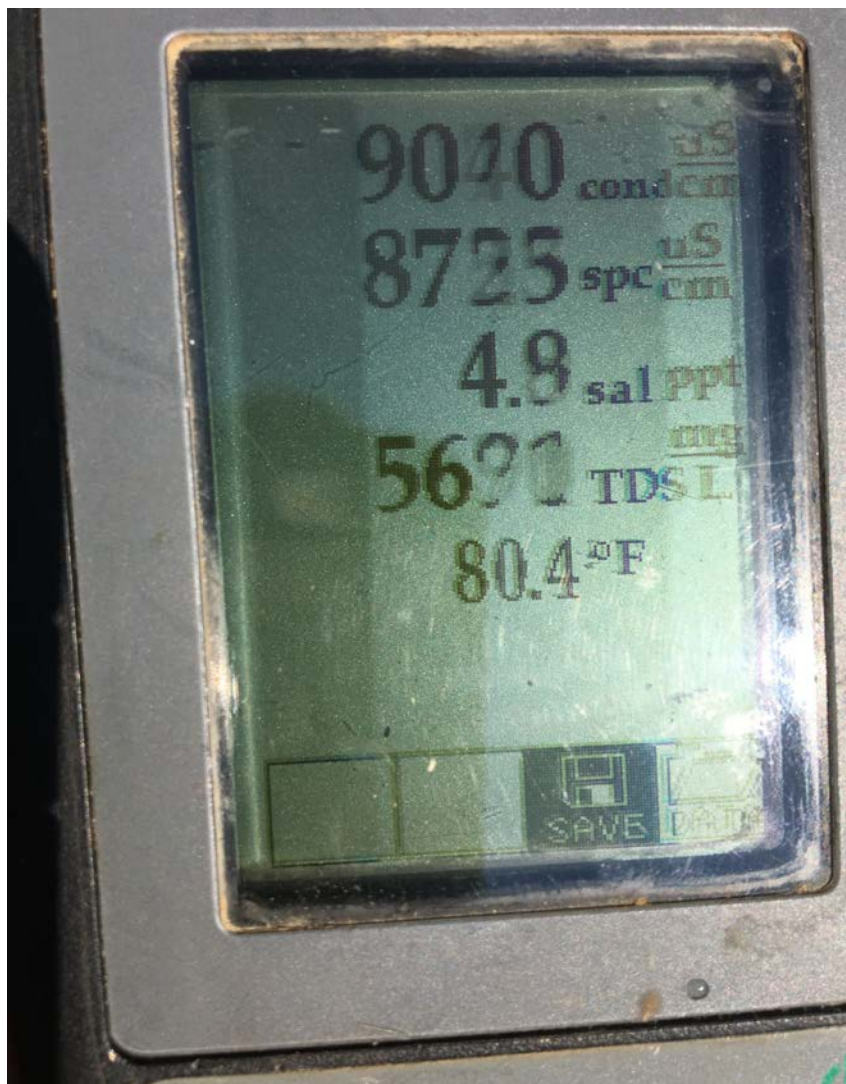
Photo No. 22

Description: The TDS on the downstream side of the dam was 5,692 mg/L due to some seepage at the dam in Elm Creek.
