**Region 6 Compliance Assurance and Enforcement Division  
INSPECTION REPORT**

| Inspection Date(s): | July 25, 2018 and August 9, 2018 | | |
| Company Name: | <b>4D Oil and Gas, LLC</b> | | |
| Facility Name: | <b><i>South Cedar Creek</i></b> | | |

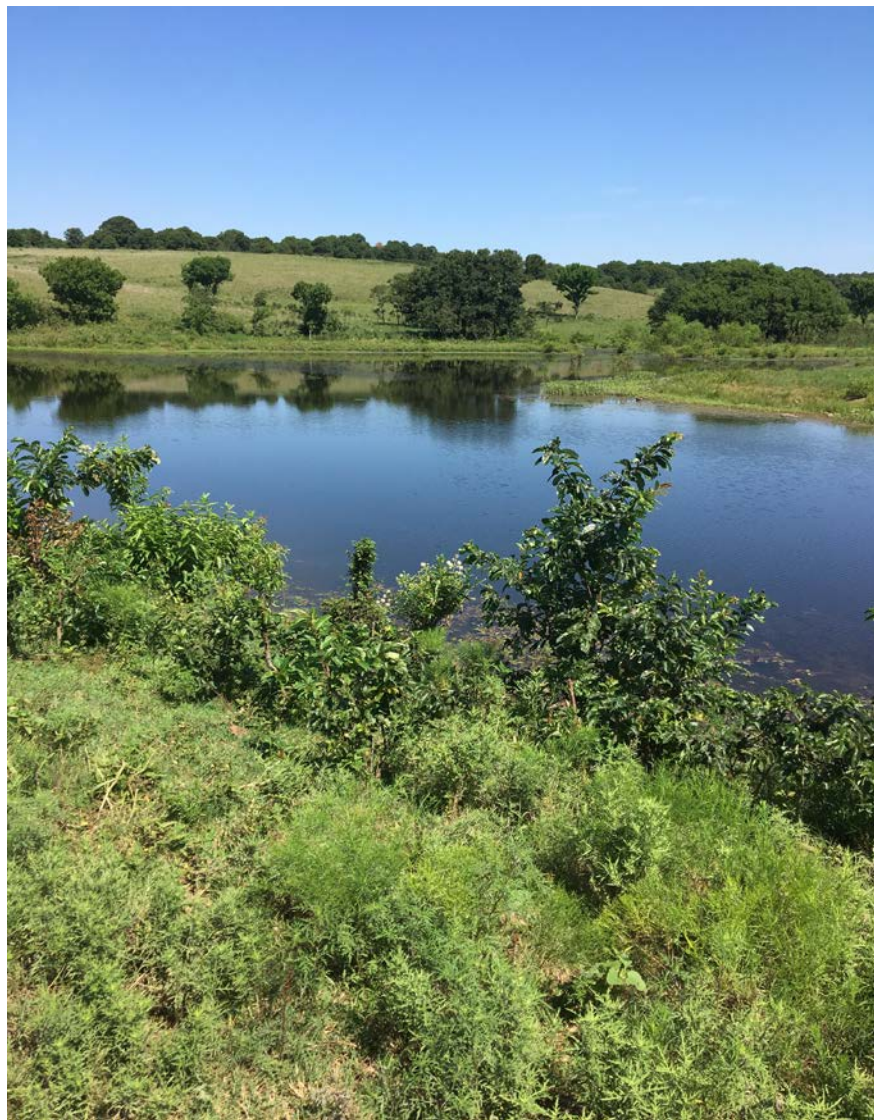
Photo No. 23

Description: This pond was located above the discharge entry point and was built on Elm Creek. It was nearly full at the time of the inspection and I observed fish in the pond.

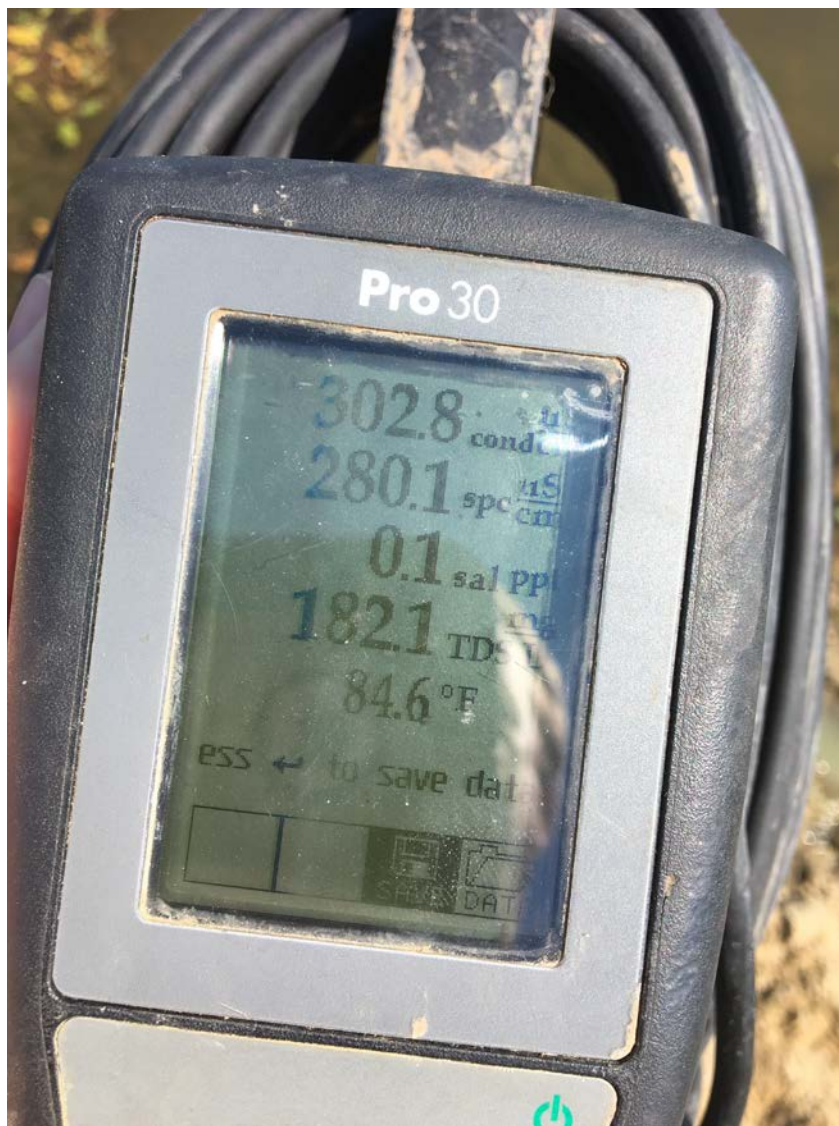
Photo No. 24

or north of the discharge site (Photo 23). The TDS of the drainage and spring water into the pond was 182 mg/L (Photo 24).

Description: The TDS of the pond was 182 mg/L. There was some seepage from the pond south to Elm Creek.

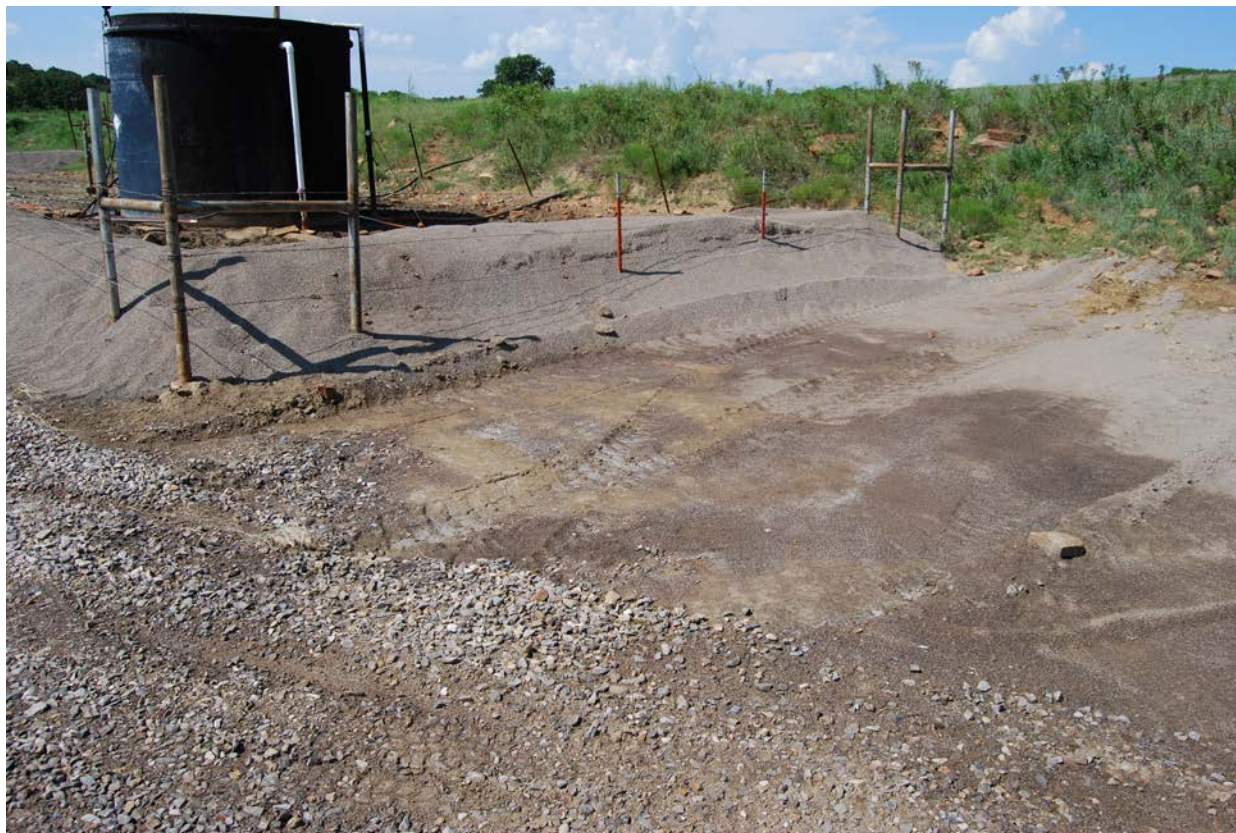
Photo No. 25

Description: I observed that some remedial activity had been done at the salt water facility. I observed brine staining and some leaks from the containment area near the corners of the berm.

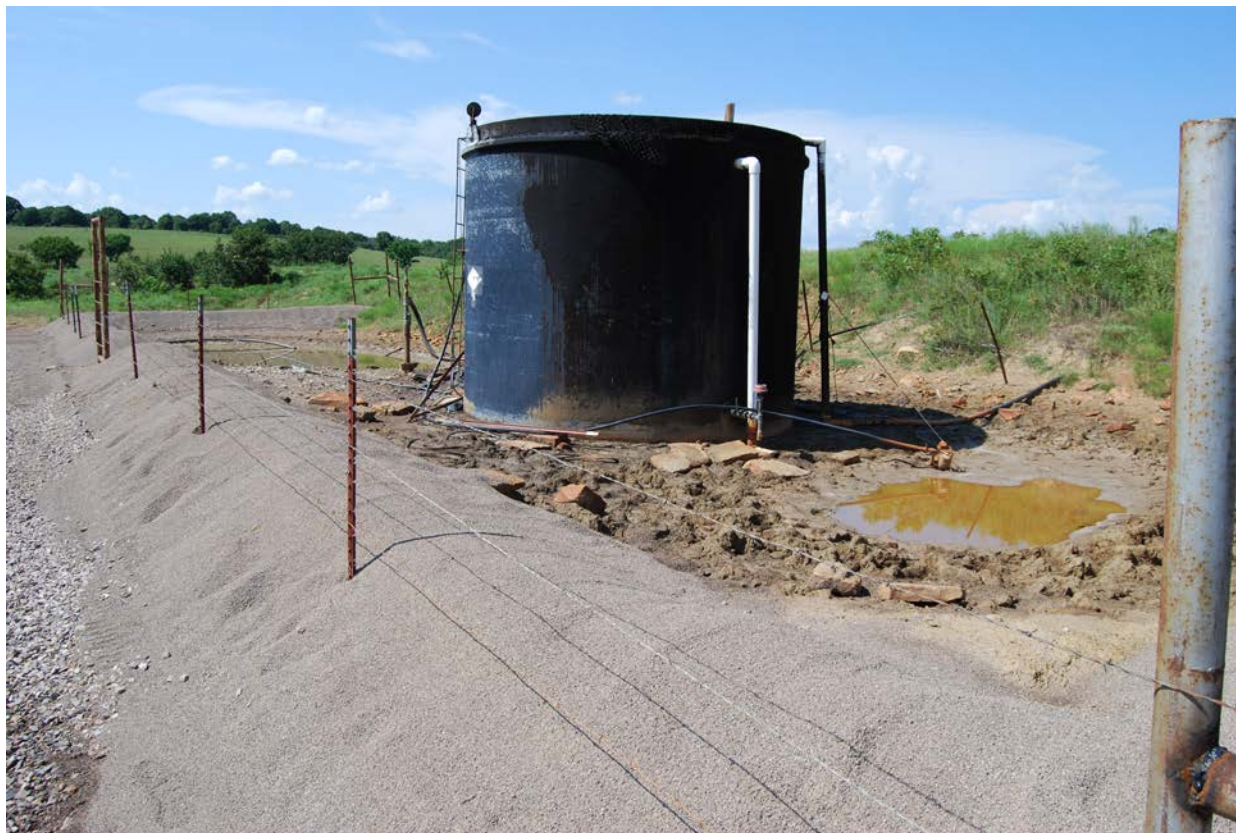
Photo No. 26

Description: The discharge that occurred on 07/25/2018 originated here. I observed that the recent work on the berm of the secondary containment area still had soil inside the containment that was not removed. There were fluids seeping from the base of the berm.

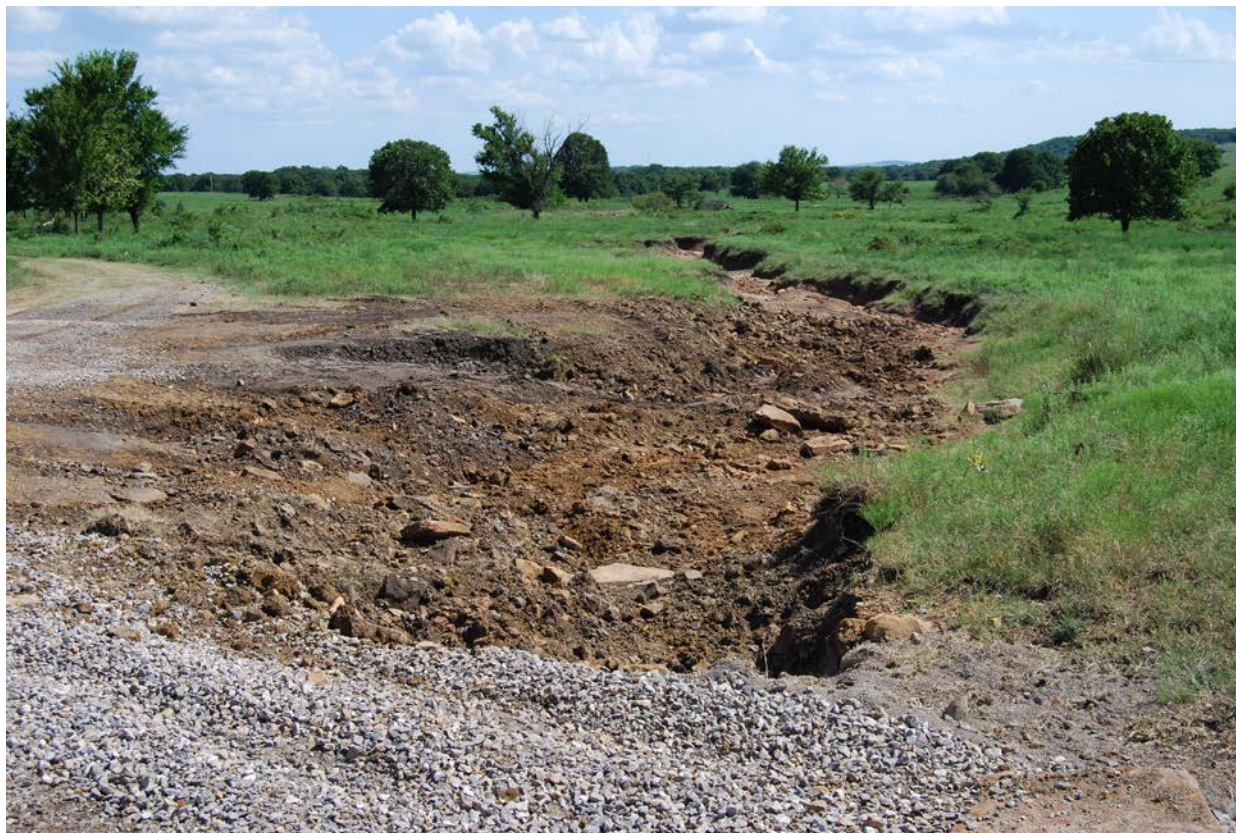
Photo No. 27

Description: There was some dirt that was removed along the flow path in the trench that leads to Elem Creek, shown here. This location was near the salt water facility.

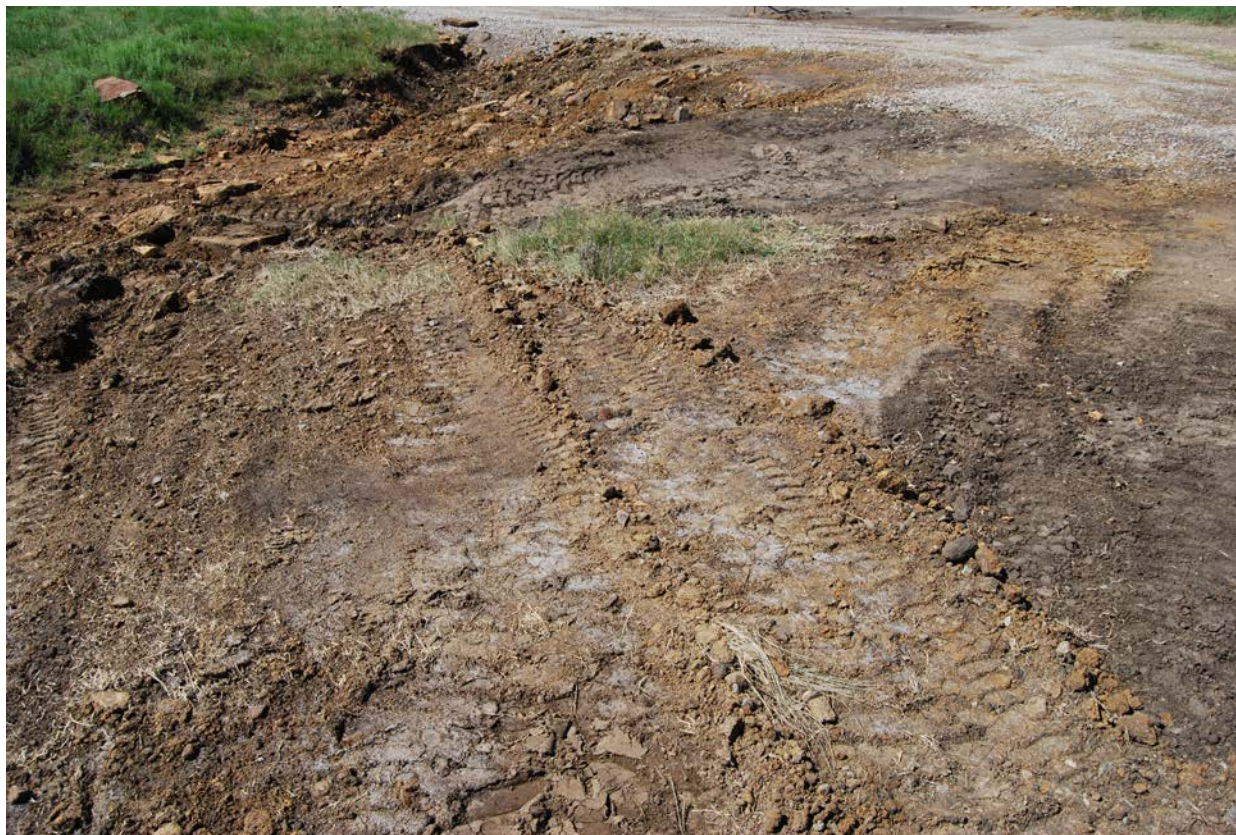
Photo No. 28

Description: I observed salt staining along the flow path again, after dirt removal, near the trench.

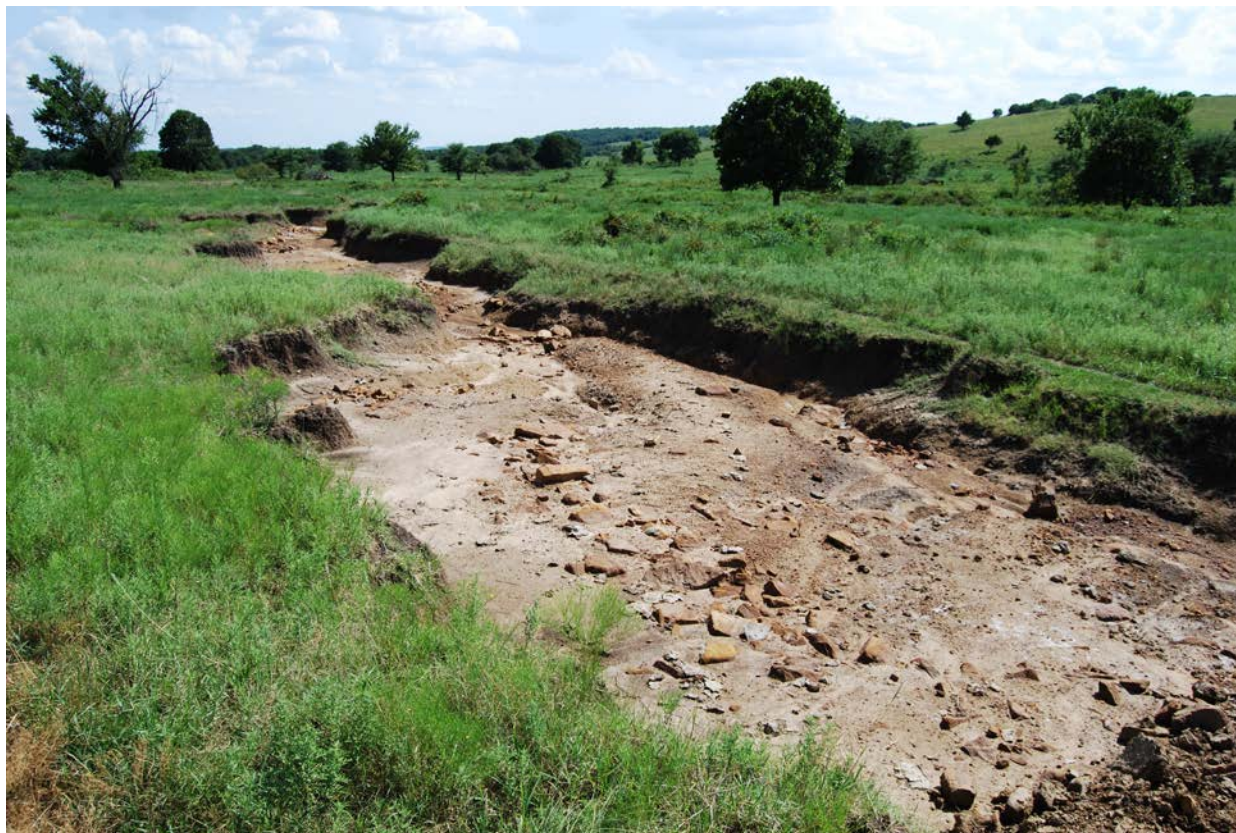
Photo No. 29

Description: I observed salt staining in the trench that had not had any remedial activity in the trench. The trench leads to Elm creek.

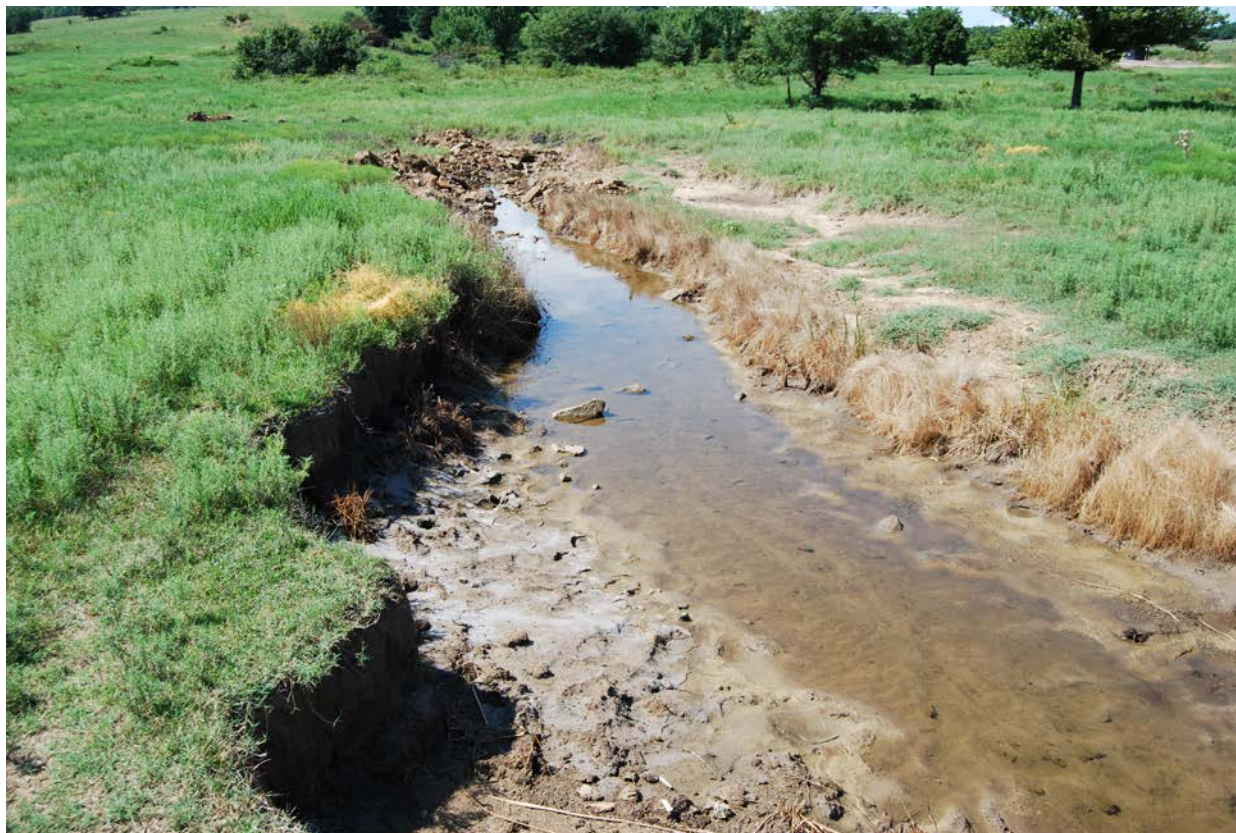
Photo No. 30

Description: This was Elm Creek just south of the trench point of entry. I observed salt staining in Elm Creek.

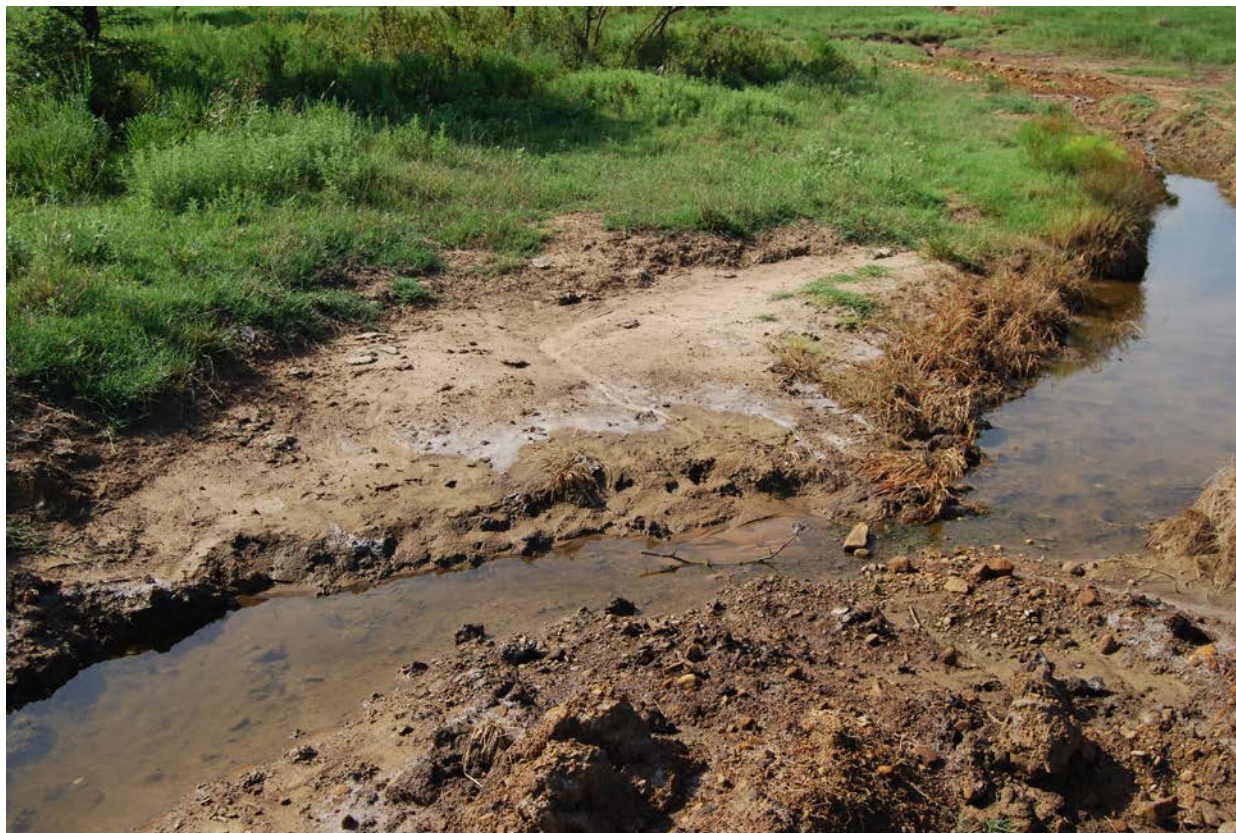
Description: I observed additional salt staining along Elm Creek, south of the point of entry.

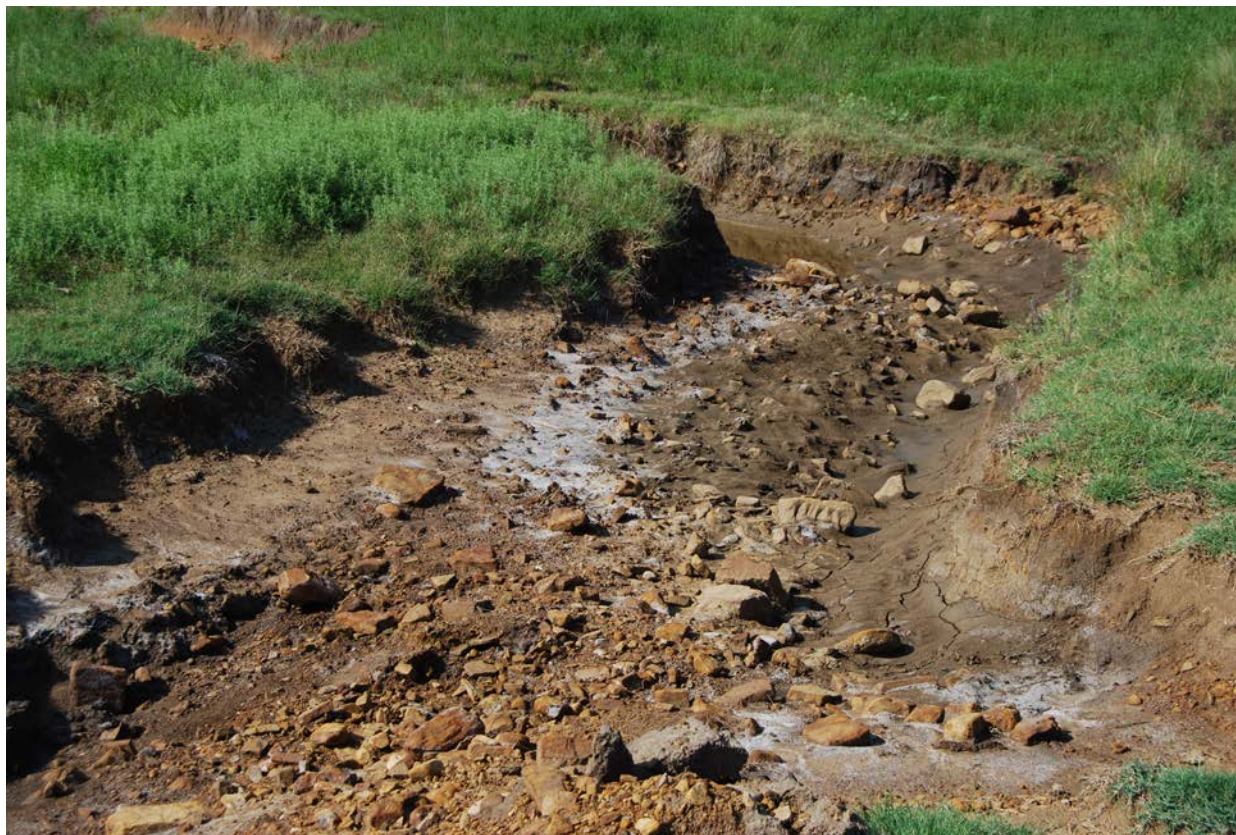
Description: I continued to observe salts and salt staining in Elm Creek south of the point of entry. This location was near Photo 32 and was stained with brine or salt.
