**Region 6 - Enforcement & Compliance Assurance Division**  
**INSPECTION REPORT**

| Inspection Date(s): | 08/03/2023 | |
| Company Name: | <b>Enlink Midstream</b> | |
| Facility Name: | <b>Lake Arlington Compressor Station</b> | |

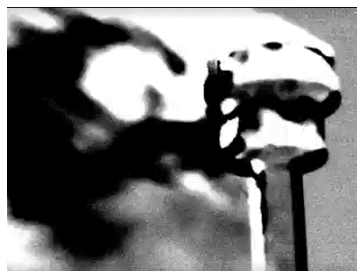
Video File Name: MOV\_0038.mp4  
Date of Video: 08/03/2023  
Time of Video: 8:41 am  
Videographer: Uma Lad  
Description: TANK-3

the process water tanks' pressure relief valves (PRVs) with the OGIC and observed emissions from the TANK-3 PRV, (see MOV\_0038 and MOV\_0039 in **Video log, Appendix 2**) and TANK-4 PRV, (see MOV\_0040 in **Appendix 2**, AOC 1). Mr. Burke explained that the tanks had been emptied before EPA's arrival on-site and the emissions were associated with flashing at the time of the inspection.

- 1) Emissions observed from the PRV's on Tank-3 and Tank-4 with the OGIC. During the closing conference, Mr. Burke stated that tanks were off-loaded prior to the on-site observation and the emissions were associated with flashing.

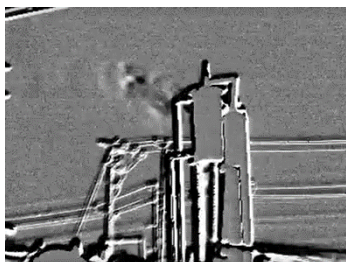
Video File Name: MOV\_0042.mp4

We continued from the process water tanks to a compressor (COMP-9). We observed emissions from COMP-9 near the pocket valve with the OGIC (see MOV\_0041 in **Appendix 2**, AOC 2). We then moved to another compressor (COMP-8). We observed emissions from COMP-8 from the compression chamber with the OGIC (see MOV-0042, **Appendix 2**, AOC 3).

- 3) Emissions observed at Compressor-8 near the compression chamber observed with the OGIC. Compressor-8 is not listed in the Facility emissions summary in the Facility's permit.

Description: COMP-8

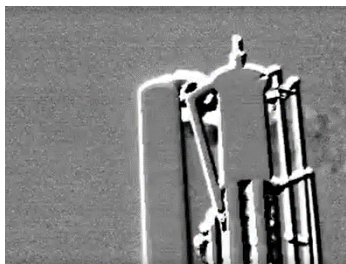
Video File Name: MOV\_0043.mp4

After the compressors, we went to the glycol dehydration units (GS-02 and GS-03). Mr. Carey explained the dehydration units work in parallel and are identical. He showed us that each dehydration unit has its own reboiler and that the reboilers use gas from the process for heat. Each component of this system was observed with the OGIC. Emissions were observed from GS-02 at the reboiler stack (see MOV\_0043 in **Appendix 2**, AOC 4) and from GS-03 at the reboiler stack (see MOV\_0044 in **Appendix 2**, AOC 5).

- 4) Emissions observed at the reboiler stack for the Glycol Dehydrator-02 with the OGIC. During the closing conference, Mr. Burke noted that possible emissions observed could be due to heat.

Description: GS-02
