**Well Inspection**  
**Osage DNR / Environmental Protection Agency**  
**1201 Elm Street, Suite 500**  
**Dallas, Texas 75270**

| <b>Inspection Reason</b> | Permit Application | <b>Responsible Company at Time of Inspection</b> | NuCera Solutions LLC | | |

### Photograph Log 3 Photos

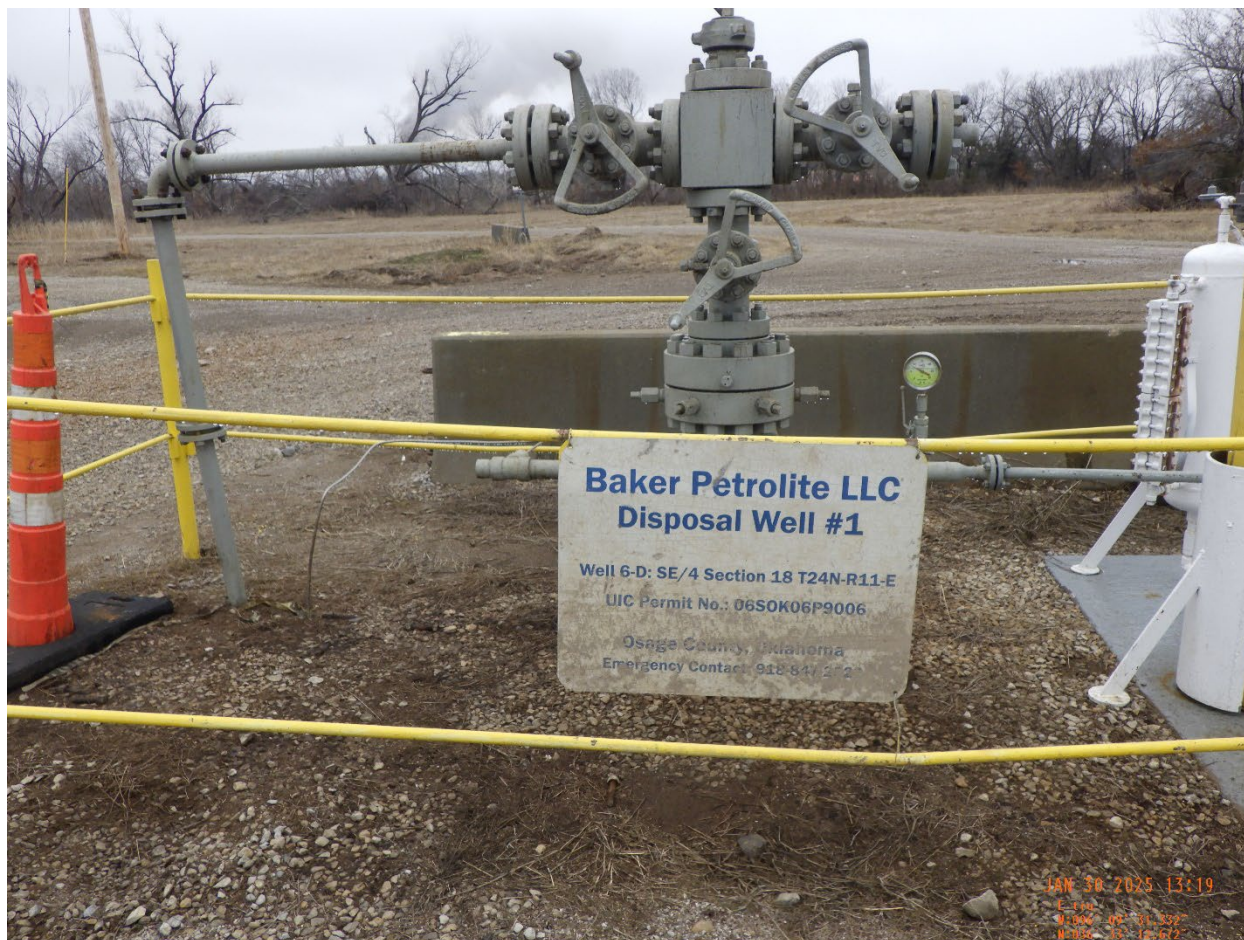
Photo No. 1

**Description:** This was the well OK9006000 at the time of the inspection.

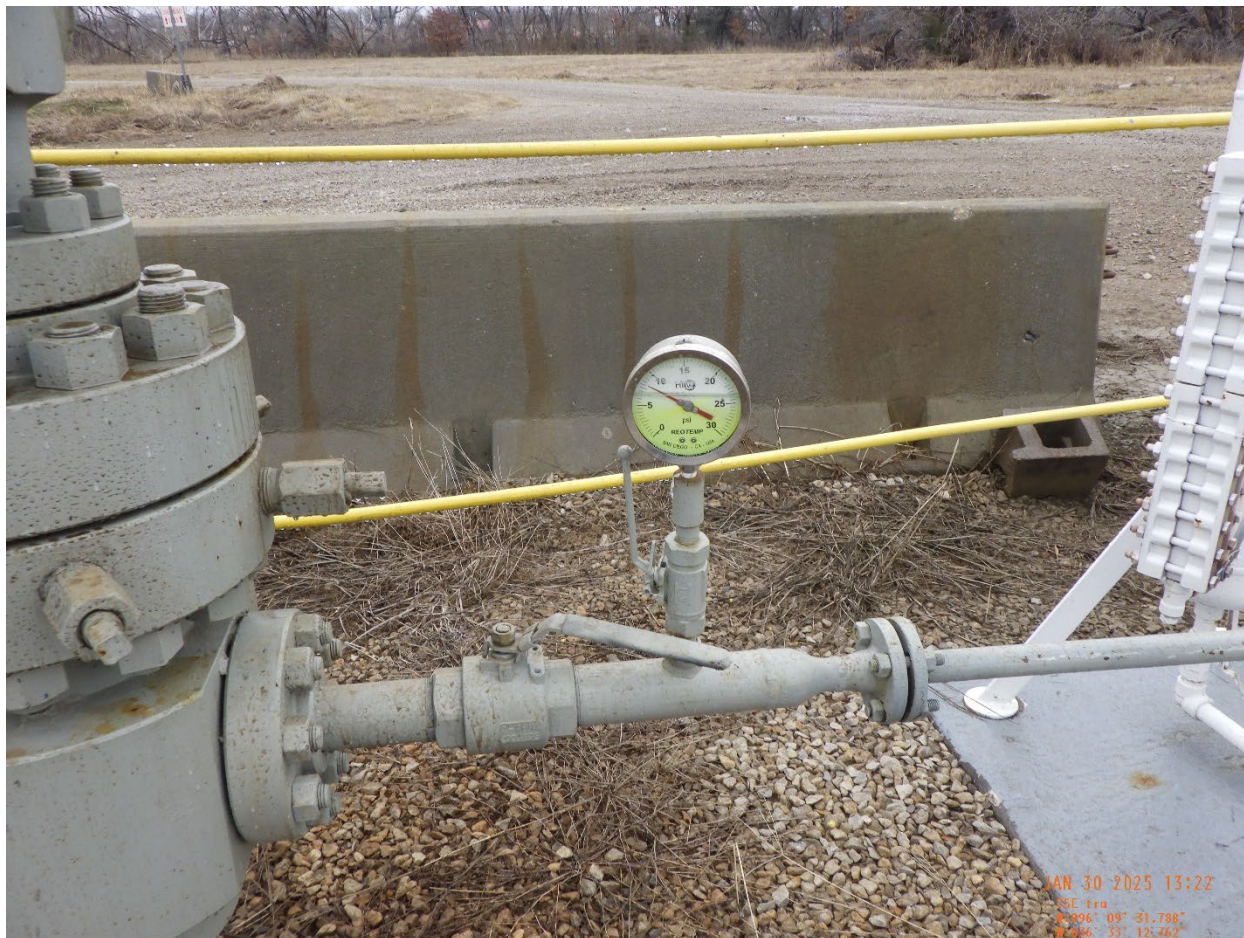
Photo No. 2

**Description:** This was the annulus pressure gauge displaying approximately 8psig being maintained on the annuls of the well.

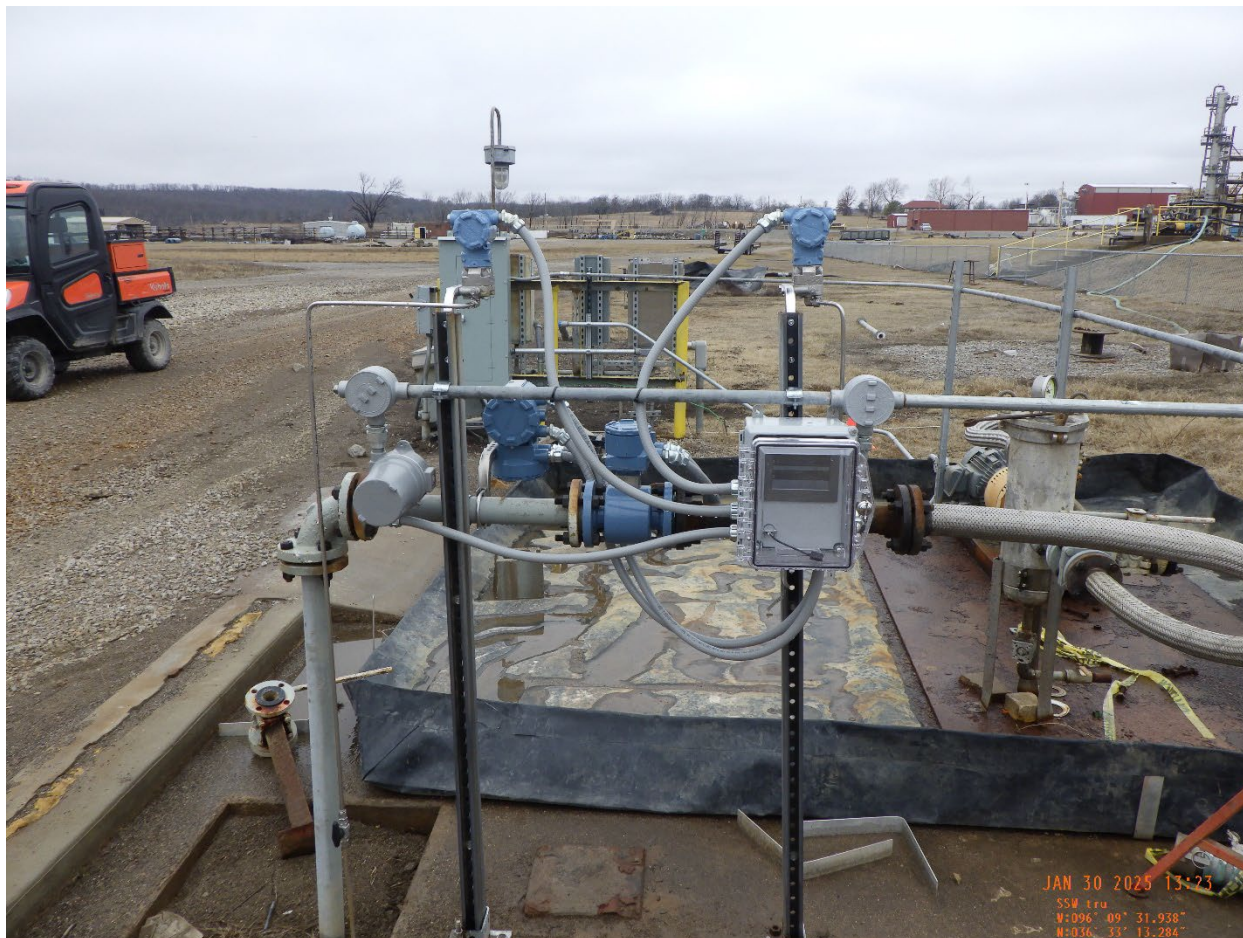
Photo No. 3

**Description:** This was the meter run and continuous tubing/annulus monitoring equipment which was connected to the well at the time of the inspection.
