## INSPECTION REPORT

| <b>Type of Inspection</b> | Compliance Evaluation Inspection | | |
| <b>Facility or Site Name</b> | Olympic Sunset View Apartments | | |
| <b>Permit Number</b> | WAR309504 | | |

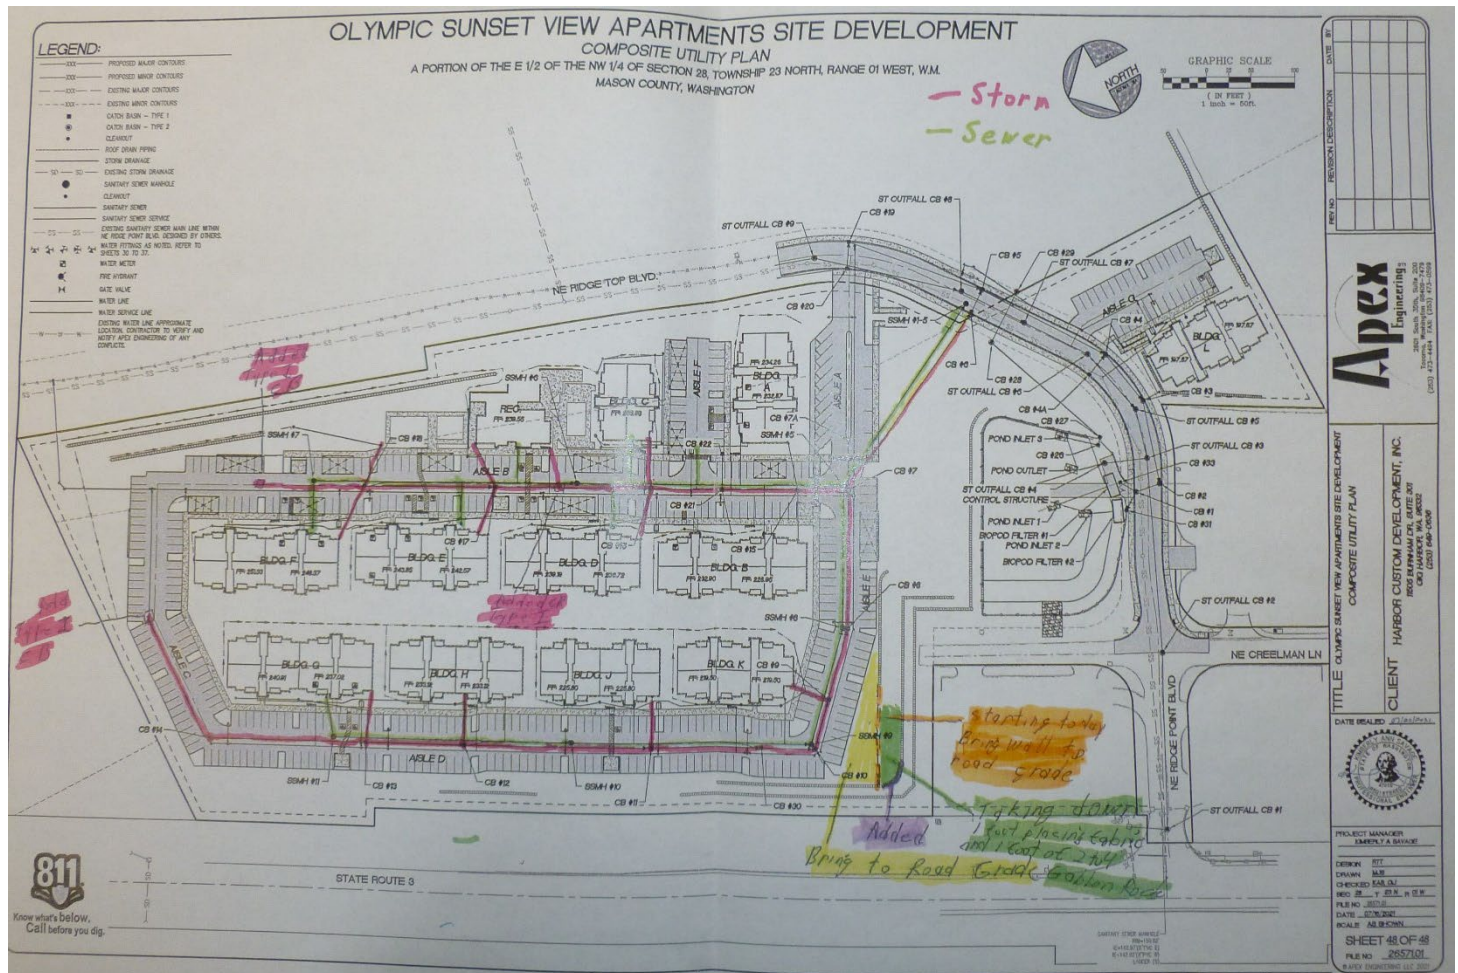
| At the time of the inspection, I reviewed the site's SWPPP map. The map is being used as a living document and is being updated periodically. However, the map appears to be missing some elements required by the permit. The SWPPP map is missing the locations of structural and non-structural BMPs; approximate slopes, contours, and direction of stormwater flow before and after major grading activities; and areas where final stabilization has been accomplished and no further construction-phase permit requirements apply. | |

| The SWPPP map, shown below, was missing the locations of structural and non-structural BMPs; approximate slopes, contours, and direction of stormwater flow before and after major grading activities; and areas where final stabilization has been accomplished and no further construction-phase permit requirements apply. | |
