**Report Title:** Clean Air Act Inspection of Collision Auto Clinic  
**Inspection Date(s):** December 5, 2023  
**Regulatory Program(s):** NESHAP

**Company Name:** Same as below  
**Facility Name:** Collision Auto Clinic  
**Facility Location:** 2206 Lawrence Avenue NE,  
Washington, DC 20018

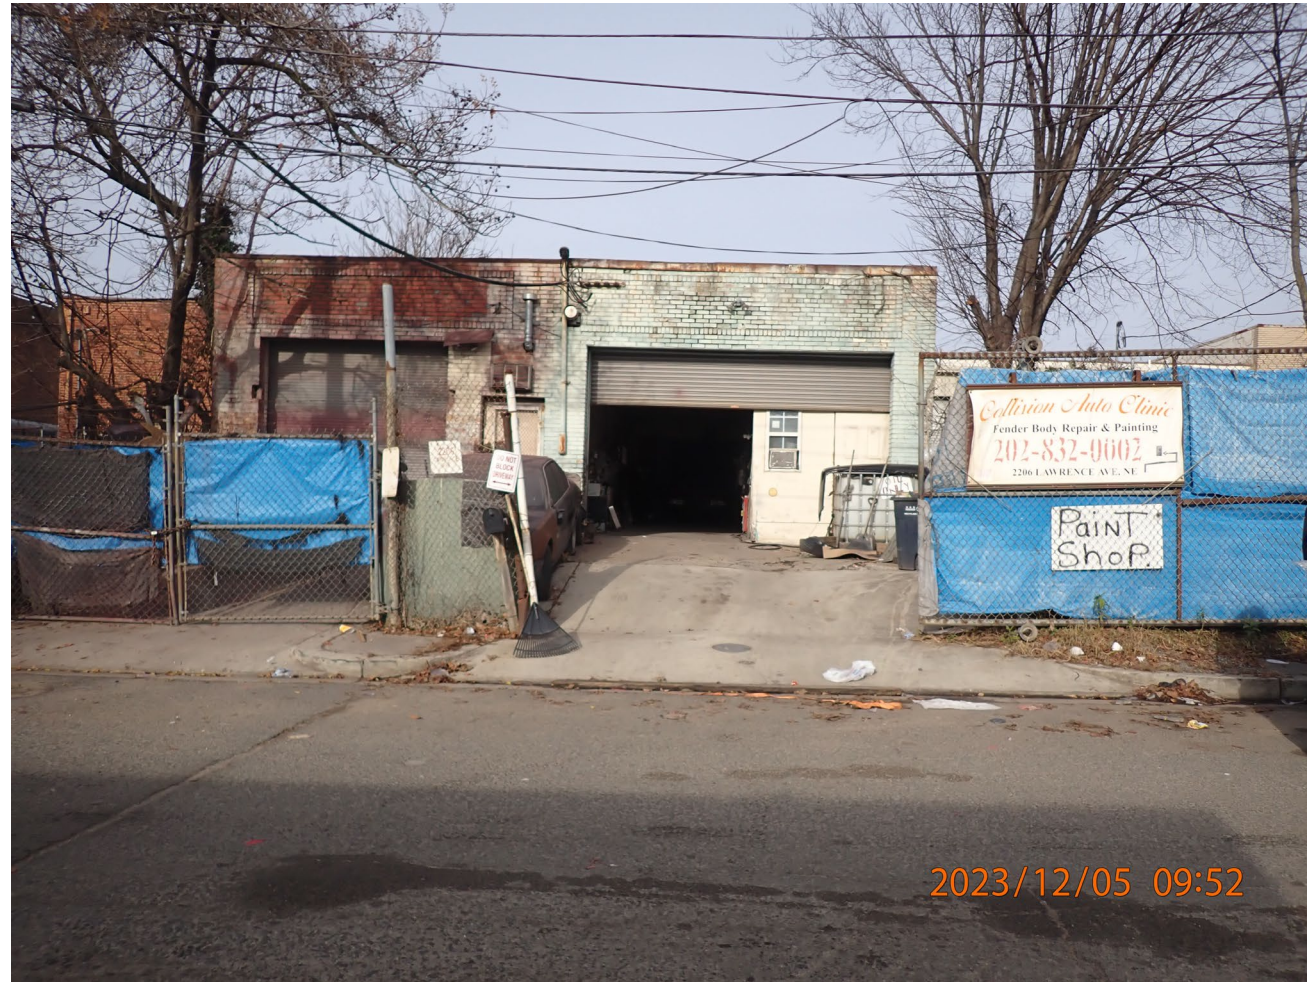
Photo Number: 1

Photo Description: Collision Auto Clinic overview

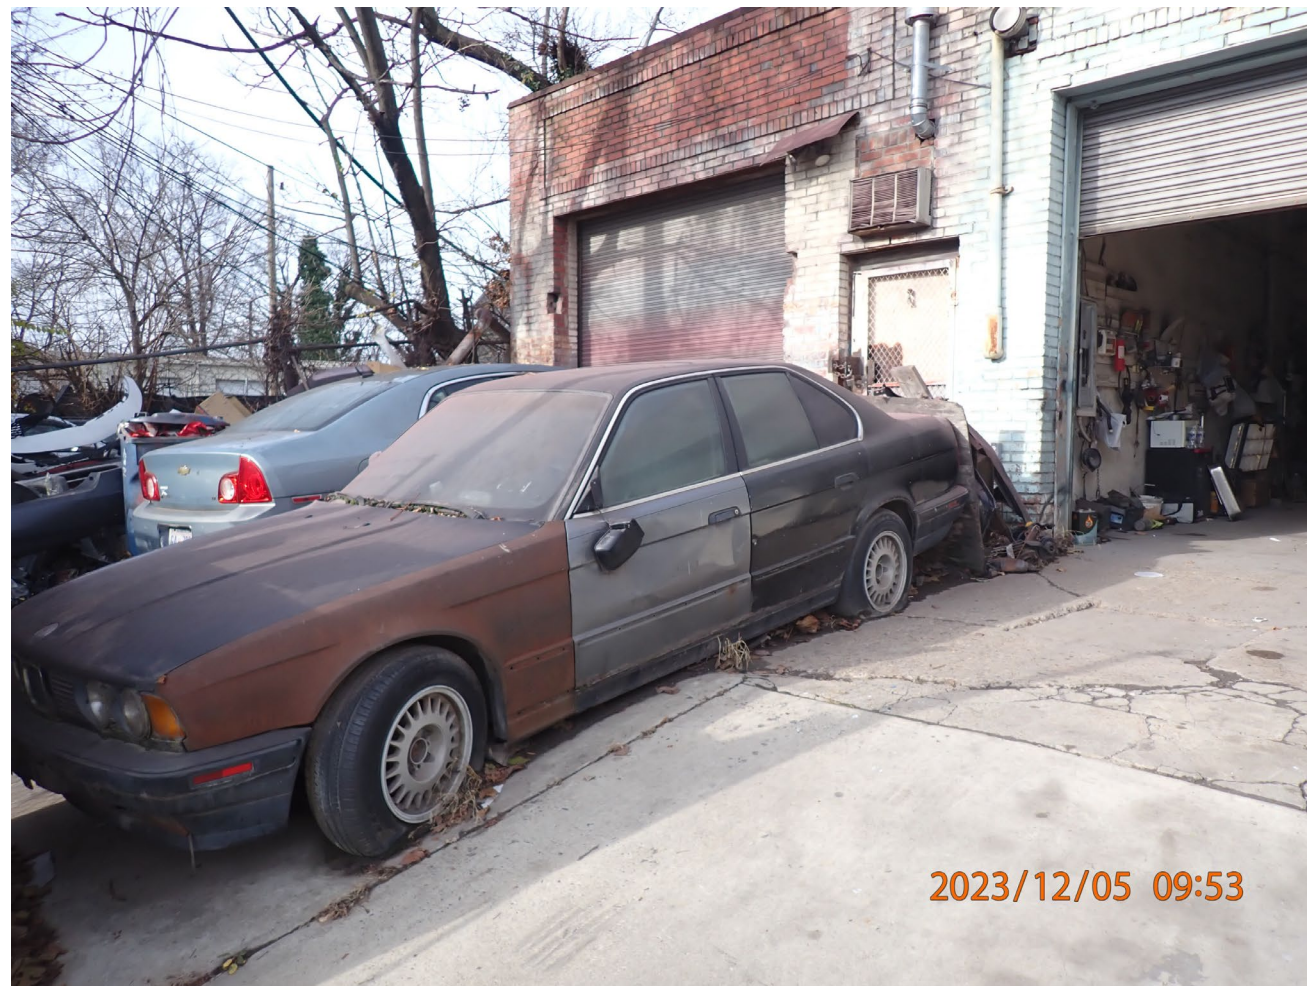
Photo Number: 2

Photo Description: Two garage bays

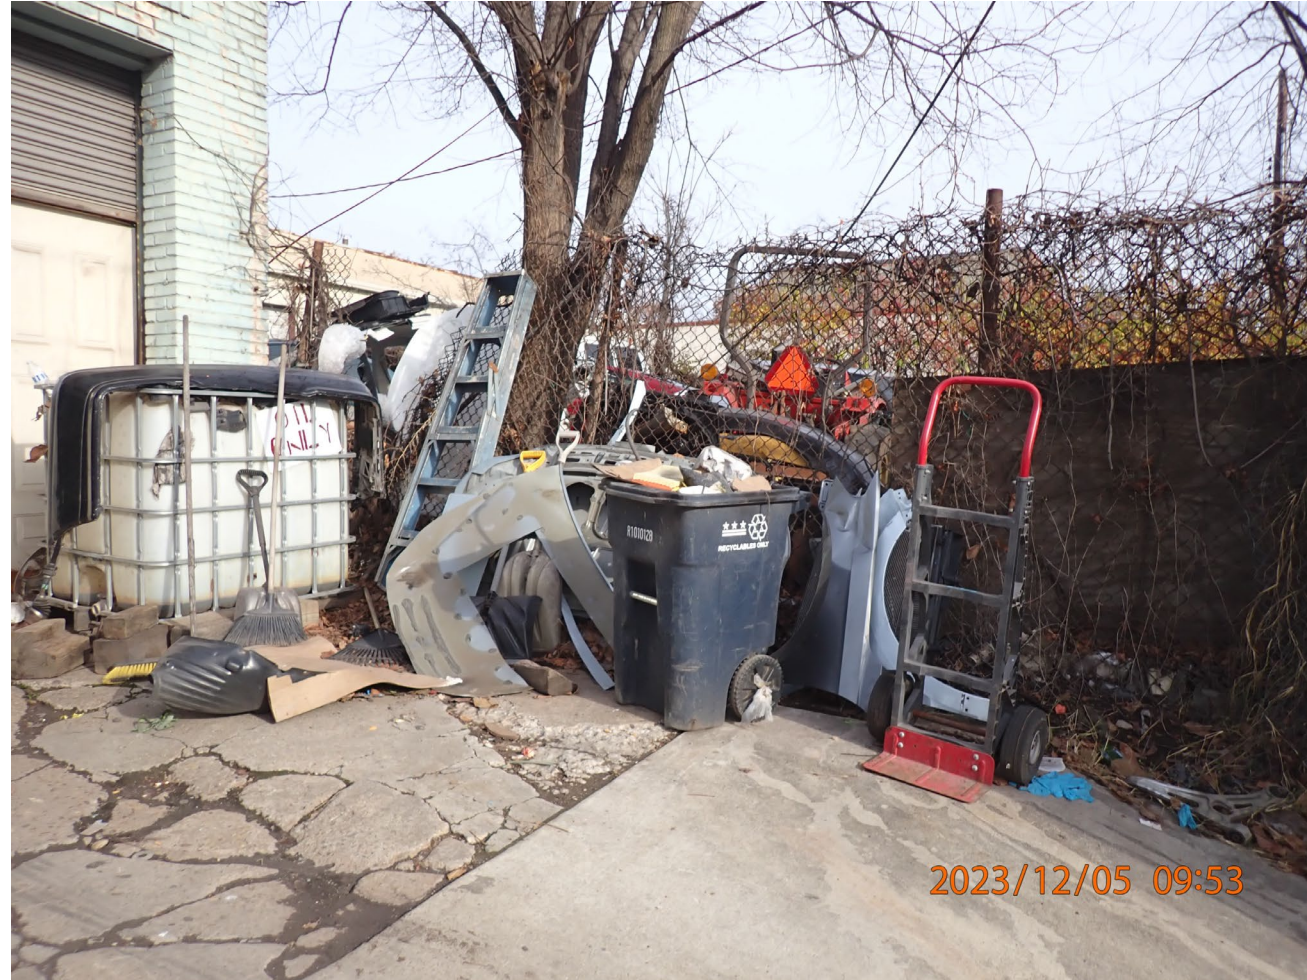
Photo Number: 3

Photo Description: Collision Auto Clinic building exterior

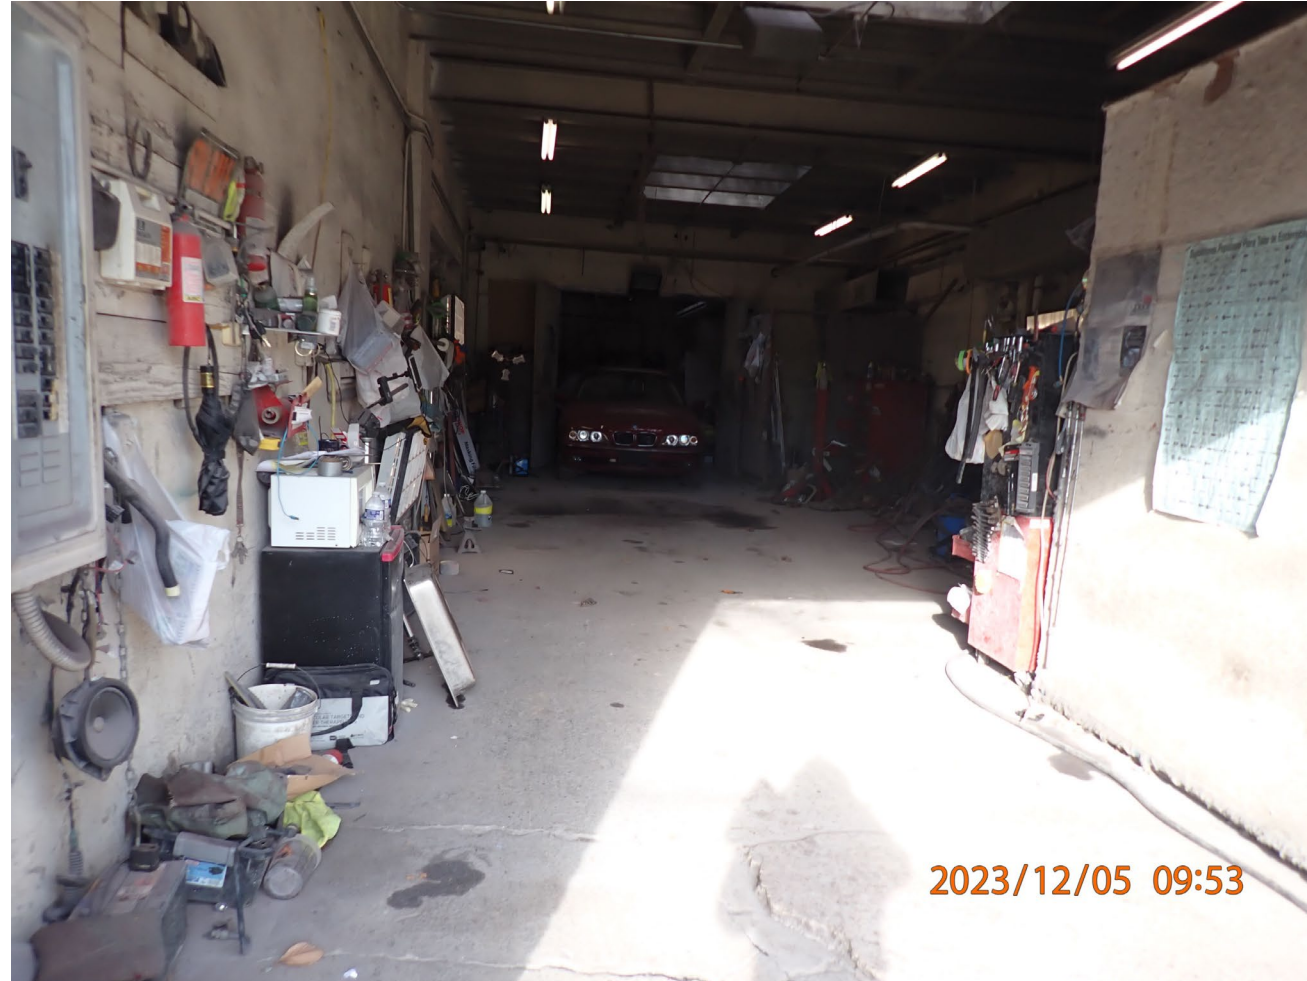
Photo Number: 4

The garage was a single bay which was deep enough to hold four cars. Since there was no paint booth to inspect, the inspection team first observed his spray guns which were located near the rear of the garage. The inspection team noted the following spray guns, some of which had limited identifying markings: H827W; H827W; HVLP Starting Line; STM HVLP; Tekna; HVLP; HVLP SATA jet NR 2000; LS 400; and Anest Iwata. The Facility stated they do not store paint, but instead only buy the paint for the job being completed. If there is any extra paint from a job, that paint will be used as a primer on another job.

Photo Description: Collision Auto Clinic garage interior

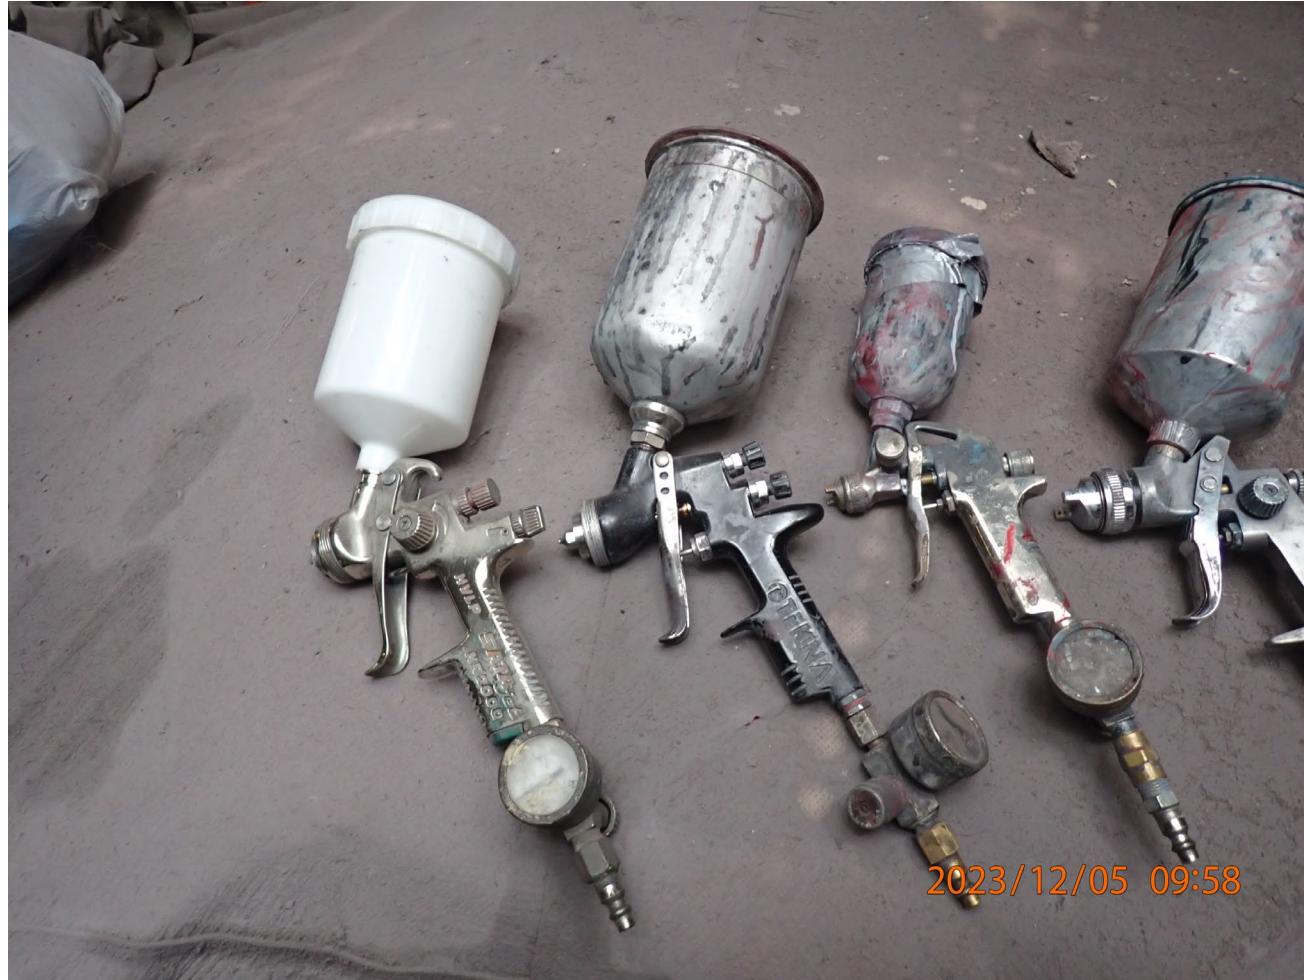
Photo Number: 5

Photo Description: Spray guns

- EPA will review the paint spray guns observed at the Facility to determine if all spray guns are high volume low pressure (HVLP), electrostatic application, airless, air-assisted airless, or an equivalent technology.
- During the inspection, the Facility did not demonstrate their spray guns were cleaned in such a way that an atomized mist or spray was not created outside of a closed container to collect the spray gun cleaning solvent.
- During the inspection, the Facility did not demonstrate that any records were being maintained as required in NESHAP 6H.

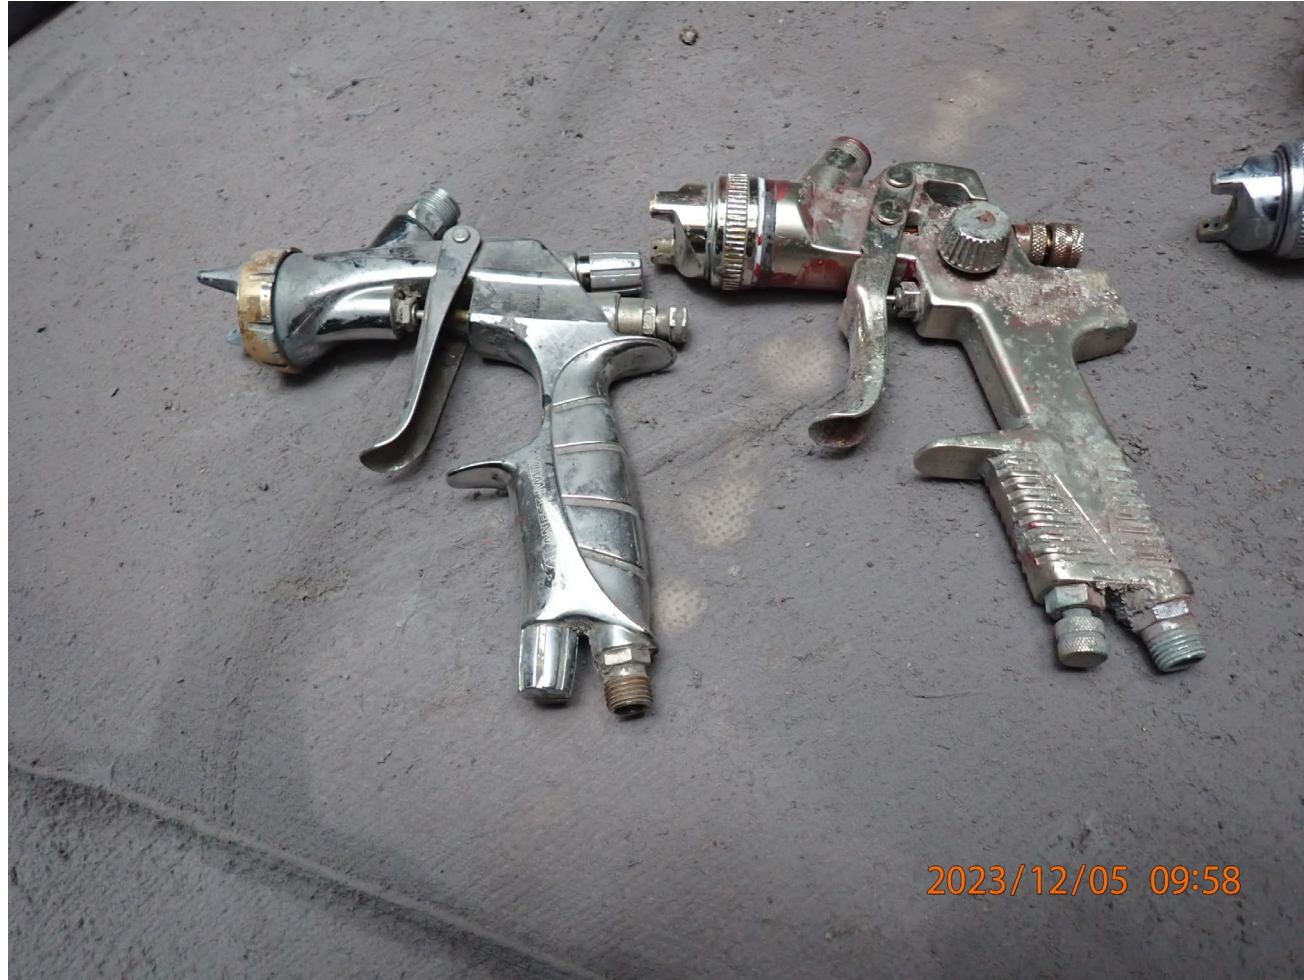
Photo Number: 6

Photo Description: Second image of different spray guns

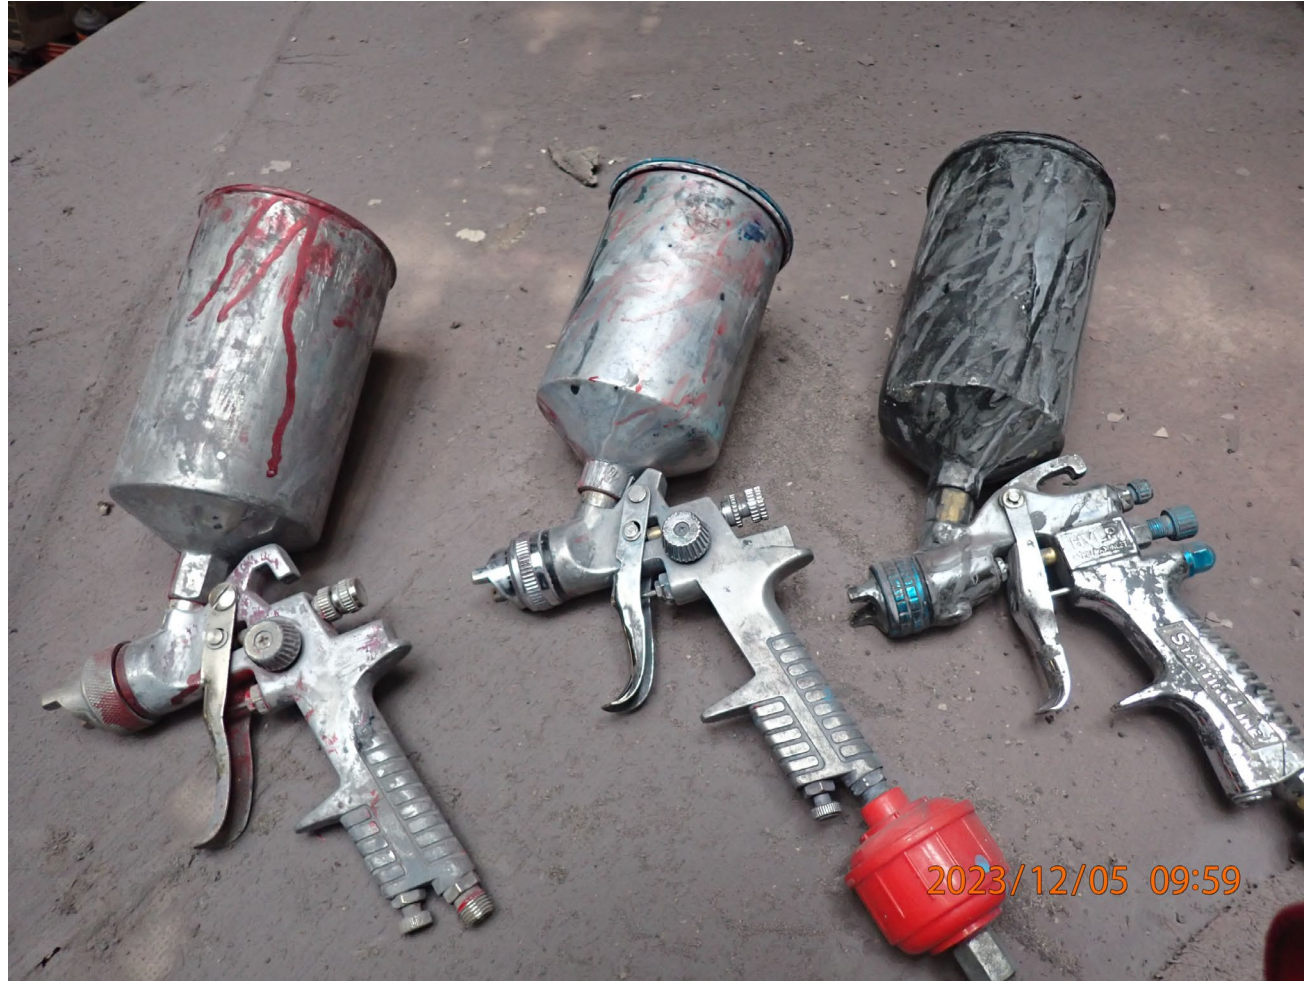
Photo Number: 7

Photo Description: Third image of different spray guns

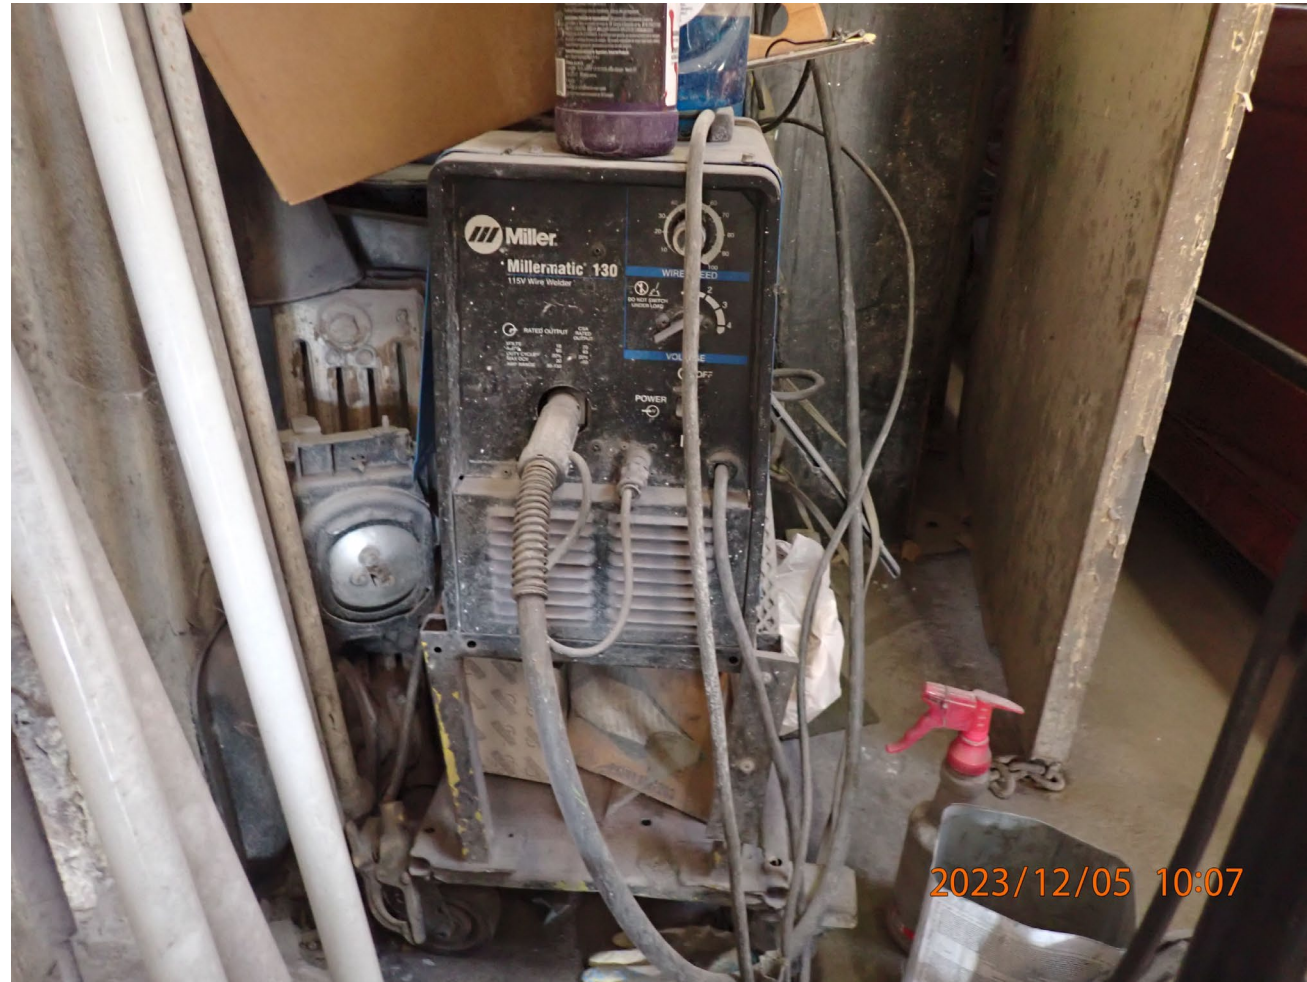
Photo Number: 8

There were two welders observed in the garage. A Millermatic 130 MIG welder and a century welder which the Facility said does not work. They stated welding is rarely done and there is no wire storage.

Photo Description: Miller Welder

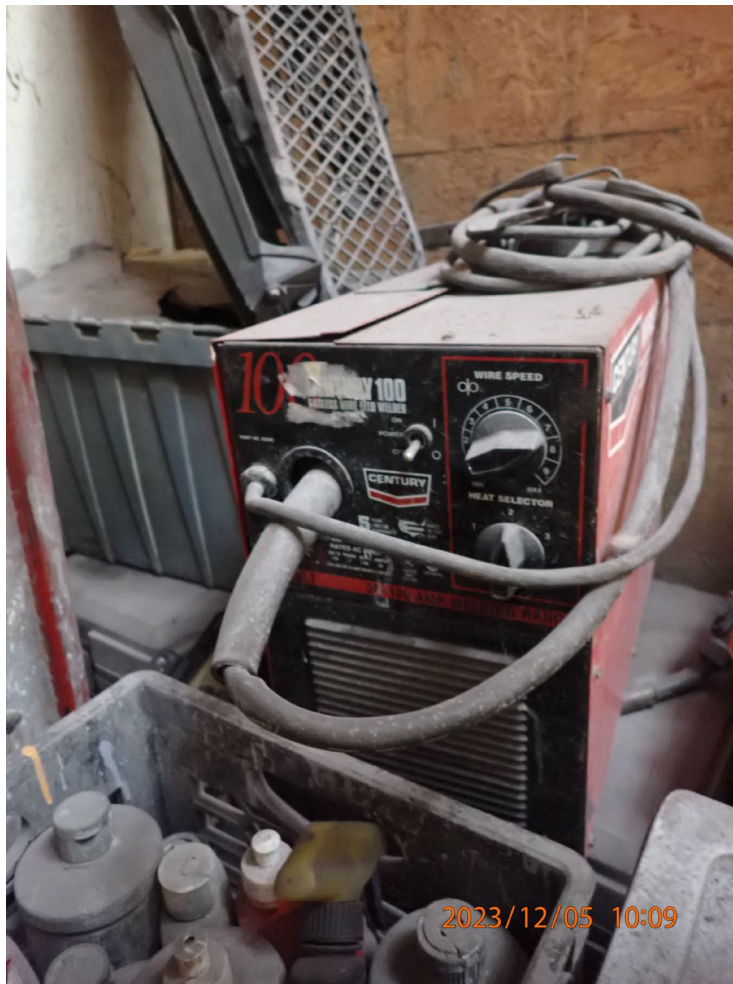
Photo Number: 9

Photo Description: Welder - not operational
