DOCUMENT DESCRIPTION: NIOSH Report - Air Sampling & Industrial Hygiene Survey - Genuine Parts Co, Rayloc

AIR SAMPLING  
&  
INDUSTRIAL HYGIENE SURVEY

GENUINE PARTS COMPANY  
RAYLOC DIVISION  
ATLANTA, GEORGIA

August, 1972

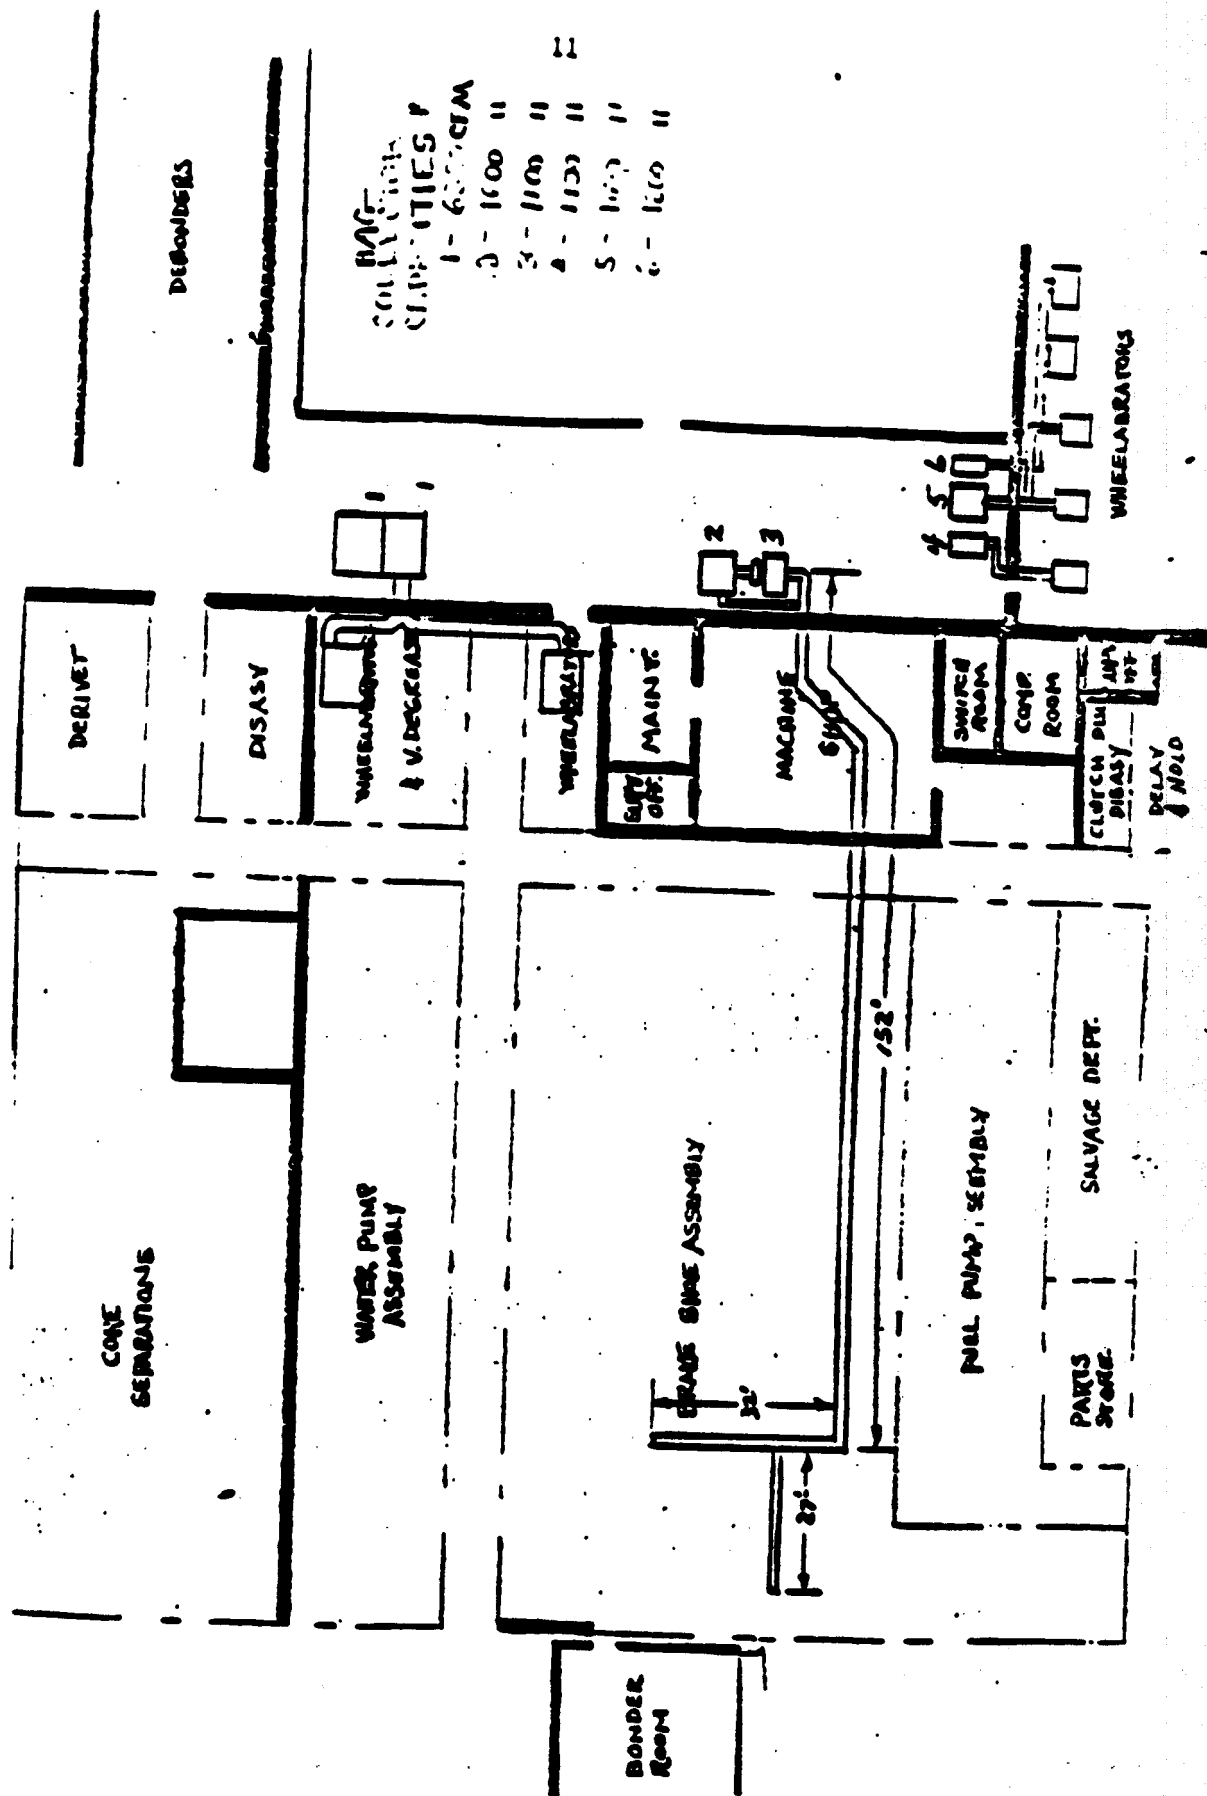
FIGURE 1: FRICTION PRODUCT LAYOUT WITH COLLECTORS

Local exhaust ventilation is provided on all 3 brake lining grinders and on all 5 "Wheelabrator" cleaning machines. These machines are vented to 6 "Wheelabrator" bag dust collectors.

Figure 1 shows a layout of the friction products area of the plant along with locations of the dust collectors and their respective capacities.

Velocity measurements at the entrance to the grinder hoods showed velocities ranging from 600 fpm to 1100 fpm. No ventilation is provided at the clutch deriveting operation.
