**Region 6 - Enforcement & Compliance Assurance Division**  
**INSPECTION REPORT**

| Inspection Date(s): | 11/08/2024 | |
| Company Name: | <b>SMI Operating Company, LLC</b> | |
| Facility Name: | <b>E Gregory #4 Tank Battery</b> | |

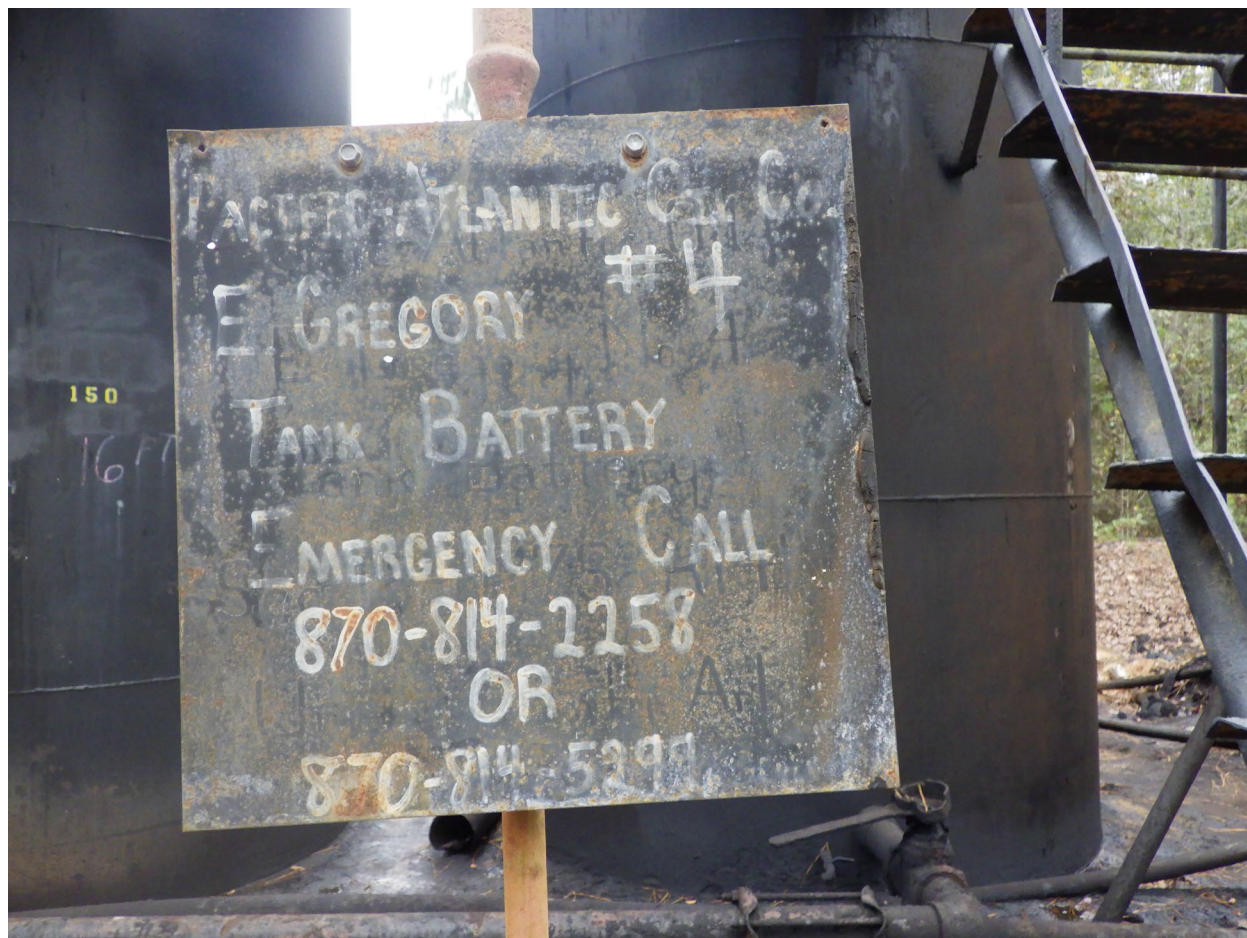
Photo No. 1

I observed the SMI Operating Company, LLC / E Gregory #4 Tank Battery facility and associated signage, secondary containment, storage tanks, and treaters/separators; see Appendix 1 (Photographs Log), see Photos No. 1 and No. 2. For additional GPS location and photo metadata, see Appendix 1.

Description: Looking SE, this photo shows the signage located at the facility.

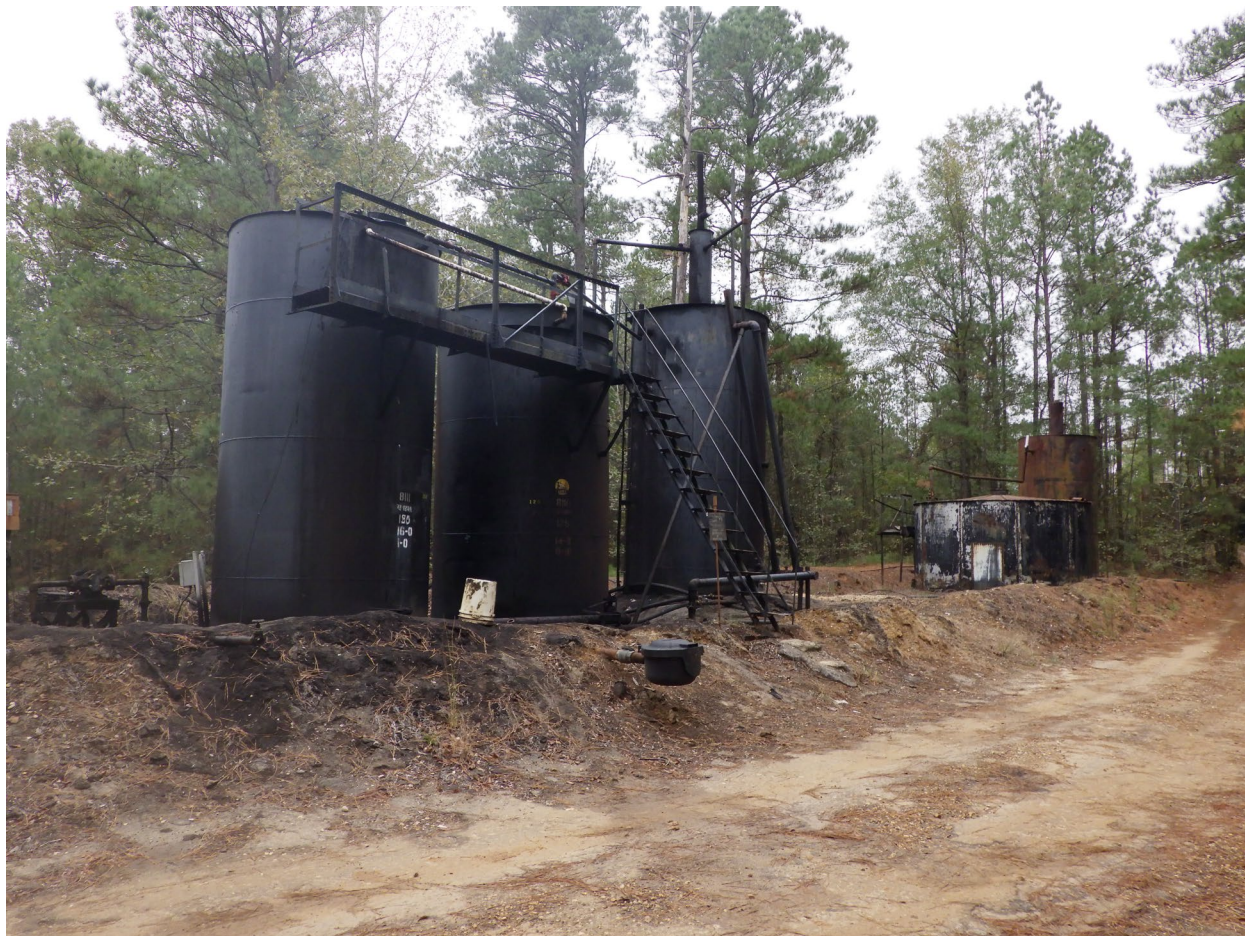
Photo No. 2

**Description:** Looking NNE, this photo shows an overview of the facility.

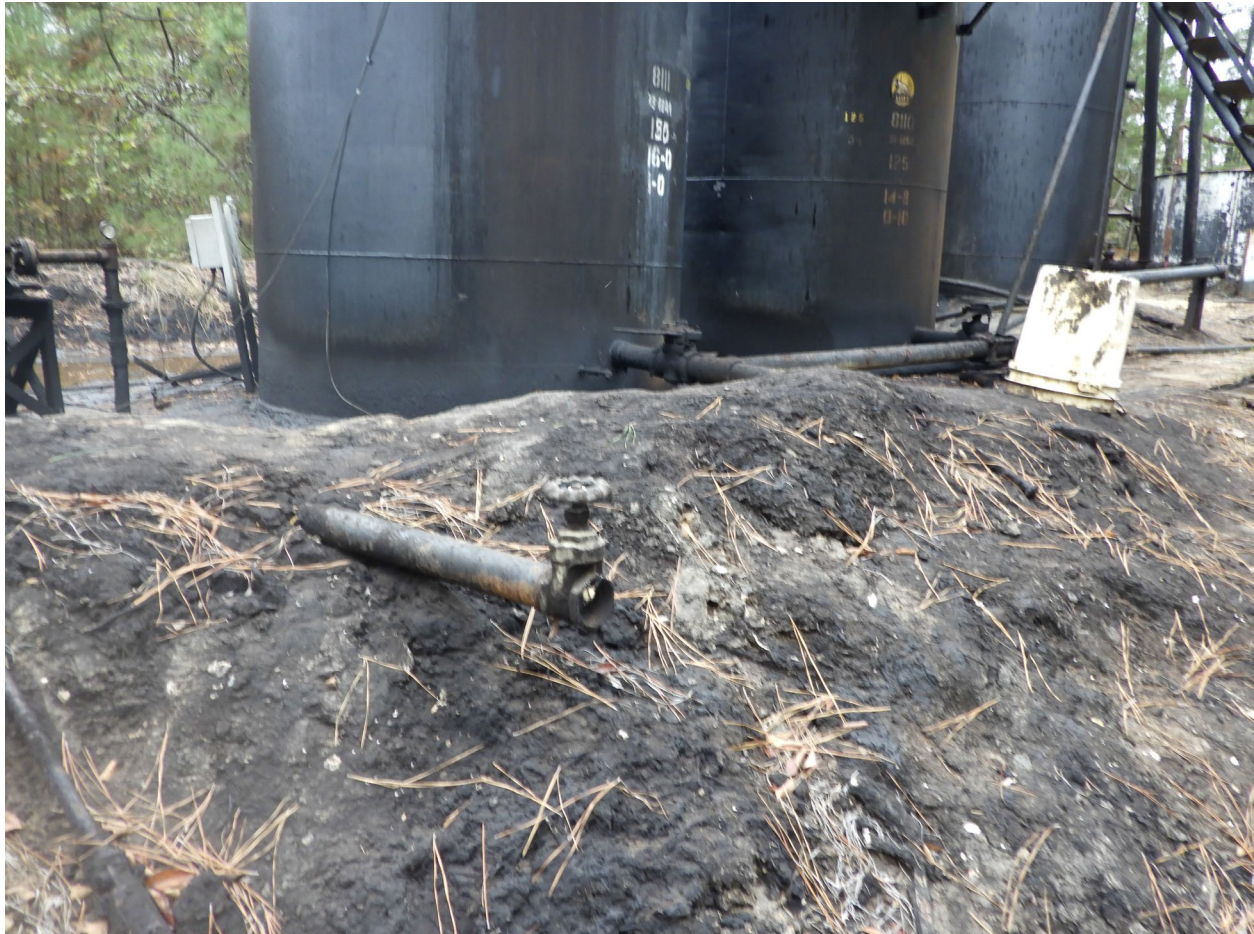
Photo No. 3

I observed a miscellaneous pipe outside secondary containment without a catchment bucket, see Photo No. 3.

**Description:** Looking NNE, this photo shows miscellaneous pipe extended outside secondary containment without a catchment bucket.

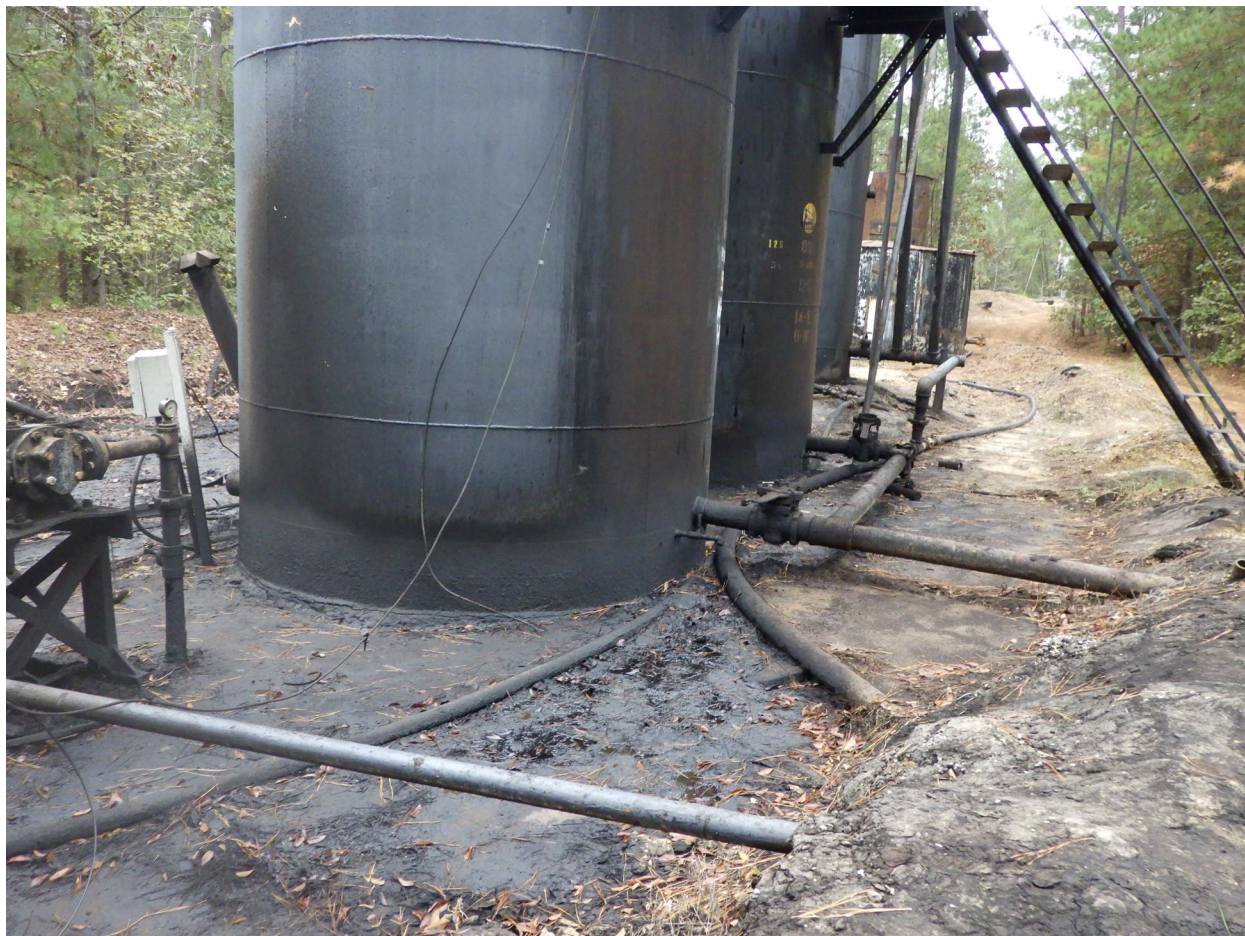
Photo No. 4

I observed an active leak of crude oil from a valve inside secondary containment, loose oil inside secondary containment, and residual oil applied to the containment berm, see Photos No. 4; No. 6 and No. 7.

**Description:** Looking NNE, this photo shows an active leak of crude oil, loose oil inside secondary containment, and residual crude oil applied to the secondary containment berm.

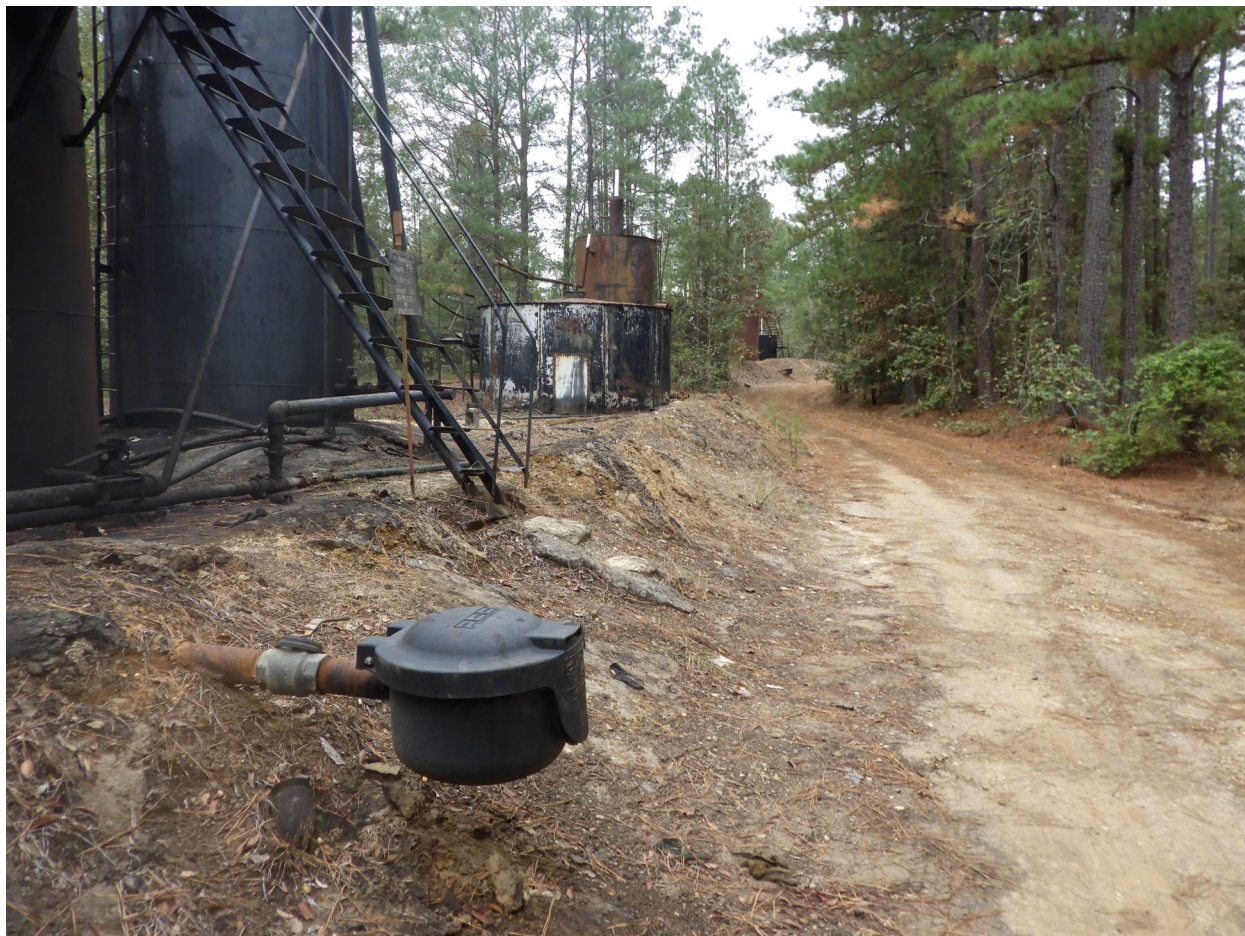
Photo No. 5

I observed a transfer line through secondary containment with a catchment bucket, see Photo No. 5.

**Description:** Looking NE, this photo shows a transfer pipe through secondary containment with a catchment bucket.

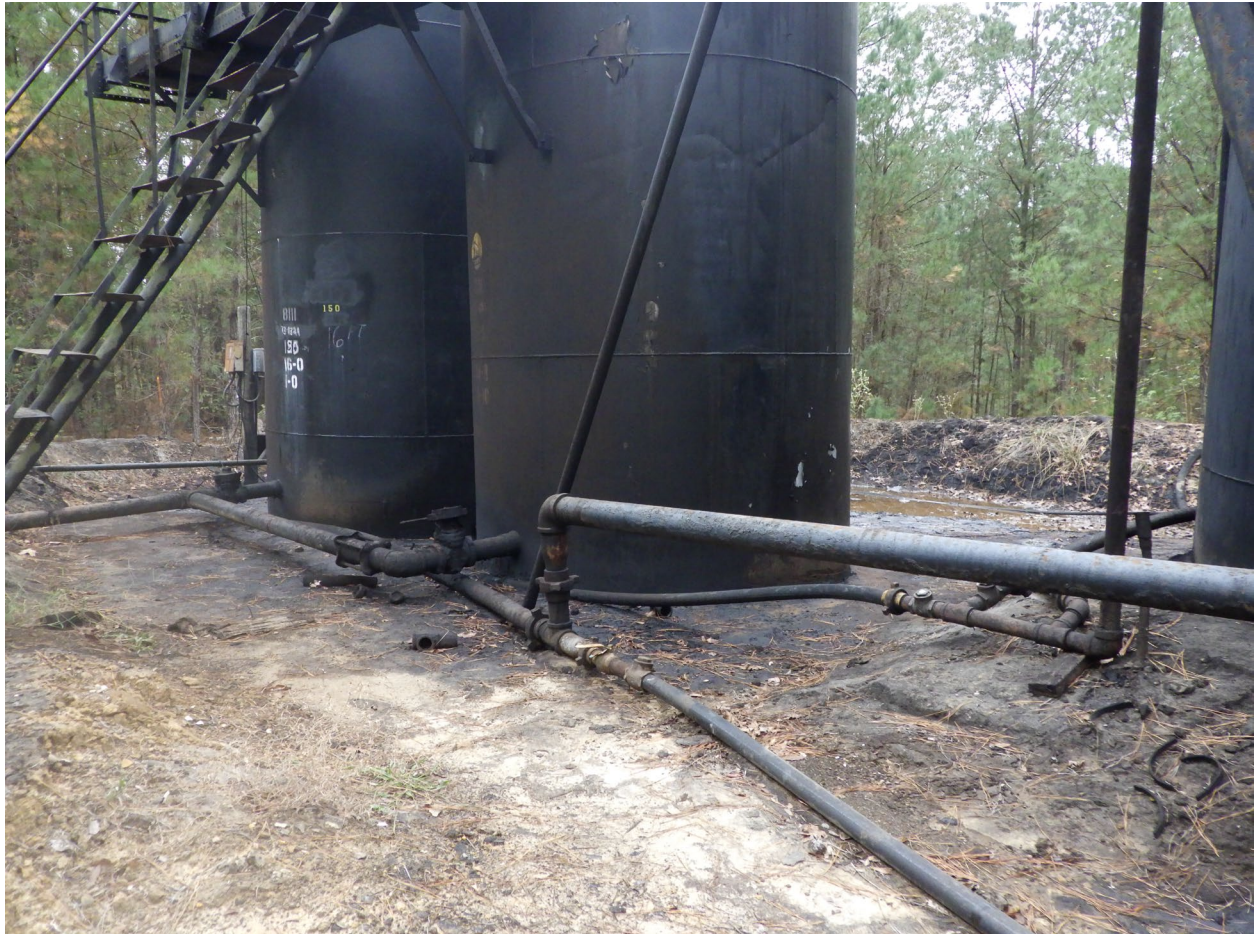
Photo No. 6

**Description:** Looking SW, this photo shows loose oil inside secondary containment.

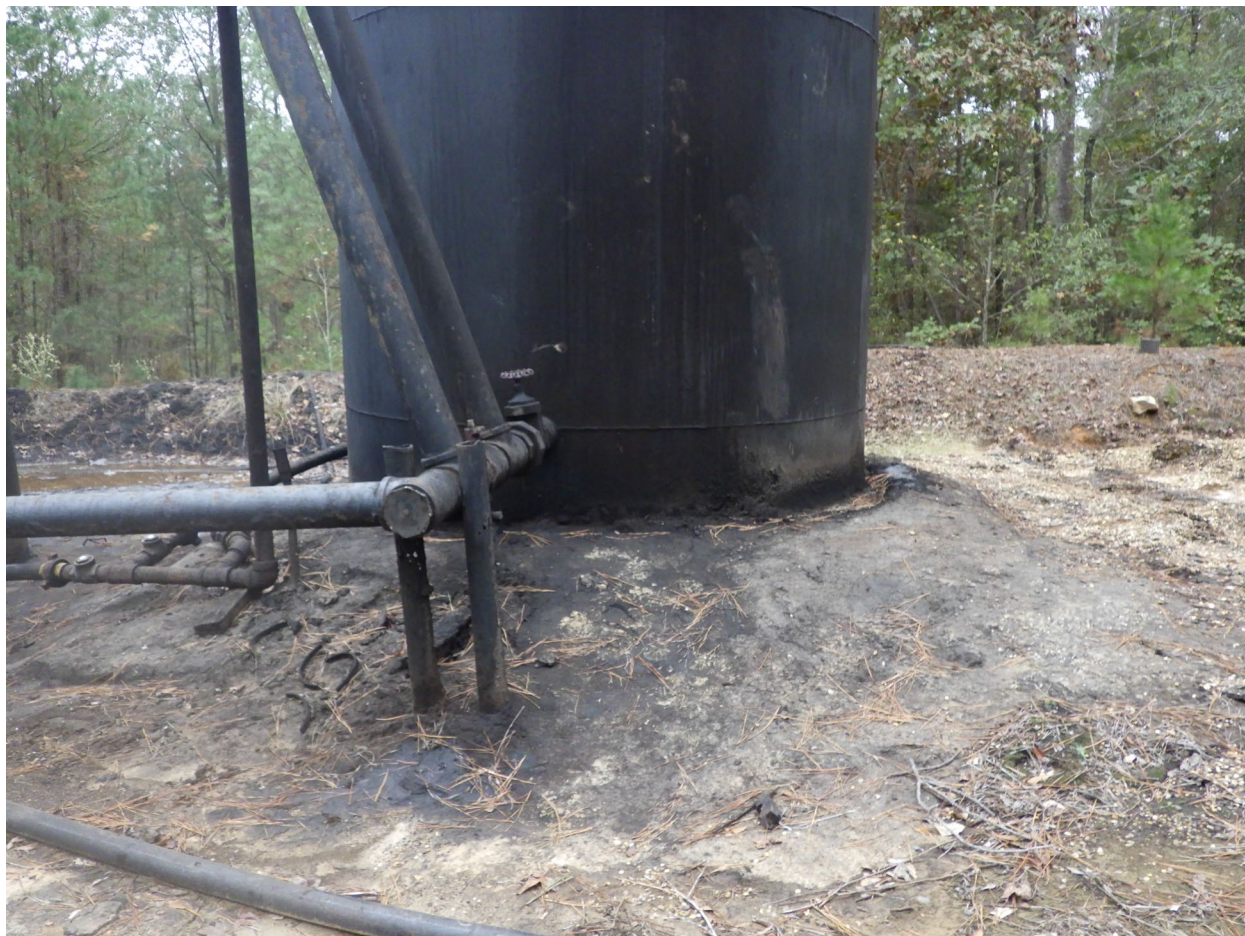
Photo No. 7

**Description:** Looking NW, this photo shows loose oil inside secondary containment.

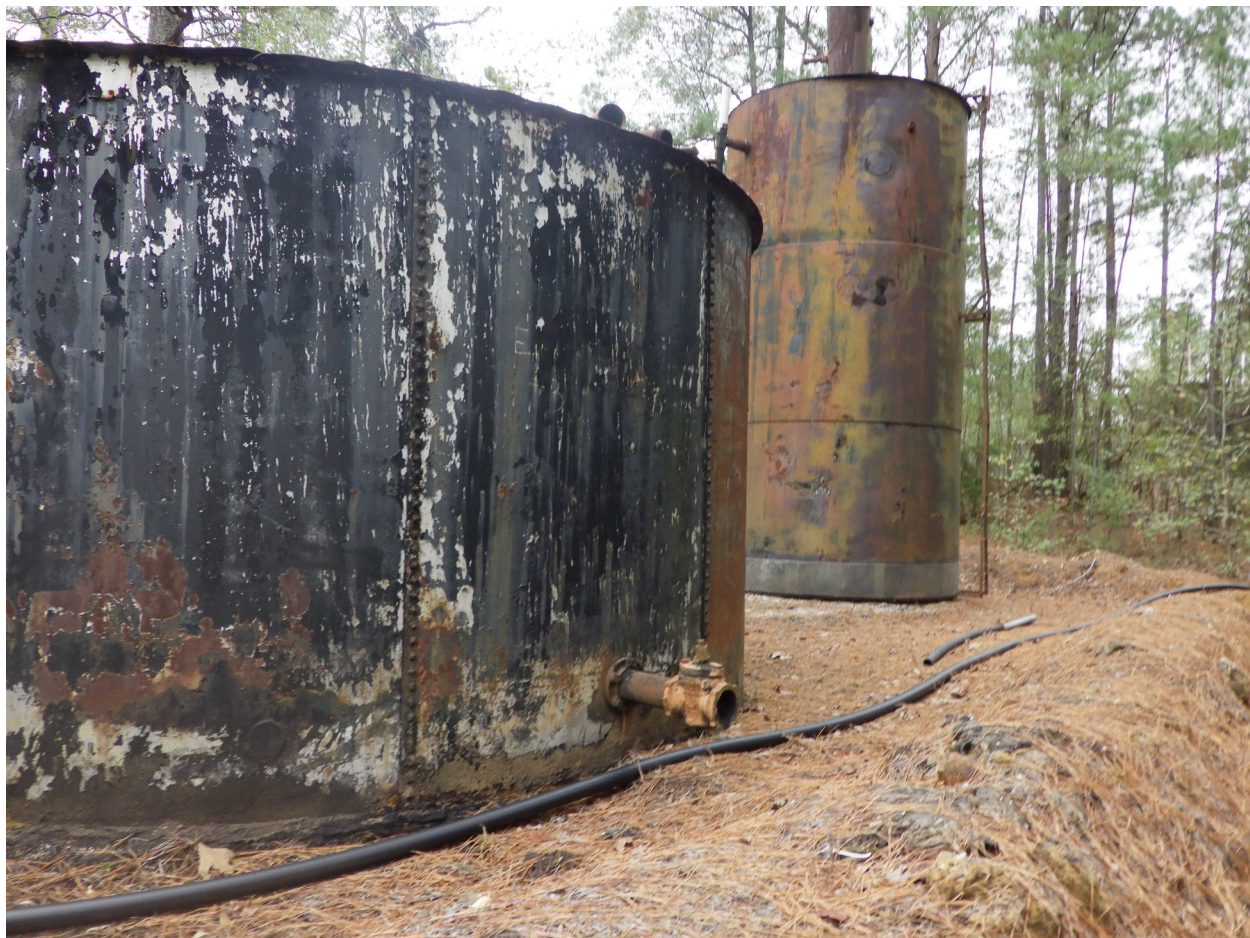
I observed two (2) tanks that appeared to be out of service without proper labeling, see Photo No. 8 and No. 9.

**Description:** Looking NNE, this photo shows two (2) tanks that appeared to be out of service without proper labeling; front view.

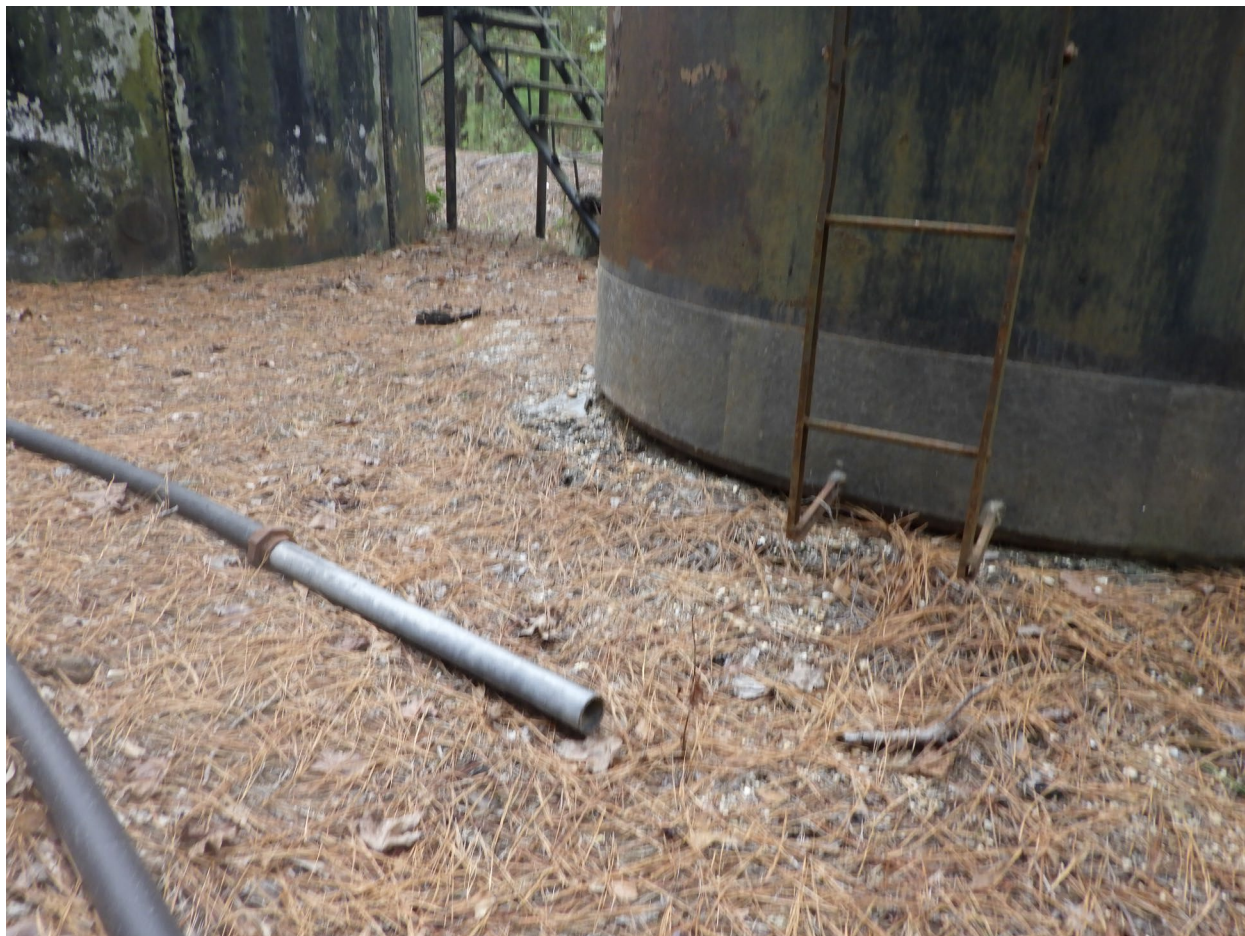
Photo No. 9

**Description:** Looking SW, this photo shows two (2) tanks that appeared to be out of service without proper labeling; back view.

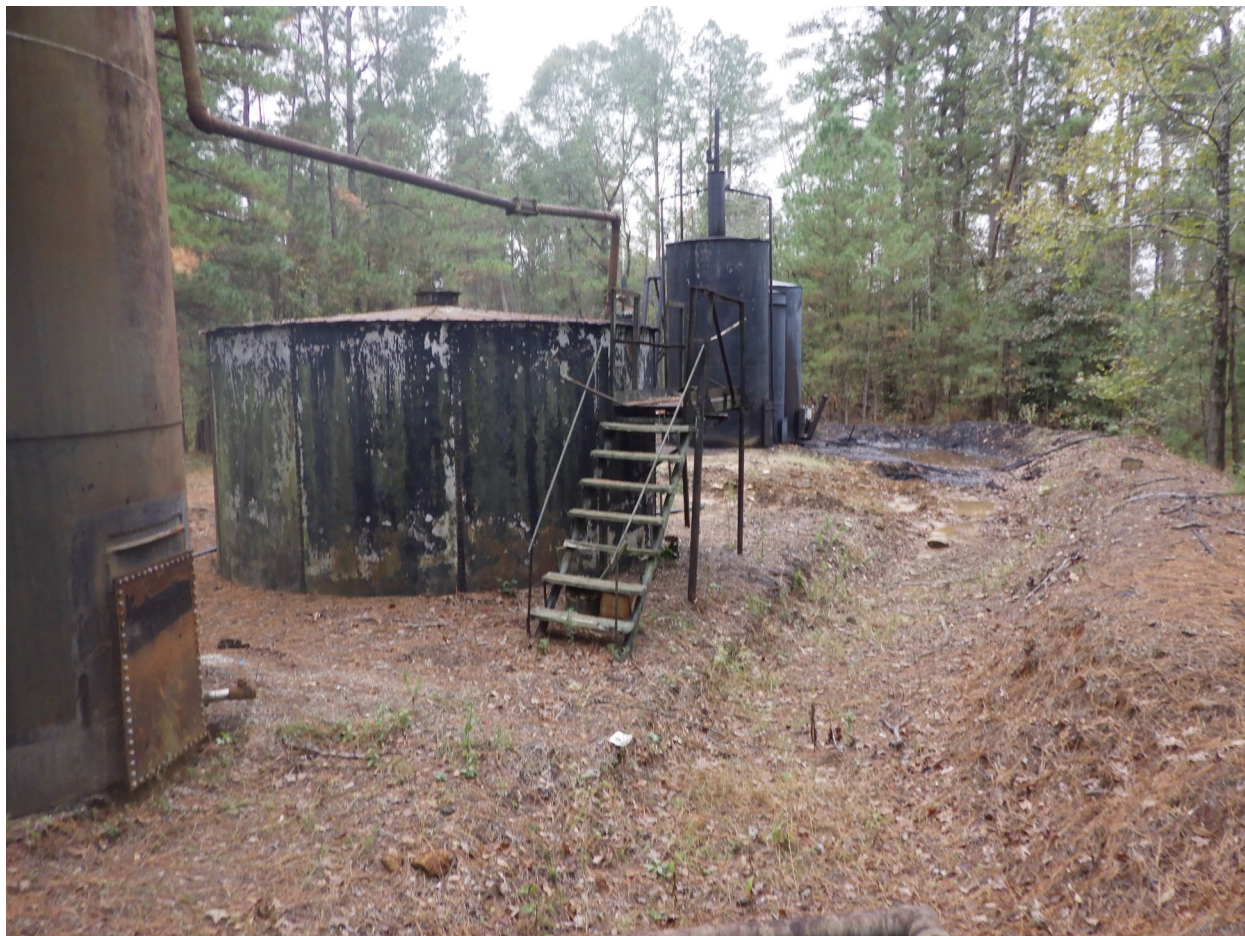
Photo No. 10

I observed loose crude oil and pooled saltwater inside secondary containment, see Photos No. 10 through No. 14.

**Description:** Looking SSE, this photo shows loose crude oil and pooled saltwater inside secondary containment.

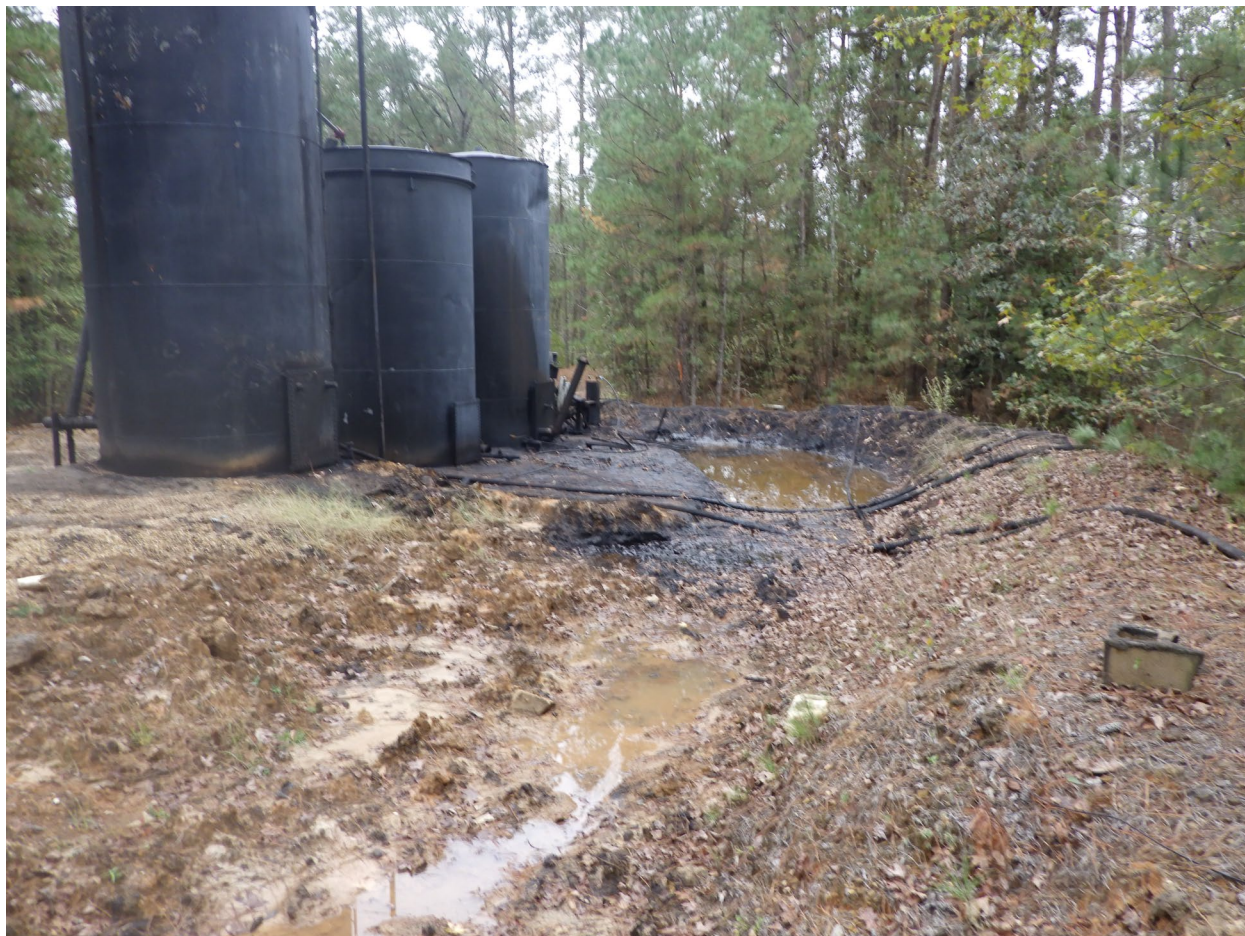
Photo No. 11

**Description:** Looking SE, this photo shows loose crude oil and pooled saltwater inside secondary containment.

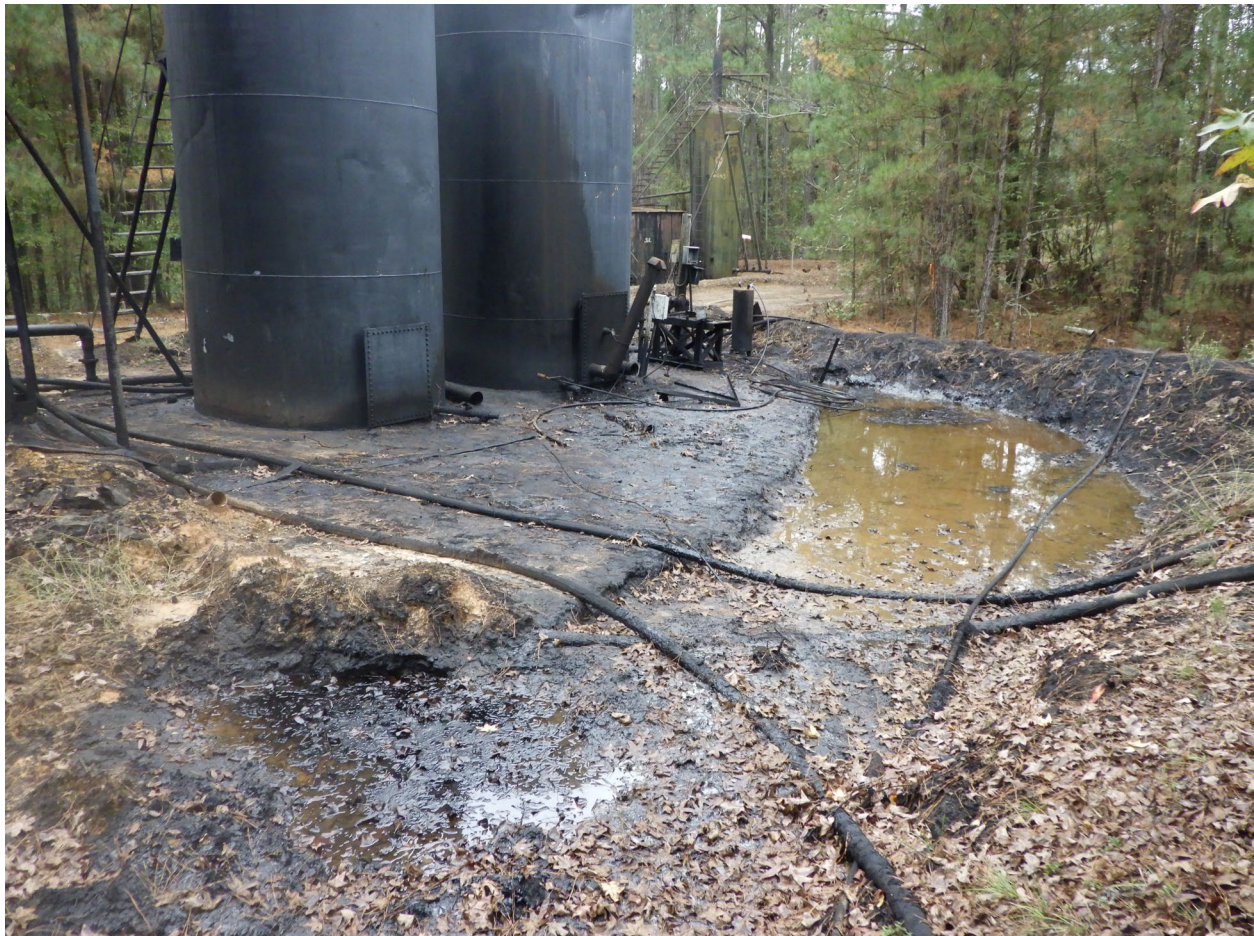
Photo No. 12

**Description:** Looking SE, this photo shows loose crude oil and pooled saltwater inside secondary containment.

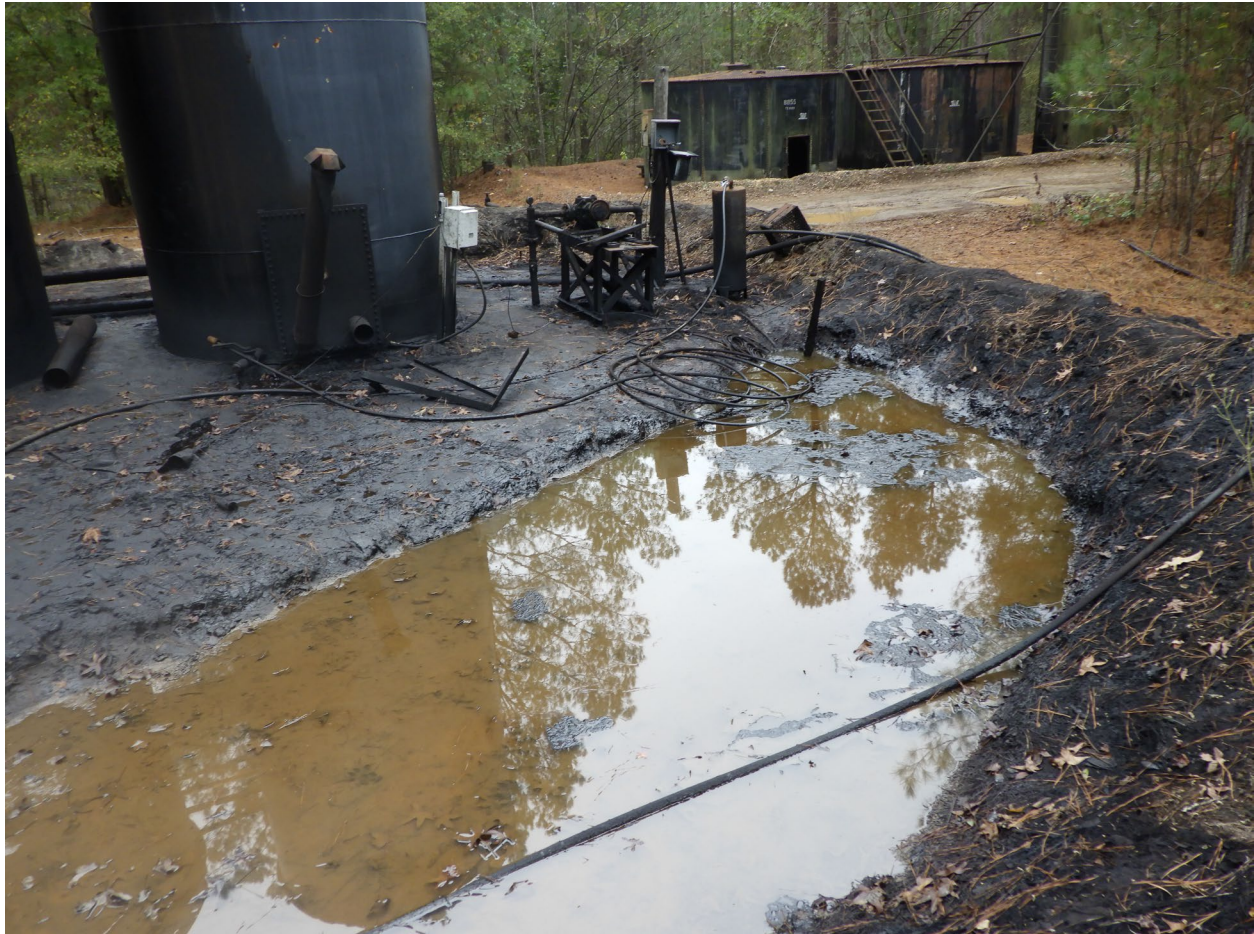
Photo No. 13

**Description:** Looking E, this photo shows loose crude oil and pooled saltwater inside secondary containment.

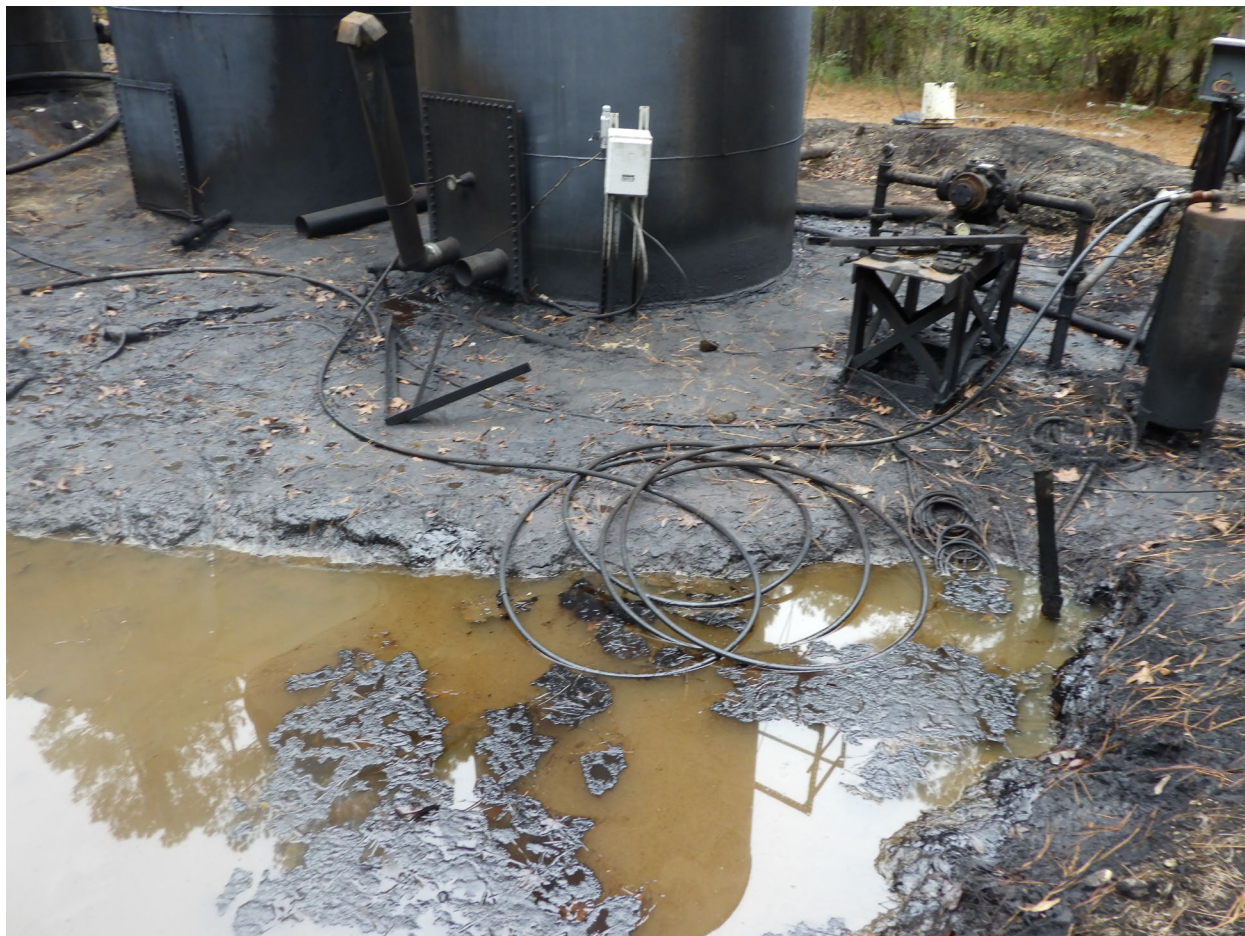
Photo No. 14

**Description:** Looking ENE, this photo shows loose crude oil and pooled saltwater inside secondary containment.

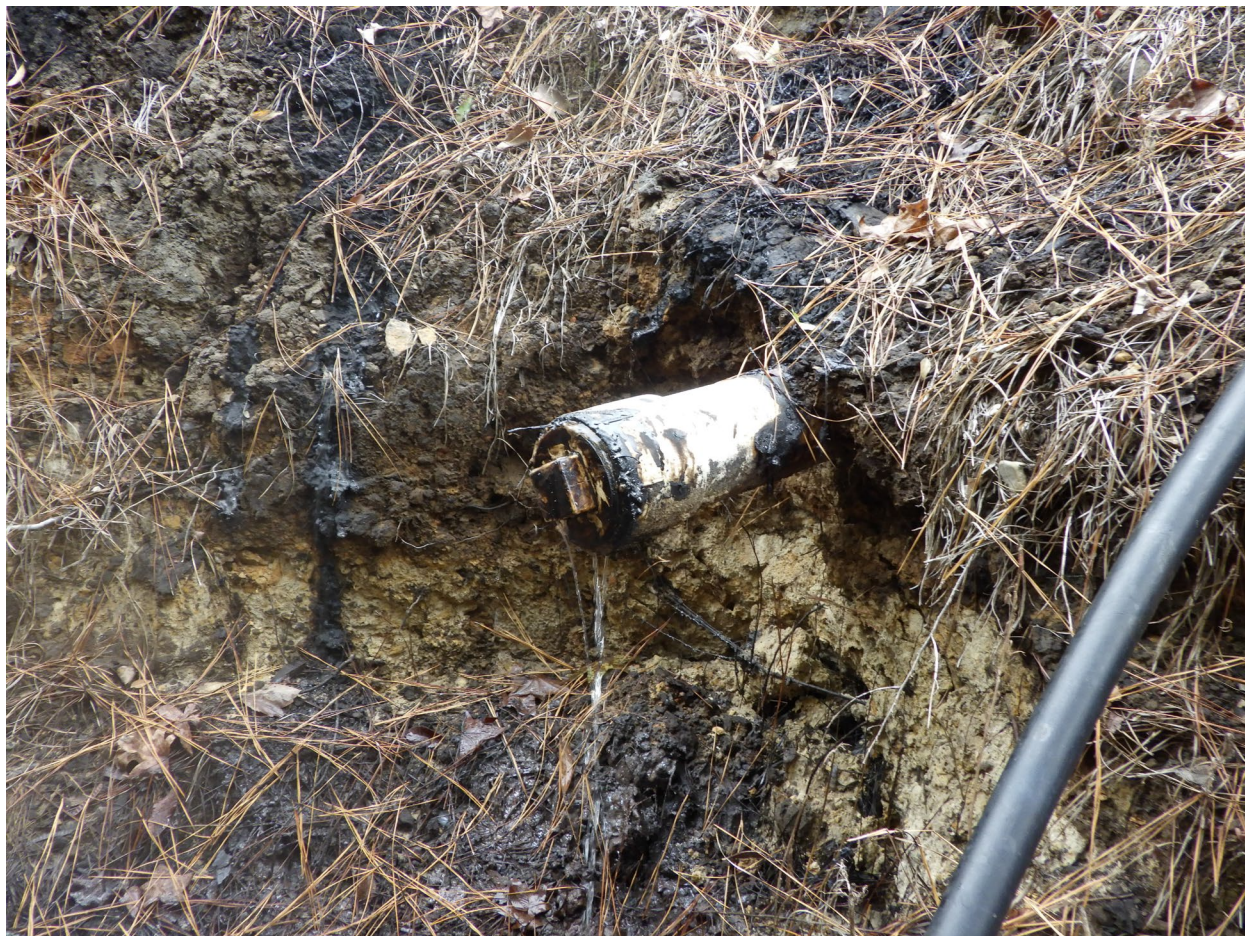
Photo No. 15

I observed an active leak of crude oil and saltwater from the partially opened drainpipe for secondary containment, see Photos No. 15 and No. 16.

**Description:** Looking NNE, this photo shows an active leak of crude oil and saltwater from the drainpipe for secondary containment.

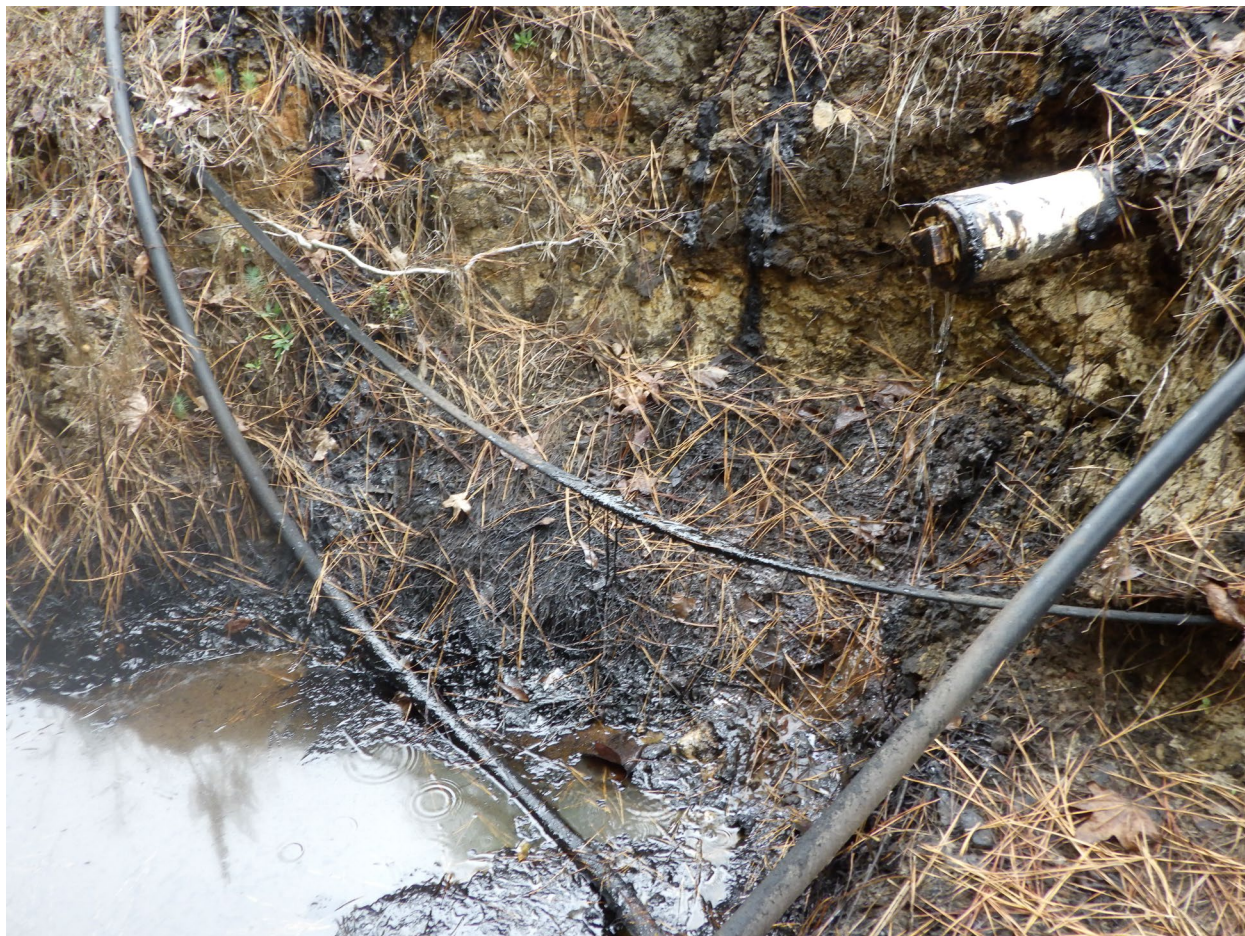
Photo No. 16

**Description:** Looking NNE, this photo shows an active leak of crude oil and saltwater from the drainpipe for secondary containment.

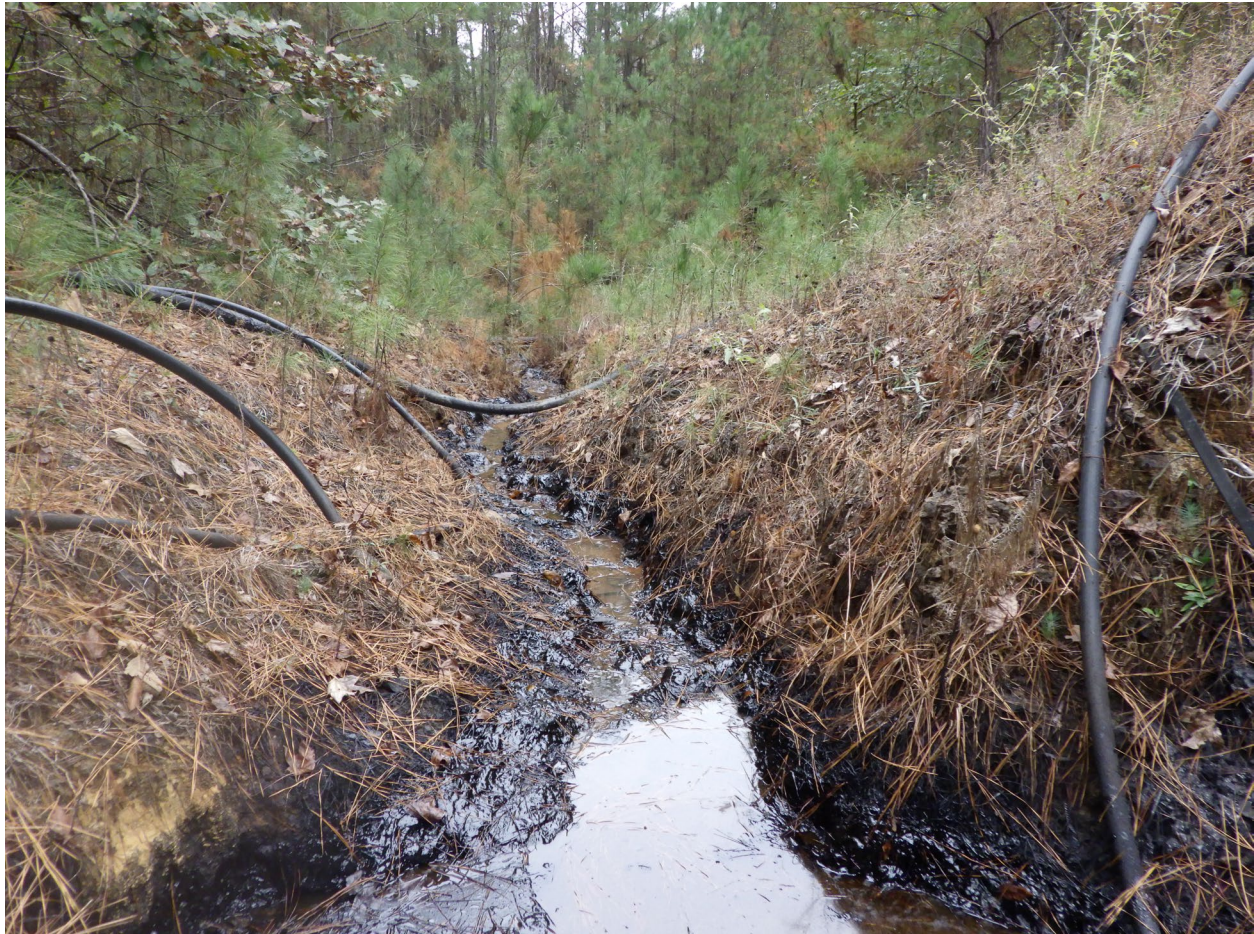
Photo No. 17

I observed the downstream flowpath of the active leak of crude oil and saltwater from the drainpipe for secondary containment, see Photos No. 17 through No. 20. Dead vegetation was noted along the downstream flowpath.

**Description:** Looking NNW, this photo shows the downstream flowpath from the active leak of crude oil and saltwater from the drainpipe for secondary containment. Dead and stressed vegetation was noted during the inspection.

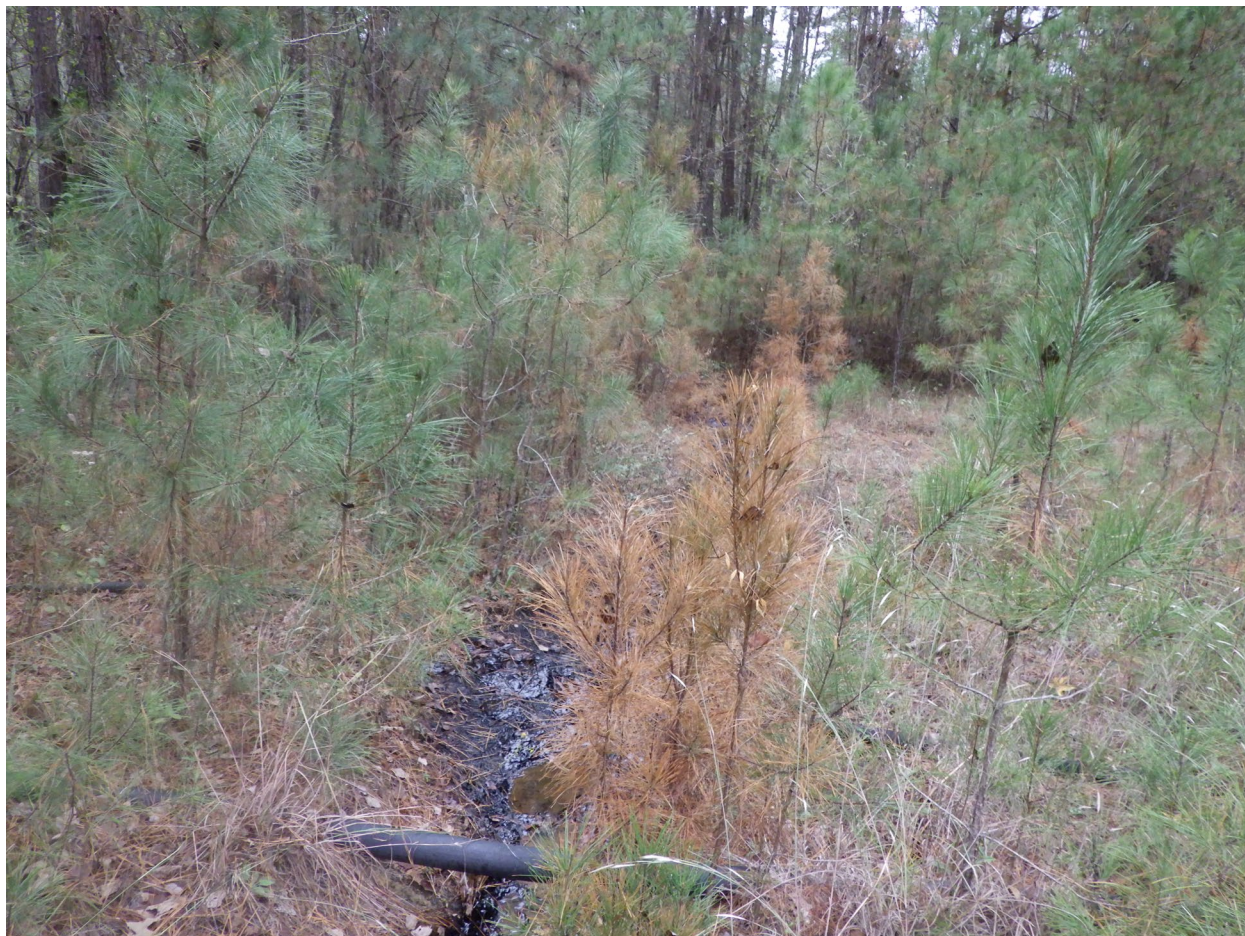
Photo No. 18

**Description:** Looking NNW, this photo shows the downstream flowpath from the active leak of crude oil and saltwater from the drainpipe for secondary containment. Dead and stressed vegetation was noted during the inspection.
