**Region 6 - Enforcement & Compliance Assurance Division**  
**INSPECTION REPORT**

| Inspection Date(s): | 11/08/2024 | |
| Company Name: | <b>SMI Operating Company, LLC</b> | |
| Facility Name: | <b>E Gregory #4 Tank Battery</b> | |

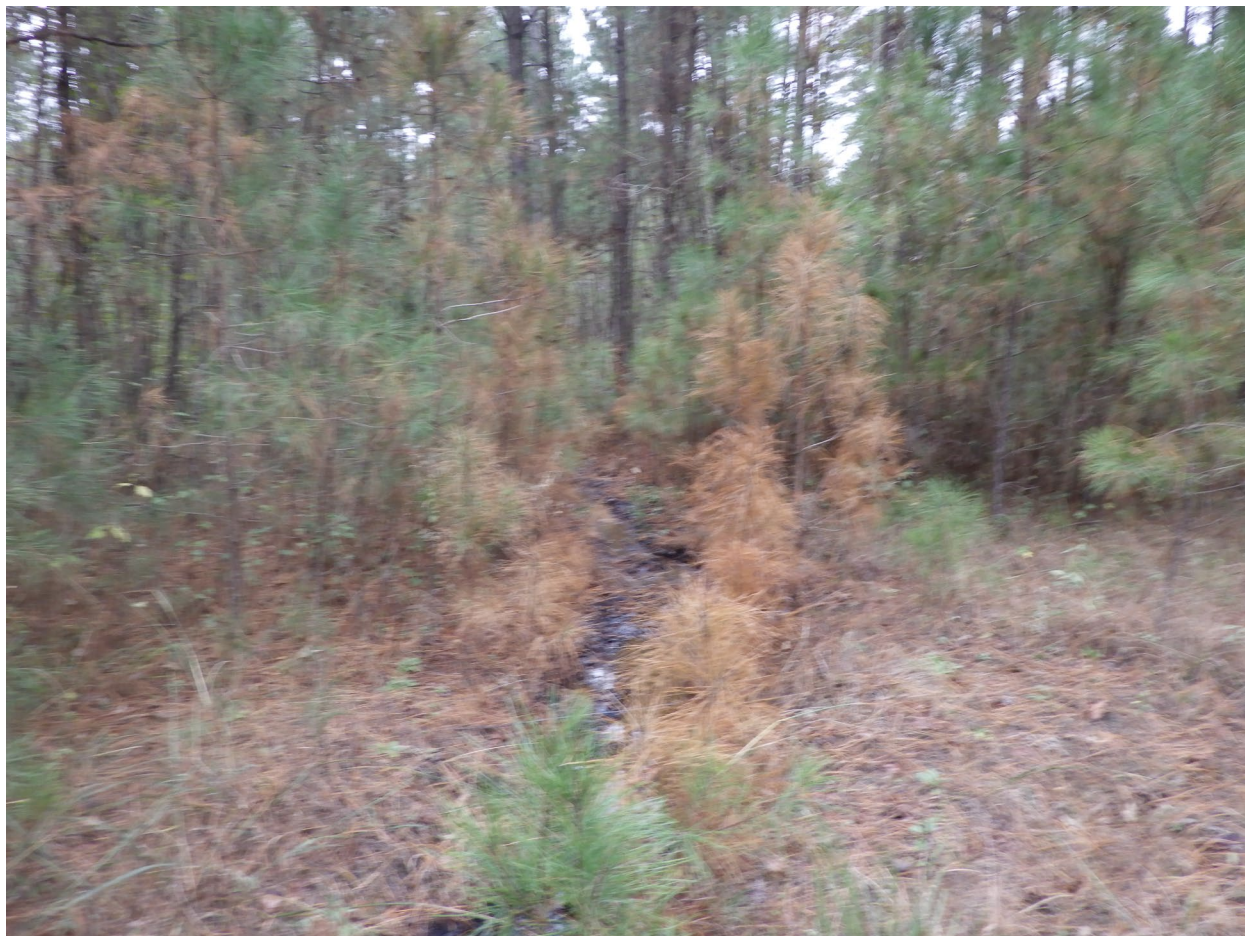
Photo No. 19

I observed the downstream flowpath of the active leak of crude oil and saltwater from the drainpipe for secondary containment, see Photos No. 17 through No. 20. Dead vegetation was noted along the downstream flowpath.

**Description:** Looking WNW, this photo shows the downstream flowpath from the active leak of crude oil and saltwater from the drainpipe for secondary containment. Dead and stressed vegetation was noted during the inspection.

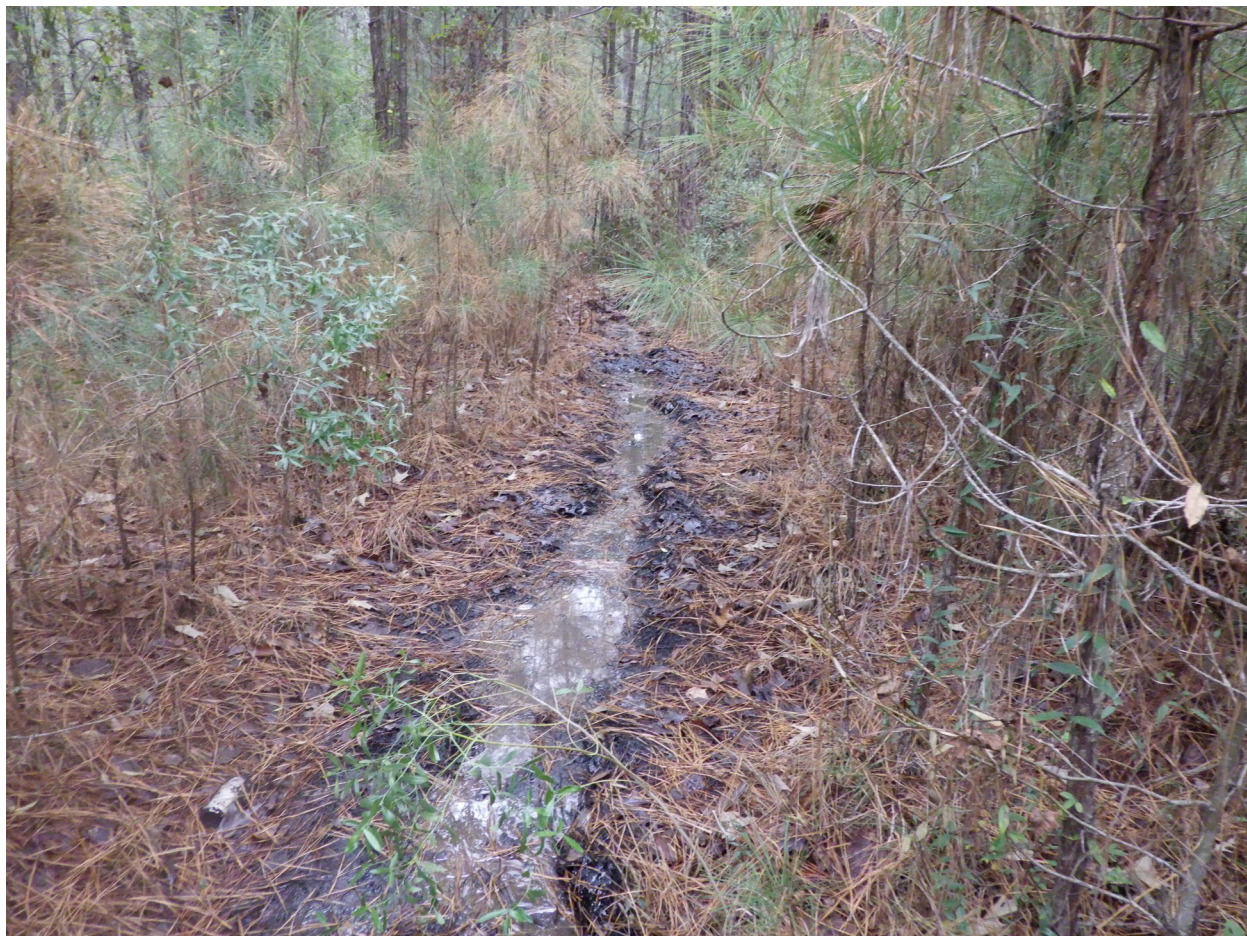
Photo No. 20

**Description:** Looking NW, this photo shows the downstream flowpath from the active leak of crude oil and saltwater from the drainpipe for secondary containment. Dead and stressed vegetation was noted during the inspection.
