**U.S. ENVIRONMENTAL PROTECTION AGENCY  
REGION III  
CLEAN WATER ACT  
COMPLIANCE INSPECTION REPORT**

**Name of Site:** The Parks at Walter Reed  
**Site Address:** 6900 Georgia Avenue NW, Washington D.C., 20012  
**Mailing Address:** 6900 Georgia Avenue NW, Washington D.C., 20012

**Unique Project Identification (UPI):** 3E22WN073A

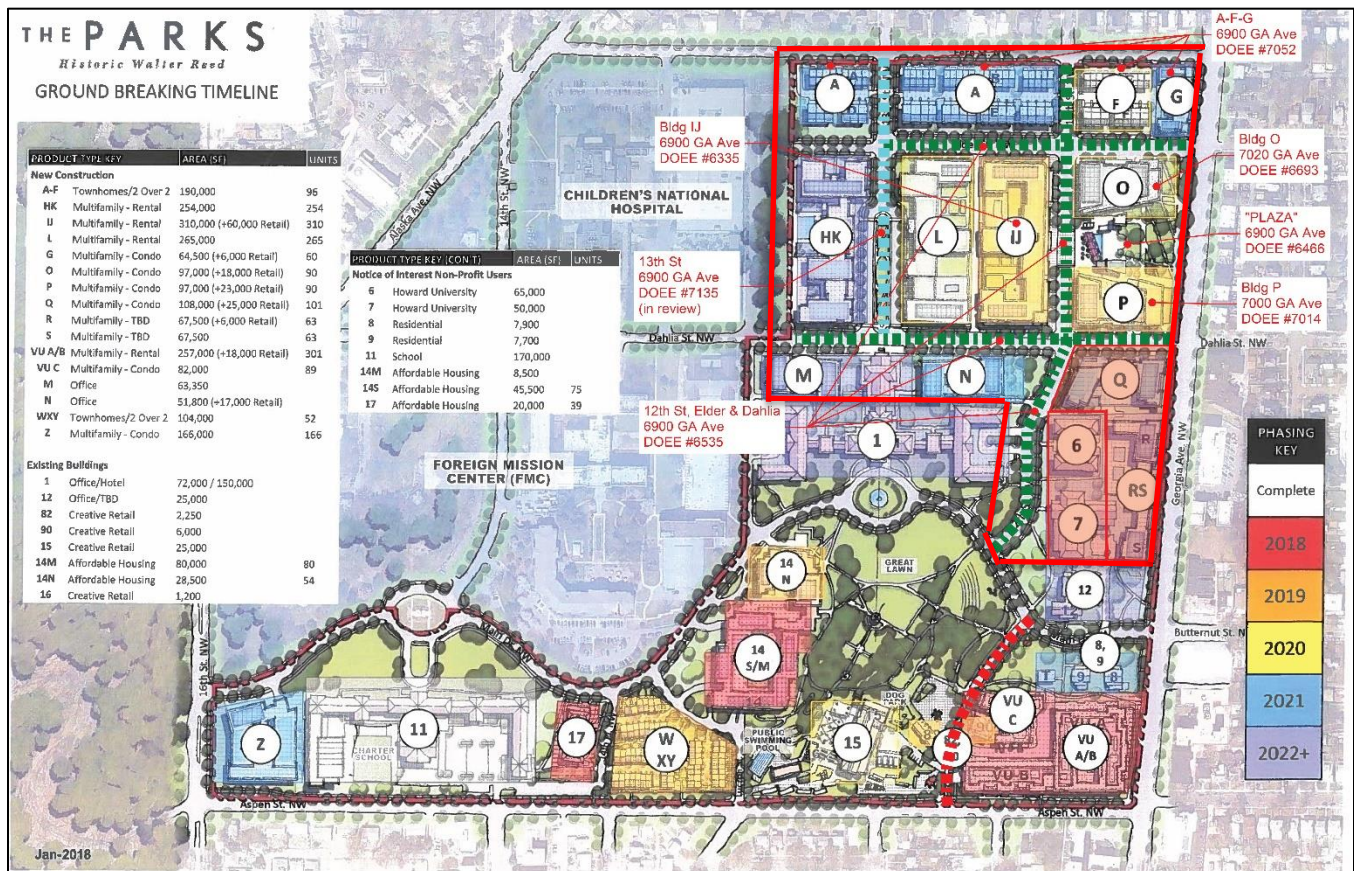
Figure 1. Overview of the entire site. The red line encompasses the approximate areas of the site under construction, most of which was disturbed, at the time of the inspection.

Site representatives stated they were unaware of any other parcel/building projects that had obtained coverage for their portion of the development. The EPA Inspection Team was unable to verify coverage for any of the other parcels in EPA's eNOI database. Disturbed areas apparently without Permit coverage were observed in the following locations as labelled in Figure 1: O, P, IJ, L, HK, M, and N as well as the three new roads being constructed at the site, 12<sup>th</sup> Street, Dahlia, and Elder (shown as green dotted lines in Figure 1).
