**Purpose:** NPDES SSO Inspection Report

**Facility:** City of Chicago Heights, Illinois

**NPDES ID Number (No NPDES Permit):** ILN000013

**Date of Inspection:** October 25, 2022

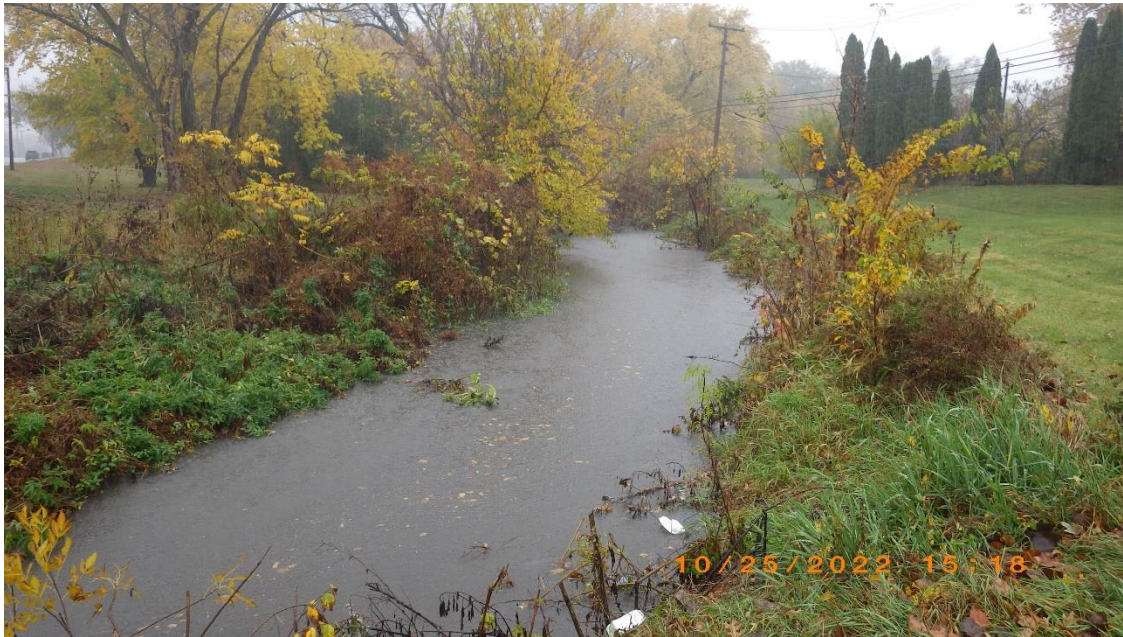
**1: RIMG0095**

EPA inspectors arrived at an unnamed tributary to Thorn Creek near the intersection of Parkside Avenue and Peoria Street at 3:18 PM. Inspectors noted vegetation along the banks of the tributary. See Photos 1 and 2.

**Description:** Overview of unnamed tributary to Thorn Creek. Note vegetation along banks.

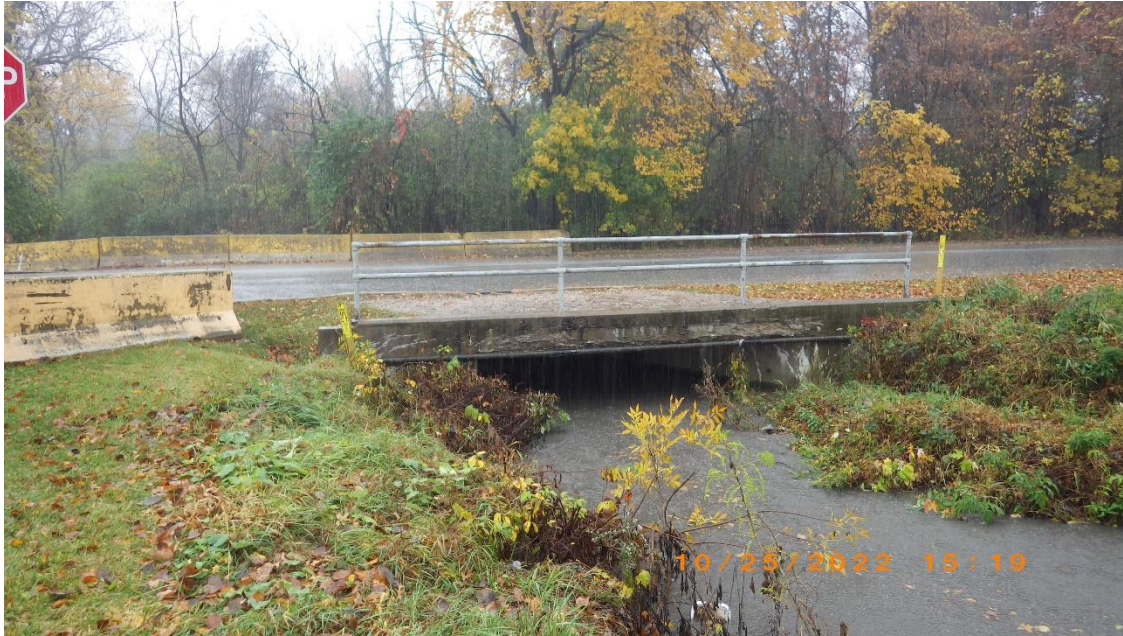
2: RIMG0096

Description: Overview of unnamed tributary to Thorn Creek.

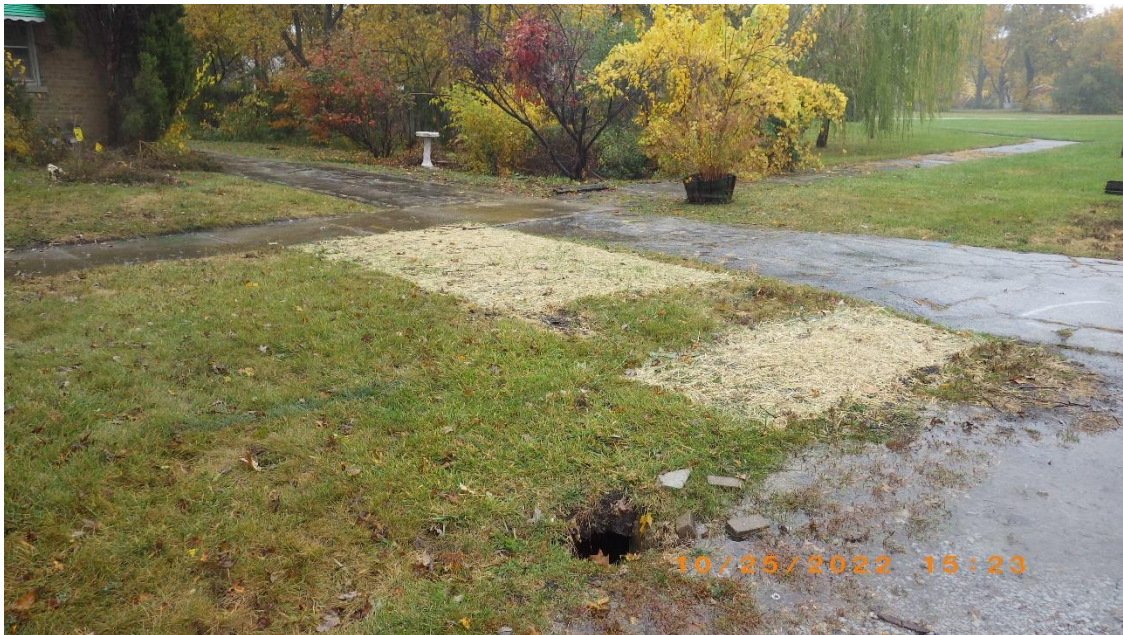
3: RIMG0097

EPA inspectors arrived at 71 Broadway at 3:22 PM. Inspectors noted an approximately 10-inch hole in a culvert in front of this address. See Photos 3 and 4.

- A culvert used to convey stormwater on Broadway was damaged;
- The storm water inlet at the intersection of West Memorial Avenue and Willow Drive was not set at a grade that allowed for effective drainage of storm water; and
- There was a large volume of standing stormwater at the intersection of West 16<sup>th</sup> Street and Division Street.

Description: Overview of hole in stormwater culvert.

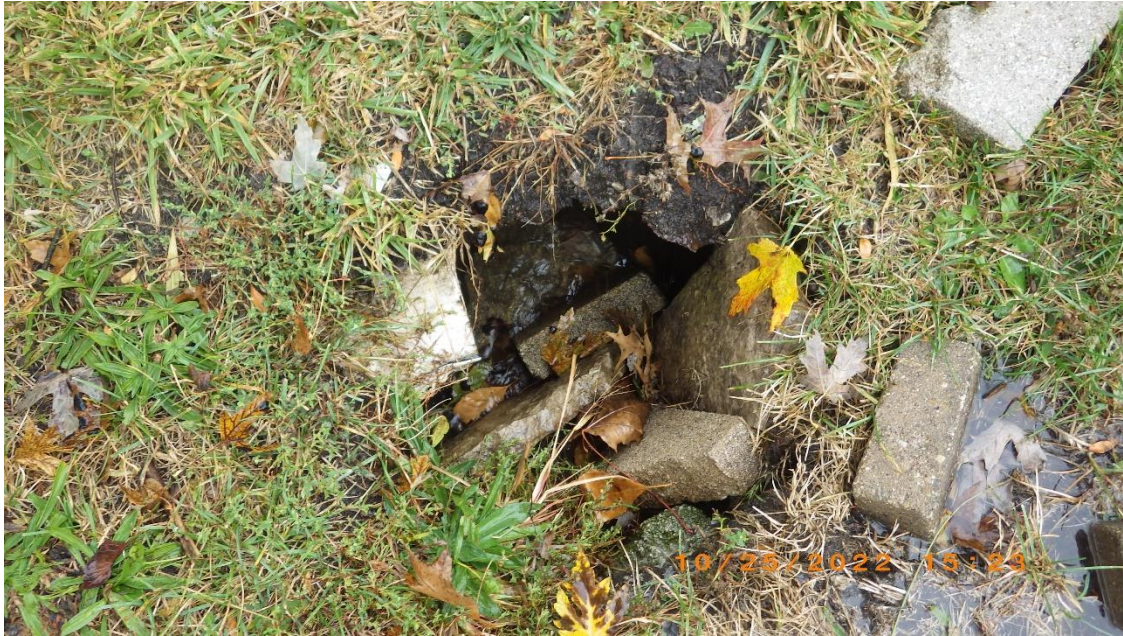
4: RIMG0098

Description: Hole in stormwater culvert.

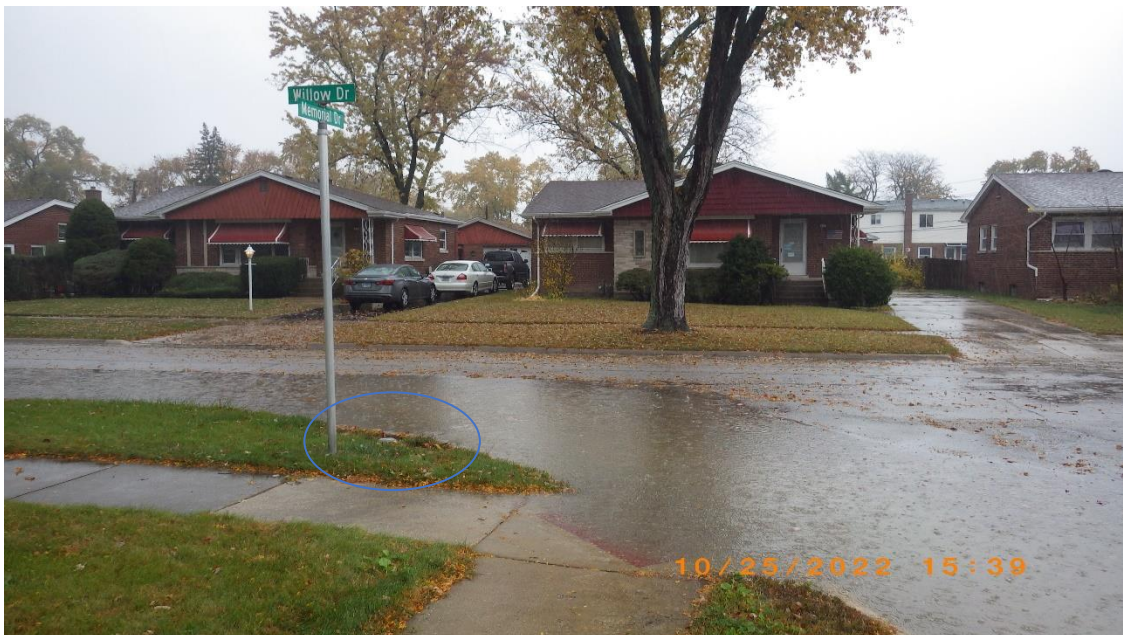
5: RIMG0099

EPA inspectors arrived at the intersection of West Memorial Avenue and Willow Drive at 3:39 PM. Inspectors noted a large amount of standing water at this intersection. The pool of water was slowly draining into a stormwater inlet. The inlet appeared to be set at a grade that did not allow effective drainage of stormwater. See Photos 5 and 6.

Description: Overview of localized flooding. Note there is a stormwater inlet at base of street sign (blue circle).

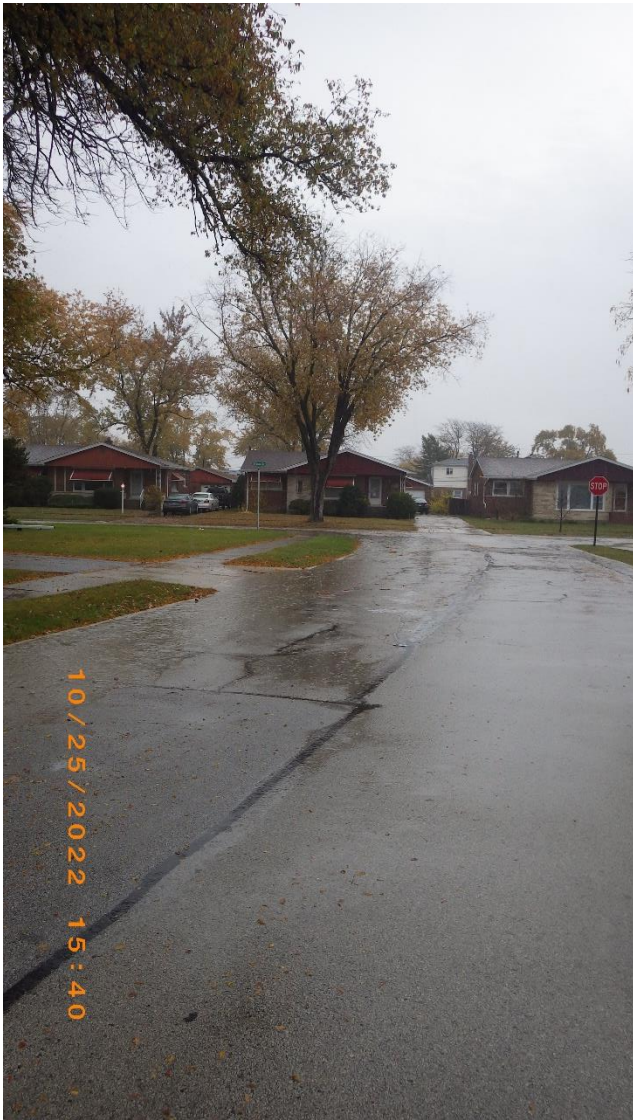
6: RIMG0100

Description: Overview of localized flooding.

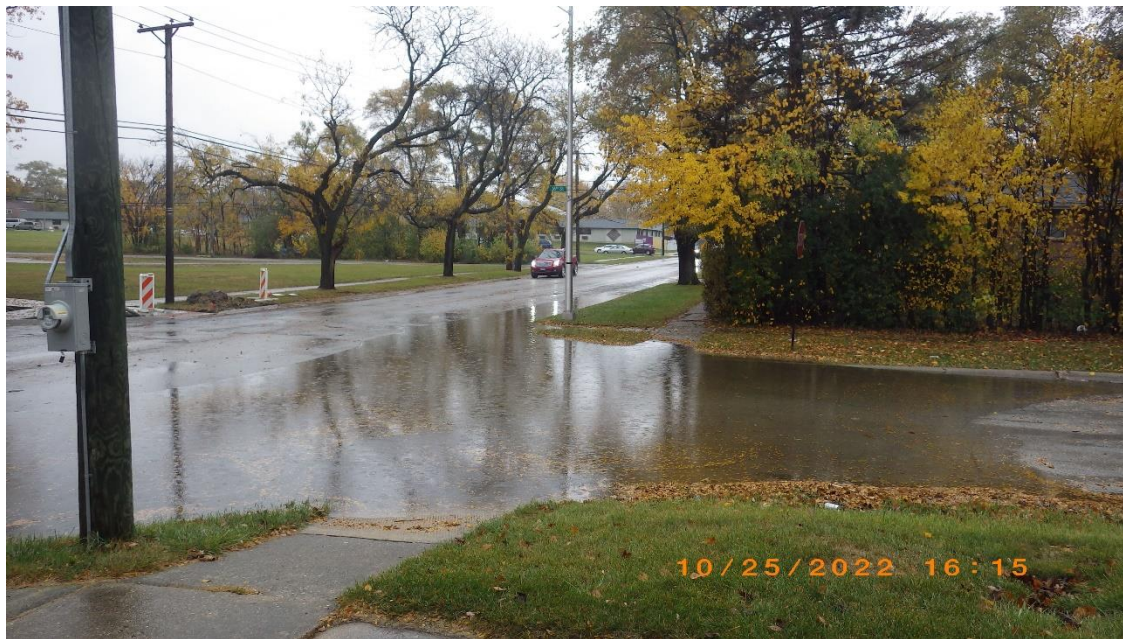
7: RIMG0101

EPA inspectors arrived at the intersection of West 16<sup>th</sup> Street and Division Street at 4:15 PM. Inspectors noted a large amount of standing water at this intersection. See Photo 7.

Description: Overview of localized flooding.
