INSPECTION REPORT

| <b>Type of inspection:</b> | CEI - Compliance Evaluation Inspection | | | | |
| <b>Facility or Site Name:</b> | CITY OF KENDALLVILLE WASTEWATER TREATMENT PLANT | | | | |
| <b>Permit Number:</b> | IN0020656 | | | | |

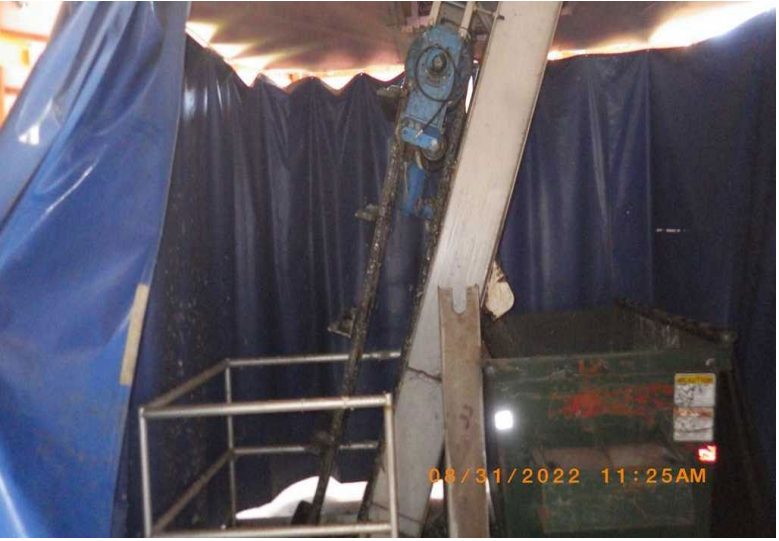
| KEND0120.JPG | |

We then walked into the Grit Building and observed the bar screen which was behind plastic curtains to minimize odor (see Photo Log image KEND0120). Patrick Howell said that aside from a recently repaired bearing issue, the bar screen is working well. I also observed a caustic chemical tank which is no longer in use (see Photo Log image KEND0121). Before leaving the Grit Building, I observed the influent composite sampler (ISCO). I noticed the sampler was refrigerated and included a thermometer (see Photo Log image KEND0122).

| Bar screen behind plastic curtain to minimize odor. | |

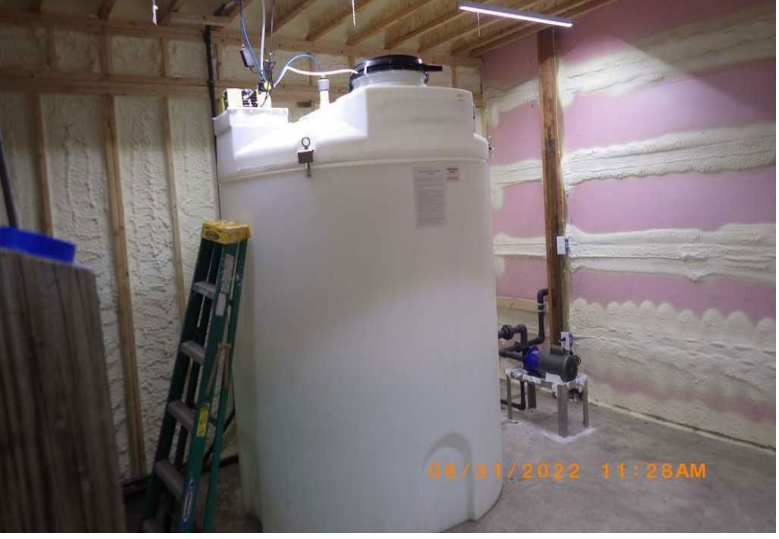
| KEND0121.JPG | |

| Tank is no longer in use. | |

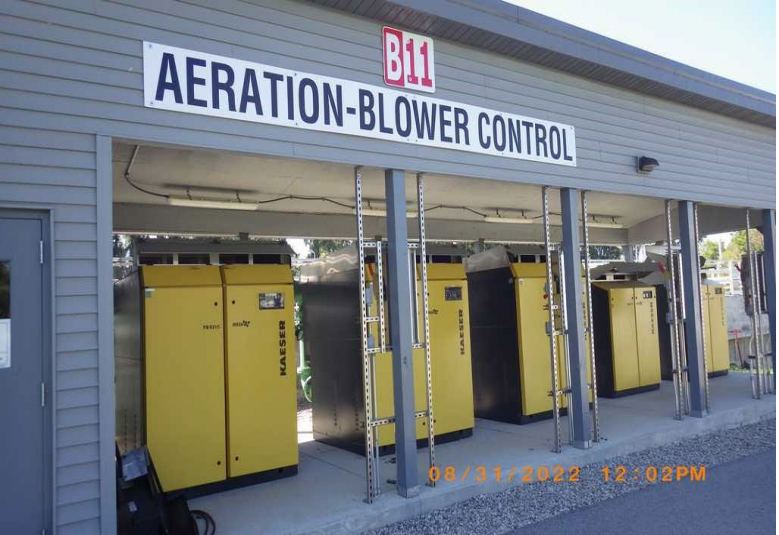
| KEND0129.JPG | |

As we walked to the aeration area I observed the aeration blowers (4). One of the blowers was out of service due to motor repairs (see Photo Log image KEND0129). Patrick Howell said he expects to put the blower back in service the following week. One of the four aeration tanks was offline due to the out-of-service blower (see aeration tanks in Photo Log image KEND0130). The Superintendent said they may be having nitrogen issues due to the out-of-service blower and aeration tank. Before leaving the aeration area we viewed the operating digester tank (see Photo Log image KEND0131).

| One of the blowers (second from the left) was out of service due to motor repairs. | |

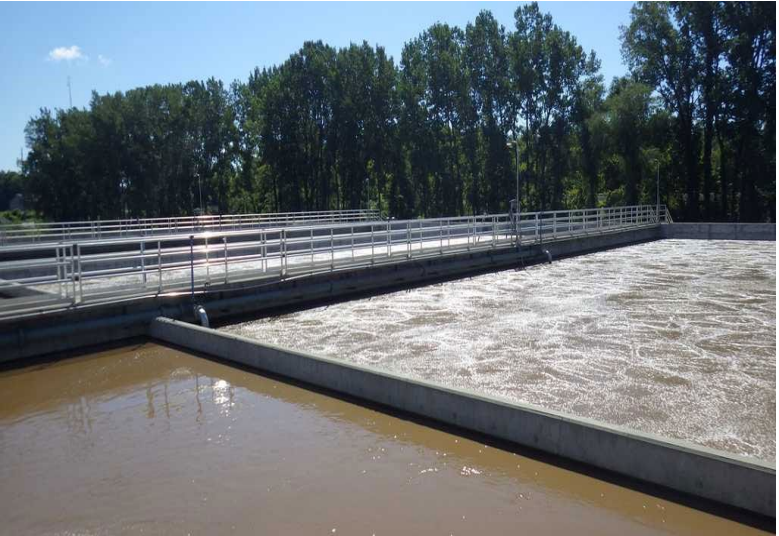
| KEND0130.JPG | |

| One of the four aeration tanks was off line due to the out-of-service blower. | |

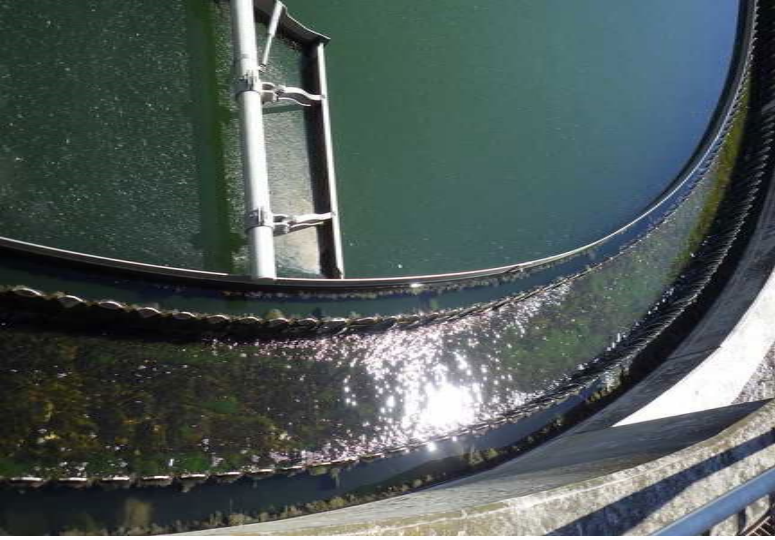
| KEND0132.JPG | |

| I observed significant vegetation growth and debris in the effluent trough and weir notches in secondary clarifier #1. | <b>Citations:</b> Permit Part II.B.1.a |

| Note the significant vegetation growth and debris in the effluent trough and weir notches. Also note skimmer capturing palm oil blobs on the surface of the secondary clarifier. | |

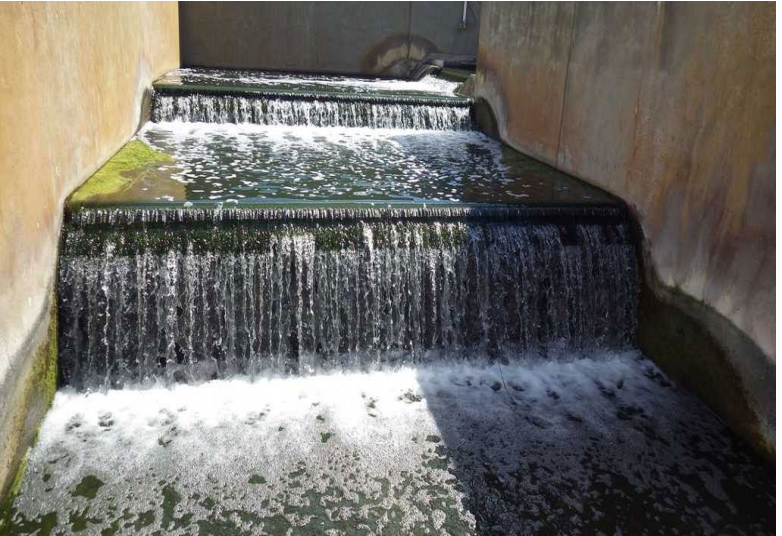
| <p>After the UV system, effluent flows into the post-aeration basin (see Photo Log image KEND0135), then over the post-aeration cascades (see Photo Log image KEND0136). I observed significant duckweed and vegetation growth in the post-aeration tank and cascades.</p> | |

| I observed significant duckweed and vegetation growth in the post-aeration tank and cascades. | <b>Citations:</b> Permit Part II.B.1.a |

| Note the significant duckweed in the post-aeration cascades. | |

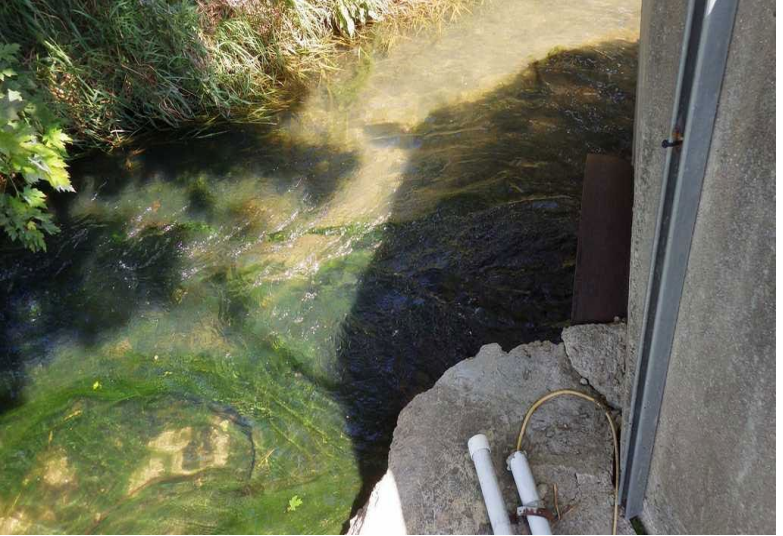
| KEND0140.JPG | |

We returned to the final outfall area at the end of the physical facility tour. I observed a clear discharge from Final Outfall #003 and noted some vegetation growth along the bed of the receiving water (see Photo Log image KEND0140). Outfall #003 discharges to an unnamed tributary just upstream of Henderson Lake.

| Outfall #003 discharges to an unnamed tributary just upstream of Henderson Lake. Discharge appeared clear. | |
