**Report Title:** Clean Air Act Inspection of Meritt Cab Association  
**Inspection Date(s):** December 6, 2023  
**Regulatory Program(s):** NESHAP, SIP

**Company Name:** Same as below  
**Facility Name:** Meritt Cab Association  
**Facility Location:** 1801 Adams St. NE,  
Washington, DC 20018

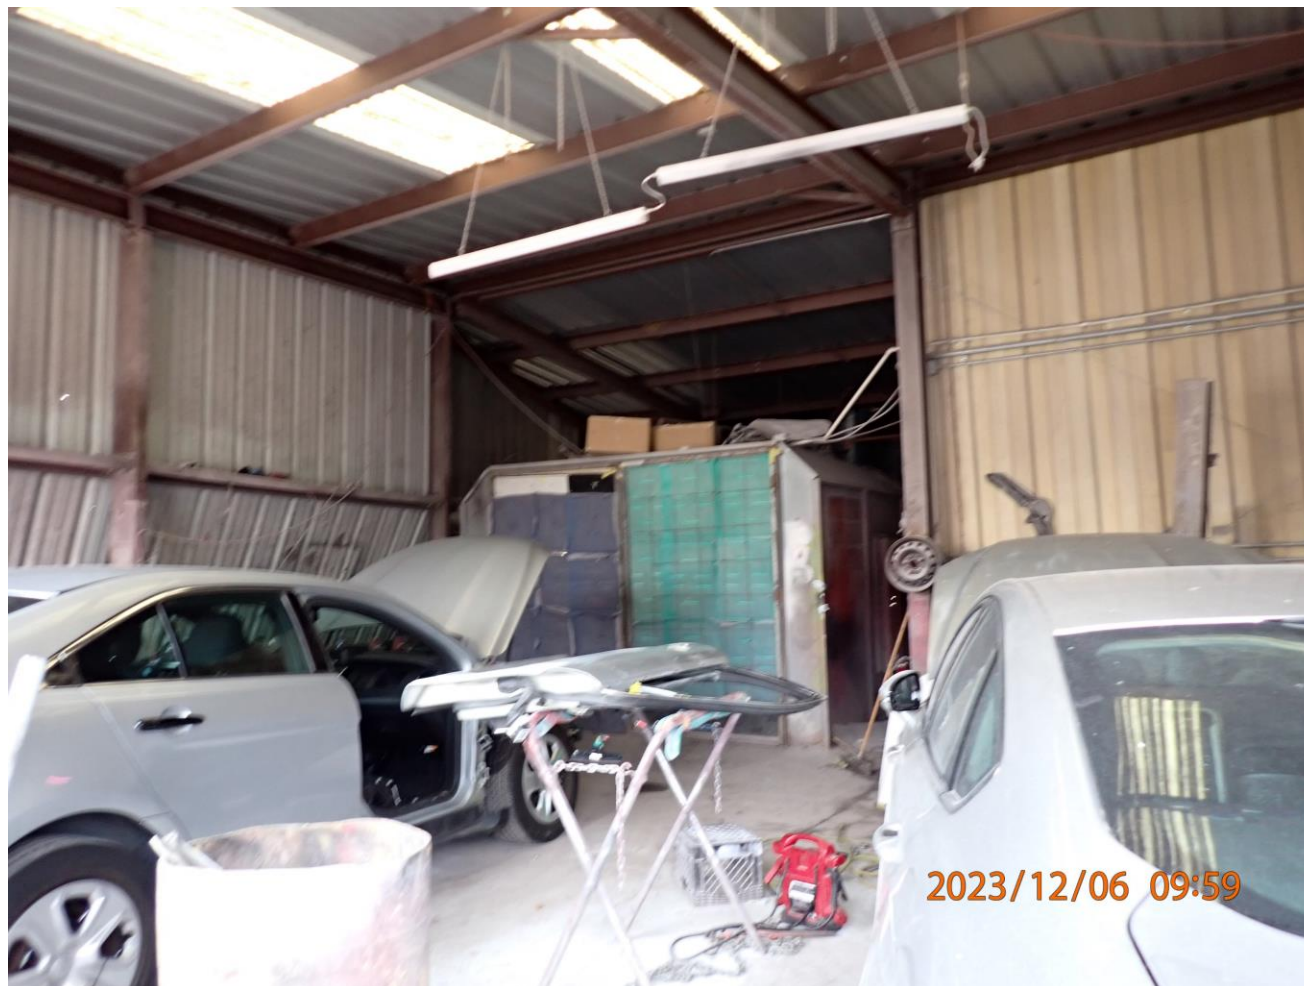
Photo Number: 50

Facility representatives turned on the spray booth so the inspection team could observe the airflow through the booth. There was very little air movement being caused by the exhaust fan which was not able to demonstrate that air was entering the booth, so the booth was not able to demonstrate a negative air flow.

Photo Description: Paint booth

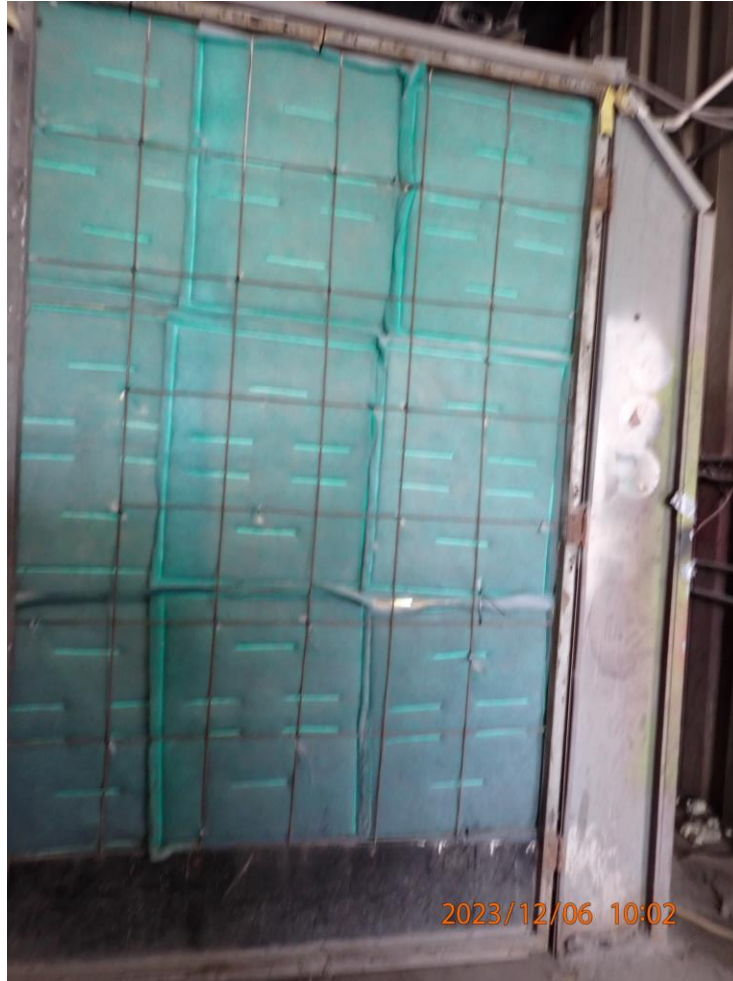
Photo Number: 51

The inspection team first went to the spray booth which was in the bay farthest to left when looking at the bay doors. There was an odor observed in the spray booth indicating painting had recently been done and there was a car inside the spray booth. The exhaust filters were located opposite the vehicle entry indicating a crossdraft spray booth. There were exhaust locations which were missing exhaust filters. All the observed filters were heavily laden with dirt, dust, or paint overspray which could potentially decrease airflow. The vehicle entry was not a full door, but a metal mesh of approximately 9" squares covered with filters.

Photo Description: Right side of paint booth vehicle entrance

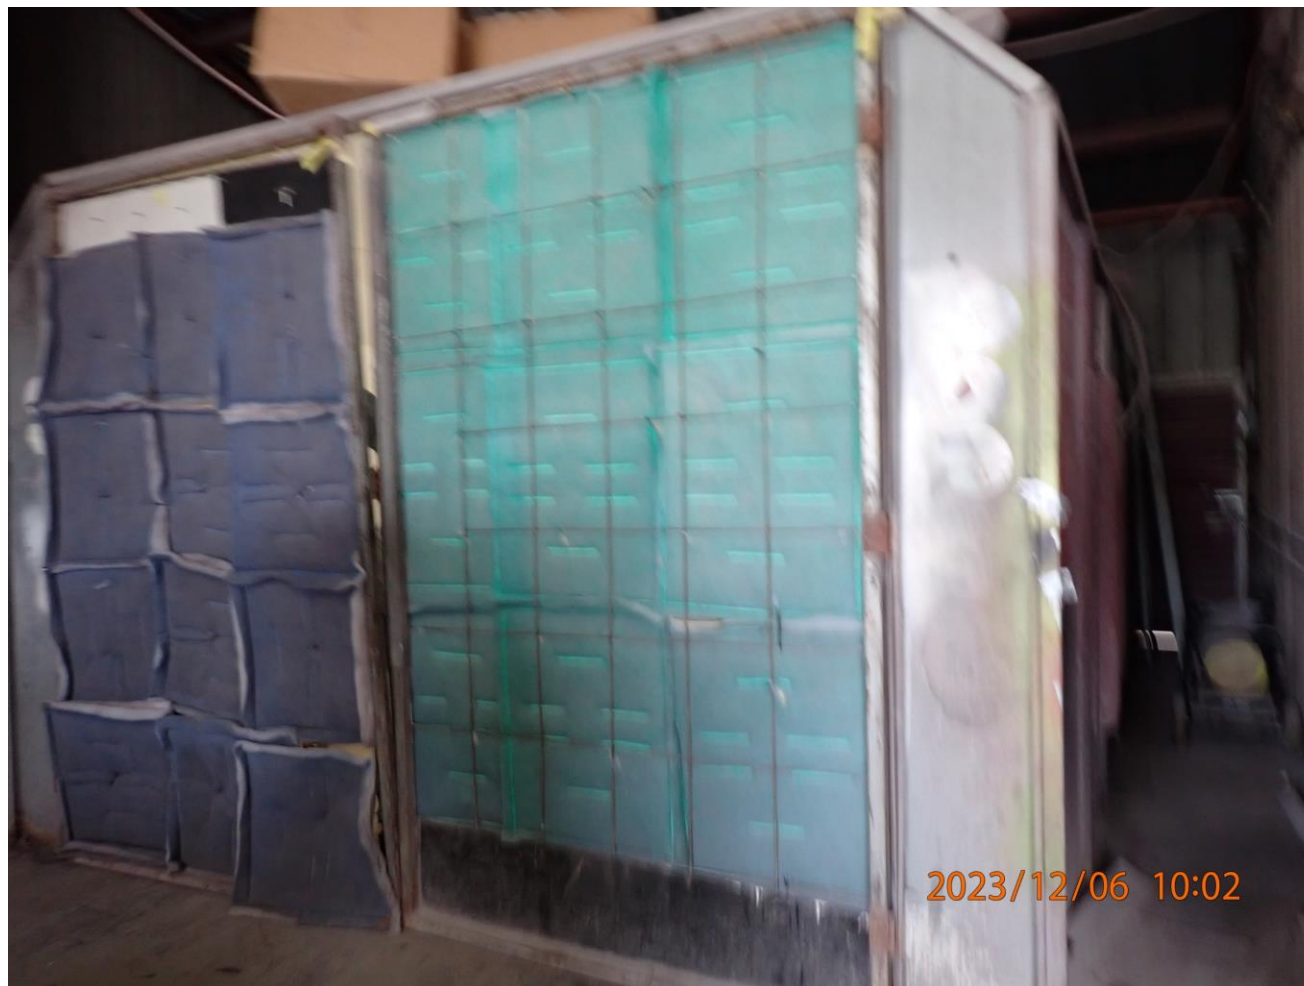
Photo Number: 52

Photo Description: Paint booth vehicle entrance

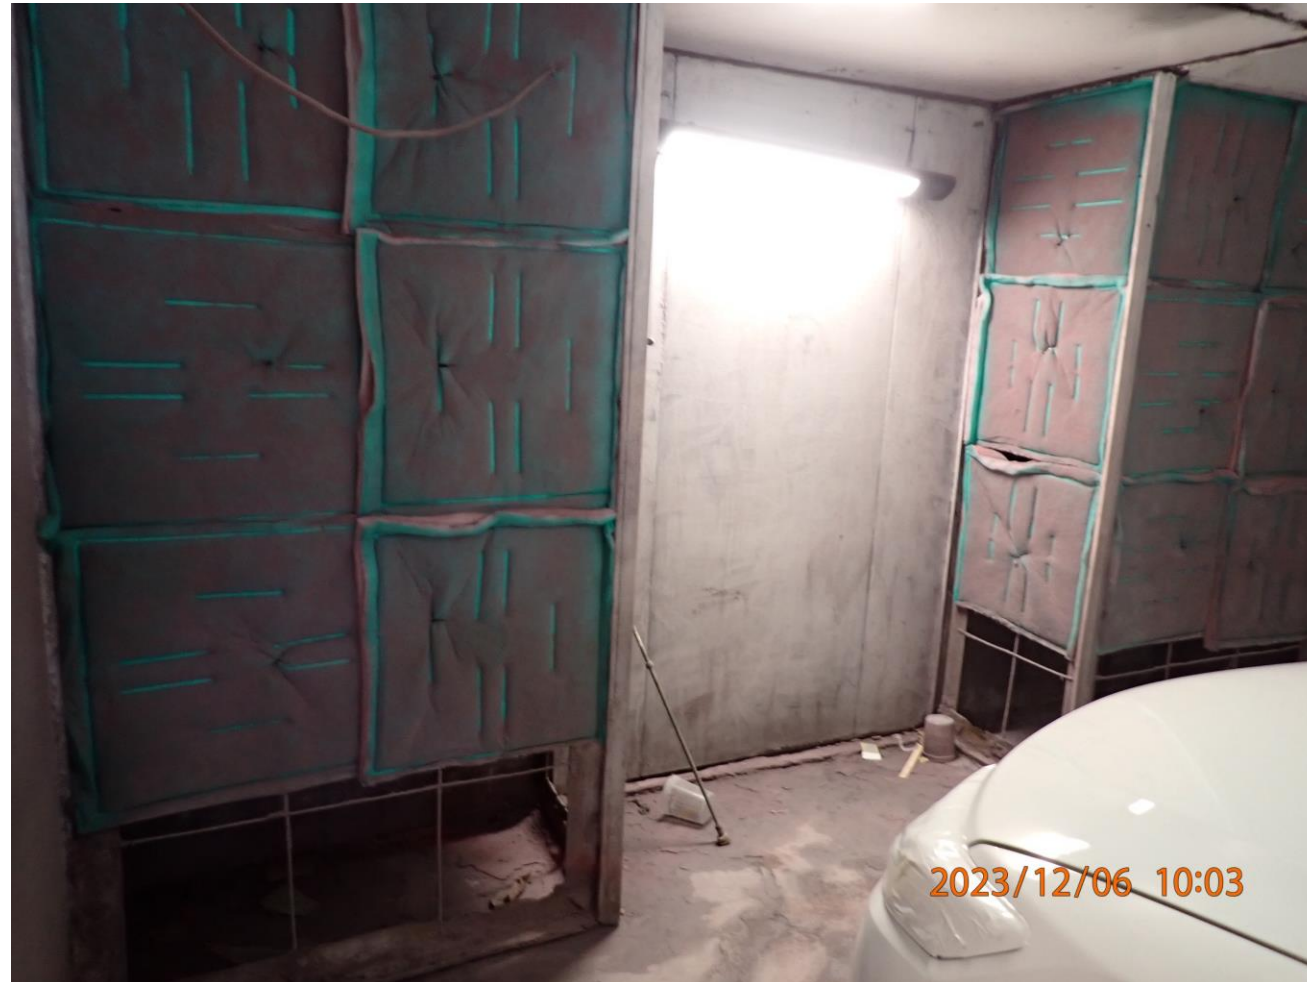
Photo Number: 53

- During the inspection, the Facility did not provide any documentation showing their painters are certified as required in NESHAP 6H.
- During the inspection, the Facility did not provide any documentation showing their filter technology achieved at least 98% capture of the paint overspray and exhaust filters were missing in the spray booth.

Photo Description: Exhaust filters in paint booth

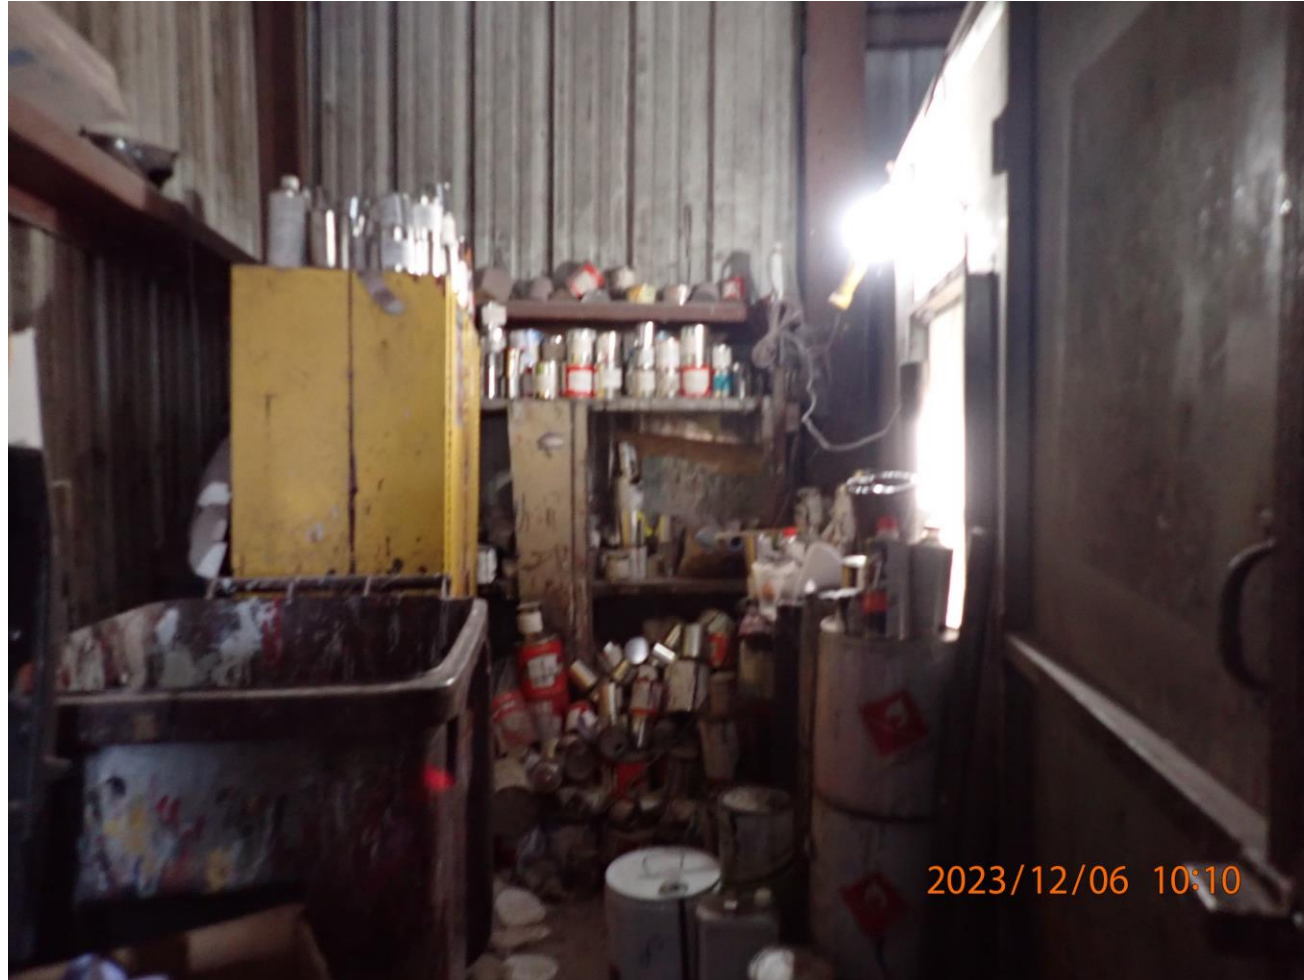
Photo Number: 54

Directly outside the spray booth was the Facility's paint storage area. There were open paint containers and an open solvent container observed in this area as well as similar odors to those observed inside the spray booth. There were cans from multiple paint lines with a couple examples

Photo Description: Paint storage area

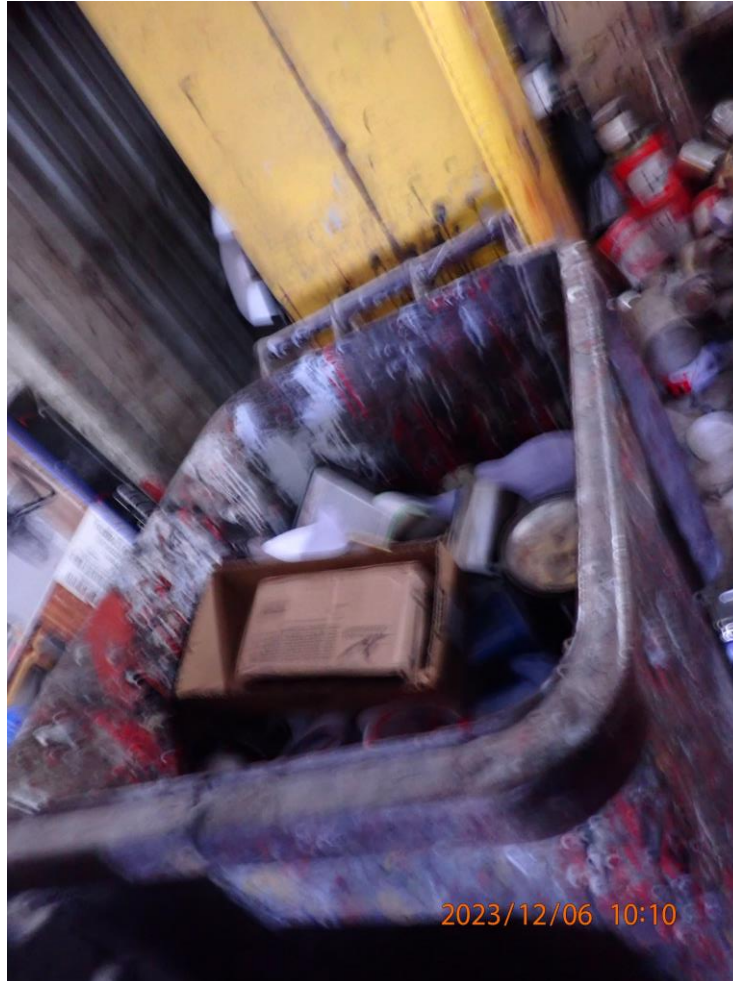
Photo Number: 55

being Wandabase HS and Nason. Two Central Pneumatic HVLP paint spray guns were located in the area. There was an open trash can with VOC laden materials. The painter described the process used to clean the spray guns. They run the solvent through the spray guns with low pressure. After going through the spray gun, the solvent runs into a smaller open container, which appeared to be approximately a pint to a quart in size. The liquid is then poured into a larger multi-gallon container which is closed once the liquid is poured. This liquid and paint waste is taken off-site at a later time.

Photo Description: Trash can in paint storage area

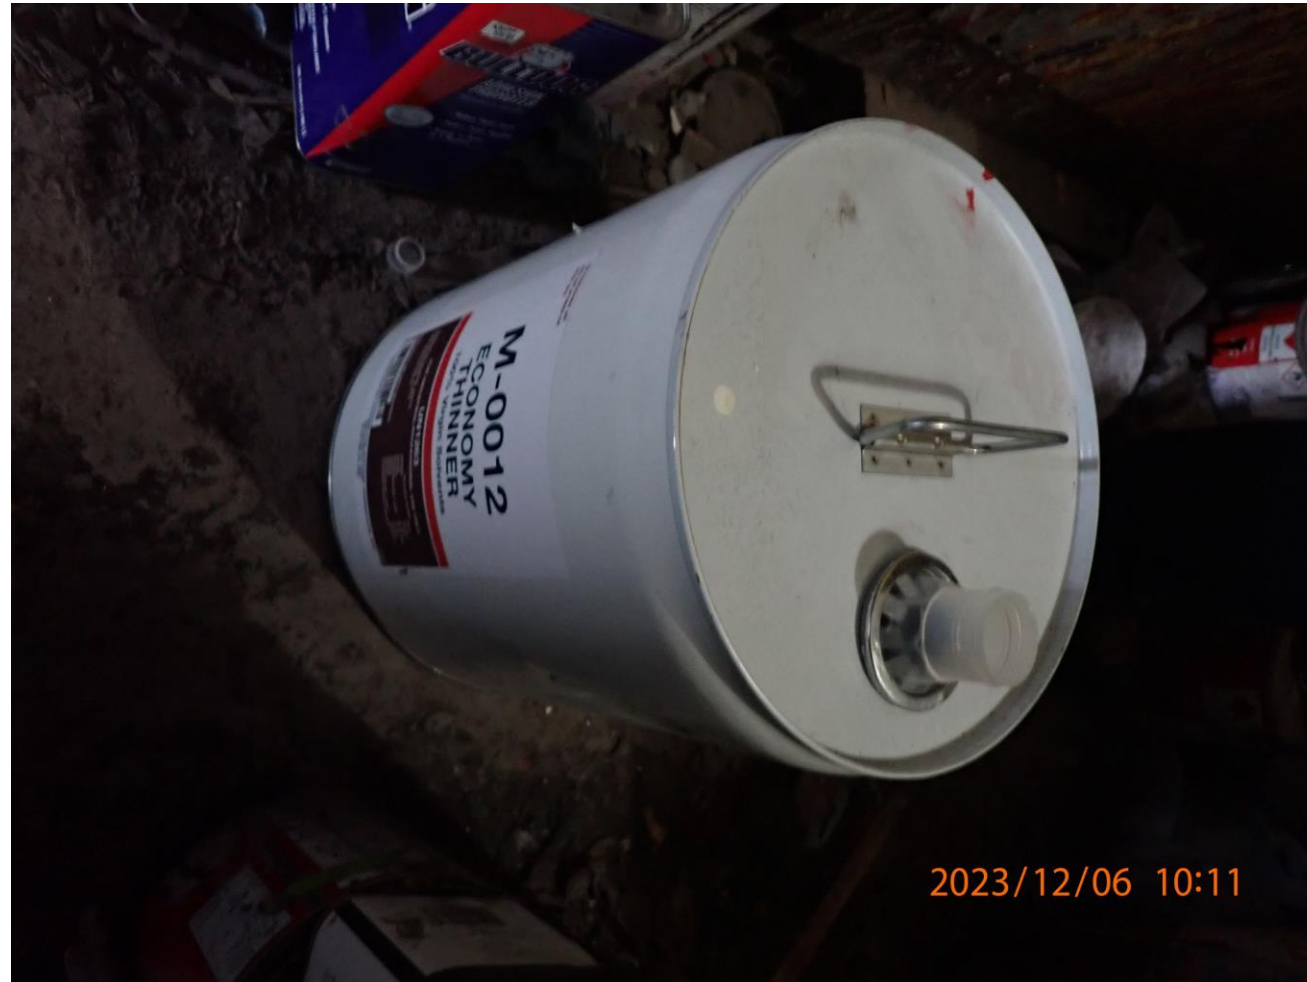
Photo Number: 56

- During the inspection, the Facility did not demonstrate their spray guns were cleaned in such a way that an atomized mist or spray was not created outside of a closed container to collect the spray gun cleaning solvent.

Photo Description: Solvent container

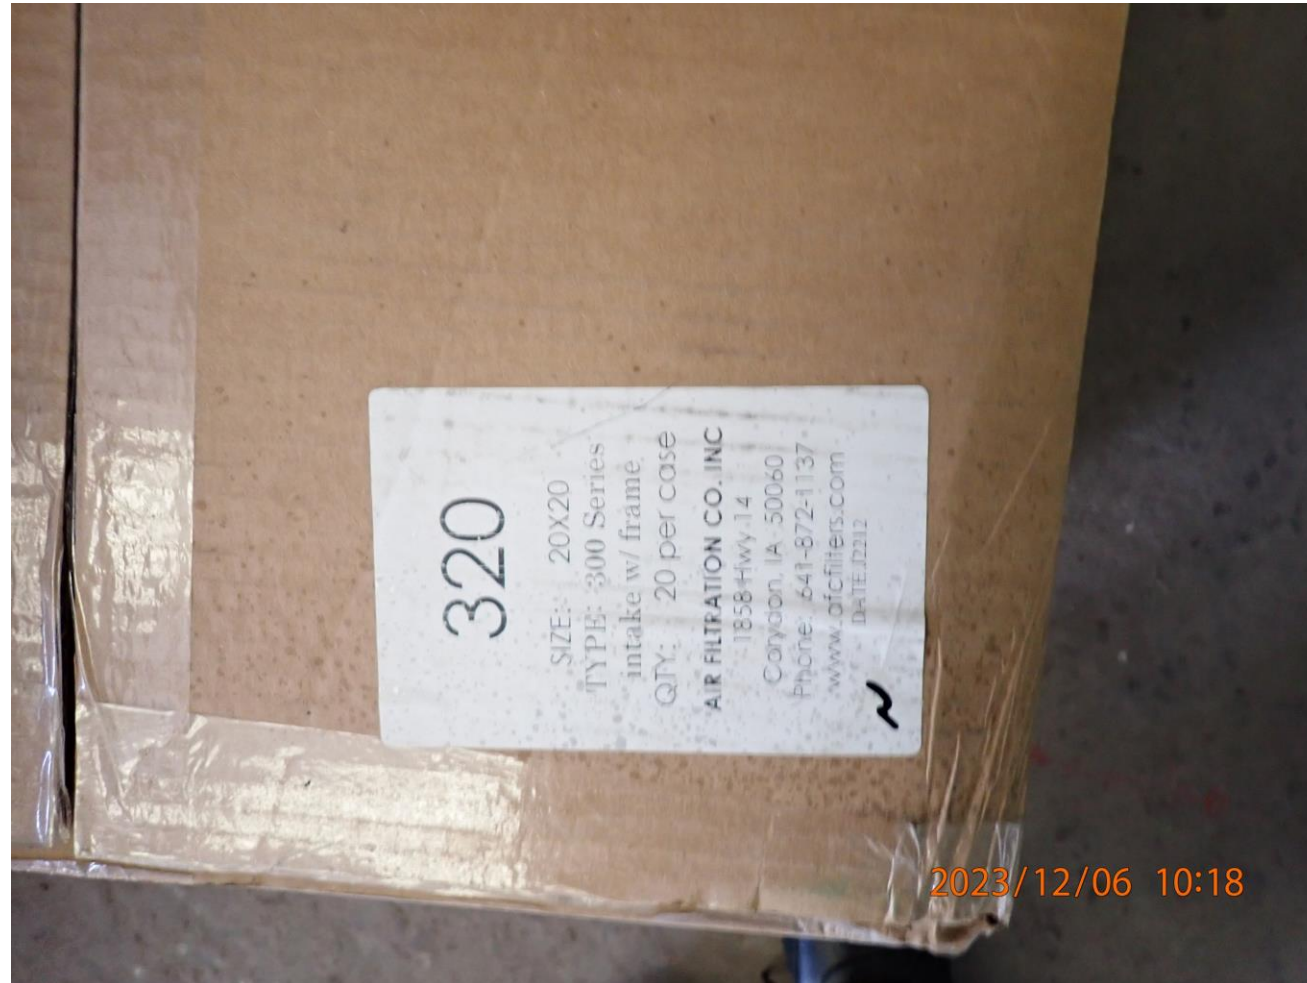
Photo Number: 57

The Facility stated they do not conduct any aftermarket exhaust work. The Facility also stated they do not use Methylene Chloride and do not conduct and chemical paint stripping. They just use an orbital sander for paint stripping. The spray booth filters were stated to be changed every two to four weeks based on use. The Facility uses 20" x 20" 300 series filters made by Air Filtration Co. Inc located in Corydon, IA.

Photo Description: Spray booth filters
