**Region 6 Compliance Assurance and Enforcement Division  
INSPECTION REPORT**

| Inspection Date(s): | 03/20-21/2018 | | |
| Company Name: | Tyson Poultry, Inc. | | |
| Facility Name: | Tyson Poultry, Inc. – Dardanelle Processing Facility | | |

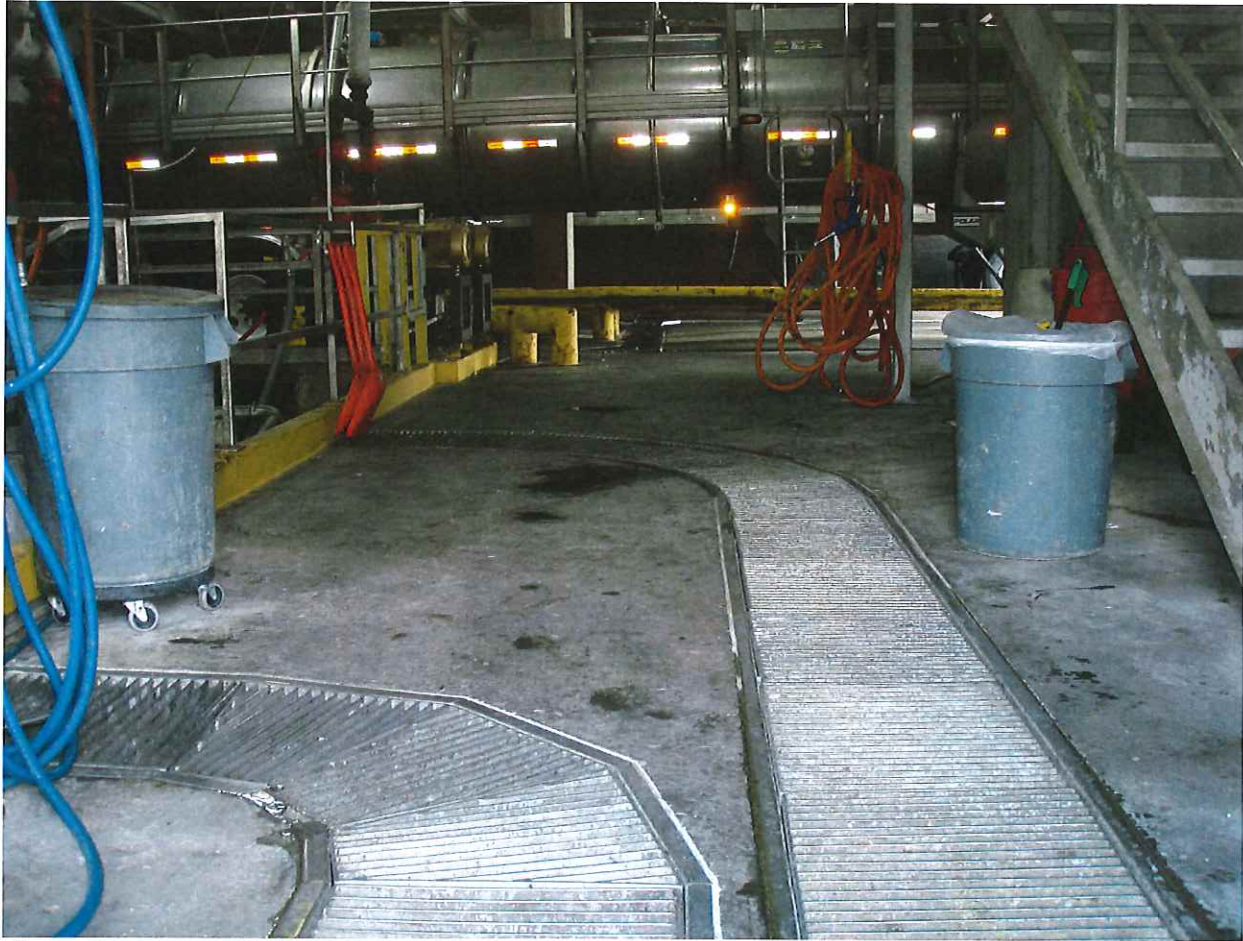
Photo No. 1

Description: Looking west at the drain trenches in the offal building. The trenches lead to the offal screens. A blood tanker was seen in the background. This area was very well maintained.

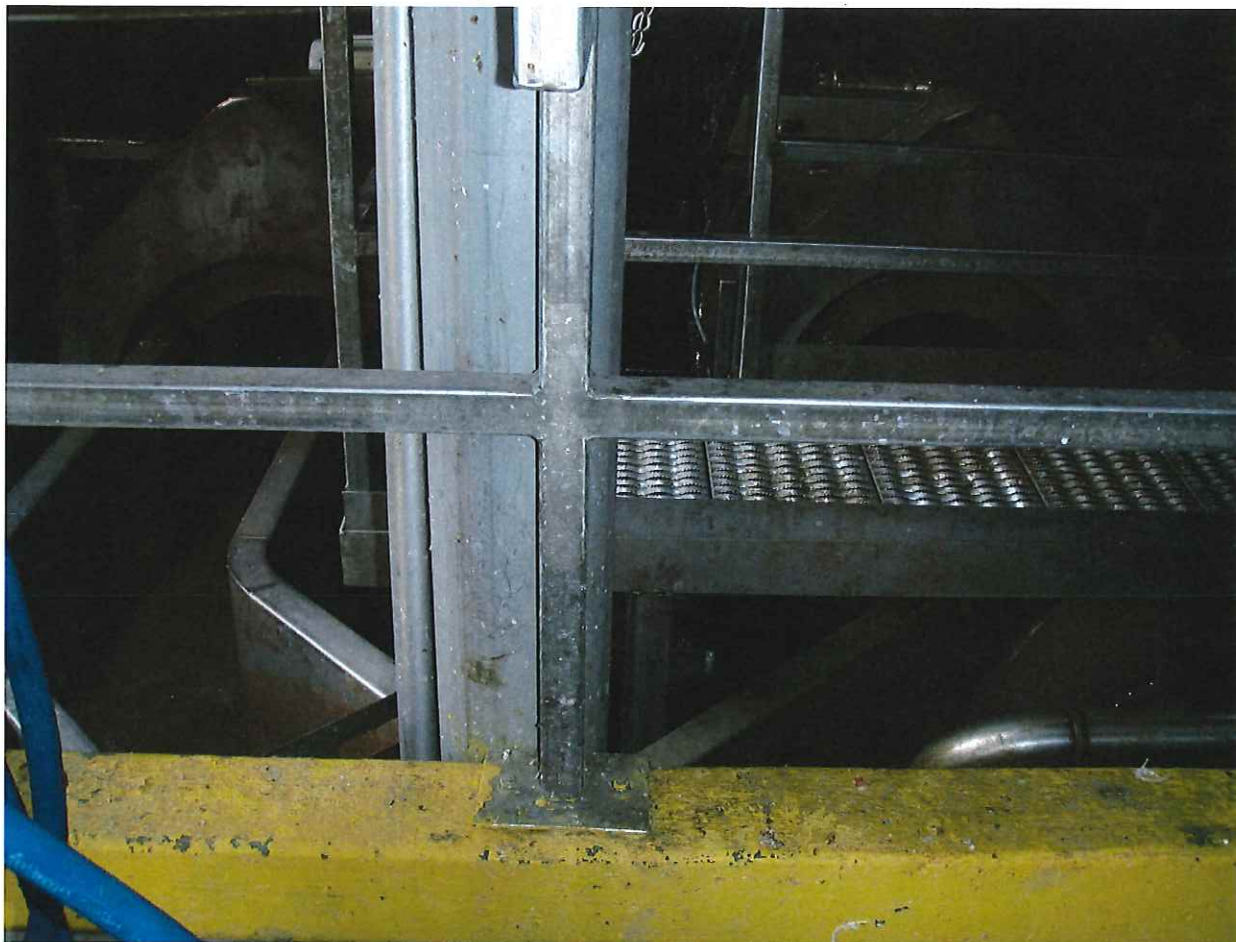
Photo No. 2

Description: Looking south at the drain trenches in the offal building with the rotating screens in the background.

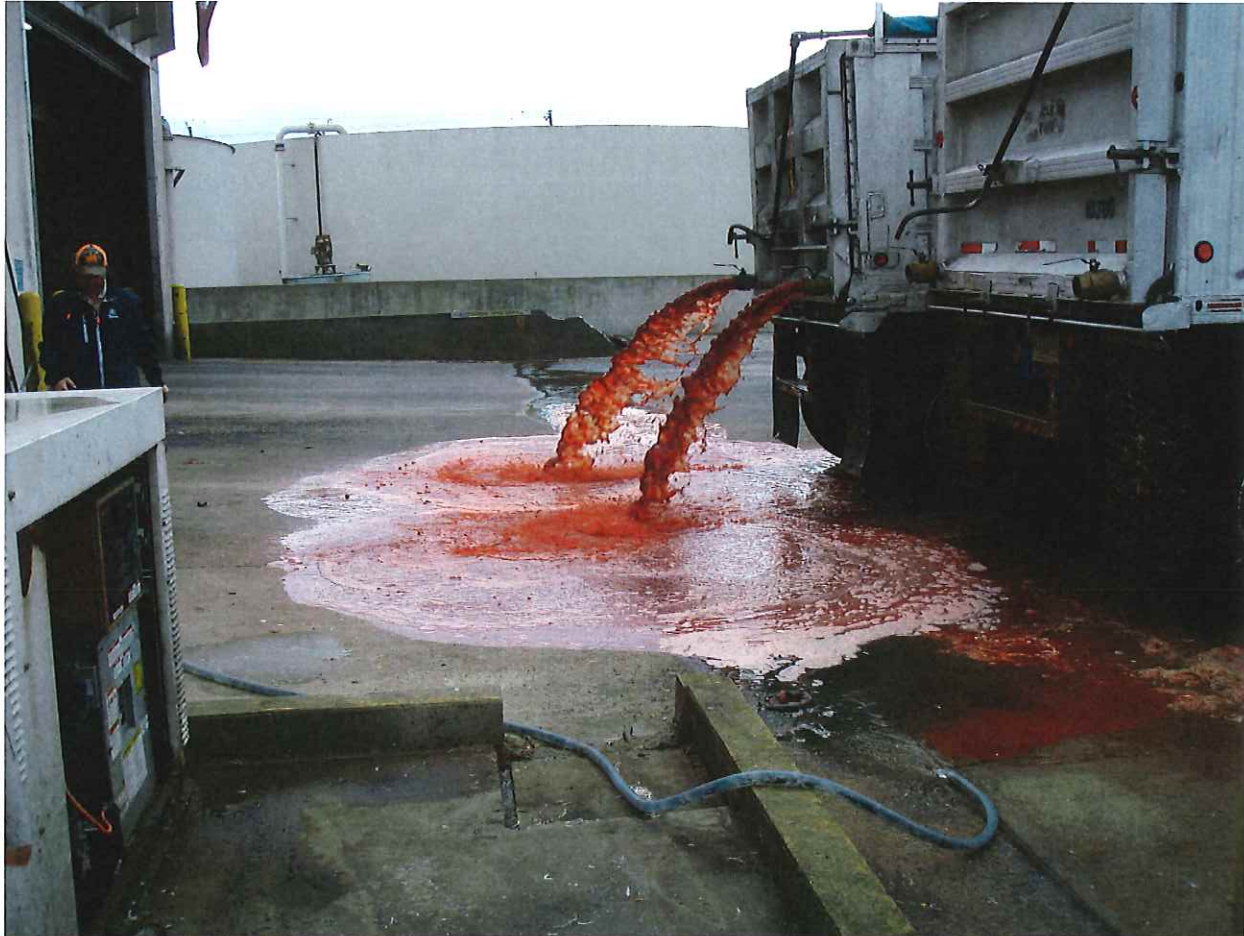
Photo No. 3

Description: Looking west at the offal trucks as they drained liquid and blood into a trench that had a drain recovery pit at the far concrete wall. The drain lead back to the offal screens seen in photo 2. A red dye was added to the offal and blood (a USDA requirement) to prevent its use in food grade products.

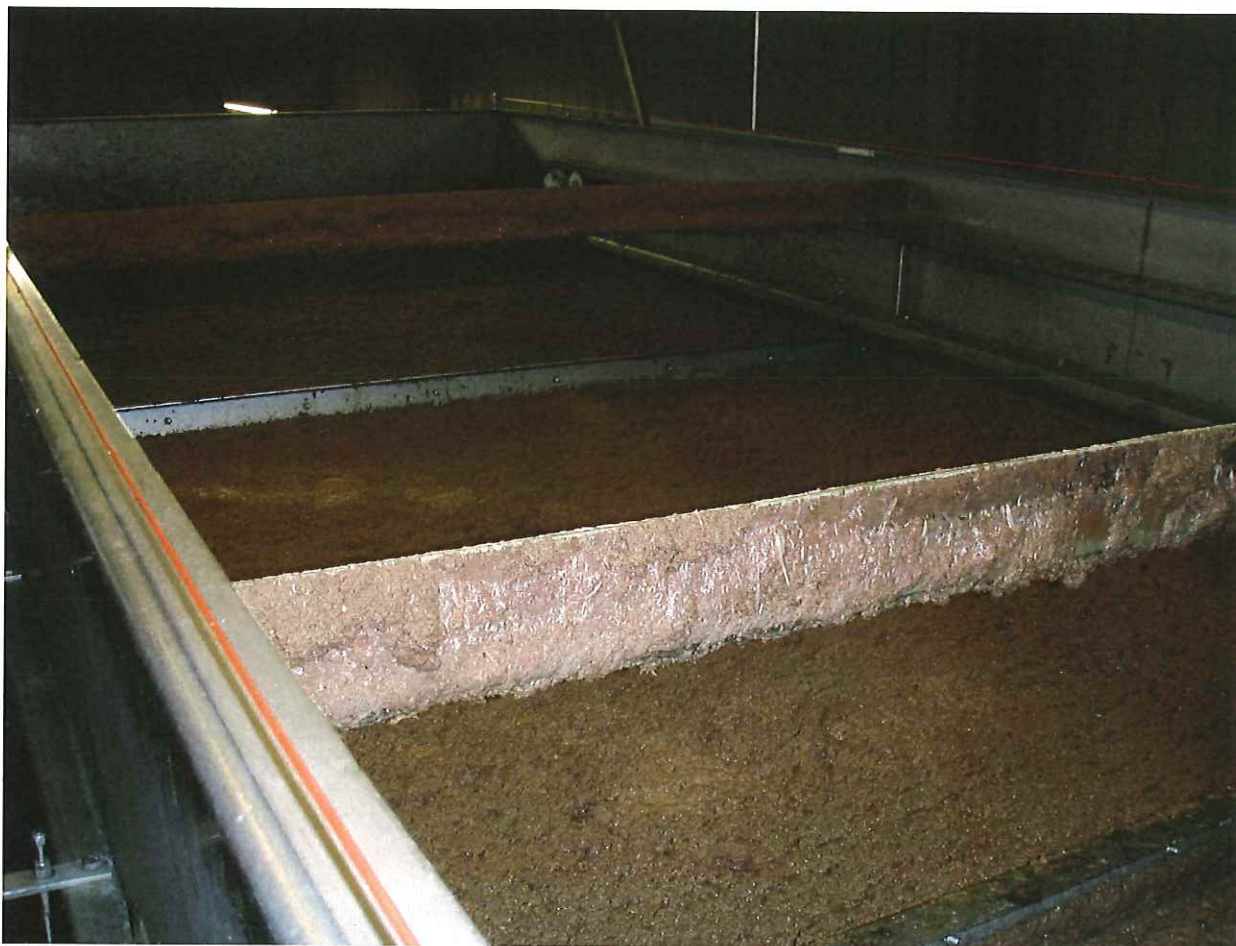
Photo No. 4

The plant wastewater treatment system is monitored and operated via SCADA (supervisory control and data acquisition) control. The offal screening and DAF units were operating efficiently in the removal of gross and fine solids. Effluent from the DAF unit was found to be somewhat clear, with no visible solids particles seen in the effluent as it went to the 7-day equalization tanks. Blood from the poultry slaughter operations was separated from the wastewater treatment system and pumped into a tanker as part of the ADEQ's permit that required the implementation of phosphorus removal best management practices.

Description: Solids coagulation seen on the DAF unit. Excellent solids removal was observed.

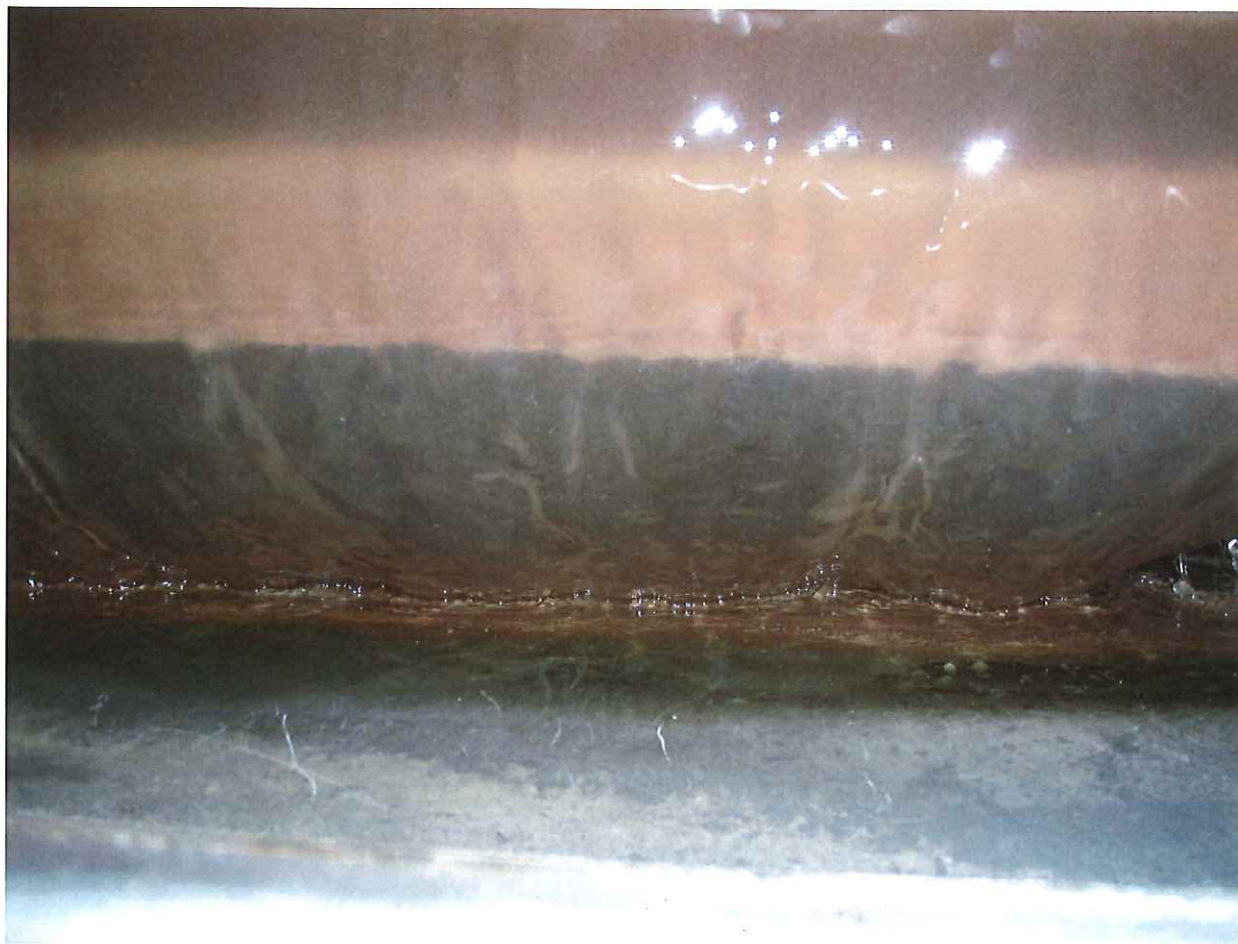
Photo No. 6

Description: Another view of the effluent discharge from the DAF unit. Excellent solids removal was observed.

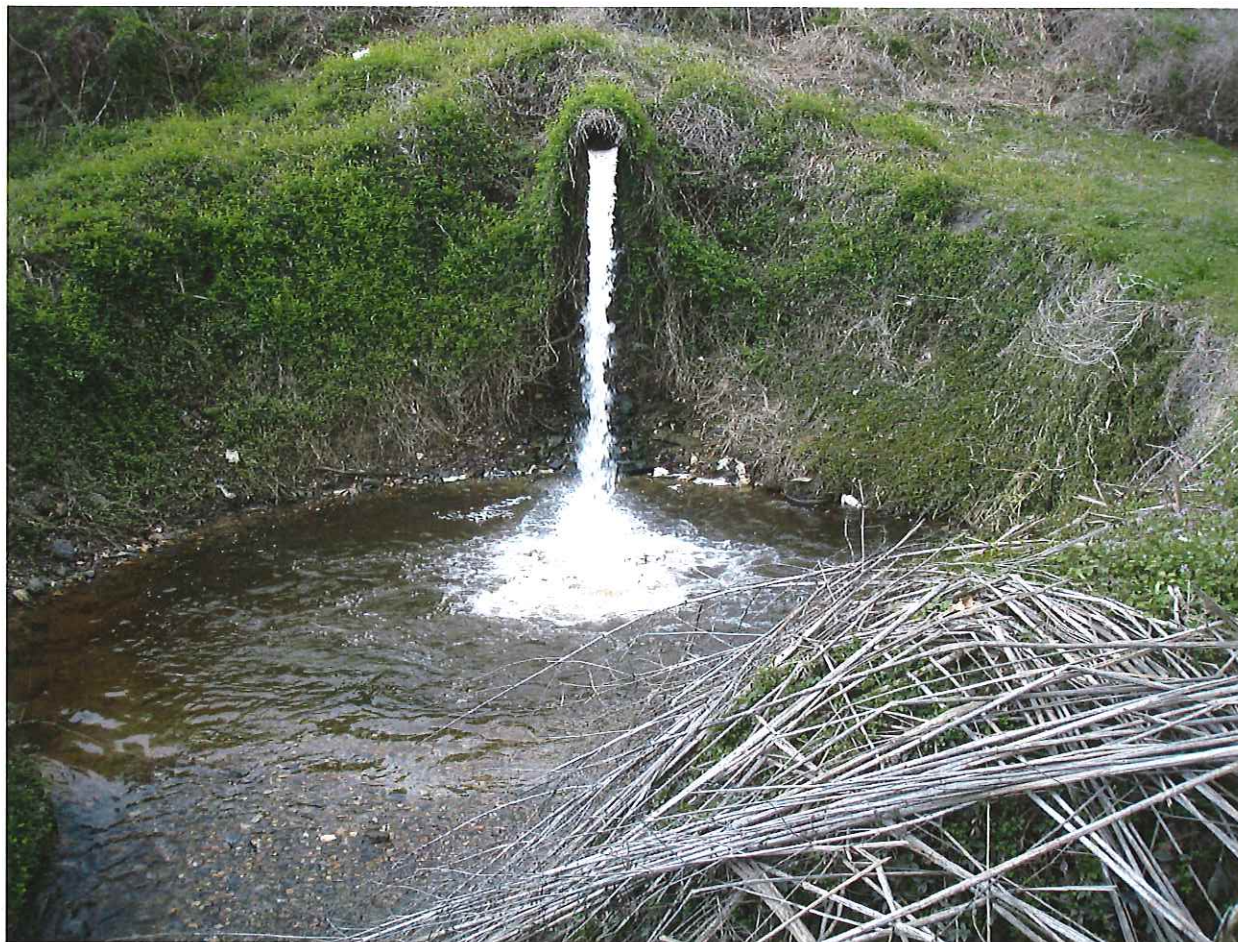
Photo No. 7

The discharge permit issued to Tyson did not mention that plant effluent would discharge thru a city storm sewer to the Arkansas River. However, the plant's 24-hour composite sampler was located following the final treatment unit (aerated chlorine contact basin), in the wastewater discharge line prior to commingling with any city storm water.

Description: The Tyson plant final effluent as it is discharged into a channel leading to the Arkansas River. The effluent discharge runs thru a City of Dardanelle storm drain that runs between the Tyson facility to this point. The photo was looking west.

- 1) The discharge permit issued to Tyson did not mention that plant effluent would discharge thru a city storm sewer to the Arkansas River. The next permit cycle should specify the discharge route more precisely.
- 2) The barometer used to calibrate the DO meter be calibrated annually, or a web source be used to provide the local barometric pressure.

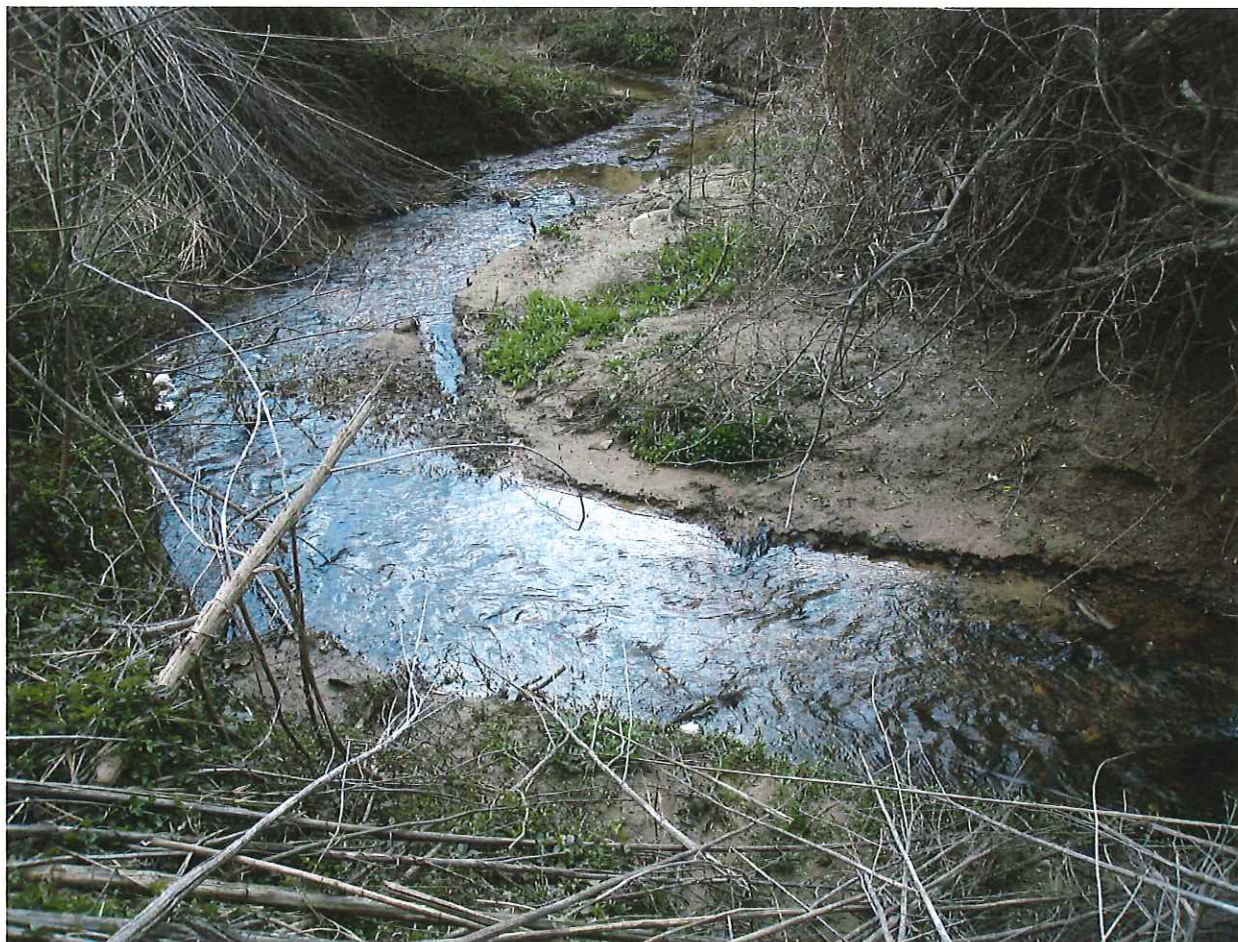
Photo No. 8

The effluent discharged to the Arkansas River was clear, free of any sheen, floatables and foam. Additionally, the channel through which the discharge flowed had a gravel base and was free of any visible plant solids.

Description: The Tyson plant final effluent as it is discharged into a channel leading to the Arkansas River. The stream had a gravel base which did not show any evidence of solids accumulation from the WWTP. This photo, which was looking south, was taken about 50' from the discharge line seen in photo 7.

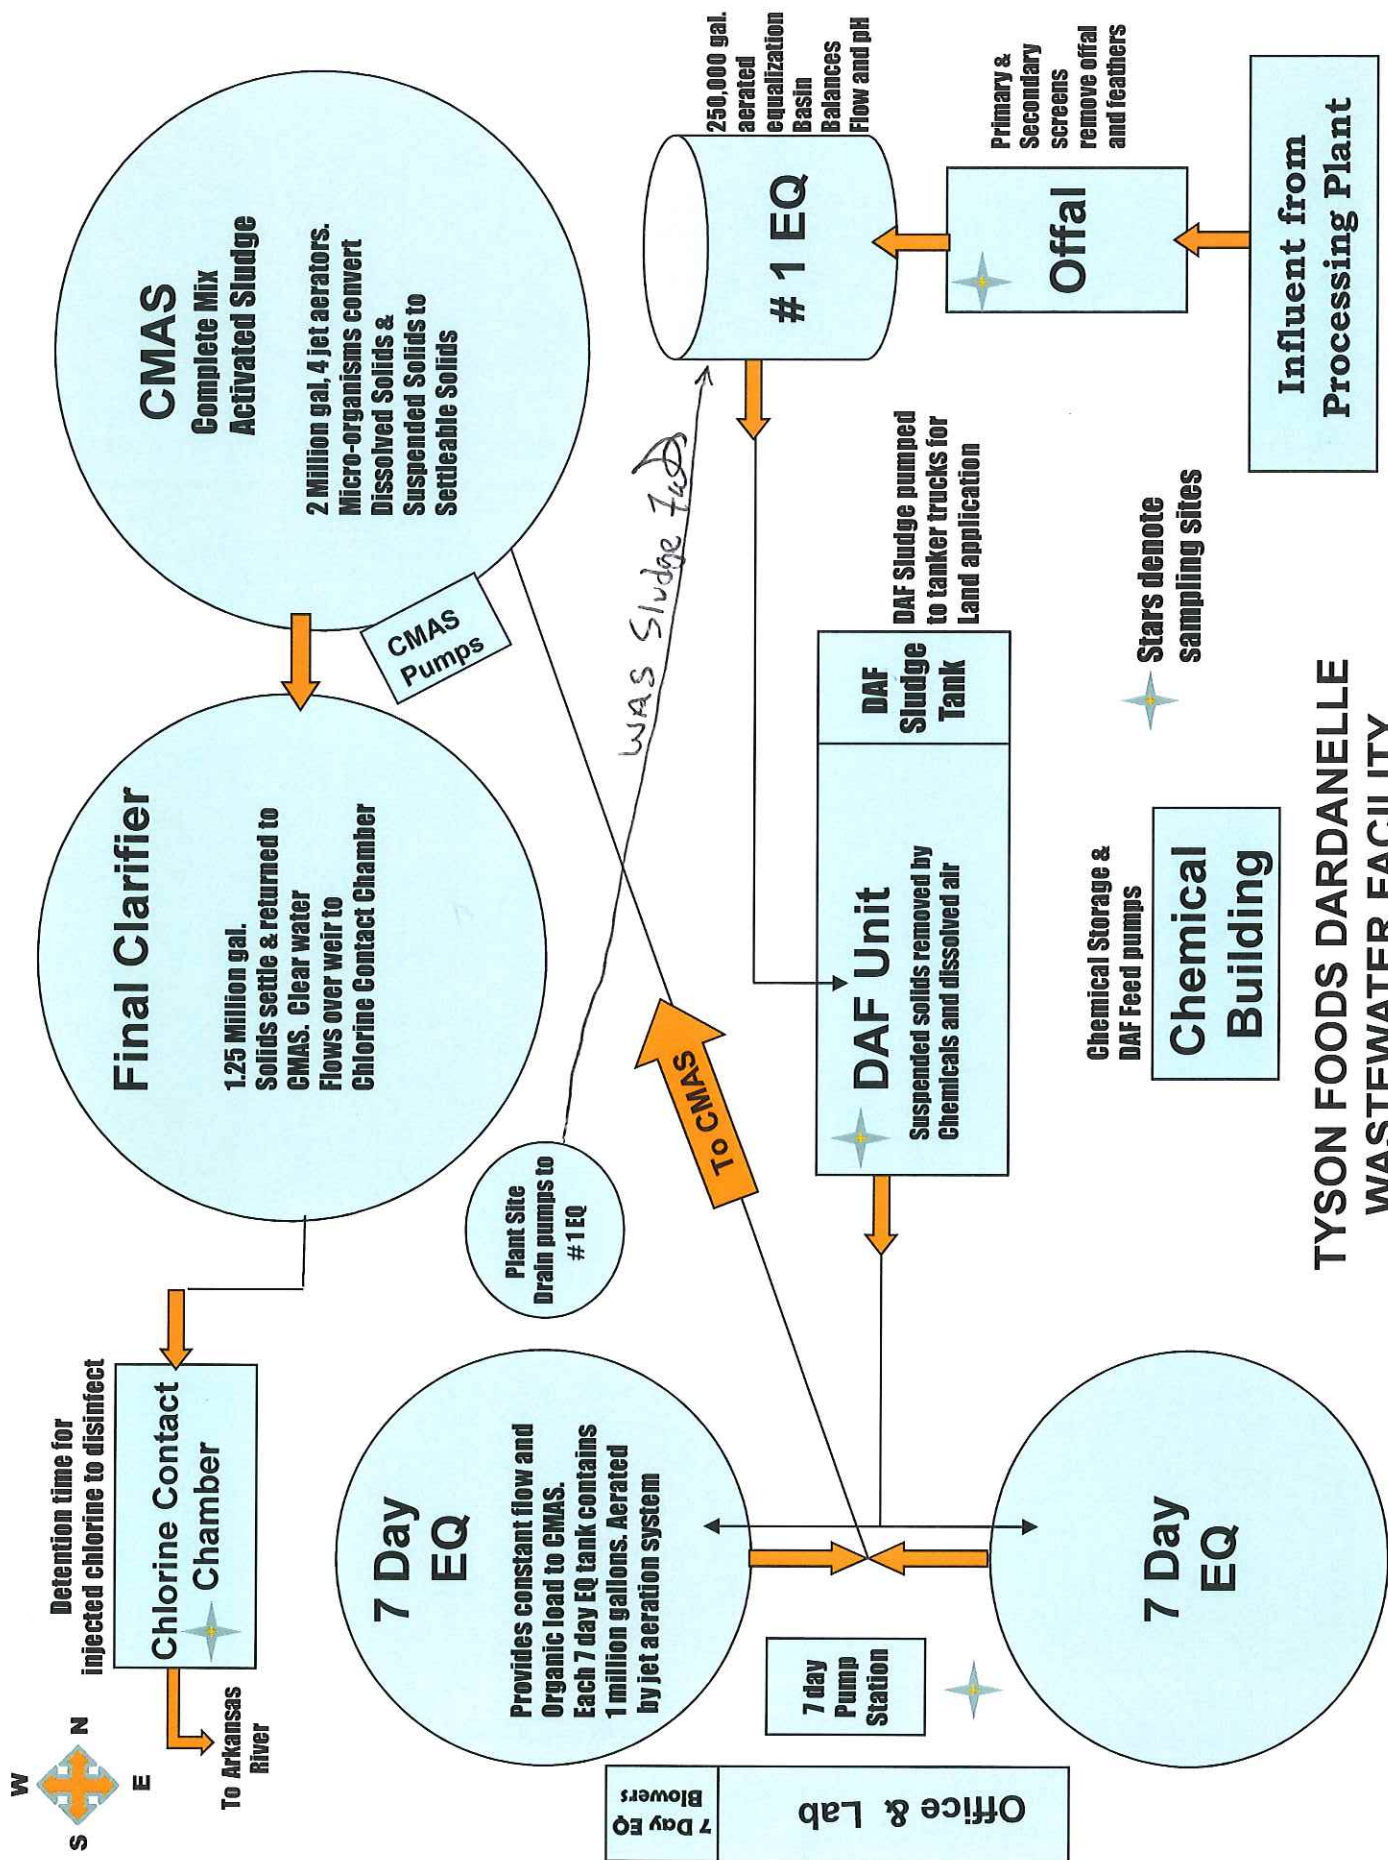
**TYSON FOODS DARDANELLE  
WASTEWATER FACILITY**

Effluent from the DAF was sent to the two 7-day 1-MG equalization tanks (to balance flows from the 5-day operating period over a 7-day wastewater treatment period). The equalization tanks equalized the flow that was sent to the 2-MG Complete Mix Activated Sludge (CMAS) aerated basin. The CMAS was followed by a 1.25 MG Final Clarifier, and thence the chlorine contact basin. The final effluent then discharged thru a shared underground City of Dardanelle storm drainage line to the Arkansas River. The use of an MS4 storm water line will be discussed later in the report. See the Plant Schematic found in Appendix 2.
