**Region 6 - Enforcement & Compliance Assurance Division  
INSPECTION REPORT**

| Regulatory Program(s) | NPDES CAFO | | |
| Company Name: | Jimenez Family Dairy LLC | | |
| Facility Name: | Jimenez Family Dairy | | |

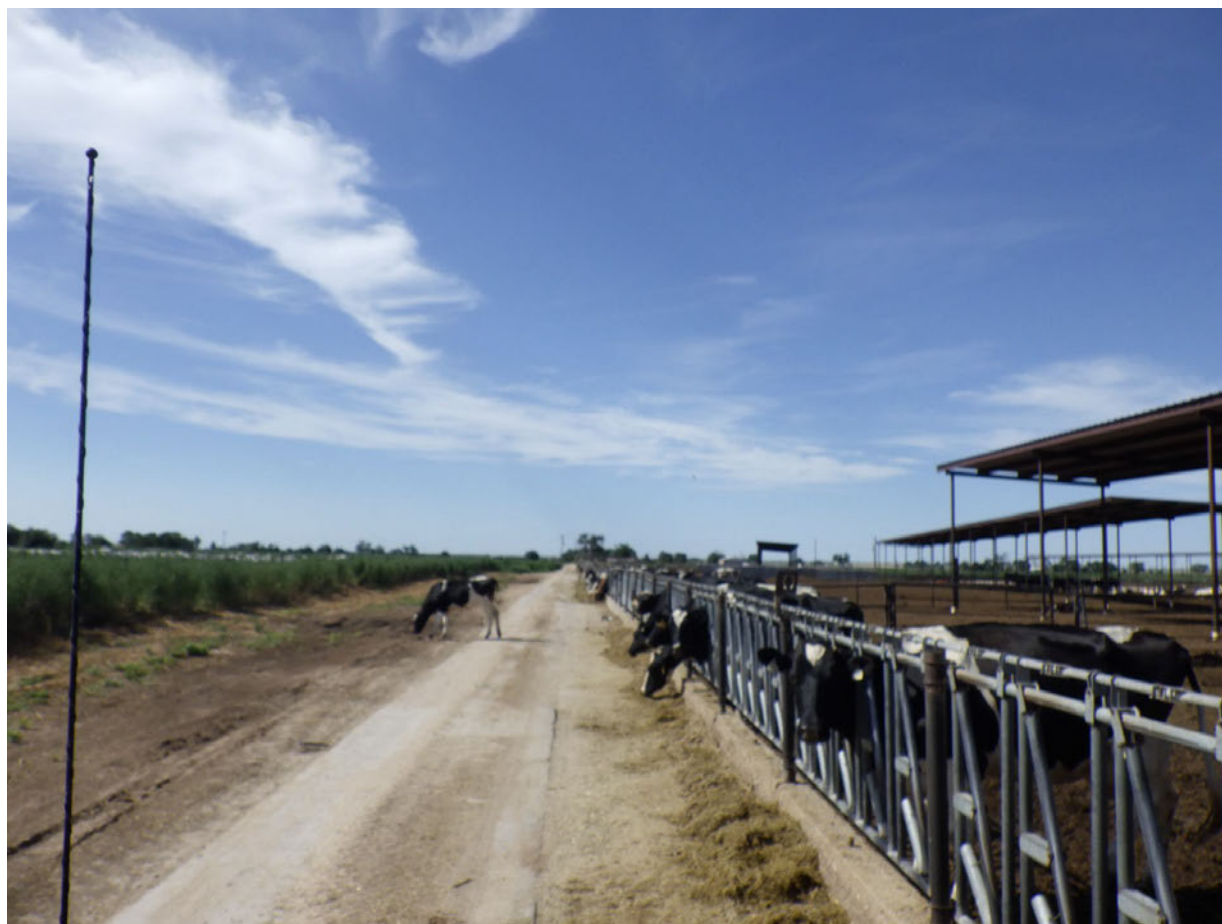
Photo No. 1

| Description: | View to the south. Eastern perimeter of the open lot pens. | | |

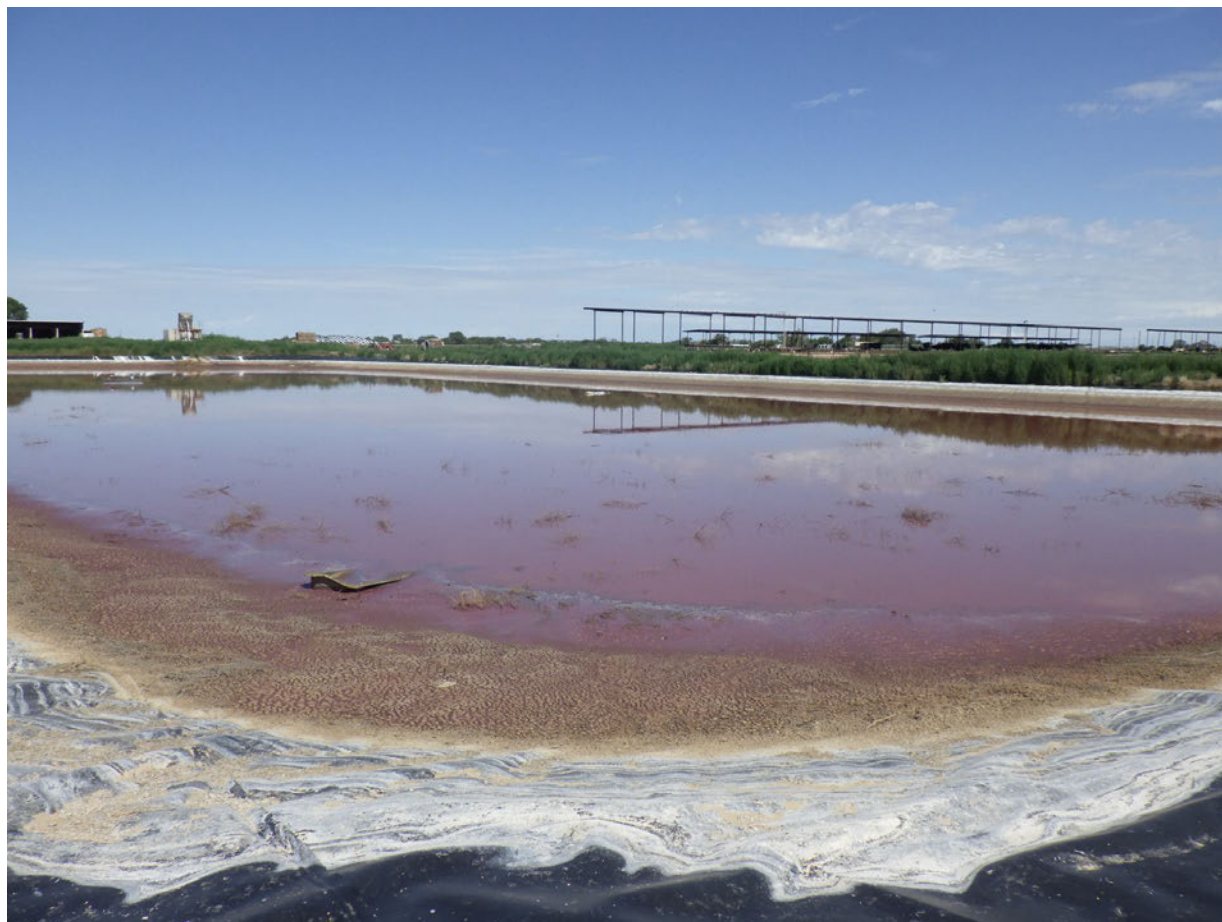
Photo No. 2

The RCS has a synthetic HDPE liner with a hydraulic conductivity rating greater than  $1 \times 10^{-7}$  cm/s. Inspection of the synthetic liner showed no signs of breaks or tears. The RCS had approximately 5 feet of freeboard (Appendix 1, Photo 2). However, there was some trash debris inside the RCS at the time of inspection (Appendix 1, Photo 2) (See Areas of Concern). There was also vegetation growth along the

1) Trash and Debris in the RCS: The presence of trash and debris in the Retention Control Structure (RCS) constitutes improper use and maintenance of the facility's waste management system. The RCS is designed to manage and contain liquid waste, not solid debris, which can interfere with its intended operation. Improper maintenance could lead to structural issues or inefficiencies in waste containment, potentially resulting in violations of Clean Water Act (CWA) requirements. Specifically, Section 301 of the CWA (33 U.S.C. § 1311) prohibits the discharge of pollutants into waters of the United States without a National Pollutant Discharge Elimination System (NPDES) permit. Ensuring the RCS is free from trash and debris is crucial to maintaining its functionality and preventing any indirect impacts on water quality.

| Description: | View to the northwest. Lagoon (RCS) on the southern end of the pens. | | |

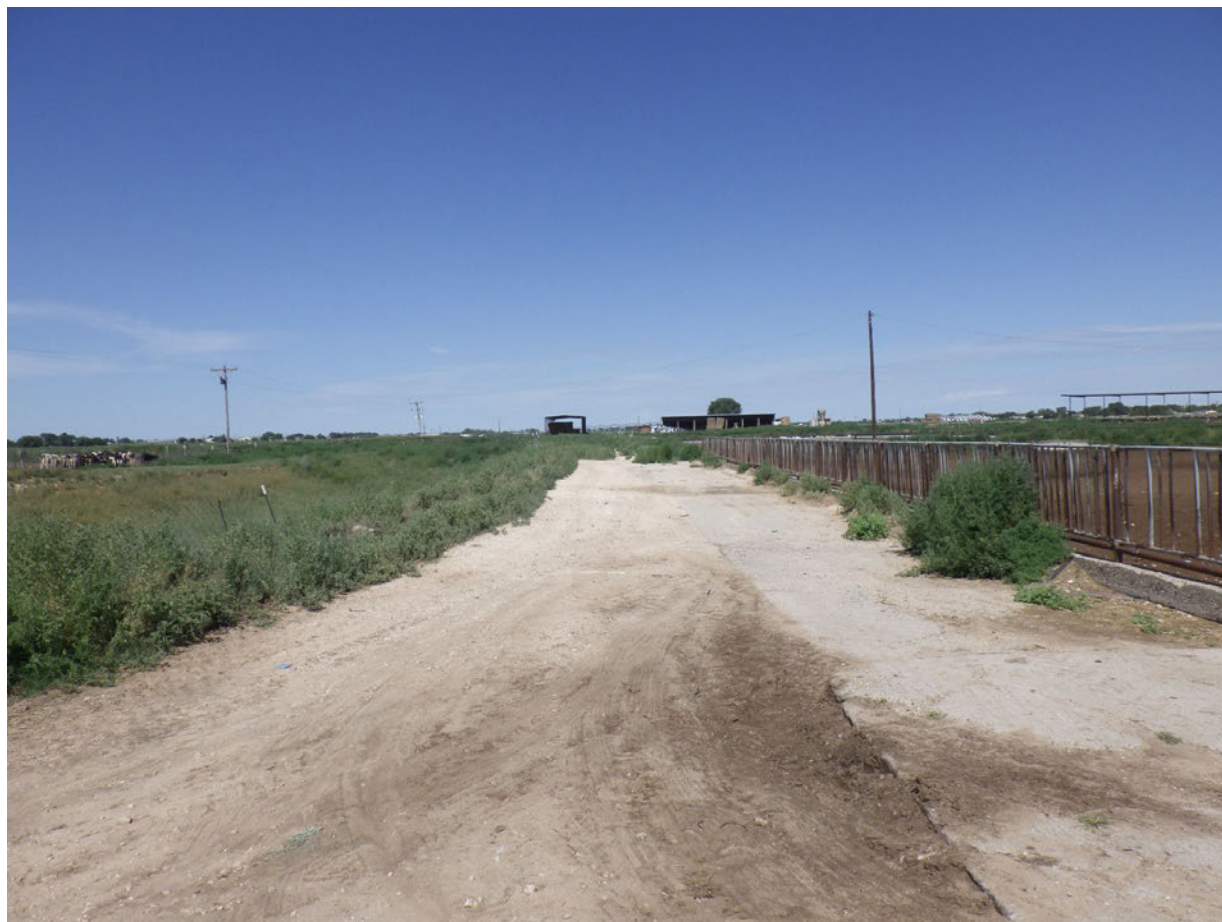
Photo No. 3

| Description: | View to the west. Southern perimeter of the facility. | | |

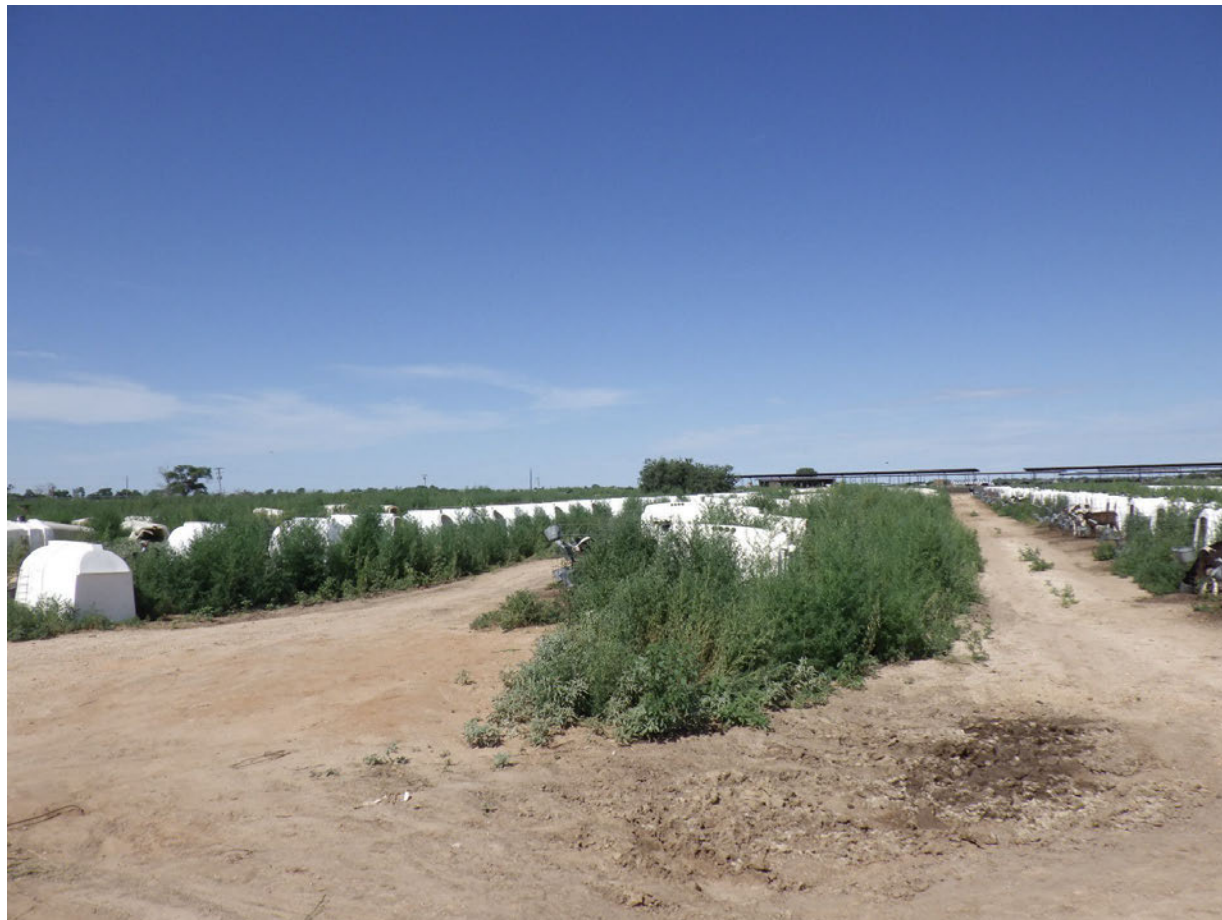
Photo No. 4

| Description: | View to the west. Calf hutches with pens in the background. | | |

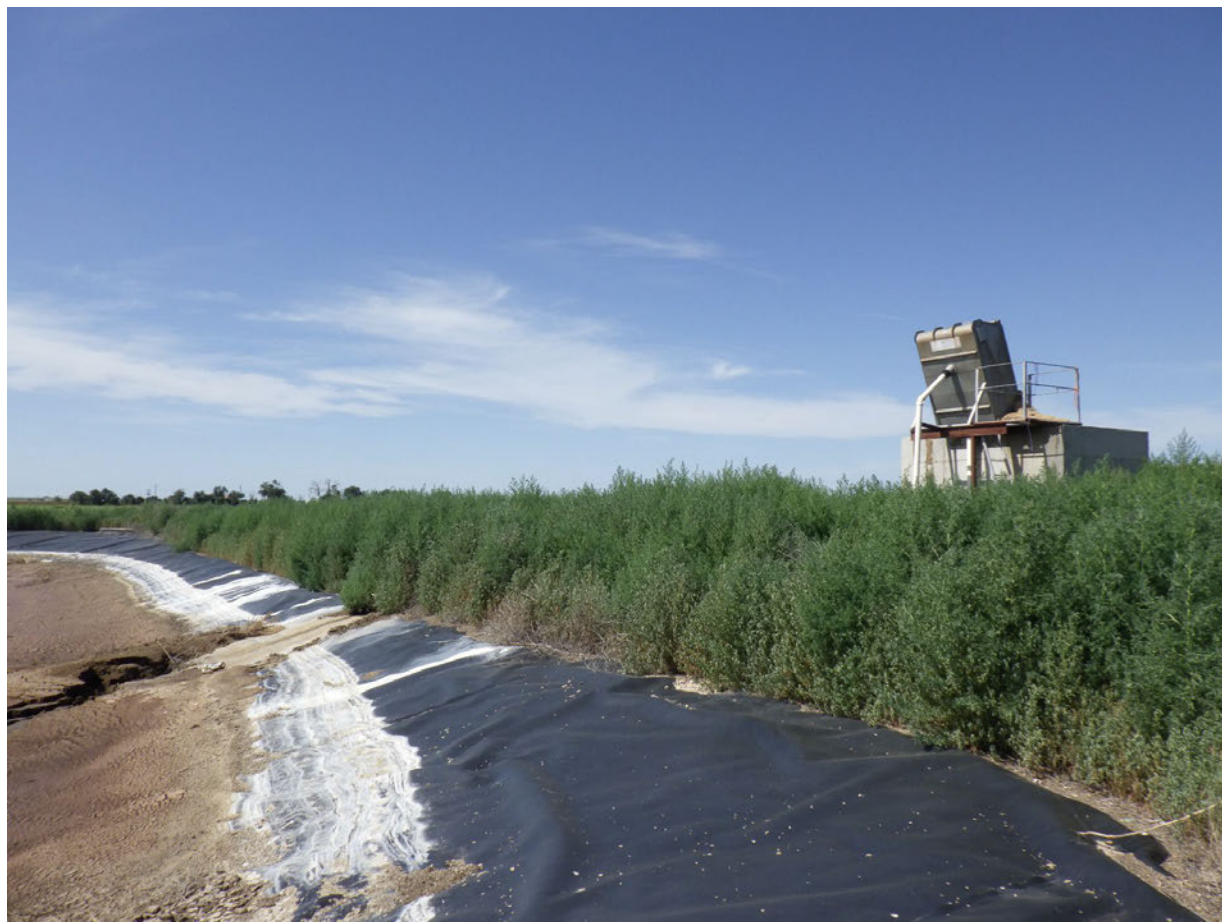
Photo No. 5

berm (Appendix 1, Photo 5) (See Areas of Concern). No visible signs of erosion were observed on embankments. The facility uses grading and perimeter berms to route runoff to the RCS.

2) Vegetation growth along the embankment of the RCS: CWA, Section 301 (33 U.S.C. § 1311) prohibits the discharge of pollutants into Waters of the United States (WOTUS) without an NPDES permit. Vegetation on the RCS embankment could lead to structural issues, resulting in unauthorized discharges into WOTUS, which would lead to a CWA violation.

| Description: | View to the southwest. Western berm of the lagoon with separator screen in background. | | |

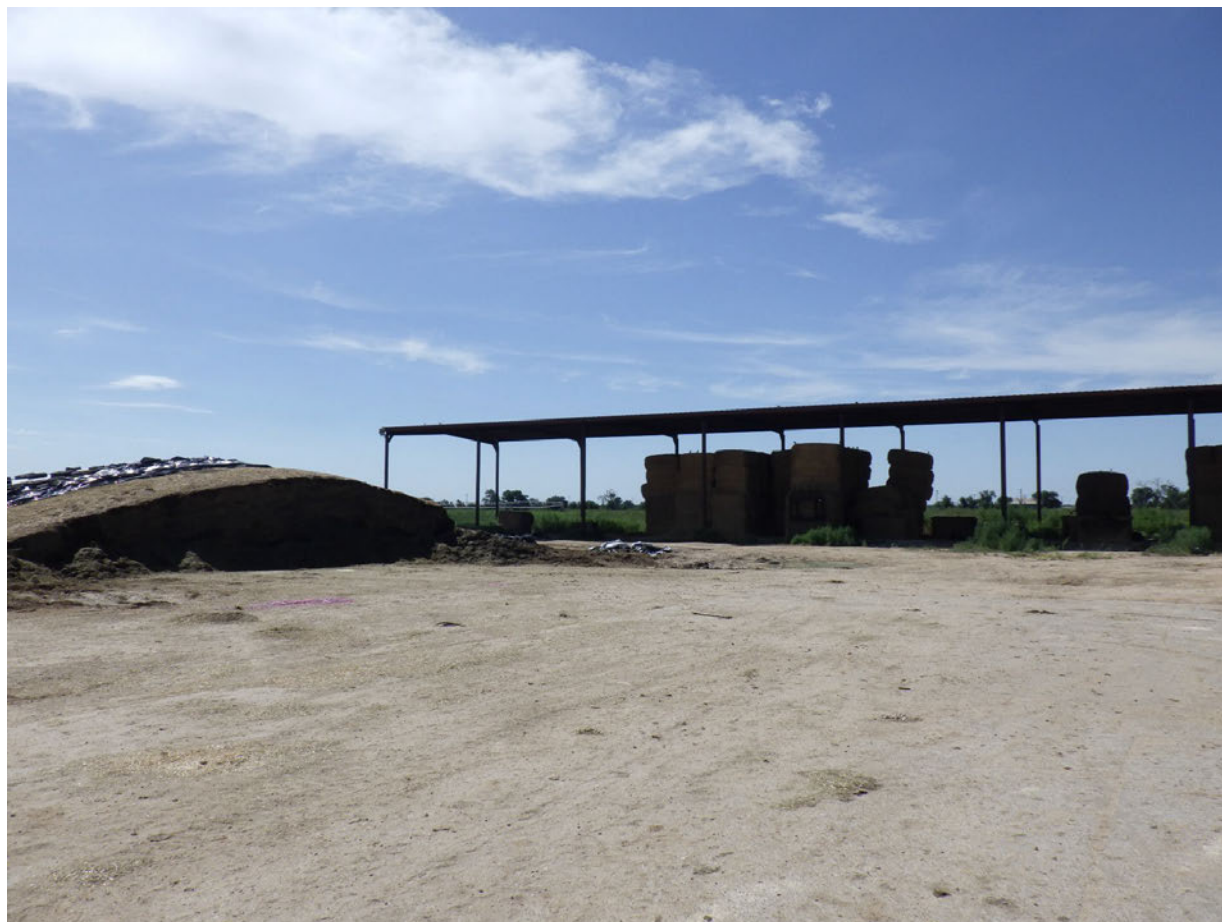
Photo No. 6

All hay, grains, and silage were stored under cover near the southwestern corner of the facility (Appendix 1, Photos 6 & 7).

| Description: | View to the southeast. Hay and silage under cover. | | |

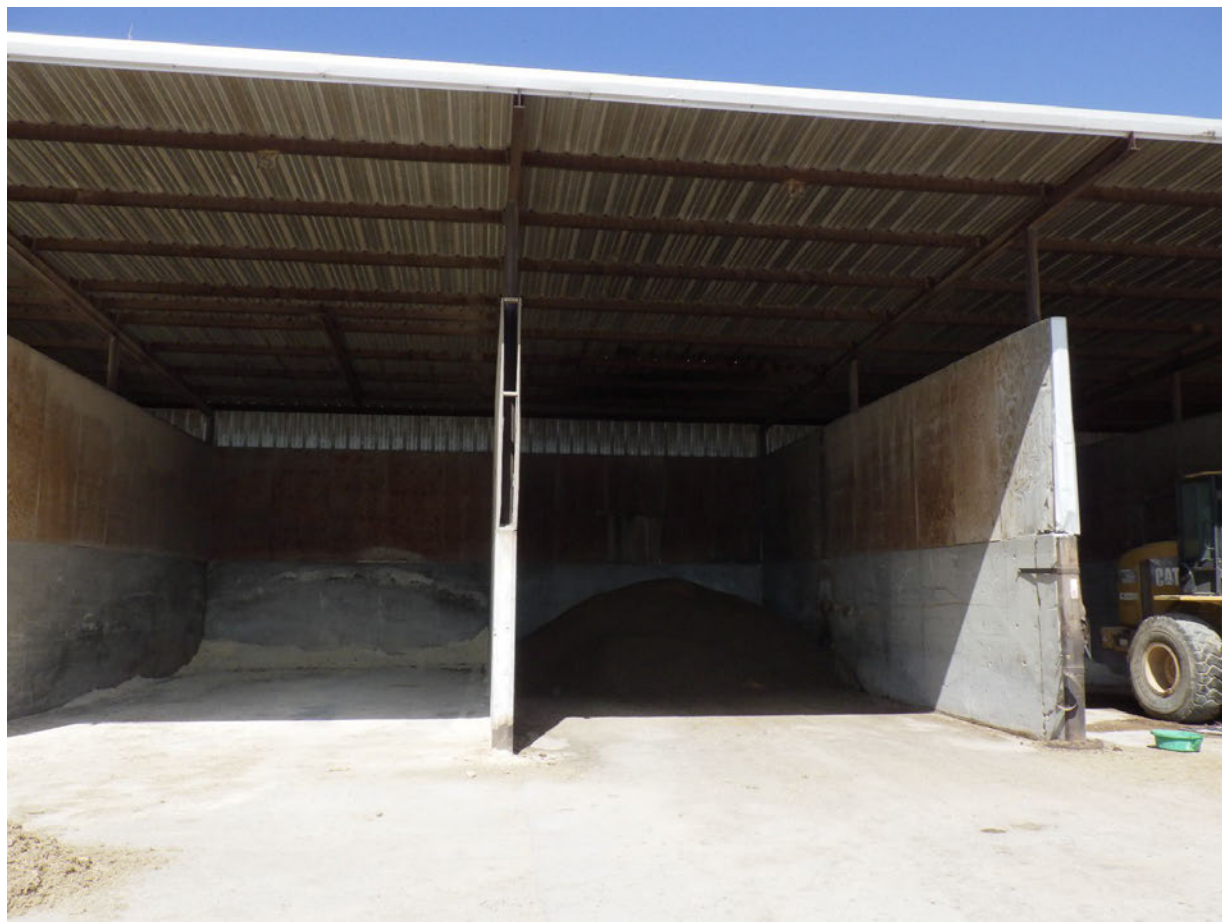
Photo No. 7

| Description: | View to the west. Grain under cover. | | |

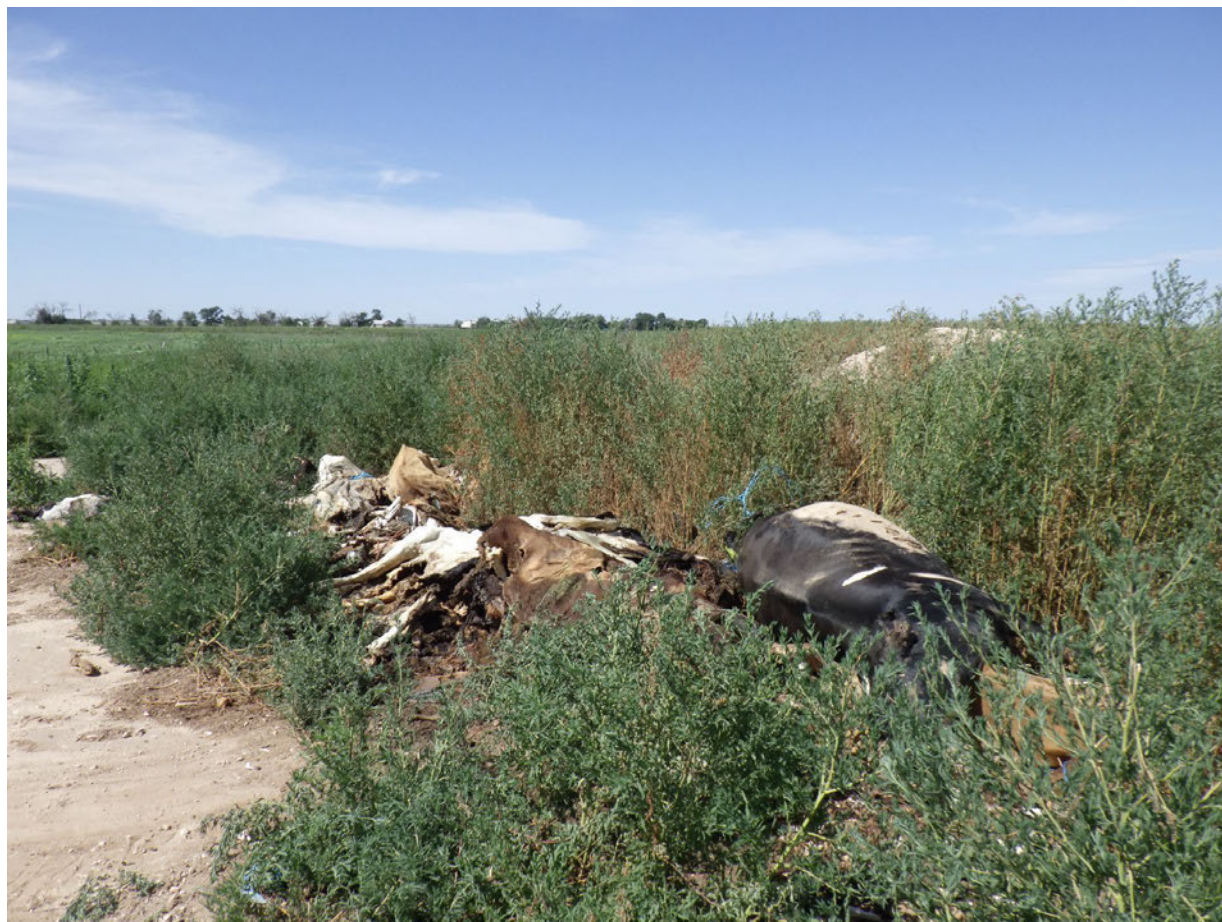
Photo No. 8

The dairy currently has multiple unburied carcasses scattered in a grassy area south of the commodity storage in the southwestern corner of the facility (Appendix 1, Photo 8) (See Areas of Concern). The owner stated that carcasses are left to dry in the field before disposal.

3) Improper disposal of mortalities on site: CWA, Section 301 (33 U.S.C. § 1311) prohibits the discharge of pollutants into WOTUS without an NPDES permit. Unburied mortalities can contribute to pollution through runoff or leaching into nearby waters, potentially impacting WOTUS.

| Description: | View to the west. Dead cow carcasses in field south of the commodity storage area. | | |

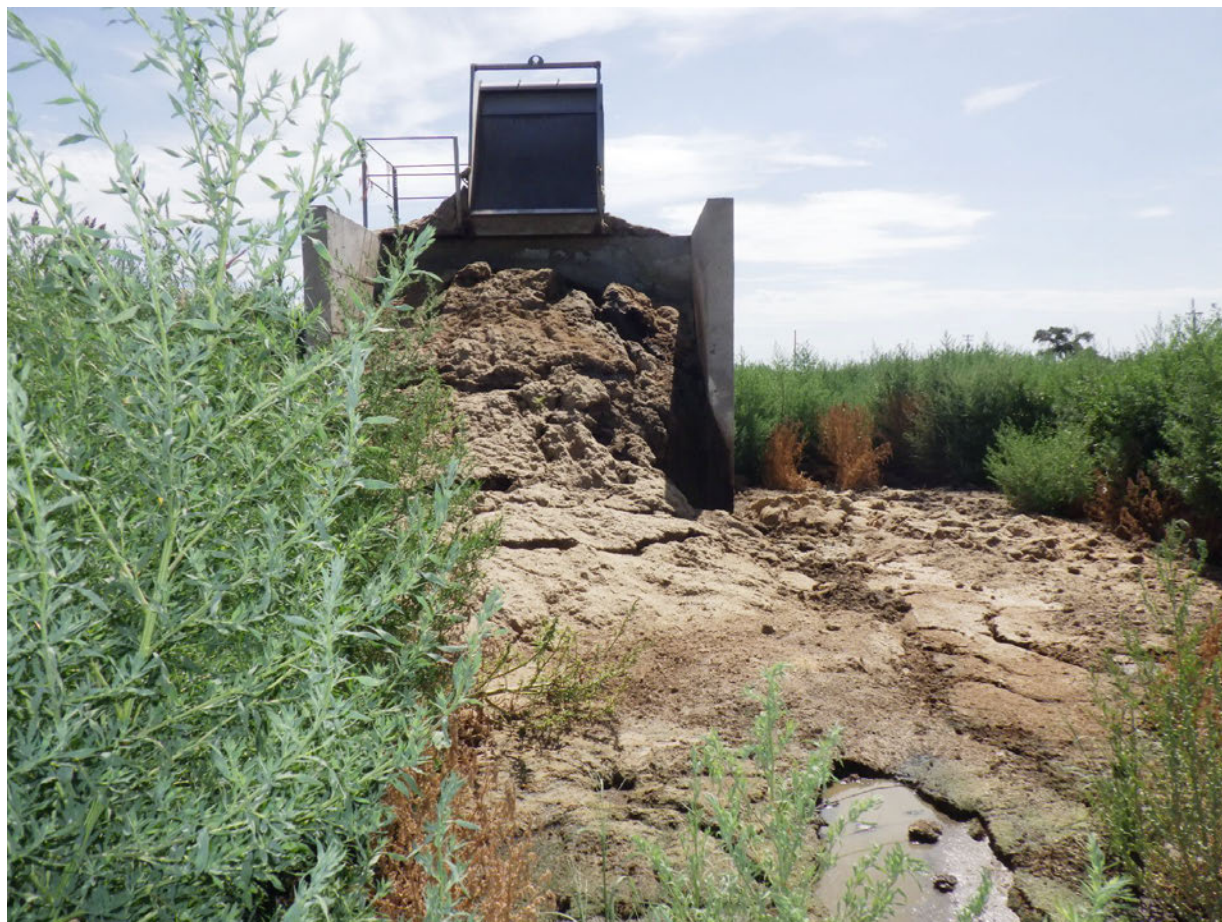
Photo No. 9

No visible manure stockpile was present on site at the time of inspection. However, there was a build-up of manure solids at the separator screen next to the RCS (Appendix 1, Photo 9).

| Description: | View to the east. Solid separating with solids built up. | | |

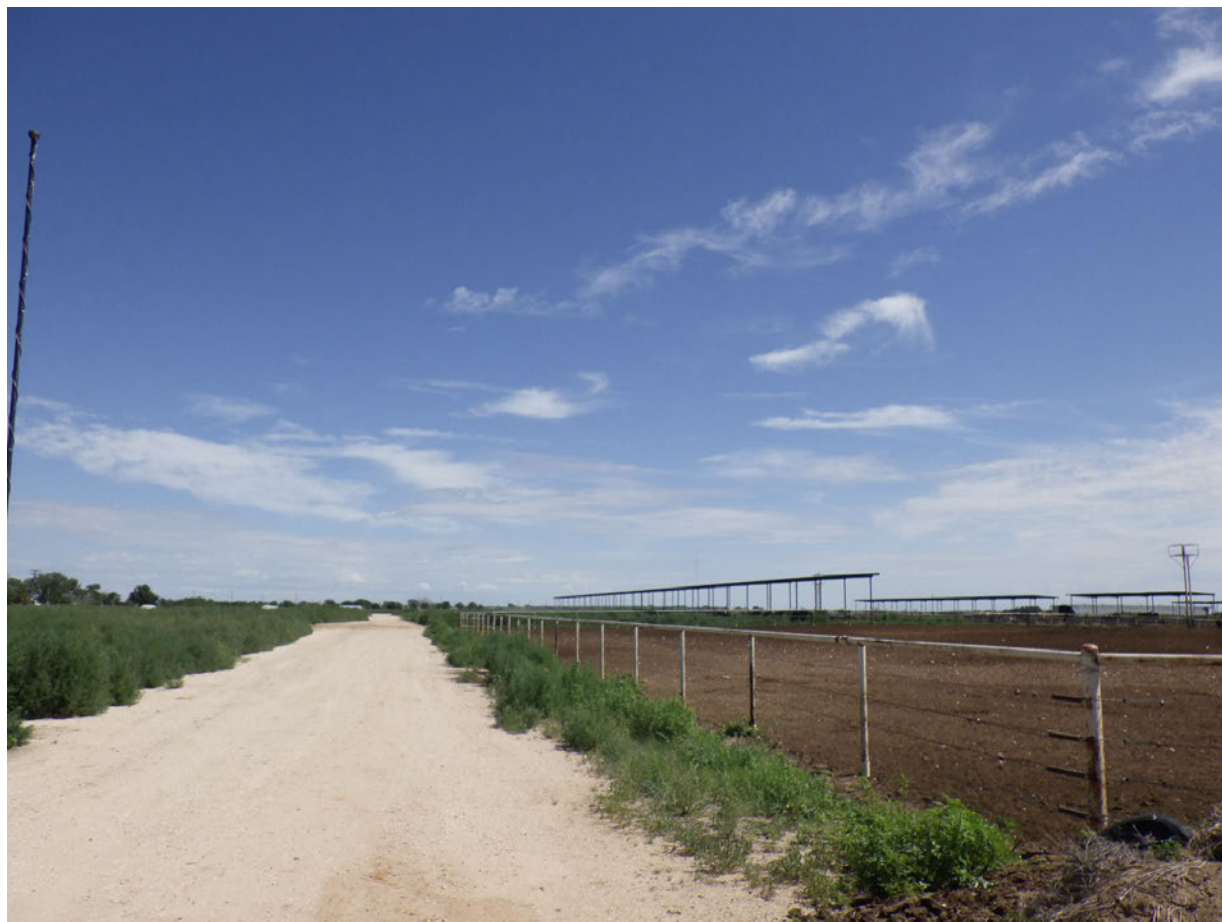
Photo No. 10

| Description: | View to the north. Western perimeter of the facility. | | |

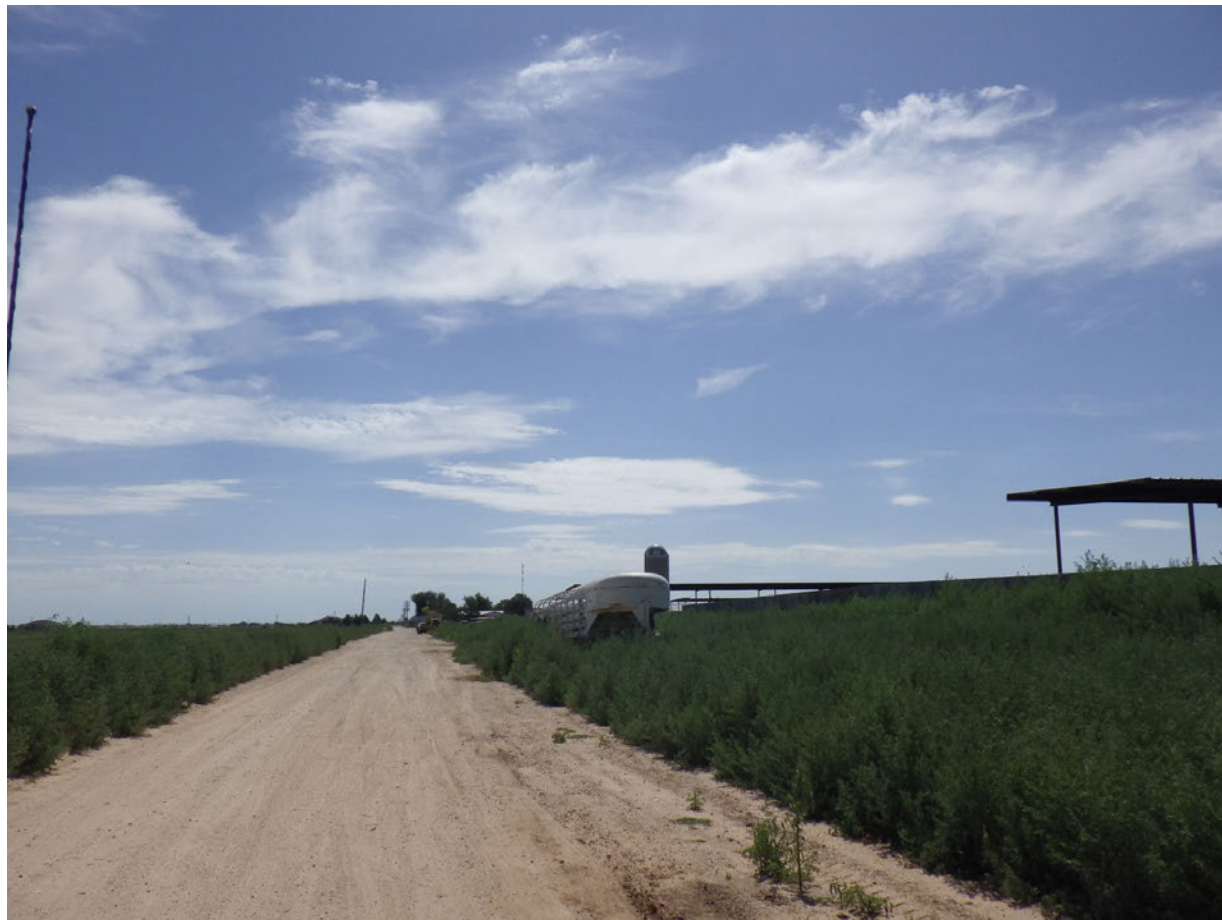
Photo No. 11

| Description: | View to the east. Northern perimeter of the facility. | | |
