Purpose: Metro East Sanitary District (MESD) – Recon Inspection Report

Facility: MESD’s Harding Ditch Stormwater Outfalls, Centreville, Illinois

Date of Inspection: April 1, 2021

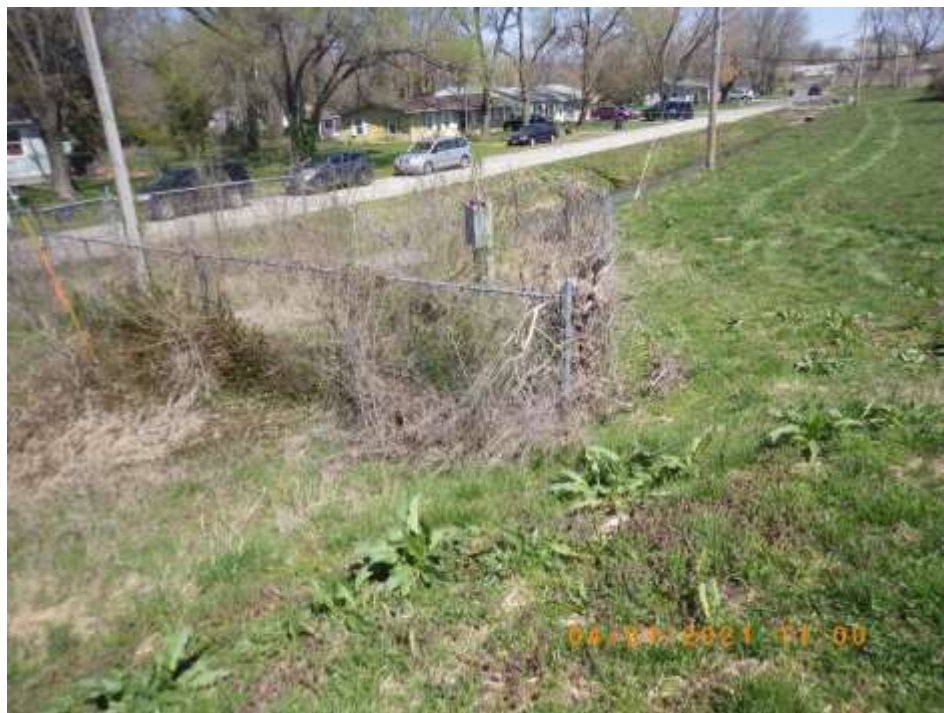
1: MESD0001

Description: stormwater pump station.

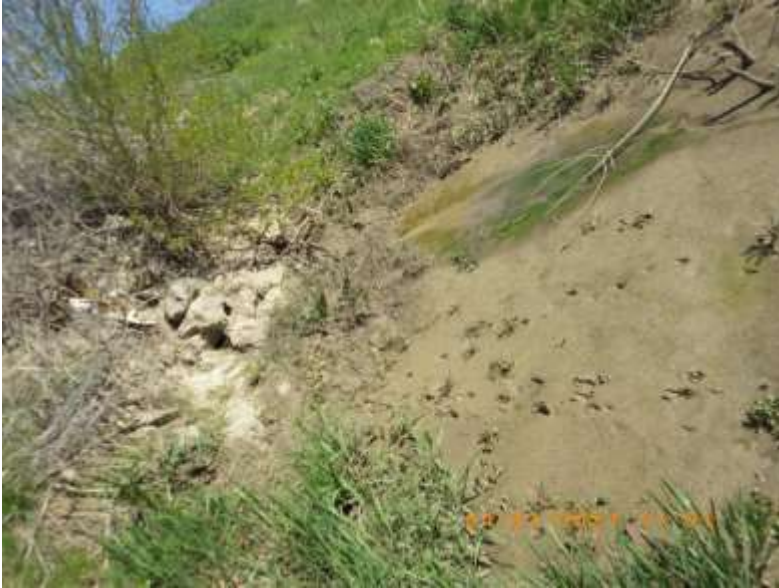
2: MESD0002

Description: outfall to Harding Ditch. The outfall appeared to be partially blocked by rocks and debris.

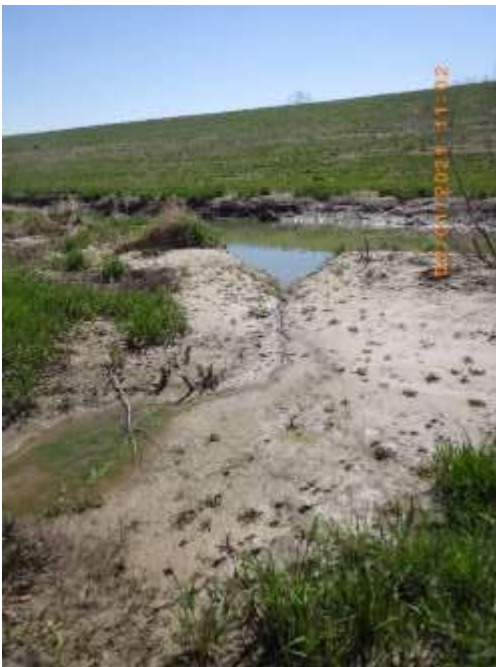
3: MESD0003

Description: short gully from outfall to Harding Creek.

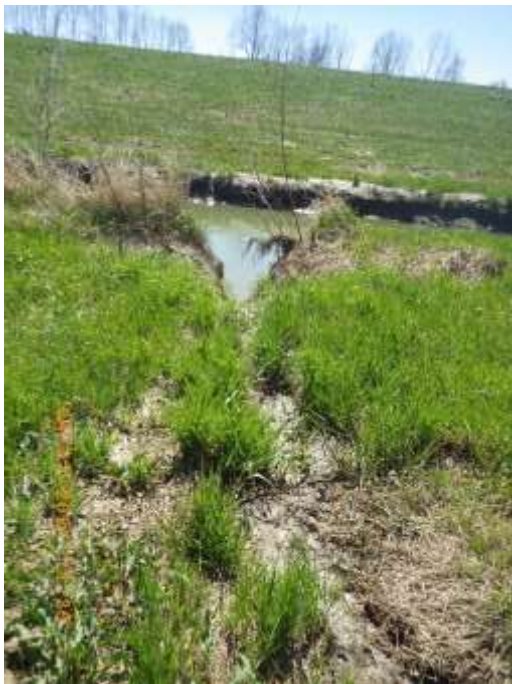
4: MESD0004

Description: outfall discharges to a short gully to Harding Ditch.

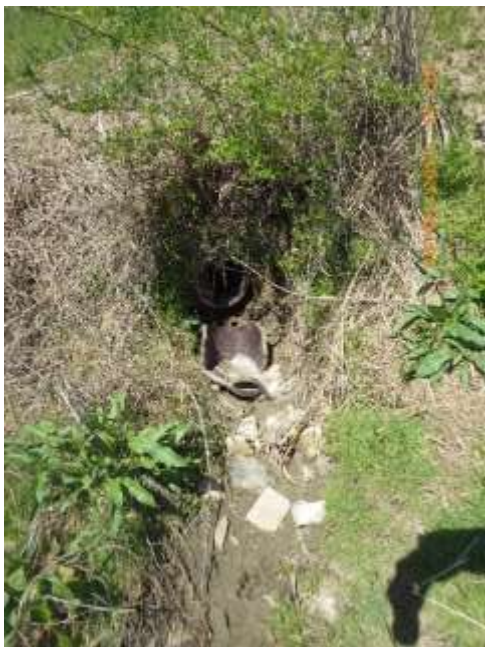
5: MESD0005

The outfall at this location discharges to a short gully to Harding Ditch (Photograph 4; MESD0004.jpg). The outfall itself appeared to be damaged and was not discharging (Photograph 5; MESD0005.jpg). The outfall pipe runs under the berm (Photograph 6; MESD0006.jpg) and conveys stormwater from a ditch and field north of the berm.

Description: outfall appeared to be damaged and was not flowing.

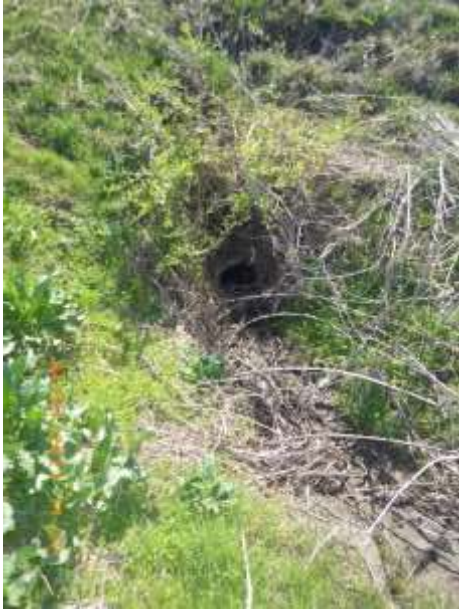
6: MESD0006

Description: outfall pipe inlet under the berm. Conveys stormwater from a ditch and field north of the berm to Harding Ditch.

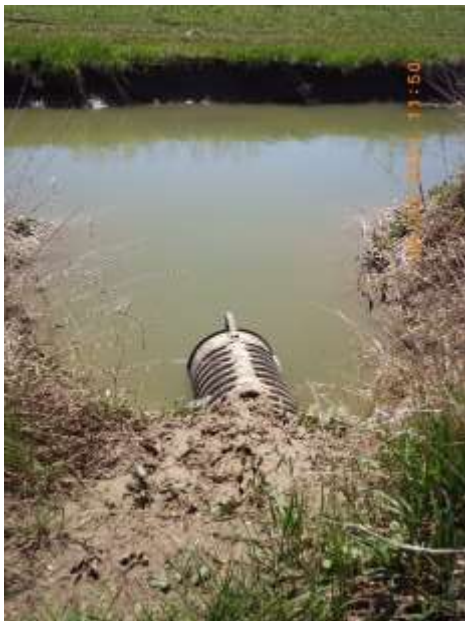
7: MESD0007

Description: The outfall at this station discharges directly to Harding Ditch and was partially submerged.

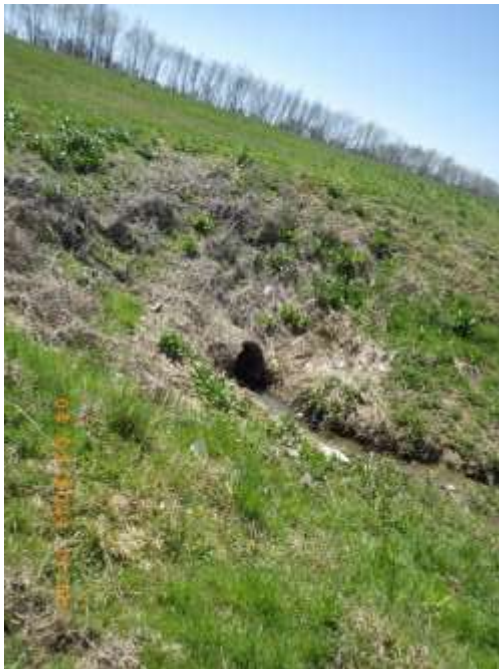
8: MESD0008

Description: outfall pipe inlet under the berm. Conveys stormwater from a ditch north of the berm to Harding Ditch.

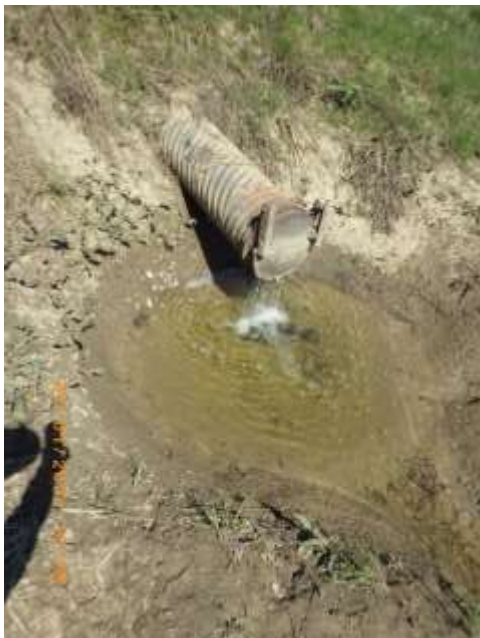
9: MESD0009

Description: corrugated metal outfall. Discharging to a short ditch to Harding Ditch.

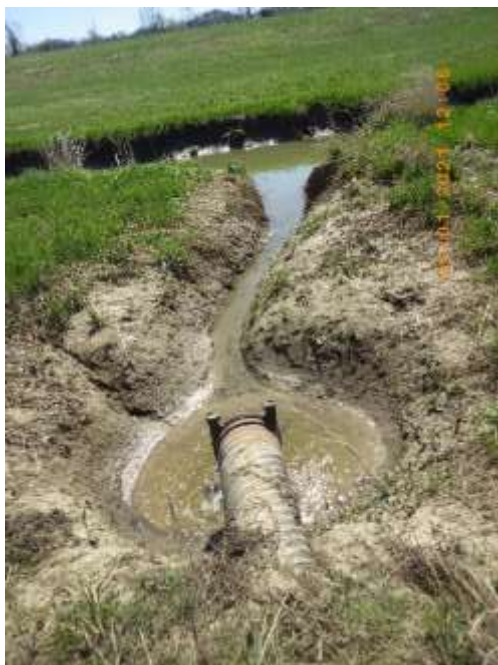
10: MESD0010

Description: Outfall discharging to a short ditch to Harding Ditch.

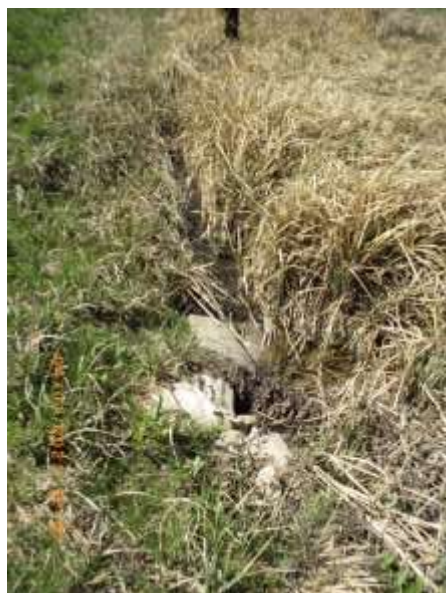
11: MESD0011

At Inspection Station #4, a corrugated metal outfall was discharging (Photograph 9; MESD0009.jpg) to a short gully to Harding Ditch (Photograph 10; MESD0010.jpg). The outfall pipe runs under the berm and conveys stormwater from a ditch north of the berm (Photograph 11; MESD0011.jpg). The corrugated pipe inlet appeared damaged and partially buried in sediment.

Description: inlet to outfall pipe running under the berm, conveying stormwater from a ditch north of the berm. The inlet appeared damaged and partially buried in sediment.

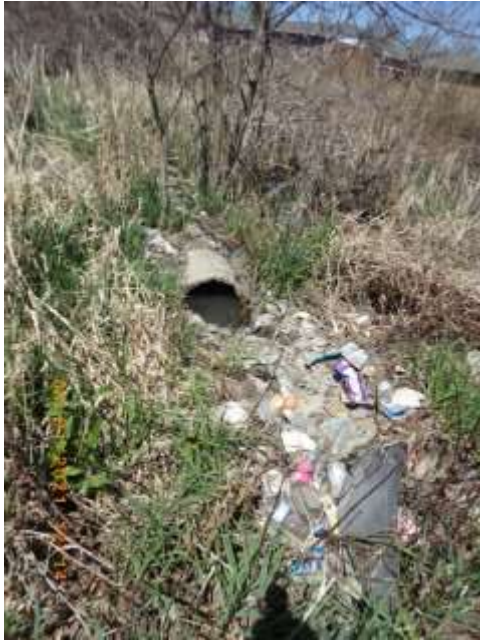
12: MESD0012

We continued to Inspection Station #5. An outfall was observed in a ditch along the base of the north side of berm and appeared to be coming from the upland area towards Camp Jackson Road (Photograph 12; MESD0012.jpg). The outfall was not discharging and I noted heavy litter and debris in the ditch. No outfall was observed on the south side of the berm along Harding Ditch at this inspection station.

Description: outfall observed in a ditch along the base of the north side of berm and appeared to be coming from the upland area towards Camp Jackson Road. Note heavy litter and debris.

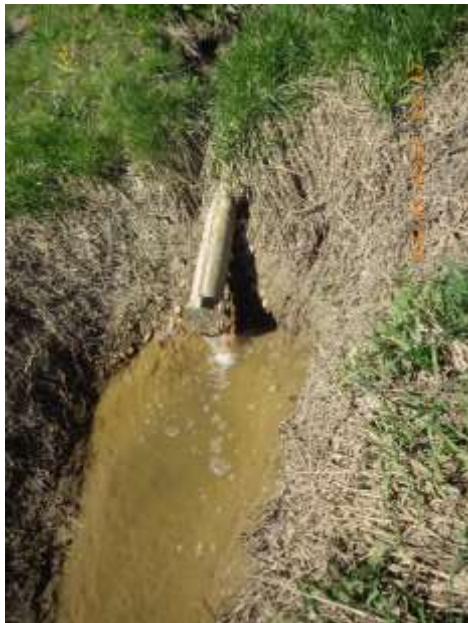
13: MESD0013

Description: outfall observed discharging at this station to a short ditch to Harding Ditch.

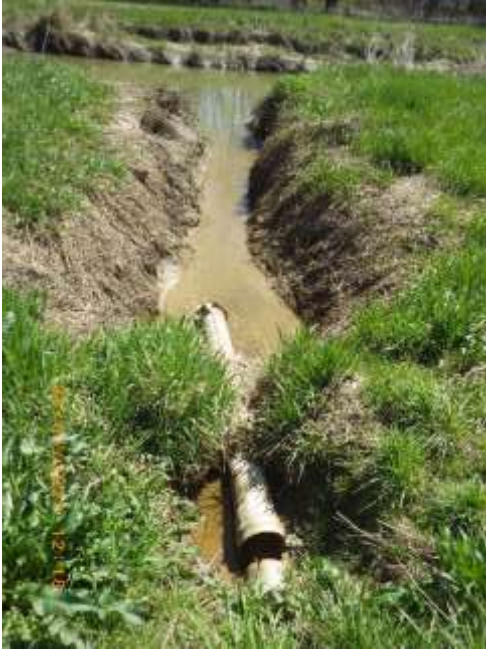
14: MESD0014

We continued along the berm to Inspection Station #6. An outfall was observed at this station and was discharging to a short ditch to Harding Ditch (Photograph 13; MESD0013.jpg). Mr. Hillman noted a sewage smell near the area of the discharge. I also noted the odor. The last section of the outfall pipe was separated from the pipe heading under the berm (Photograph 14; MESD0014.jpg). The outfall pipe runs under the berm and neither the other end of the pipe or an inlet was visible on the north side of the berm.

Description: outfall pipe was separated from the pipe heading under the berm.

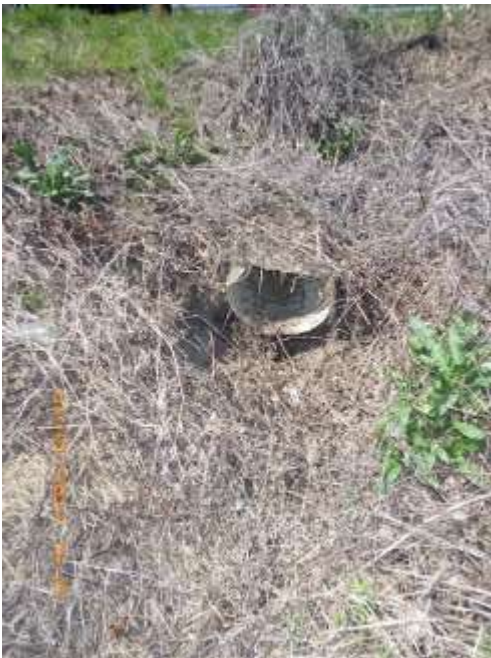
15: MESD0015

We continued along the berm to Inspection Station #7. In this area there is no drop off in elevation on the north side of the berm. I observed an outfall along the south side (Harding Ditch side) of the berm and it was not discharging (Photograph 15; MESD0015.jpg). The outfall pipe runs under the berm and neither the other end of the pipe or an inlet was visible on the north side of the berm.

Description: outfall along the south side (Harding Ditch side) of the berm.

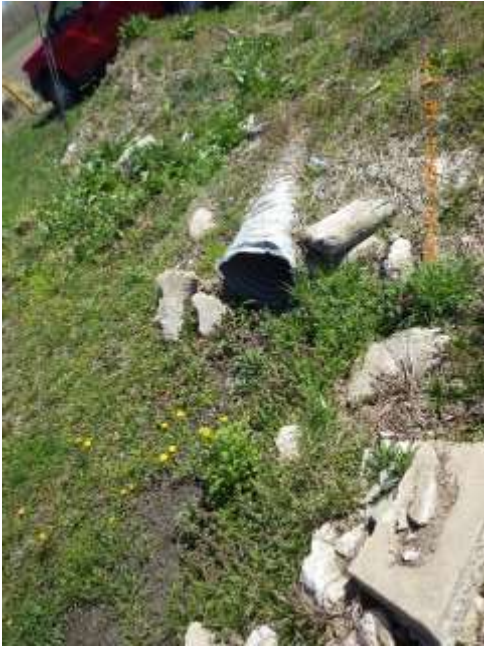
16: MESD0016

Description: inlet of metal pipe heading under the berm and to the outfall on Harding Ditch.

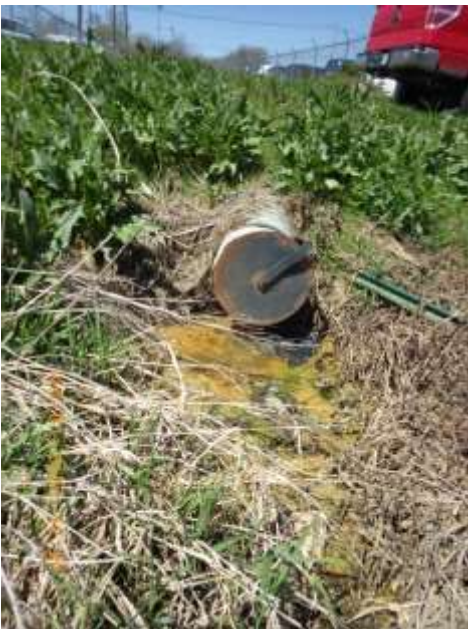
17: MESD0017

Description: outfall to Harding Ditch not visibly discharging but a small pool of rust-colored water was observed under the outfall.
