**Region 6 – Enforcement & Compliance Assurance Division**  
**INSPECTION REPORT**

| Inspection Date(s): | 06/22-23/2021, 6/30/2021 | |
| Company Name: | <b>Motiva Enterprises, LLC</b> | |
| Facility Name: | <b>Dallas Marketing Terminal</b> | |

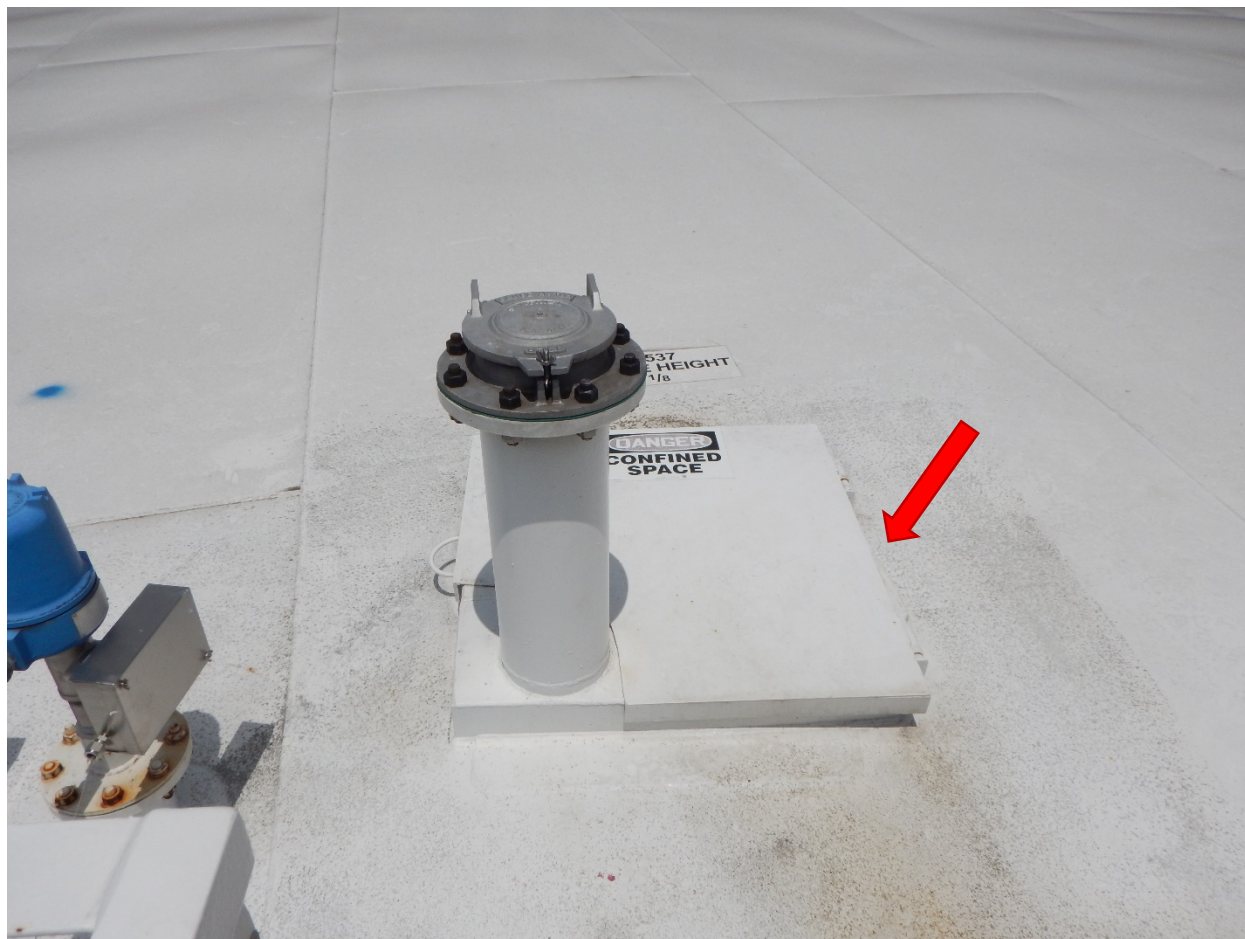
Photo No. 1

We climbed Tank 29537 (storing diesel) and observed light hydrocarbons emanating from the access hatch near the sample well. See Photo 1 for the location of the leak. Following additional observations of the storage tanks referenced in Table 1, we walked to the location where the terminal injects butane into the piping that feeds the loading racks. Motiva uses this butane to adjust the Reid vapor pressure ("RVP") of the gasoline for seasonal changes. We also observed the terminal's oil-water separator and other tanks storing additives blended into the gasoline and diesel. In this area of the terminal, I detected odors near an additive tank. Mr. Boehmer identified the likely source, the tape gauge of Tank 5457 (storing additive). I confirmed light hydrocarbons coming from the tape gauge with the FLIR camera.

| Description: | Access hatch of Tank 39537; arrow notes the location at which EPA observed hydrocarbon emissions using the FLIR camera. |

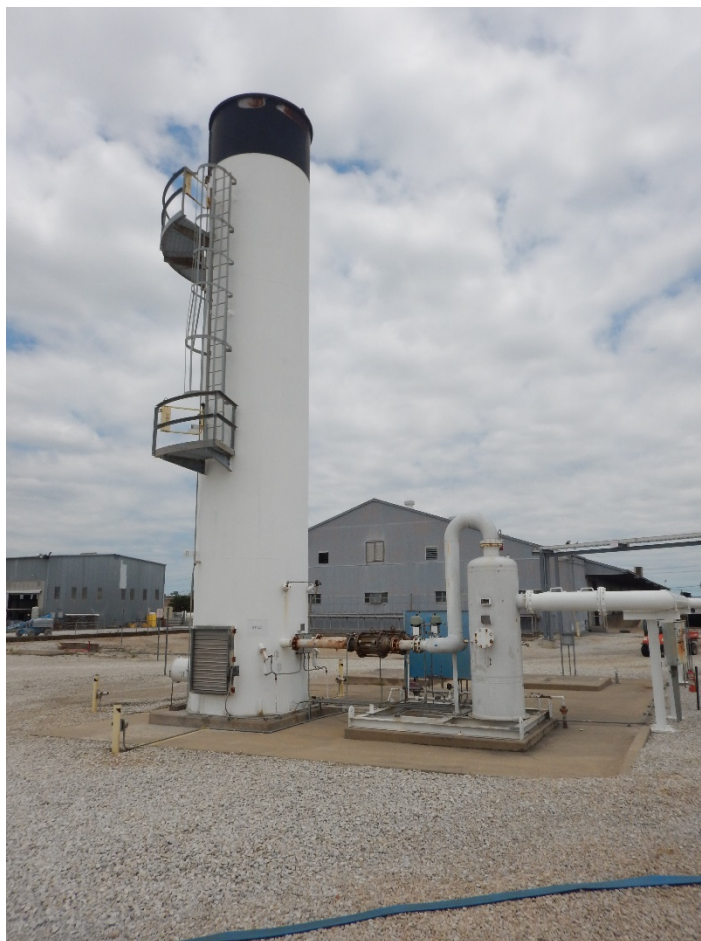
Photo No. 2

We later observed the devices the terminal uses to control emissions from loading operations. The back-up control device is a John Zink vapor combustion unit ("VCU") that thermally destructs the loading vapors. See Photo 2. The primary control device is a vapor recovery unit ("VRU") that uses a carbon adsorption system to recover gasoline product that can be returned to the storage tanks. Mr. Boehmer stated that the VRU was currently out of service due to a defect with a valve; therefore, vapors from loading operations were being routed to the VCU at the time of the inspection. See Photo 3. Mr. Boehmer noted that Motiva had ordered a replacement valve for the VRU prior to the inspection.

| Description: | Vapor combustion unit at terminal to control emissions from loading operations. |

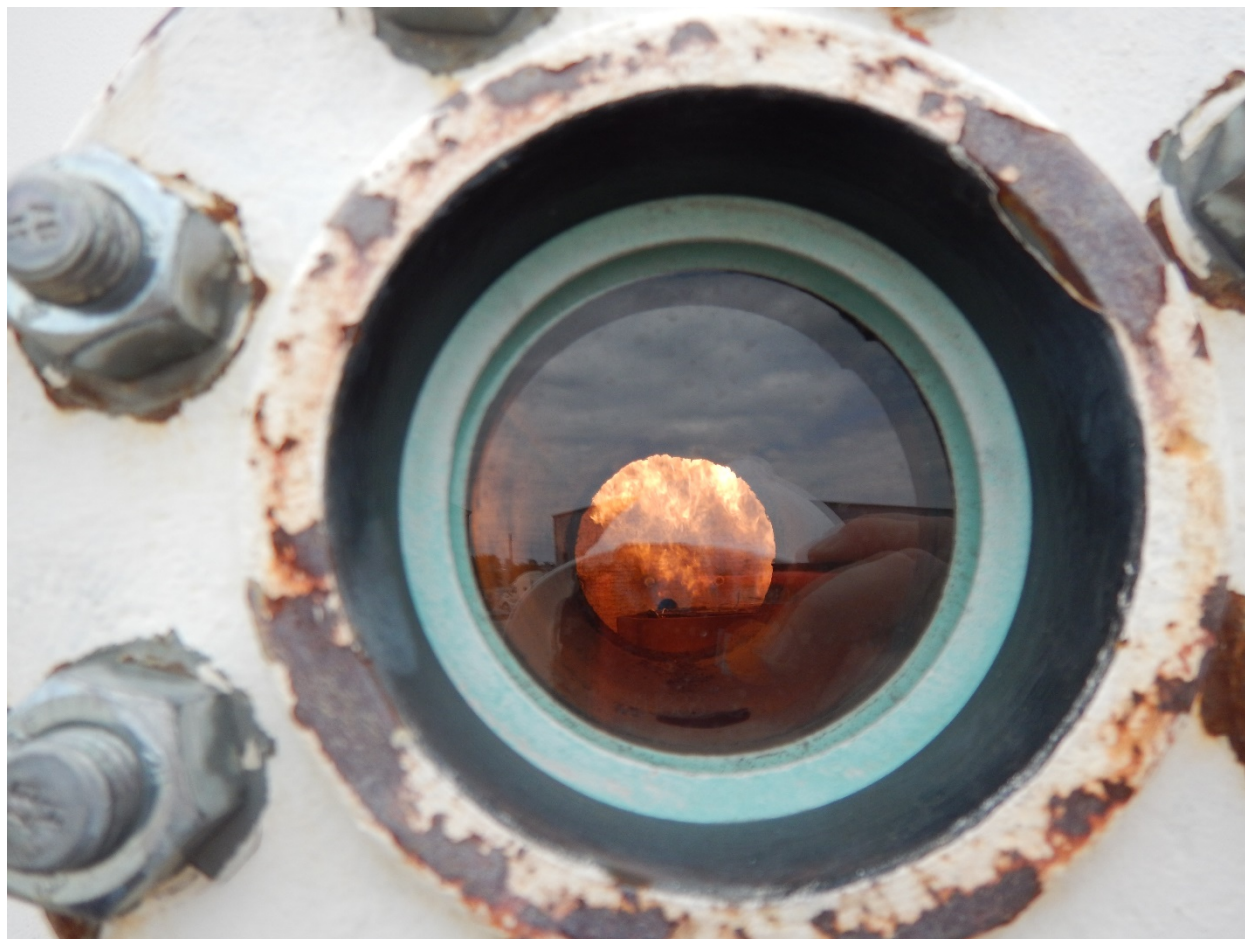
Photo No. 3

| Description: | Sight glass into VCU showing flames; VCU was controlling emissions from loading operations at the time of the inspection. |

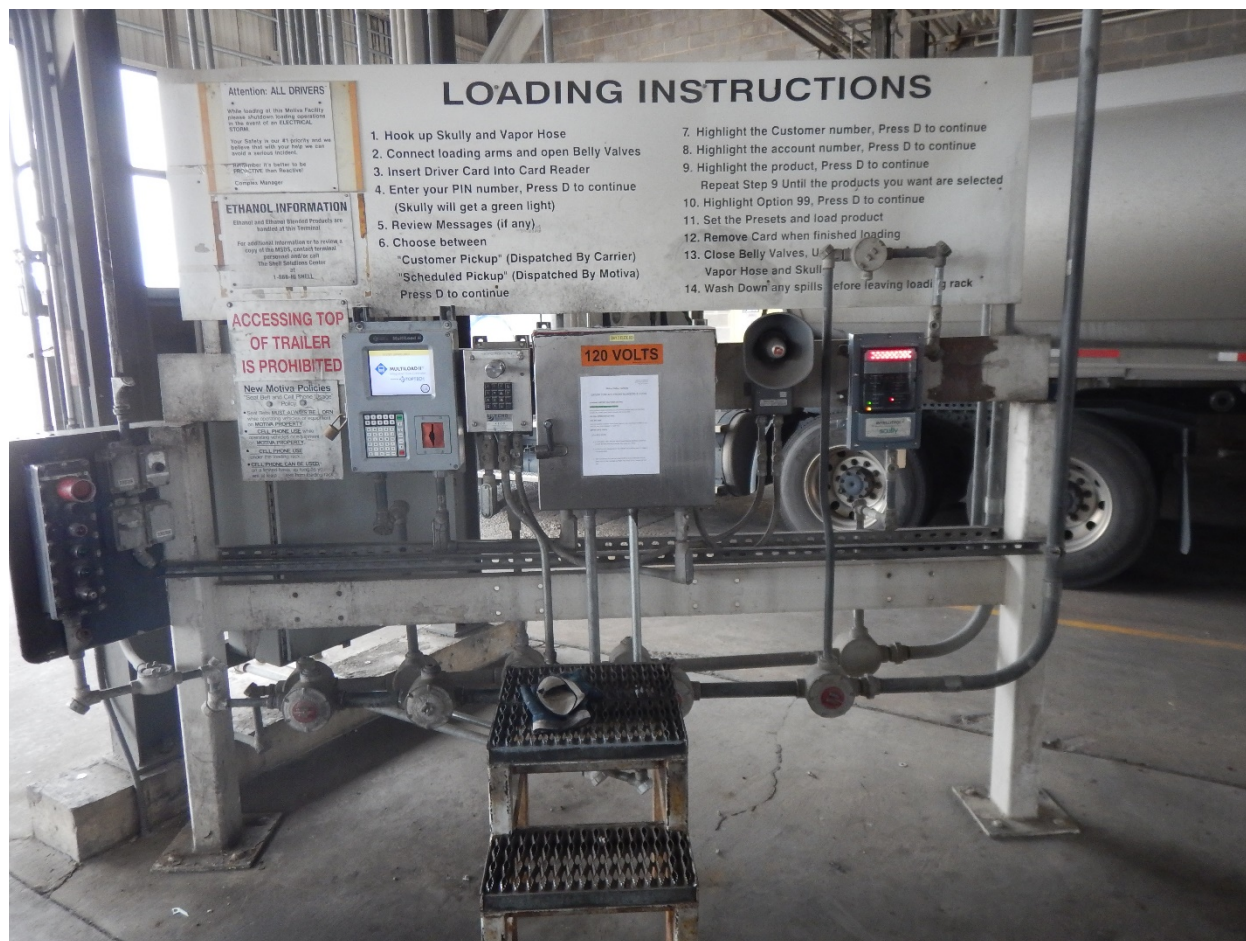
Photo No. 4

We observed the loading racks and loading operations at the terminal. Mr. Boehmer showed us the location where blending occurs at the racks, the MultiLoad II loading interface, and the Scully system. See Photo 4 for a photograph of the loading interface system. We returned to the office for a brief phone call with Ms. McElroy before departing the terminal at 15:15.

| Description: | Loading interface system used by truckers prior to loading; a loading interface system is located at each bay. |

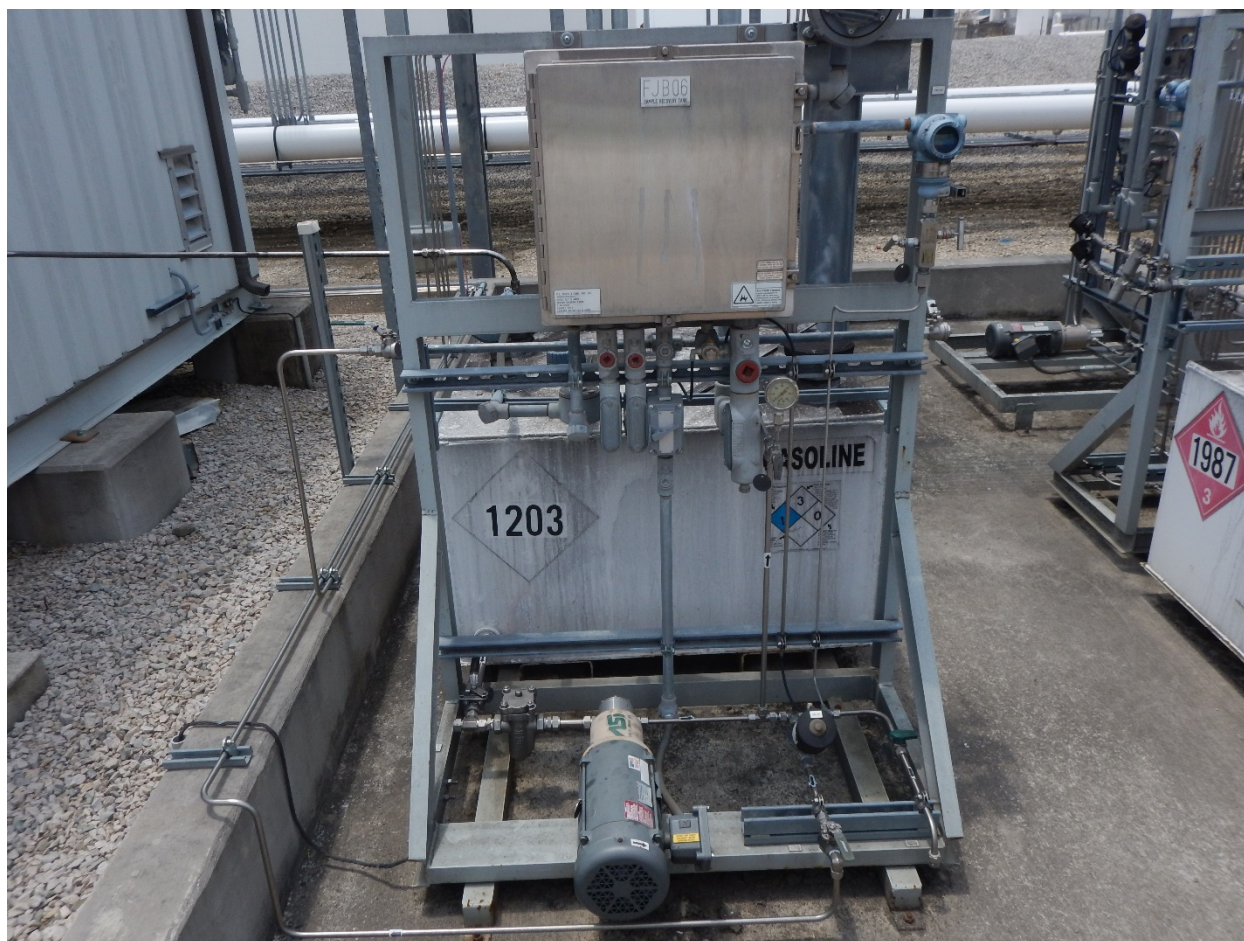
Photo No. 5

We later observed a sample recovery tank at Skid FJB06 where I detected light hydrocarbons using the FLIR camera. See Photo 5 and 6 for the location of the skid and the leaking component. Using Motiva's 4-gas meter, we observed readings less than 500 ppm VOC with an estimated lower explosive limit ("LEL") of 3%. After viewing the sample recovery tank, we returned to the loading rack. At Bay 5, Mr. Rosenthal and I encountered odors at the back of a trailer loading gasoline. After using the FLIR camera, I observed emissions at Bay 5's flame arrestor. See Photo 7 for a photo of the flame arrestor. Displaced vapors from the truck travel through this arrestor during loading operations and then through additional piping to the downstream vapor processing system. We used Motiva's 4-gas meter again, and I observed a reading of about 1,200 ppm VOC with an estimated LEL of greater than 10%. The meter also noted that the LEL was outside the calibrated range. See Area of Concern (AOC) 1.

| Description: | FJB06 skid used for sampling gasoline. |

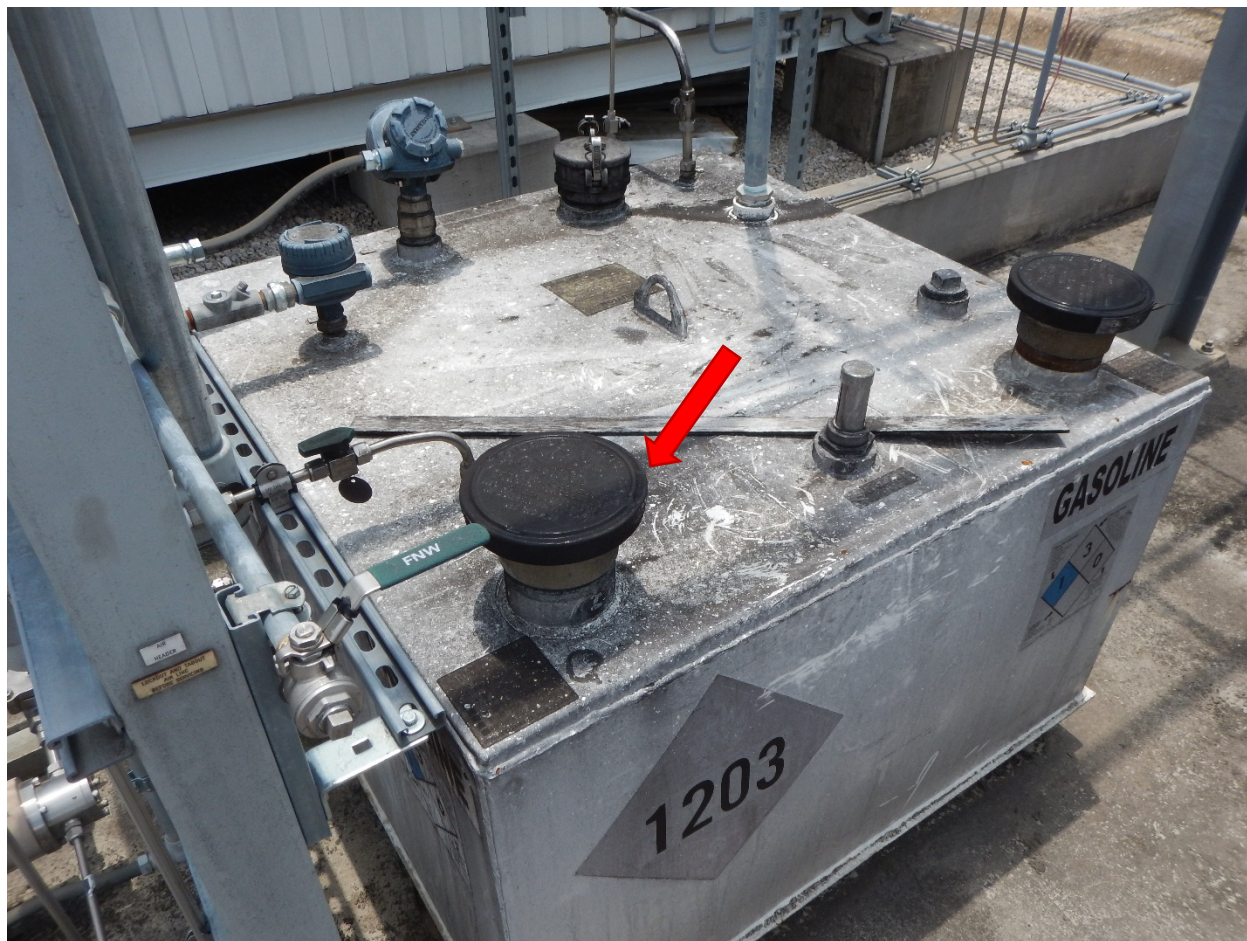
Photo No. 6

| Description: | Rear of FJB06 skid with gasoline tank; arrow notes the location at which EPA observed hydrocarbon emissions using the FLIR camera. |

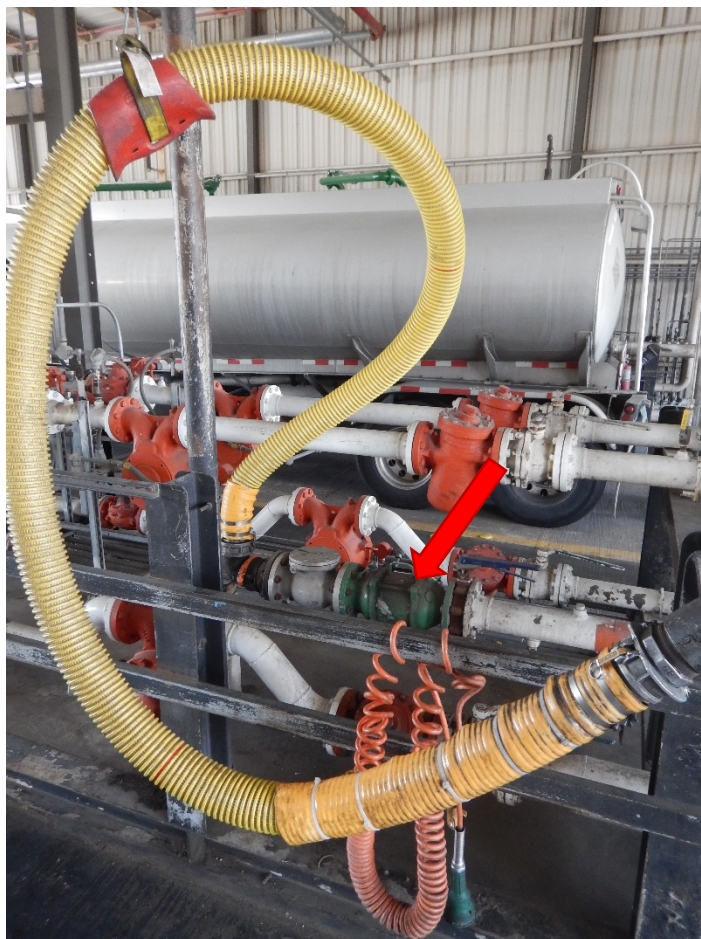
Photo No. 7

#### **1) Hydrocarbons Observed with the FLIR Camera at the Flame Arrestor**

EPA observed hydrocarbon vapors using the FLIR camera at Bay 5's flame arrestor. Motiva is required to equip the loading rack with a vapor collection system that transports displaced vapors from the cargo tanks to a control device that reduces total organic compounds. Additionally, Motiva's 4-gas meter documented elevated LEL and VOC readings that may indicate that Motiva is not operating and maintaining an affected source in a manner consistent with safety and good air pollution practices for minimizing emissions. Note: the LEL measurement did not factor in the meter's calibration gas and/or LEL correction factors that may be necessary to adjust for gasoline vapors.

| Description: | Bay 5 flame arrestor; arrow notes the location at which EPA observed hydrocarbon emissions using the FLIR camera. |
