**Region 6 - Enforcement & Compliance Assurance Division**  
**INSPECTION REPORT**

| Inspection Date(s): | 12/11/2023 | |
| Company Name: | <b>LBOC, LLC</b> | |
| Facility Name: | <b>ALPHIN B Tank Battery</b> | |

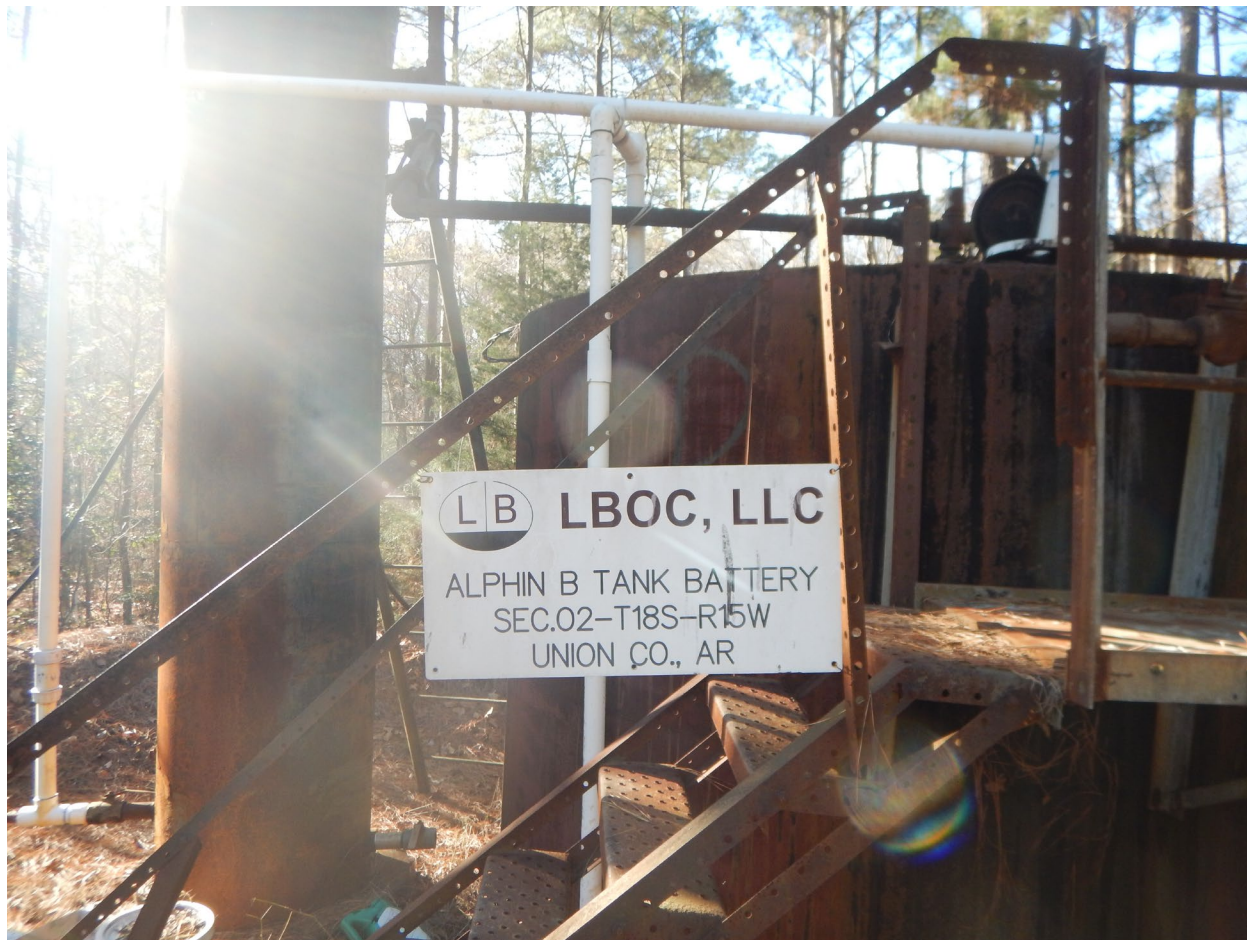
Photo No. 1

I observed the facility sign, secondary containment, oil tanks, saltwater, heater treater, and pipes located at the facility, see Appendix 1 (photo log), photo No. 1 and photo No. 2. for additional GPS location and photo metadata, see Appendix 1.

**Description:** This photo was taken looking W at the facility showing the facility sign.

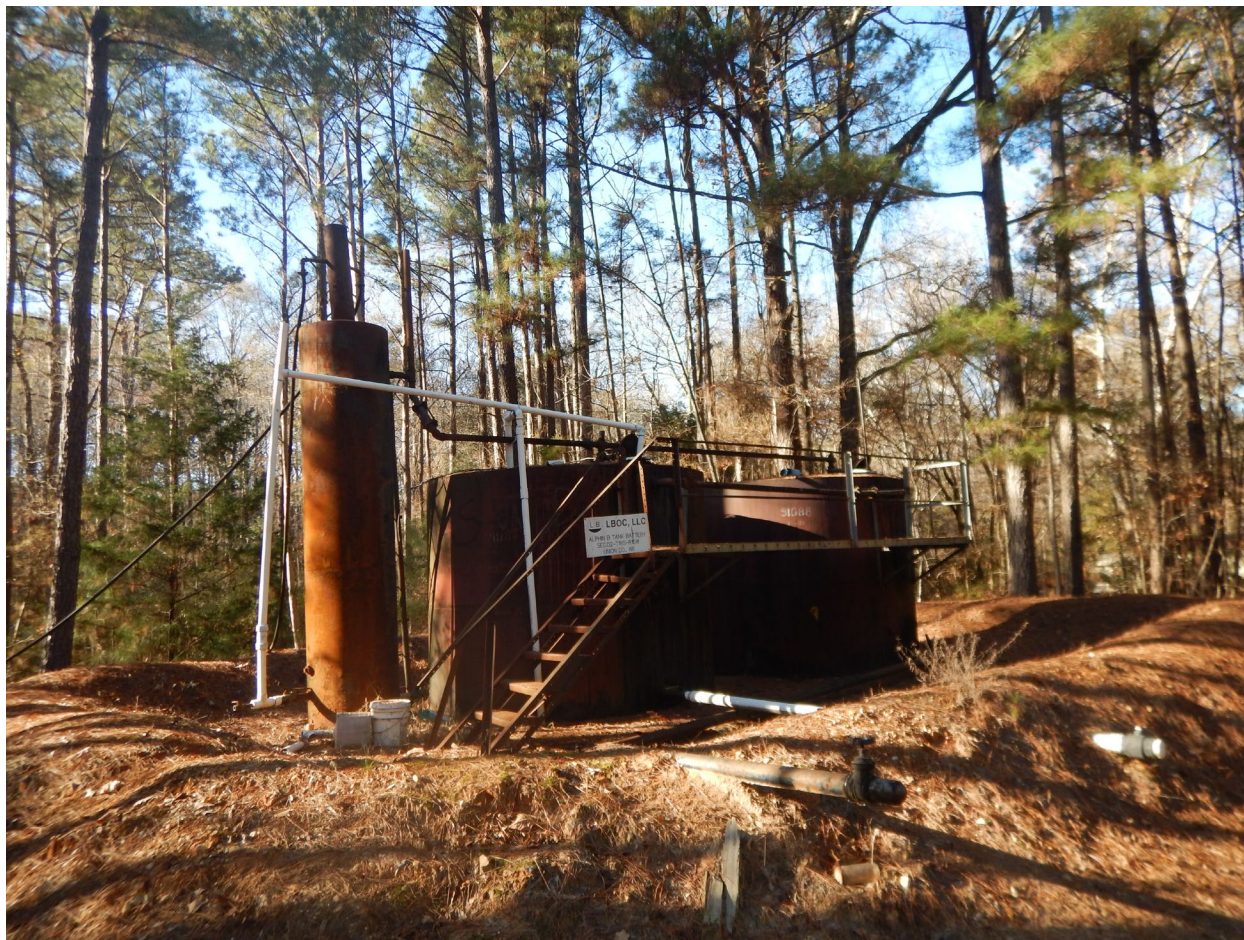
Photo No. 2

**Description:** This photo was taken looking W showing an overview of the facility.

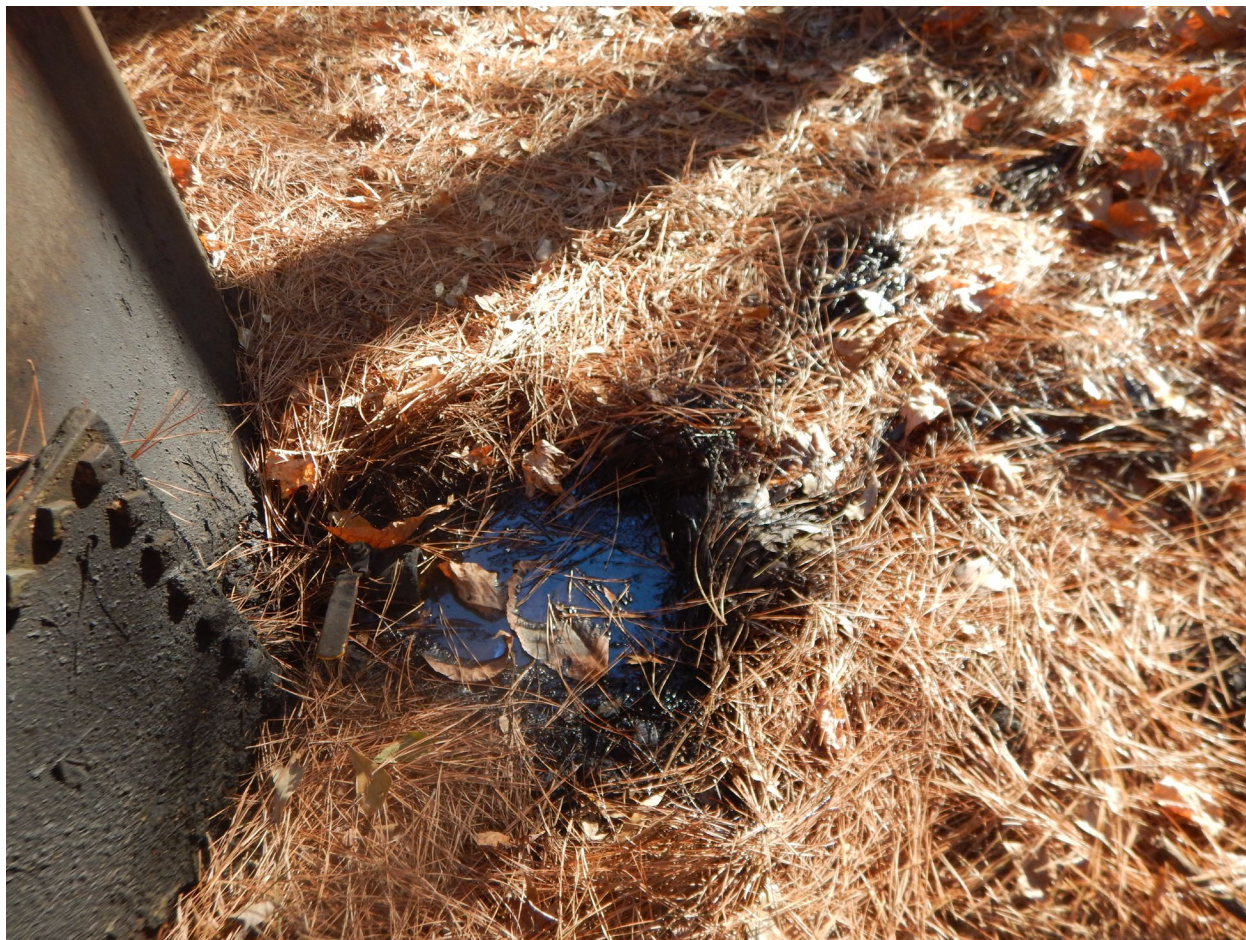
Photo No. 3

I observed loose oil within secondary containment near the oil tank valve, see photo No. 3.

No closing conference was held due to no LBOC, LLC. staff being present during the inspection. Areas of concern at the time of the inspection include: 1) loose oil within secondary containment; and 2) open secondary containment drainage valve outside of secondary containment with water below it.

**Description:** This photo was taken looking S at the facility showing loose oil from oil tank.

Inspector will conduct follow-up phone calls with the company representatives over the coming weeks and months to ensure areas of concern are properly addressed.

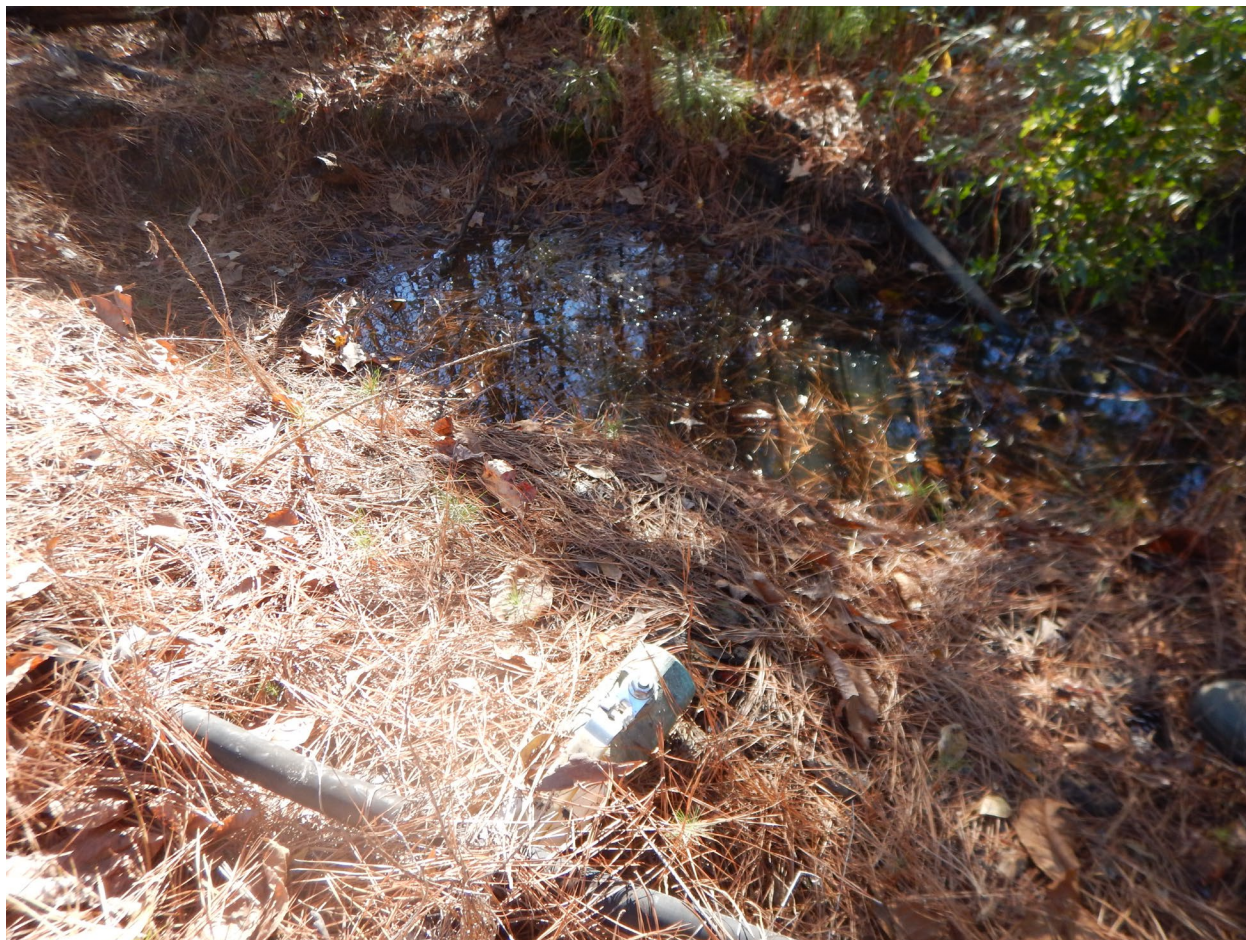
Photo No. 4

I observed an open secondary containment drainage valve outside of secondary containment with water below it, see photo No. 4.

**Description:** This photo was taken looking W at the facility showing an open and uncapped secondary containment drainage valve outside of secondary containment and water below it.
