## NPDES Stormwater Inspection Report – MS4

| National Database Information | |
|---|---|
| Inspection ID: <b>202405_COR090040</b> | |

| Facility Location Information <small>(Name/Location/ Mailing Address)</small> | |
|---|---|
| Site/Facility Name & Location:<br><b>City of Pueblo MS4</b><br><b>201 S Mechanic St.</b><br><b>Pueblo, CO 81003</b> | Email Report to:<br><b>John Sakariason</b><br><b>Stormwater Coordinator</b><br><b>City of Pueblo</b><br><a href="mailto:jsakariason@pueblo.us">jsakariason@pueblo.us</a> |

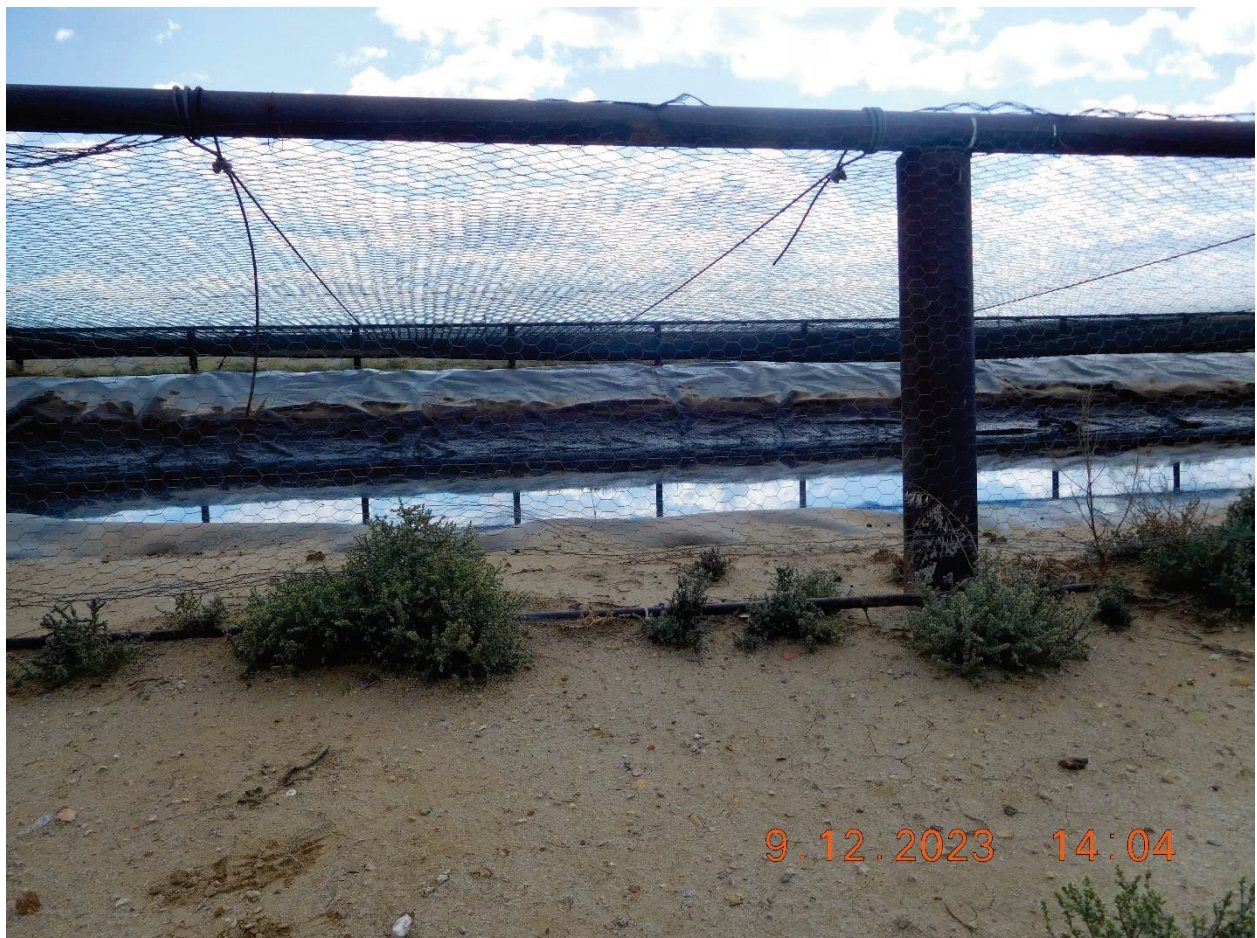
At the settling pit, I observed that the netting was in a degraded condition, with multiple holes and tears and a section pulled back. I also observed ground-level gapping below the mesh wire fencing around the pit, and that a section had been removed on one side. See photos 2238-2242.

Photo 2238: DSCN2238.jpg – photo of ground-level gapping in the netting over the slop/skim pit.

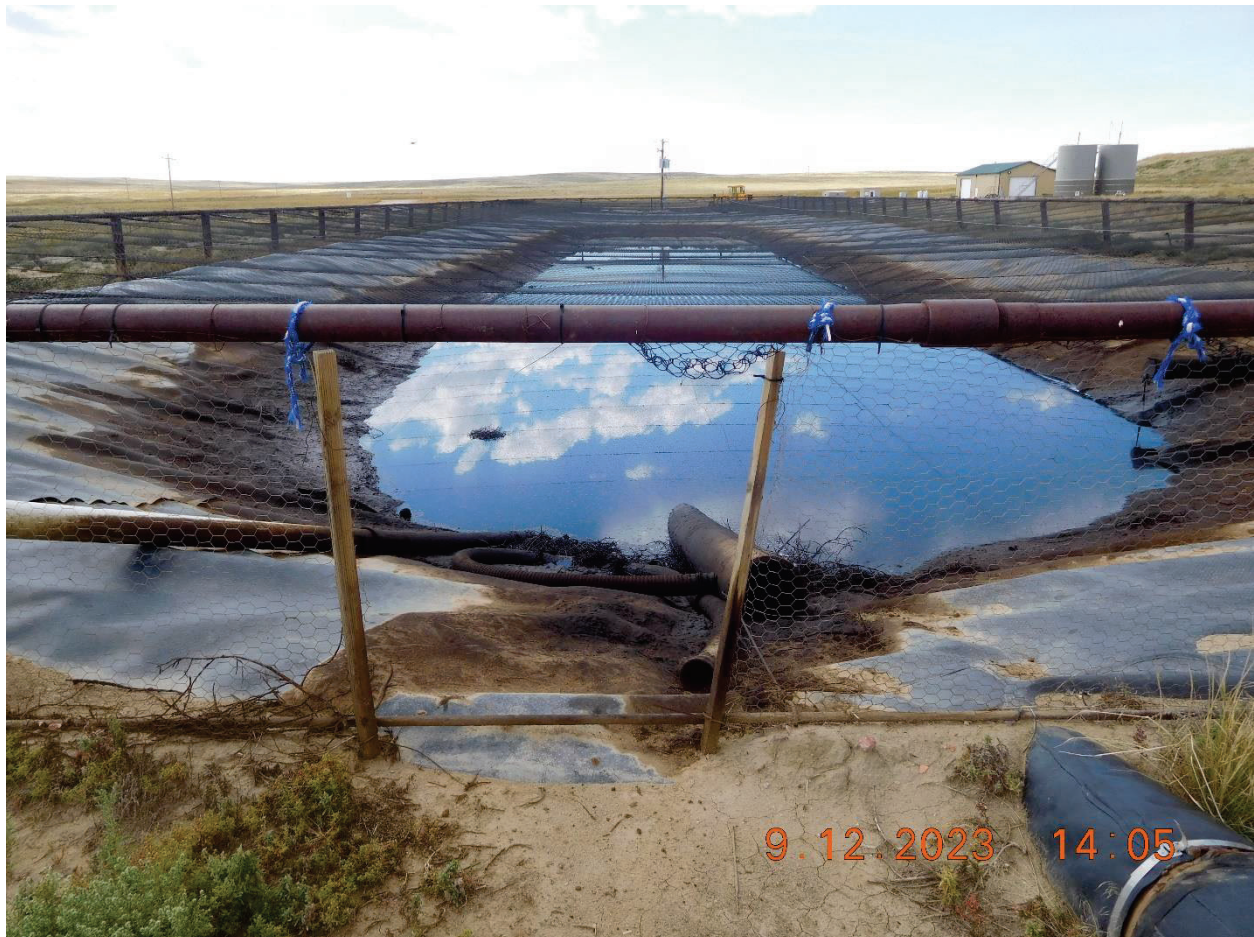
Photo 2239: DSCN2239.jpg – photo of a section of fencing around the slop/skim pit where the fencing has been removed, leaving an open gap that does not physically restrict wildlife access to the oily waste.

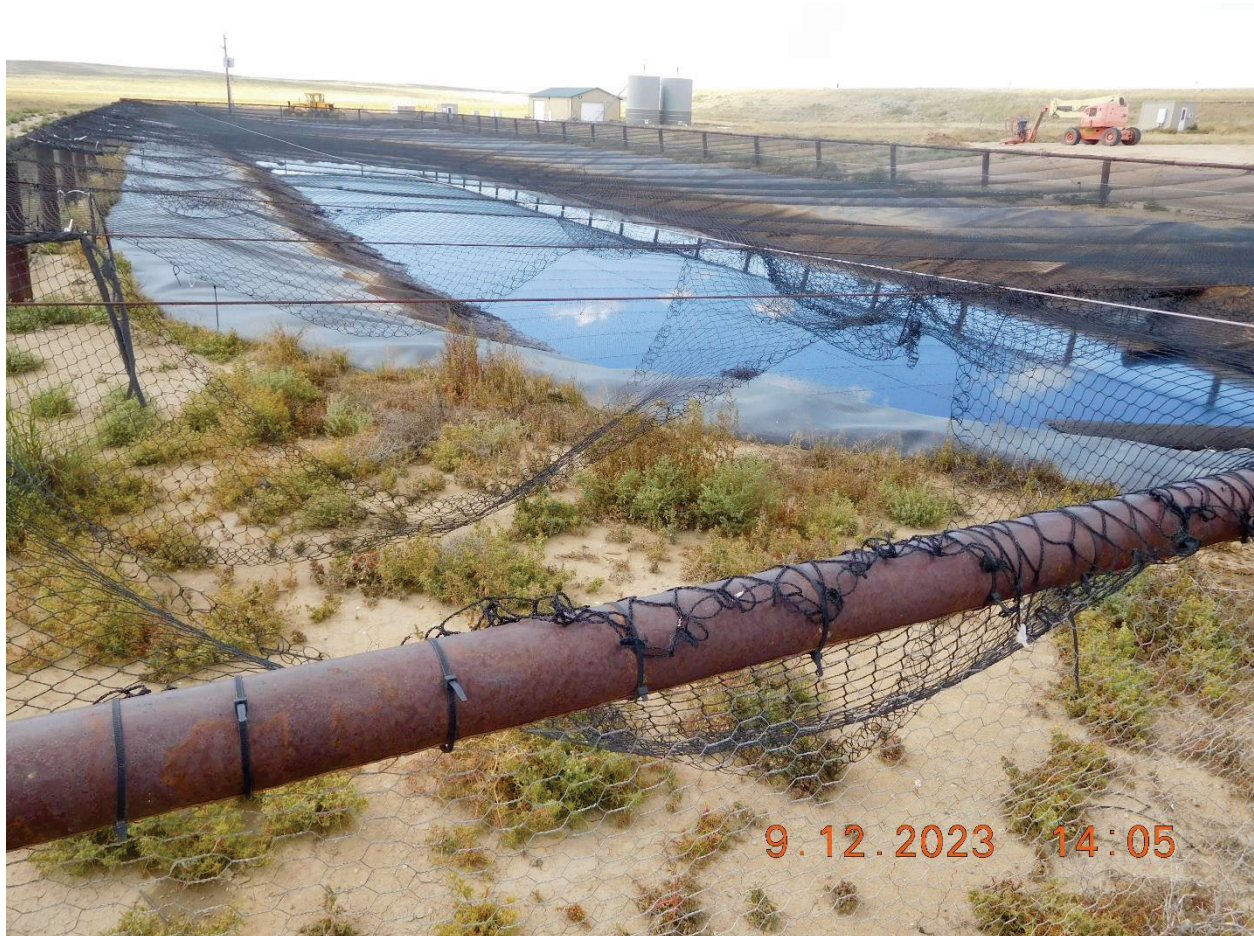
Photo 2240: DSCN2240.jpg – photo of the top of the netting over the slop/skim pit with large holes and a significantly degraded condition.

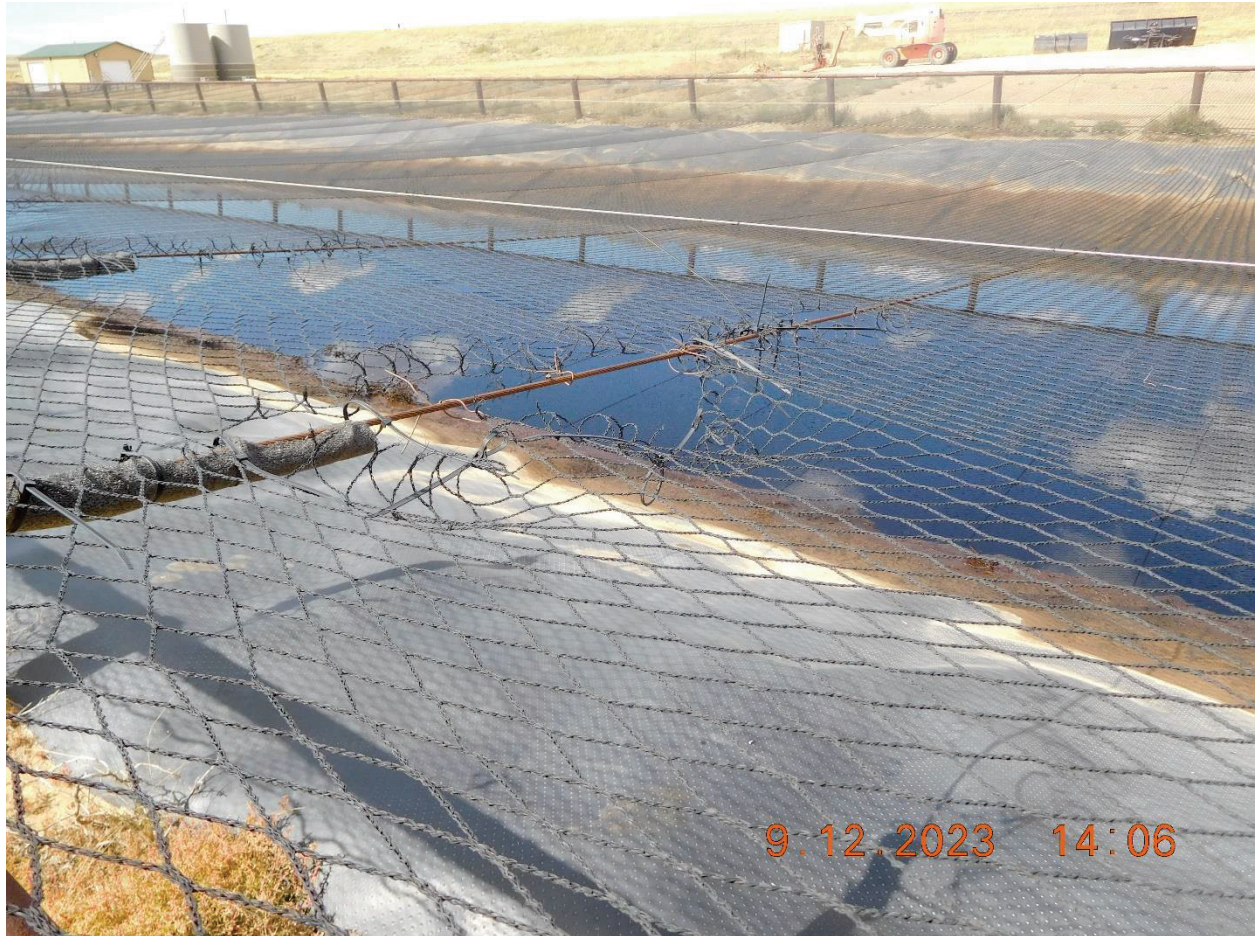
Photo 2241: DSCN2241.jpg – photo of a hole in the netting over the slop/skim pit.

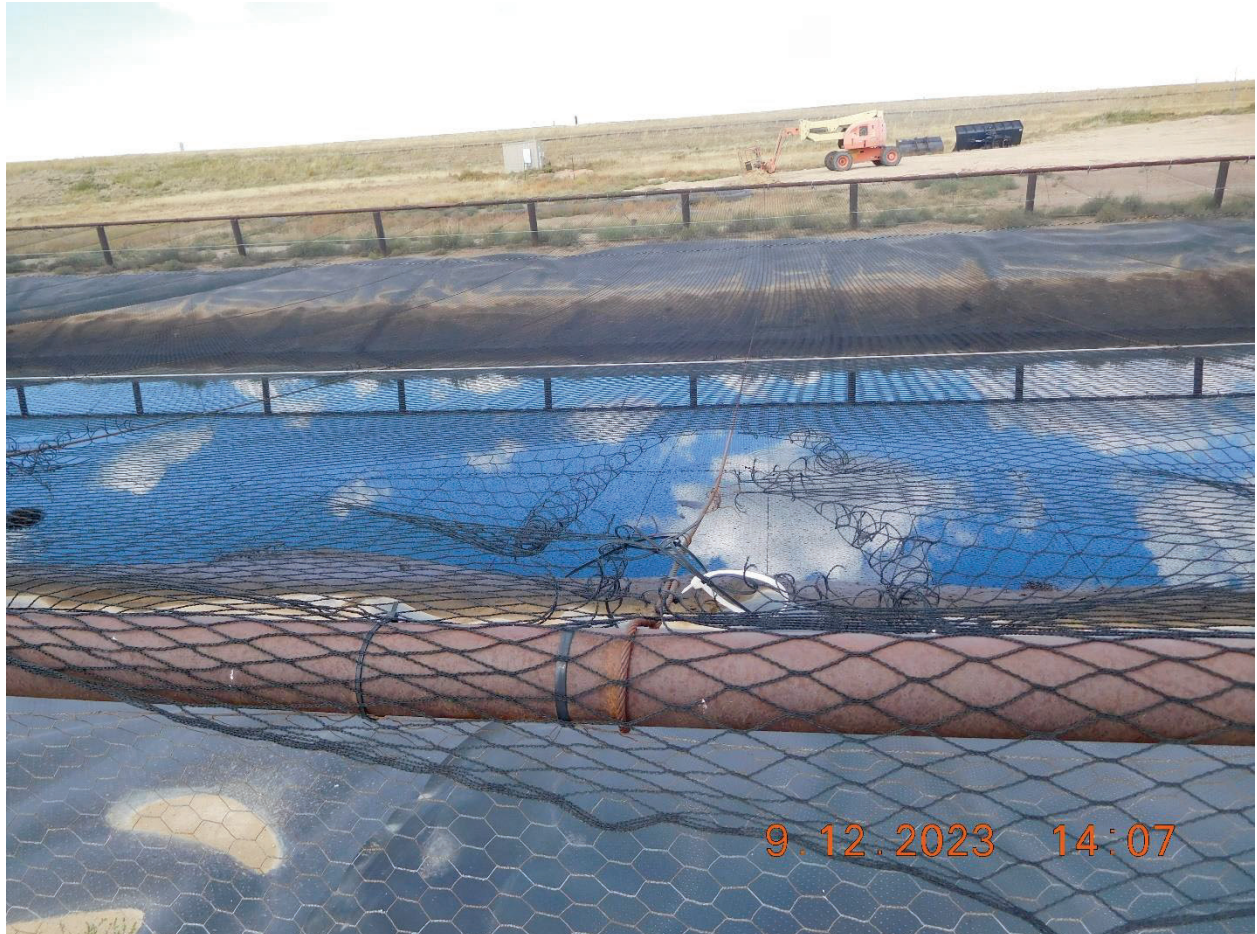
Photo 2242: DSCN2242.jpg – photo of a hole in the netting over the slop/skim pit.

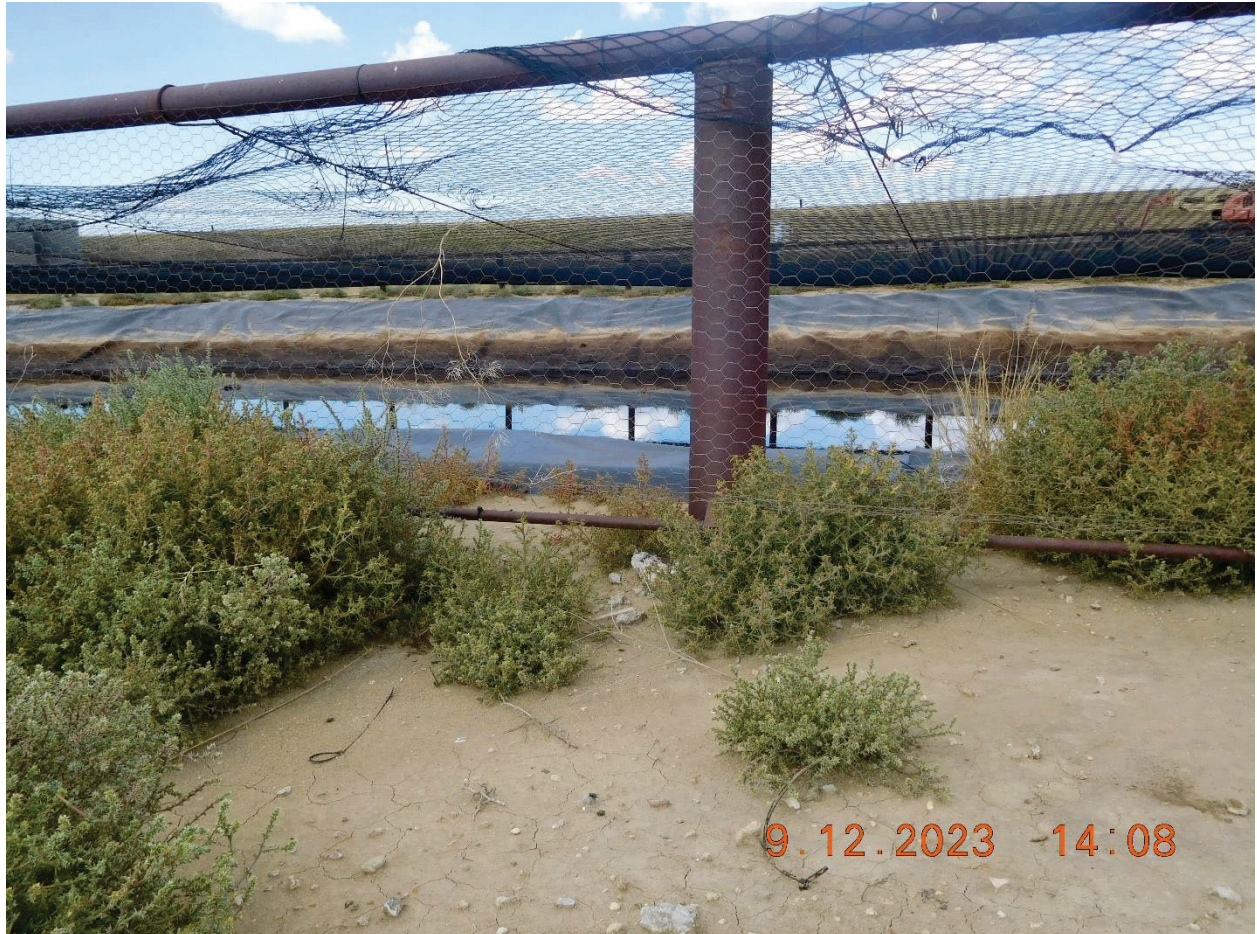
Photo 2243: DSCN2243.jpg – photo of ground-level gapping in the netting and fencing around the slop/skim pit.

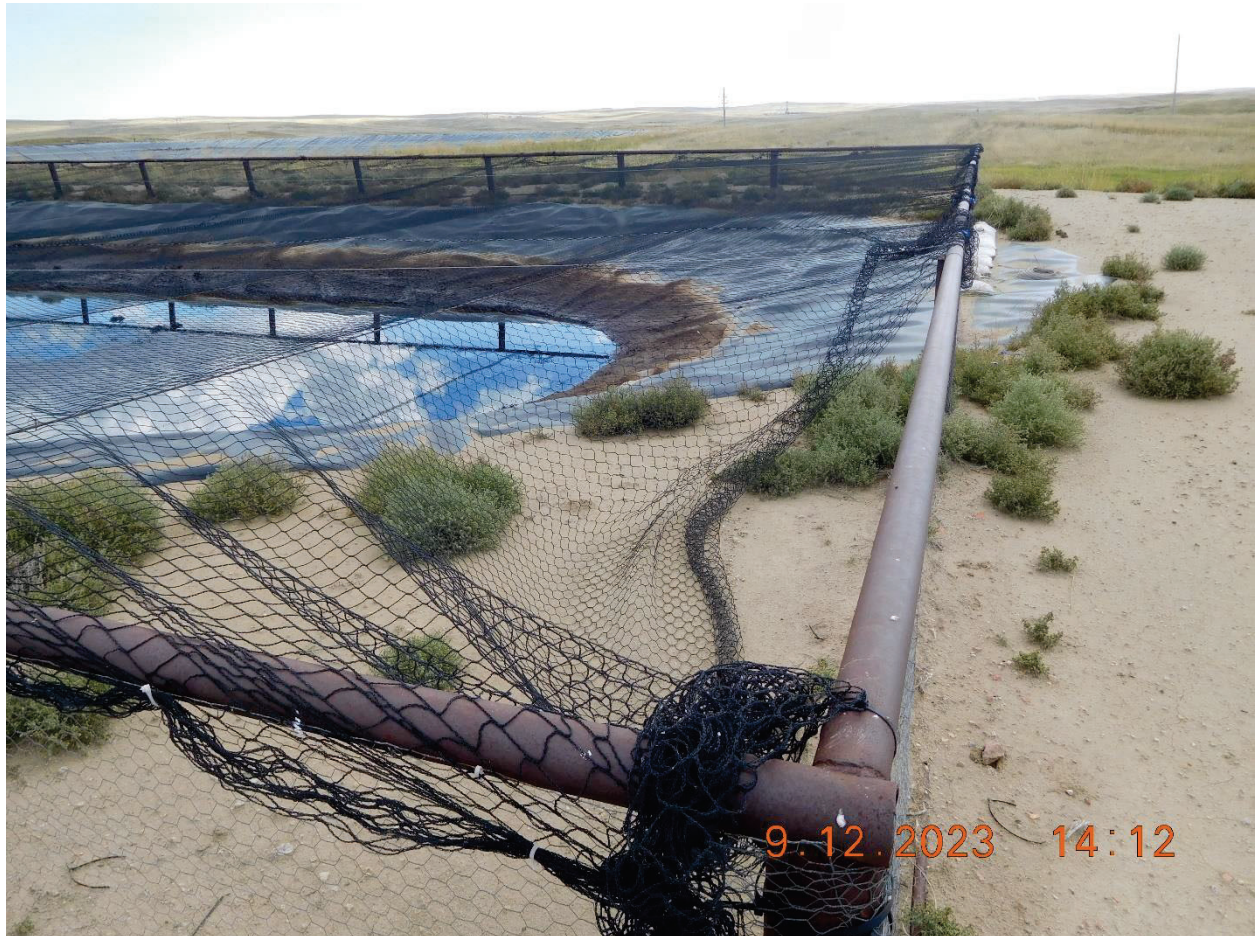
Photo 2244: DSCN2244.jpg – photo of the slop/skim pit netting pulled back at the northwest corner.

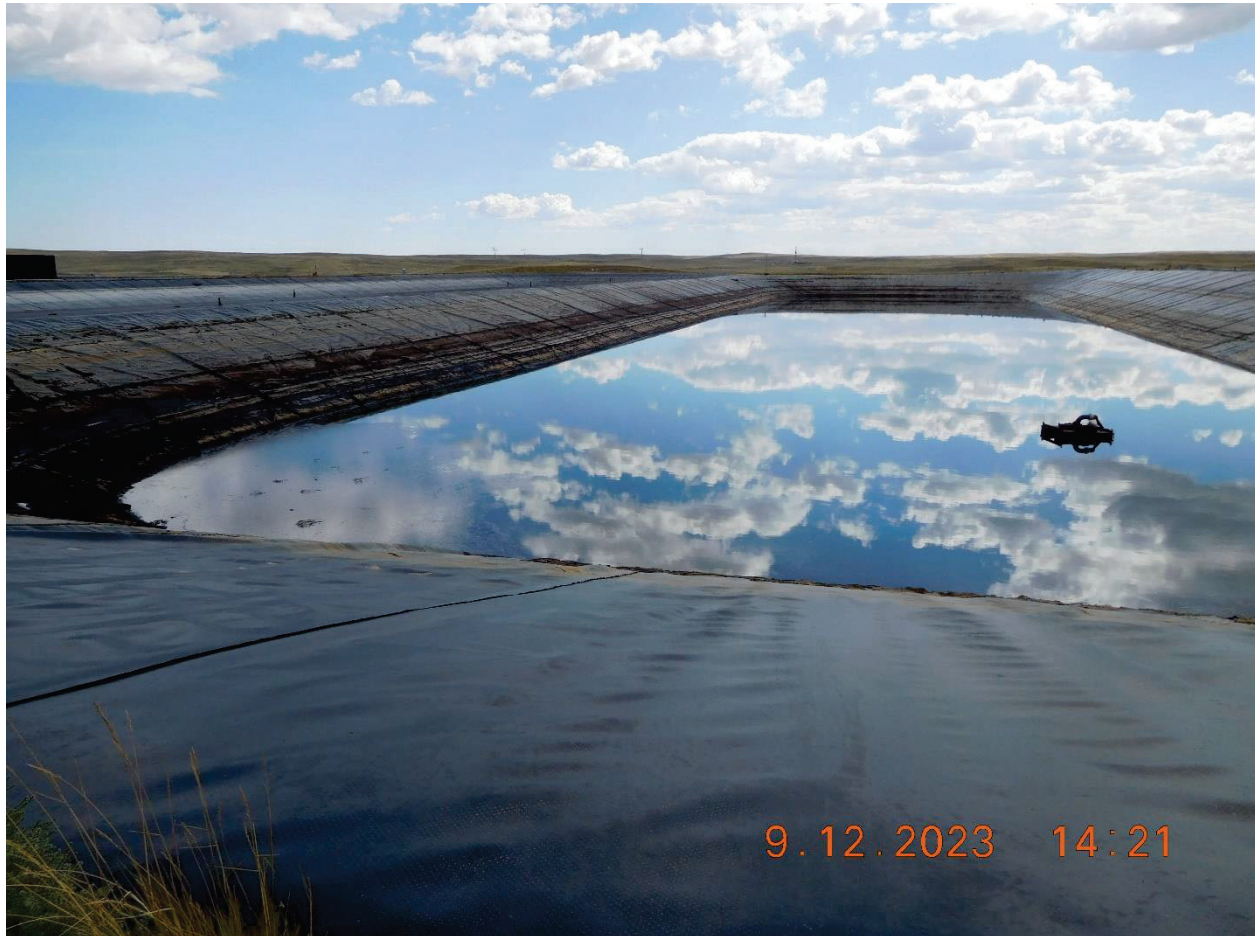
At Pond 2, I observed that a small amount of oil was present on the surface of the pond, covering an estimated 1% of the pond surface. See photos 2245-2246.

Photo 2245: DSCN2245.jpg – photo of Pond 2, with oil visible floating on the surface at the northwest corner.

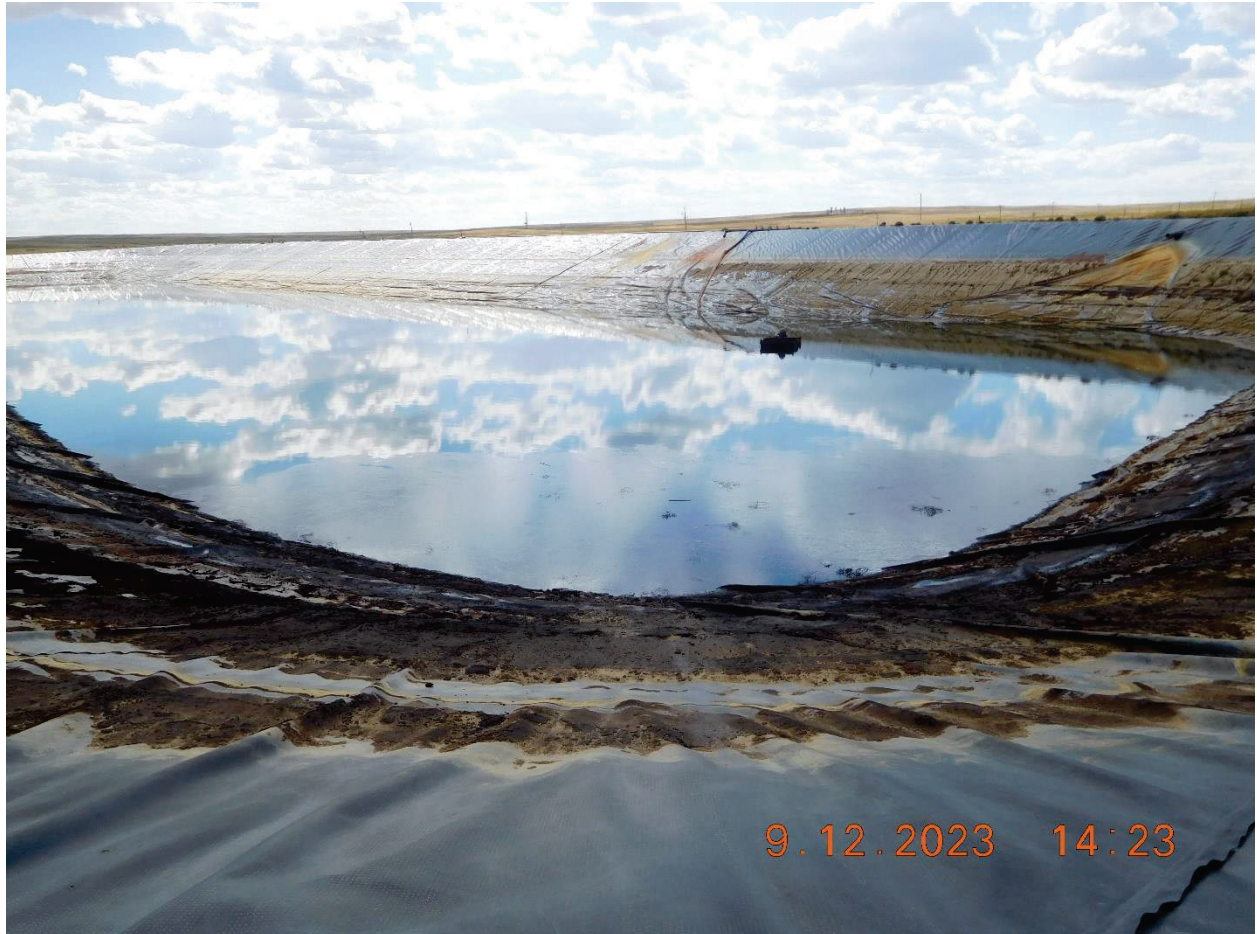
Photo 2246: DSCN2246.jpg – additional photo of Pond 2.

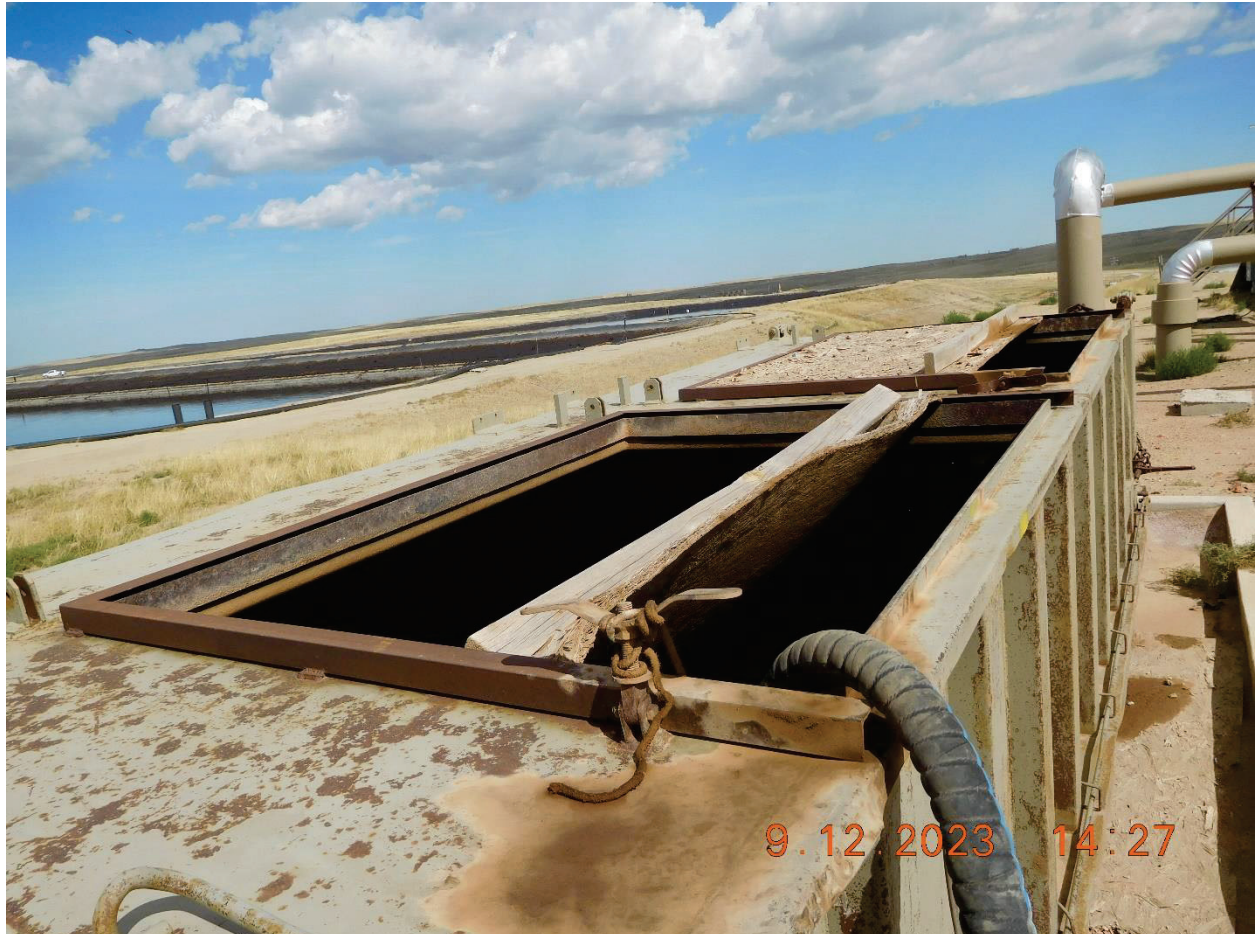
In the area of a tank battery north of Pond 2, I observed a mobile tank containing oily waste that was open on top with no netting or other mechanism in use that would physically restrict wildlife access to the oily waste. See photo 2247.

Photo 2247: DSCN2247.jpg – photo of a frac tank containing oily waste and with openings on top that were not closed, netted, or otherwise restricting wildlife access to the oily waste.

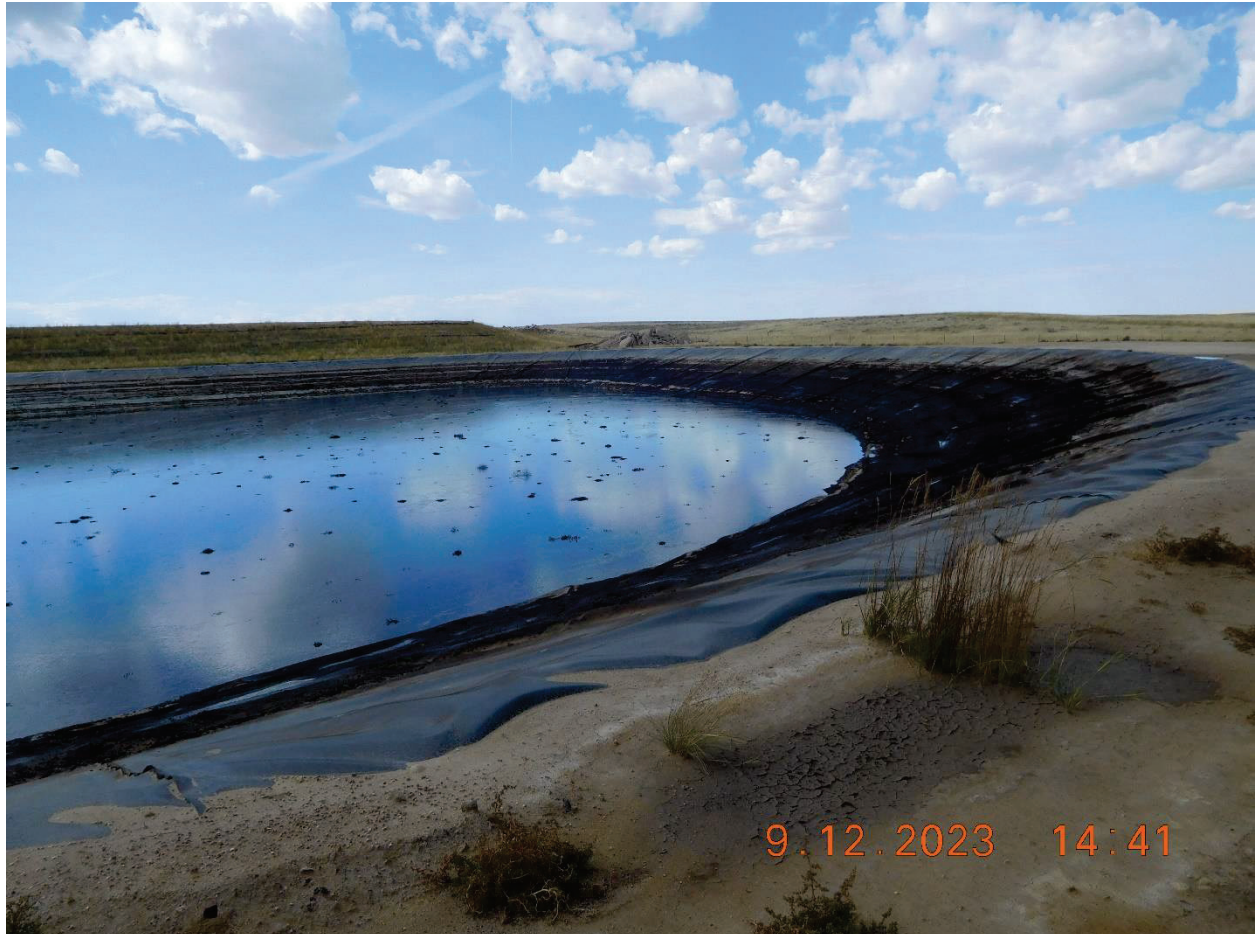
At Pond 9, I observed that at least 15% of the pond surface was covered in floating oil, and at Pond 10 approximately 5% of the surface was covered in floating oil. See photos 2248-2252. At Pond 10, a hydrocarbon boom had been placed at one corner to control floating oil, but some oil was present on the pond surface beyond the boom.

Photo 2248: DSCN2248.jpg – photo of Pond 9 with oil floating on at least 15% of the pond surface.

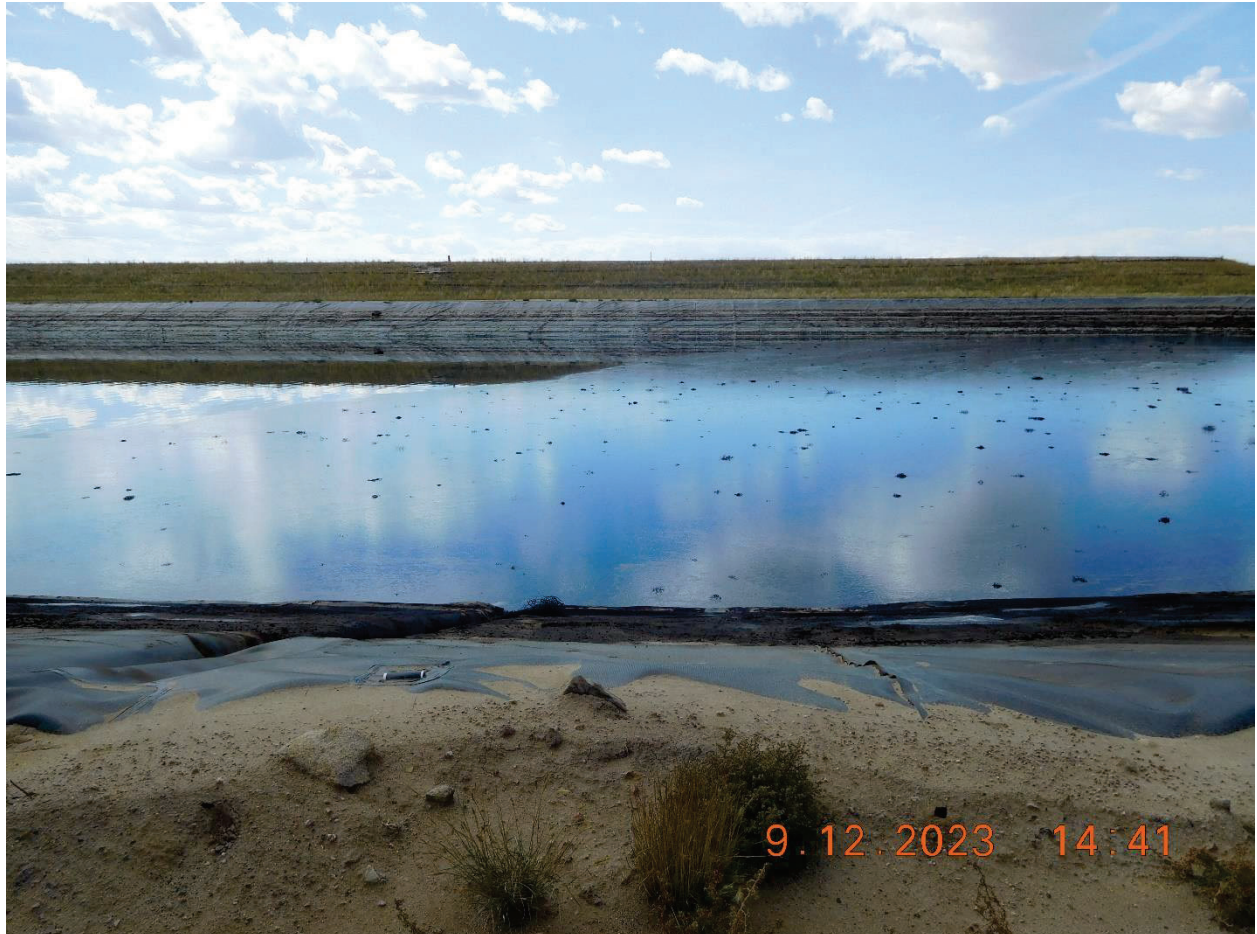
Photo 2249: DSCN2249.jpg – photo of Pond 9, panned left from photo 2248.

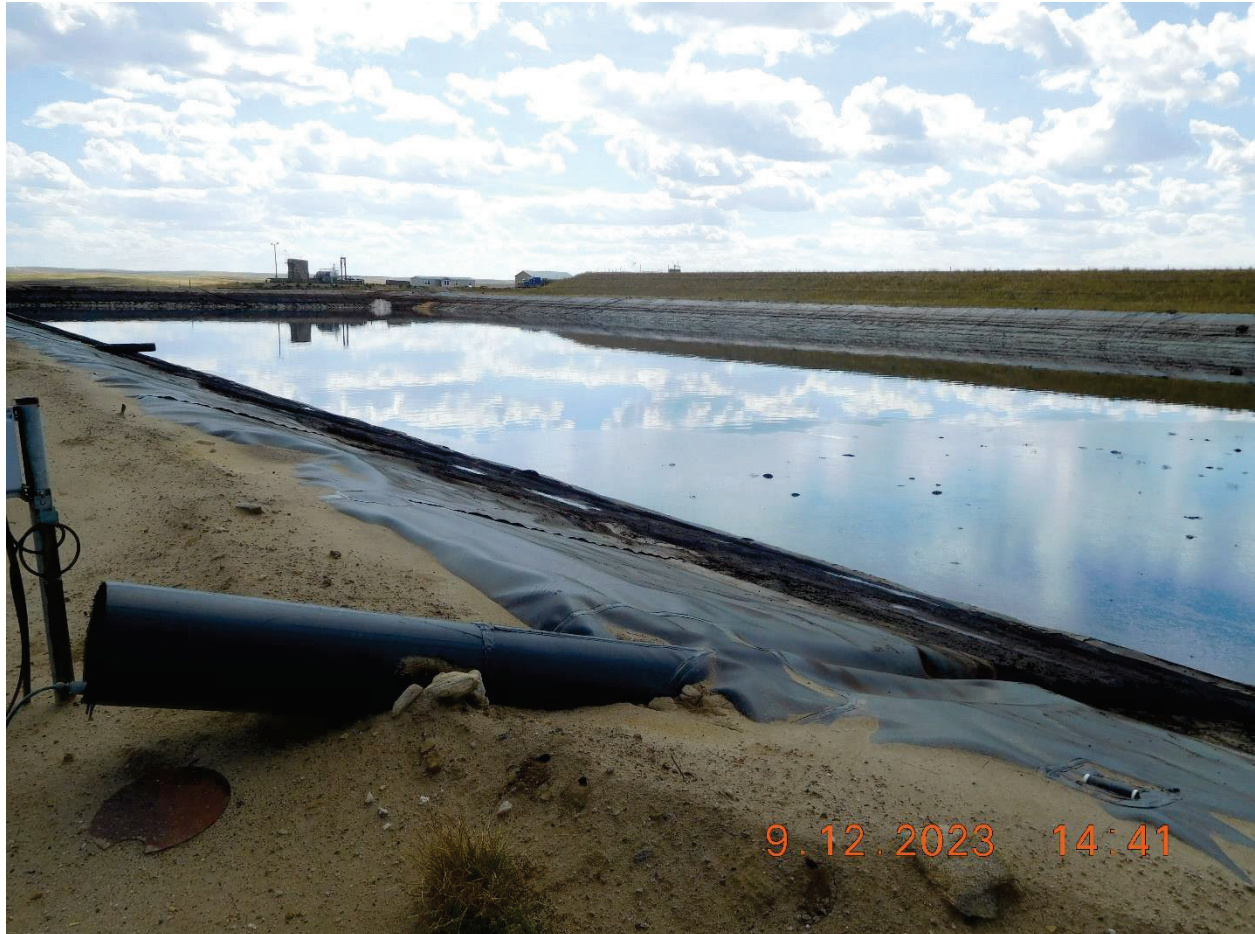
Photo 2250: DSCN2250.jpg – photo of Pond 9, panned left from photo 2249.

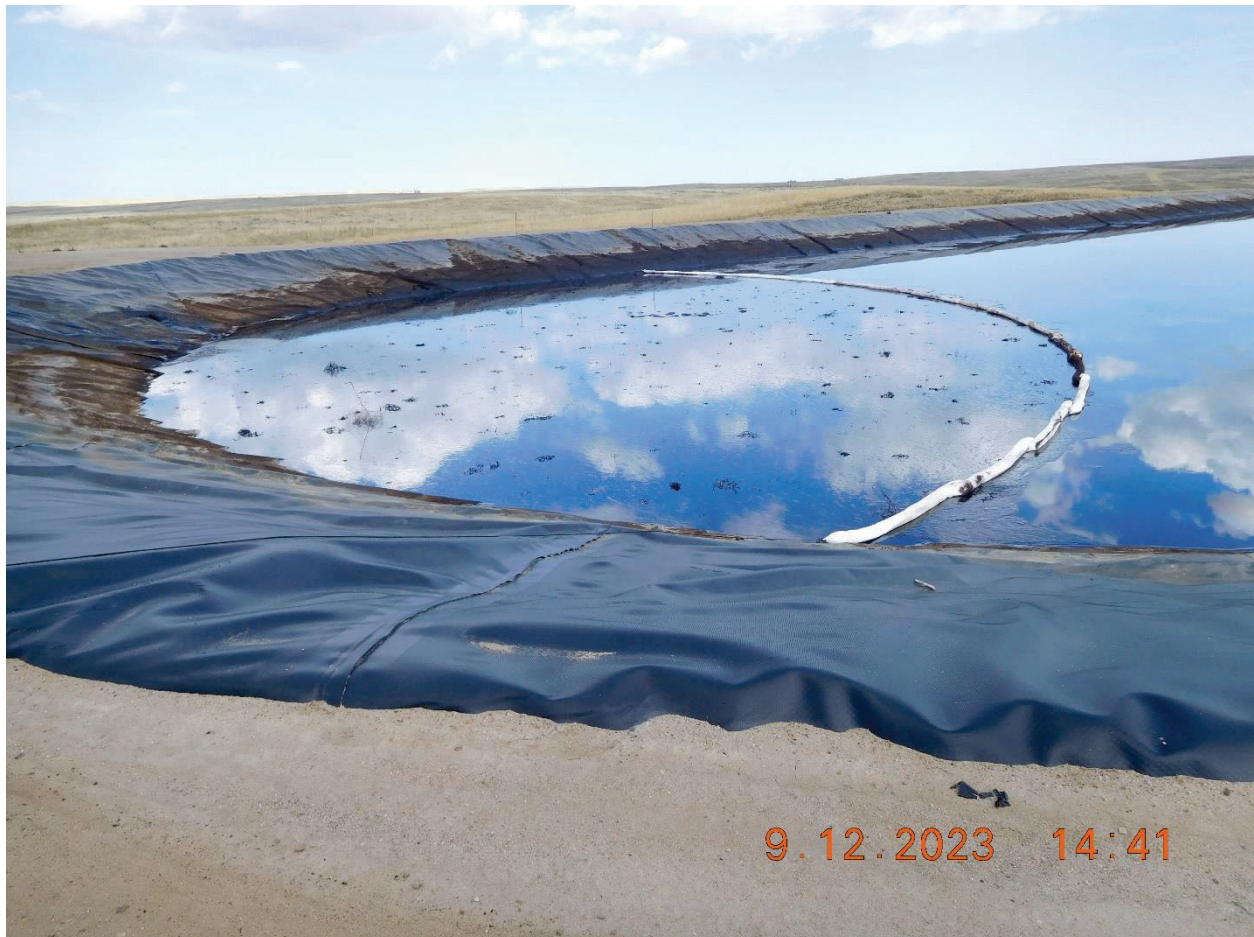
Photo 2251: DSCN2251.jpg – photo of Pond 10, with oil on approximately 5% of the surface of the pond. Photo shows a hydrocarbon boom with floating oil both inside and outside of the boom.

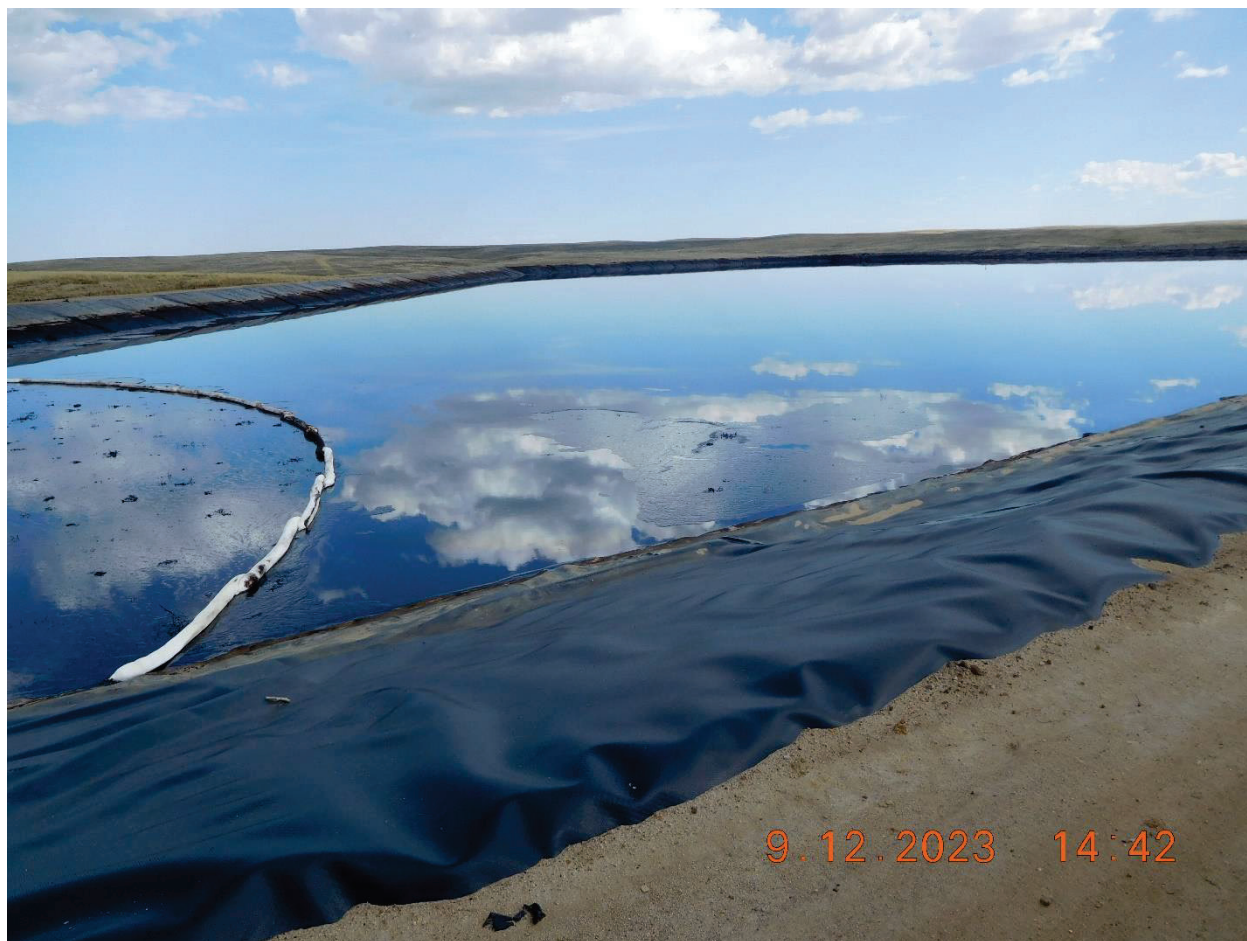
Photo 2252: DSCN2252.jpg – photo of Pond 10, panned right from photo 2251.
