**Region 6 Compliance Assurance and Enforcement Division  
INSPECTION REPORT**

| Inspection Date(s): | 5/28/19 | | |
| Facility Name: | Wildcat Dairy, LLC | | |
| Identification/Permit Number: | TXG921255 | | |

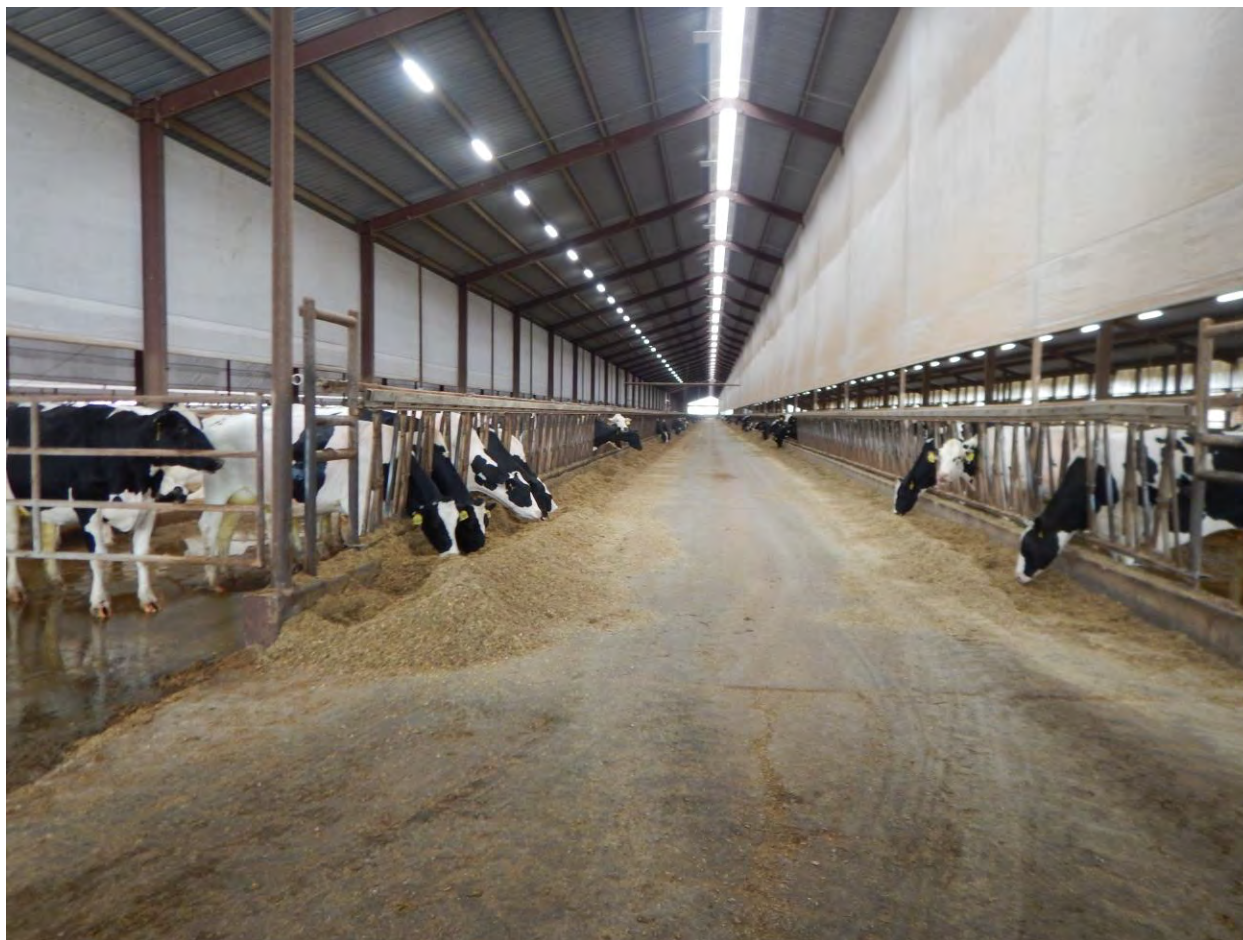
Photo No. 1

Description: Looking north inside the ventilated freestall. The barn had curtains to help channel the air for cross ventilation.

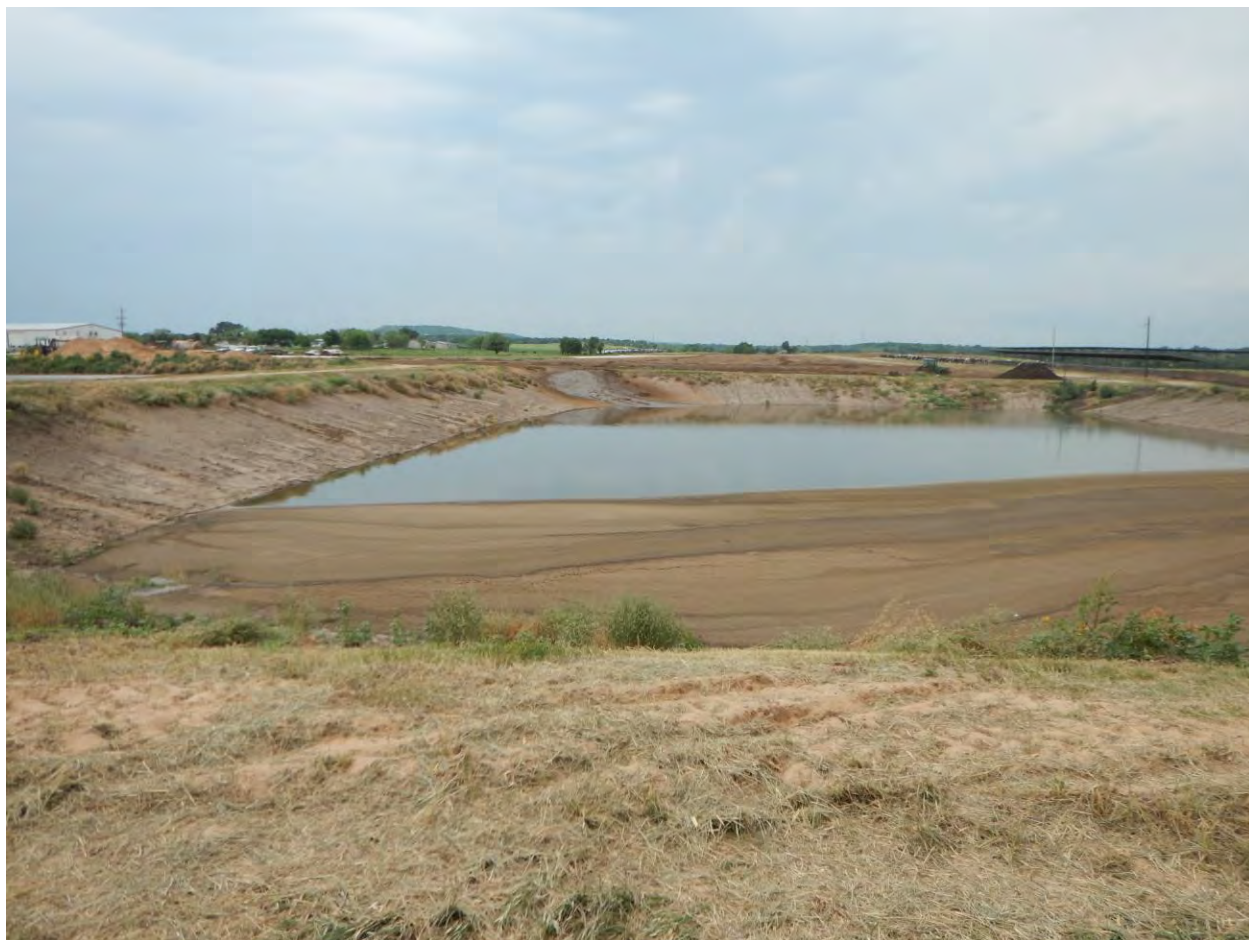
Photo No. 2

Description: Looking south at the dairy's Surge Pond 3. This is a clay lined lagoon which is cleaned out approximately every three years.

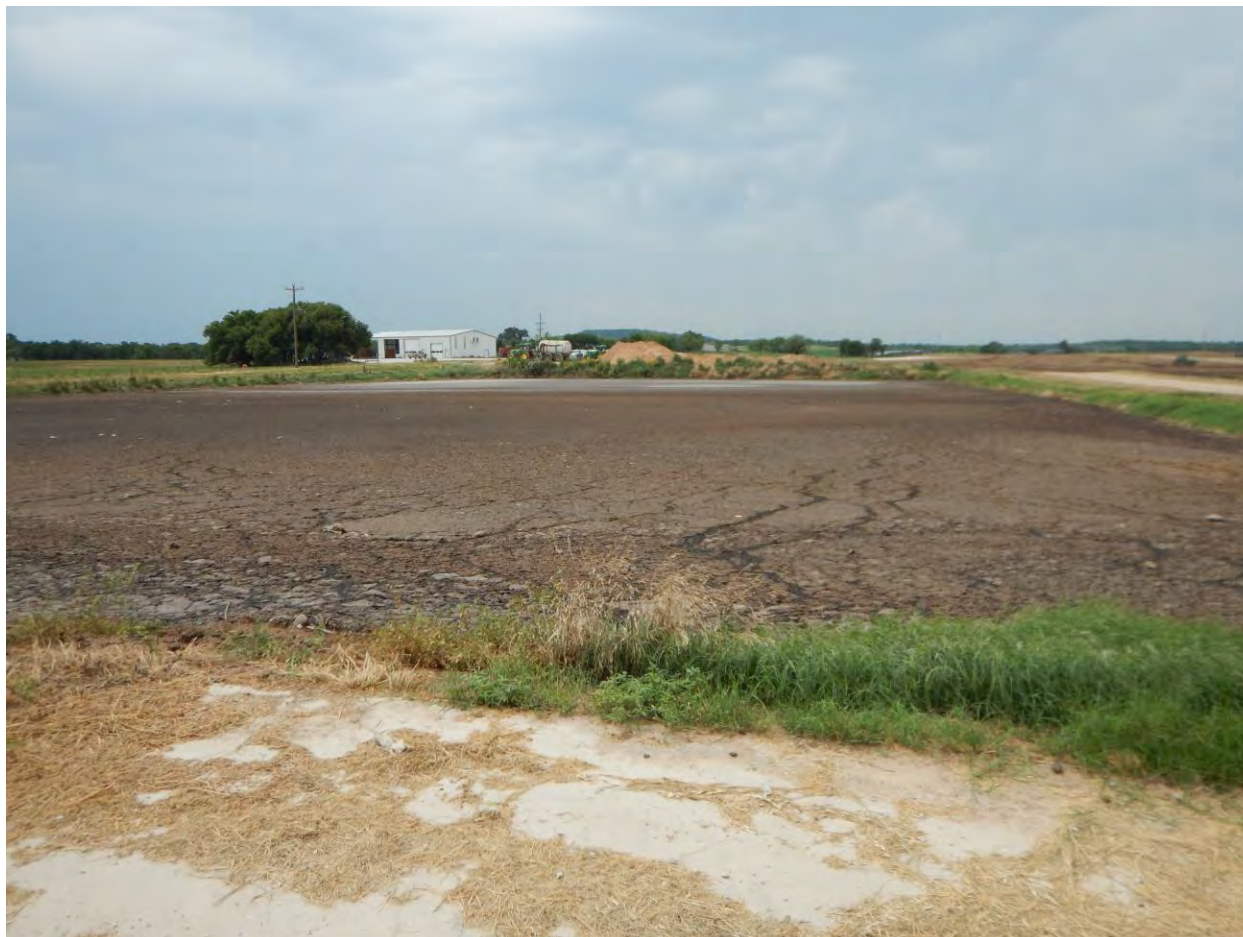
Photo No. 3

Description: Looking south at the dairy's Slurry Basin 2. This is the second of two slurry pits which was located east of Surge Pond 3.

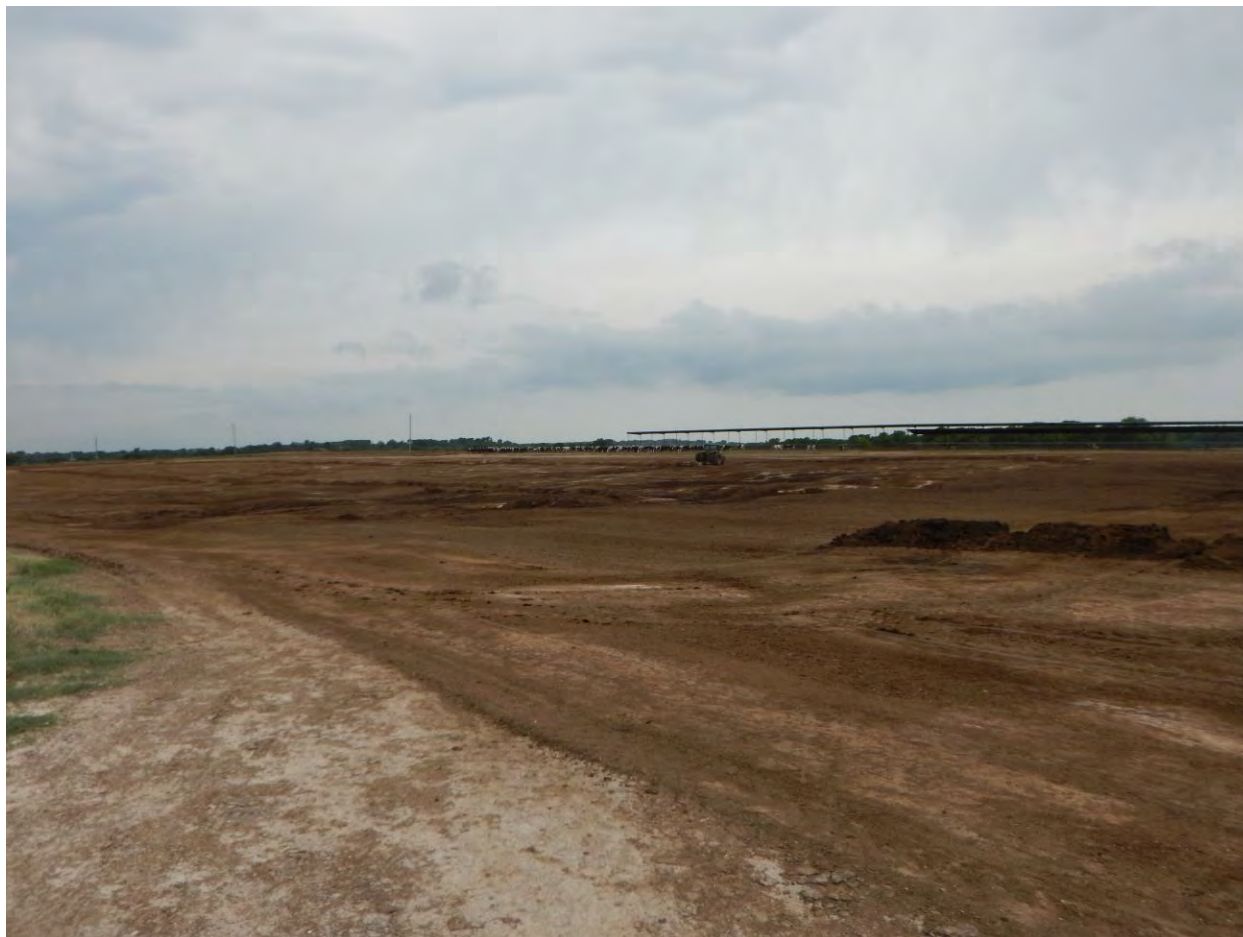
Photo No. 4

Manure solids were stored as windrows in either the Slurry/Manure Drying Area or in the Composting Area located southeast of RCS 1-Expansion. Manure contained within the Slurry/Manure Drying Area was neatly arranged in dried windrows and I observed a tractor working this area during the inspection. The Slurry/Manure Drying Area appeared to be very well managed.

Description: Looking southwest at the windrow preparation occurring at the manure drying area.

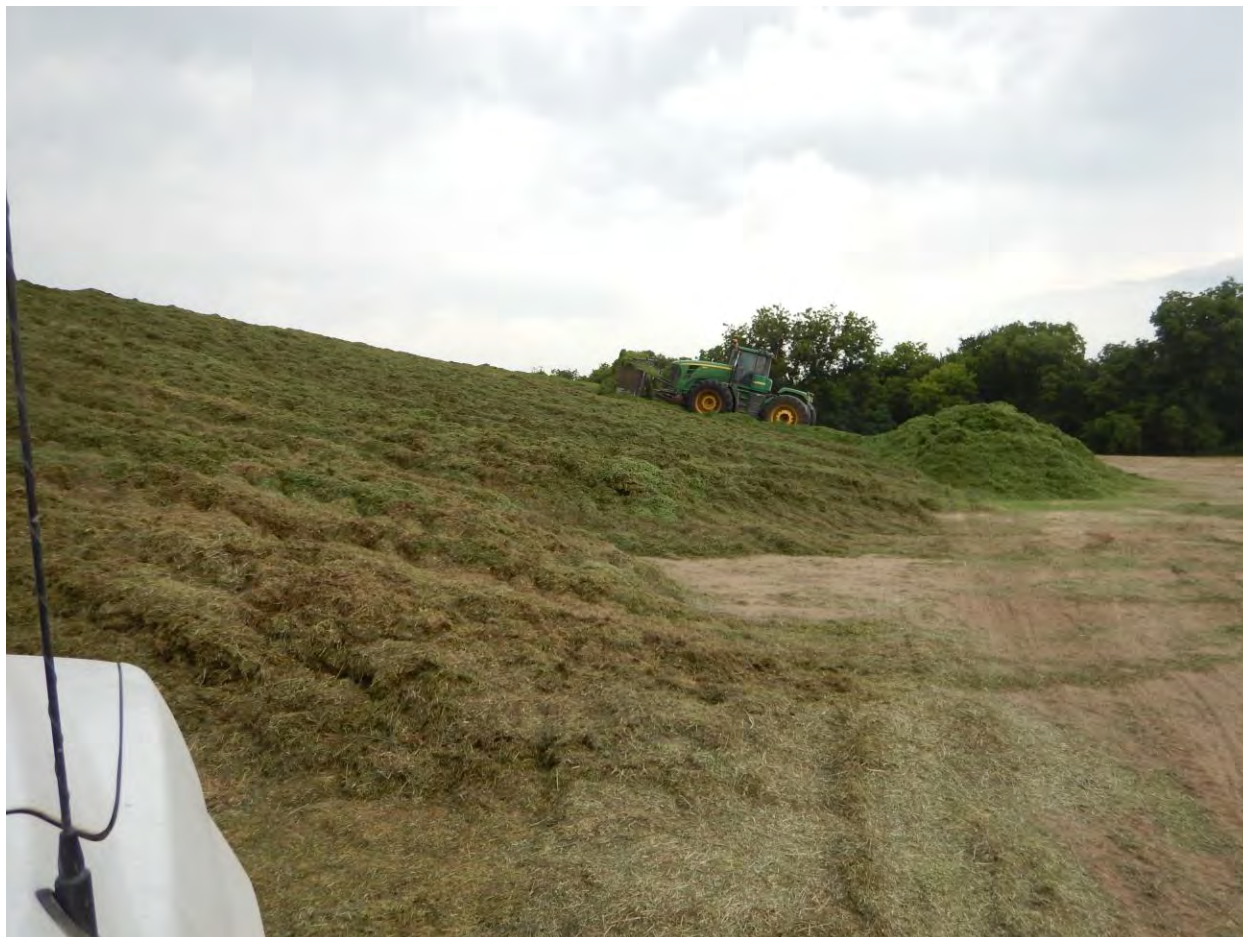
Photo No. 5

On the day of the inspection I observed the commodity storage barns to be in good condition. I also observed the covered silage bunkers and silage socks. Additionally, at the time of the inspection a new silage bunker was being constructed from the recently harvested winter wheat (photos 5 – 6).

Description: Looking south at freshly harvested silage being built into a stockpile.

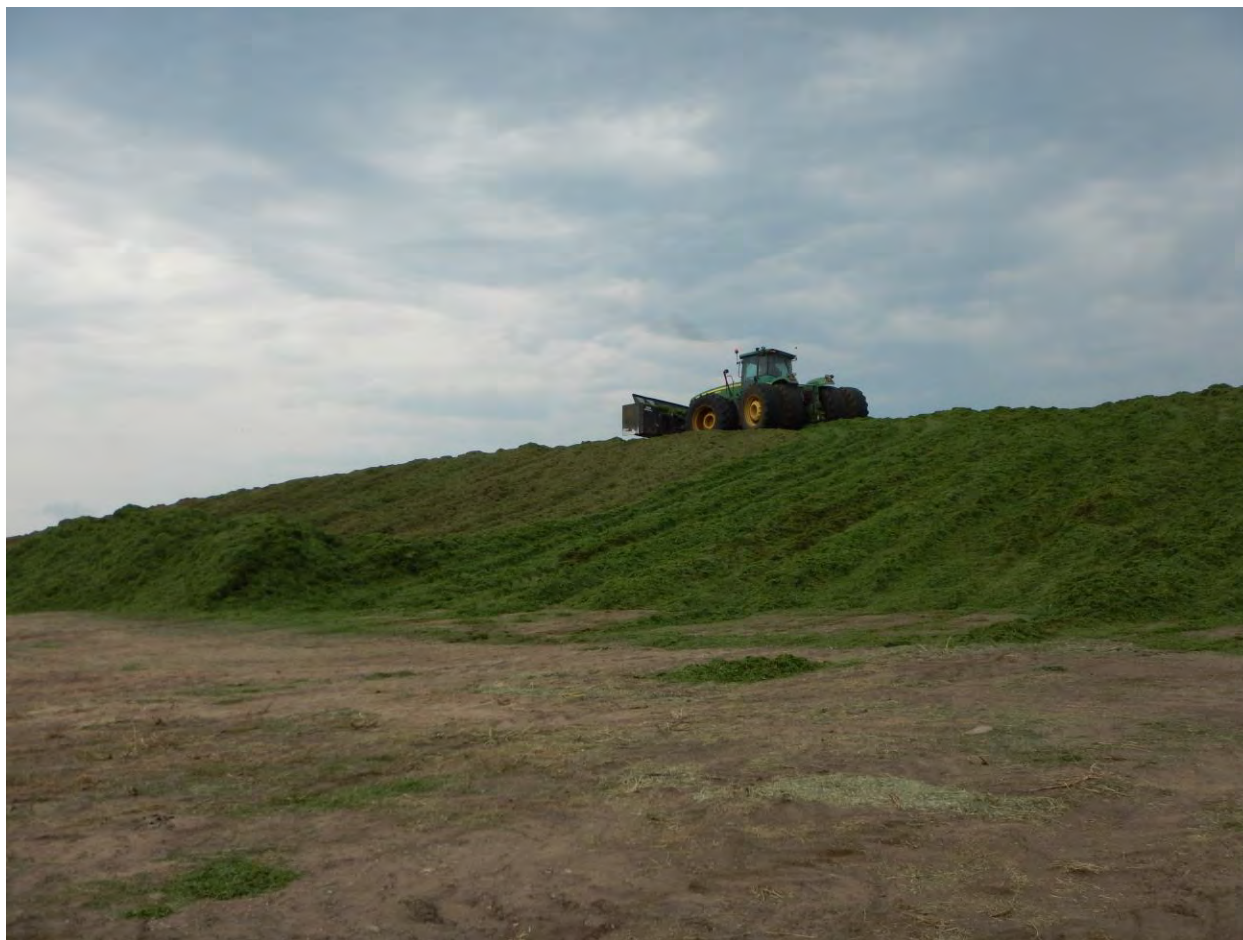
Photo No. 6

Description: Looking northeast at the new silage stockpile.

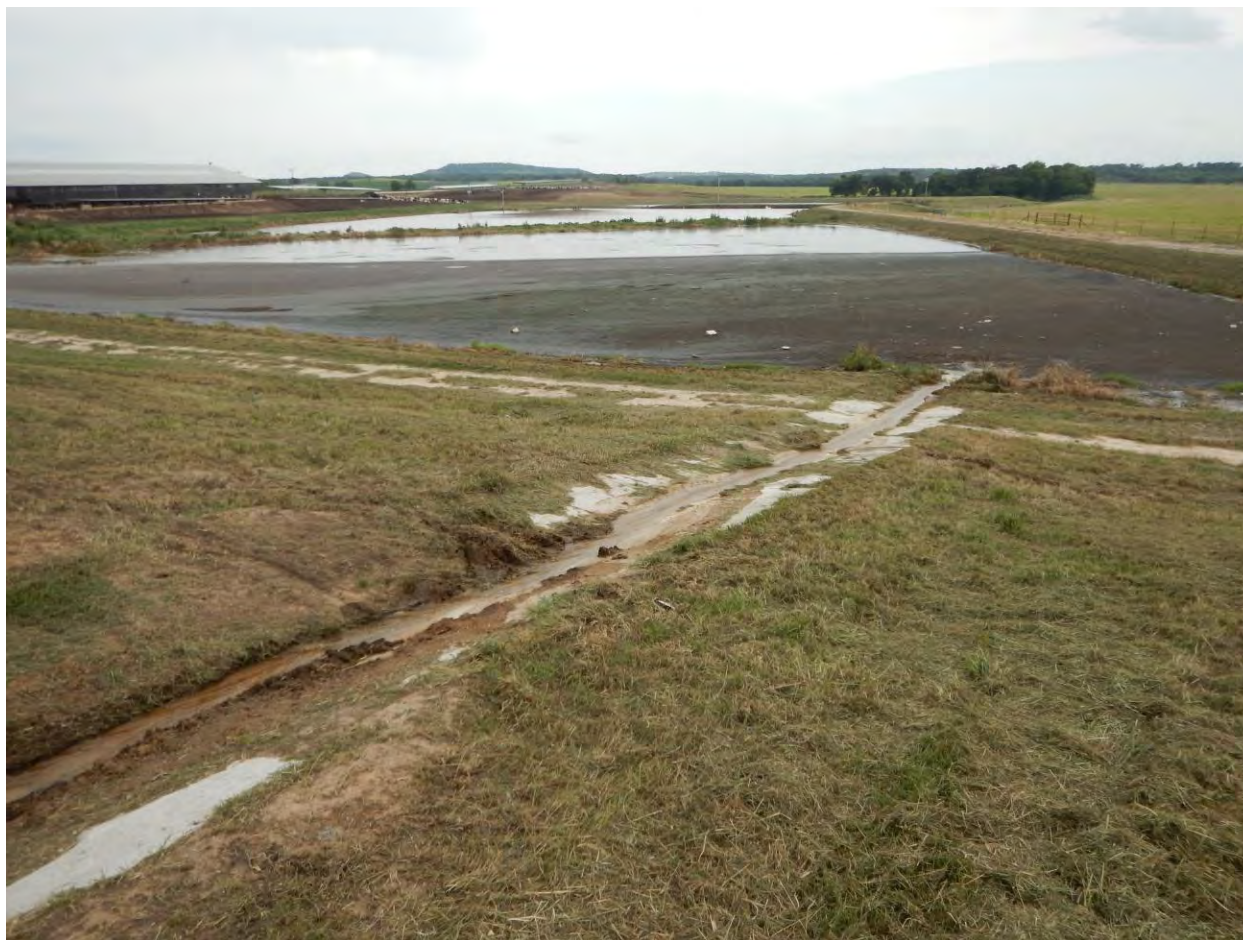
Photo No. 7

Description: Looking south at the Settling Basin with RCS 1 and RCS 1-Expansion in the background.

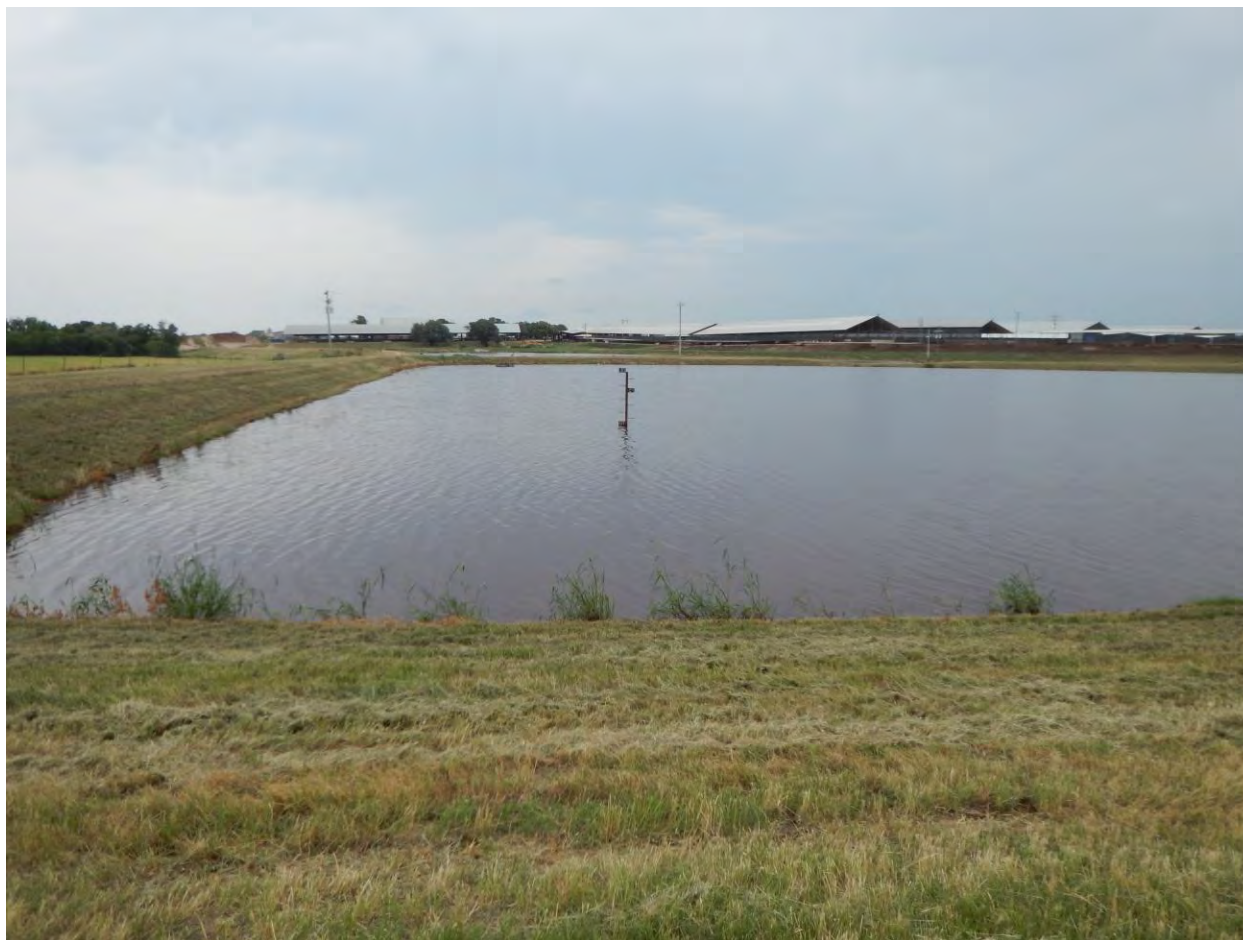
Photo No. 8

On the day of the inspection I found that the wastewater level in RCS 1-Expansion lagoon was one foot over the 25-yr/24-hr rain event mark as shown on the pole marker and based on site records of lagoon measurements. The two lagoons appeared to be very well constructed and managed, with RCS 1-Expansion having greater than six feet of freeboard. Additionally, the berms on the dairy site were well designed and constructed. Berms and lagoon embankments were well maintained and covered with dense vegetation. The entire dairy site including the lagoon embankments were well mowed.

1. The wastewater level in RCS 1-Expansion was approximately one foot above the 25-yr/24-hr rain event mark per TXG 921255 Part III.A.10 (a)(1).

Description: Looking north at RCS 1-Expansion. Note the pole marker and the greater than six feet of freeboard. Note the well mowed and maintained embankment.

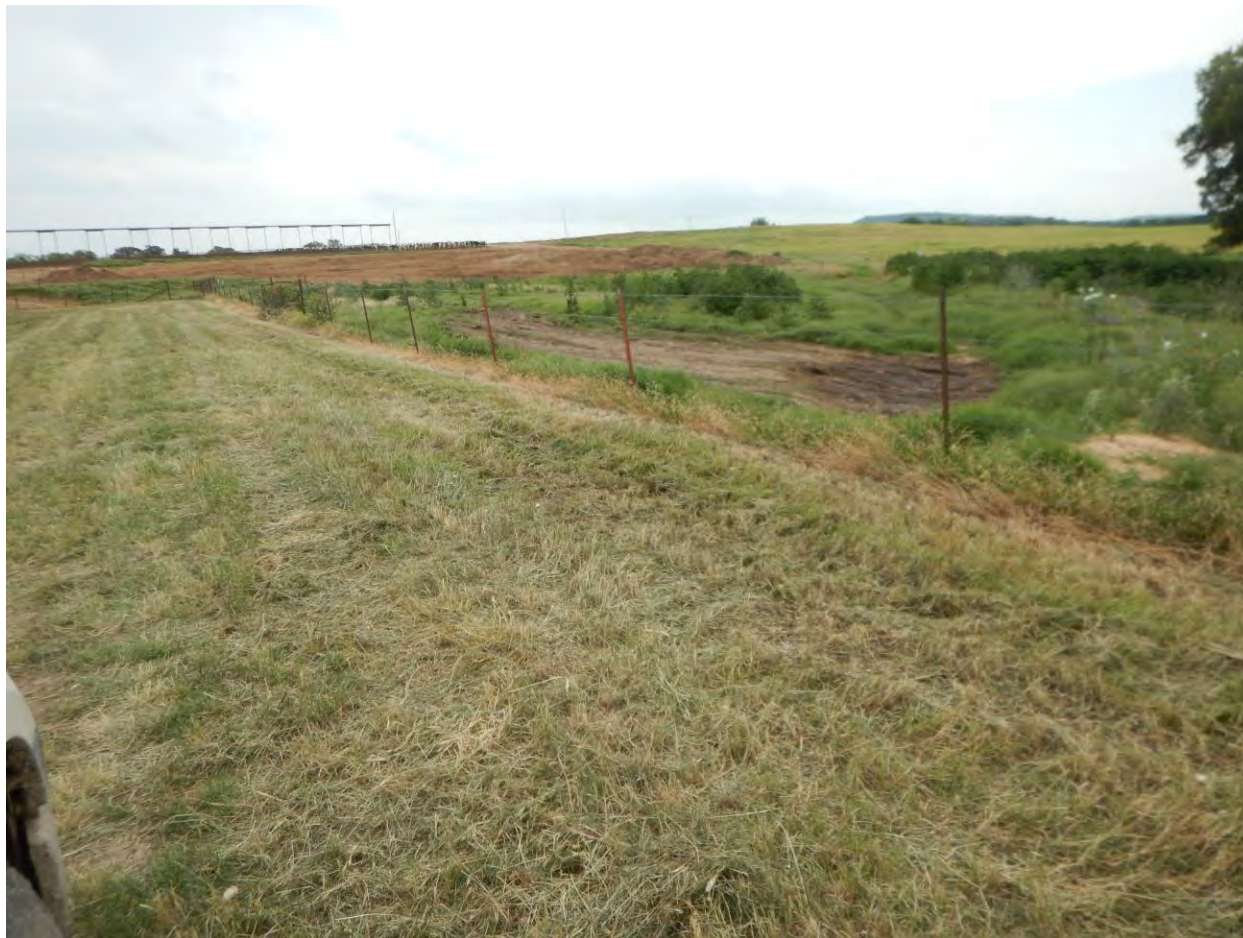
Photo No. 9

The manure windrows being used for mortality composting were bermed to direct wastewater into RCS 1. This manure/mortality composting area also appeared to be well managed (photo 9).

Description: Looking east-southeast at the mortality/composting area. This area is bermed to drain to RCS 1. Note the well mowed RCS 1- Expansion embankment seen in the foreground.

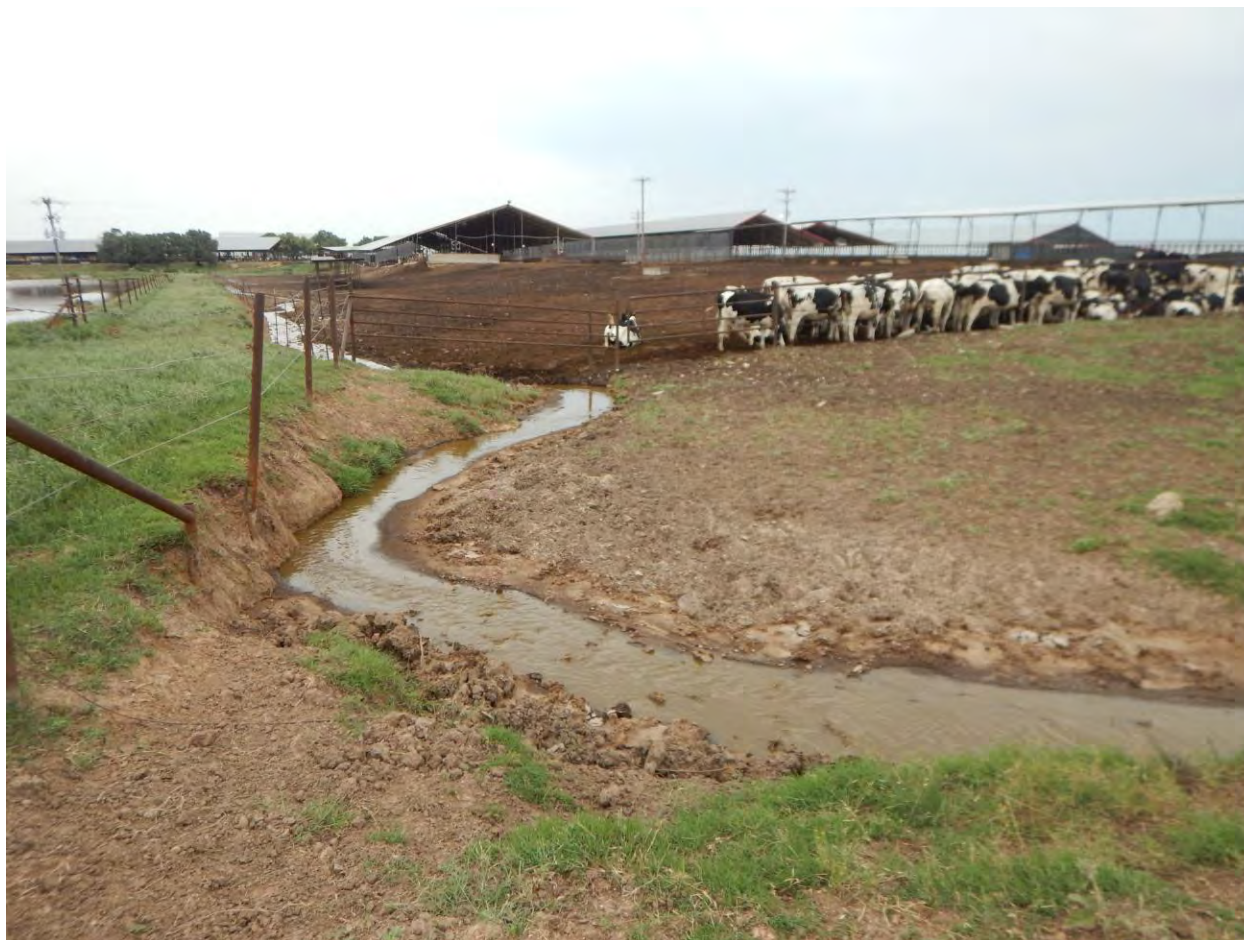
Photo No. 10

Description: Looking north at the dry cow pens, which like the manure/mortality composting area, drains by bermed channel into RCS 1.

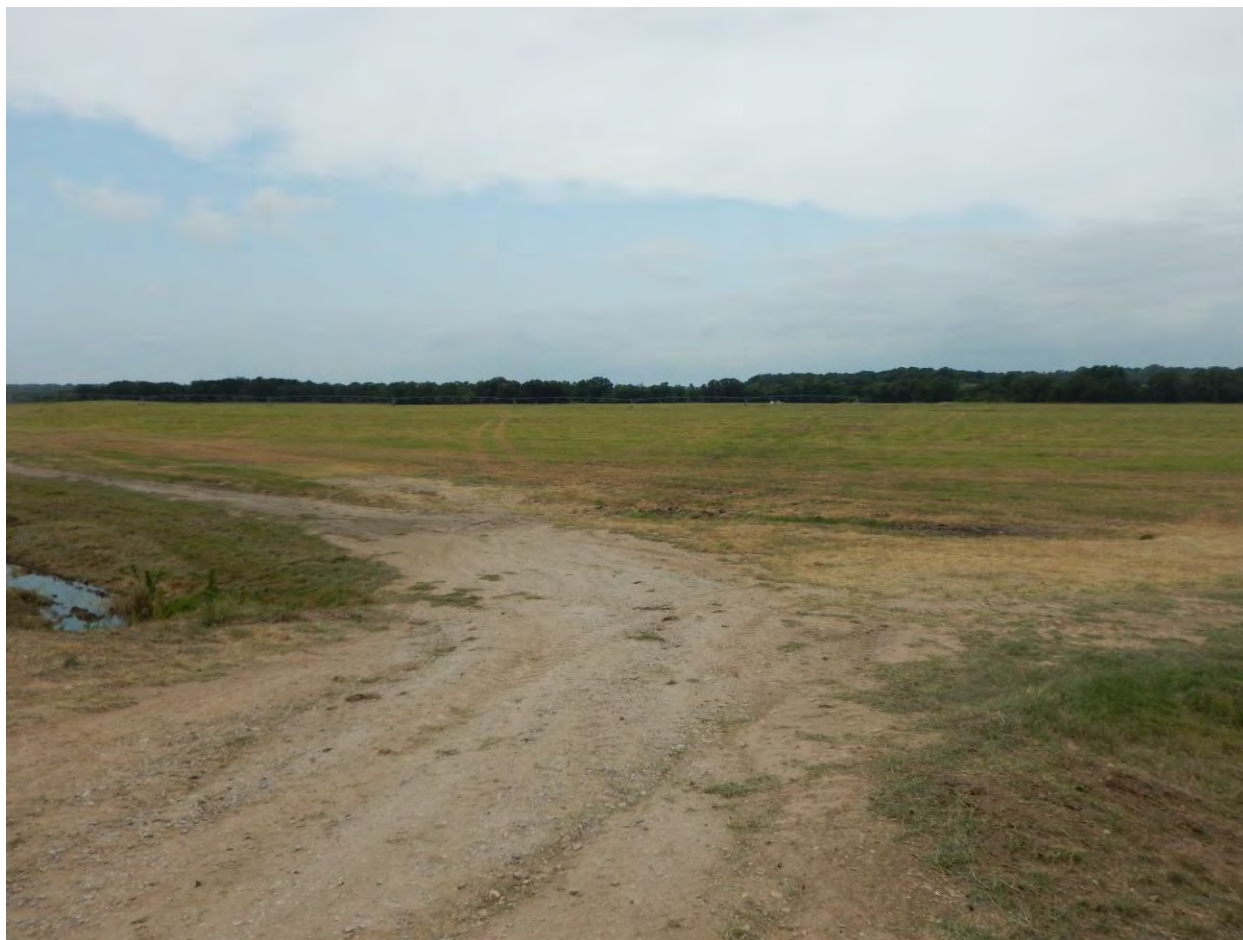
Photo No. 11

On the day of the inspection, I observed the Land Management Units to be in good condition and free from any evidence of overapplication such as ponding or puddling. LMU 2 was the last field to which wastewater was land applied on 5/16/2019, approximately 12 days prior to the EPA site inspection.

Description: Looking southwest at LMU 2 which is equipped with a center pivot. This is the last field to which wastewater was applied on 5/16/2019. A small drainage way is located in the foreground, upslope of the grade of the land and buffered from the application pivot.
