**INSPECTION REPORT**

| <b>Type of inspection:</b> | CEI - Compliance Evaluation Inspection | |
| <b>Permittee Name:</b> | Cleveland-Cliffs Steel Corp. – Mansfield Works | |
| <b>Permit Number:</b> | OH0006840 | |

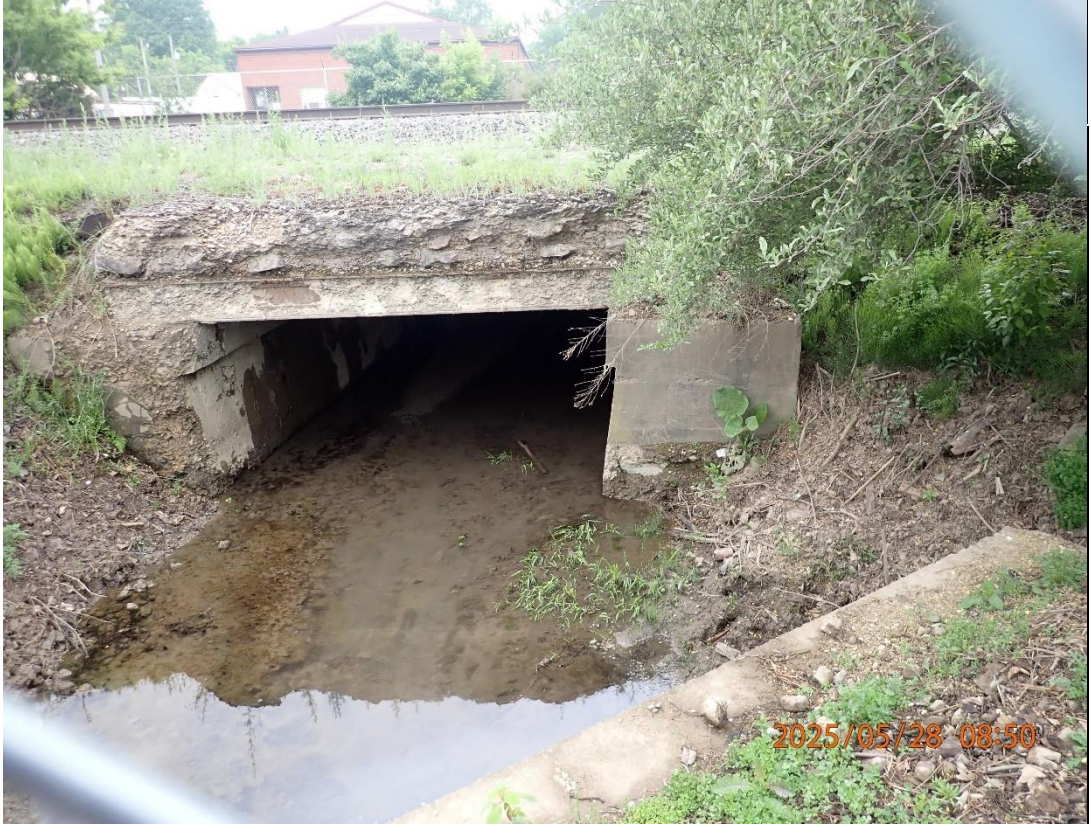
| <b>Photo Description:</b><br>Outfall 005. Offsite sampling location. | | | |

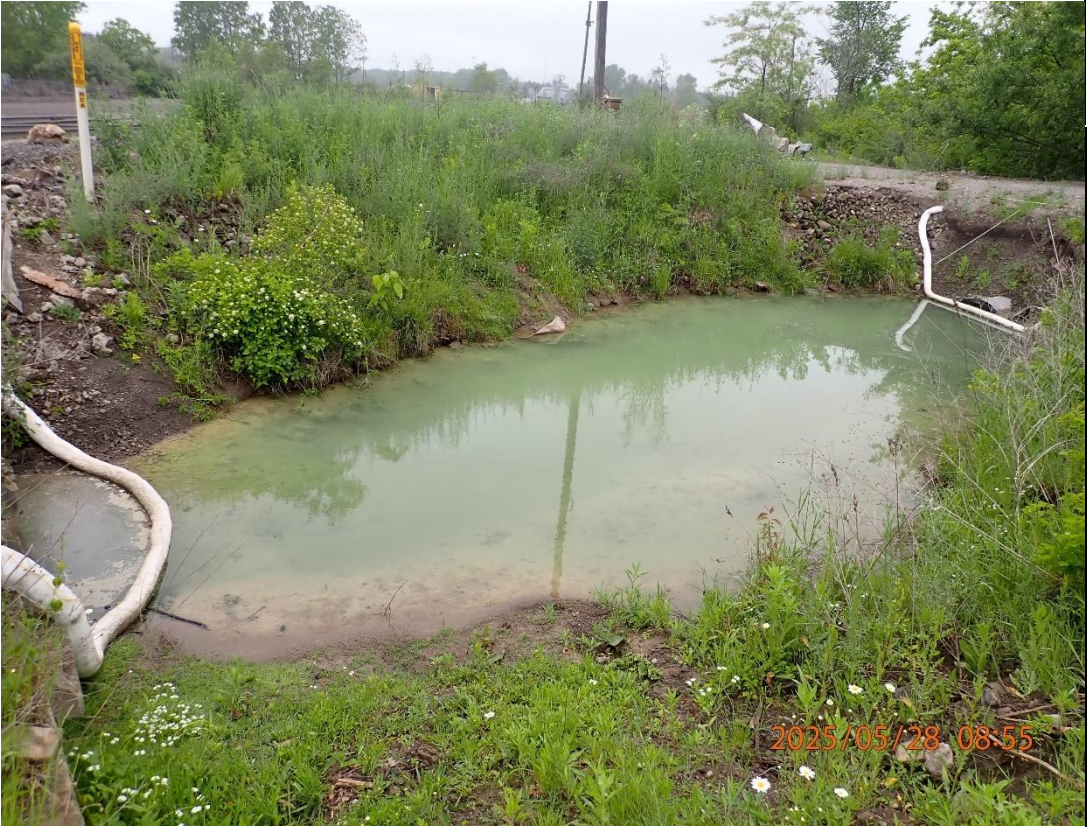
| <b>Unique Identifying No.</b> | <b>Observation</b> | <b>Area of Concern?</b> |
|---|---|---|
| <b>MS5-OB-001</b> | During the site tour, inspectors observed a metal sheet in the effluent channel for Outfall 005. (Photo 2) | Yes |

| No. | |
|---|---|
| <b>MS-OB-001</b> | <p>During the site tour, inspectors observed a metal sheet in the effluent channel for Outfall 005. (Photo 2)</p> <p>NPDES Permit Part IV. Stormwater Control Measures and Pollution Prevention Programs. Part C – <u>Minimize Exposure</u> - You shall minimize the exposure of manufacturing, processing, and material storage areas (including loading and unloading, storage, disposal, cleaning, maintenance, and fueling operations) to rain, snow, snowmelt, and runoff by either locating these industrial materials and activities inside or protecting them with storm resistant coverings.</p> |

| <b>Photo Description:</b><br>Outfall 005 effluent channel. | | | |

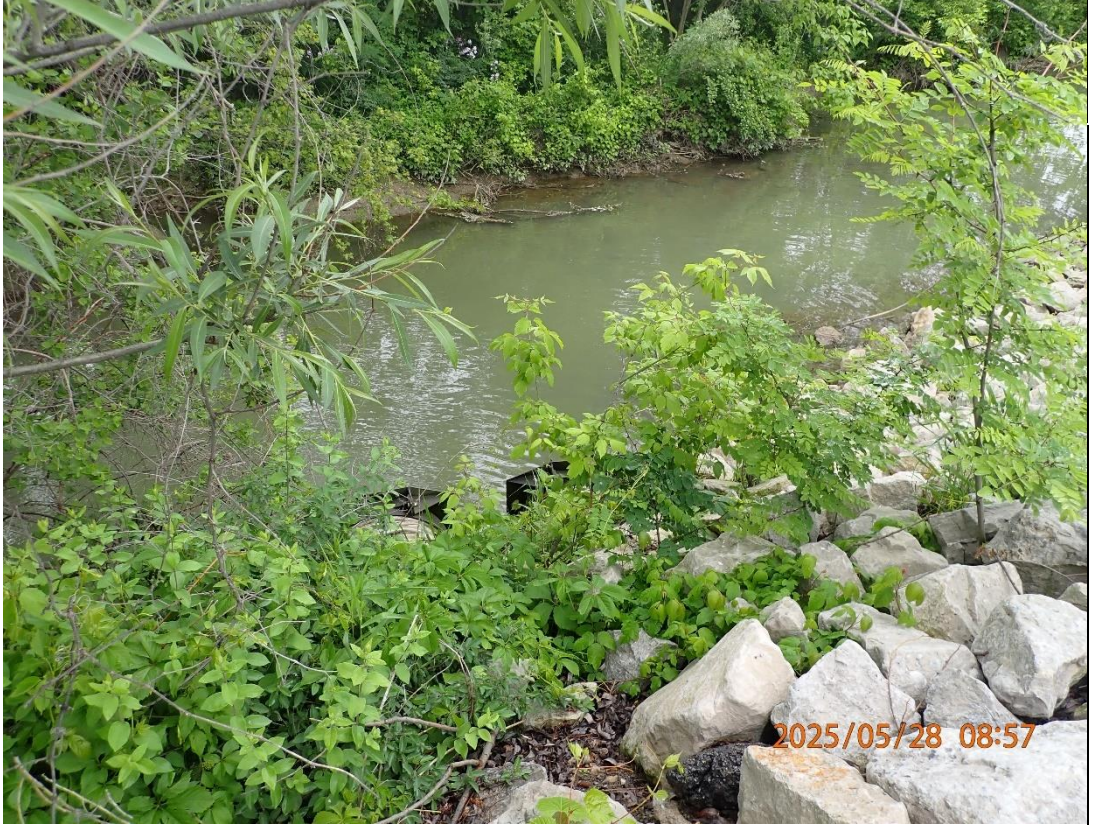
| <b>Photo Description:</b><br>Outfall 005 effluent storm doors on pipes. | | | |

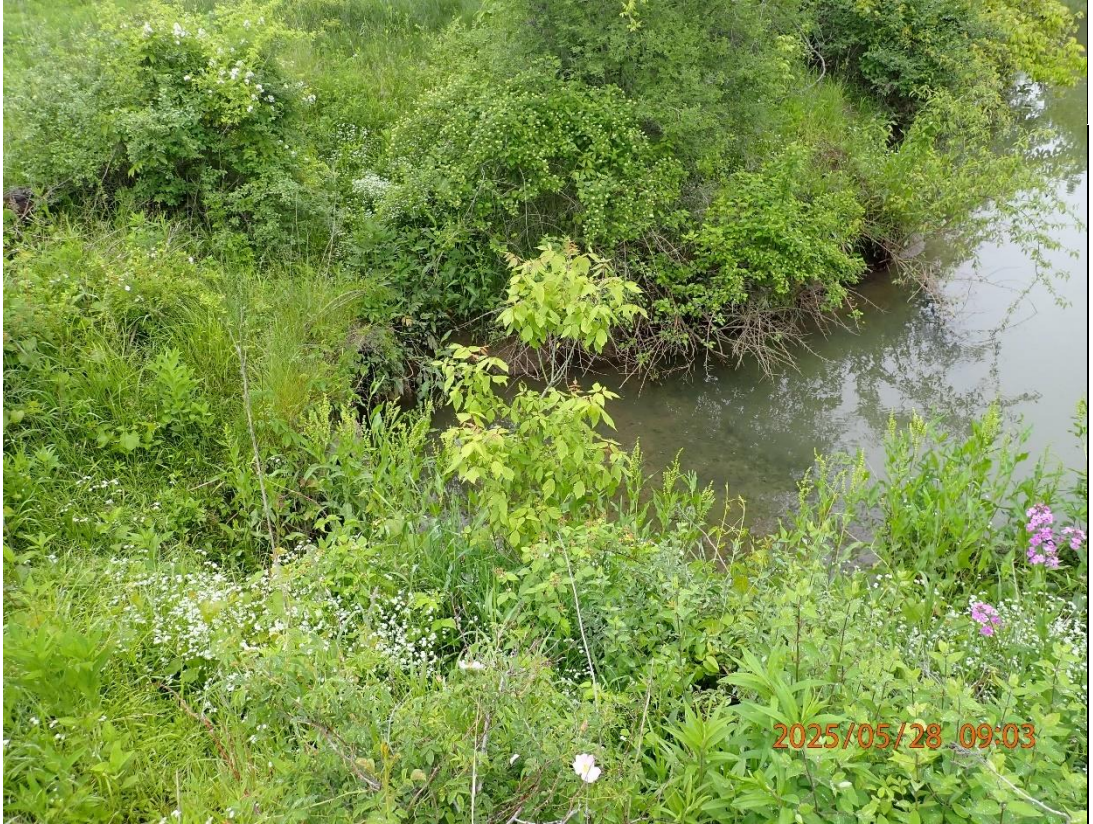
| <b>Photo Description:</b><br>Outfall 006 effluent. | | | |

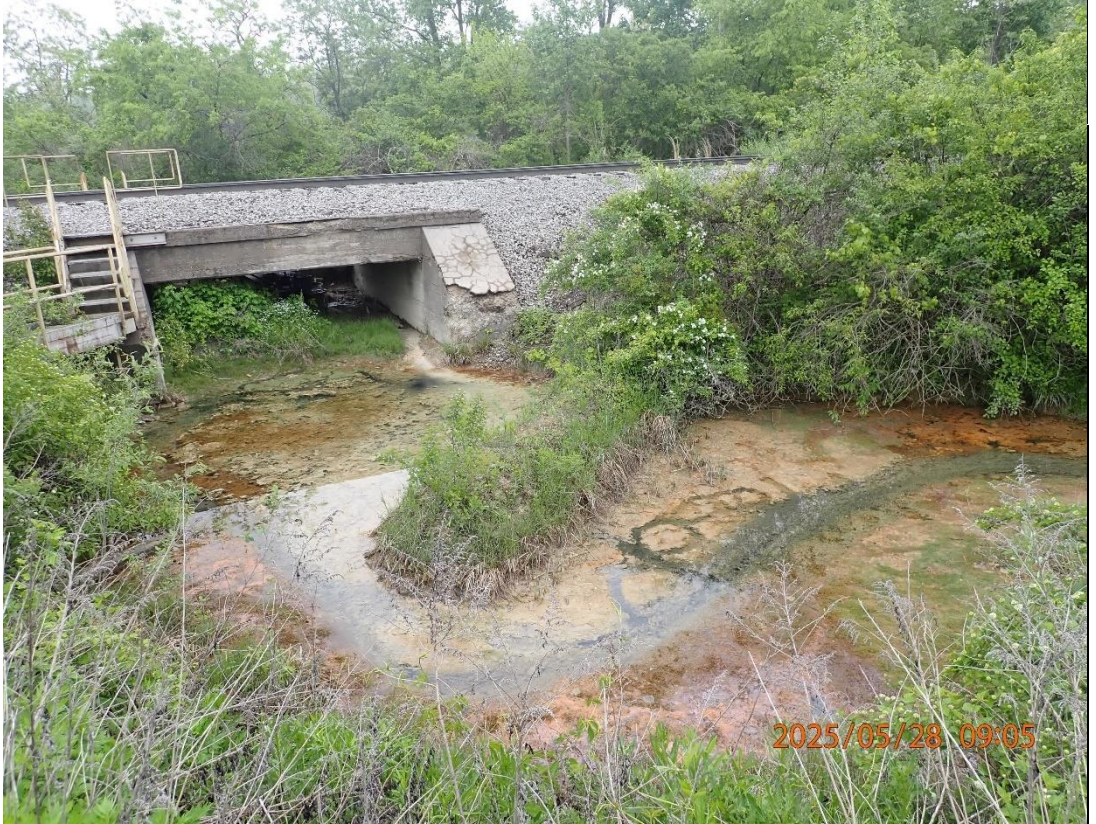
| <b>Photo Description:</b><br>Outfall 006 influent. | | | |

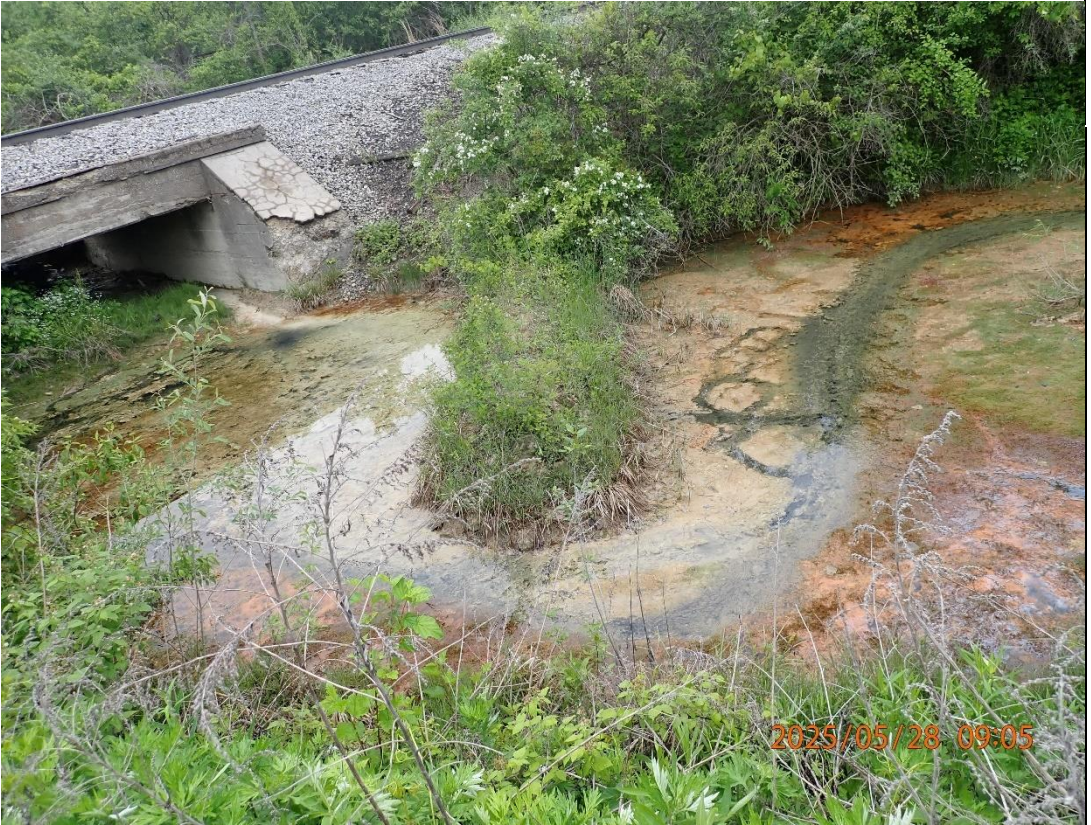
| <b>Photo Description:</b><br>Outfall 006 influent from Stein Slag Processing. Visible sheen from slag runoff. | | | |

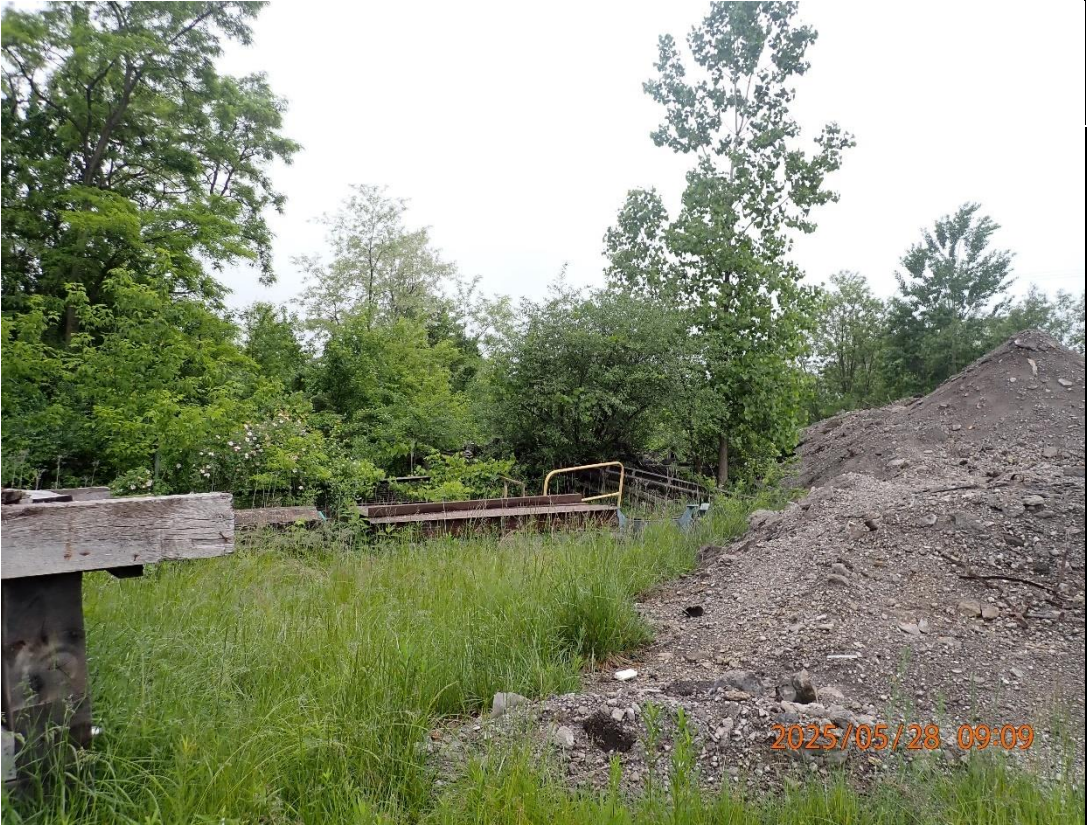
| <b>Unique Identifying No.</b> | <b>Observation</b> | <b>Area of Concern?</b> |
|---|---|---|
| <b>MS5-OB-002</b> | During the site tour, inspectors observed a pile of scrap metal and debris near Outfall 006. (Photo 7) | Yes |

| No. | |
|---|---|
| <b>MS-OB-002</b> | <p>During the site tour, inspectors observed a pile of scrap metal and debris near Outfall 006. (Photo 7)</p> <p>NPDES Permit Part IV. Stormwater Control Measures and Pollution Prevention Programs. Part C – <u>Minimize Exposure</u> - You shall minimize the exposure of manufacturing, processing, and material storage areas (including loading and unloading, storage, disposal, cleaning, maintenance, and fueling operations) to rain, snow, snowmelt, and runoff by either locating these industrial materials and activities inside or protecting them with storm resistant coverings.</p> |

| <b>Photo Description:</b><br>Rocky pile and metal scrap bordering river near Outfall 006. | | | |

| No. | |
|---|---|
| | On July 16, 2025, the Facility provided USEPA with documentation of clean-up activities of scrap metal debris around the "Clean Fill Area" near Outfall 006. |

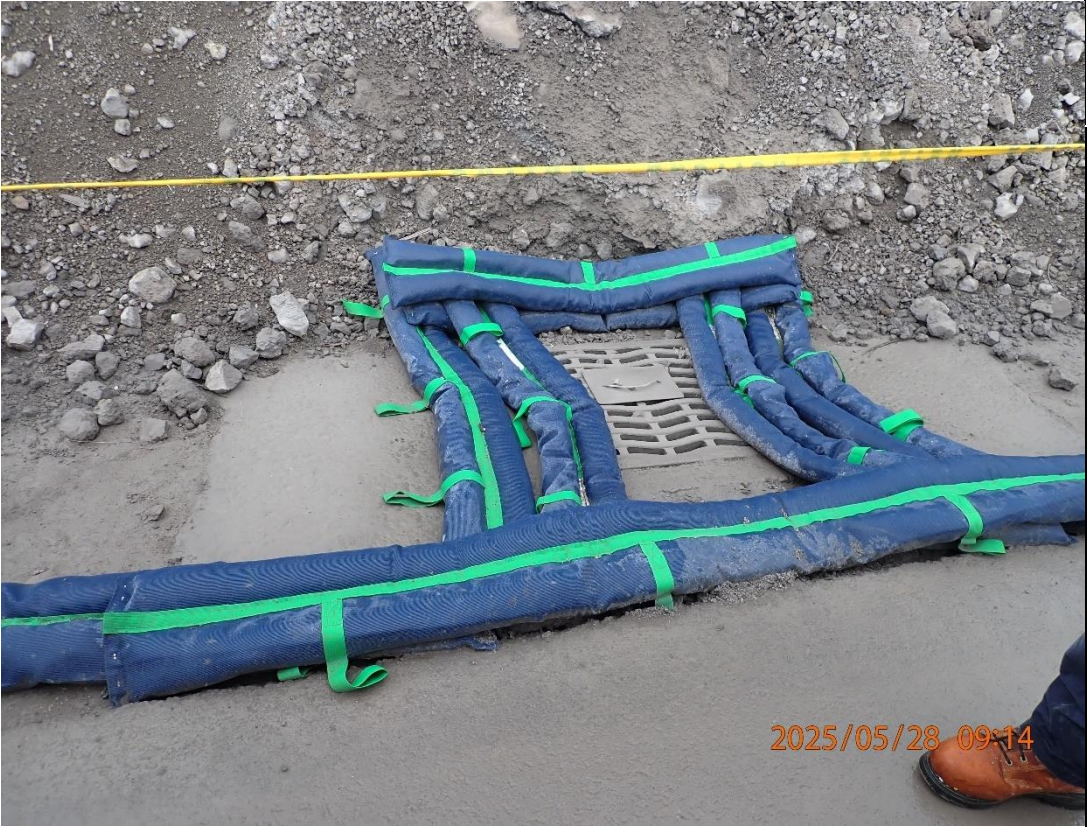
| Unique Identifying No. | Observation | Area of Concern? |
|---|---|---|
| <b>MS5-OB-003</b> | During the site tour, inspectors observed new stormwater barriers and filters surrounding storm water drains around the Facility. (Photo 8) | No |

| <b>Photo Description:</b><br>Outfall 011 storm drain inlet.<br>Surrounded by new filters. | | | |

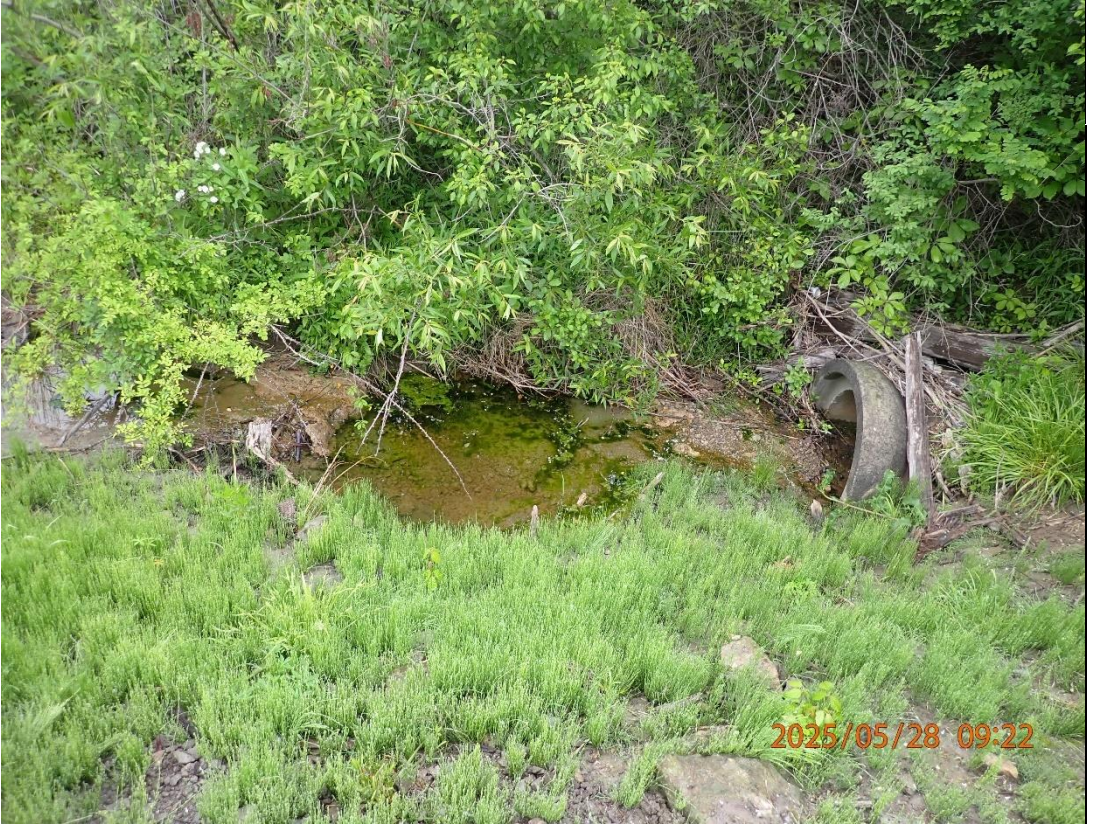
| <b>Photo Description:</b><br>Outfall 007. | | | |

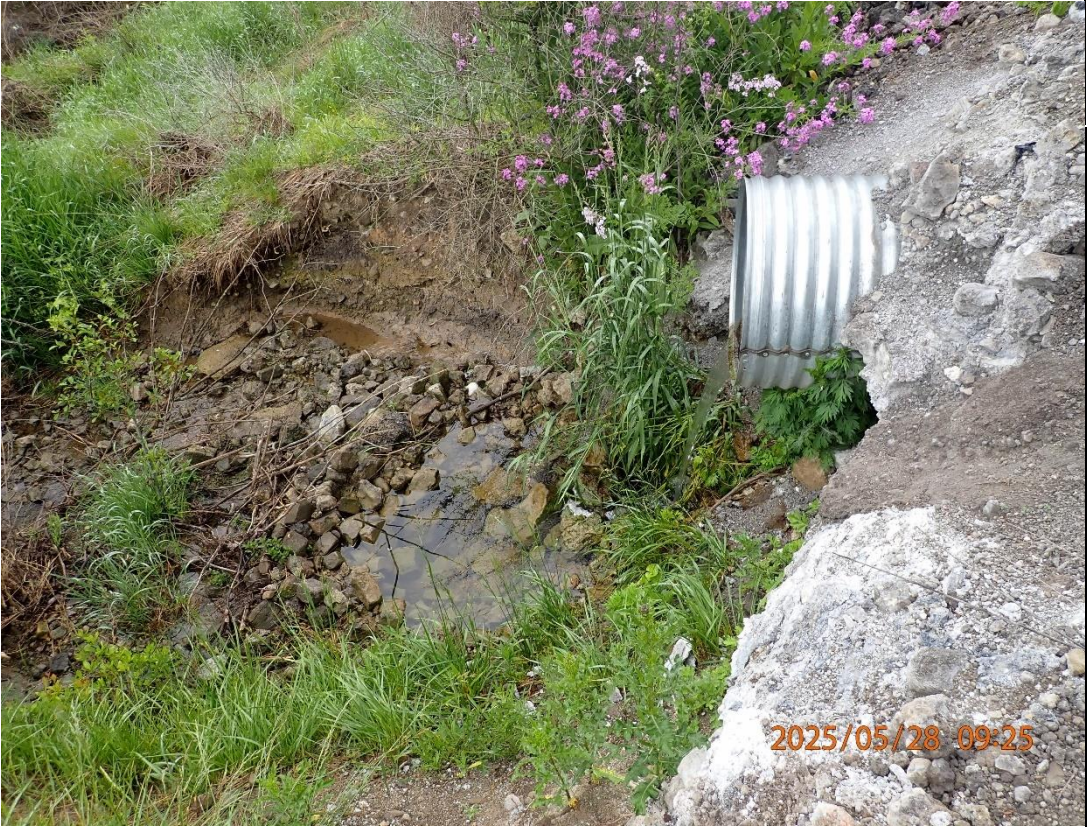
| <b>Photo Description:</b><br>Outfall 009 Stein runoff backend. | | | |

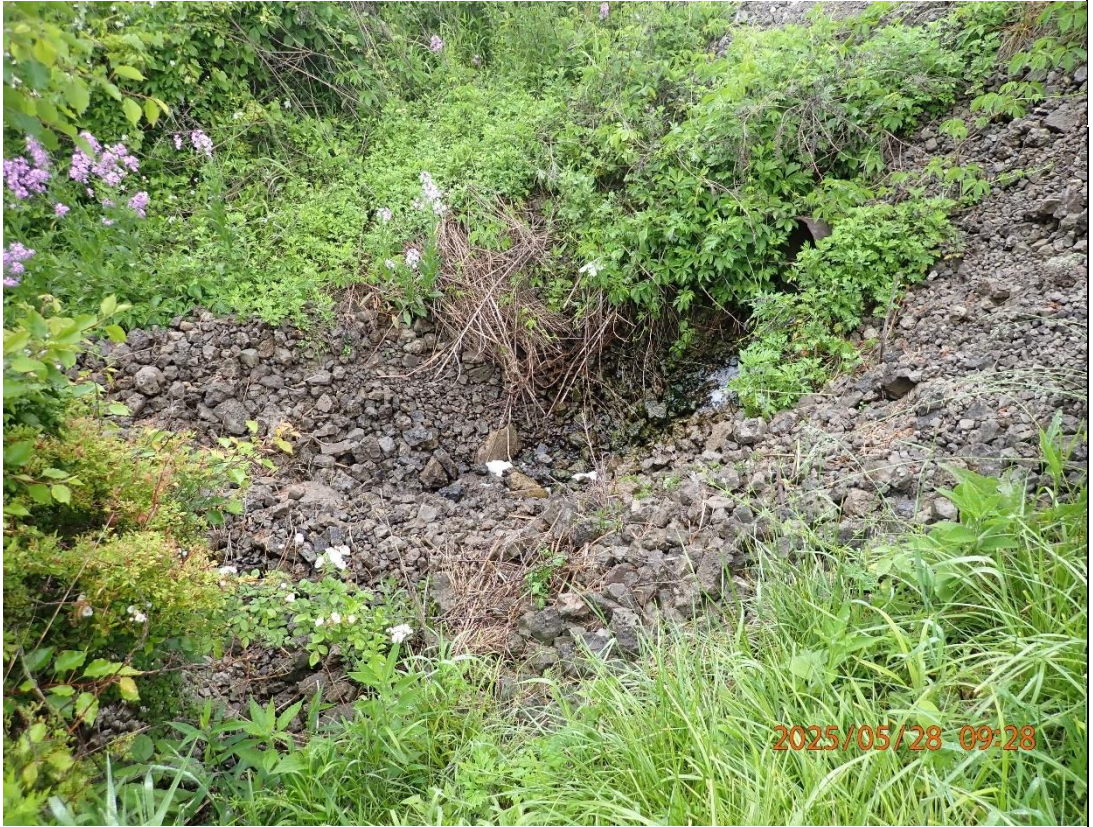
| <b>Photo Description:</b><br>Runoff from natural holding pond. | | | |

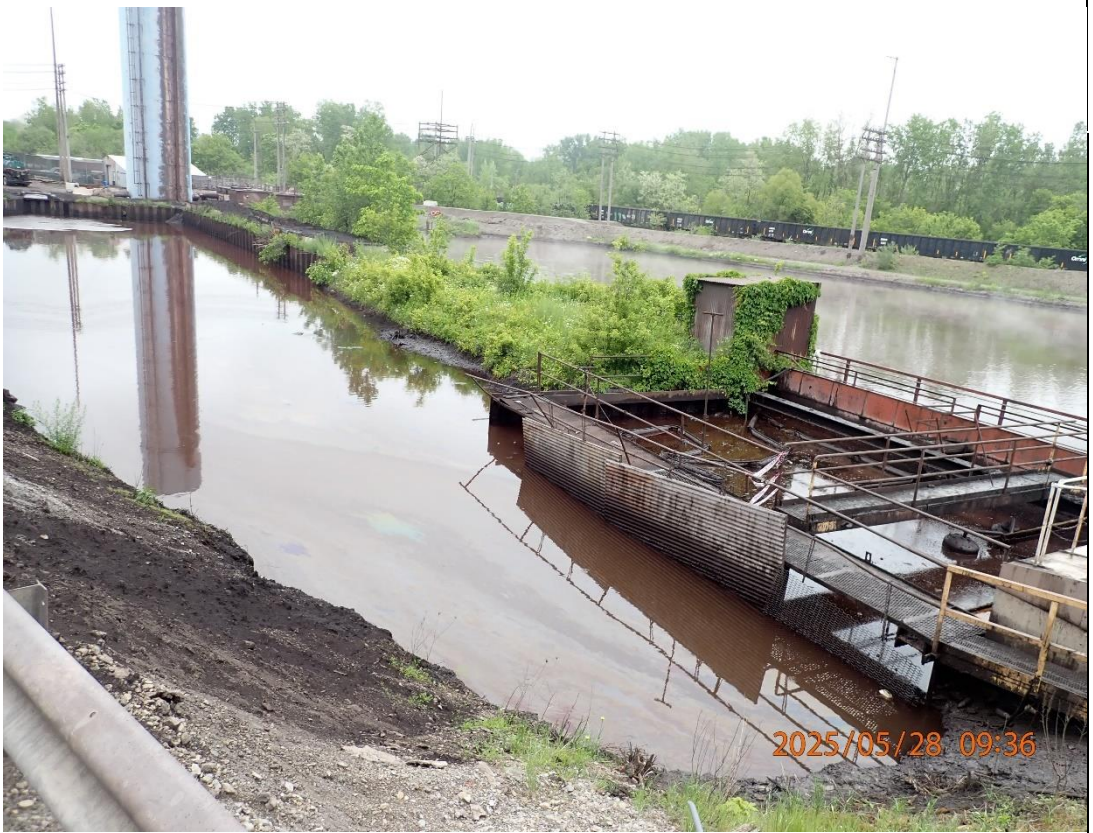
| <b>Photo Description:</b><br>Smaller hot mill pond with oil skimmer. | | | |

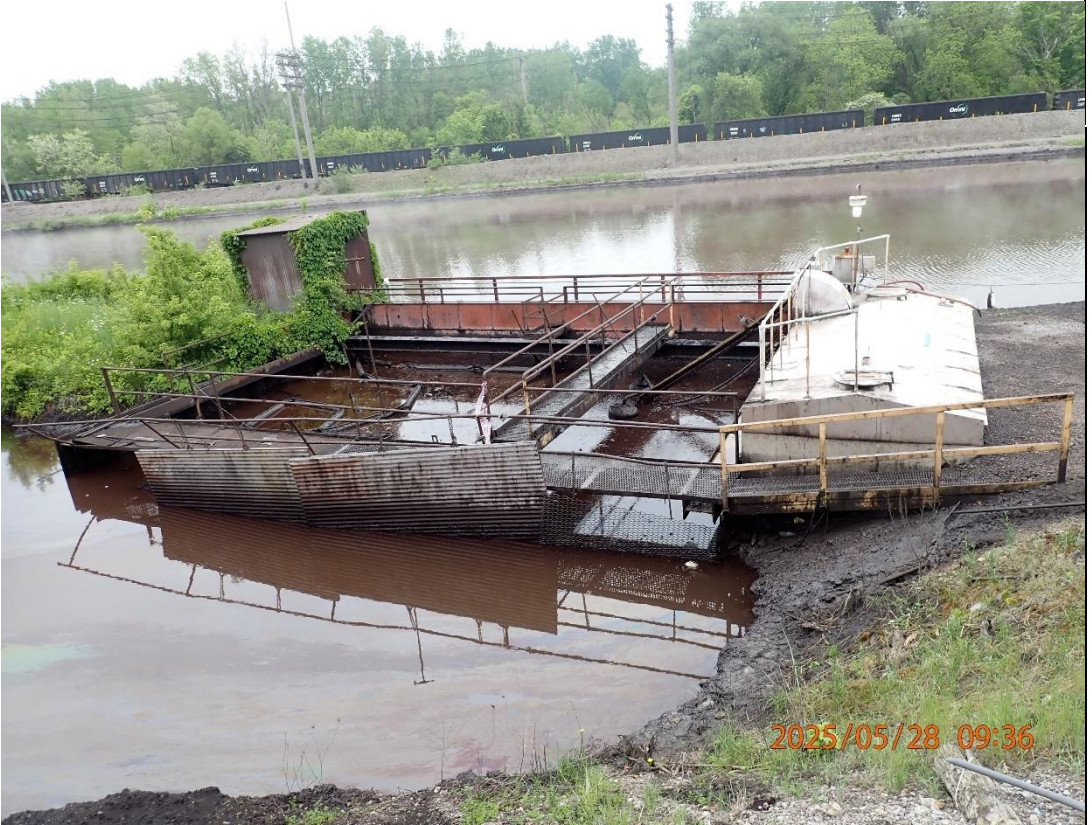
| <b>Photo Description:</b><br>Oil skimmer in hot mill pond. | | | |

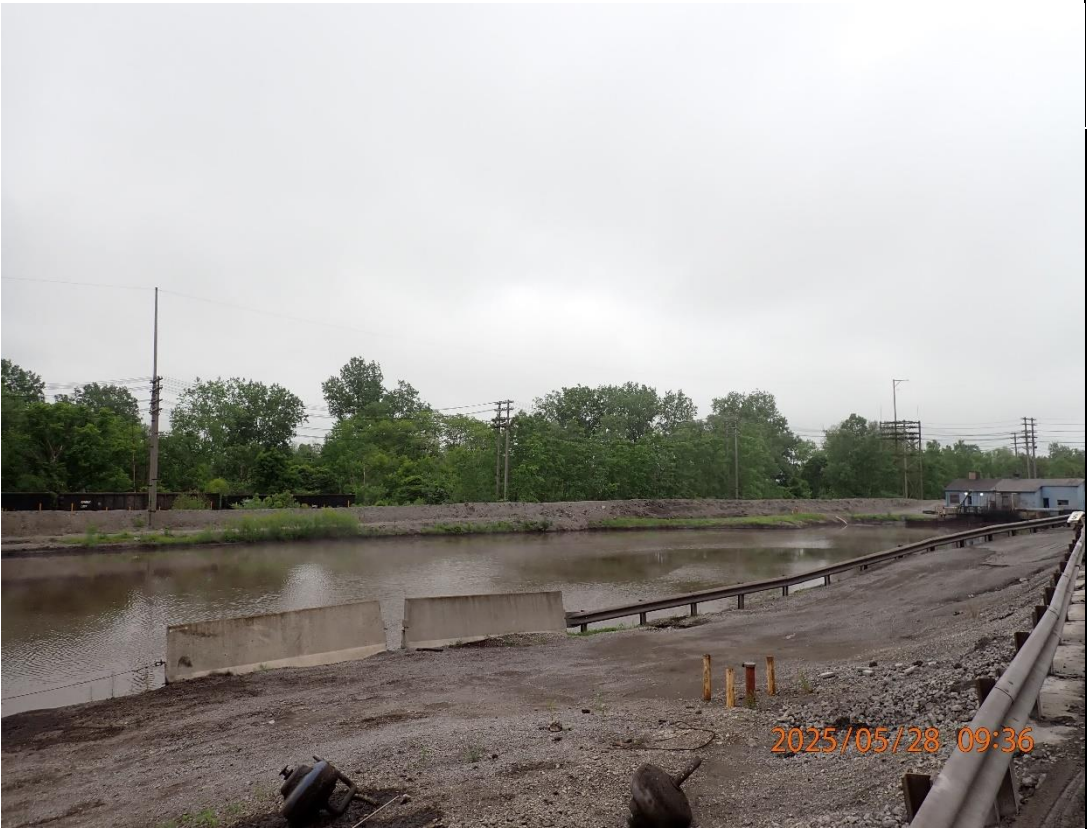
| <b>Photo Description:</b><br>Hot mill pond south polyfloc pump. | | | |

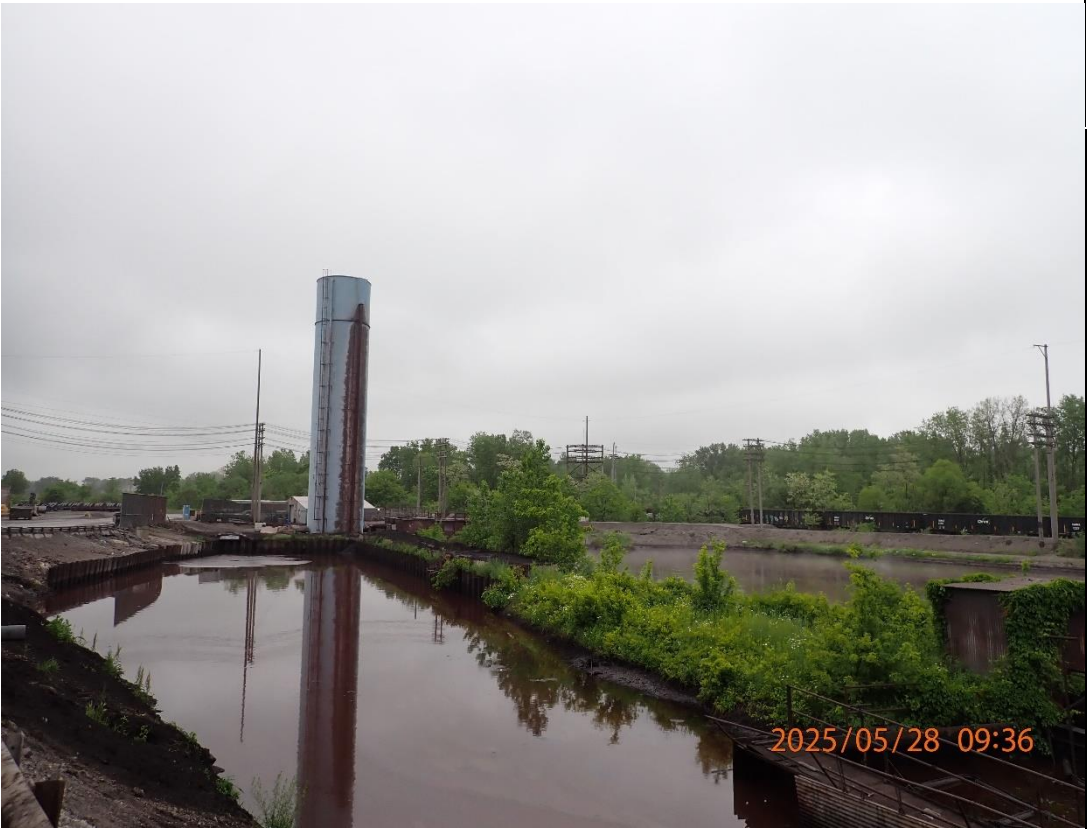
| <b>Photo Description:</b><br>Large hotmill north polyfloc recycled water tower. | | | |

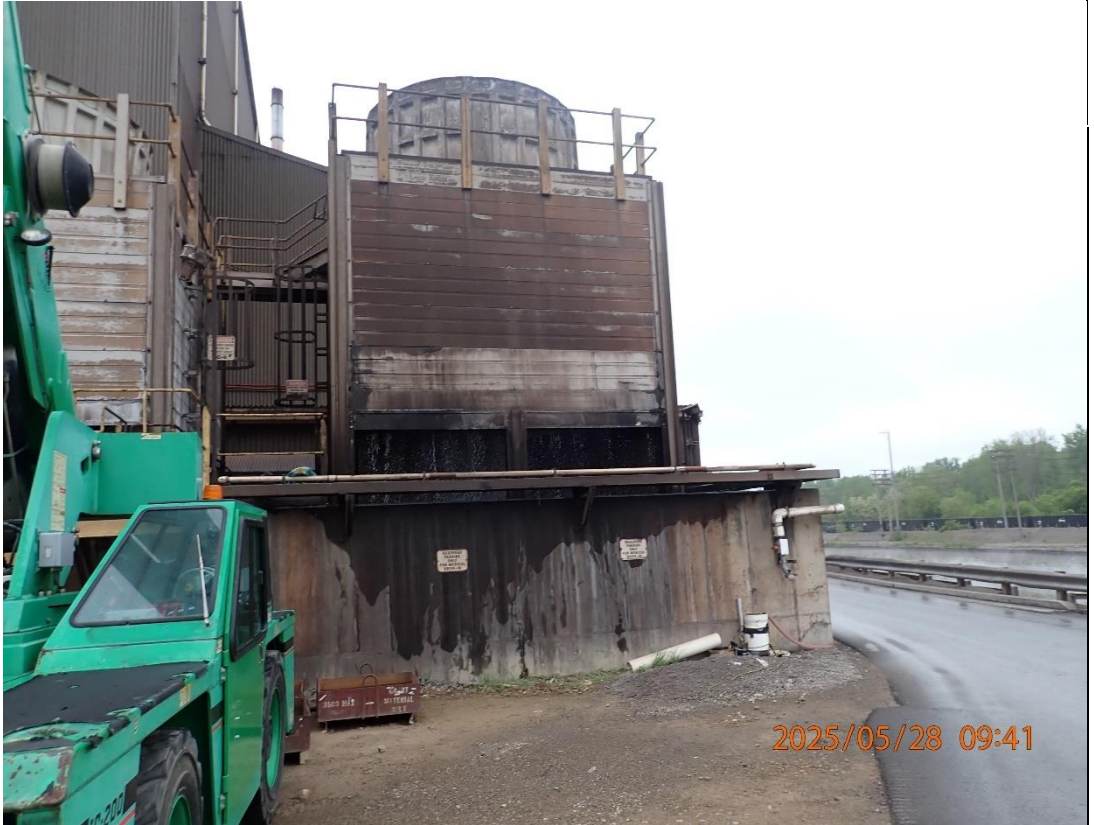
| <b>Photo Description:</b><br>Caster cooling towers. | | | |

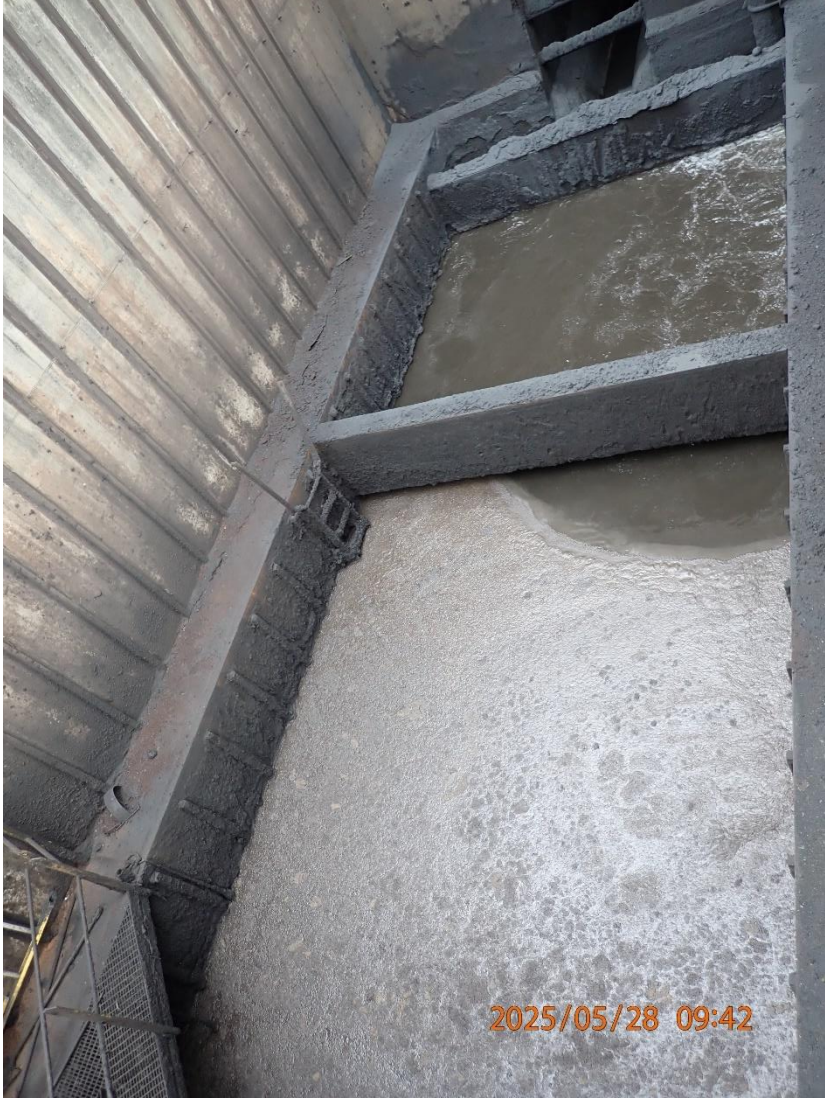
| <b>Photo Description:</b><br>Scale pit. | | | |

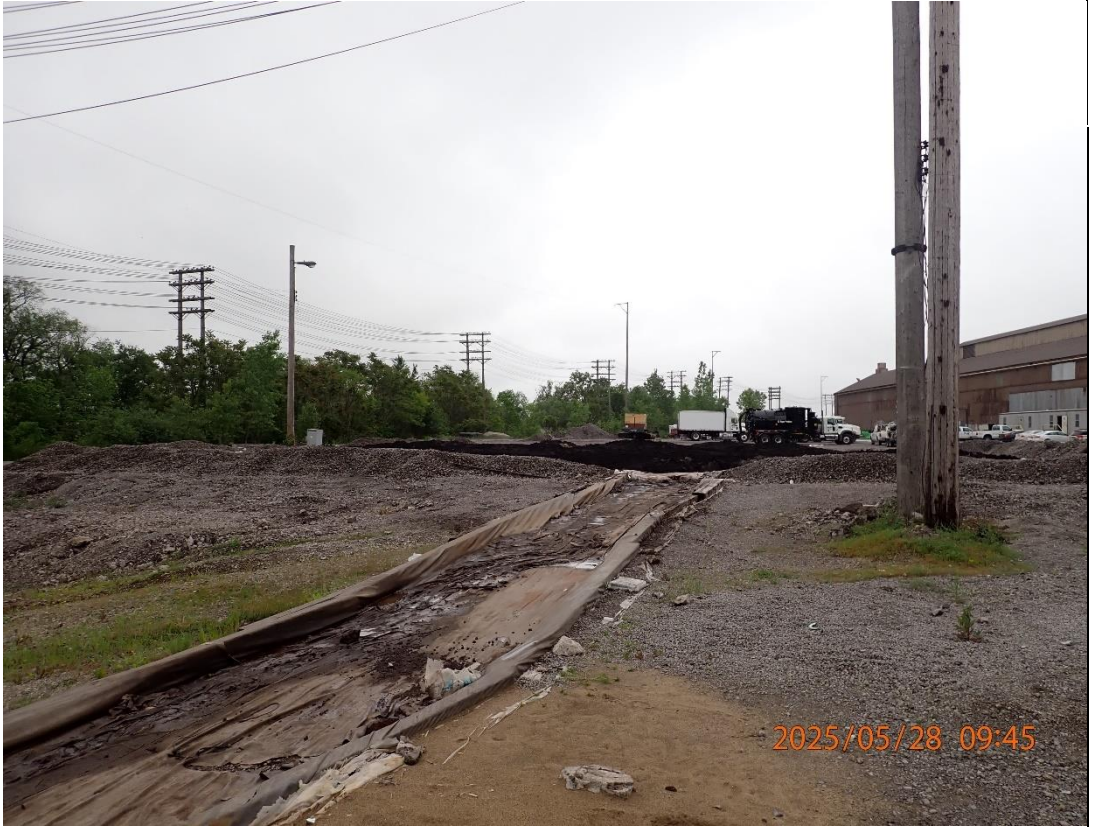
| <b>Photo Description:</b><br>Drying sludge with runoff channel to hot mill pond. | | | |

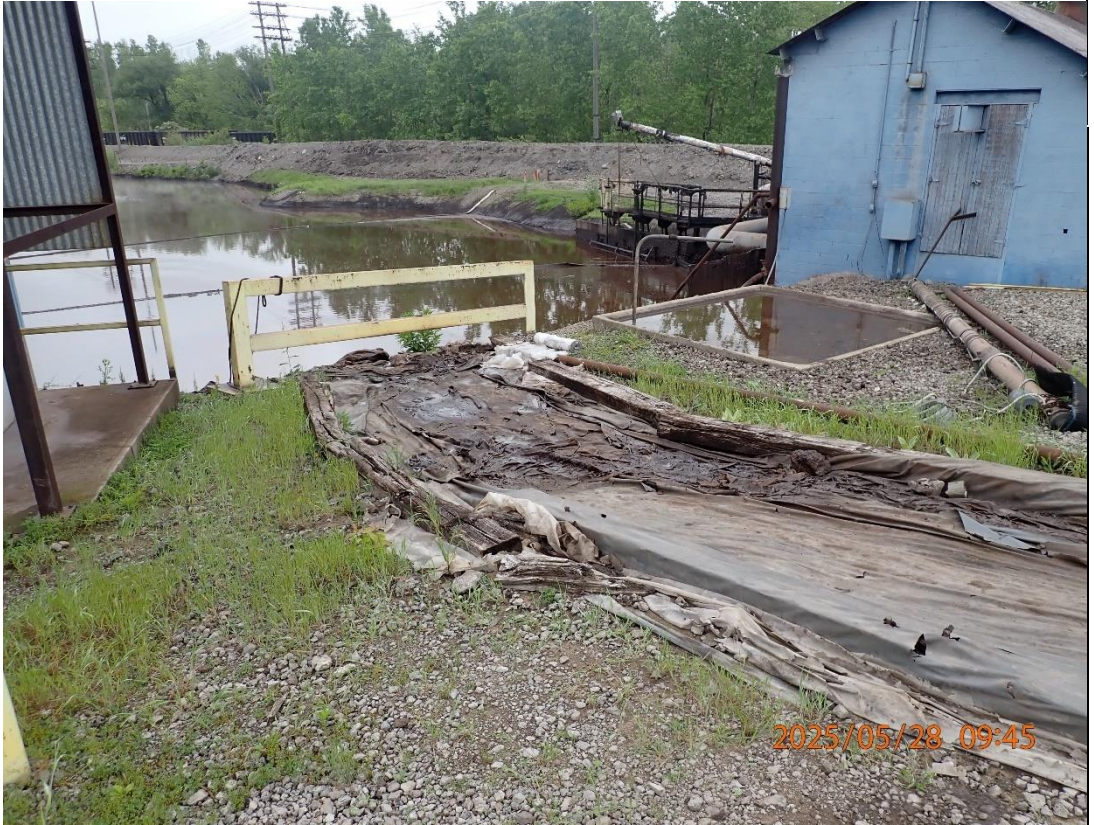
| <b>Photo Description:</b><br>Drying channel from sludge to hot mill pond. | | | |

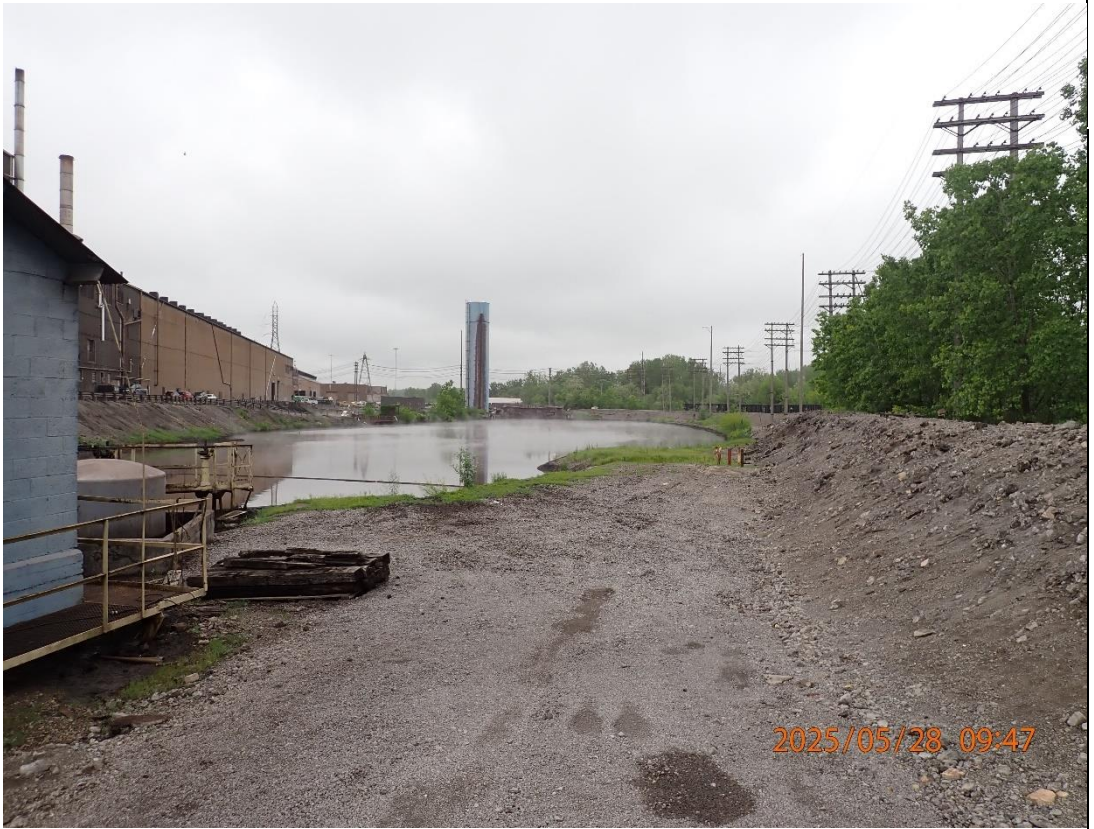
| <b>Photo Description:</b><br>Large hot mill pond. | | | |

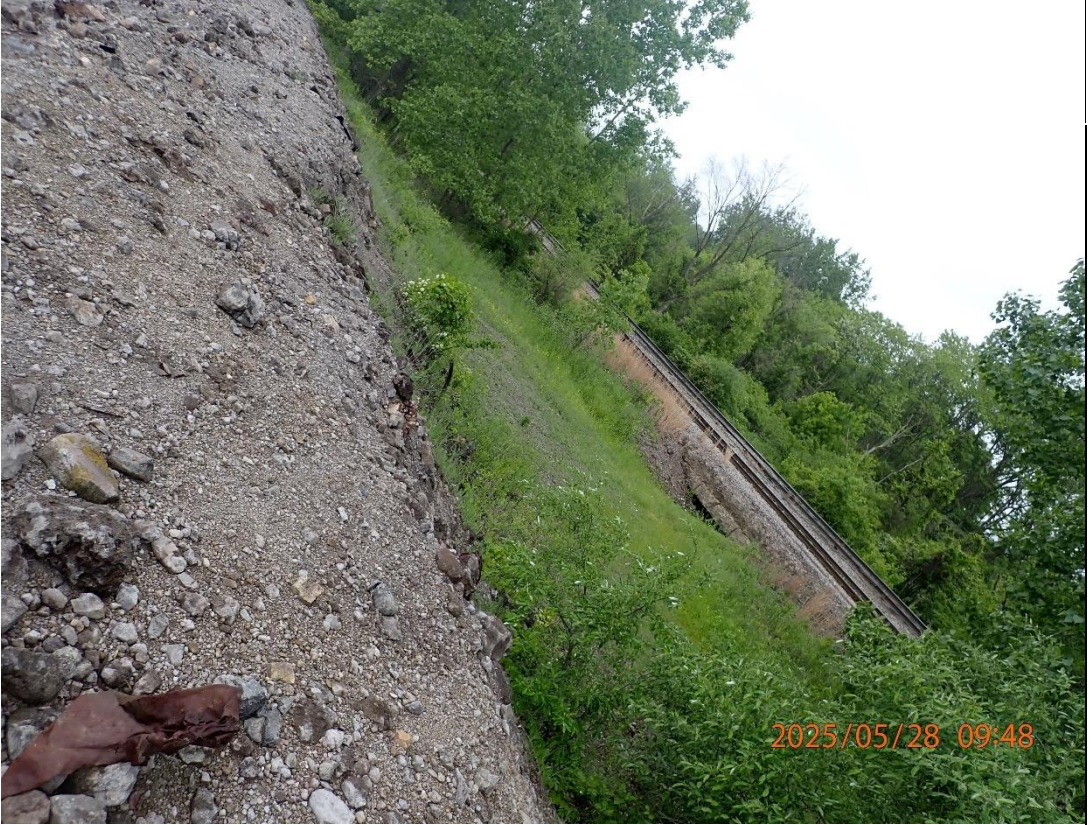
| <b>Photo Description:</b><br>Outfall 012. | | | |

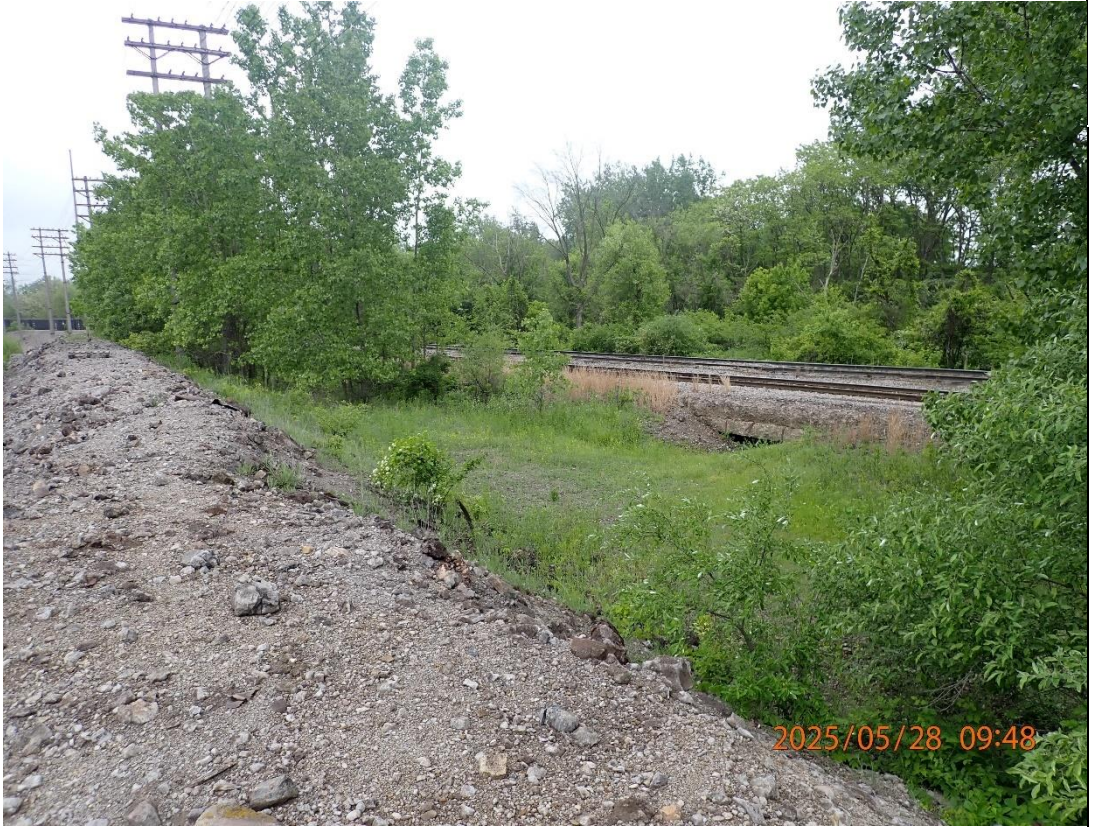
| <b>Photo Description:</b><br>Outfall 012. | | | |

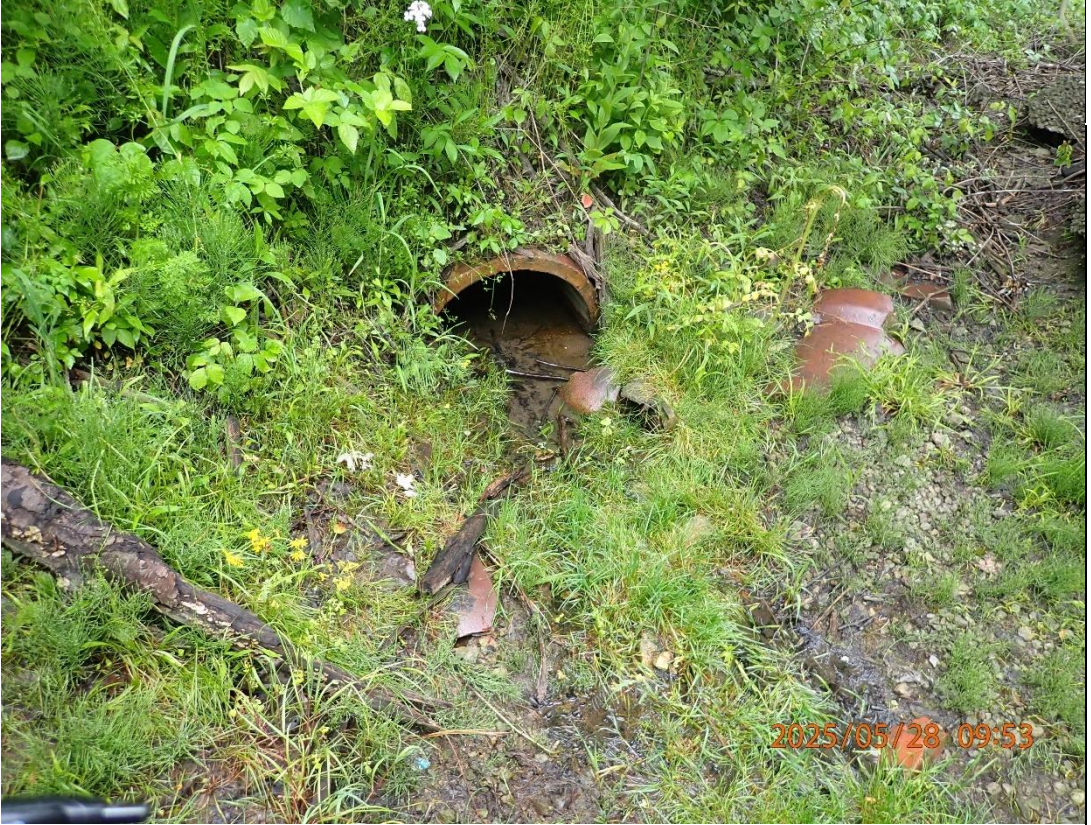
| <b>Photo Description:</b><br>Outfall 008. Only gets flow during heavy rain events. | | | |

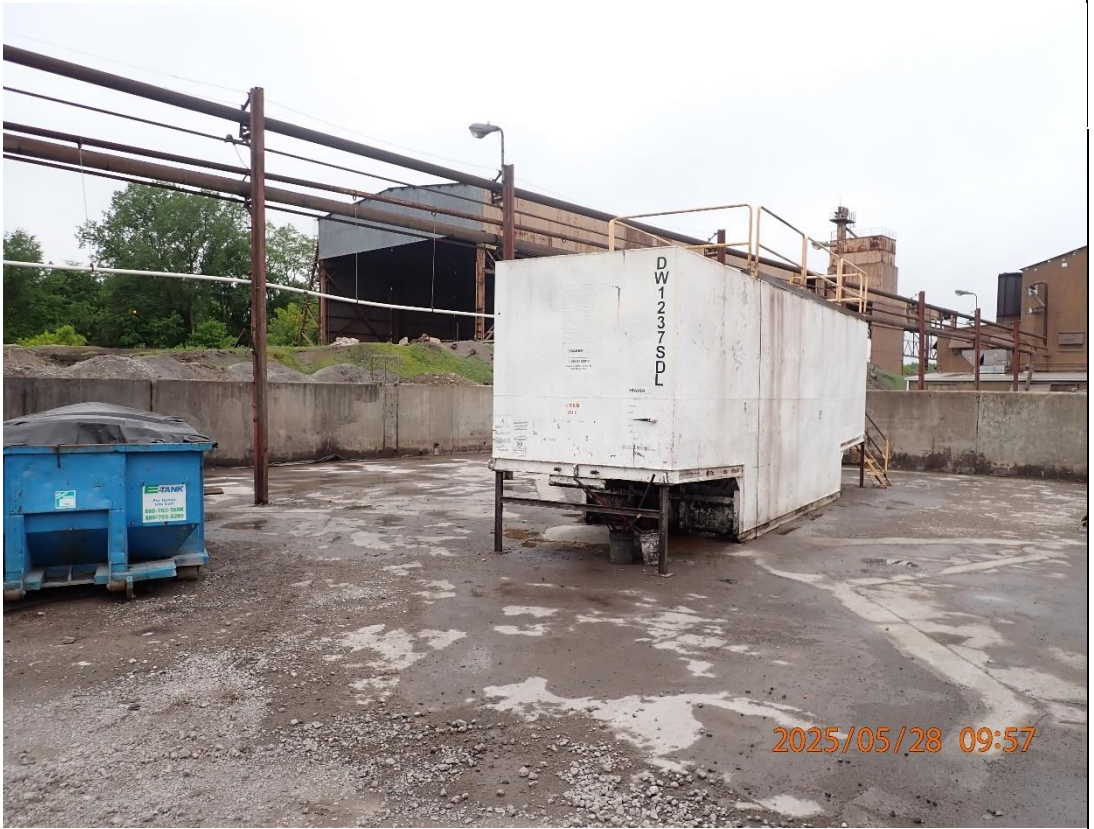
| <b>Photo Description:</b><br>Used oil storage area. | | | |
