**INSPECTION REPORT**

| <b>Type of inspection:</b> | CEI - Compliance Evaluation Inspection | |
| <b>Permittee Name:</b> | Cleveland-Cliffs Steel Corp. – Mansfield Works | |
| <b>Permit Number:</b> | OH0006840 | |

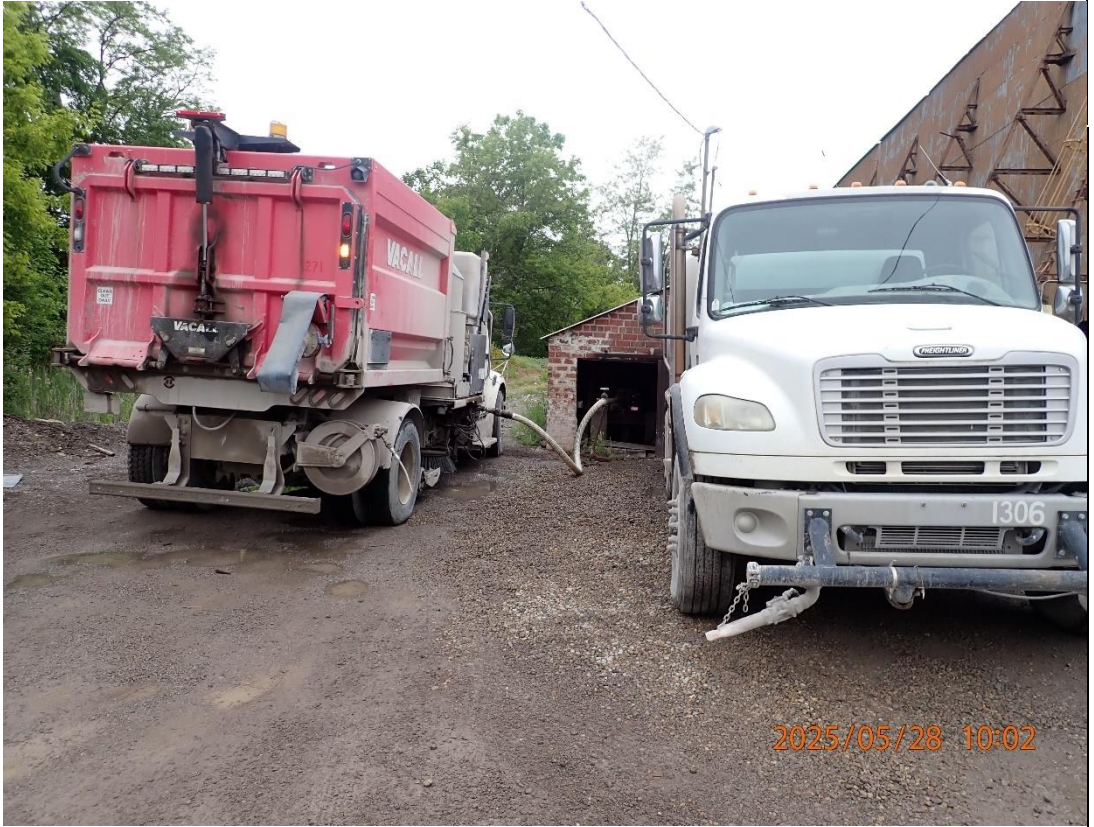
| <b>Photo Description:</b><br>Pump hose from well. Water used for dust control. | | | |

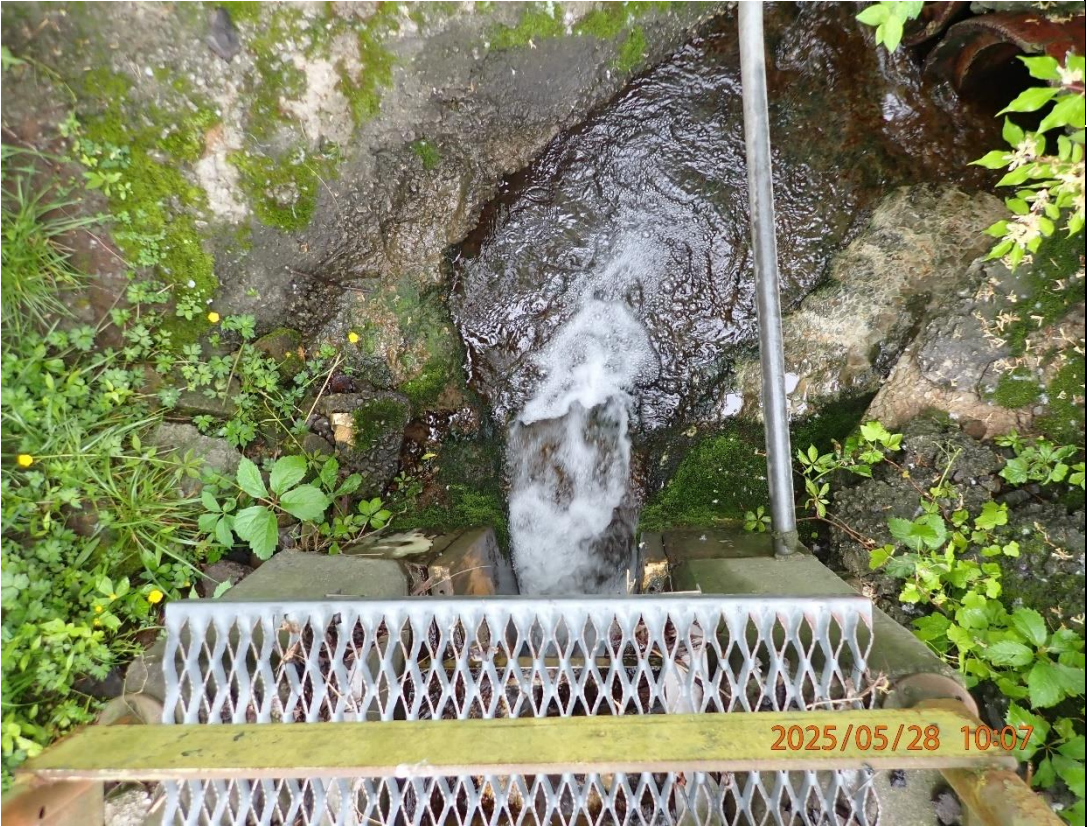
| <b>Photo Description:</b><br>Outfall 003 | | | |

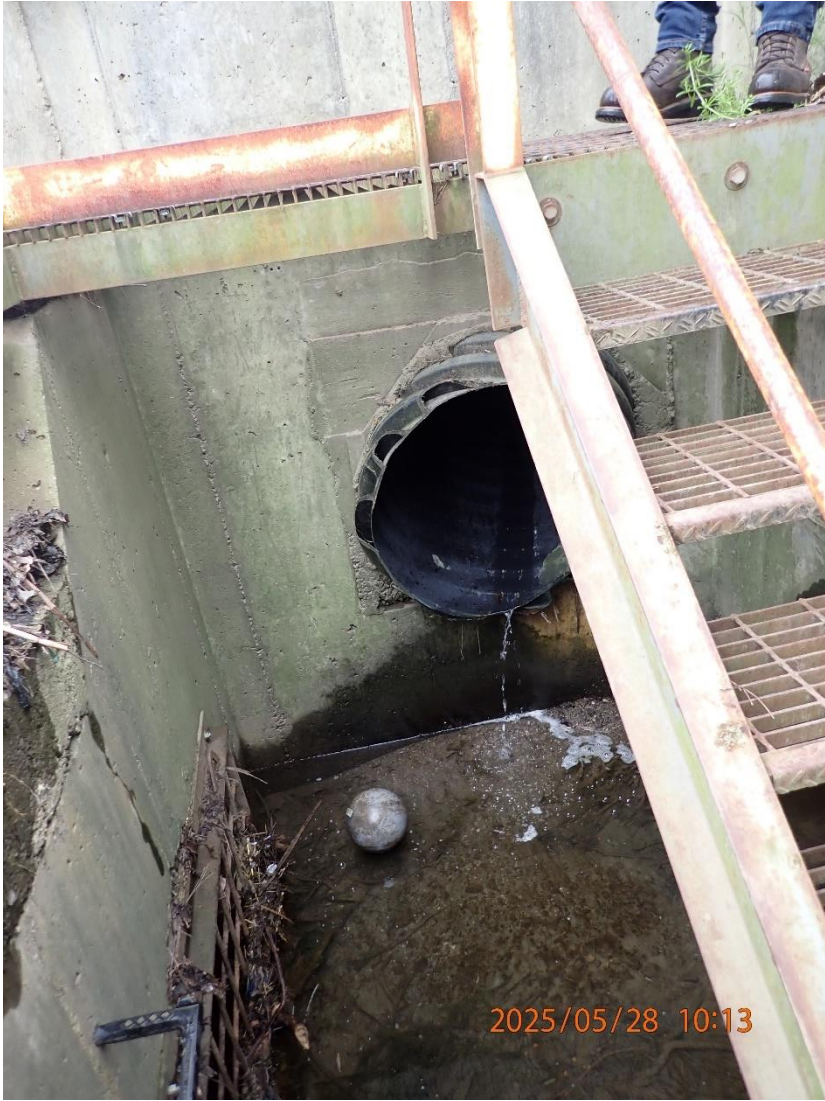
| <b>Photo Description:</b><br>Outfall 003 influent from offsite. | | | |
