## REGION 10 Enforcement Division

### INSPECTION REPORT

| <b>Facility or Site Name:</b> | Schlumberger Technology Corporation East Facility | | | |

Type of inspection: CEI - Compliance Evaluation Inspection

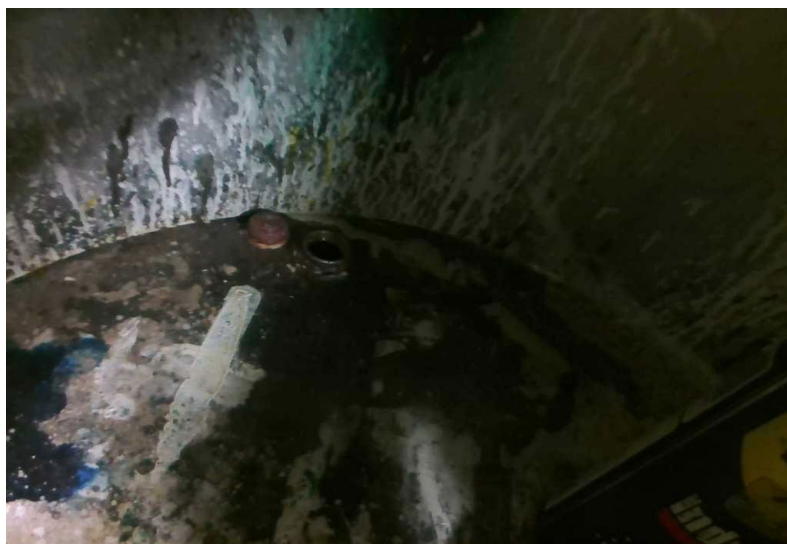
| IMG-202206091129552955984934.jpg |

| At the time of the inspection, I saw a 55-gallon container, marked with the word “BAD”, that was approximately 1/3 full of an unknown liquid. Brian Goza, Bulk Plant, jostled the container and said it was about a third full. Neither Mr. Giza nor Mr. Muir knew what the container held. | |

| unknown liquid. Neither Mr. Giza nor SM knew what the container held. | 262.11 | |

| View of 55-gallon container, seen here marked with the word "BAD," that was approximately 1/3 full of an unknown liquid. |

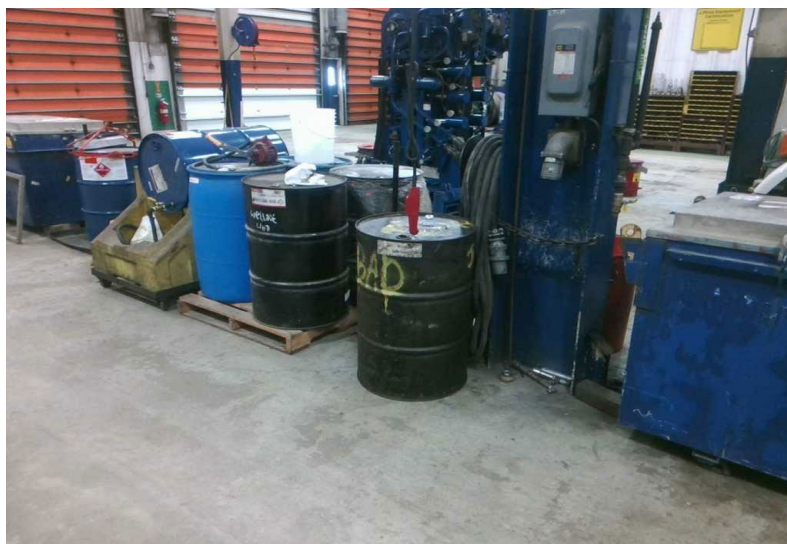
| IMG-20220609113003303954204.jpg |

| Another view of 55-gallon container, seen here marked with the word "BAD," that was approximately 1/3 full of an unknown liquid. |

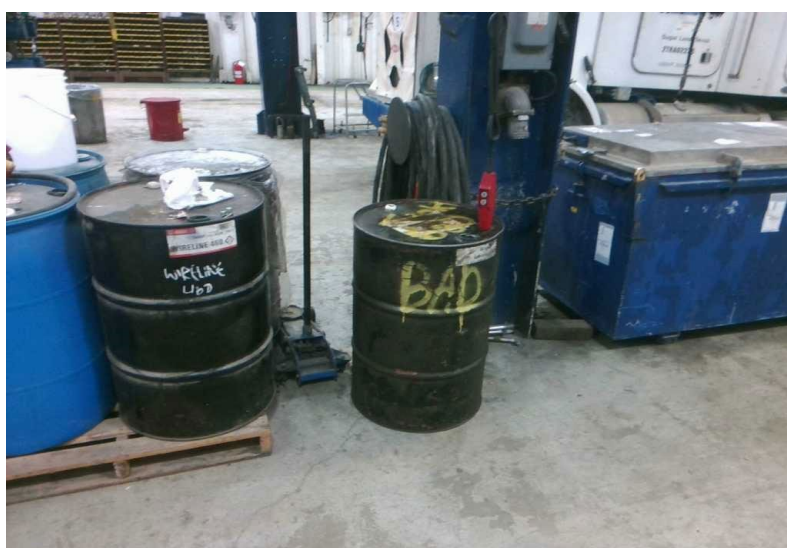
Close-up view of 55-gallon container, seen here marked with the word "BAD," that was approximately 1/3 full of an unknown liquid.

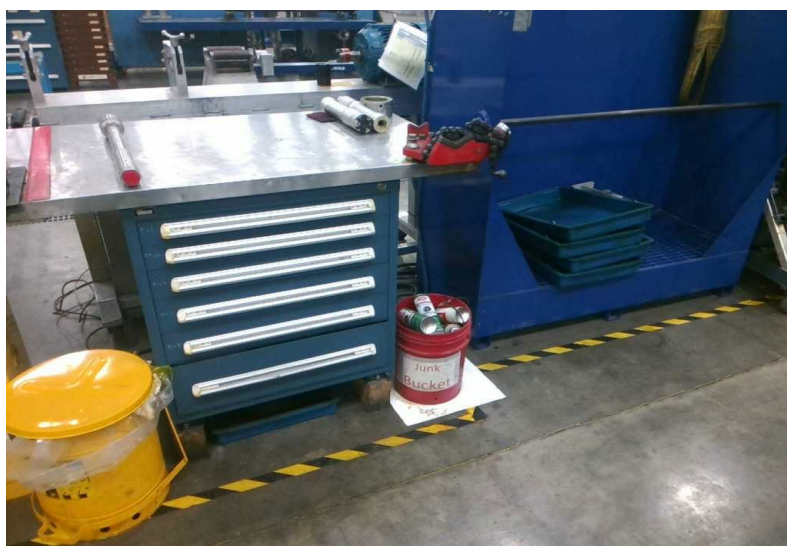
IMG-20220609110948948900639.jpg

Another view of 5-gallon bucket that held six punctured aerosol cans.

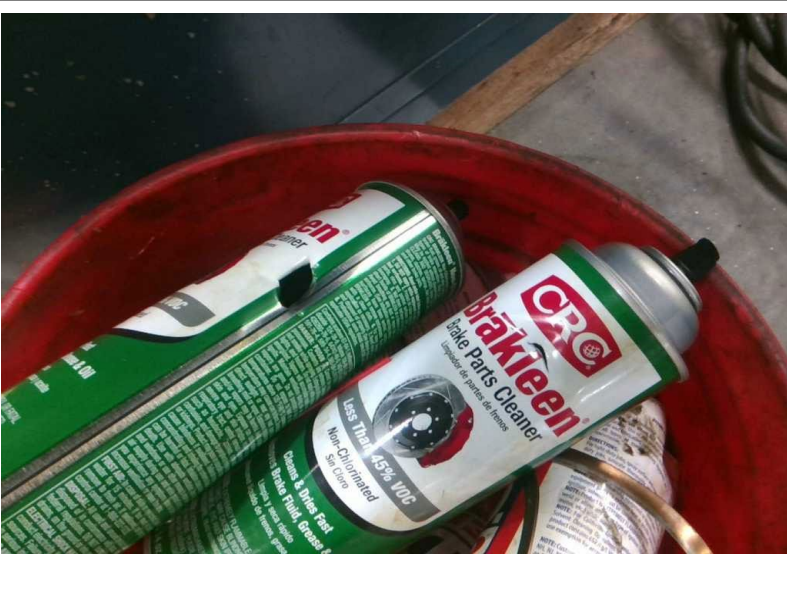
| <p>[Title]</p> <p>IMG-202206091109569561050568.jpg</p> <p>06/09/2022 11:09 AM (AKT)</p> <p>Jon Jones</p> <p>Drilling and Measurement (D&amp;M) shop/Tool Rebuild shop</p> <p>No CBI</p> <p>No PII</p> <p>Close-up view of the punctured aerosol cans, showing the large puncture holes.</p> | |

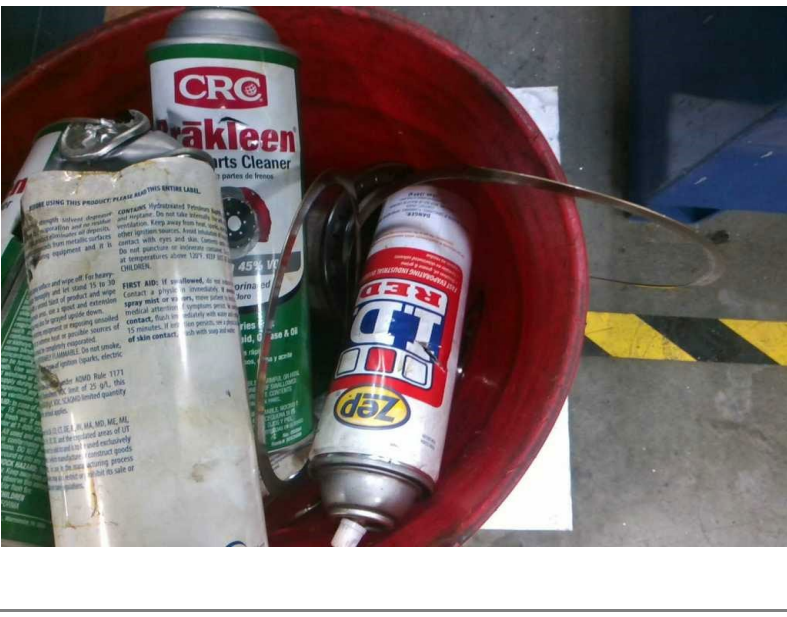
| <p>[Title]</p> <p>IMG-202206091110231023978954.jpg</p> <p>06/09/2022 11:10 AM (AKT)</p> <p>Jon Jones</p> <p>Drilling and Measurement (D&amp;M) shop/Tool Rebuild shop</p> <p>No CBI</p> <p>No PII</p> <p>Another close-up view of the punctured aerosol cans, showing the large puncture holes.</p> | |

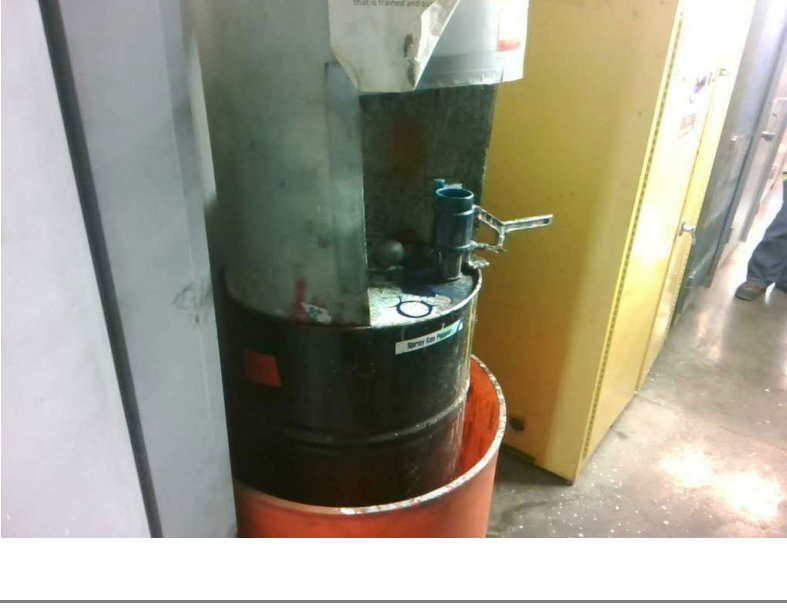
At the time of the inspection, I saw a 55-gallon container with attached aerosol can popper that was not closed, labeled with the words "Hazardous Waste," or marked with a hazard indicator.

| <p>[Title]</p> <p>IMG-202206091035383538661751.jpg</p> <p>06/09/2022 10:35 AM (AKT)</p> <p>Jon Jones</p> <p>Drilling and Measurement (D&amp;M) shop/Utility Room</p> <p>No CBI</p> <p>No PII</p> <p>View of 55-gallon container with attached can popper that is open.</p> | |

At the end of the inspection, it was determined that the facility was a Very Small Quantity Generator (VSQG) and the labeling and marking requirements for the containers of hazardous waste were not applicable. The facility provided documentation, following the inspection that the container had now been closed, labeled with the words "Hazardous Waste," and marked with a hazard indicator.

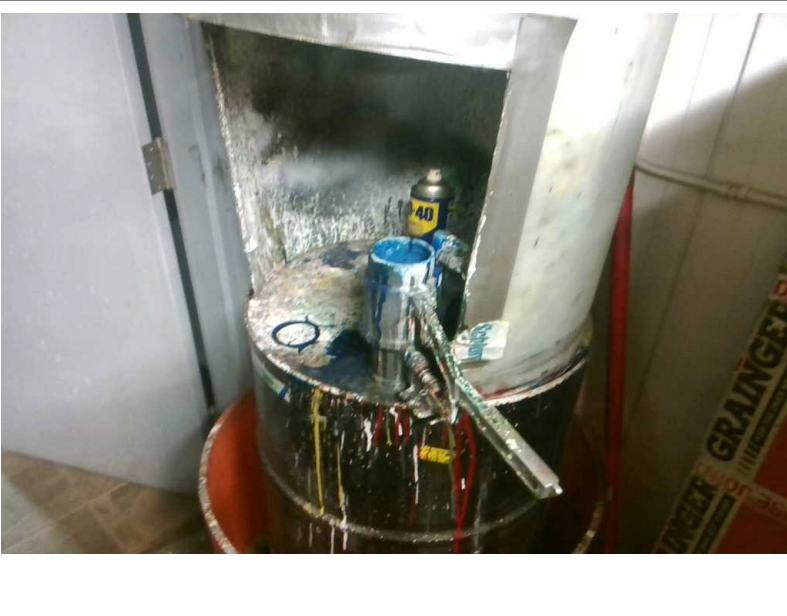
| <p>[Title]</p> <p>IMG-202206091035573557743270.jpg</p> <p>06/09/2022 10:35 AM (AKT)</p> <p>Jon Jones</p> <p>Drilling and Measurement (D&amp;M) shop/Utility Room</p> <p>No CBI</p> <p>No PII</p> <p>Another view of 55-gallon container with attached can popper that is open.</p> | |

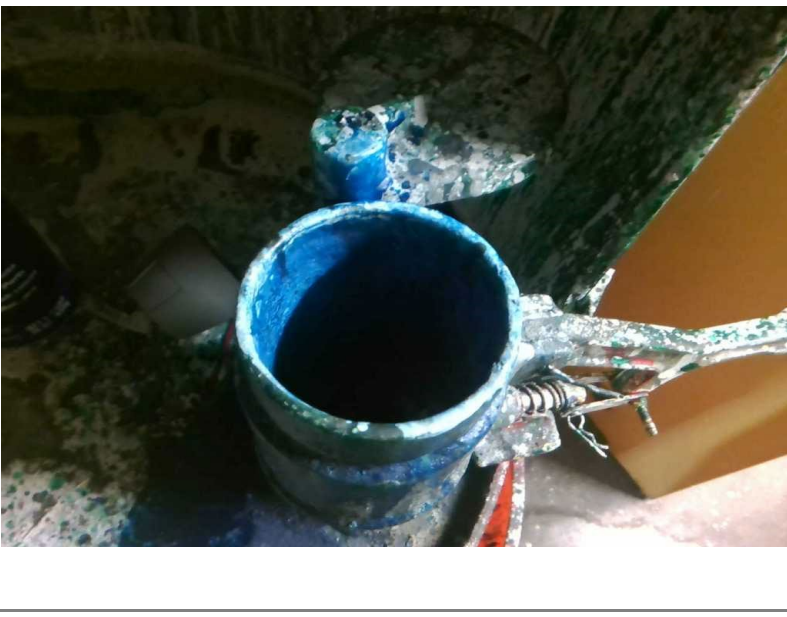
| <p>[Title]</p> <p>IMG-202206091036133613823957.jpg</p> <p>06/09/2022 10:36 AM (AKT)</p> <p>Jon Jones</p> <p>Drilling and Measurement (D&amp;M) shop/Utility Room</p> <p>No CBI</p> <p>No PII</p> <p>Close-up view of 55-gallon container with attached can popper that is open.</p> | |

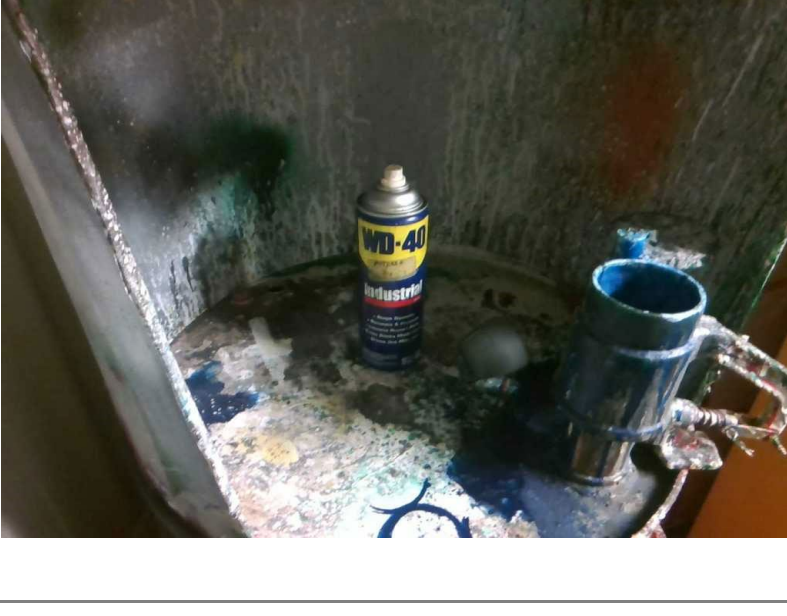
| <p>[Title]</p> <p>IMG-202206091037323732847446.jpg</p> <p>06/09/2022 10:37 AM (AKT)</p> <p>Jon Jones</p> <p>Drilling and Measurement (D&amp;M) shop/Utility Room</p> <p>No CBI</p> <p>No PII</p> <p>Another view of 55-gallon container with attached can popper that is open.</p> | |

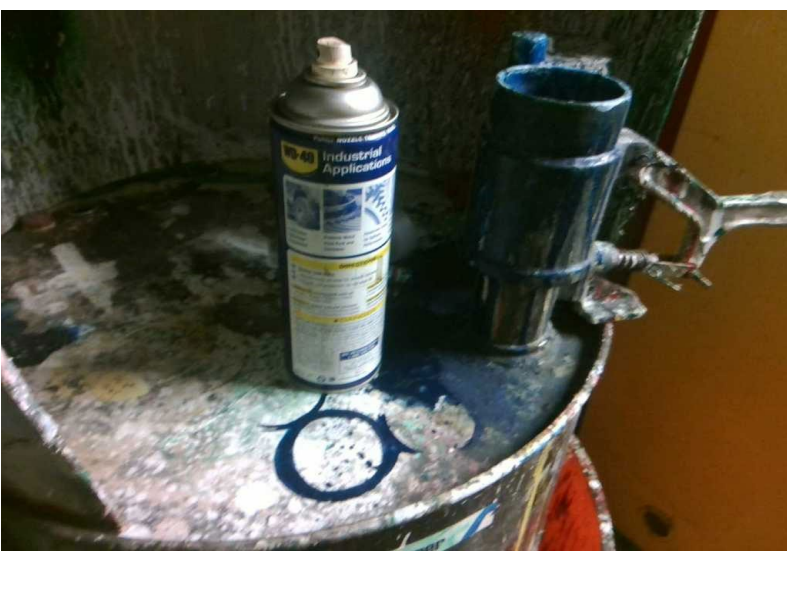
| <p>[Title]</p> <p>IMG-202206091037423742894576.jpg</p> <p>06/09/2022 10:37 AM (AKT)</p> <p>Jon Jones</p> <p>Drilling and Measurement (D&amp;M) shop/Utility Room</p> <p>No CBI</p> <p>No PII</p> <p>Another view of 55-gallon container with attached can popper that is open.</p> | |

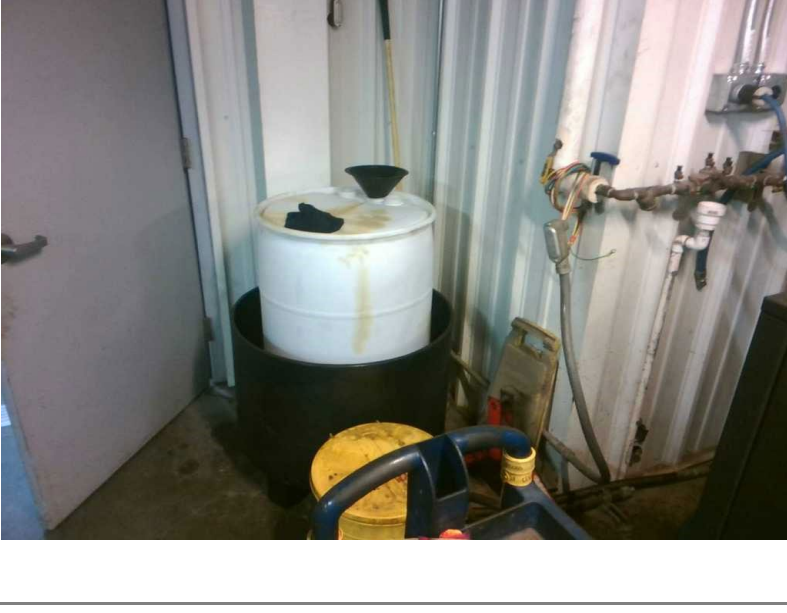
I also saw a 55-gallon poly container that was being used to accumulate used oil. At the time of the inspection, the container was not labeled with the words "Used Oil." The container held approximately 10-gallons of used oil, based on jostling the container.

| A 55-gallon poly container was being used to accumulate used oil. ATI, the container had approximately 10 gallons of used oil in it and was not labeled with the words "Used Oil." | <b>Citations:</b><br><br>279.22(c)(1) | <b>Sections:</b> |

| <p>[Title]</p> <p>IMG-202206091042454245733889.jpg</p> <p>06/09/2022 10:42 AM (AKT)</p> <p>Jon Jones</p> <p>Drilling and Measurement (D&amp;M) shop/Utility Room</p> <p>No CBI</p> <p>No PII</p> <p>View of 55-gallon poly container that was being used to accumulate used oil. The container is seen here not labeled with the words "Used Oil."</p> | |

The facility provided documentation (see Document Log) following the inspection that the container had been labeled with the words "Used Oil."

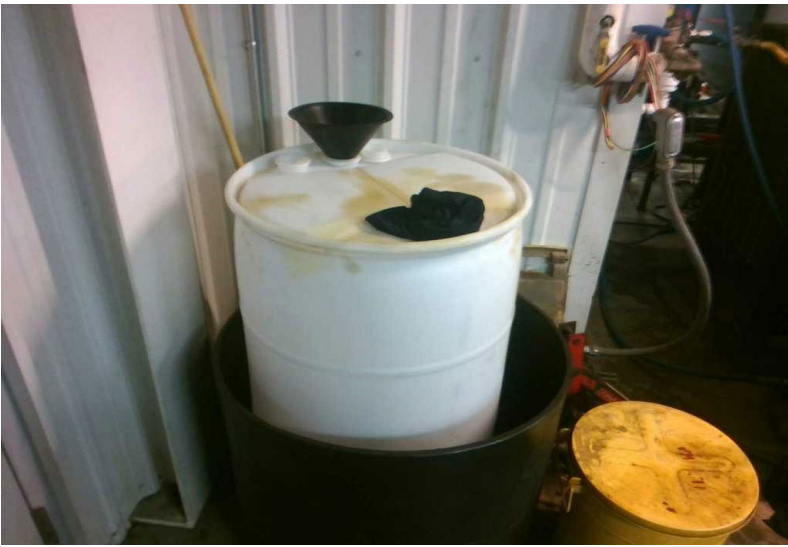
| <p>[Title]</p> <p>IMG-202206091042544254693513.jpg</p> <p>06/09/2022 10:42 AM (AKT)</p> <p>Jon Jones</p> <p>Drilling and Measurement (D&amp;M) shop/Utility Room</p> <p>No CBI</p> <p>No PII</p> <p>Another view of 55-gallon poly container that was being used to accumulate used oil. The container is seen here not labeled with the words "Used Oil."</p> | |

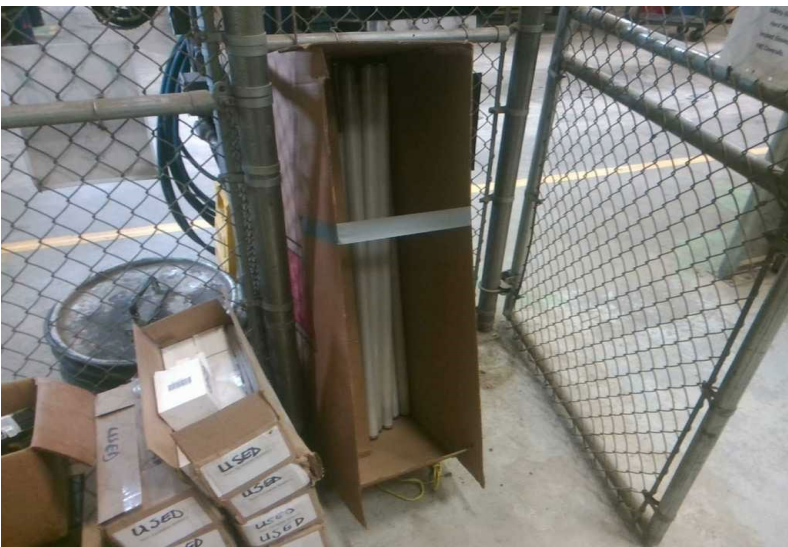
At the time of the inspection, I saw an open cardboard box that according to Mr. Muir, contained waste fluorescent lamps. The container held eight loose lamps and a box that contained additional lamps. The box held 22 lamps. The container was labeled with the words "Universal Waste -lamps", but it was not closed.

| <p>[Title]</p> <p>IMG-202206090933183318997117.jpg</p> <p>06/09/2022 09:33 AM (AKT)</p> <p>Jon Jones</p> <p>Front shop/Parts cage</p> <p>No CBI</p> <p>No PII</p> <p>View of cardboard box that contains waste fluorescent lamps and is not closed.</p> | |

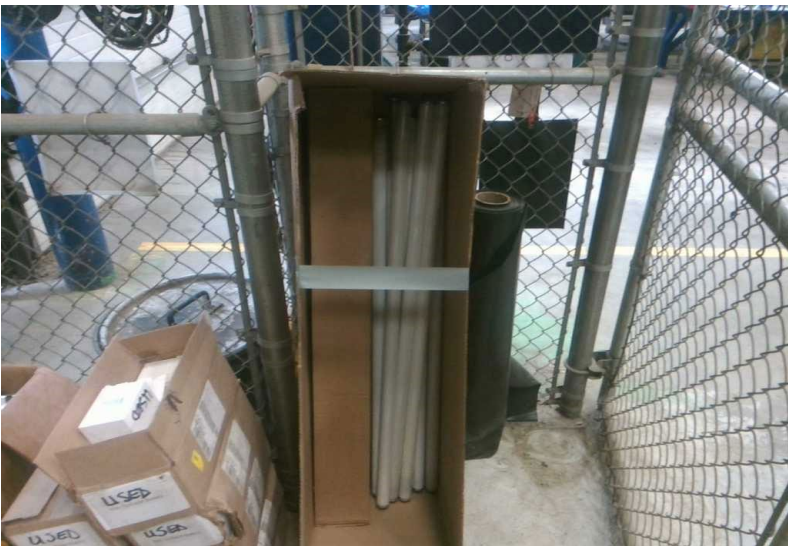
| <p>[Title]</p> <p>IMG-2022060909332733271058791.jpg</p> <p>06/09/2022 09:33 AM (AKT)</p> <p>Jon Jones</p> <p>Front shop/Parts cage</p> <p>No CBI</p> <p>No PII</p> <p>Another view of cardboard box that contains waste fluorescent lamps and is not closed.</p> | |

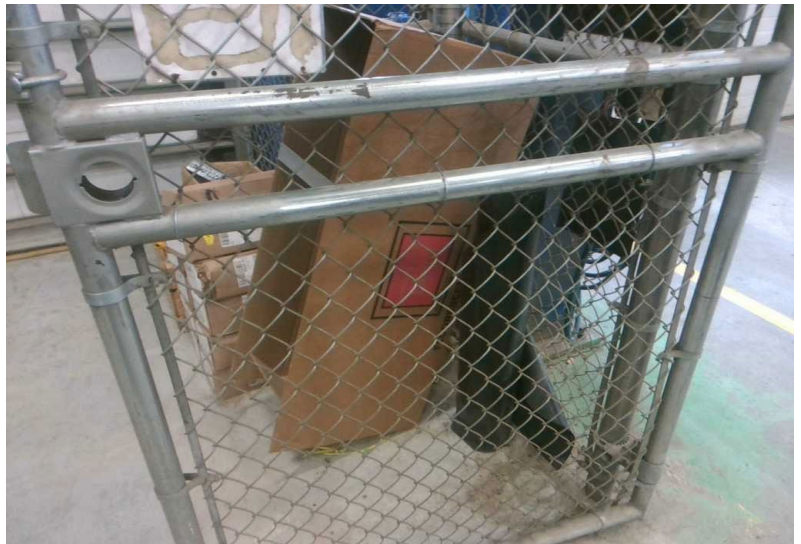
Another view of cardboard box that contains waste fluorescent lamps and is not closed.

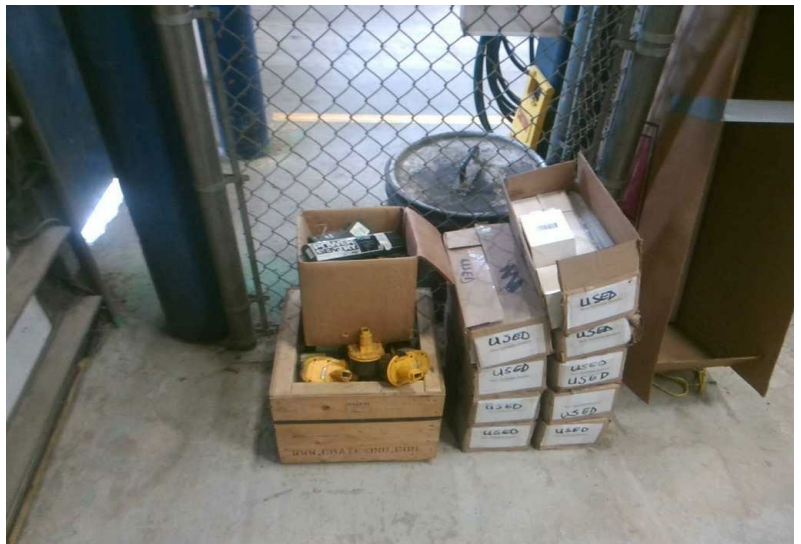
IMG-202206090934123412881032.jpg

I also saw a small cardboard box, that held between 25 and 30 Ni-Cad batteries, that was on top of a larger wooden box that also held an additional six Ni-Cad batteries and ten small lead acid batteries. Neither of the two boxes were labeled with the words Universal Waste-batteries, Waste-batteries, or Used-batteries.

View of two boxes of waste batteries, seen here on the left. Neither of the two boxes were labeled.

The facility provided documentation (see Document Log) following the inspection that the boxes had been labeled with the words "Universal Waste - Batteries."

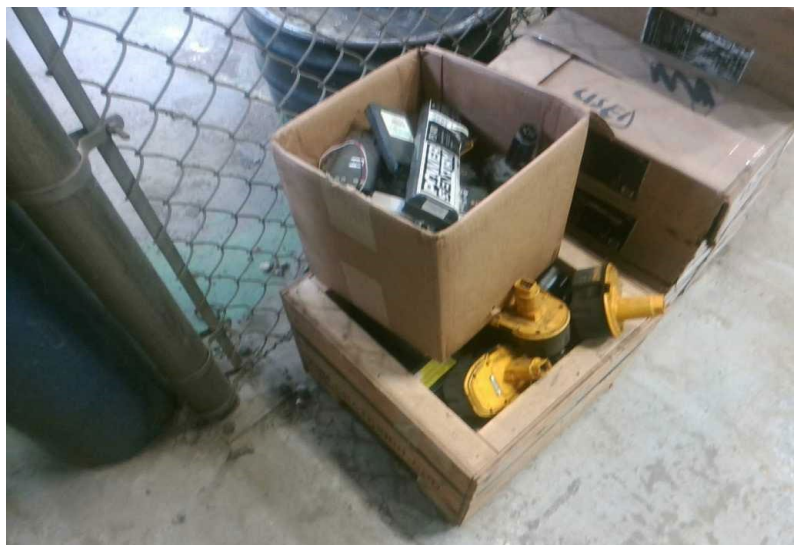
IMG-202206090934193419823949.jpg

Another view of the two boxes of waste batteries. Neither of the two boxes were labeled.

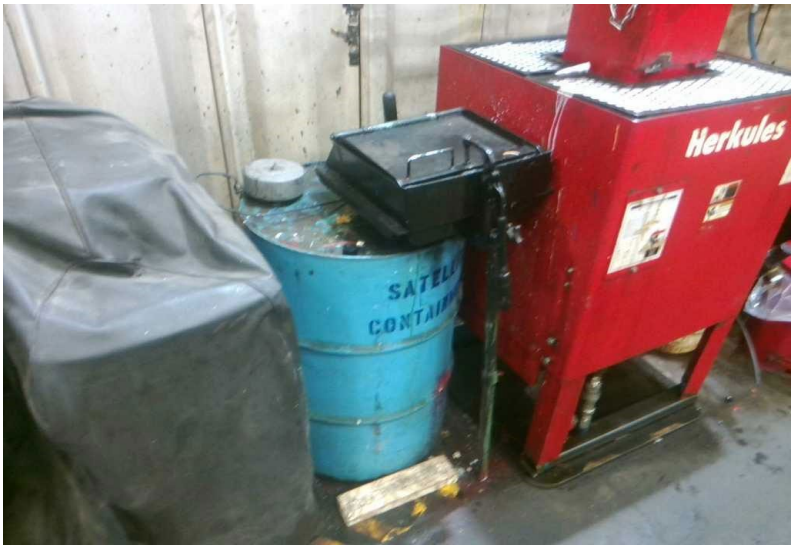
At the time of the inspection, I saw a 55-gallon container with an attached aerosol can popper. According to Mr. Muir, the container was a SAA container for aerosol can residue. I saw that the container was labeled with the words "Satellite Containment." The container was not labeled with the words "Hazardous Waste," or marked with a hazard indicator.

| <div>[Title]</div> <div>IMG-202206090947354735918850.jpg</div> <div>06/09/2022 09:47 AM (AKT)</div> <div>Jon Jones</div> <div>Front shop/Pit Bay/oil storage</div> <div>No CBI</div> <div>No PII</div> <div>View of 55-gallon container with an attached can popper.</div> | |

At the end of the inspection, it was determined that the facility was a VSQG and the labeling and marking requirements for the containers of hazardous waste were not applicable. The facility provided documentation, following the inspection (see Document Log) that the container had been closed, labeled with the words "Hazardous Waste," and marked with a hazard indicator.

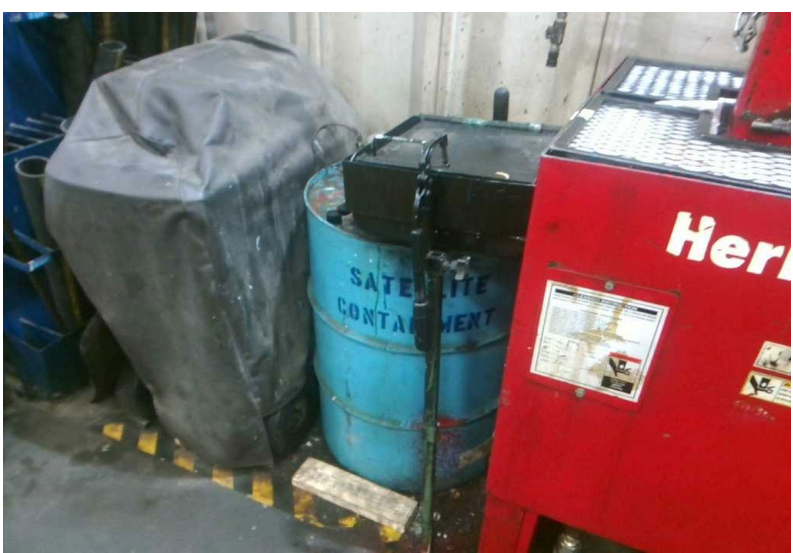
| <div>[Title]</div> <div>IMG-202206090947444744916667.jpg</div> <div>06/09/2022 09:47 AM (AKT)</div> <div>Jon Jones</div> <div>Front shop/Pit Bay/oil storage</div> <div>No CBI</div> <div>No PII</div> <div>Another view of 55-gallon container with an attached can popper.</div> | |

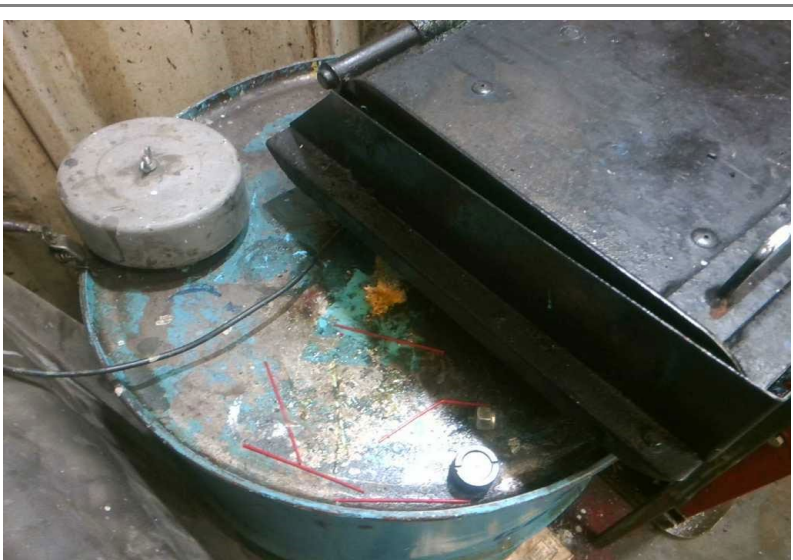
| <div>[Title]</div> <div>IMG-20220609094805485996350.jpg</div> <div>06/09/2022 09:48 AM (AKT)</div> <div>Jon Jones</div> <div>Front shop/Pit Bay/oil storage</div> <div>No CBI</div> <div>No PII</div> <div>Another view of 55-gallon container with an attached can popper.</div> | |

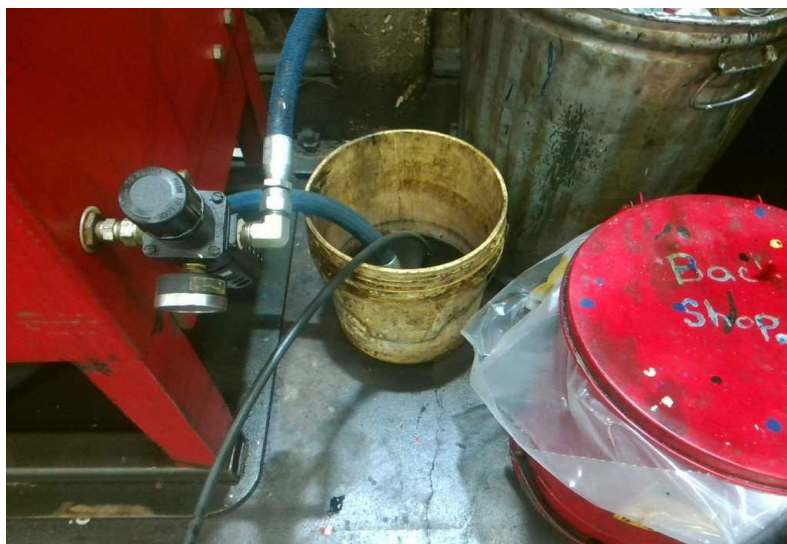
| IMG-2022060909551855181076229.jpg |

The facility had an oil filter crusher and I saw an open 5-gallon bucket that was being used to accumulate the used oil from the filter crusher. At the time of the inspection, the 5-gallon bucket was not labeled with the words "Used Oil." The container was approximately 1/3 full of used oil.

| An open 5-gallon bucket was being used to accumulate the used oil from the filter crusher. The 5-gallon bucket was not labeled with the words "Used Oil." The container was approximately 1/3 full of used oil. | <b>Citations:</b><br><br>279.22(c)(1) | <b>Sections:</b> |

| Another view of the 5-gallon bucket that was being used to accumulate the used oil from the filter crusher and seen here, not labeled with the words "Used Oil." |

The facility provided documentation (see Document Log), following the inspection that the container had been labeled with the words "Used Oil."

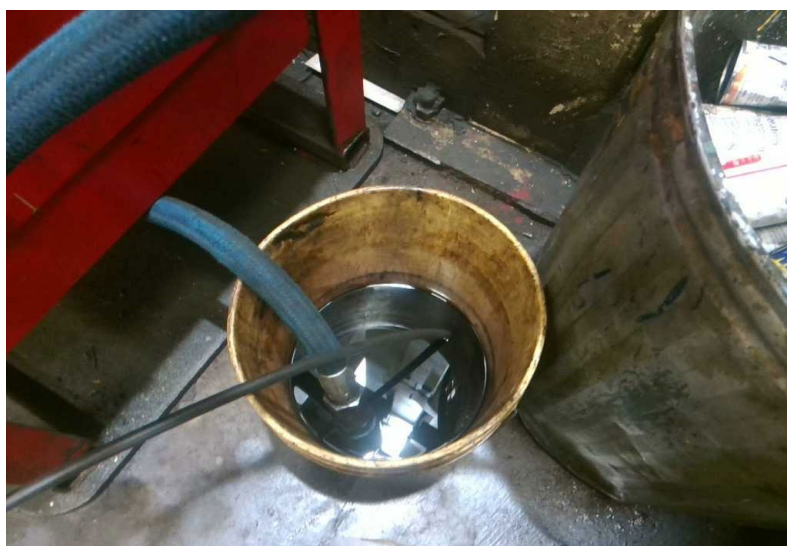
| IMG-202206090955245524933878.jpg |

| Close-up view of the 5-gallon bucket that was being used to accumulate the used oil from the filter crusher and seen here, not labeled with the words "Used Oil." |

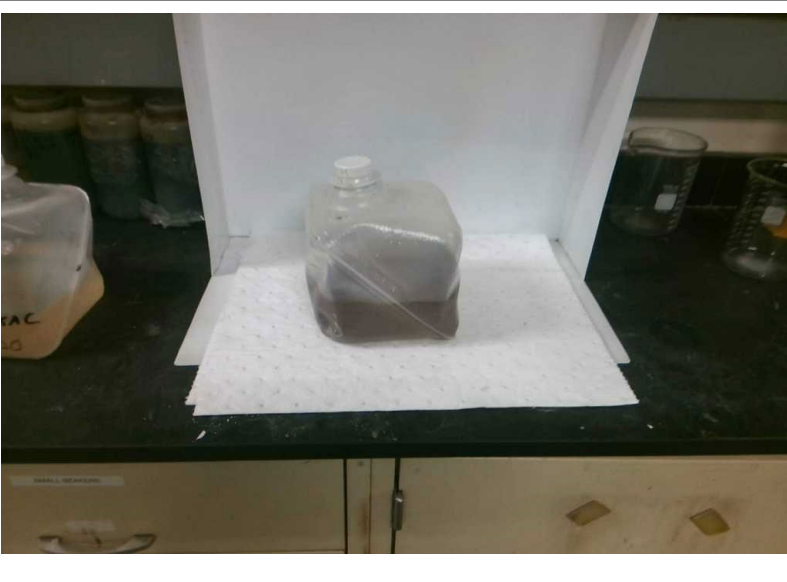
| <p>Roarke Burnett, Lab Technician, was the person in charge of this area.</p> <p>At the time of the inspection, Mr. Burnett pulled a waste silver nitrate container from out of a cabinet. The container was a 5-gallon bucket that held a 1-gallon cube-tainer. The container was not labeled with the words "Hazardous Waste," or marked with a hazard indicator.</p> <p>Mr. Burnett labeled the cube-trainer during the inspection.</p> <p>At the end of the inspection, it was determined that the facility was a VSQG and the labeling and marking requirements for the containers of hazardous waste were not applicable.</p> | |

| <p>[Title]</p> <p>IMG-202206091020482048443875.jpg</p> <p>06/09/2022 10:20 AM (AKT)</p> <p>Jon Jones</p> <p>QA/QC Lab/Cabinet adjacent to sink</p> <p>No CBI</p> <p>No PII</p> <p>View of the cube-tainer of waste silver nitrate.</p> | |

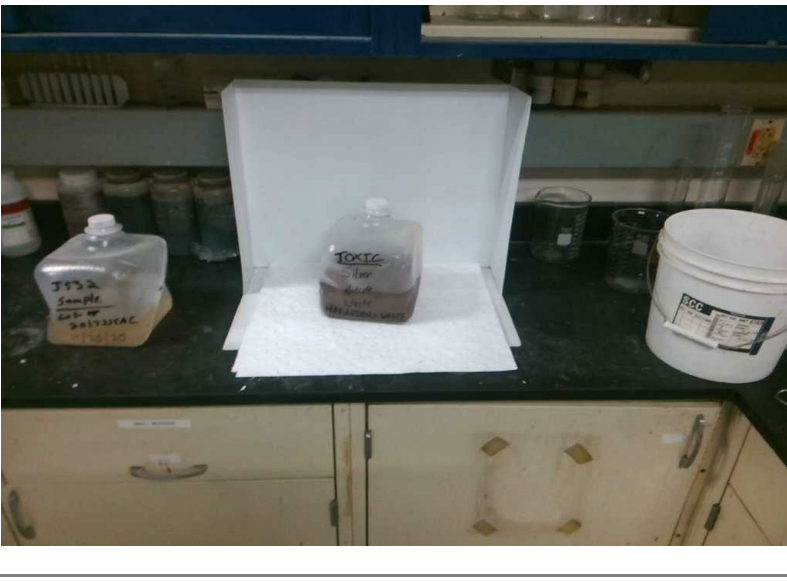
| <p>[Title]</p> <p>IMG-202206091023342334592400.jpg</p> <p>06/09/2022 10:23 AM (AKT)</p> <p>Jon Jones</p> <p>QA/QC Lab/Cabinet adjacent to sink</p> <p>No CBI</p> <p>No PII</p> <p>View of the cube-tainer after being labeled.</p> | |

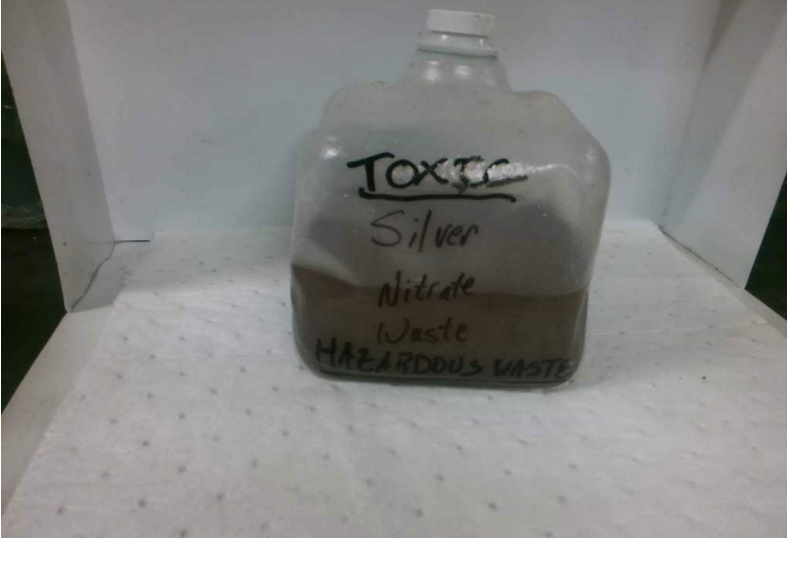
| <p>[Title]</p> <p>IMG-202206091023392339360947.jpg</p> <p>06/09/2022 10:23 AM (AKT)</p> <p>Jon Jones</p> <p>QA/QC Lab/Cabinet adjacent to sink</p> <p>No CBI</p> <p>No PII</p> <p>Close-up view of the cube-tainer after being labeled.</p> | |
