Region 2 Caribbean Environmental Protection Division  
Multimedia Permits and Compliance Branch

CAA Inspection Report

**Inspection Date:** 6/17/2024  
**Facility Name:** Cortes Industrial Organization Inc.  
**Facility Address:** Rio Cañas Industrial Park, Central Street, North Corner, Caguas, PR 00725  
**Coordinates:** Lat: 18.298767 / Long: -66.052418  
**ICIS-Air ID #:** PR0000007202500135  
**EPA Lead Inspector:** Alex Rivera, Enforcement Officer, [rivera.alex@epa.gov](mailto:rivera.alex@epa.gov), 787-977-5845  
**Facility Contact(s):** Yanelle Pérez, General Manager, 787-607-9029, [yperez@cortesindustrial.com](mailto:yperez@cortesindustrial.com)  
Ken Bonilla, Plant Manager, 787-643-4341, [kbonilla@cortesindustrial.com](mailto:kbonilla@cortesindustrial.com)  
Angel L. Bastardo, Plant Manager Assistant, 787-477-0864, [angelb@cortesindustrial.com](mailto:angelb@cortesindustrial.com)

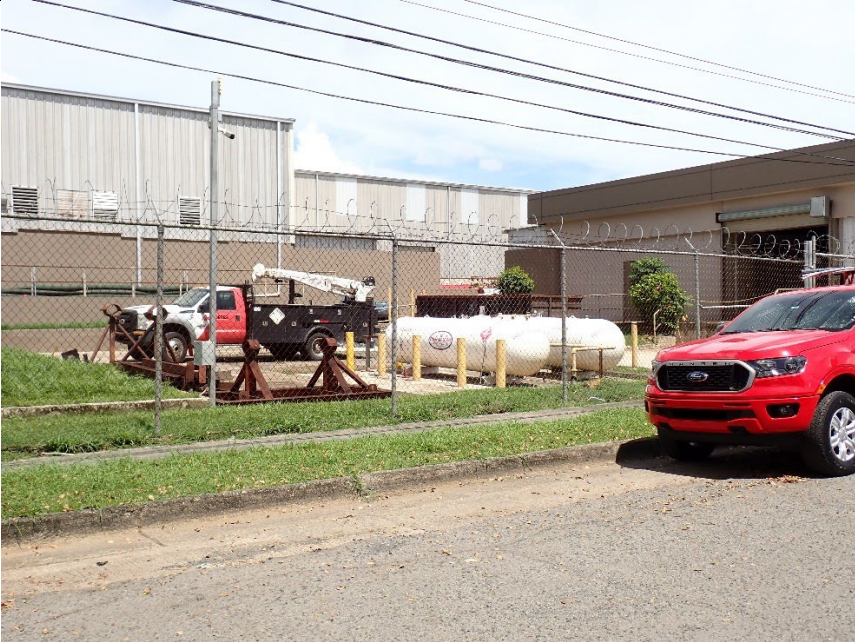
2	P6170038.JPG

<p data-bbox="573 716 1388 743">Partial view of the east facing portion of the Facility and its LPG storage tanks.</p>	6/17/2024	10:33 am
3	P6170039.JPG

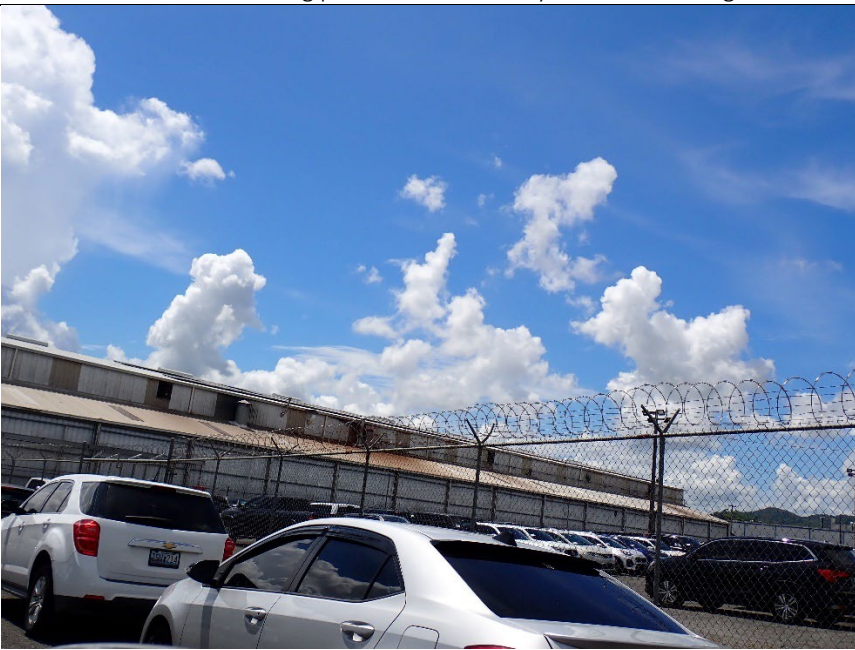
<p data-bbox="573 1393 1094 1421">Partial view of the west facing part of the Facility.</p>	6/17/2024	10:35 am

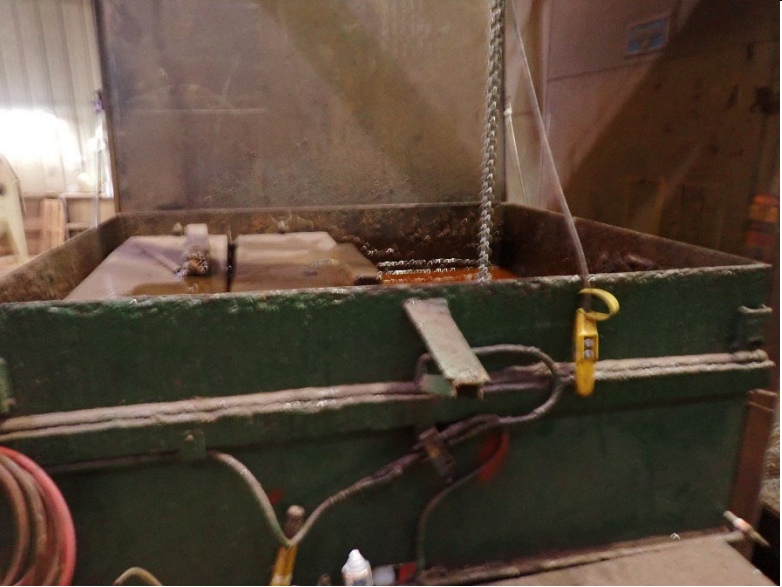
16	P6170053.JPG

8. Mr. Bastardo indicated that the Facility also applies varnish by submersion. The Facility has a rectangular tank on which equipment is submerged into a solution consisting of varnish and xylene (dilution). See image P6170053 in Appendix A for more details.

6/17/2024	2:57 pm
<p>Partial view of the Facility for varnish application by submersion.</p>				
17	P6170054.JPG

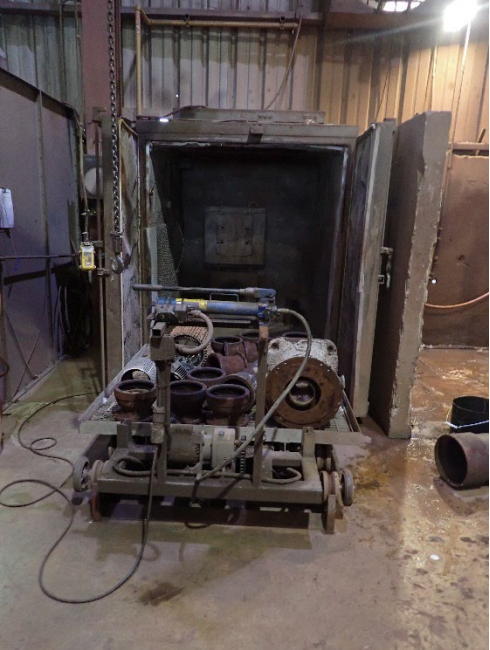
9. Ms. Pérez and Mr. Bastardo escorted the inspector to the rear portion of the Facility, which faces south, and on which the back part of the Facility two (2) burn-off ovens can be observed. Each burn-off oven has its own stack, and a primary and secondary burner chamber. After observing the burn-off ovens chambers, the inspector was once again escorted inside of the Facility to observe one of the burn-off ovens, which was open at the time of the inspection and had recently processed equipment placed in a crate in front of the unit front door. Mr. Bastardo showed the inspector the burn-off oven temperature

recording instrumentation. See images P6170051, P6170052, and P6170054 in Appendix A for more details.

6/17/2024	2:55 pm
<p>Partial view of one of Facility two burn-off ovens and material recently burnt-off.</p>
