## **Appendix A**

## **Photograph Log**

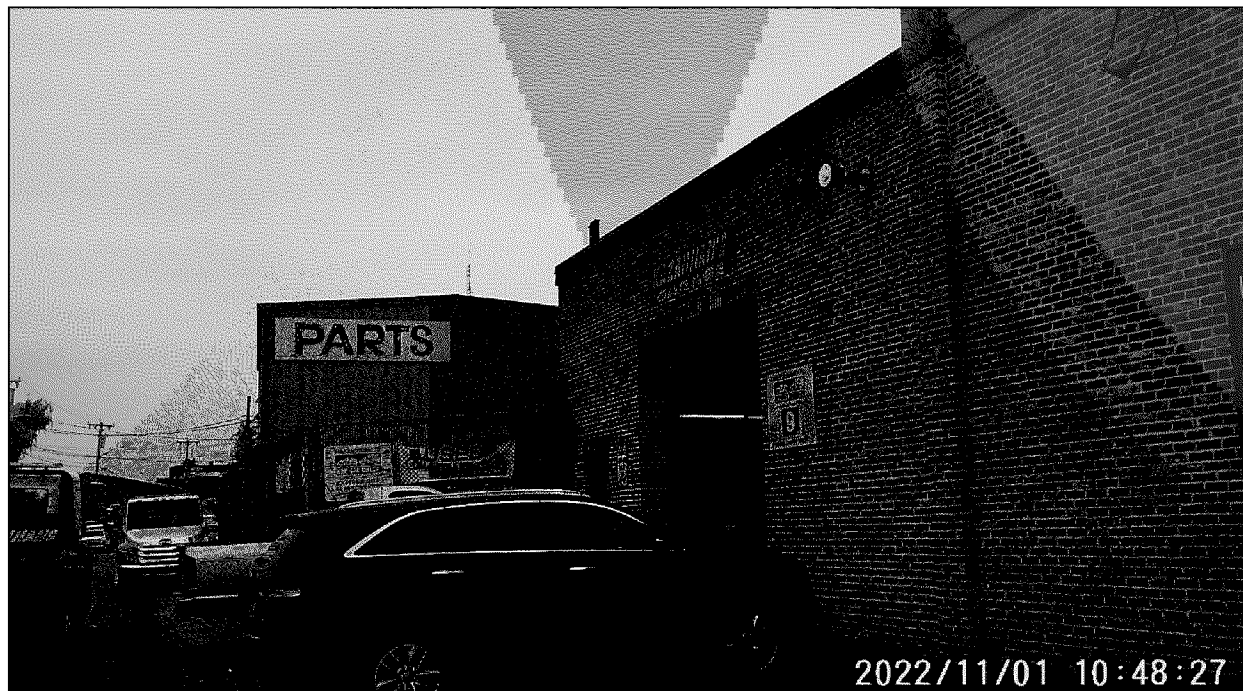
**Photograph 1.** View, facing west, of the front of the Facility from Dutton Street.

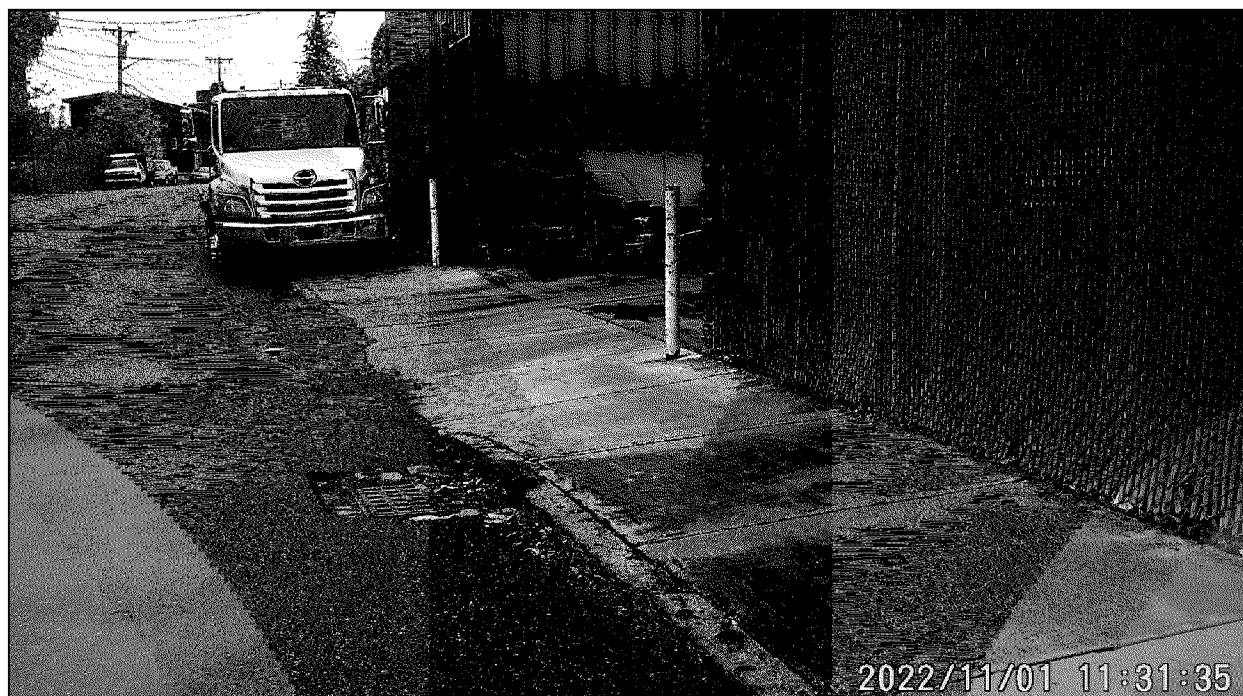
**Photograph 2.** View, facing west, of the entrance to the yard from Dutton Street and a storm drain.

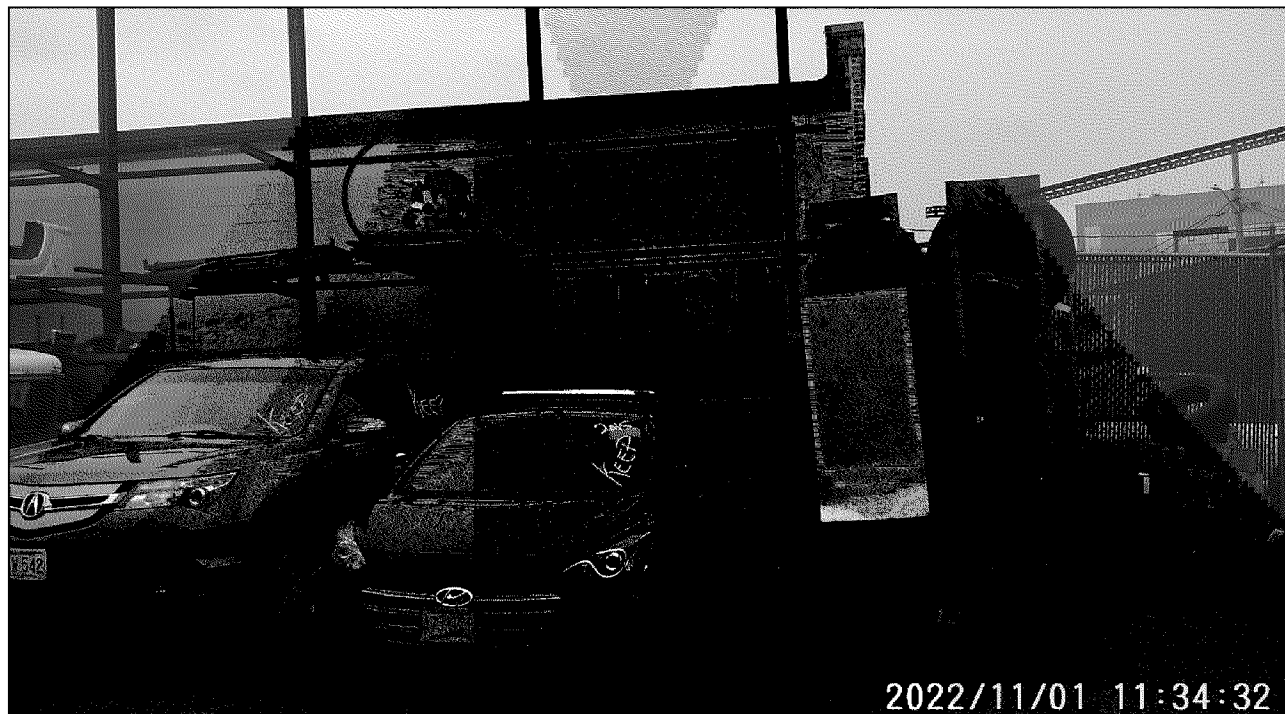
**Photograph 3.** View, facing east, of vehicles tires, and one engine (circled) stored in the yard. The engine was not covered and was not stored in secondary containment.

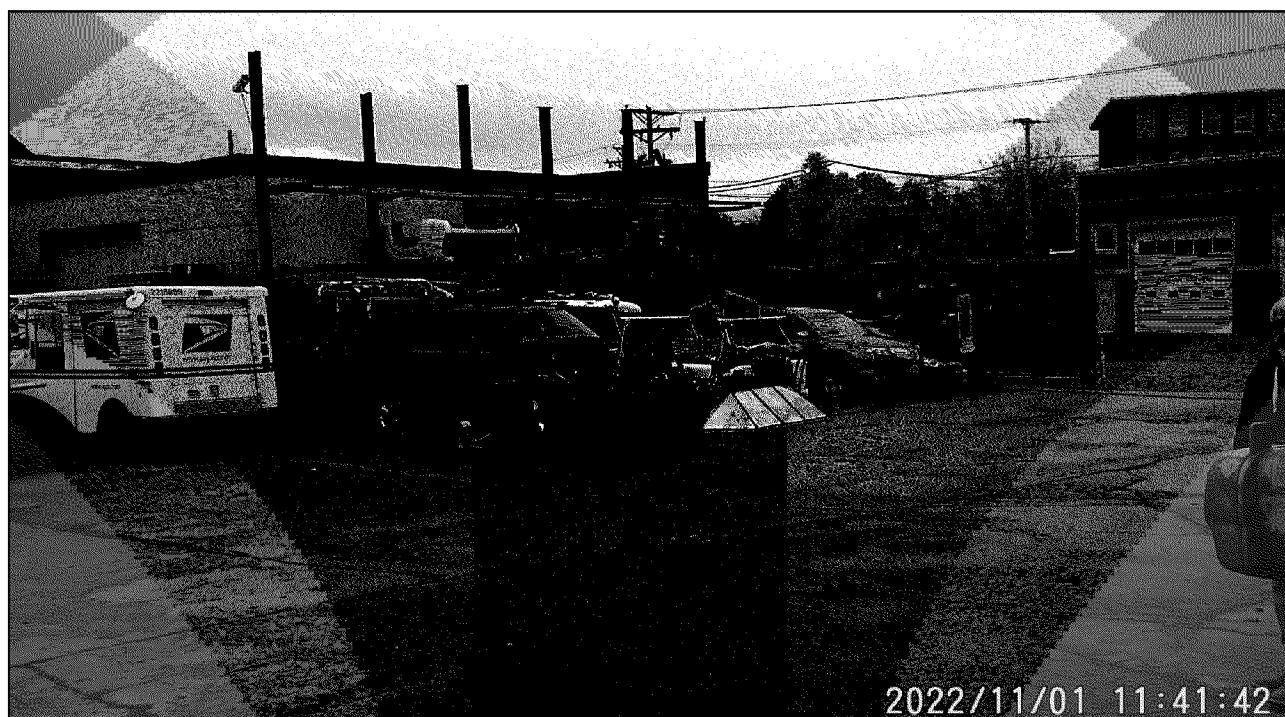
**Photograph 4.** Additional view, facing south, of the yard and the entrance from Dutton Street.

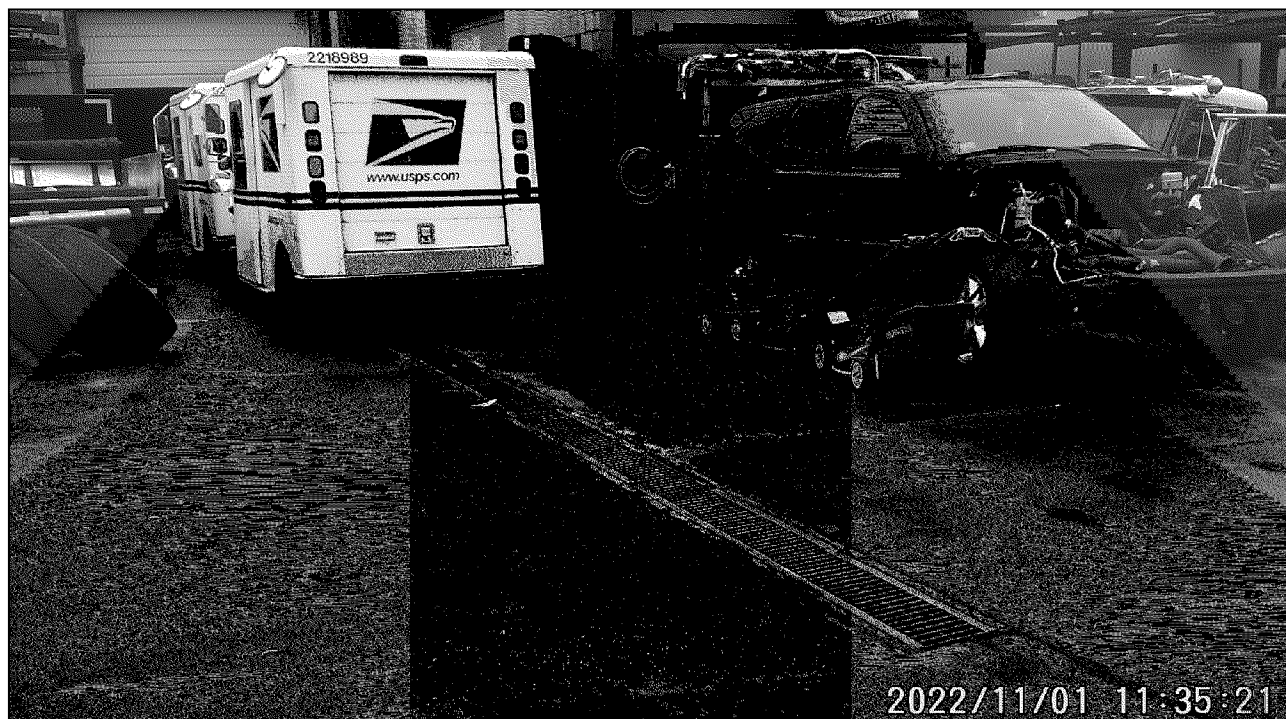
**Photograph 5.** View, facing east, of vehicle storage and one of three trench drains observed in the yard.

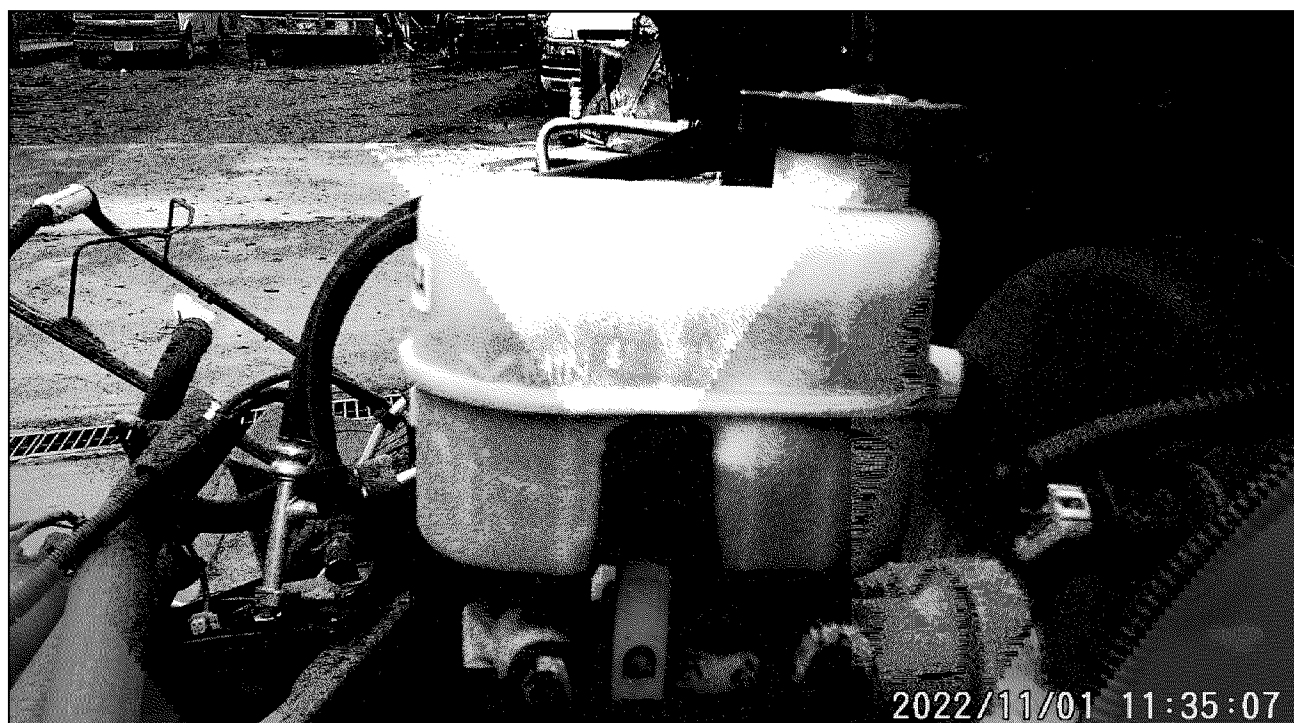
**Photograph 6.** View, facing north, of an engine coolant reservoir with fluids observed in the black vehicle from Photograph 5.

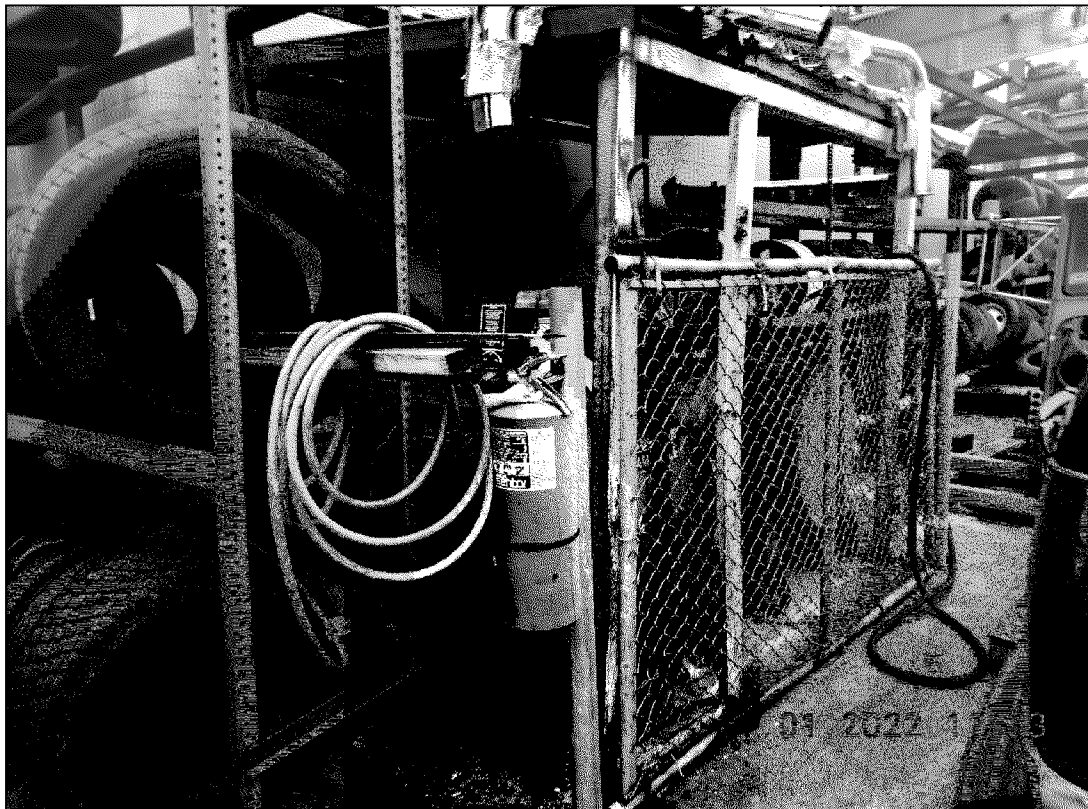
**Photograph 7.** View of the gasoline and antifreeze tanks stored in the yard.

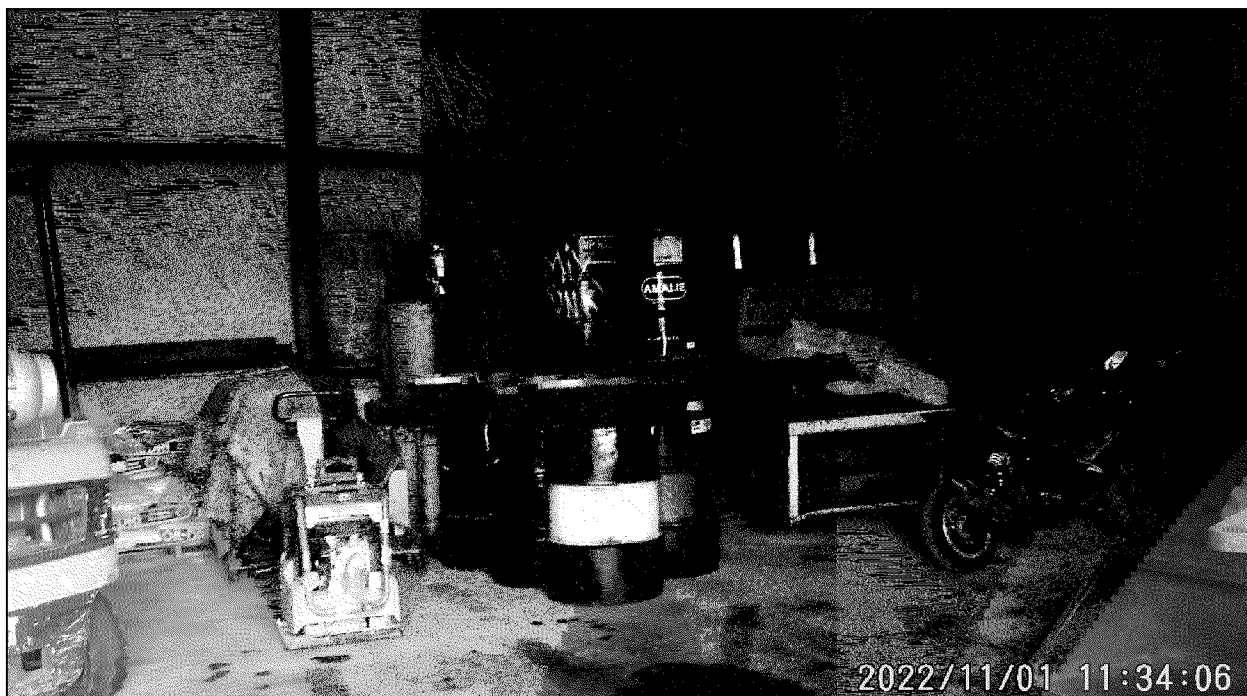
**Photograph 8.** View, inside the southern garage, of 55-gallon drums storing used oil. The drums were not within secondary containment.

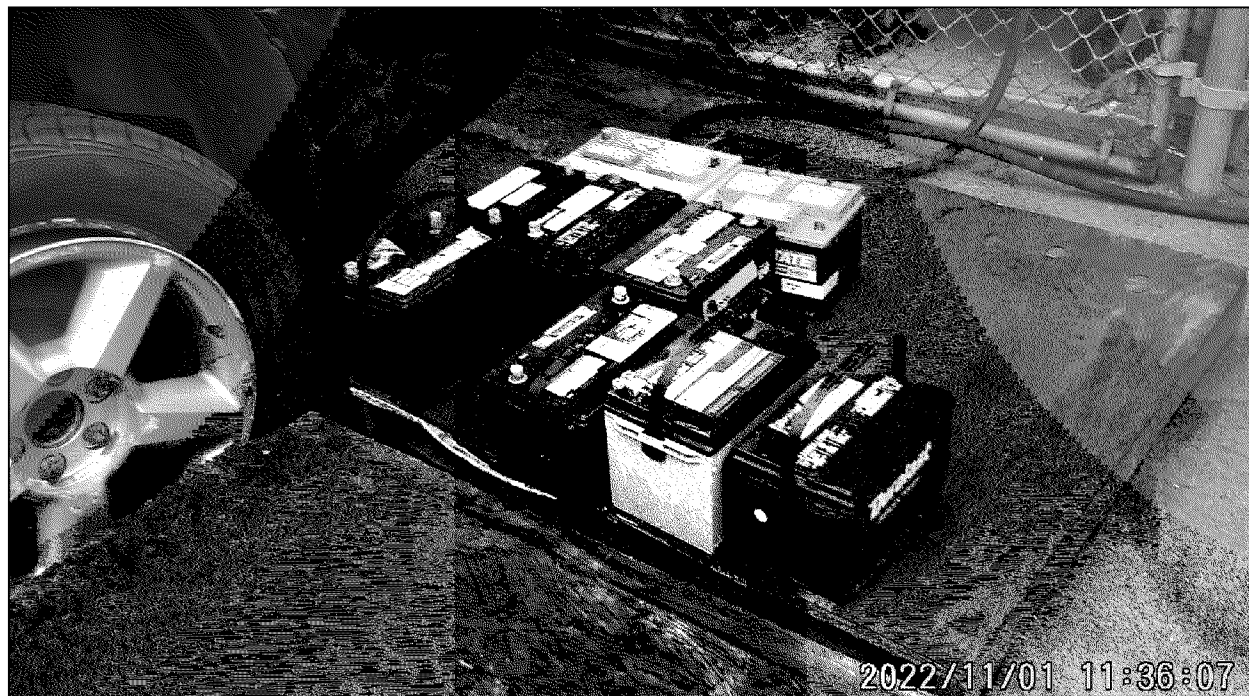
**Photograph 9.** View of used, car batteries stored outside in the yard without cover or secondary containment.

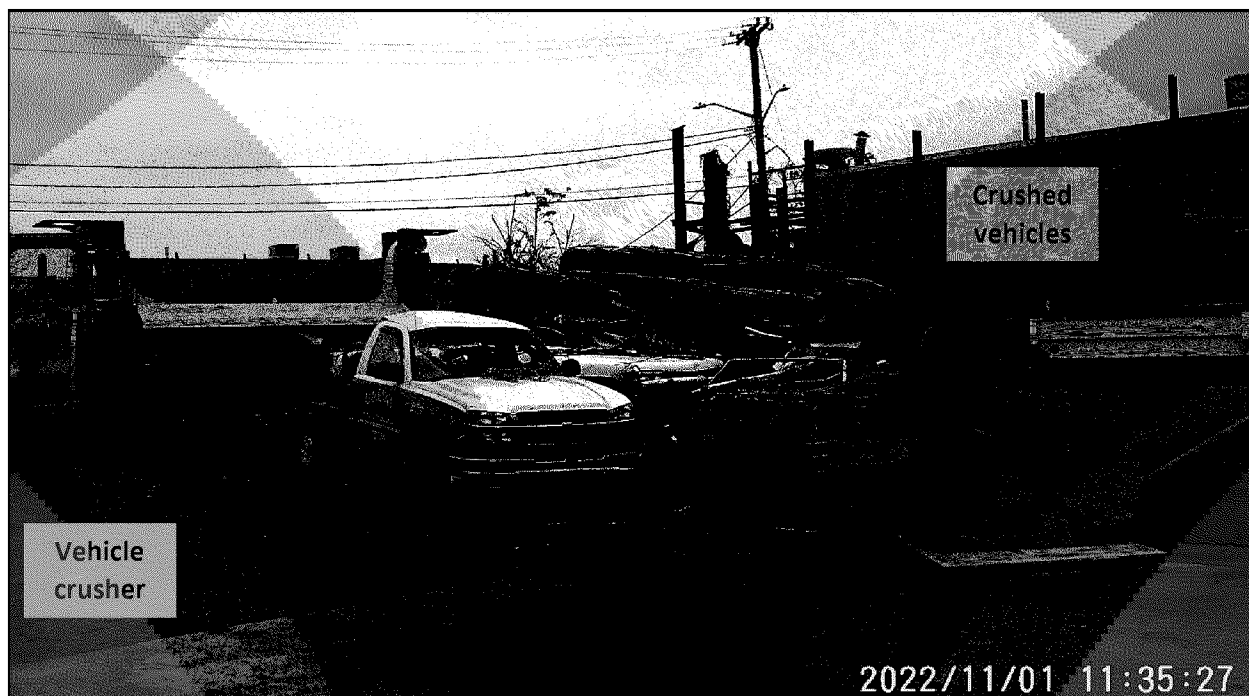
**Photograph 10.** View, facing north, of the onsite vehicle crusher with vehicles which have been crushed and are waiting to be transported offsite.

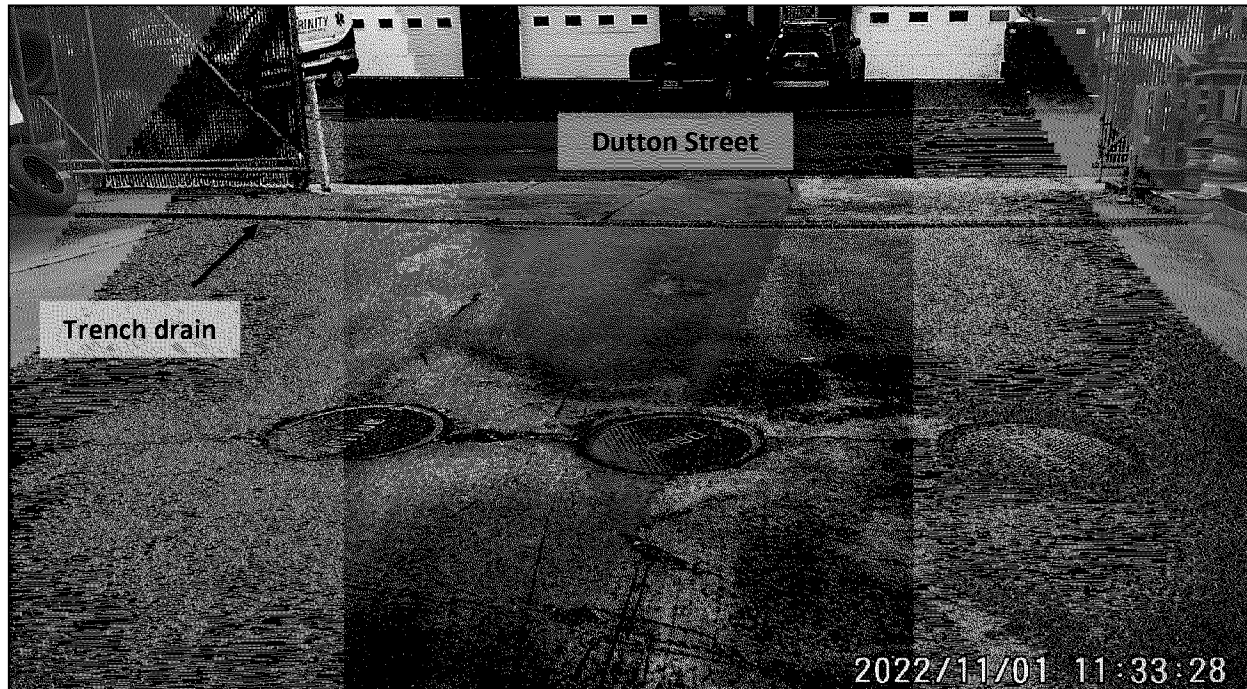
**Photograph 11.** View, facing south, of manholes connected to the three underground holding tanks which overflow into the combined sewer in Dutton Street. Stormwater collected in the three onsite trench drains flows to the holding tanks.

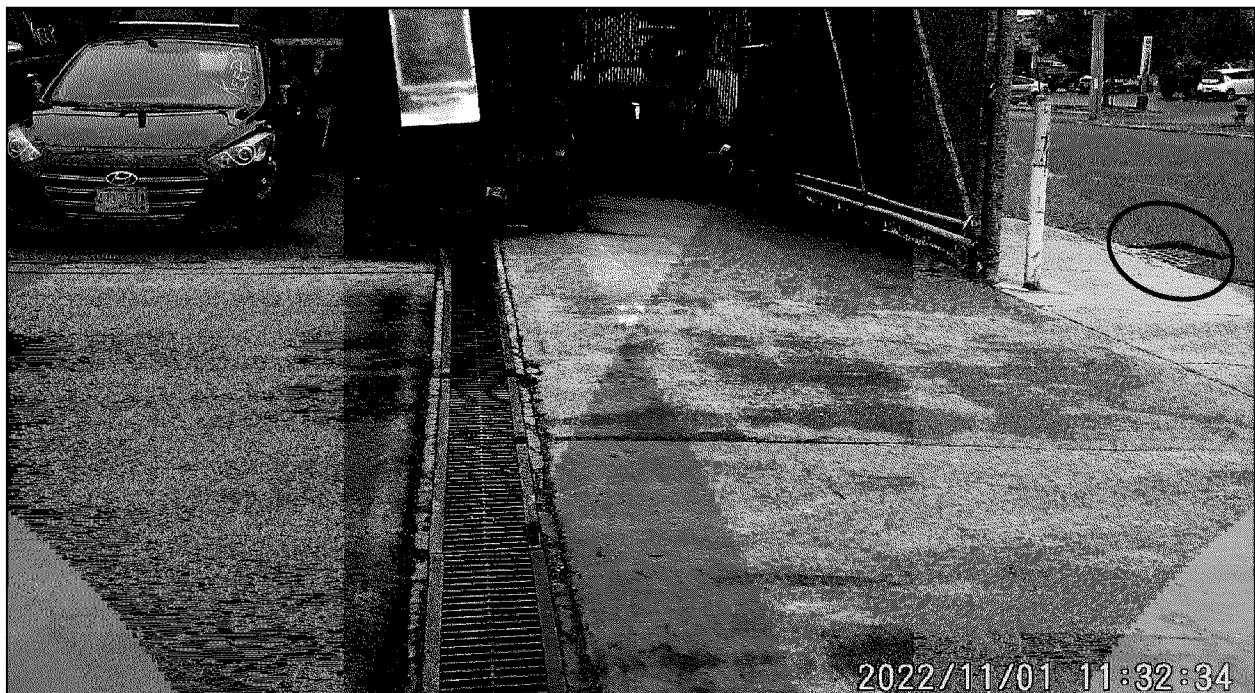
**Photograph 12.** View, facing east, of the trench drain shown in Photograph 11 and a City of Lowell combined storm sewer drain (red).

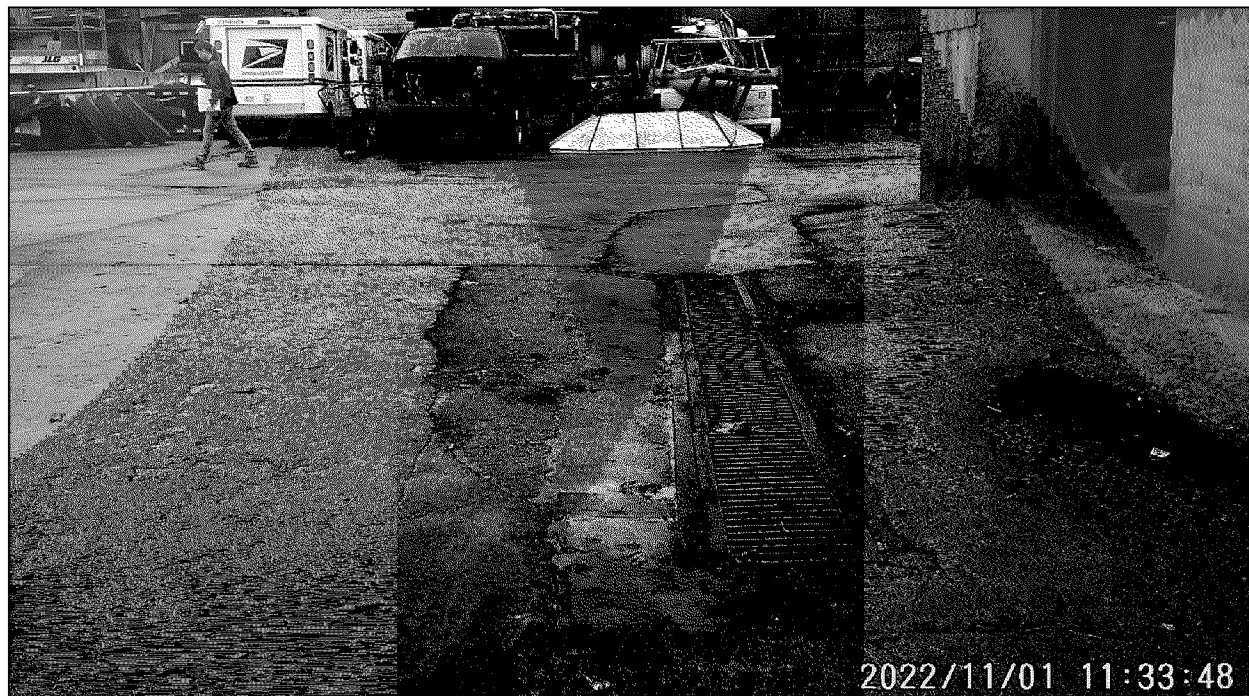
**Photograph 13.** View, facing east, of the third trench drain at the Facility to the north of the southern garage.

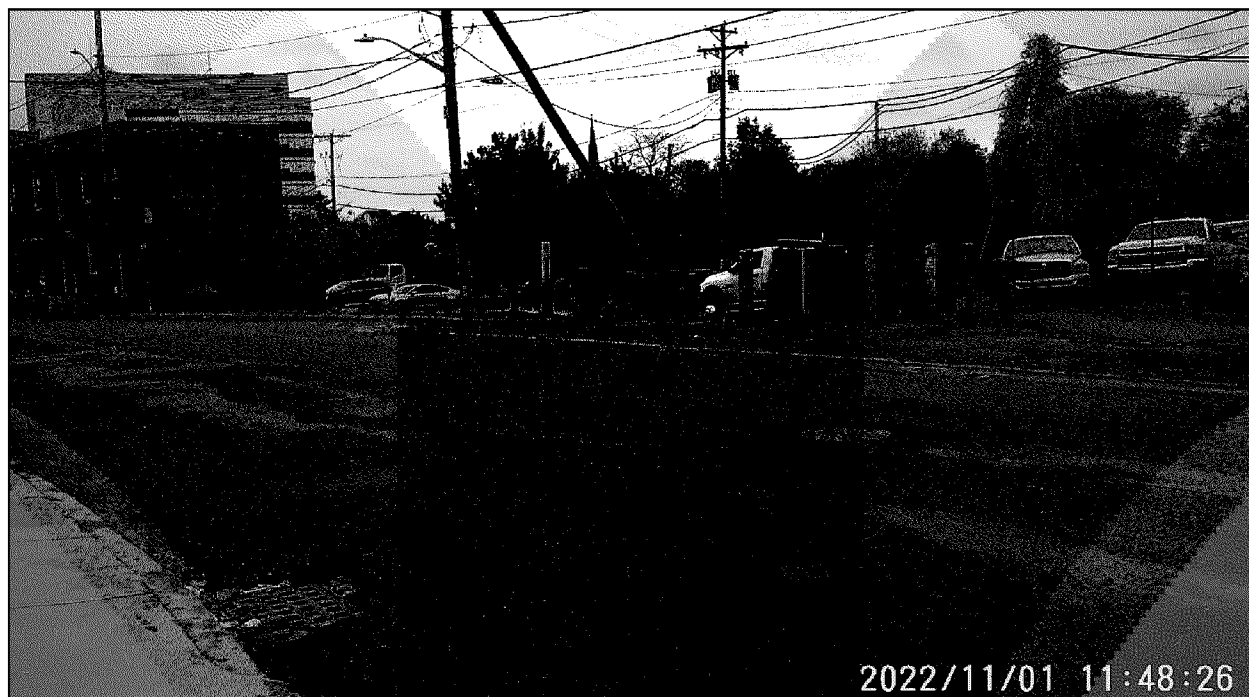
**Photograph 14.** View, facing southeast, of the storm drain shown in Photographs 2 and 12 looking towards the Pawtucket Canal.

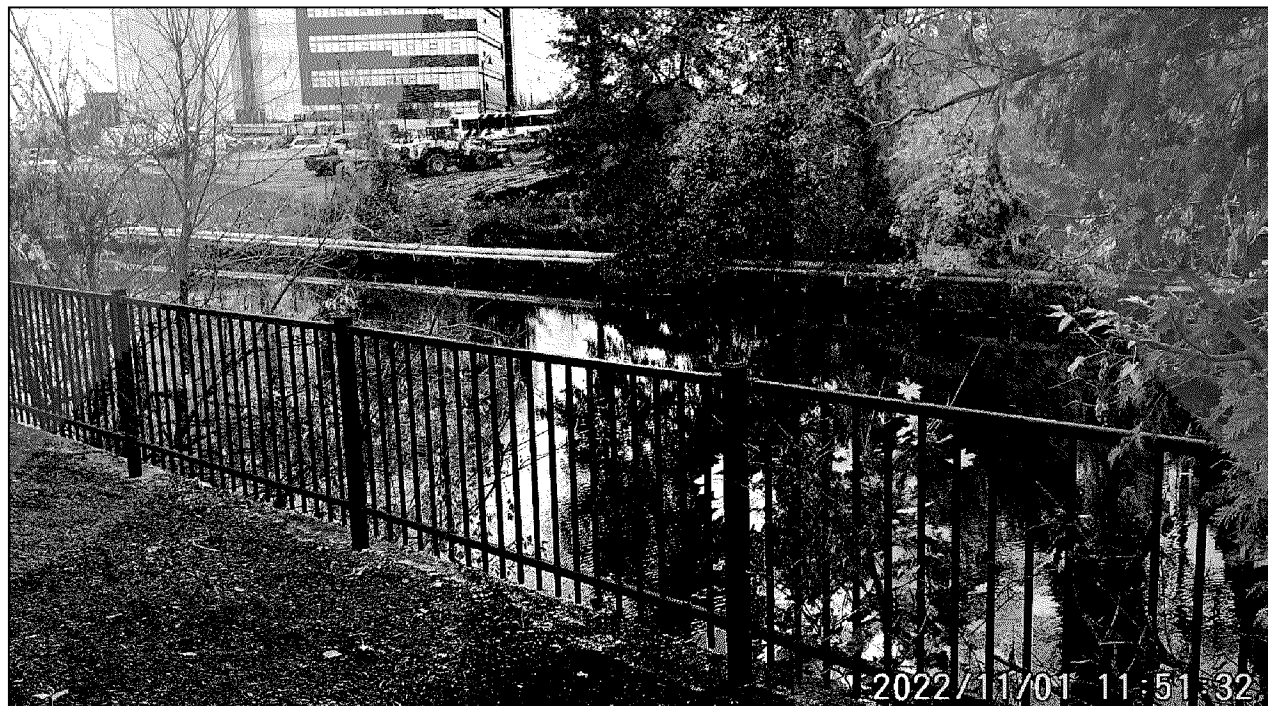
**Photograph 15.** View, facing southeast, of the Pawtucket Canal, approximately 350' south-southeast of the Facility.

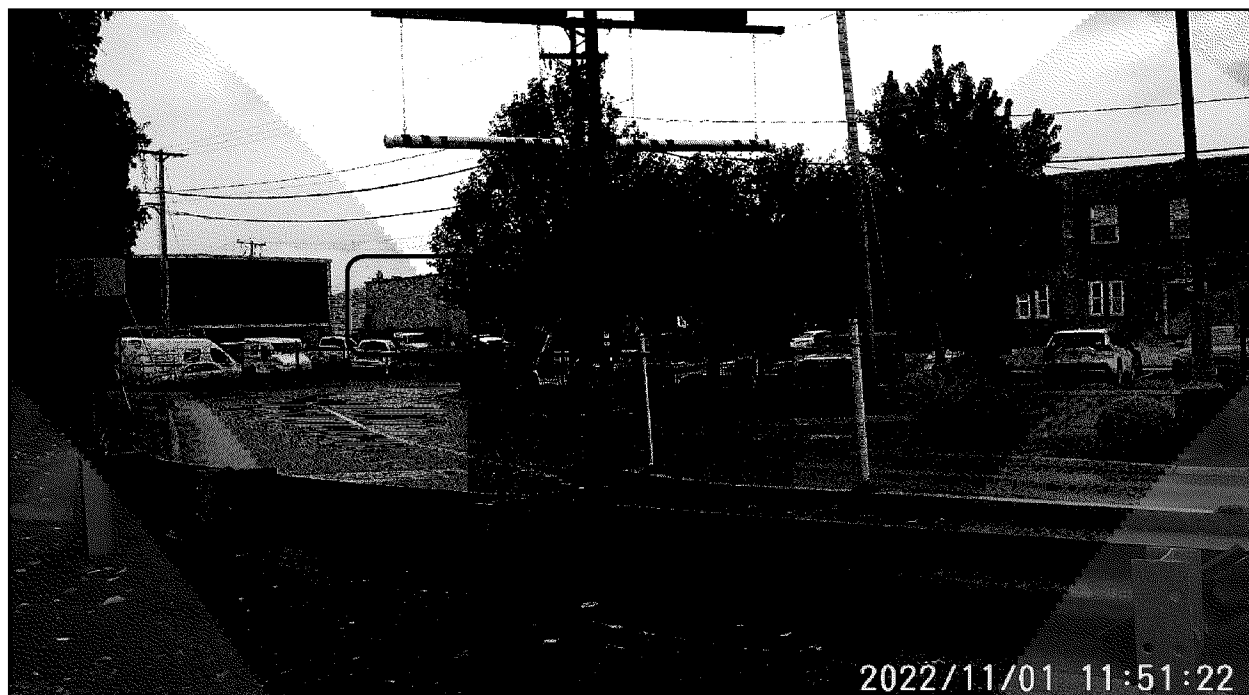
**Photograph 16.** View, facing northwest, from the Pawtucket Canal looking towards the facility (red).

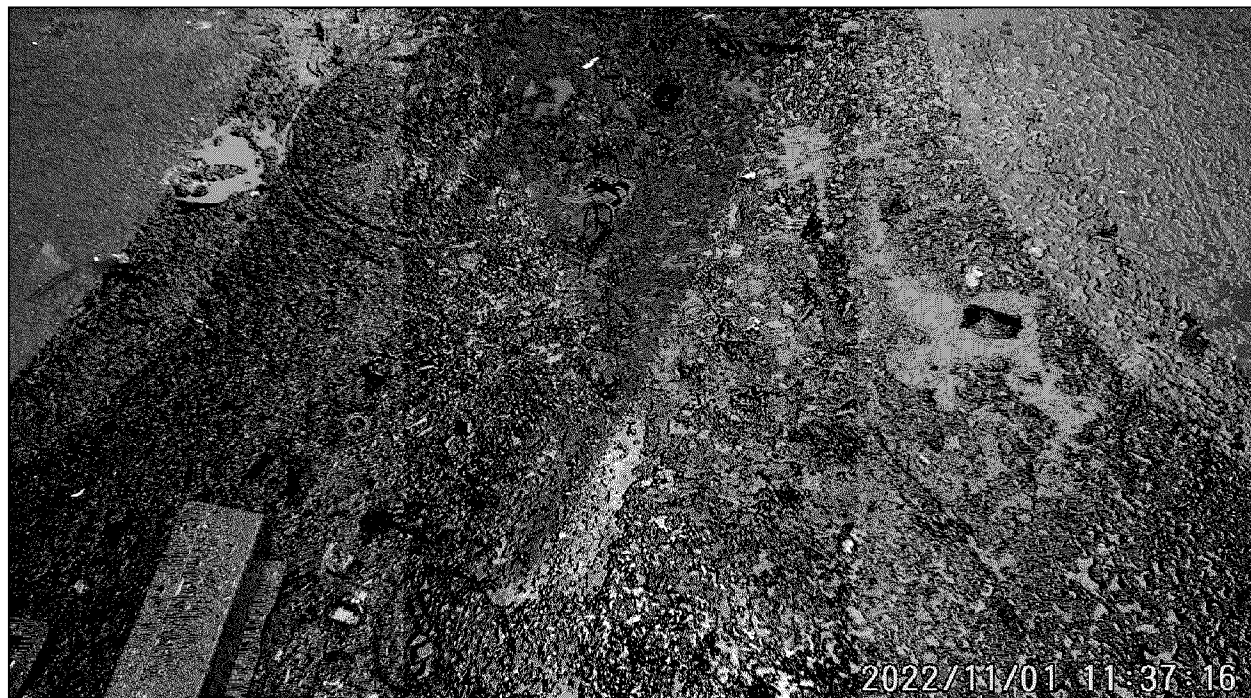
**Photograph 17.** View of petroleum sheen observed on the ground surface near the onsite crusher.

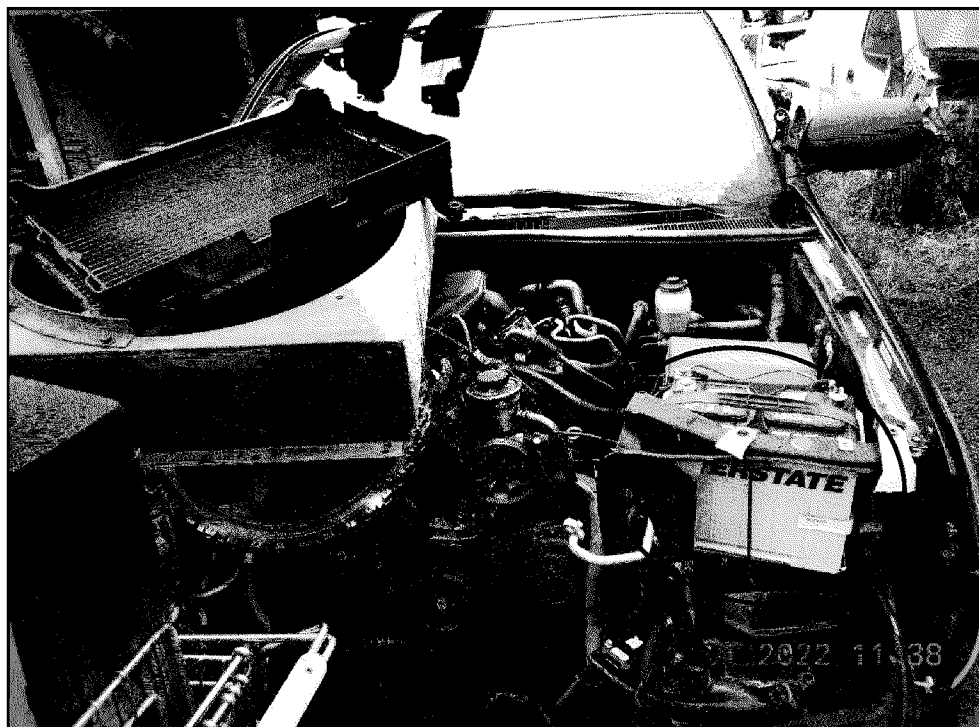
**Photograph 18.** View, facing east, of a vehicle stored in the northwest portion of the yard with a battery still in the car and exposed to stormwater (red).
