# NPDES Compliance Inspection Report

## Swanson Brothers Lumber Company, Inc. Noti, Oregon

Permit #: ORR221264

Inspection Date: March 24, 2021

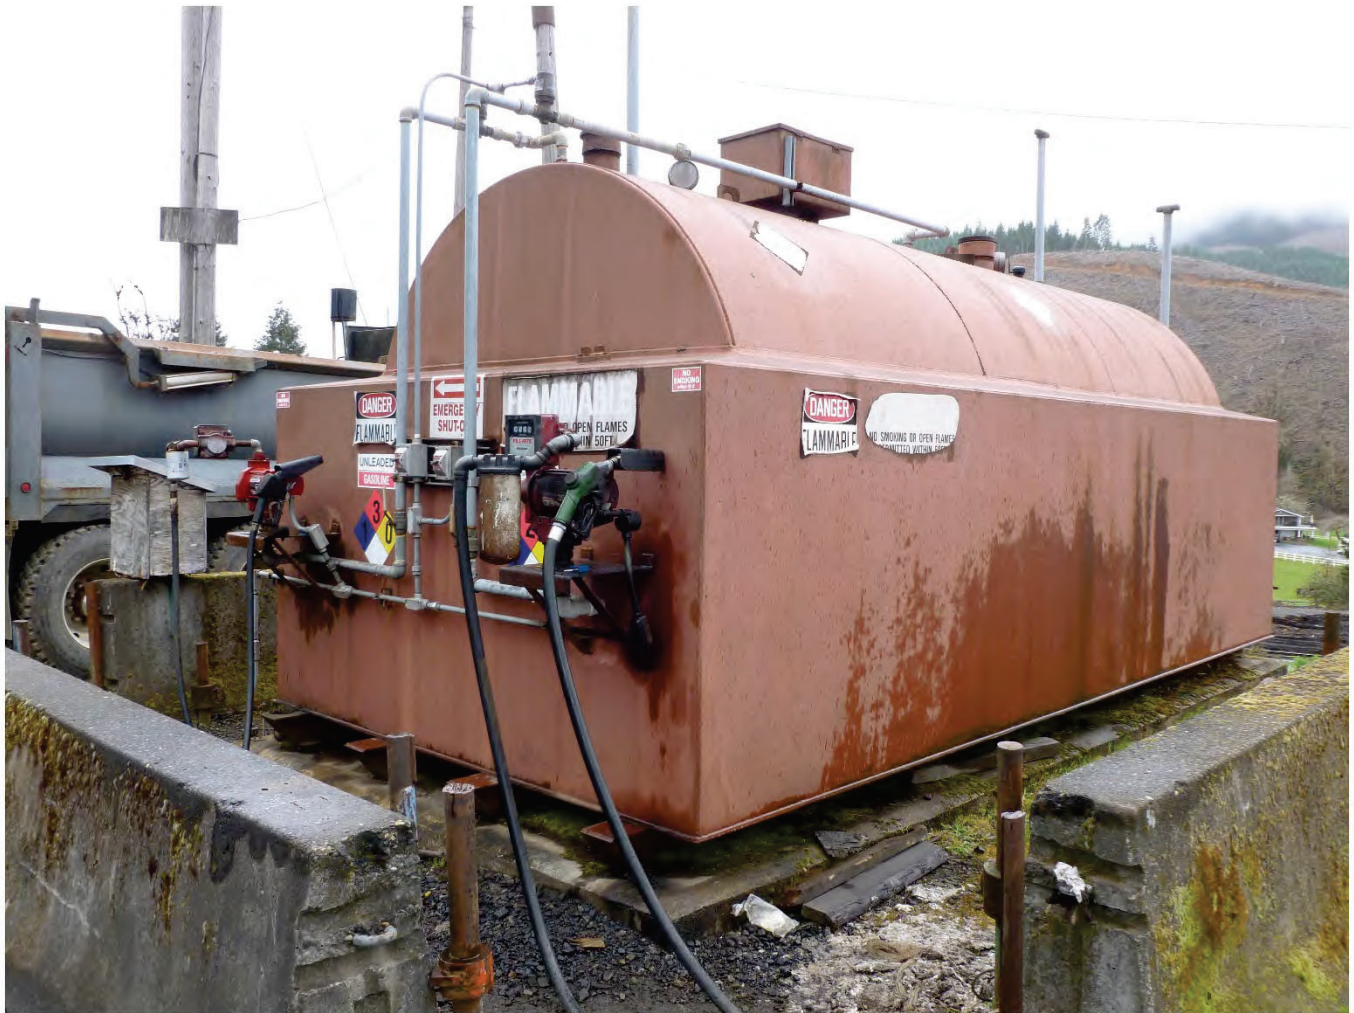
The facility office sits on a small hill over-looking much of the site's operations. From my position on the hill, I saw a fuel tank and decided to start the tour at that point. The three of us walked to the fuel tank. The tank (**Photos 1 & 2**) is double-walled. The tank has two compartments which allows it hold both gas and diesel. It contains up to 2,000 gallons of gasoline and 6,000 gallons of diesel.

**Photo 1 / P1000814** – Gas/Diesel Tank, double-walled, side, facing west

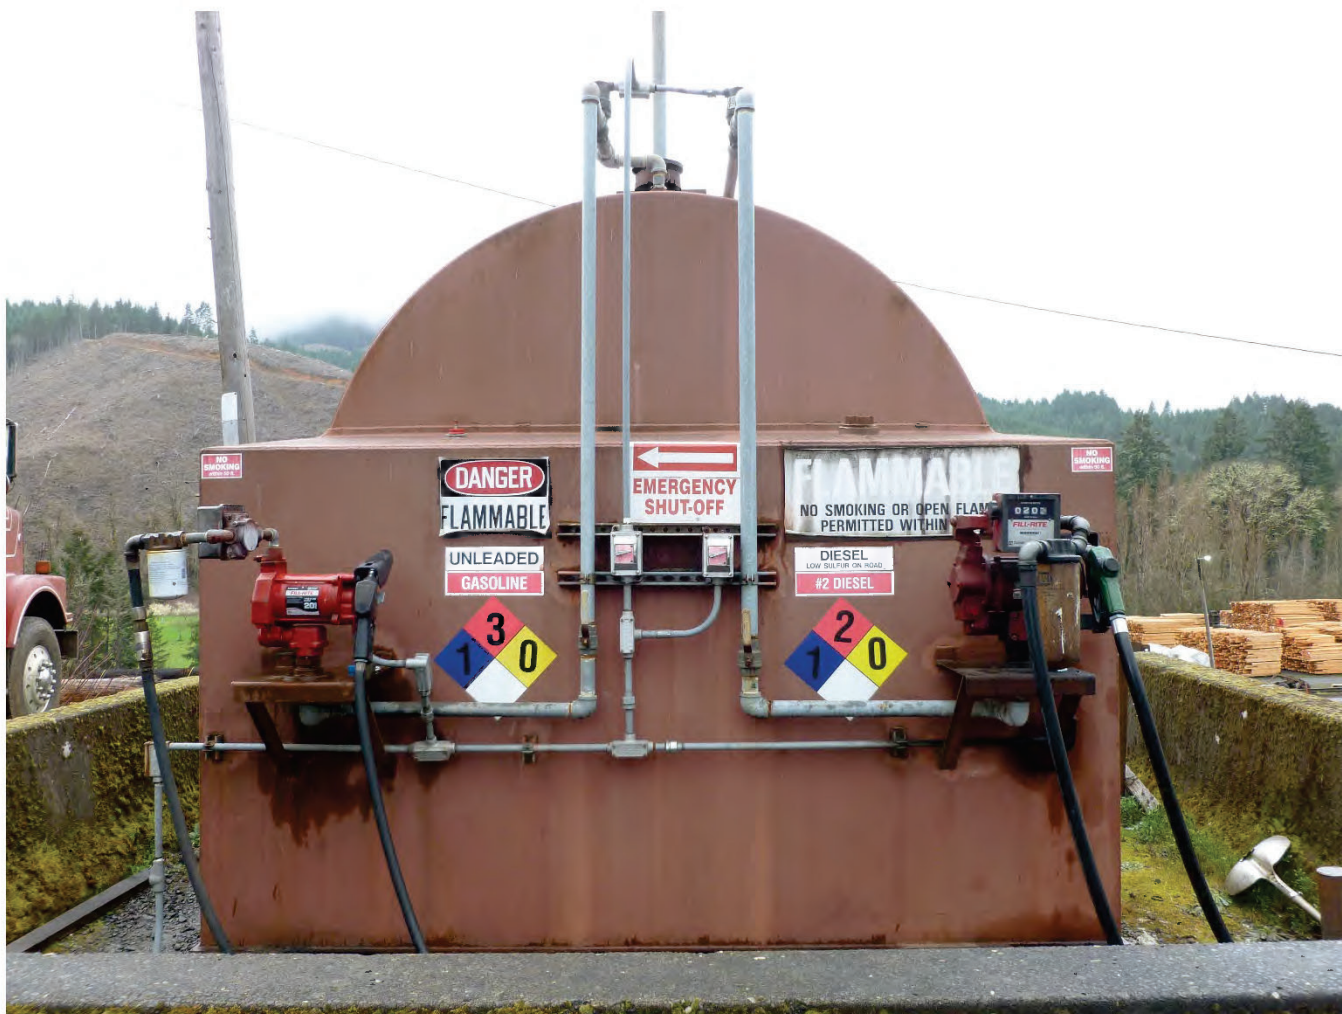
Photo 2 / P1000815 – Gas/Diesel Tank, double-walled, front, facing west

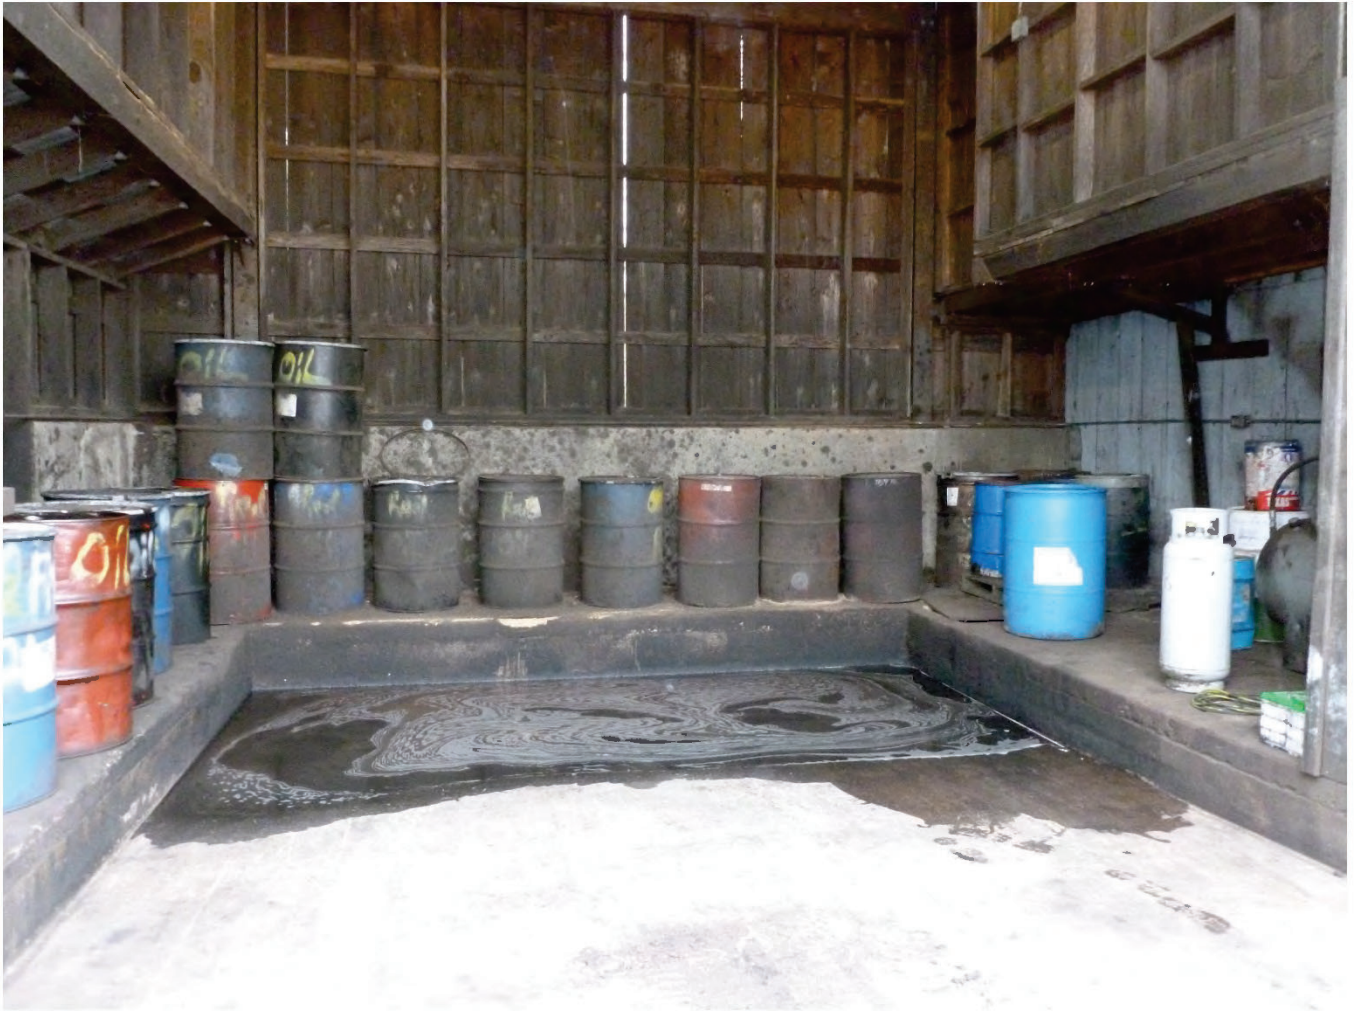
**Photo 3 / P1000816 – Vehicle Wash-down Area**

From the fuel tank, we proceeded to the maintenance shop. Attached to the shop is a vehicle washdown pit (**Photo 3**). As seen in the photo, the pit has a quantity of standing water. Per Mr. Jacobs, water that accumulates in the pit through vehicle washing operations and rainfall events does not leave the site. Facility personnel bring in wood shavings to absorb the water. The wood shavings are then allowed to dry and hauled off-site for disposal.

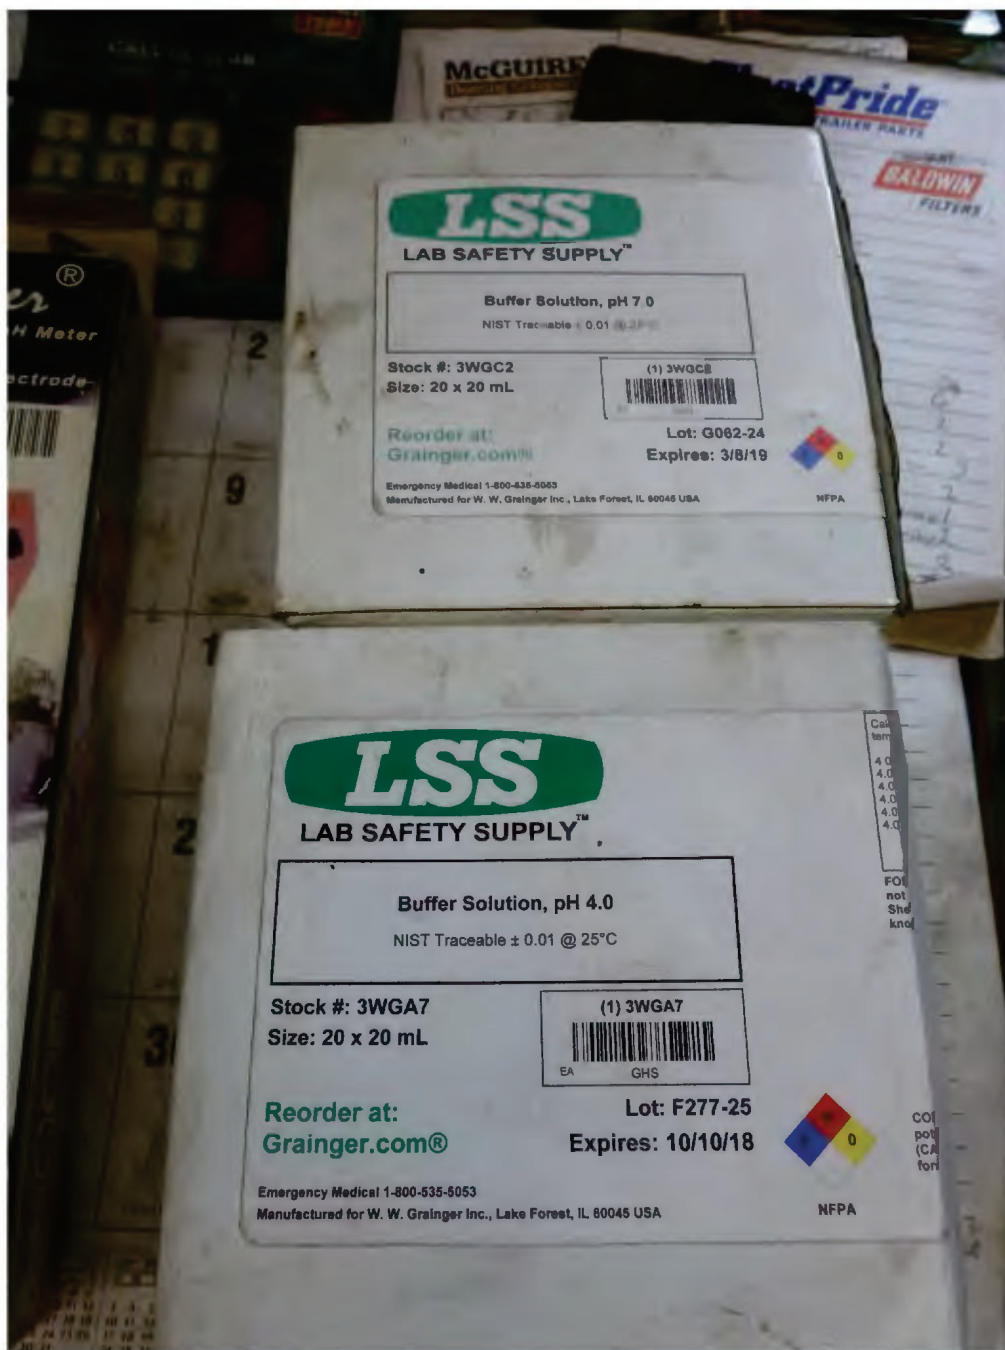
We went into the maintenance shop and I spoke with Mr. Bob Clover, the facility mechanic. In addition to maintaining the facility's vehicles, Mr. Clover is responsible for conducting pH sampling. I asked Mr. Clover how often he calibrates the pH meter. He said he calibrates the meter prior to every sampling activity. I asked him if I could look at the pH meter and buffer solutions he uses to calibrate the meter. He pulled out the 4.0 and 7.0 buffer solutions (**Photo 4**) and I observed their packaging. The 4.0 buffer solution expired on October 10, 2018. The 7.0 buffer solution expired on March 8, 2019. I pointed out this observation and Mr. Clover said he would order some new buffers.

At the time of the inspection, I examined the pH probe, as well as, the 4.0 and 7.0 calibration buffer solutions. The 4.0 buffer solution expired on October 10, 2018. The 7.0 buffer solution expired on March 8, 2019.

Photo 4 / P1000819 – pH Buffer Solutions

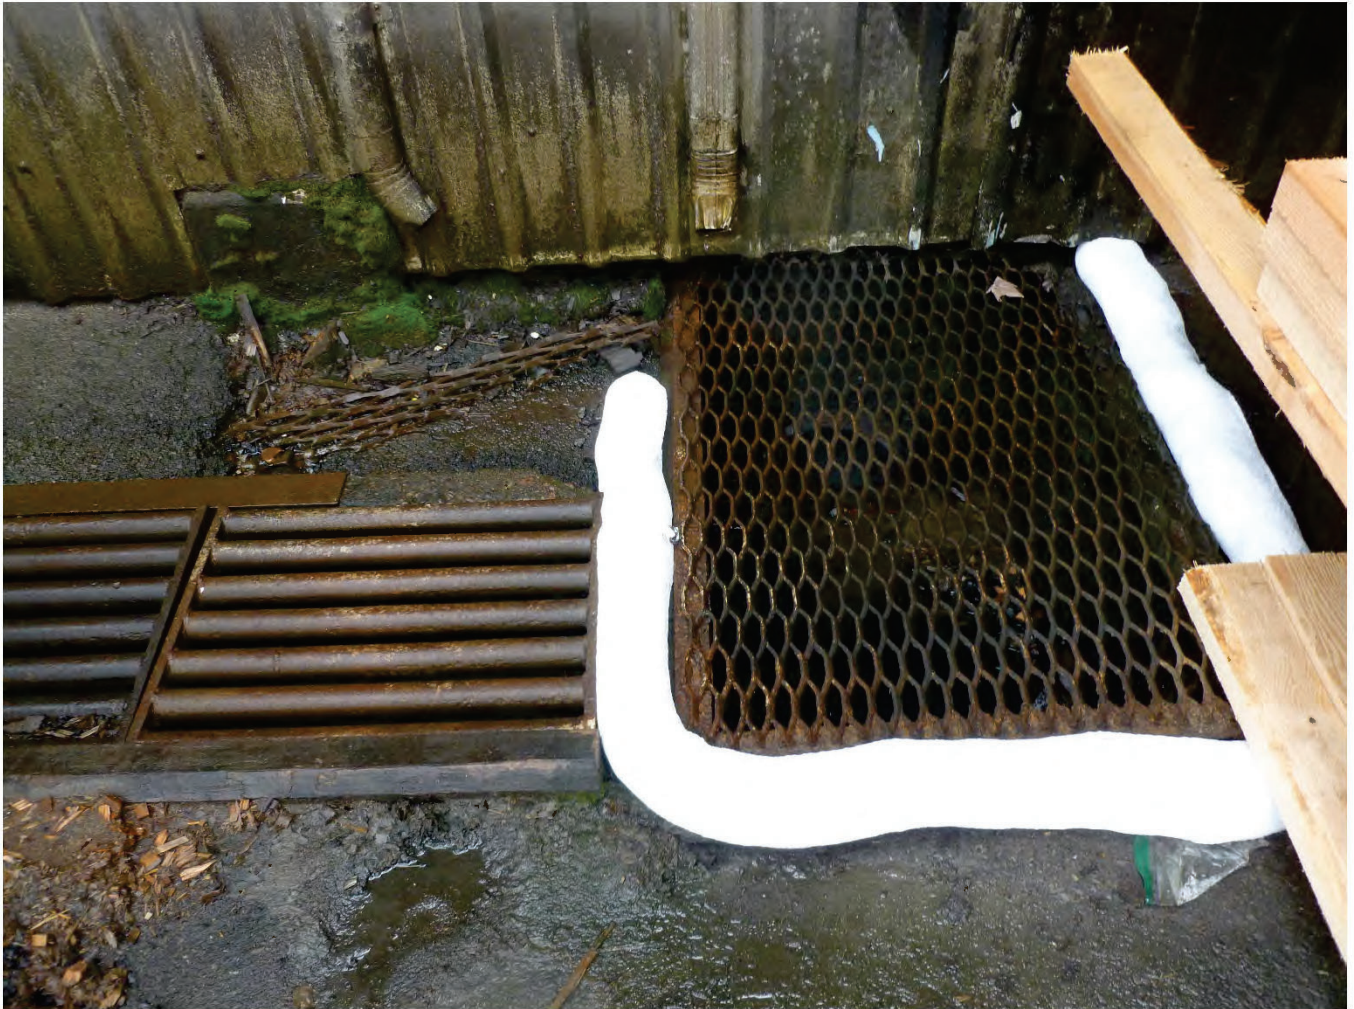
As we were leaving the maintenance shop, I observed a catch basin (**Photo 5**) near the building. The catch basin's grate was partially encircled by a filter sock. According to Mr. Jacobs, the filter sock is used to prevent sawdust and other particulate matter from entering the basin and the socks are changed out monthly. The facility maintains several catch basins throughout the site to collect and divert stormwater to the outfalls.

**Photo 5 / P1000820** – Catch Basin, with filter sock

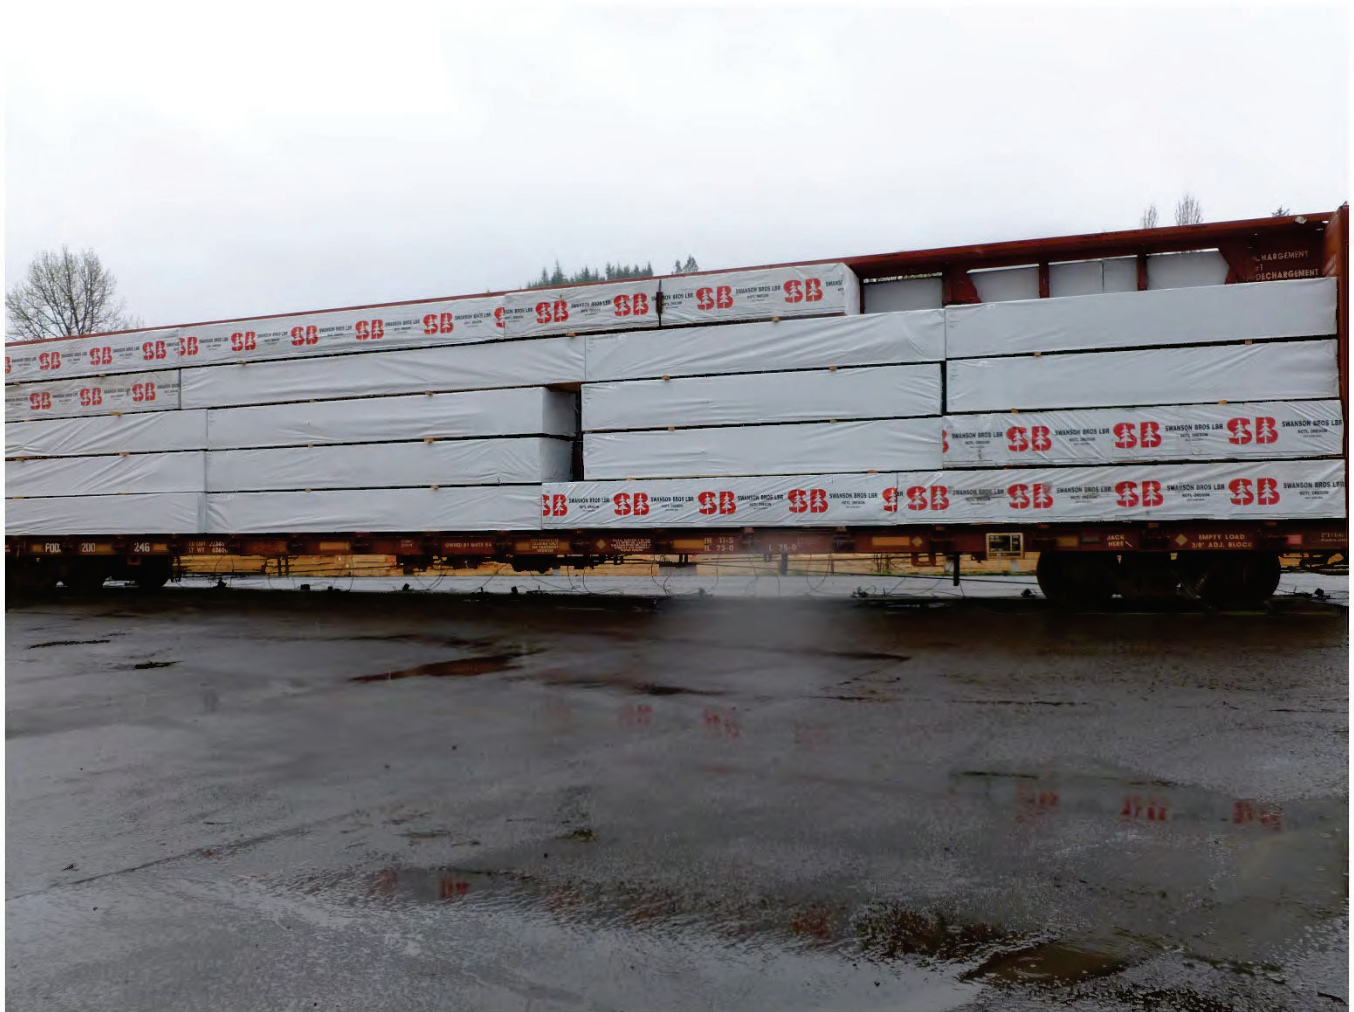
**Photo 6 / P1000821 – Packaged Product on Railcar**

Finished products are stored outside while awaiting ship out (**Photo 6**) or pick up (**Photo 7**).

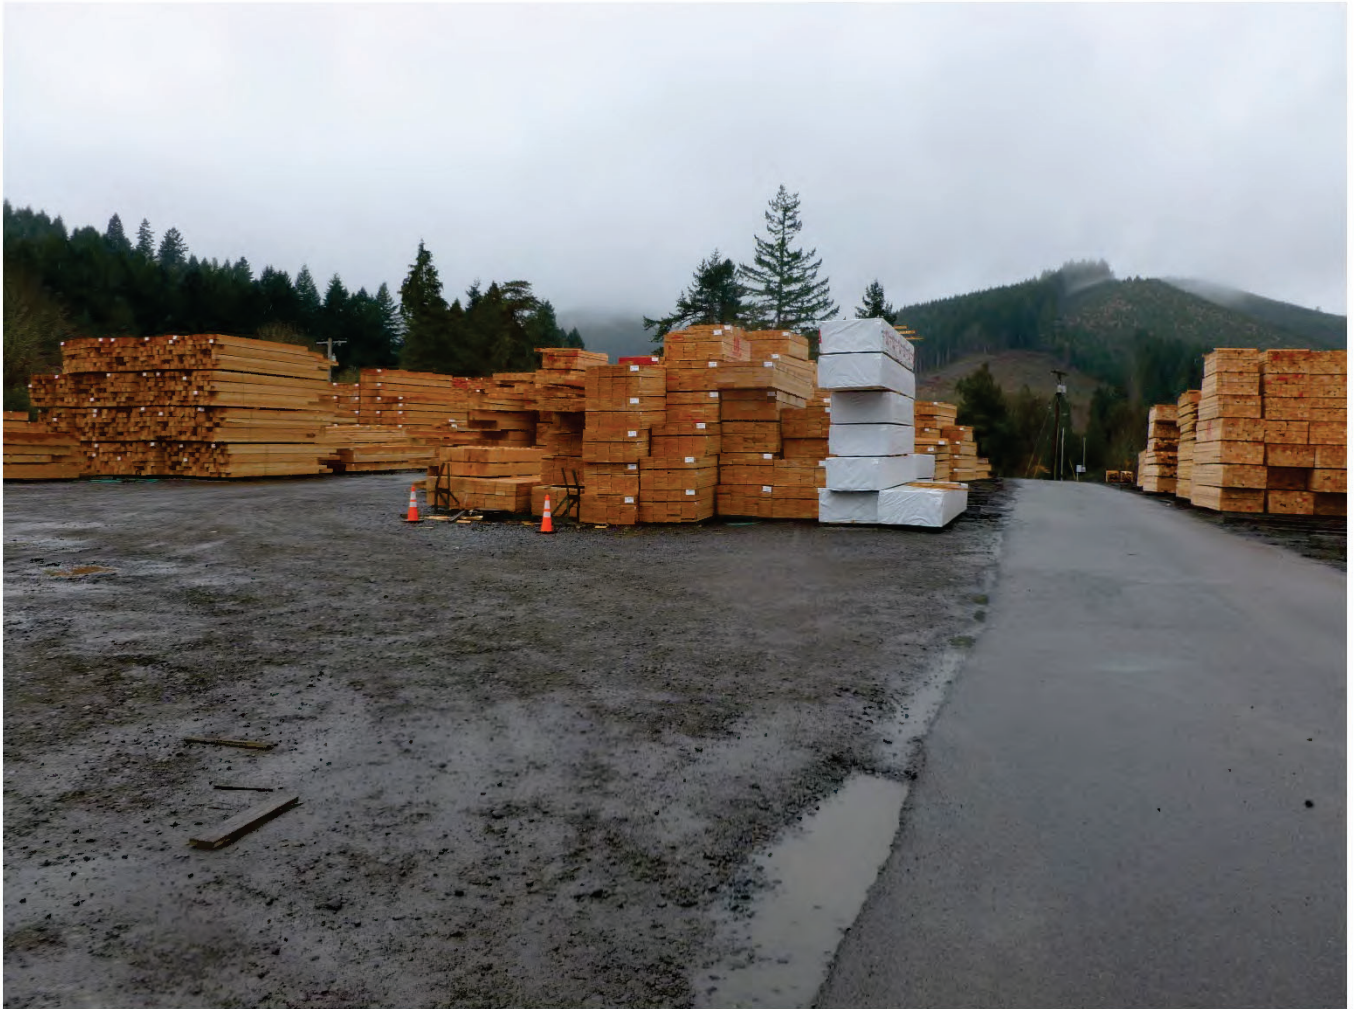
**Photo 7 / P1000823** – Product, awaiting pick up

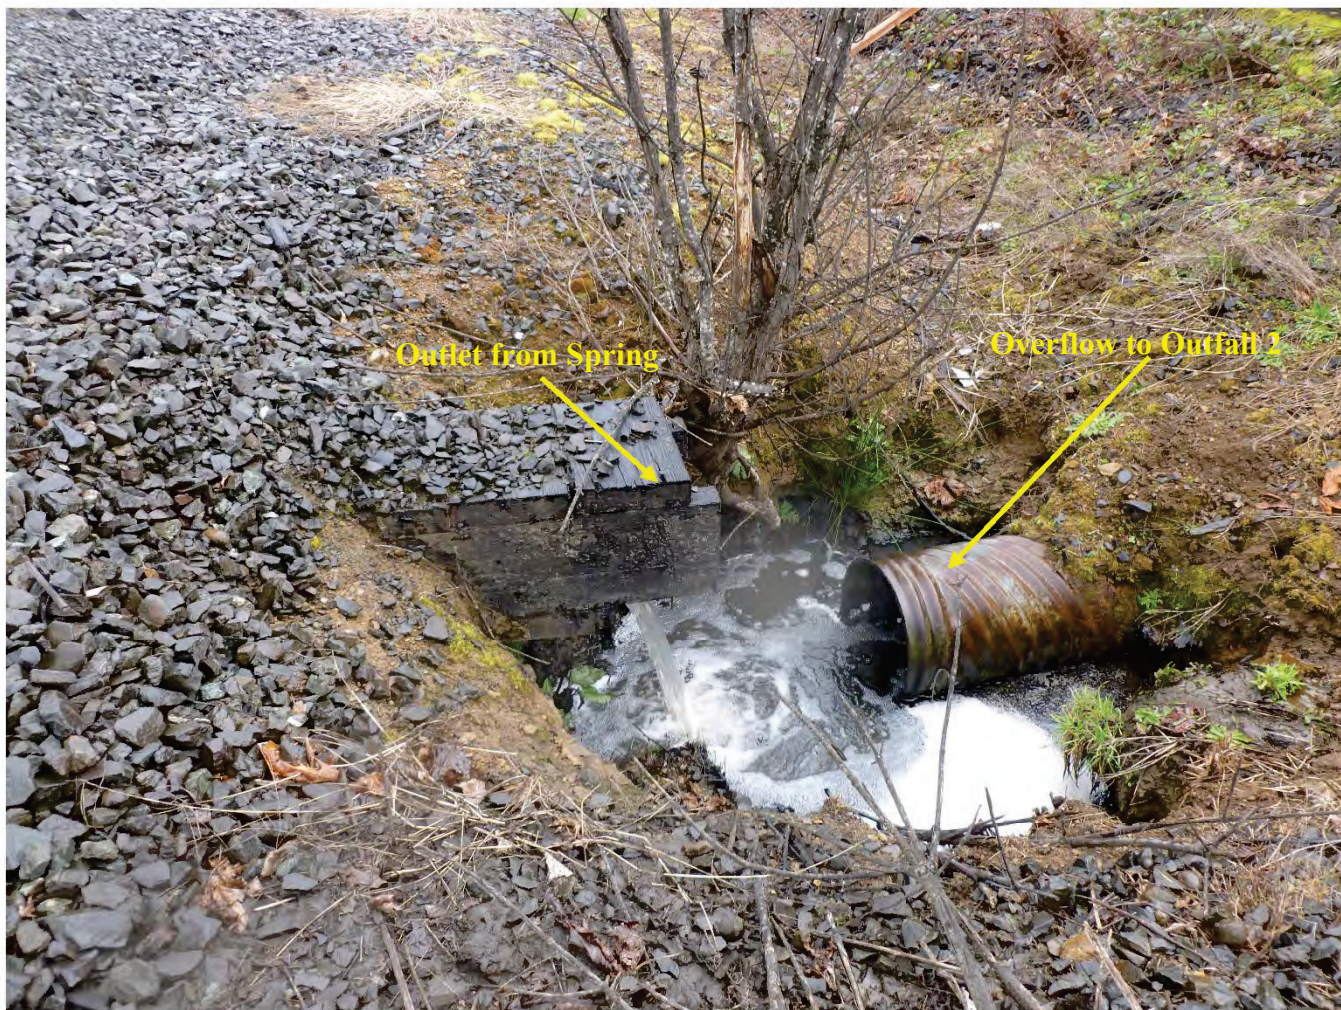
During the tour, Mr. Konnie told me that there was a natural spring to the north that flows across the property. The flow is channelized through culverts to pass under roadways. I asked to see where the spring outlet surfaces (**Photo 8**). The spring water flows into a depression. Once the depression is filled to a certain level, the water overflows into a pipe which leads to Outfall 002. From the spring outlet, we walked to Outfall 002 (**Photo 9**). A grab sample is collected as water overtops the sandbag. The water from Outfall 002 flows east to a grassy field. On the east side of the site, a pipe (**Photo 10**) directs flow into a ditch that leads to Outfall 001 (**Photo 11**). We continued walking to Outfall 003 (**Photo 12**). Outfall 003 was overgrown with blackberry vines and had minimal flow at the time of the inspection.

**Photo 8 / P1000822** – Outlet Flow from Spring

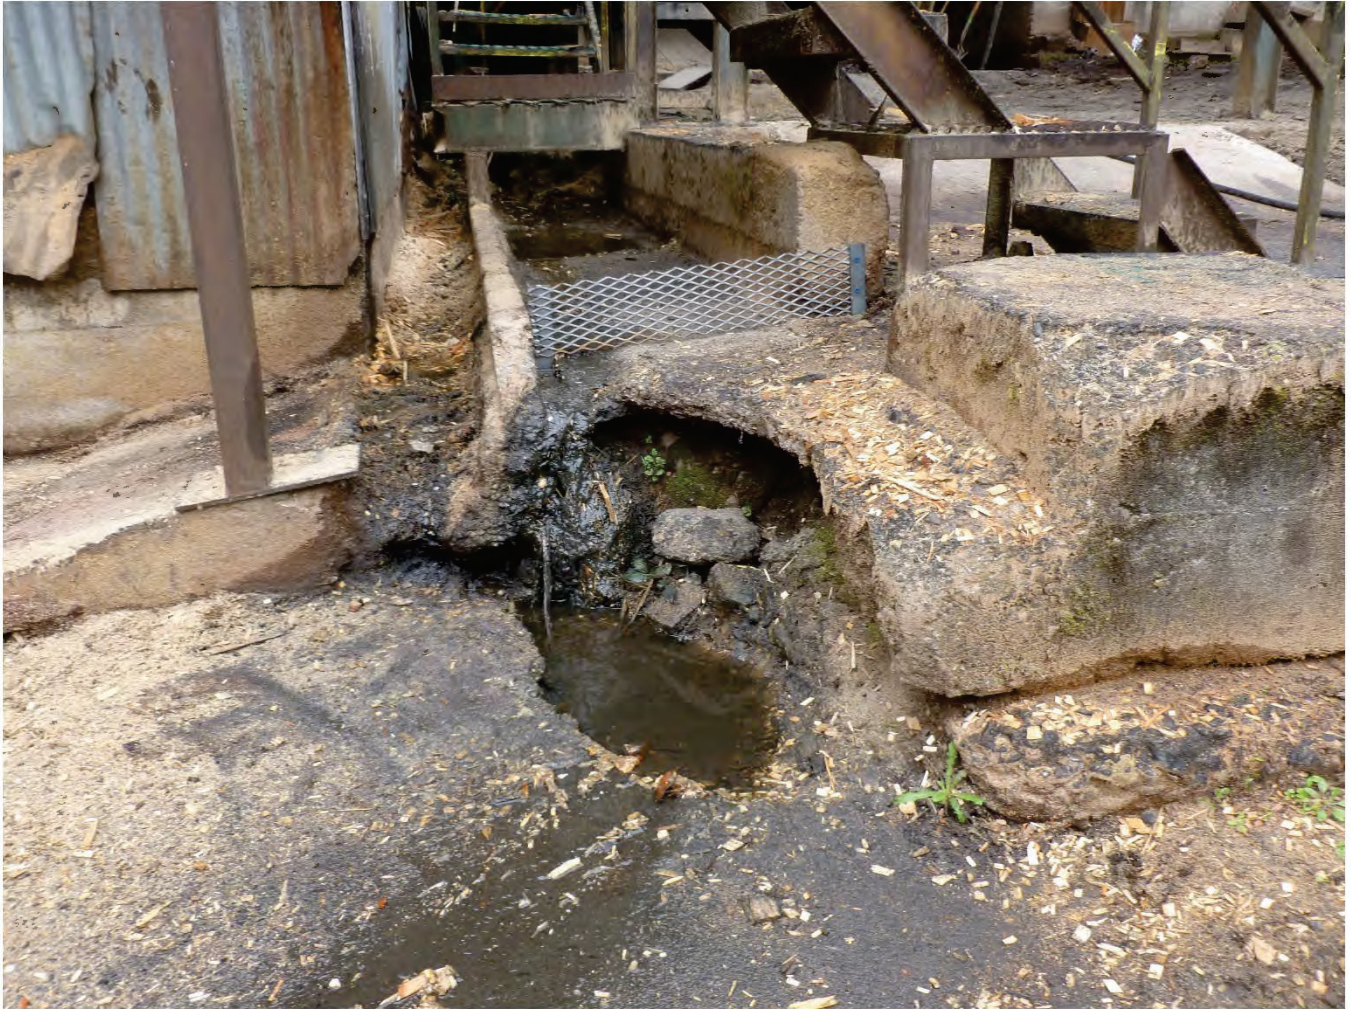
The final area I inspected was part of the changes implemented to address the zinc containing leachate flow from the rooftops. Water flows from the roof gutters (**Photo 13**) into a catch basin (**Photo 14**). The catch basin is filled with a biochar-based treatment media that removes the zinc. The stormwater then flows to the outfalls through underground piping.

**Photo 13 / P1000828** – Outflow from Roof

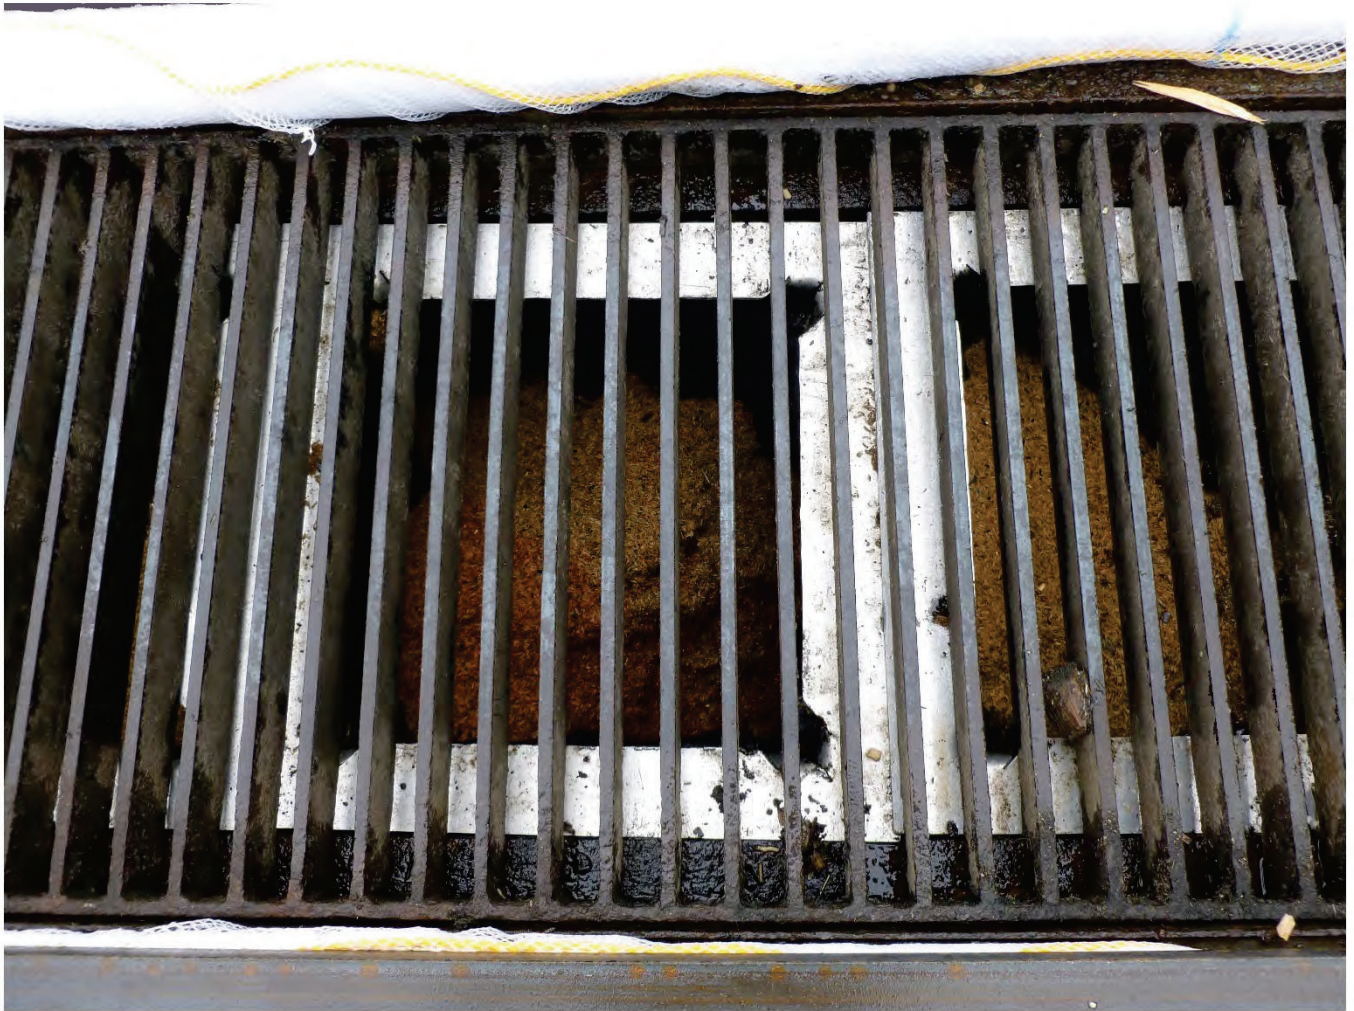
**Photo 14 / P1000830** – Catch Basin with Media, close-up
