# **REPORT OF COMPLIANCE EVALUATION INSPECTION**

AT  
City of Salina Public Water Supply  
300 West Ash Street  
Salina, Kansas 67402

October 7-9, 2025

BY  
U.S. ENVIRONMENTAL PROTECTION AGENCY  
Region 7  
Enforcement and Compliance Assurance Division (ECAD)

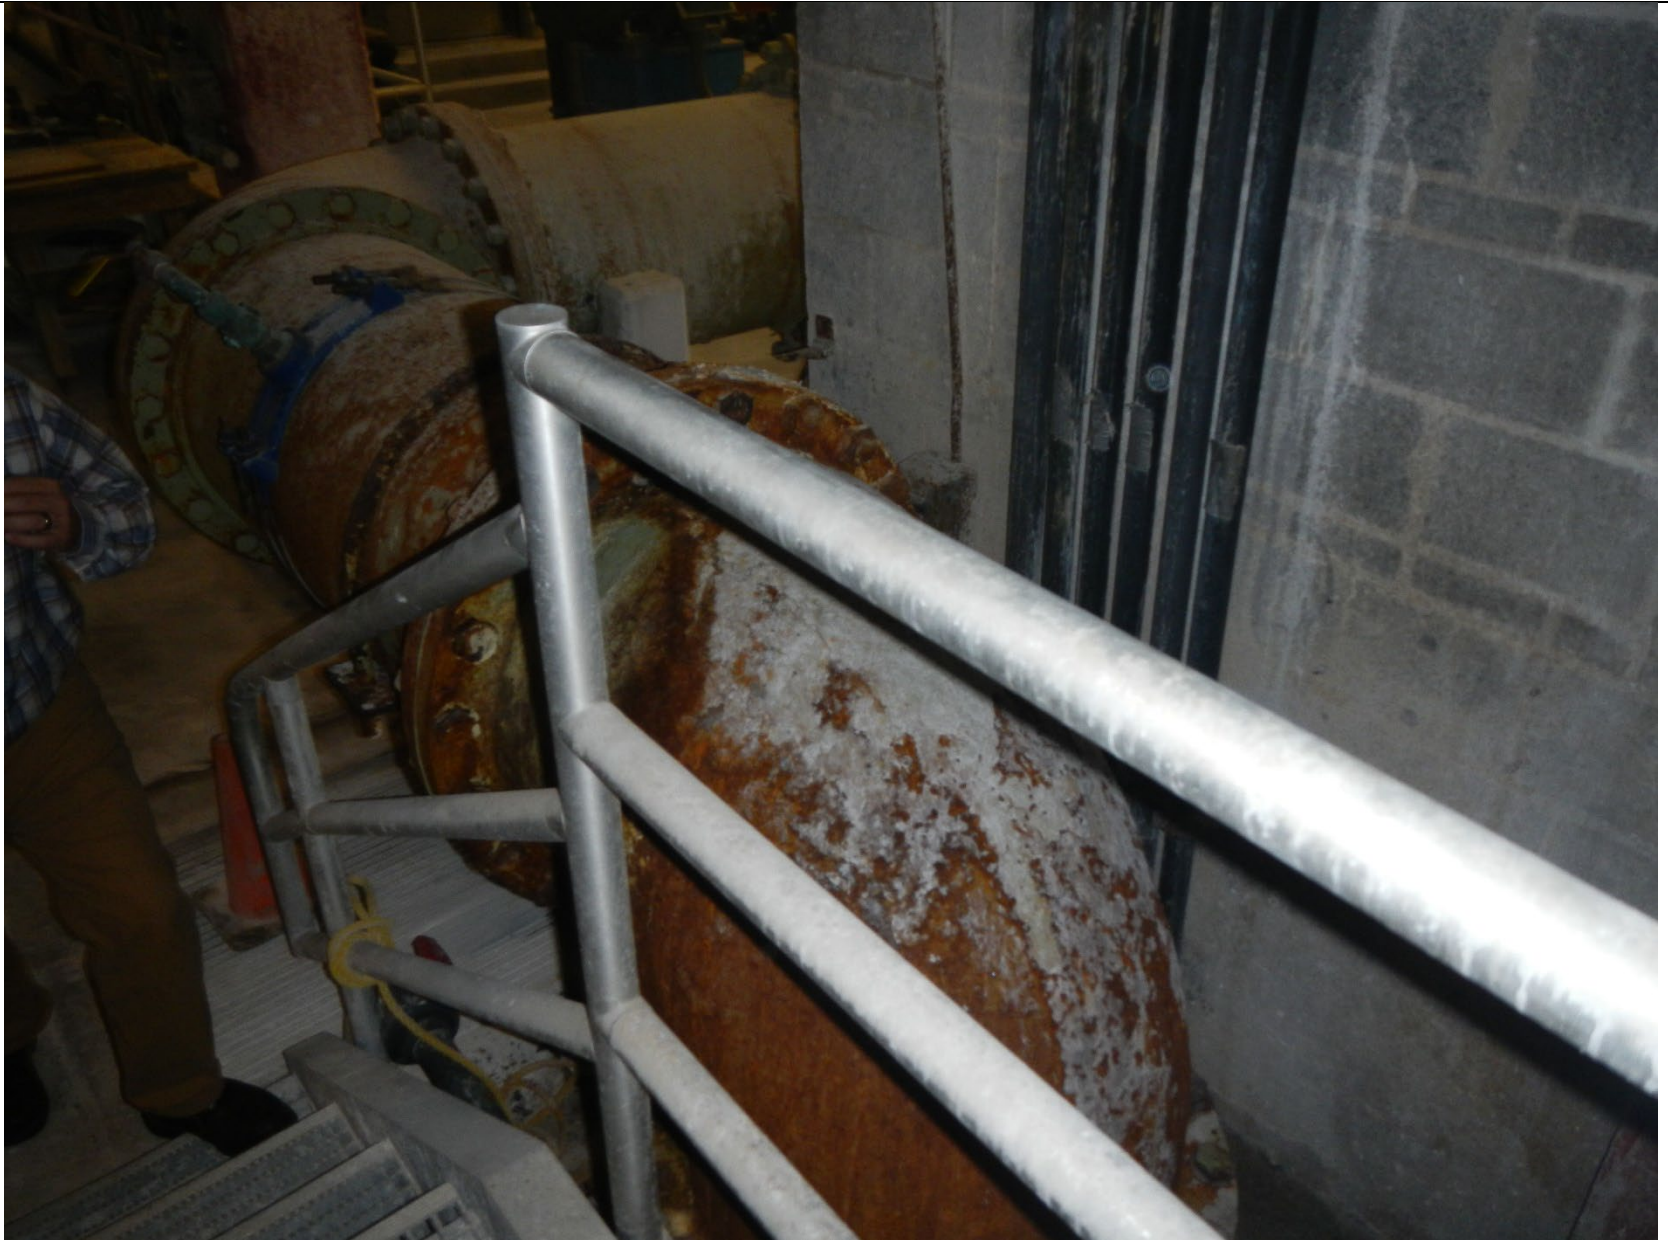
| Digital Image Number | File Name | Description | Date and Time Digital Image Taken |
|---|---|---|---|
| 10 | DSCN5117.JPG | Piping showing heavy corrosion and rusting | 2025:10:07 12:41:06 |

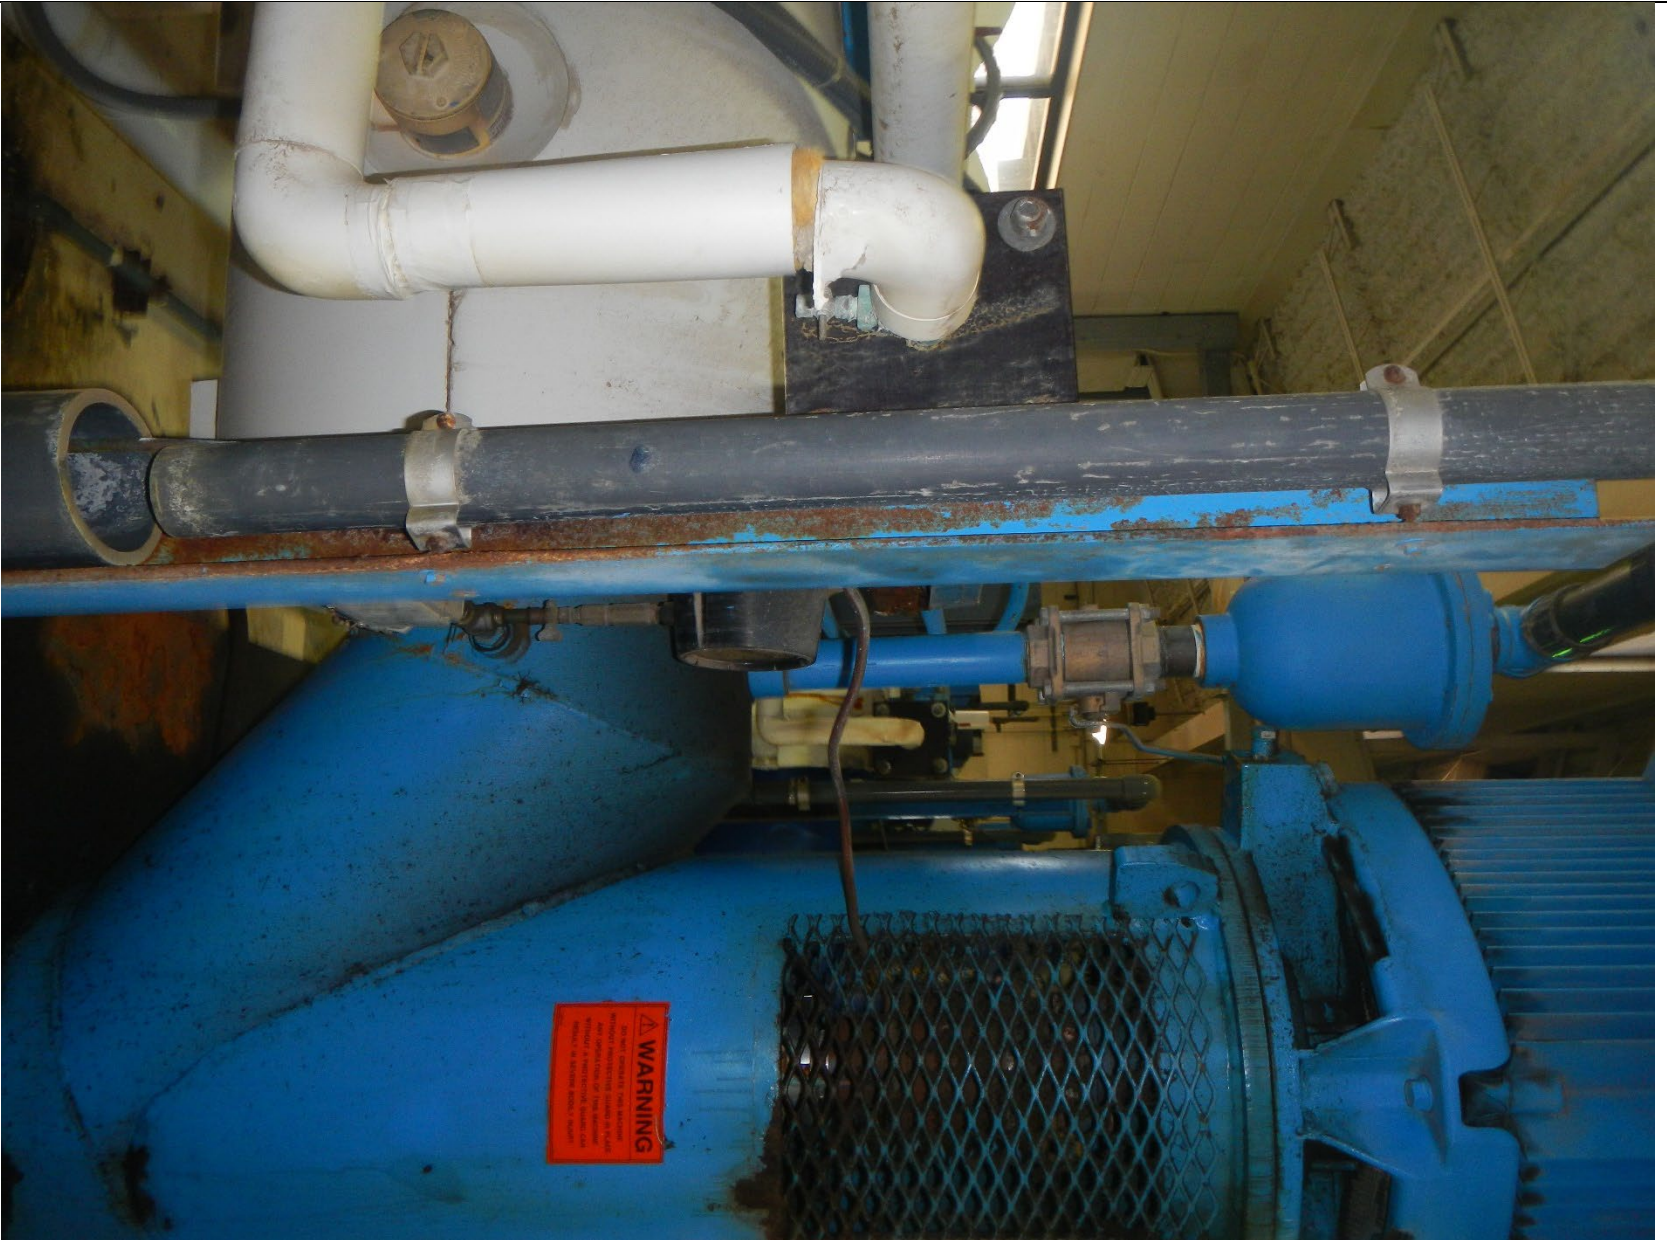
| Digital Image Number | File Name | Description | Date and Time Digital Image Taken |
|---|---|---|---|
| 13 | DSCN5120.JPG | Air relief valve (ARV) not screened on finished water pump | 2025:10:07 14:08:17 |

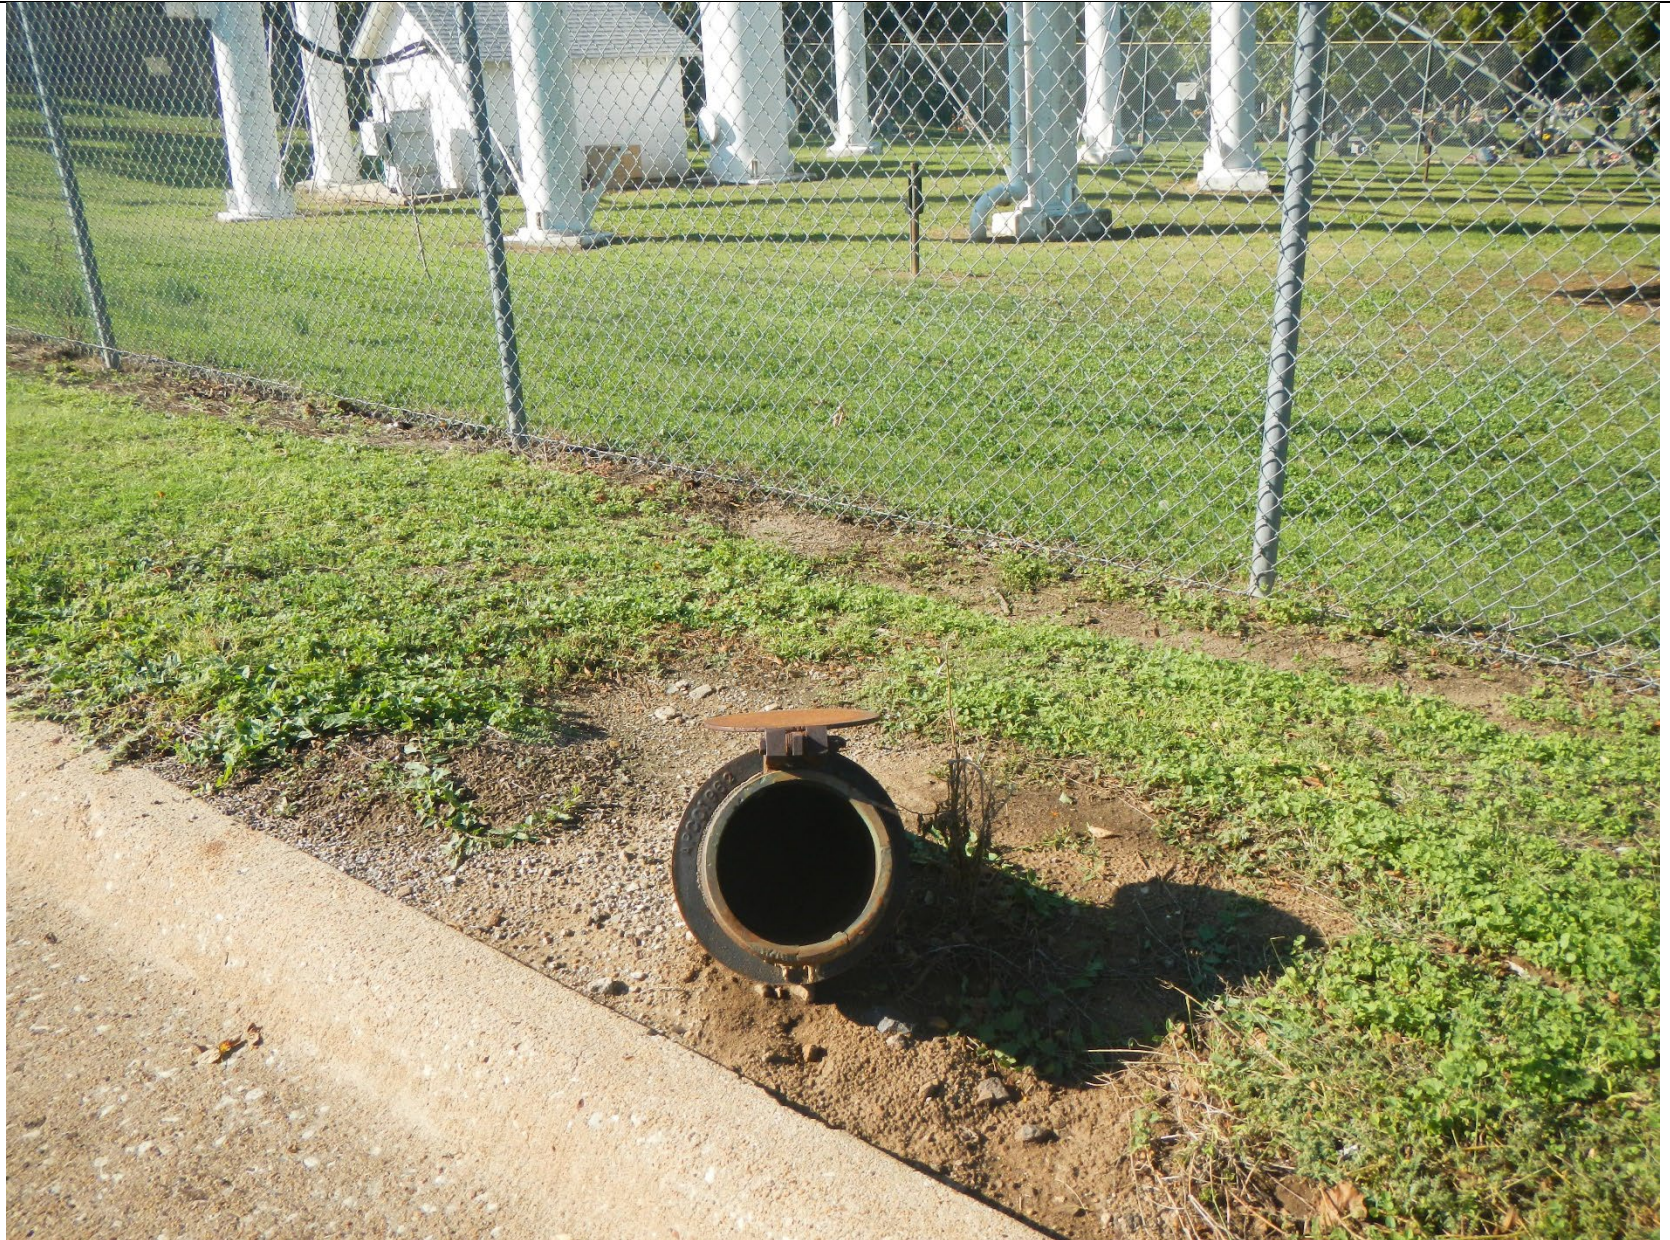
While inspecting the system’s finished water storage structures, I also observed that multiple overflow pipes were screened with mesh larger than 24-mesh (photo 39) or were missing a screen (photos 19, 21, 36, and 61). This was noted as preliminary finding #3 on the NOPF that was left on-site. In the system’s October 10, 2026, response, they noted that KDHE minimum design standards (MDS) required screens to have openings less than 0.25-inch (4-mesh) on overflow pipes. System personnel asked if Region 7 recommended the less than 0.25-inch screen or the 24-mesh screen. While the system would only be required to use the less than 0.25-inch screen in KDHE’s MDS, EPA highly recommends system’s use 24 mesh screen or smaller. Also, KDHE’s MDS requires that if the overflow pipe has a flap gate, it must be self-closing and have an integral screen.

| Digital Image Number | File Name | Description | Date and Time Digital Image Taken |
|---|---|---|---|
| 19 | DSCN5126.JPG | Gypsum tower overflow discharge at street curb. Overflow had a flapper gate, but did not have an integral screen. | 2025:10:07 15:16:06 |

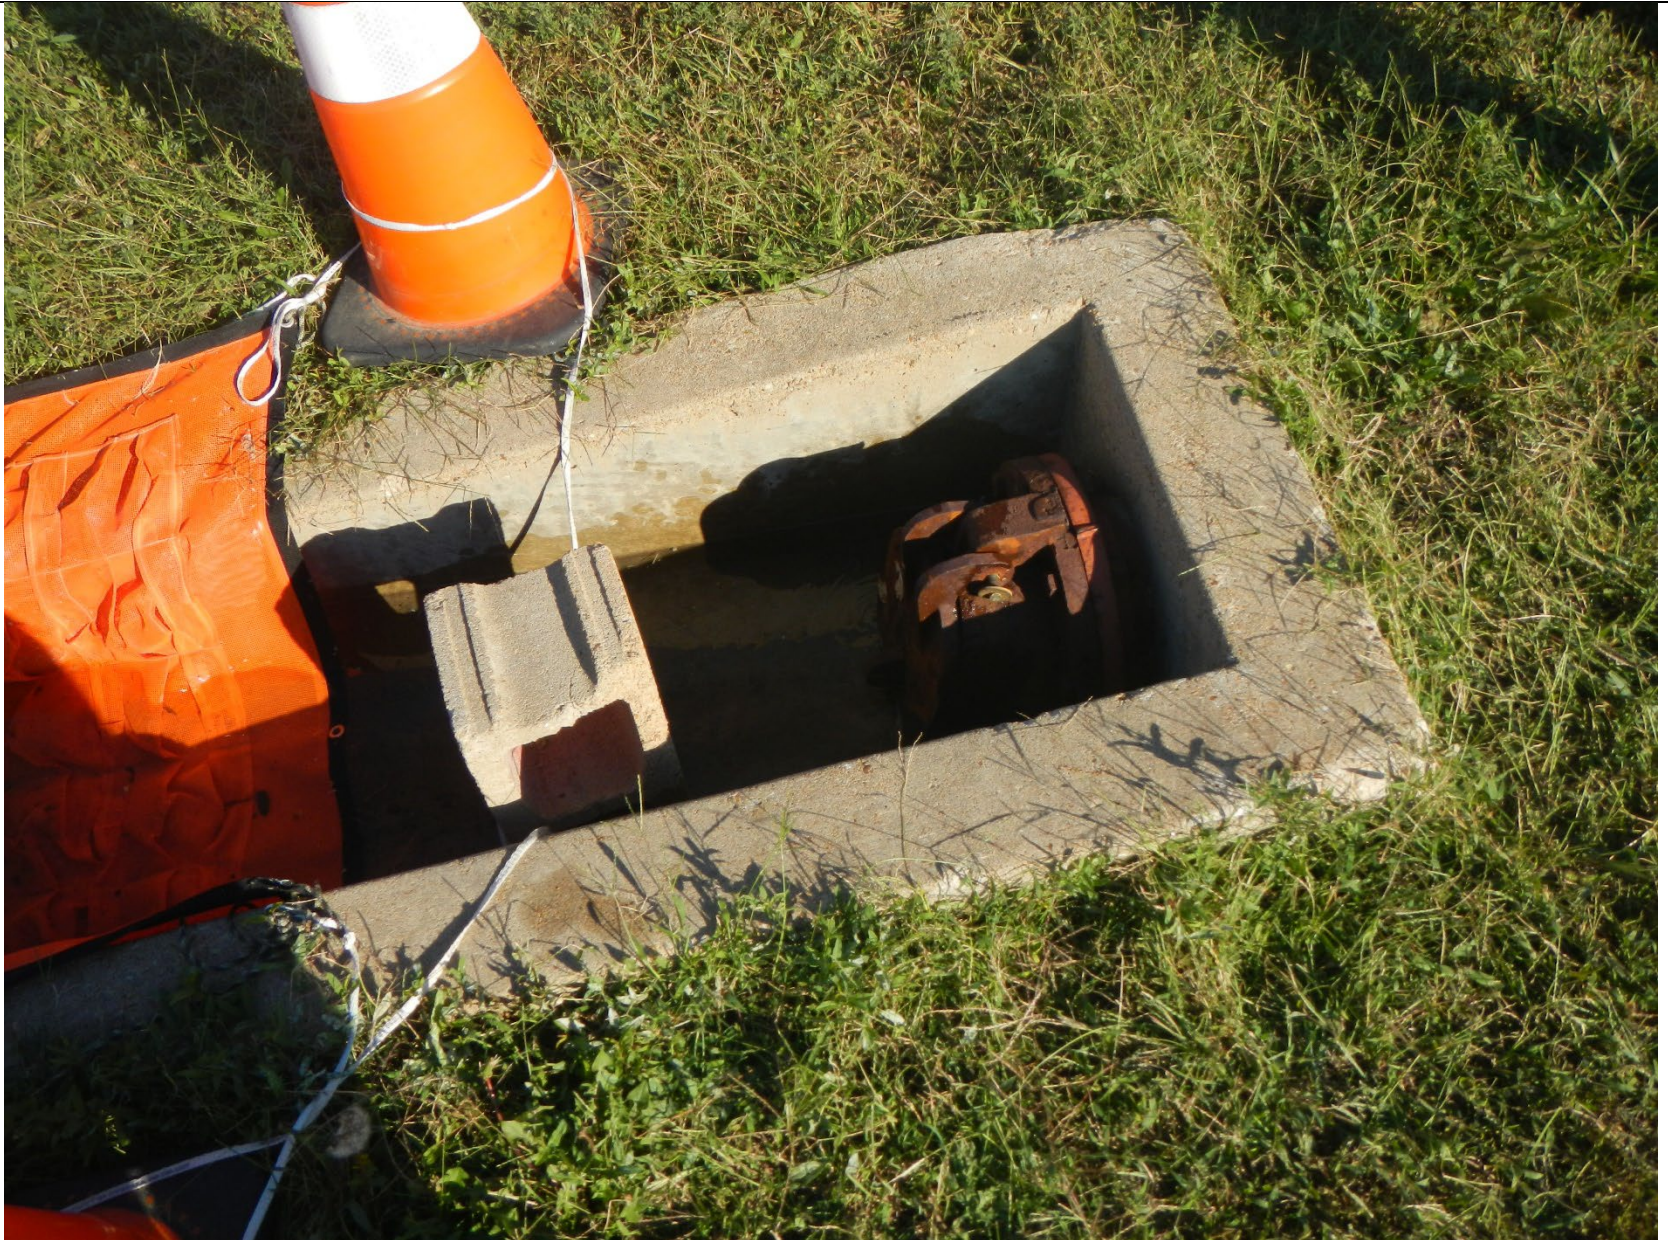
| 21 | DSCN5128.JPG | Markley Tower overflow. Had a flapper gate without an integral screen. | 2025:10:07 15:34:16 |

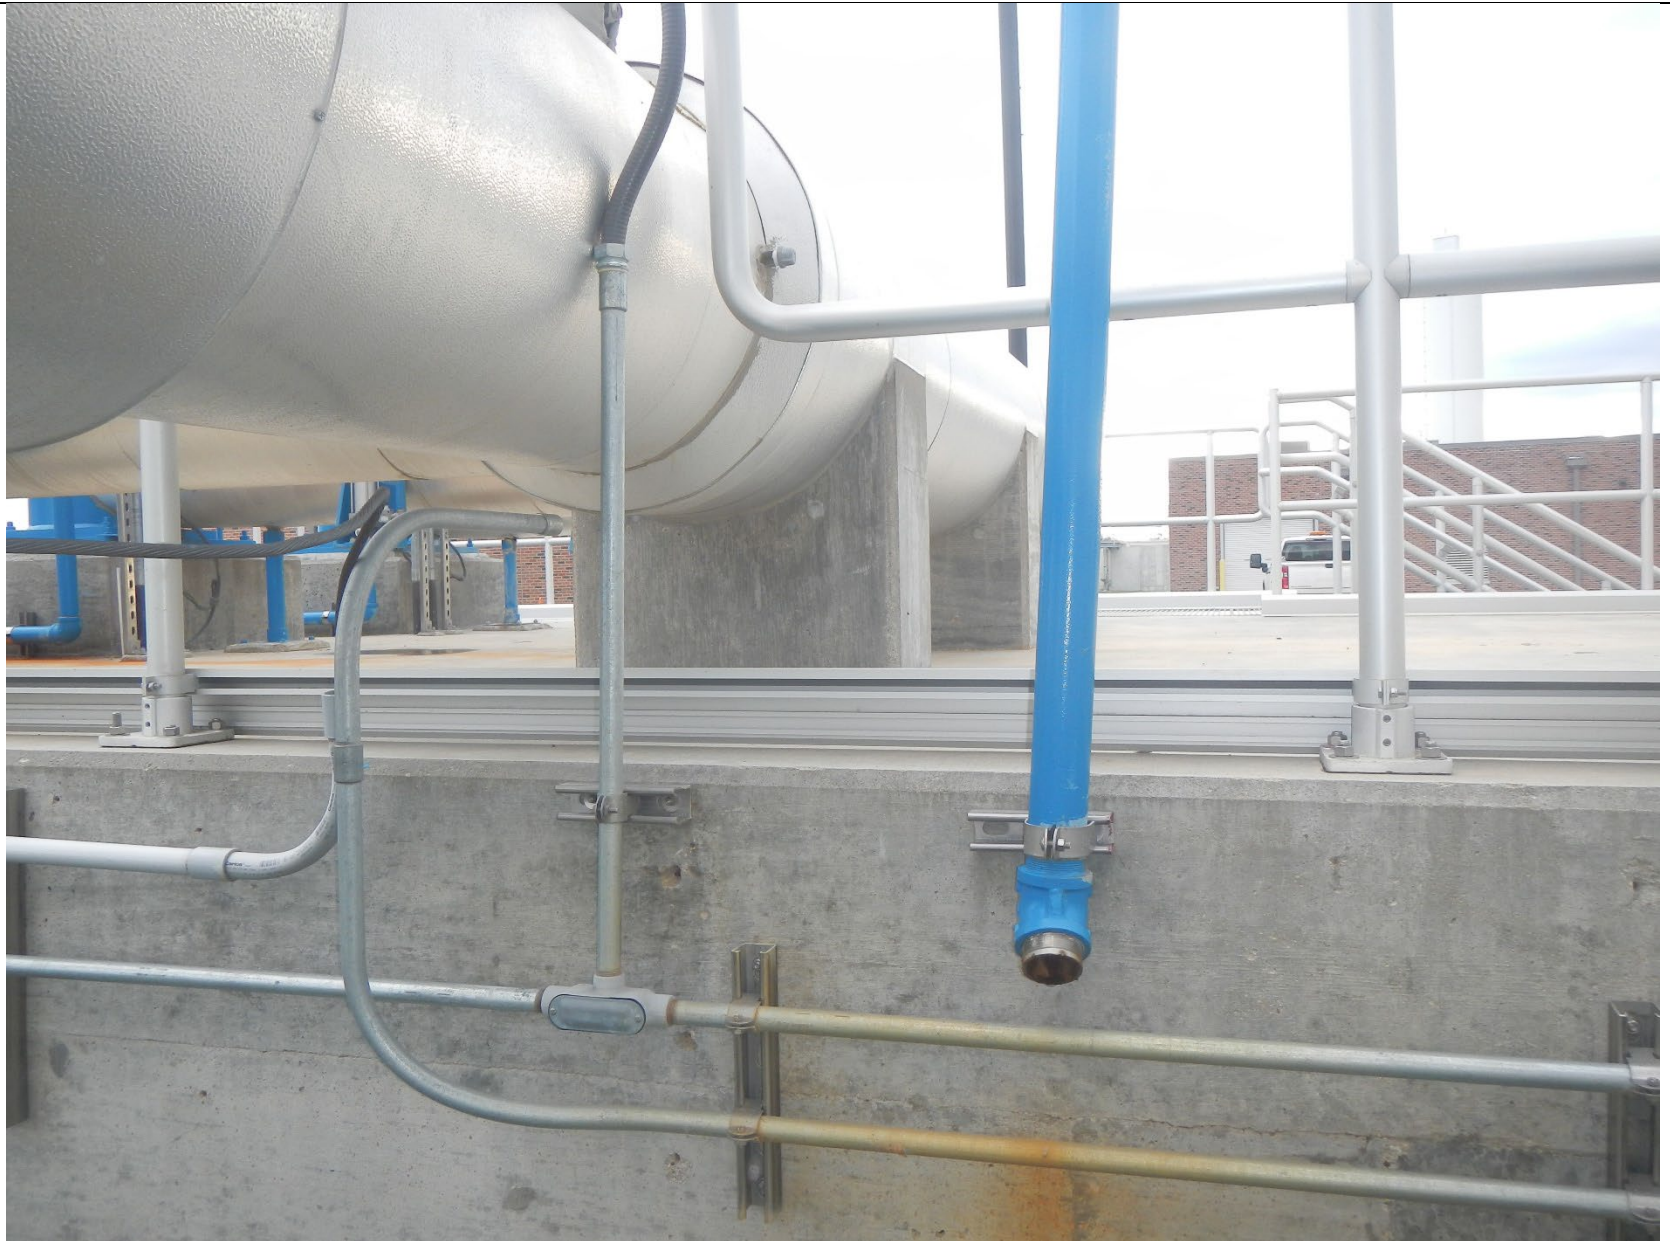
At the time of inspection, I observed ARVs on finished water pumps throughout both plants that had discharge pipes that were not properly screened (photo 26). This was noted as part of preliminary finding #4 on the NOPF that was left on-site.

| 26 | DSCN5133.JPG | Unscreened ARV overflow pipe. | 2025:10:08 08:09:44 |

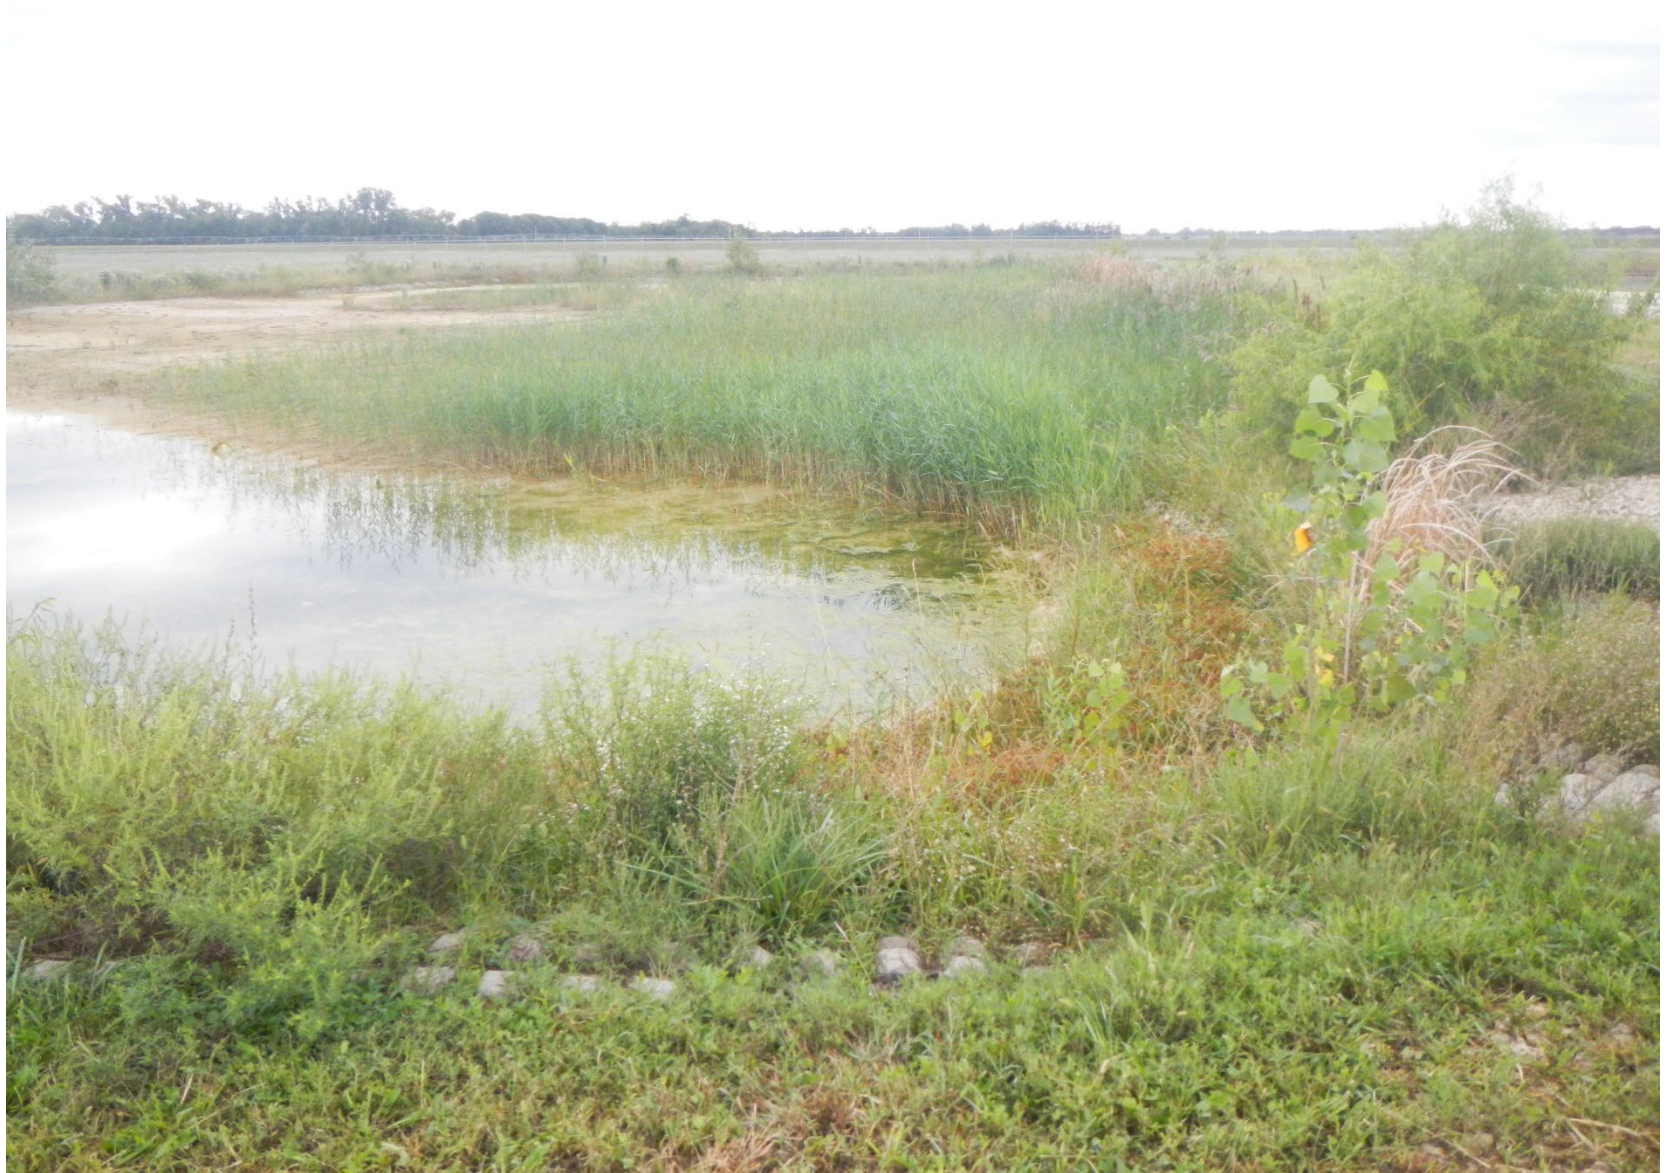
At the South Plant, I observed the backwash basins had a large amount of woody vegetation growing in the berms and around the inlet structure (photos 30-31). I explained to system personnel that this vegetation needs to be removed to ensure the integrity of the basin berms are maintained and to keep the intake structure from being damaged. This was noted as item #6 on the NOPF that was left on-site.

| 30 | DSCN5137.JPG | South plant sludge holding basin with woody vegetation in the berms. | 2025:10:08 08:42:07 |

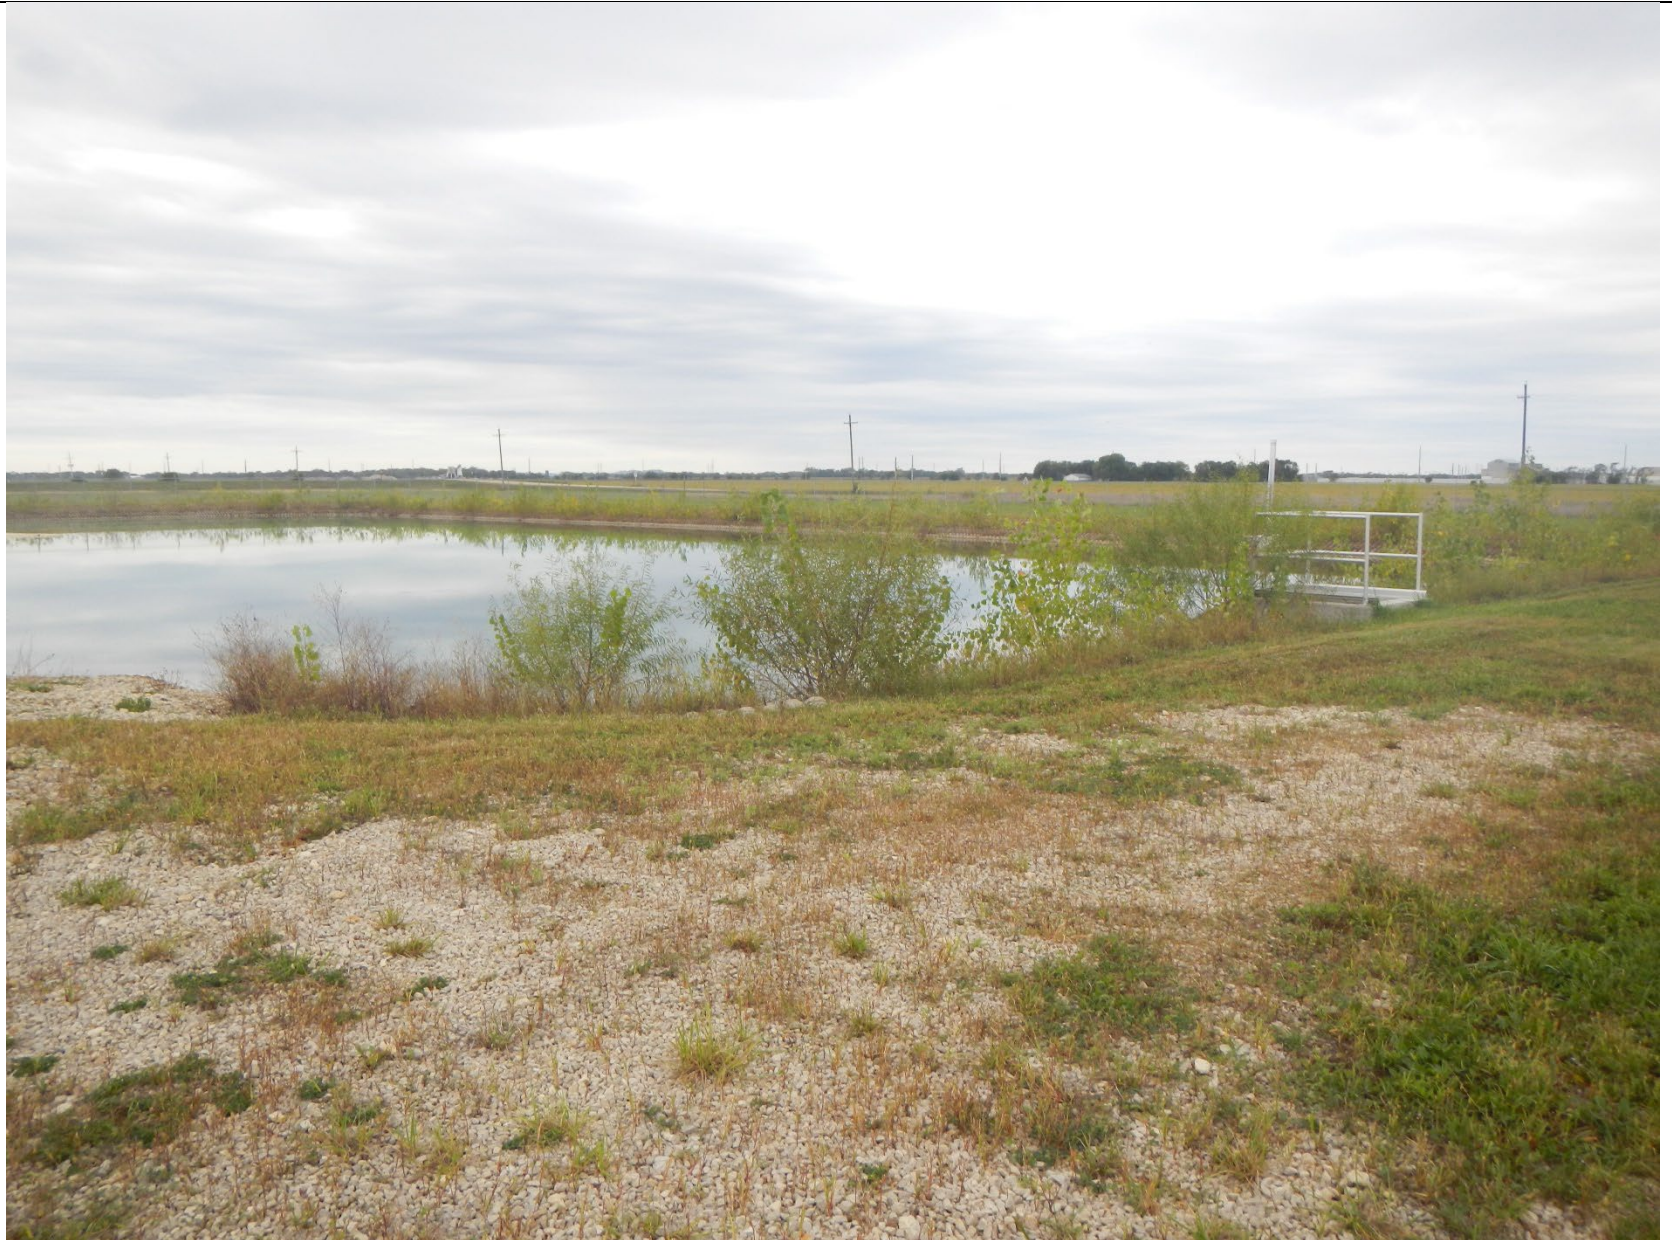
| 31 | DSCN5138.JPG | South plant sludge holding basin with woody vegetation in the berms and next to the intake structure. | 2025:10:08 08:42:40 |

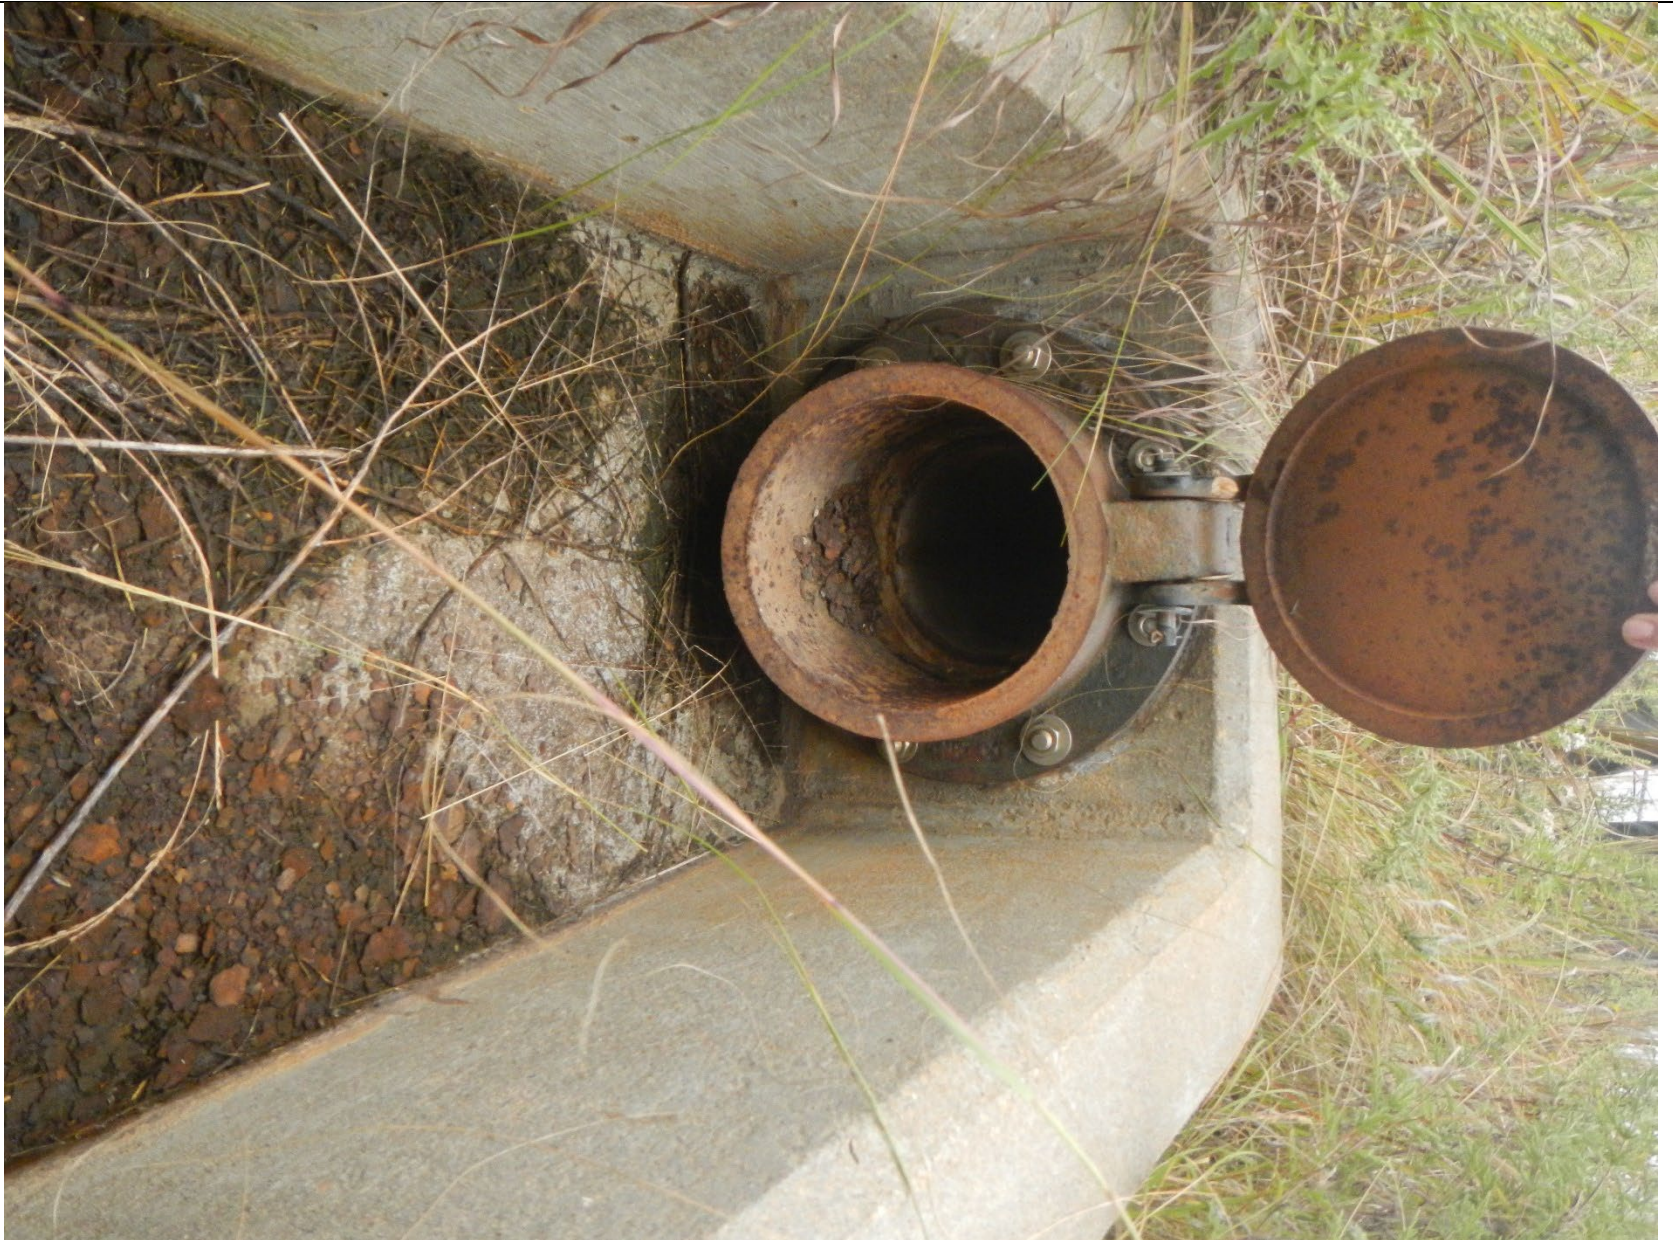
| 36 | DSCN5143.JPG | Burma Tank overflow pipe with flapper and no integral screen. | 2025:10:08 10:10:34 |

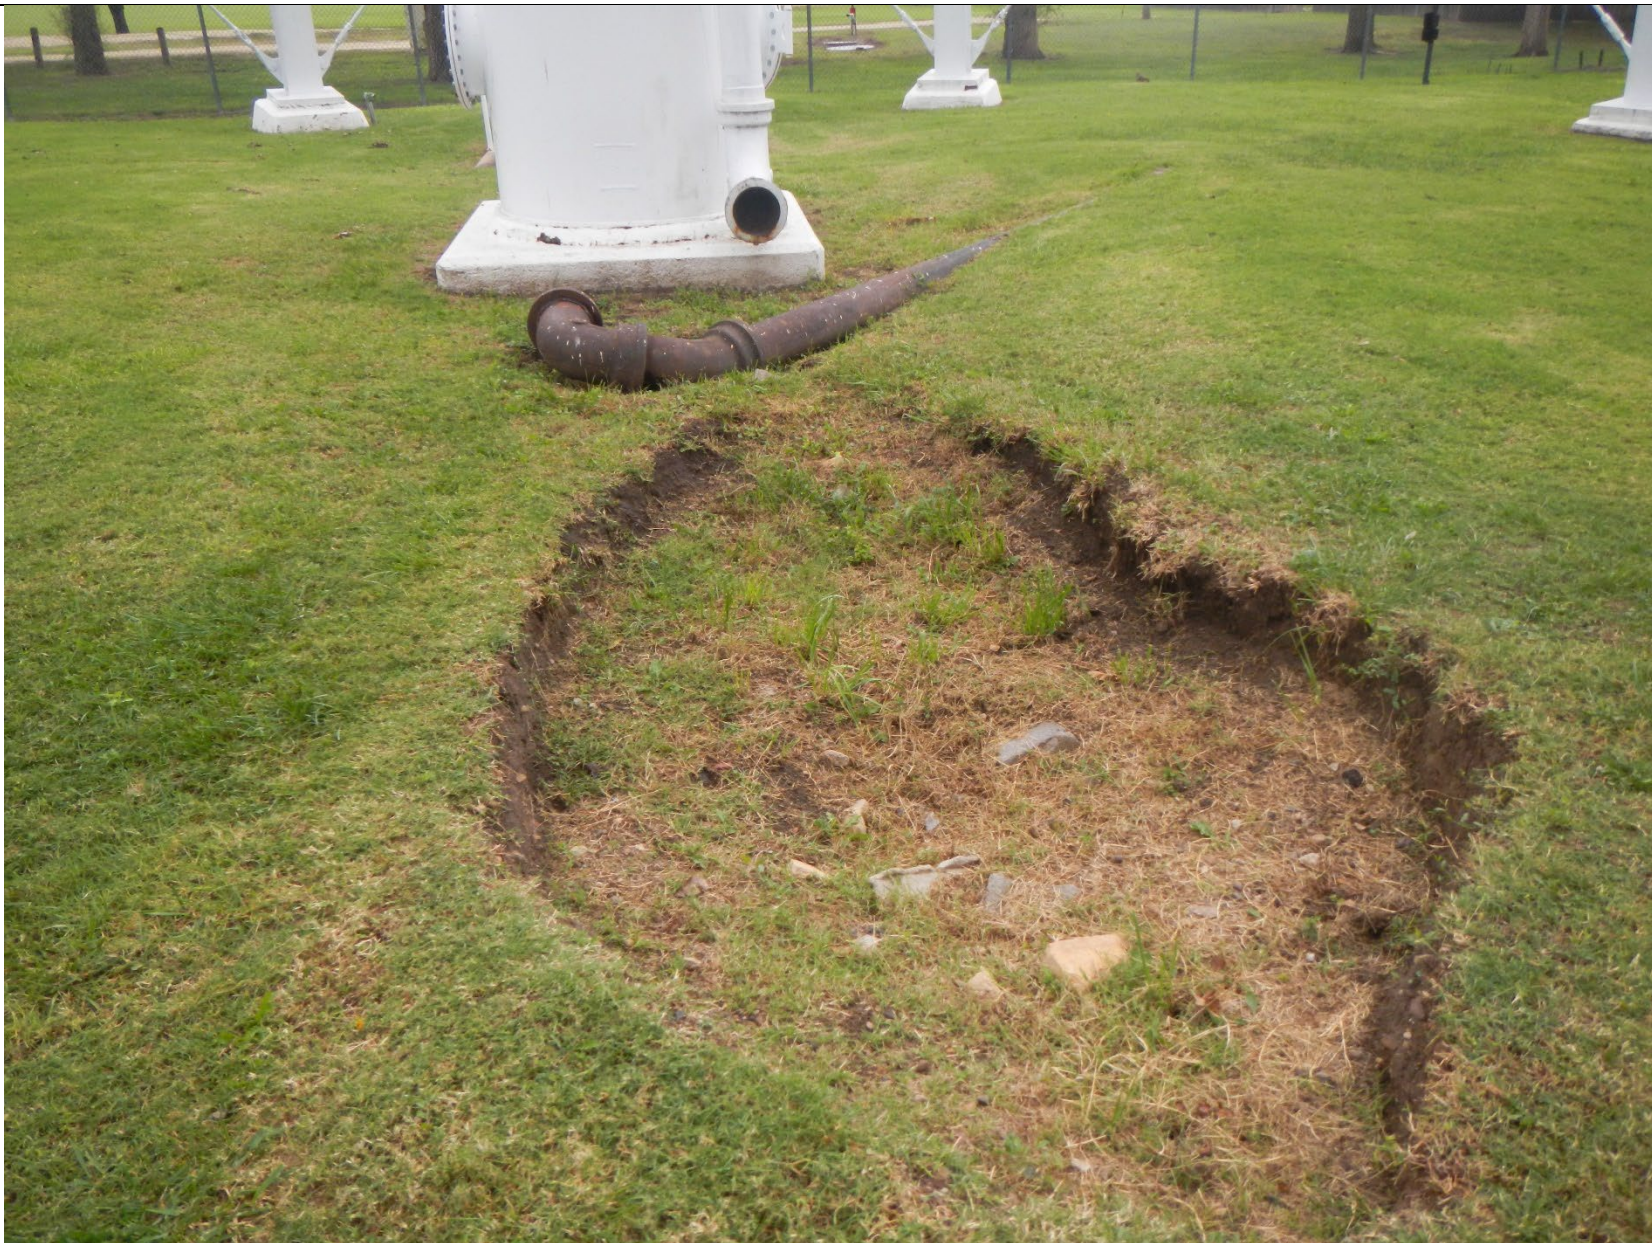
| 38 | DSCN5145.JPG | Sunset Tower overflow pipe erosion and settling soil/sod. | 2025:10:08 10:51:16 |

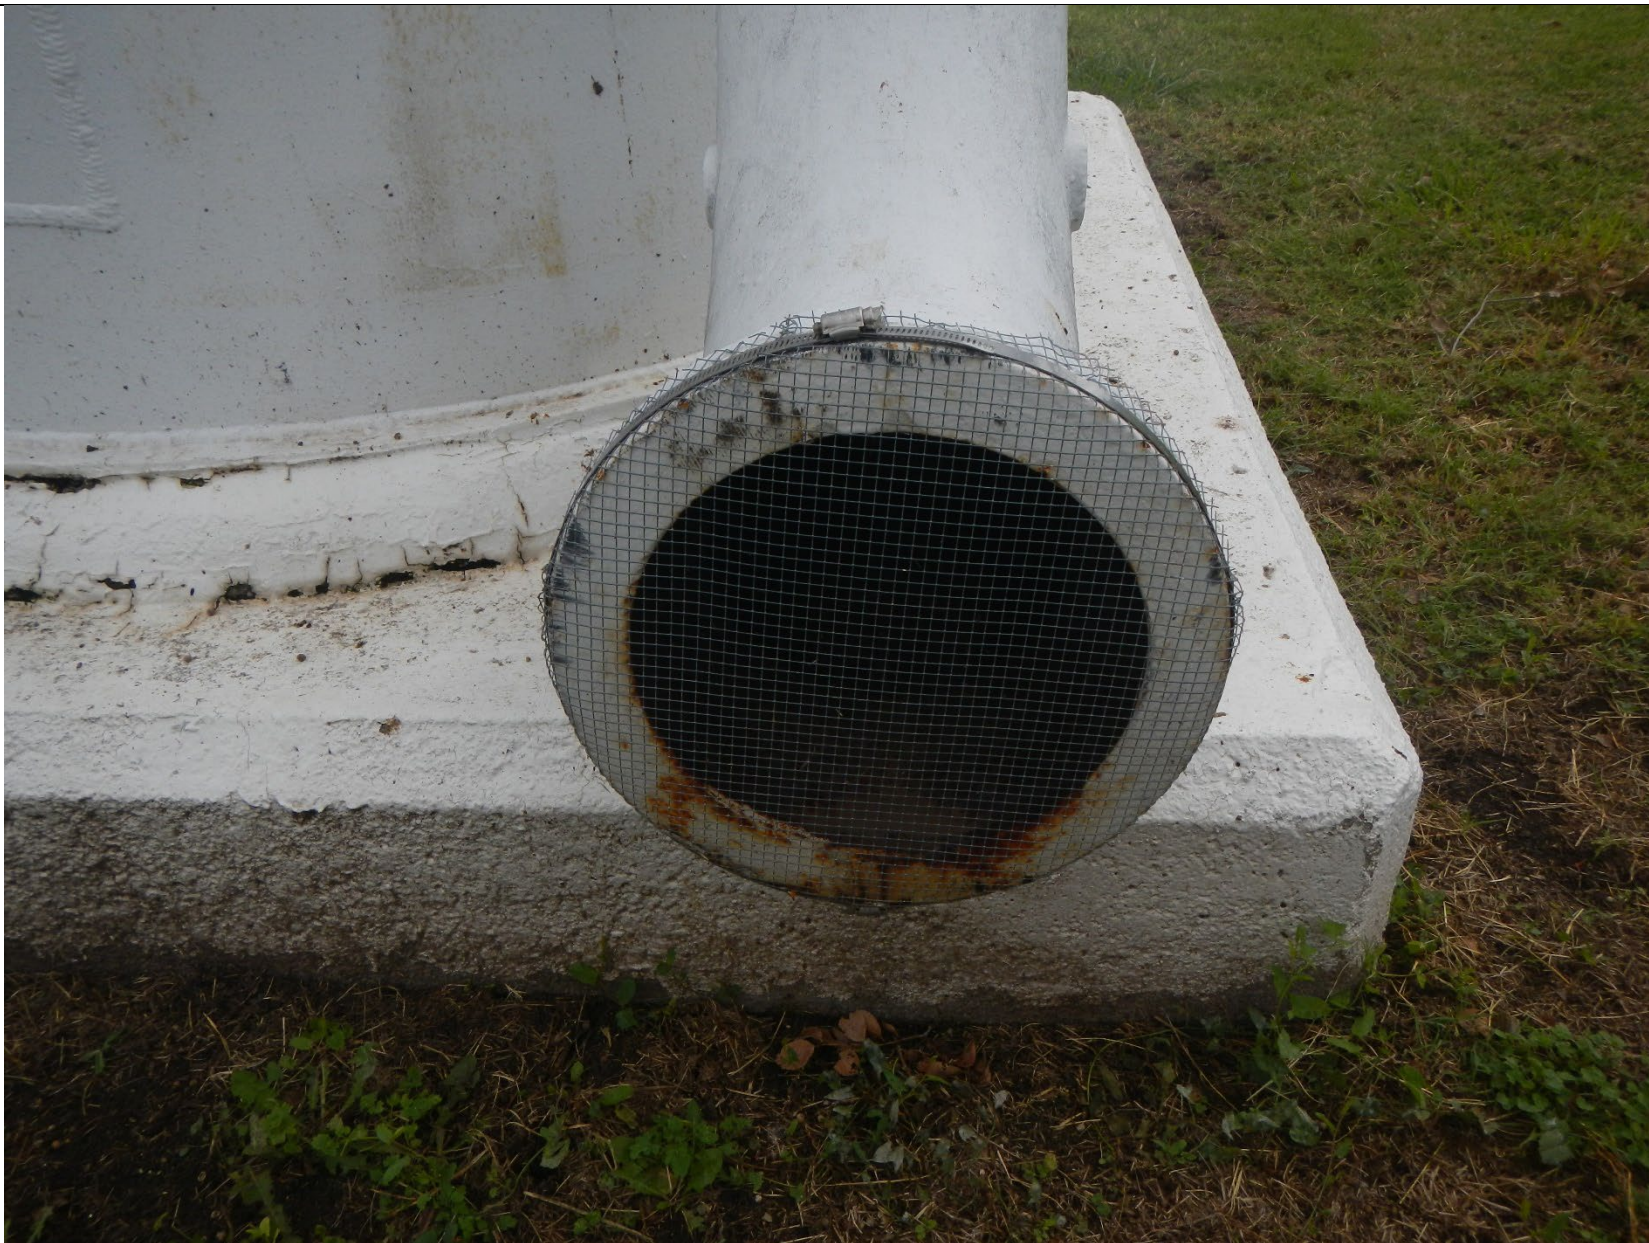
| 39 | DSCN5146.JPG | Sunset Tower overflow pipe screen larger than 24-mesh. | 2025:10:08 10:51:31 |
